**DOT/FAA/TC-26/15**

# **National Airport Pavement Test Facility Construction Cycle 9**

## **Volume 3—Geosynthetic Test**

Final Report

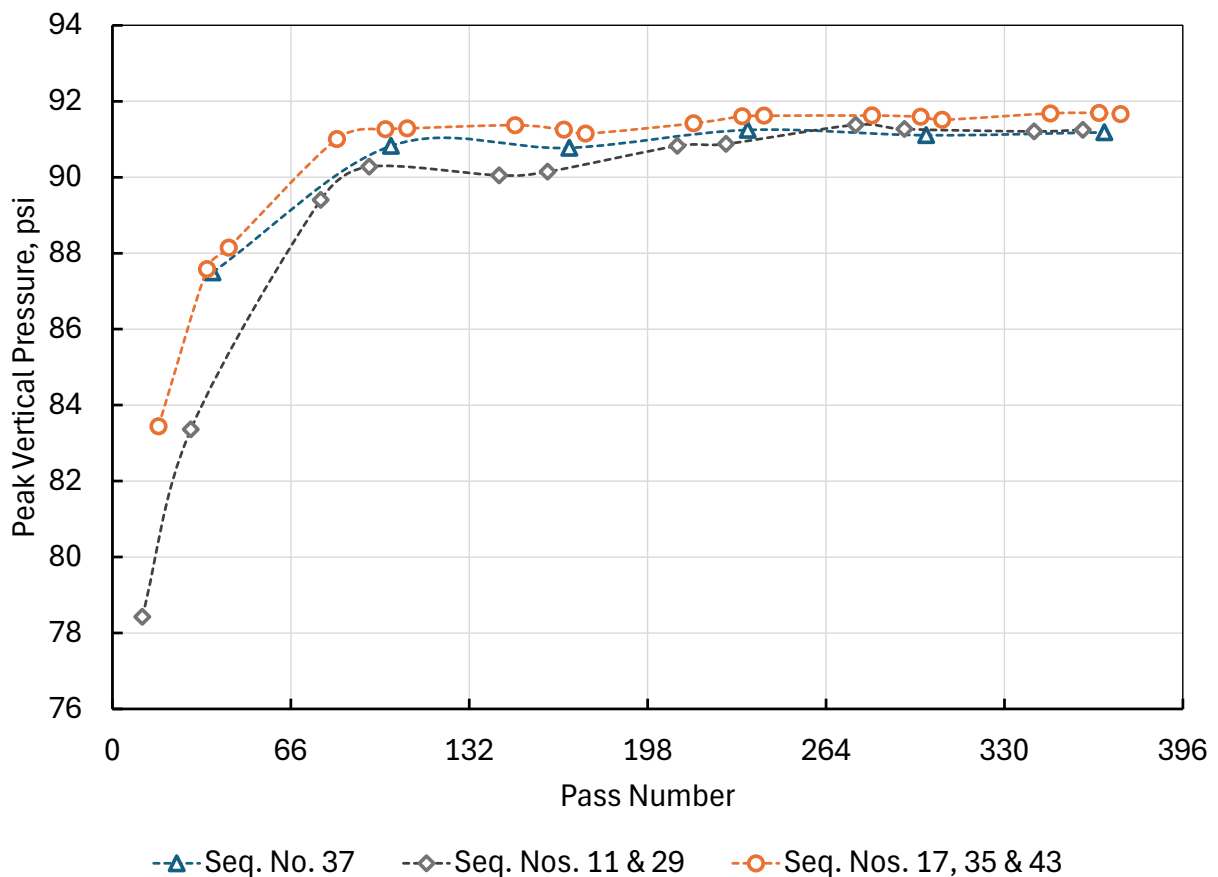
Figure 46 shows peak responses for PC-LFC-3S-1 for the first six repetitions of the wander pattern. As discussed in the following section, responses on the critical tracks (tracks +3 and -3) tended to fall into three groups, determined by the track number of the preceding pass in the wander pattern. Peak stress increased significantly during the first wander pattern execution (passes 1–66) then stabilized above 90 psi. A rapid early stress increase may show densification of the granular material under the heavy gear loads. Above 90 psi, some of the peak signals are cut off, so PC responses above this limit could not be used for analysis.

Figure 46. Peak Response for PC-LFC-3S-1 (top of P-209MR base) for Critical Tracks +3 and -3

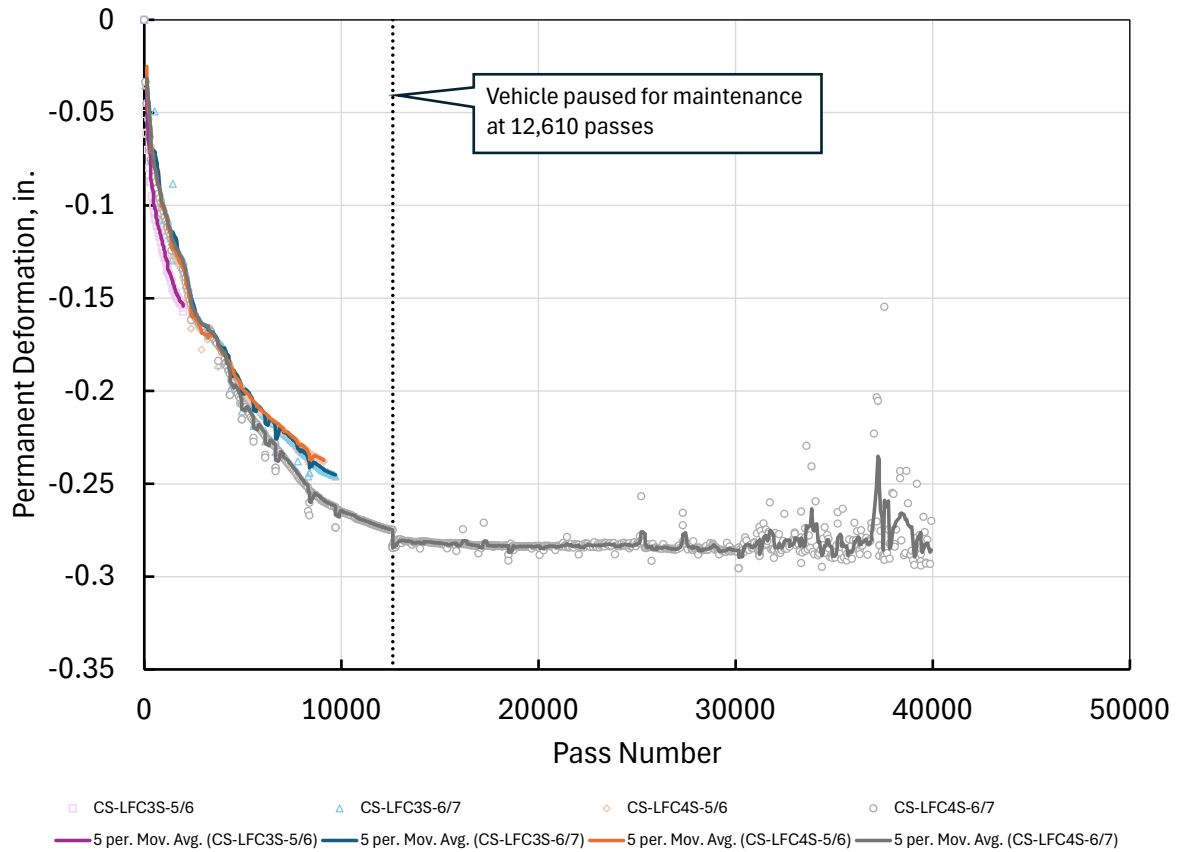
about 5,000 passes, after which LFC-4S-6.7 diverged slightly. Eventually, all CS in the base course either failed or reached a plateau limit.

Figure 48. Permanent Deformation in CS Pairs in Crushed Aggregate Base Course

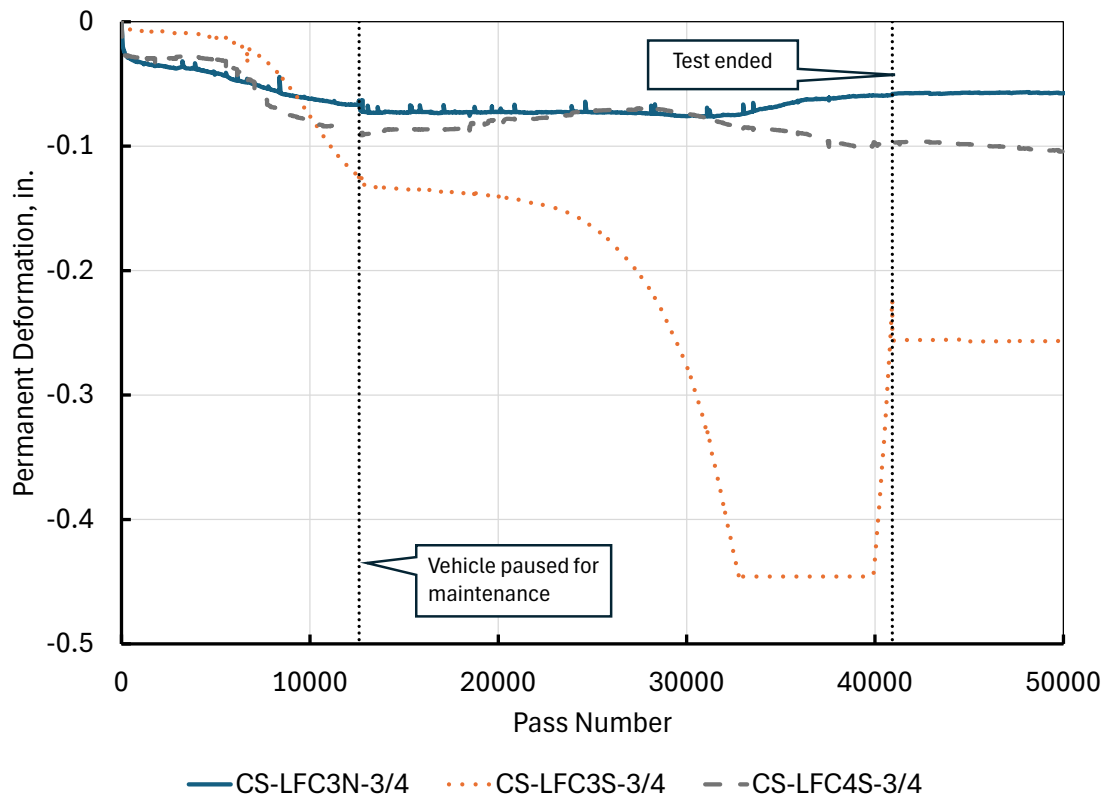
Figure 58 plots permanent deformation at the top of the subgrade against the number of passes. After 7,500 passes, the rate of permanent deformation increased sharply in LFC-3S but remained stable in the other two test items. After the trafficking hiatus (October 2021 to February 2022), permanent deformation continued to increase in LFC-3S—first gradually, then rapidly, eventually reaching the sensor’s limit at approximately 33,000 passes. After 40,000 passes, the readings recovered somewhat but should be considered unreliable due to the large distortions. Figure 58 is evidence of a bearing capacity failure in LFC-3S that did not affect LFC-3N or LFC-4S.

Figure 58. Permanent Deformation at Top of Subgrade

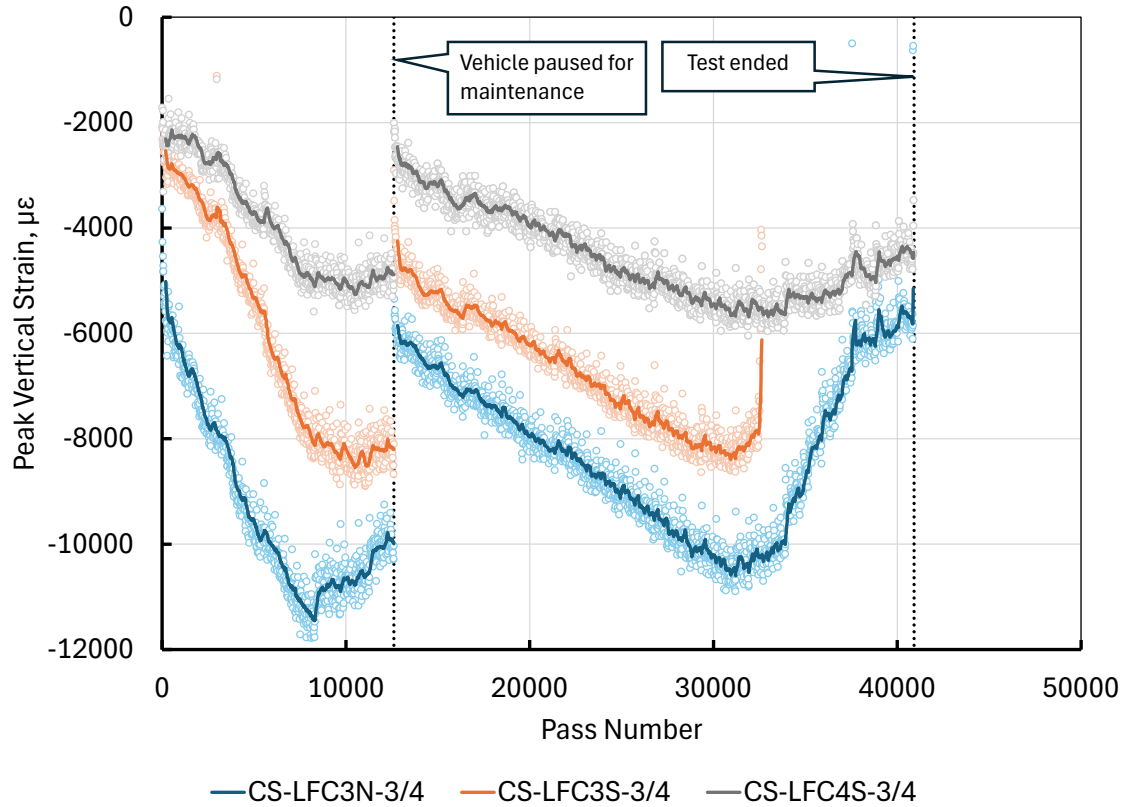
Figure 59 shows subgrade compressive strain during traffic. Compressive strains from CS pairs in the subgrade exhibited seasonal variation linked to temperature-related changes in AC stiffness, similar to CS pairs in the base and subbase layers. However, the subgrade strain magnitudes were substantially higher than those in the base and subbase. This could be attributed to the large disparity in stiffness between fine-grained clay and coarse-grained unbound base and subbase materials. The compressive strains in test item LFC-4S (control) were consistently higher than strains in the other two test items. The subgrade coil sensor stacks were installed at an offset of 12.75 ft, which coincides with the tire path under wander track 0. In-place characterization of the as-built subgrade with LWD, D-PSPA, and GeoGauge indicated consistently lower stiffness in the center area (15-ft transverse offset) of LFC-3N than that in the other two test items (see Figures 6, 7, and 8).

Figure 59. Compressive Strain at Top of Subgrade  
(Solid lines show a 15-point moving average.)

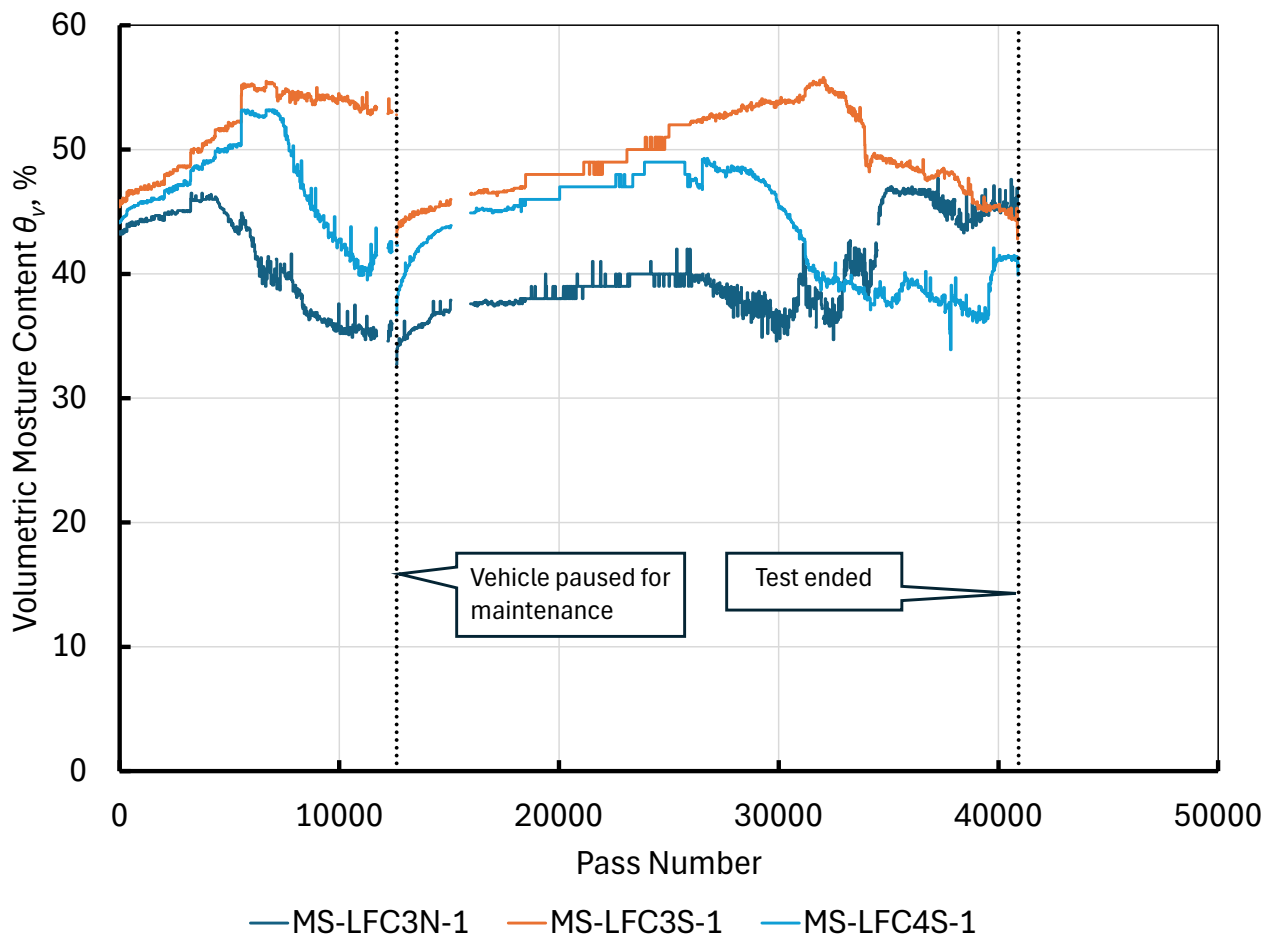
Figure 60. Change in Subgrade  $\theta_v$  with Traffic
