Report No. UT-26.02

**ENHANCING ACCESSIBILITY
FOR INDIVIDUALS WITH
LIMITED MOBILITY:
LEVERAGING AI AND
CYCLING DATA FOR AN
INCLUSIVE ACTIVE
TRANSPORTATION NETWORK**

Utah Department of Transportation
Research & Innovation Division

**Final Report
January 2026**

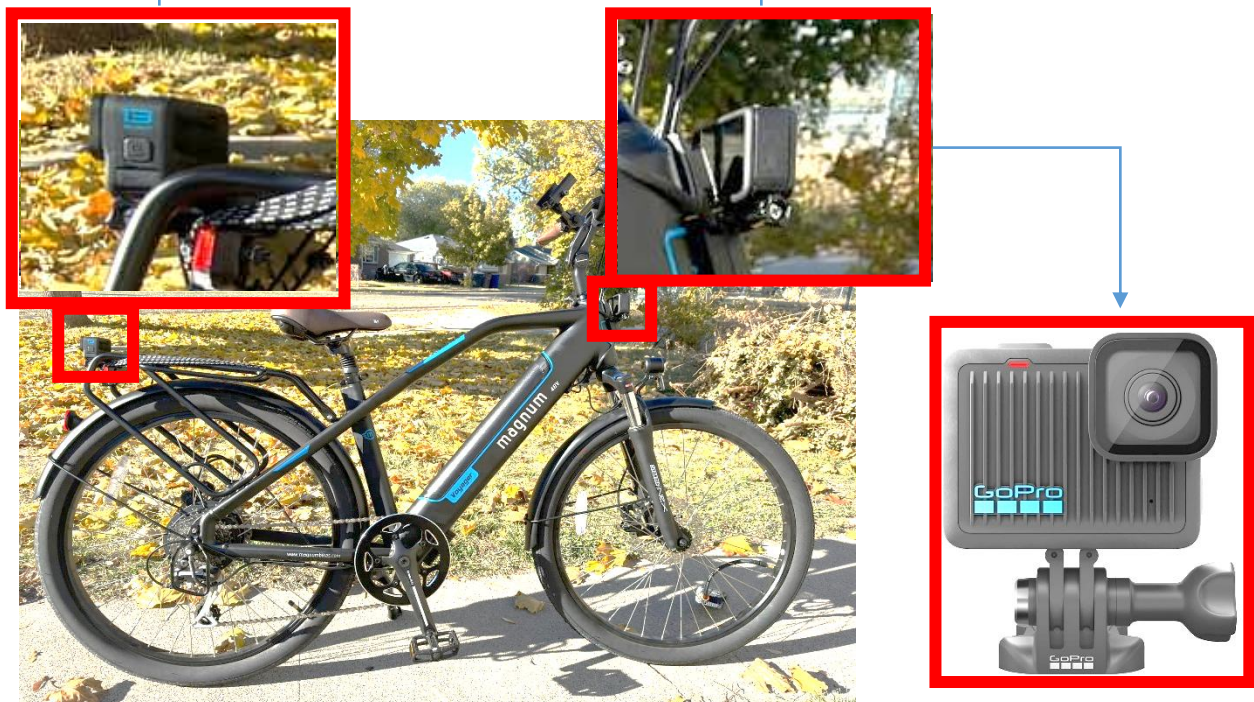
Figure 3-1: Data Bike setup

Hardware Configuration and Mounting. The Data Bike was constructed using a Magnum Voyager electric bicycle as the base frame with aluminum alloy frame. It was equipped with dual high-resolution GoPro cameras, one mounted at the front and another at the rear, allowing for bidirectional surface and environmental imaging (as shown in **Error! Reference source not found.**). Access to GoPro Cameras were collected from the GoPro embedded metadata

(tri-axial accelerometer) and recorded redundantly using a smartphone vibration-sensor application.

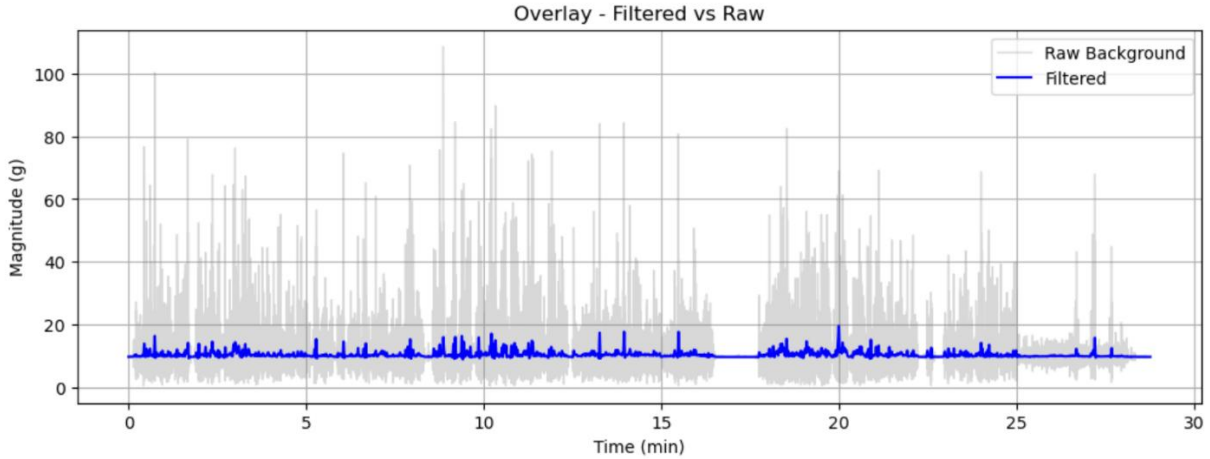
Figure 3-3: Raw and Filtered Magnitude of Acceleration

Acceleration Magnitude and Smoothing. Tri-axial accelerometer signals were converted to a single magnitude time series. A zero-phase 4th-order Butterworth low-pass filter was applied to reduce high-frequency sensor noise prior to differentiation (see Appendix A). Threshold calibration rides were conducted over known smooth and rough segments to determine jerk thresholds that minimize false alarms while capturing relevant events.

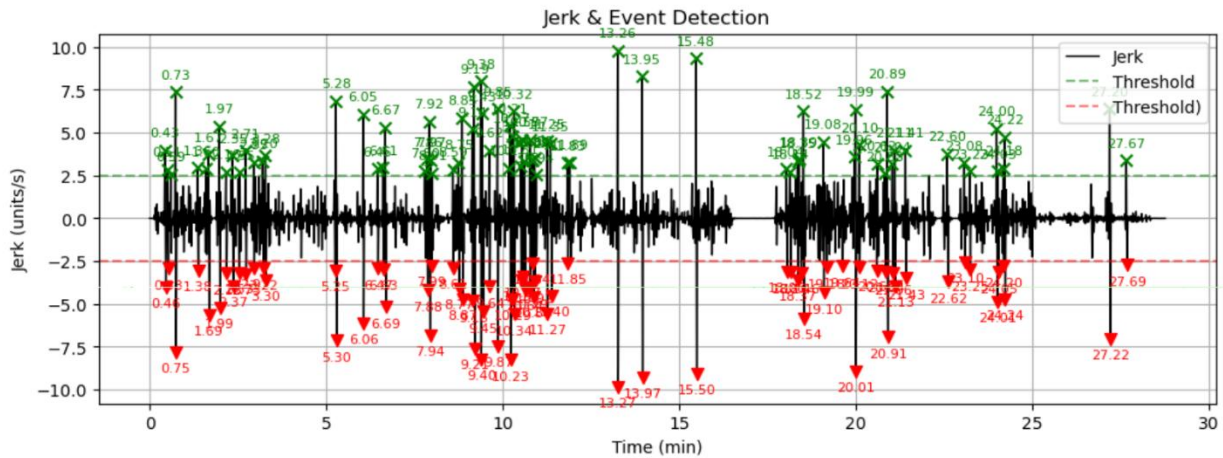
Figure 3-4: Detection of jerk based on threshold calibration

Jerk Computation and Thresholding. Jerk was computed as the derivative of the smoothed acceleration magnitude. The threshold for event detection was empirically determined from pilot rides and maintained constant during full-scale surveys; the threshold value and calibration methodology are documented in Appendix A. Because jerk magnitude depends on

speed, maintaining a speed range (10–16 mph) was essential for reproducibility. GPS-derived speed was used to screen out near-zero-speed intervals (stops) and to interpret unusually large events that may correspond to emergency braking. We can see sample plot showing the jerks as shown in Figure 3-4.

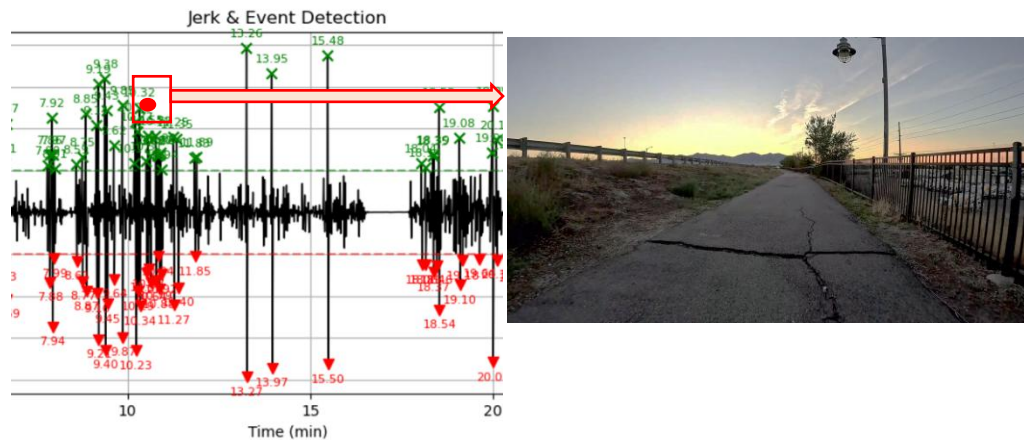
Figure 3-5: Extraction of crack image based on jerk timestamp

Frame Extraction Offsets. Upon identifying high-jerk timestamps, the corresponding video frames were extracted from the synchronized GoPro footage using automated scripts. We

applied multiple temporal offsets during frame extraction to ensure accurate spatial alignment between jerk events and their causative events. Since the camera visually captures defects and surface conditions before the bike physically encounters them (and thus before vibrations are felt), we extracted frames at 0.25, 0.5, and 0.75-second intervals prior to each jerk timestamp. This multi-offset approach addresses the inherent delay between visual detection and physical response while providing images of defects and surface conditions at varying distances from the camera. The resulting three images per jerk event capture the defect from different perspectives and scales,

improving model robustness and ensuring that at least one frame accurately represents the defect that caused the corresponding vibration. The extracted frames were compiled into a dedicated repository for manual inspection and subsequent analysis using object detection models to classify surface defects and surface conditions (Figure 3-5).

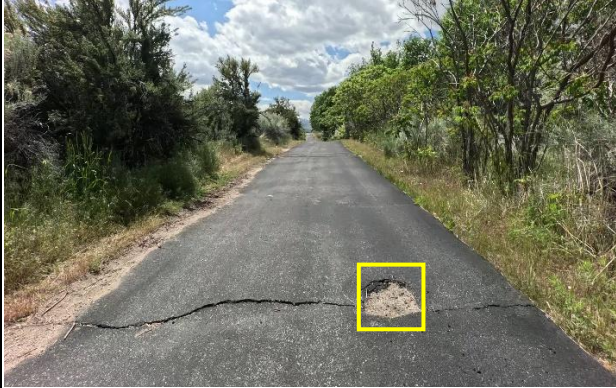
Surface Conditions Categories	Description
<p>Pothole</p>

<p>A bowl-shaped depression in the trail surface, typically caused by water infiltration and wear, poses a trip hazard or discomfort for pedestrians and jarring impact for cyclists and wheelchair users.</p>
<p>Longitudinal Crack</p>

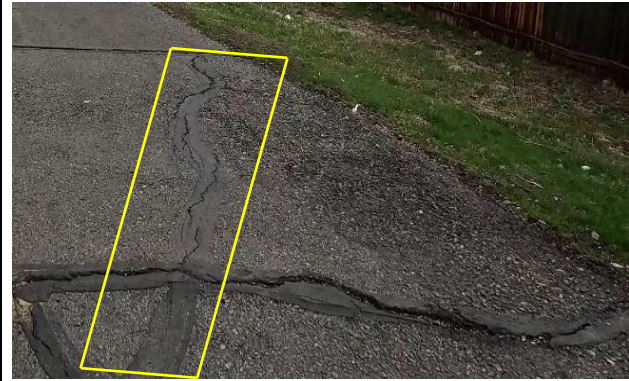
<p>A crack that runs parallel to the direction of the trail, often due to poor joint bonding or ground movement, can affect wheelchair or stroller stability. Moisture infiltration accelerates pavement deterioration.</p>

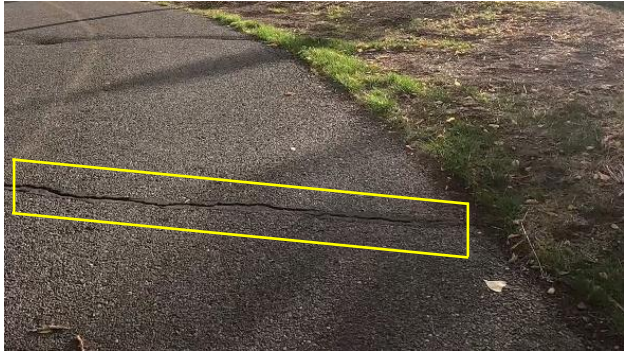
Surface Conditions Categories	Description
<p data-bbox="196 254 444 285">Transverse Crack</p>

<p data-bbox="841 373 1419 590">A crack running perpendicular to the trail path, commonly due to temperature changes or aging materials, leading to minor surface disruption. Particularly problematic for small-wheeled mobility devices, indicating a potential for future pothole formation.</p>
<p data-bbox="196 720 415 751">Alligator Crack</p>

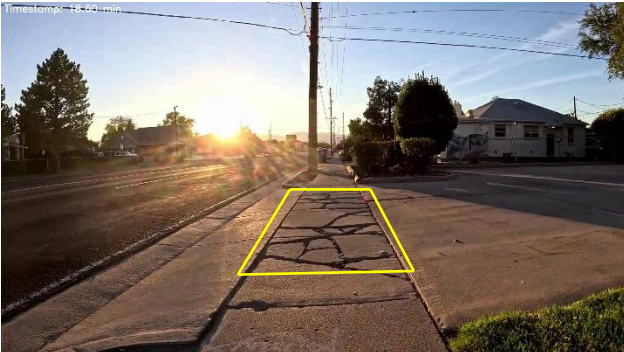
<p data-bbox="841 842 1419 1024">A series of interconnected cracks resembling alligator skin, typically indicating structural fatigue and requiring surface replacement. Rough surface impedes rolling mobility devices, high priority for maintenance.</p>
<p data-bbox="196 1157 386 1188">Misalignment</p>

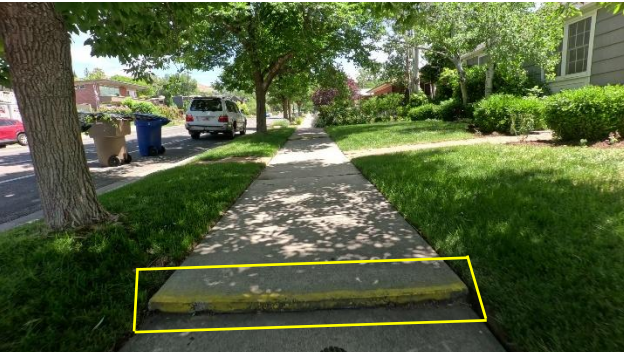
<p data-bbox="841 1262 1419 1514">A vertical or horizontal shift between pavement sections, usually caused by tree roots or subsidence, creates a significant tripping hazard; impassable obstacle for wheelchairs when vertical offset exceeds 0.5 inches (ADA threshold); can occur in both flexible and rigid pavements.</p>

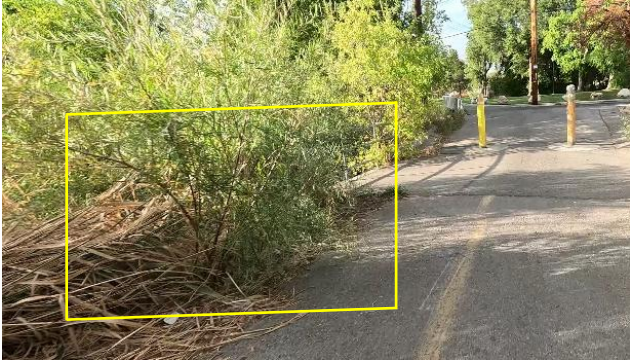
Surface Conditions Categories	Description
<p data-bbox="198 252 474 285">Vegetation Obstacle</p>

<p data-bbox="841 306 1414 625">Overgrown plants, bushes, or branches encroaching into the usable trail width below ADA minimum (60 inches). These conditions reduce effective width and sight distance creating safety concerns. Vegetation may be avoided without generating a strong vibration response; detection therefore relies on whether vegetation is visible in extracted frames and can be missed.</p>
<p data-bbox="198 693 386 726">Pole Obstacle</p>

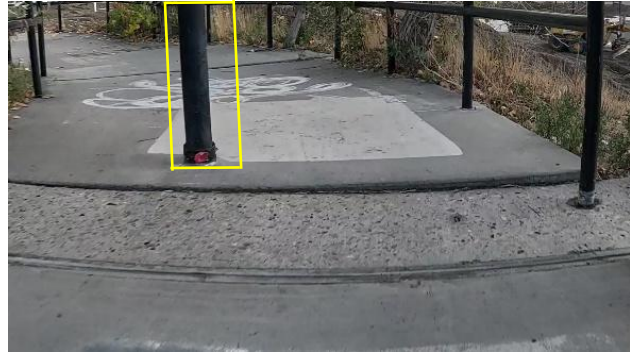
<p data-bbox="841 779 1414 1062">Fixed objects such as signposts, bollards, or utility poles placed close to or within the usable trail width. These may pose collision risks and constrain lateral clearance. Because riders typically steer around poles, the jerk-triggered system may under-sample them; they are retained as contextual features rather than defects.</p>

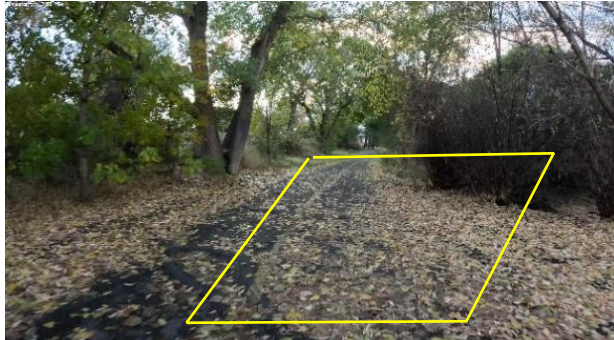
<p data-bbox="198 1165 418 1199">Debris Obstacle</p>

<p data-bbox="841 1272 1409 1451">Loose gravel, branches, excessive leaf accumulation, trash, or other foreign materials on the trail surface can cause slipping, falling, or impede movement along with rolling hazard for small wheels.</p>

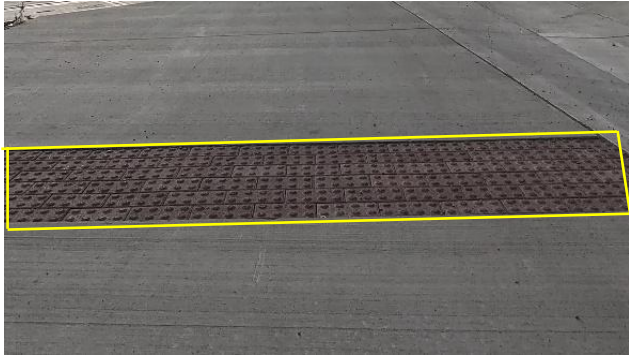
Surface Conditions Categories	Description
<p>Tactile Pavement</p>

<p>Textured surface features used at crossings or transitions to provide cues. This category is included as a contextual feature; its condition becomes relevant when the feature is damaged, misaligned, or creates a localized hazard.</p>
<p>Rail Crossing</p>

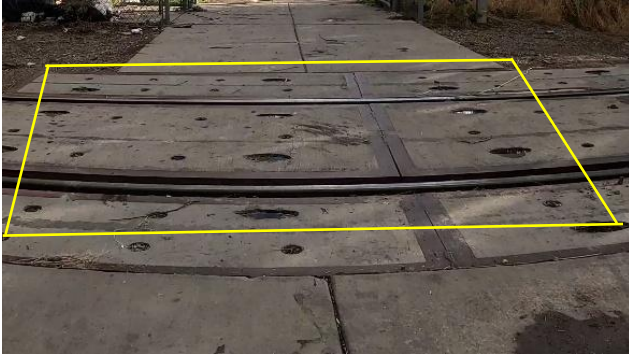
<p>Locations where a trail intersects rail infrastructure. Condition issues become relevant when the crossing creates unevenness, gaps, or other hazards. Rail crossings are treated as contextual features, and only damaged or hazardous crossings warrant maintenance action.</p>

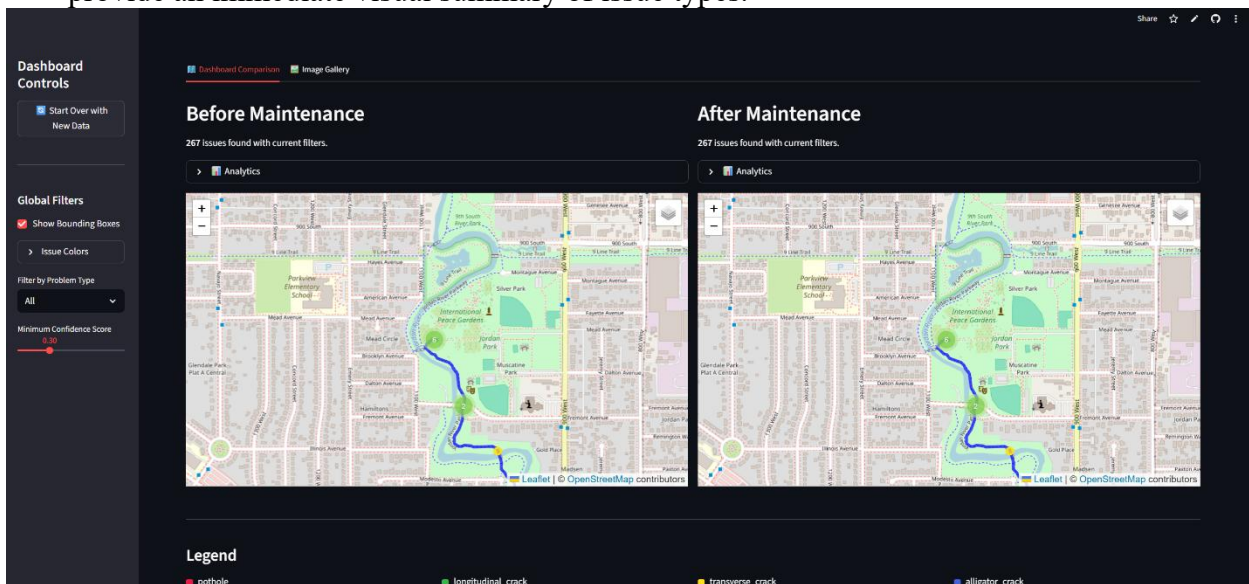
- **Interactive Map Display:** Geospatial points for all detected defects and surface conditions are displayed on a high-resolution map. Each point is color-coded by defect category to provide an immediate visual summary of issue types.

Figure 4-4: Interactive Map with Hotspots Identified

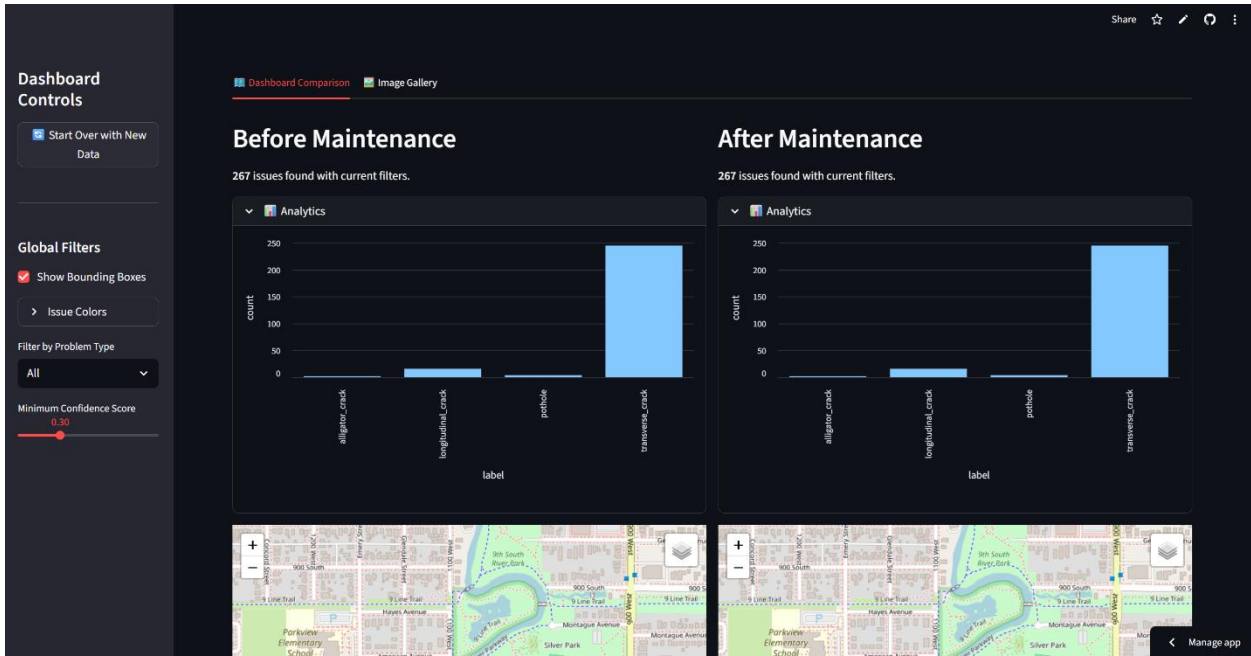
- **Summary Analytics and Charts:** The dashboard includes summary statistics and charts that update in real-time as the map is filtered. These widgets provide an aggregated overview, displaying metrics such as the total number of defects and surface conditions, the distribution of defect categories, and a bar chart illustrating defect counts by trail

Figure 4-7: Analytics Summary Chart
