**INVESTIGATION OF BRIDGE DECK CRACKING IN
VARIOUS BRIDGE SUPERSTRUCTURE SYSTEMS**

FHWA/IN/JTRP-2002/25

School of Civil Engineering
Purdue University

Purdue University
West Lafayette, Indiana 47907
February 2003

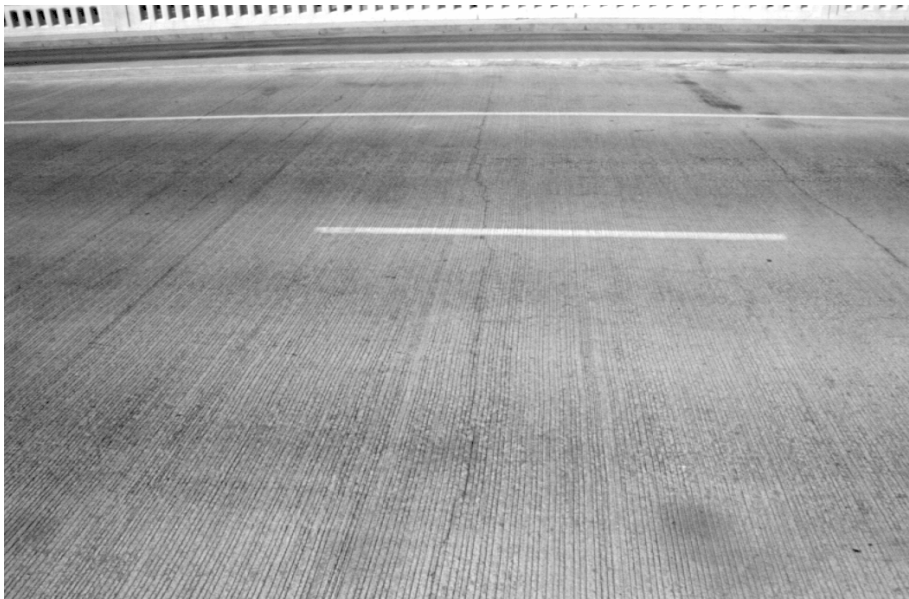
Figure 1.1: Transverse Cracking (Bridge 3)

Many bridges in the state of Indiana have been identified to have cracking in the concrete deck. Cracking has been identified in the negative and positive moment regions of bridges on both the top and bottom surfaces. In some structures, only top surface cracking is visible due to the use of stay-in-place steel forms. The cracking can appear before or shortly after the opening of the structure to live loads. Significant crack widths and various degrees of cracking exist in different bridge systems including both concrete and steel superstructures. Figure 1.1 shows a bridge with multiple transverse cracks.

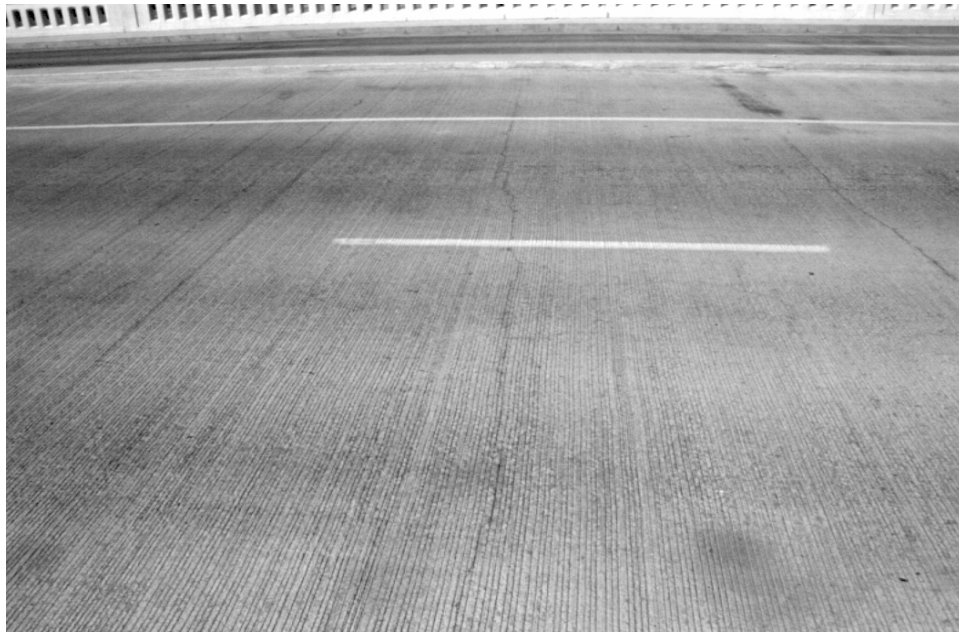
Figure 2.1: Transverse Cracking (Bridge 3)

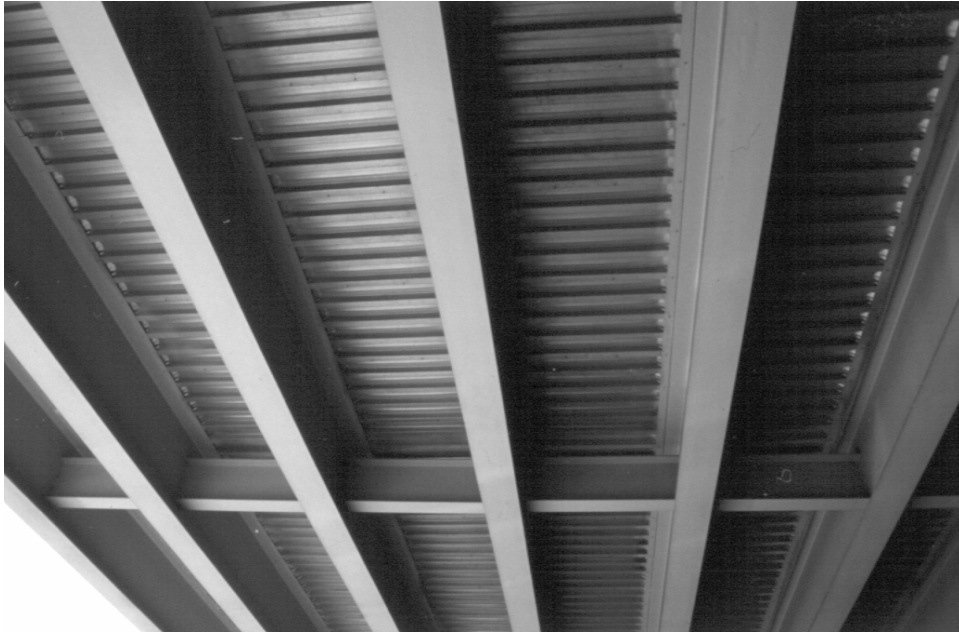
Figure 2.2: Steel I-Beam Superstructure with Stay-in-Place Forms (Bridge 3)

Of the bridges inspected, 7 were known to have used stay-in-place steel forms and 6 of these bridges had transverse cracks. Figures 2.2 and 2.3 show the stay-in-place steel forms. The 2-in. thick stay-in-place steel forms are corrugated galvanized steel and are screwed to a 3-in. by 2-in. galvanized cold-rolled steel angle. The cold-rolled angle was welded directly to the top flange in the positive moment region and welded to a steel bar resting on the top of the flange in the negative moment region where welding is not permissible (Figure 2.4). Figure 2.5 shows a cross section of the bridge deck slab at a girder that incorporates the use of stay-in-place steel forms.

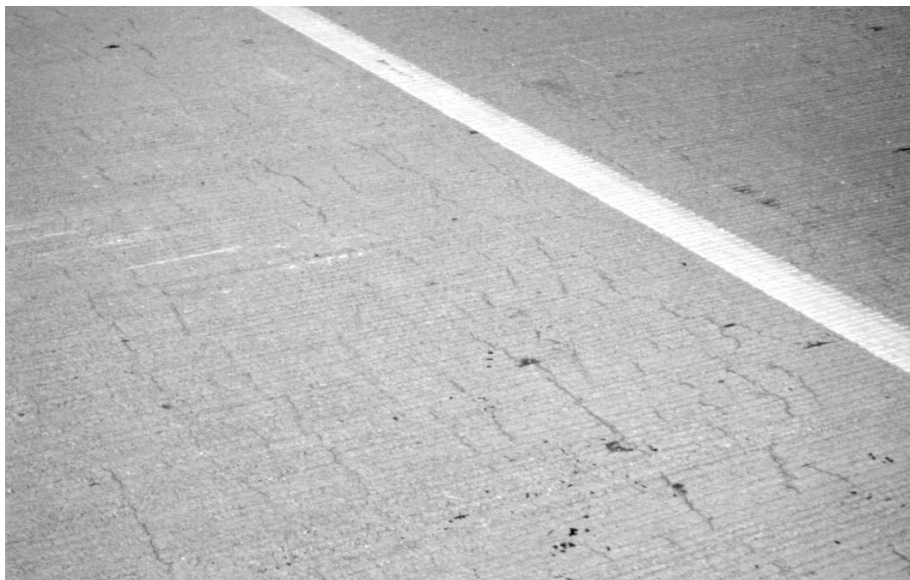
Figure 2.8: Map Cracking in Overlay (Bridge 6)

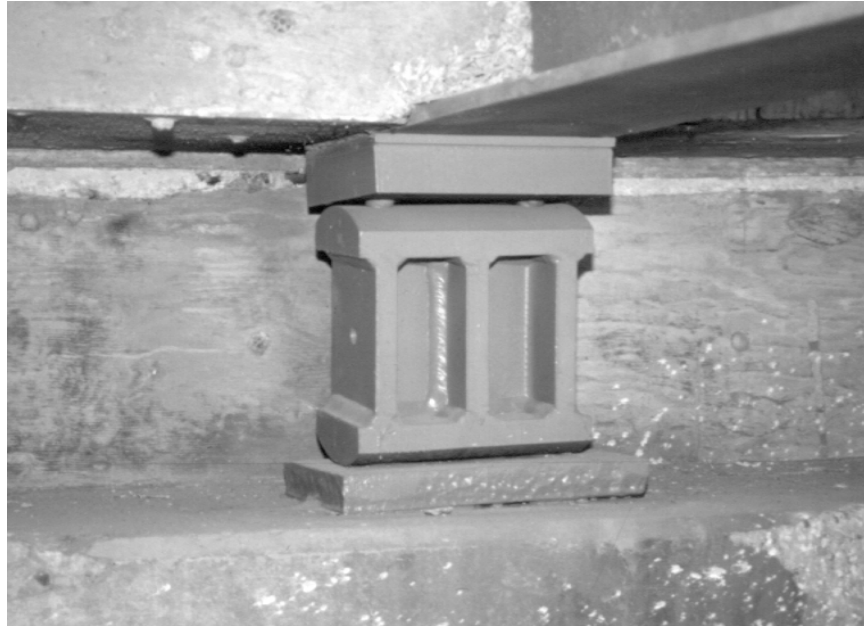
Figure 2.9: Unseated Rocker Support for Steel I-Beam Girder (Bridge 4)

During the inspection, concerns other than deck cracking were also noted. Bridge 4 had no observed cracking on the bridge deck; however, there were several loose rockers supporting the steel I-Beam girders as shown in Figure 2.9.

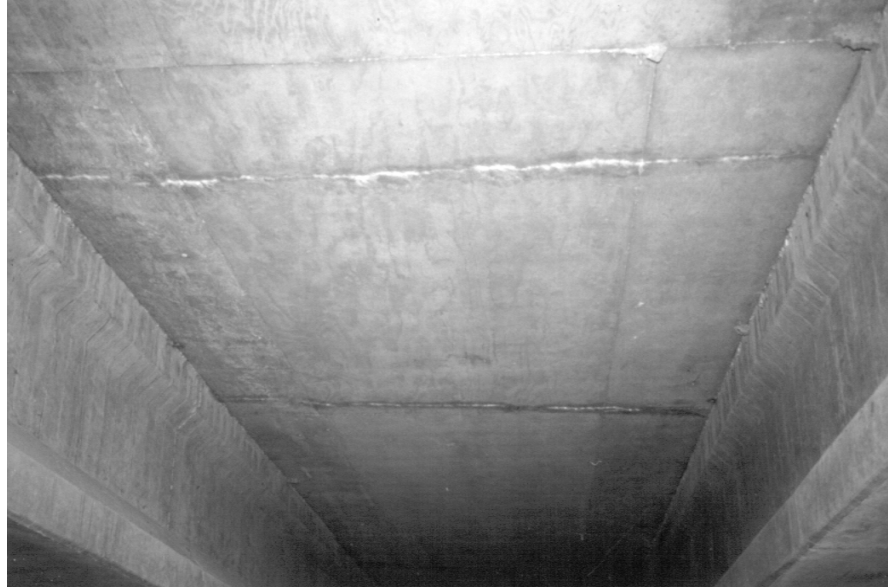
Figure 2.10: Transverse Cracks (Bridge 19)

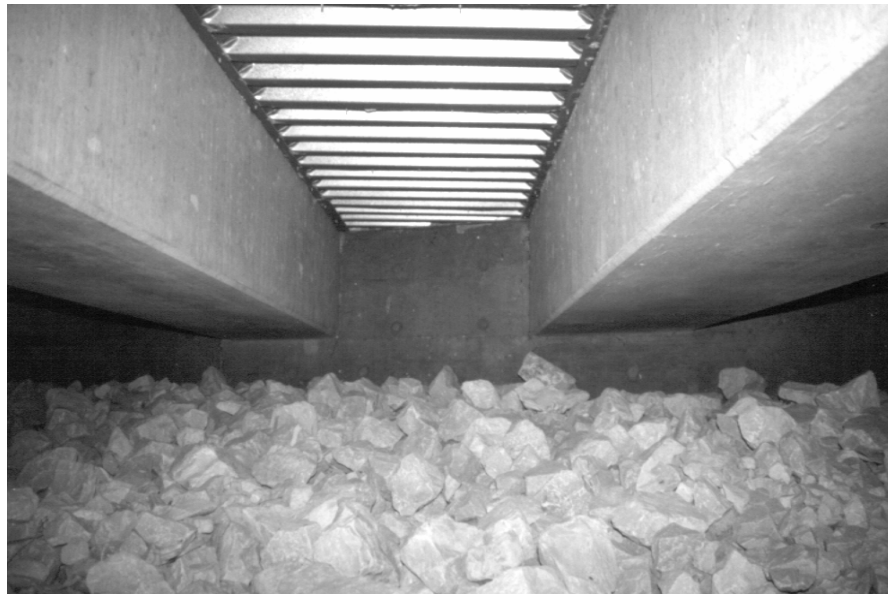
Figure 2.11: Precast Spread Box Girder Superstructure with Stay-in-Place Forms (Bridge 20)

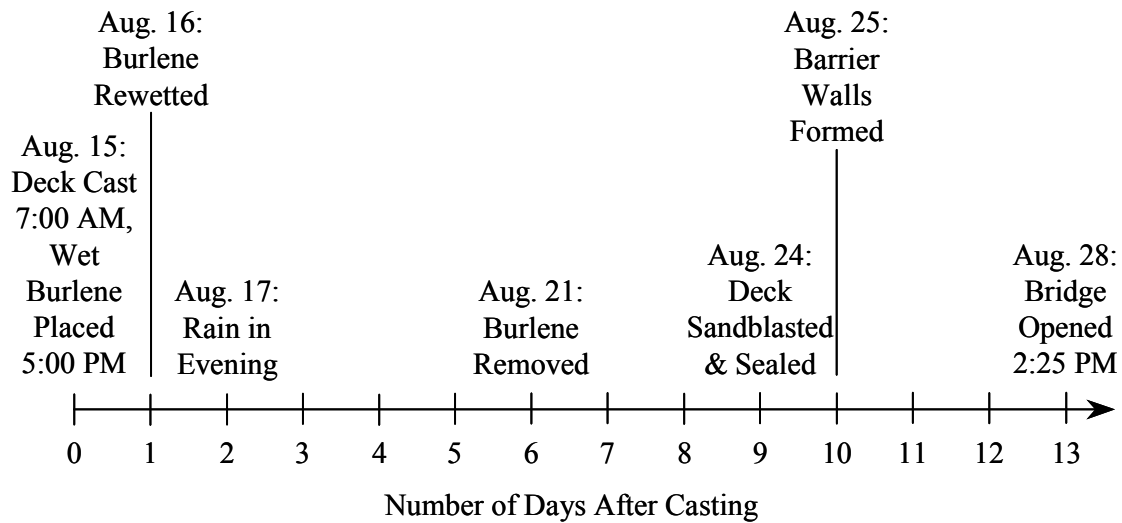
Figure 3.14: Time Line between Casting and Opening of Bridge

To complete the bridge construction, barrier walls were slip formed on the 10th day. The bridge was opened to traffic the 13th day, August 28, 2000 at 2:25 PM. Figure 3.14 illustrates the sequence of events between casting the deck and opening the bridge to traffic.

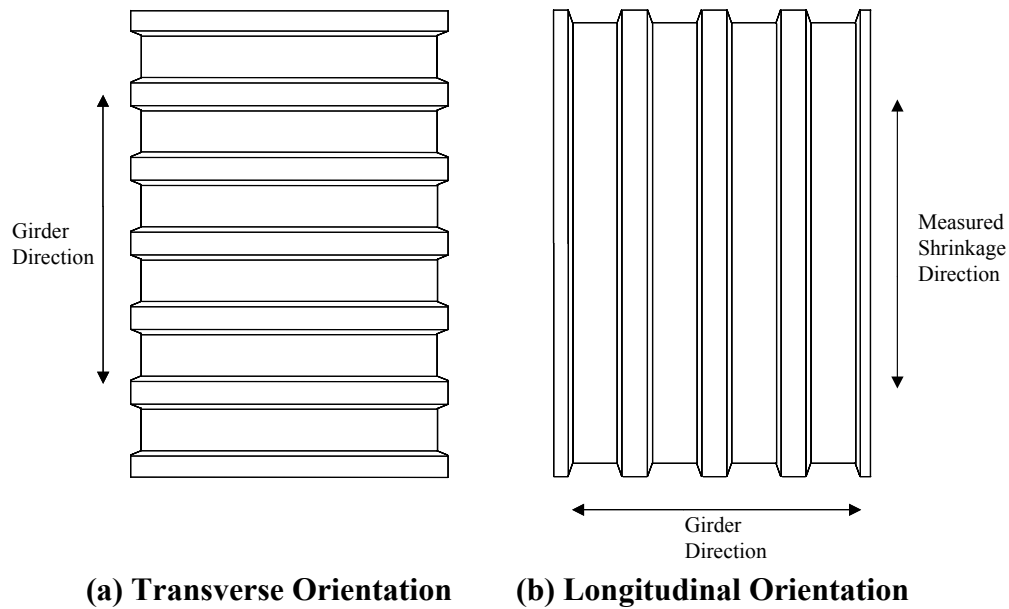
Figure 5.5: Plan View of a Deck Pan

The orientation of a wood form will not affect how a bridge deck shrinks, but the orientation of a SIP deck pan may. Because a deck pan is designed to span in the transverse direction of the bridge span (Figure 5.3), its bending resistance is much larger when the pan ribs are parallel to that direction. Therefore, if shrinkage induces bending in a bridge deck, a SIP will create more restraint in the transverse direction of the bridge than the longitudinal direction (Figure 5.5). As a result, form orientation may affect shrinkage and early-age-cracking.

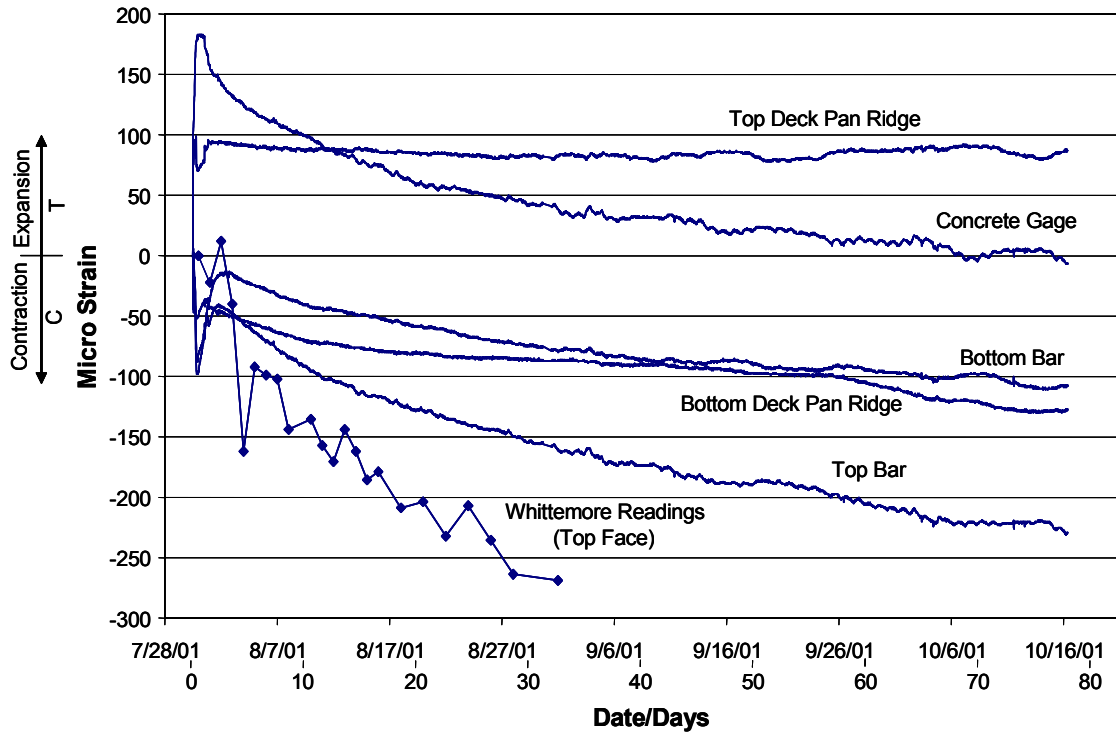
Figure 5.34: Shrinkage Measurements (Specimen 1)

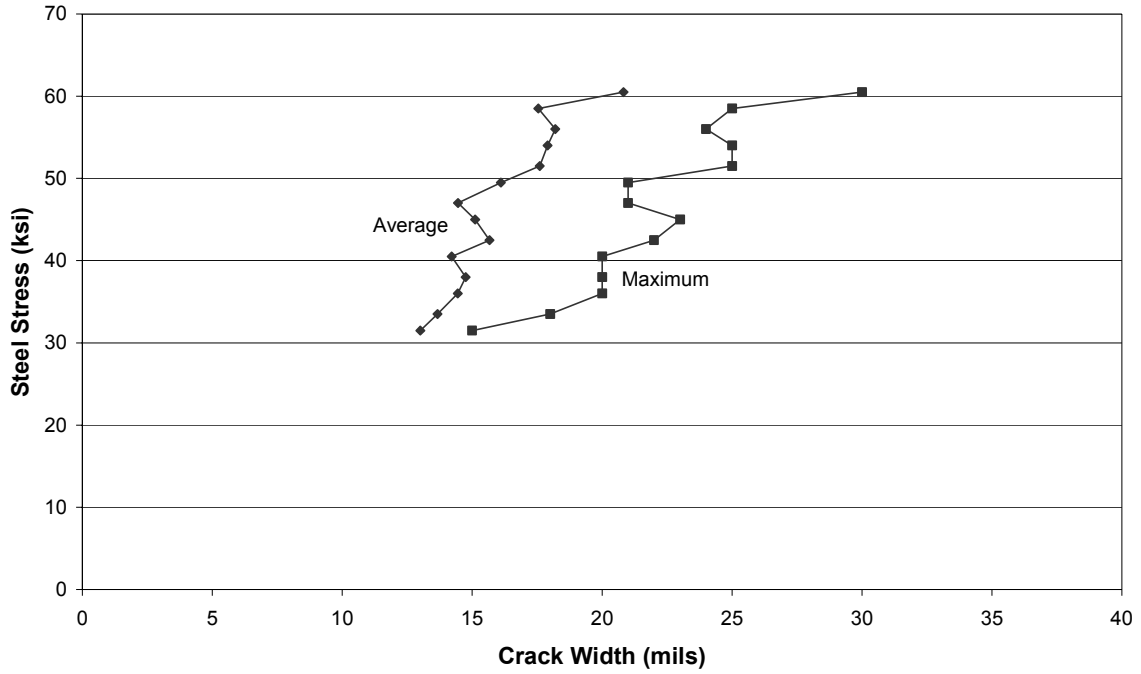
Figure G.7: Average and Max Crack Size Growth (E12-12)
