TECHBRIEF

Impacts of Wildfires on Highway Assets

FHWA Publication No.: FHWA-HRT-26-005

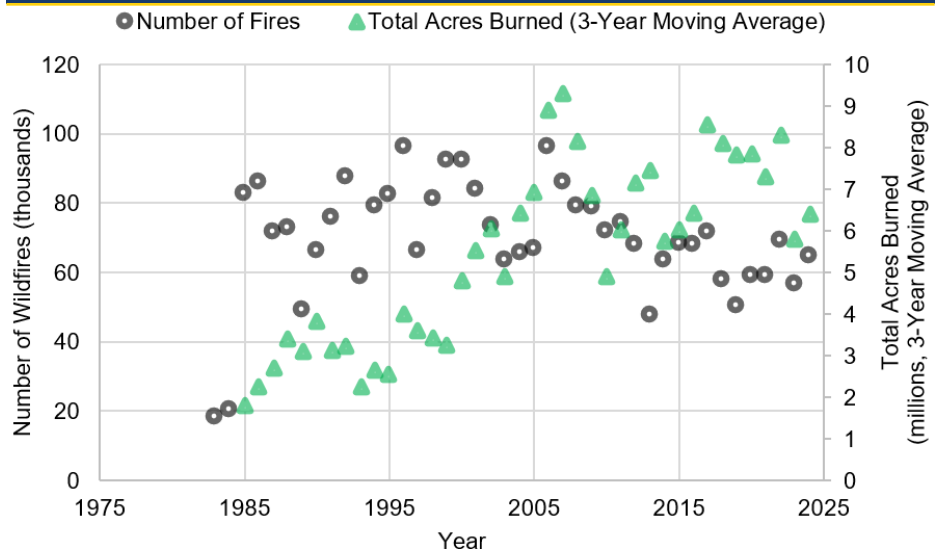
Figure 1. Graph. Total number of wildfires per year and acres burned per 3-yr period in the United States (NIFC n.d.).

Over the past several decades, the United States has seen a steady increase in the intensity and extent of wildfires, especially in the Western States. Figure 1 presents data on the number of wildfires and total acres burned in the United States between 1981 and 2021 (National Interagency Fire Center (NIFC) n.d.). While the number of wildfires shows a relatively constant trend, the total acres burned over a 3-yr period shows a steady increase. According to recent data, the largest and most destructive wildfires have mostly occurred since 2000 (Legislative Analyst's Office 2020).

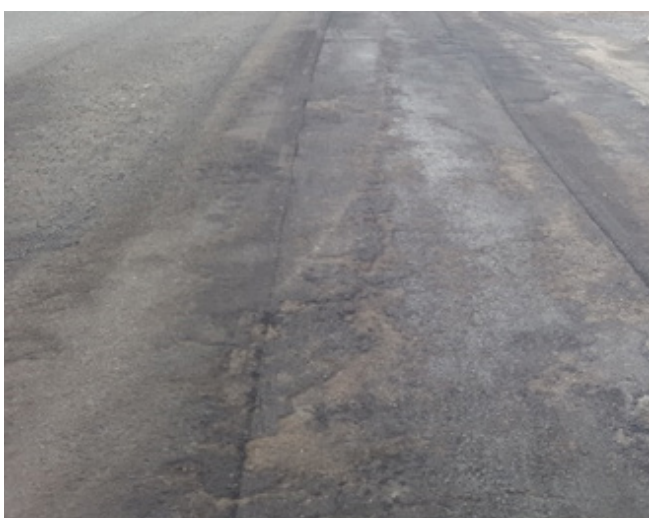
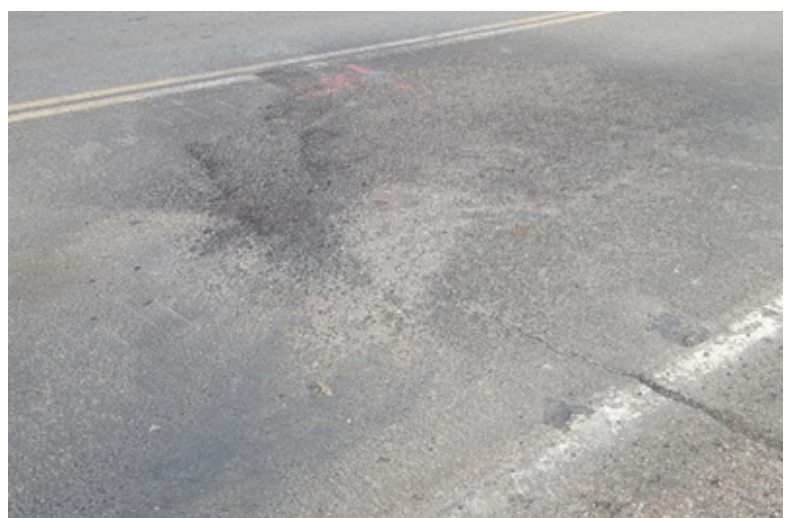
Figure 2. Photo. Examples of fire-scorched pavement surfaces.

A. Delamination.

B. Raveling.

- Direct impacts:
 - Surface damage during the fire event, which could lead to melted pavement, potholes, raveling, and delamination (as shown in figure 2).
 - Strength loss, shrinkage, and cracking of pavement materials due to exposure to extreme temperatures.
- Indirect impacts:
 - Structural damage to the pavement because of the increase in both the number and weight of the heavy truck traffic loadings from detoured traffic, fire suppression vehicles, postfire cleanup operations, and rebuilding activities.

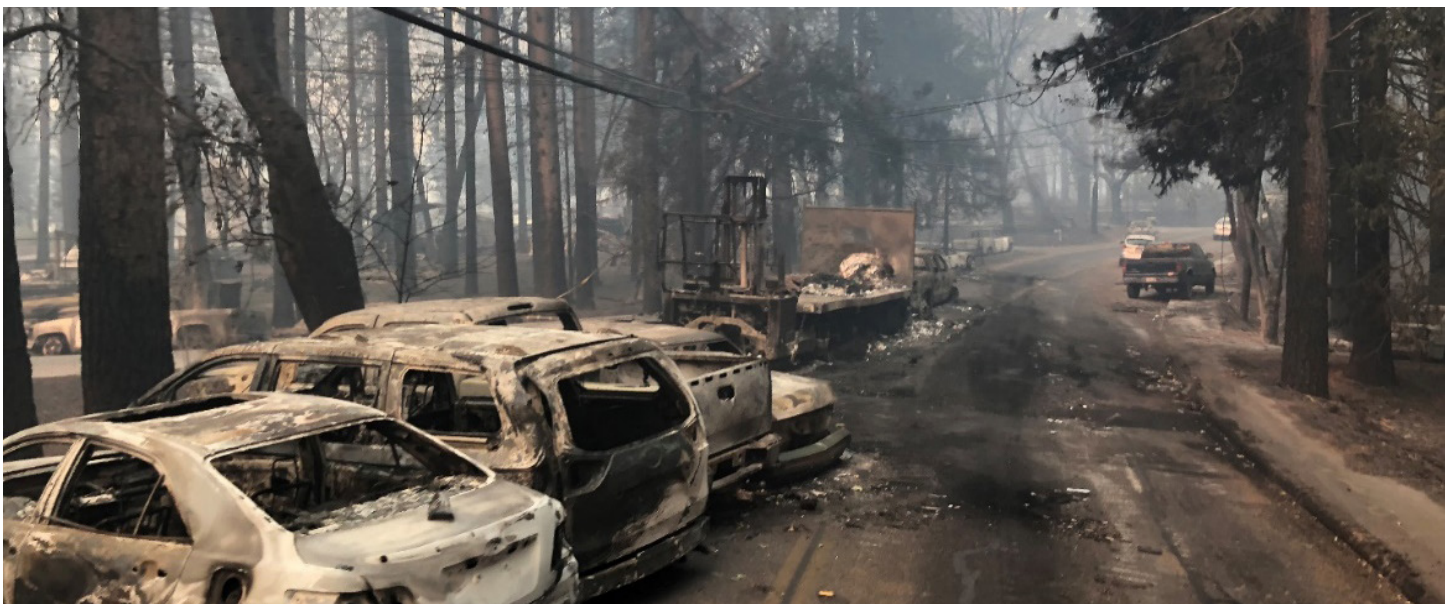
Figure 3. Photo. Damage to asphalt pavement due to Camp Fire (National Institute of Standards and Technology 2023).

Fire damage to asphalt materials is most severe in tunnels, where the fire is enclosed and can break down the stability of the asphalt mixture and produce toxic fumes. However, fire impacts on asphalt pavements can be found outside of tunnels as well. During wildfires, asphalt roadways do not generally undergo combustion due to two main reasons. First, aggregates, fillers, and air (generally noncombustible materials) comprise approximately 90 percent of the asphalt concrete mixture by volume. Second, the ignition temperature of asphalt binder is between 880 and 1,060 °F (California Department of Transportation (Caltrans) 2003), significantly higher than the mix temperatures typically reached. However, the typical roadway temperatures of up to 566 °F during wildfire events are likely to melt the binder (Barzegar and Wen 2023). Fire also can arise from other sources (such as stalled or abandoned cars), which can lead to roadway damage. For example, during the 2018 Camp Fire near Paradise, CA, vehicles left on or next to the road became ignition sources for the fire, producing extreme heat (Mattox 2020). This event resulted in substantial damage to the asphalt surface, as shown in figure 3.

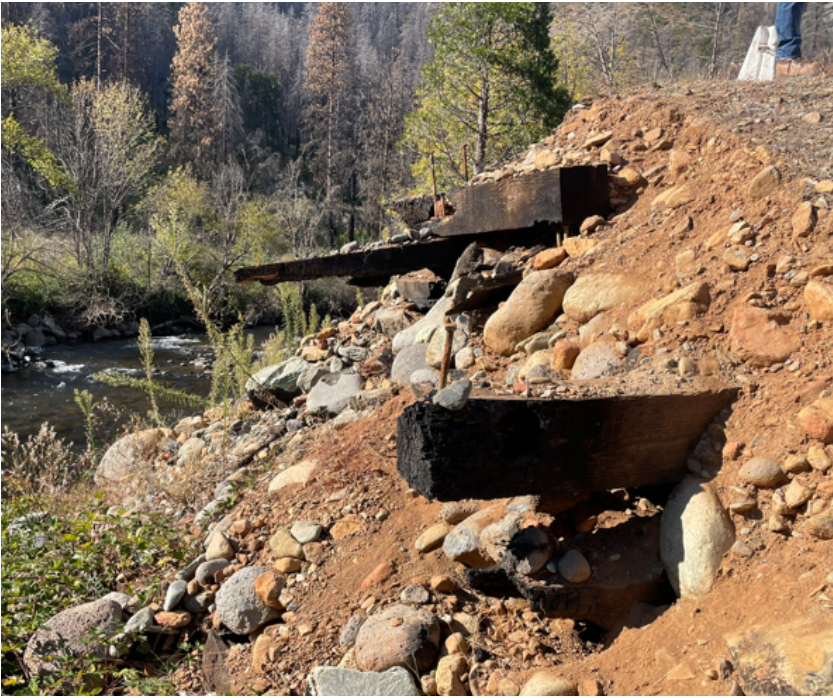
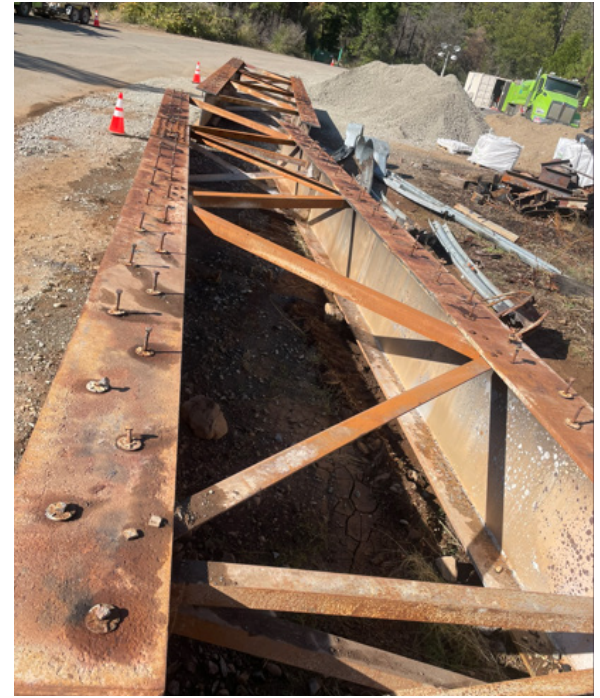
Figure 4. Photos. Remains of a fire-damaged timber bridge in Plumas National Forest.

A. Timber substructure elements with signs of severe fire damage.

B. Recovered steel girder with intact cross bracing.

Bridges are vital components of a transportation network because they provide transportation connectivity to safely cross features, such as waterways, railways, roadways, and other obstructions. However, high-temperature fires can threaten structural bridge members and lead to collapse (Garlock et al. 2011). Additionally, no common design standards or codes related to fire protection of bridges currently exist (Refai 2020). Figure 4 shows the remains of a burned timber bridge that collapsed during the Dixie Fire in Plumas National Forest, CA, in 2021.

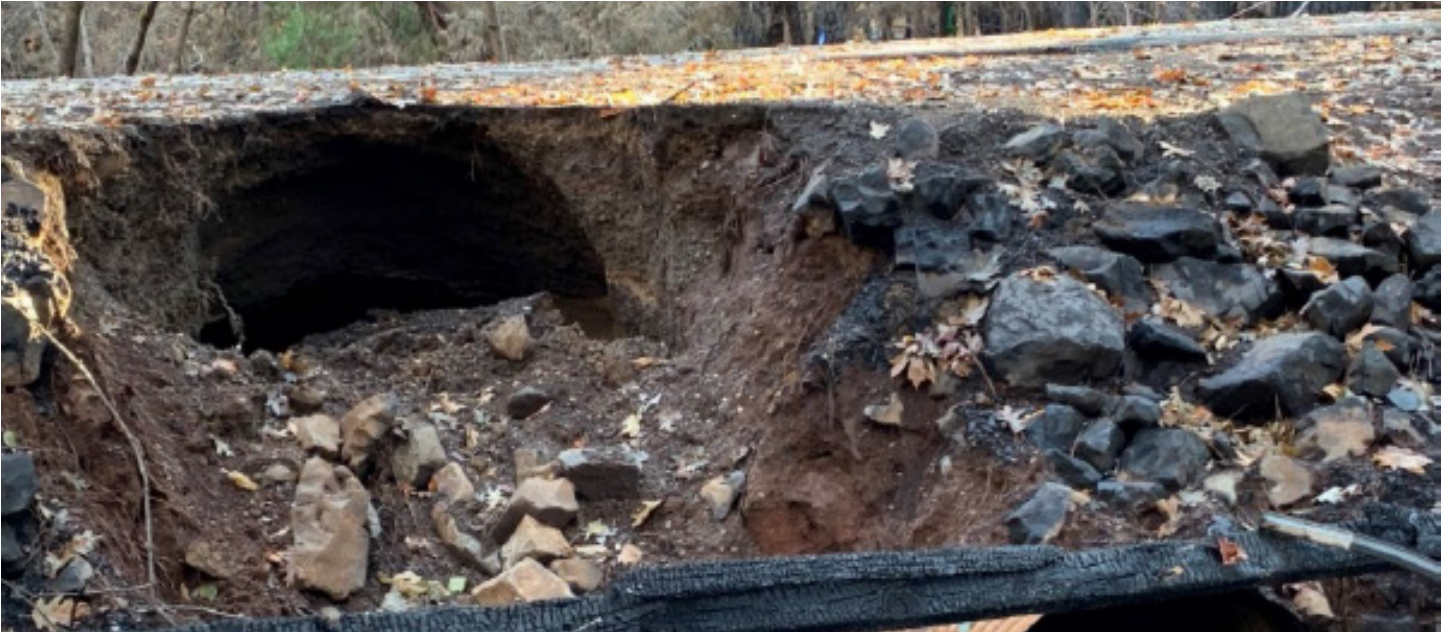
Figure 5. Photo. Collapsed culvert after Camp Fire (Mattox 2020).

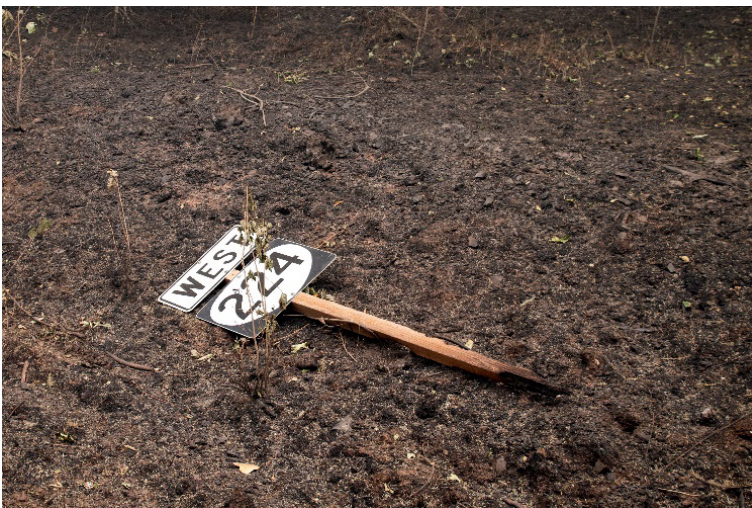
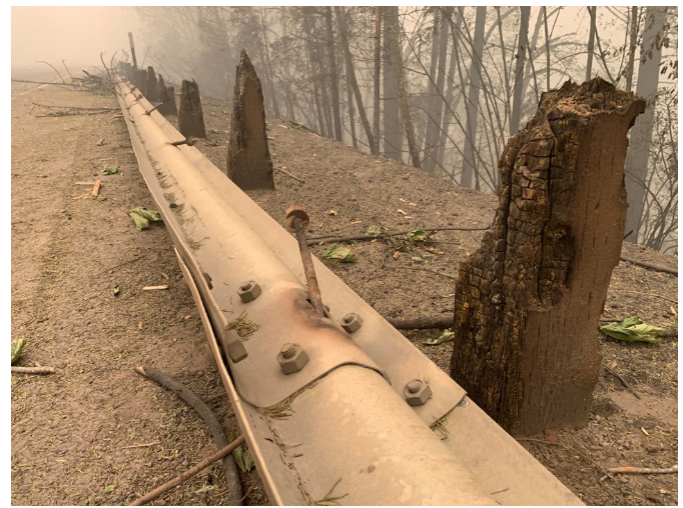
Figure 6. Damage to signs and guardrails due to 2020 Oregon wildfires (Creative Commons n.d.).

A. Sign damaged by wildfire.

B. Guardrail post destruction.

Wildfires can have lasting impacts on other key transportation infrastructure assets, such as signs, signals, and guardrails. During the 2020 Oregon wildfires, for example, temperatures increased to the point where metal signs were warped, and the wooden ties holding up guardrails vaporized (Ross 2020). Damage to guardrails, signage, and fencing are direct impacts noted by several agencies (figure 6). One agency observed an entire traffic signal and its underground wiring destroyed by a wildfire.³

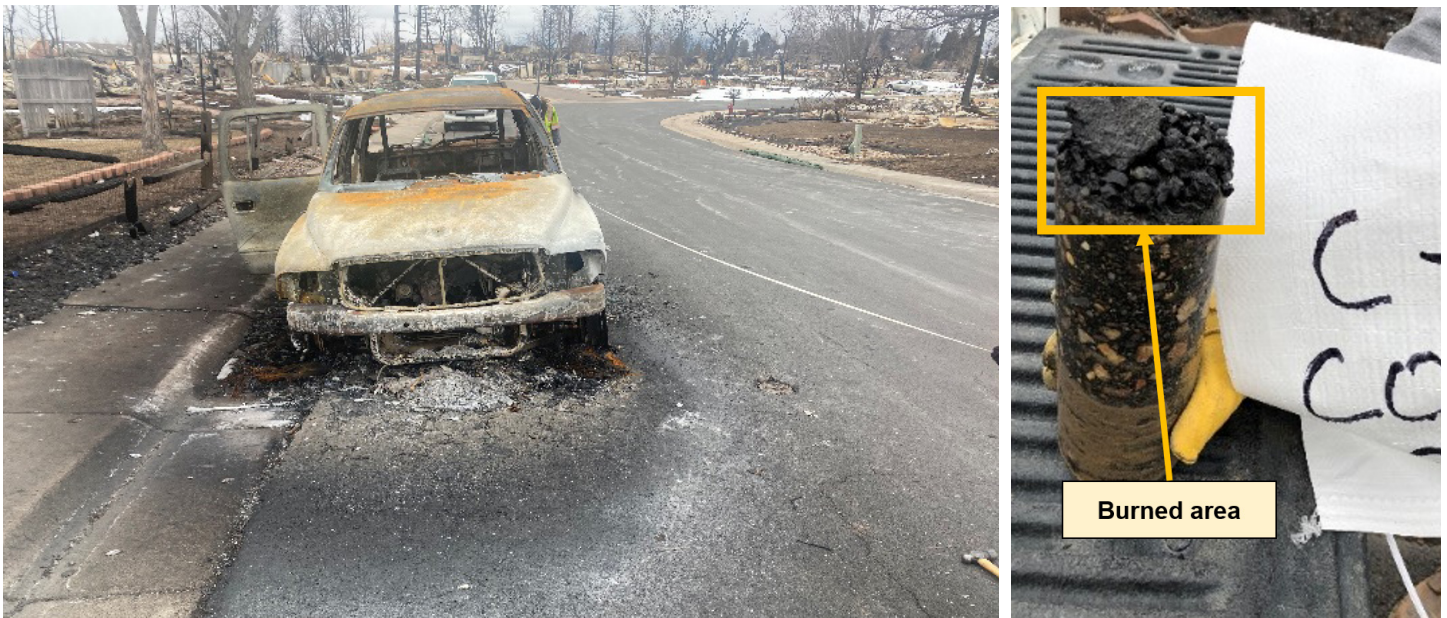
Figure 7. Photos. Severely burned pavement after Marshall Fire.

A. Burned pavement from car.

B. Burned core.

- Direct impacts of wildfires on pavements are generally limited and localized. Agencies noted that the direct impacts of wildfires on pavements (e.g., pavement damage because of burned asphalt) are mainly due to abandoned vehicles left on the road that become fuel sources for the fire.^{12,13} Based on limited coring conducted after the Marshall Fire in burned areas beneath vehicles, Senseney (2024) reported that the asphalt appeared to have sustained heat-related damage to a depth of approximately 2.5 to 3.5 inches below the pavement surface; this damage needed the removal of up to 4 inches of asphalt

before the placement of an overlay. Figure 7 shows an example of a severely burned area during the Marshall Fire and a core extracted from the burned location.

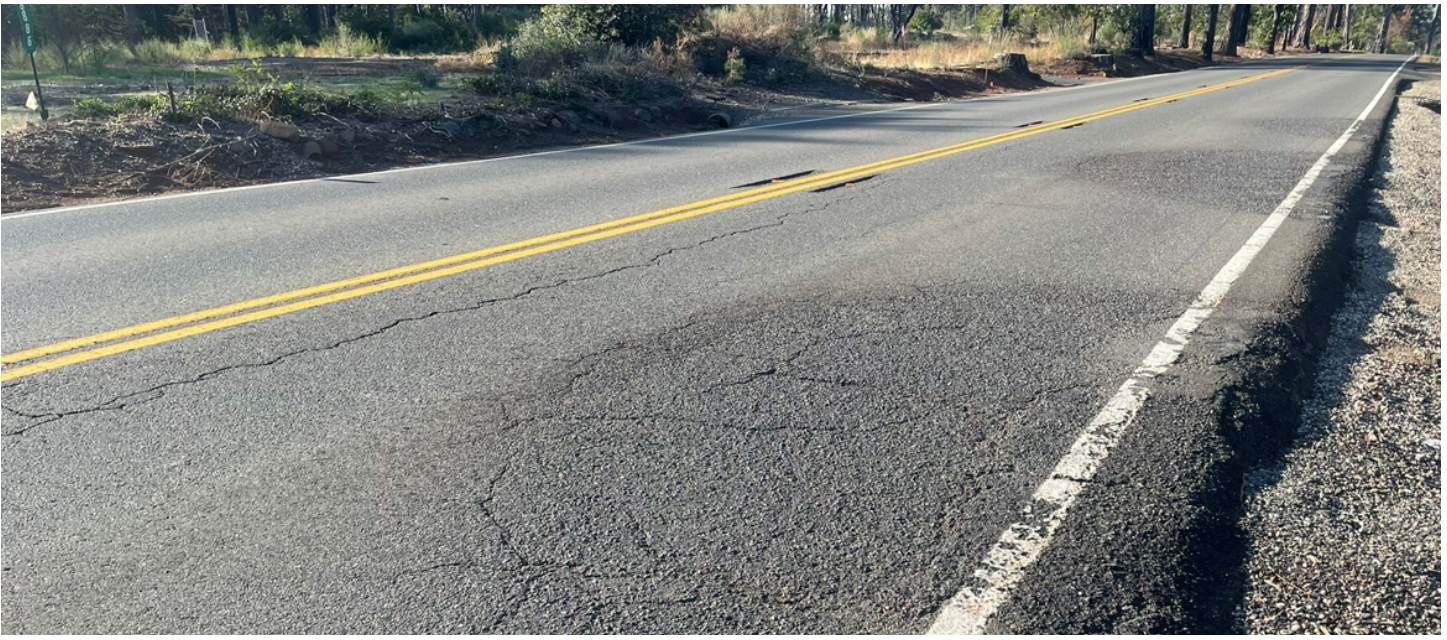
Figure 8. Photo. Cracking and raveling in burned area on Skyway Road in Paradise.

- Burned asphalt pavement areas are more susceptible to cracking and raveling. Asphalt pavement surfaces that have experienced high temperatures during wildfires are likely to experience accelerated cracking and raveling (Mattox 2020). Several burn scars on Skyway Road in Paradise exhibited raveling and cracking within 2 yr after the Camp Fire (figure 8). Note the raveling and cracking in figure 8 does not extend past the burn scar into other pavement that was likely exposed to excess heat but did not have a fuel source (e.g., an abandoned car) parked directly over it.
- Indirect impacts from wildfires tend to cause most of the damage to pavements and other transportation infrastructure. The main indirect impacts are due to postfire flooding, debris

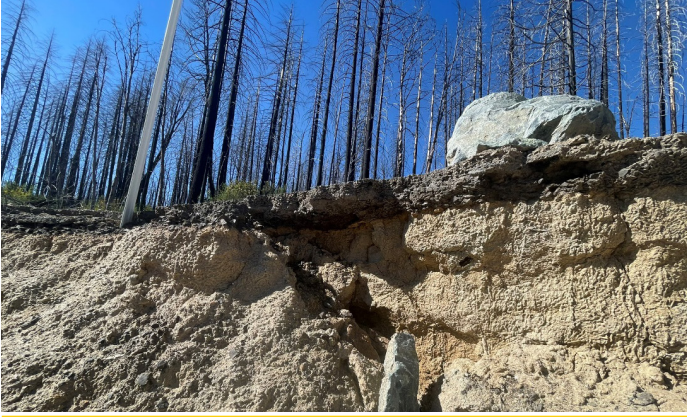
Figure 9. Photo. Washout due to postfire flooding on a U.S. Forest Service Road in Plumas National Forest.

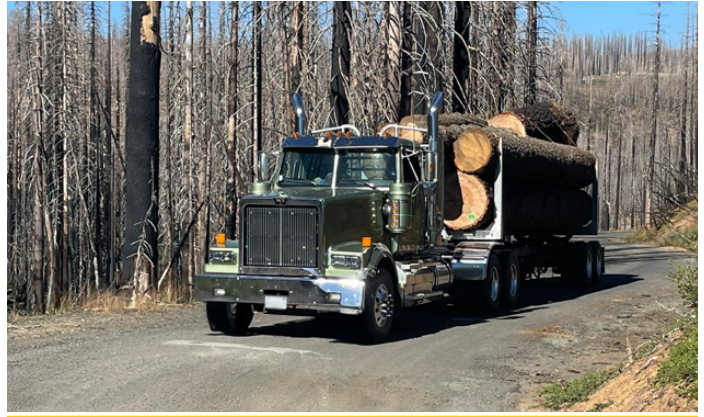
Figure 10. Photo. Timber-hauling truck on U.S. Forest Service Road in Plumas National Forest.

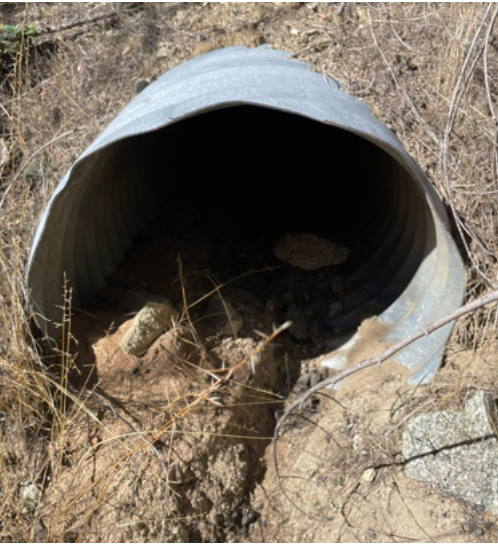
Figure 11. Photo. Clogged culvert.

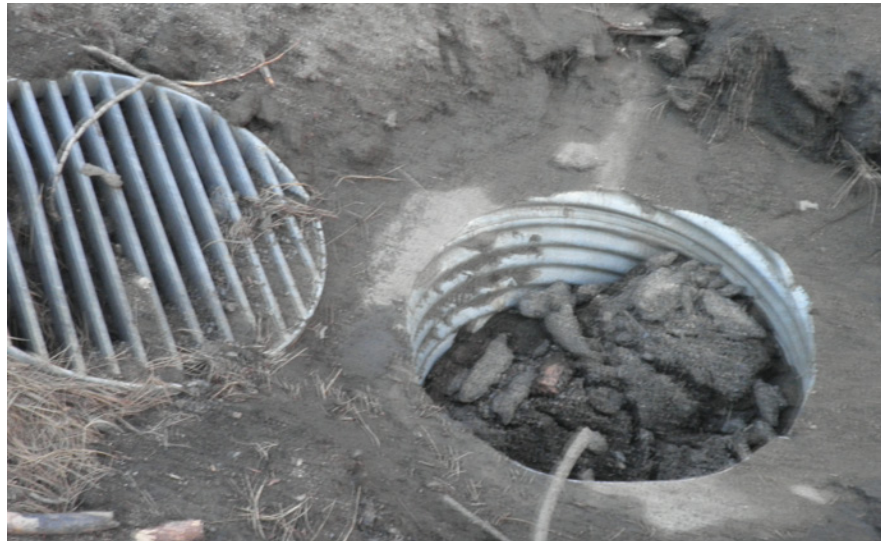
Figure 12. Photo. Clogged drop inlet.

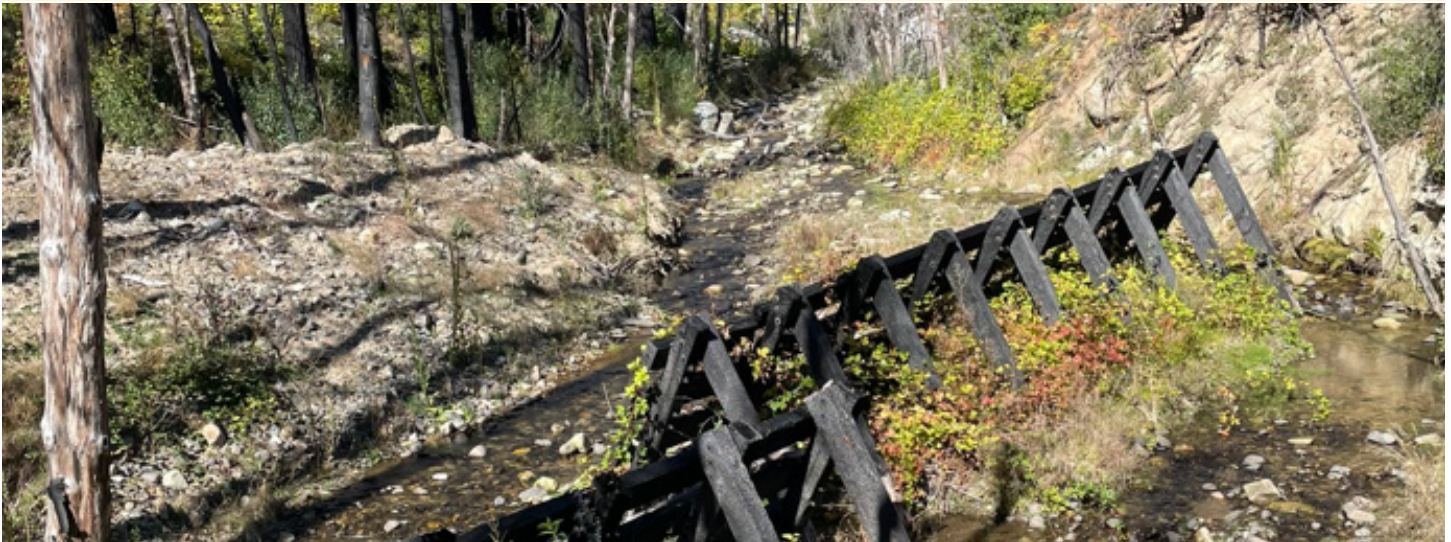
Figure 13. Photo. Trash racks to catch debris in downstream flow area in Plumas National Forest.

- Trash racks placed in strategic locations can limit damage to roads. Placement of trash racks in expected downstream flow areas can prevent debris that can clog culverts and potentially make roads impassable.¹⁷ Figure 13 shows a wooden trash rack structure in Plumas National Forest.
- Geogrids and geotextiles can provide stability to road surfaces. The U.S. Forest Service personnel indicated the use of geogrids and geotextiles beneath the bituminous surface treatment layer helped in preventing complete washouts of the road surface after flooding events in certain areas.¹⁸
- Effective communication and coordination among all involved agencies are vital to successful fire management and disaster response efforts. By fostering relationships and maintaining open lines of communication (between multiple agencies, such as county maintenance units, fire departments, emergency

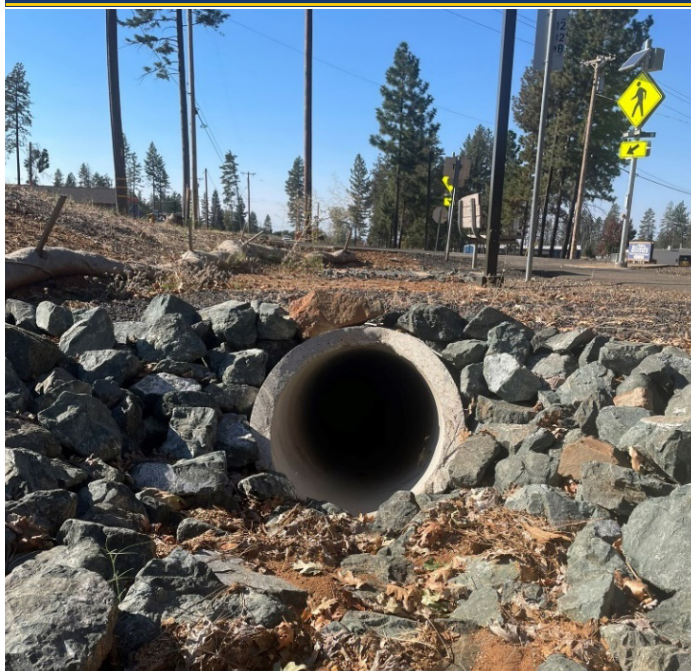
Figure 14. Photo. Concrete culvert pipe in Paradise, replacing an HDPE pipe.

- Use fire-resistant materials: In fire-prone areas, the authors recommended that agencies consider using fire-resistant materials, such as concrete and steel, for culverts in place of HDPE, PVC, or corrugated metal pipes. For example, the Town of Paradise replaced all HDPE culverts
