Oxygen Enhanced Fires in LD-3 Cargo Containers

May 1999

DOT/FAA/AR-TN98/29

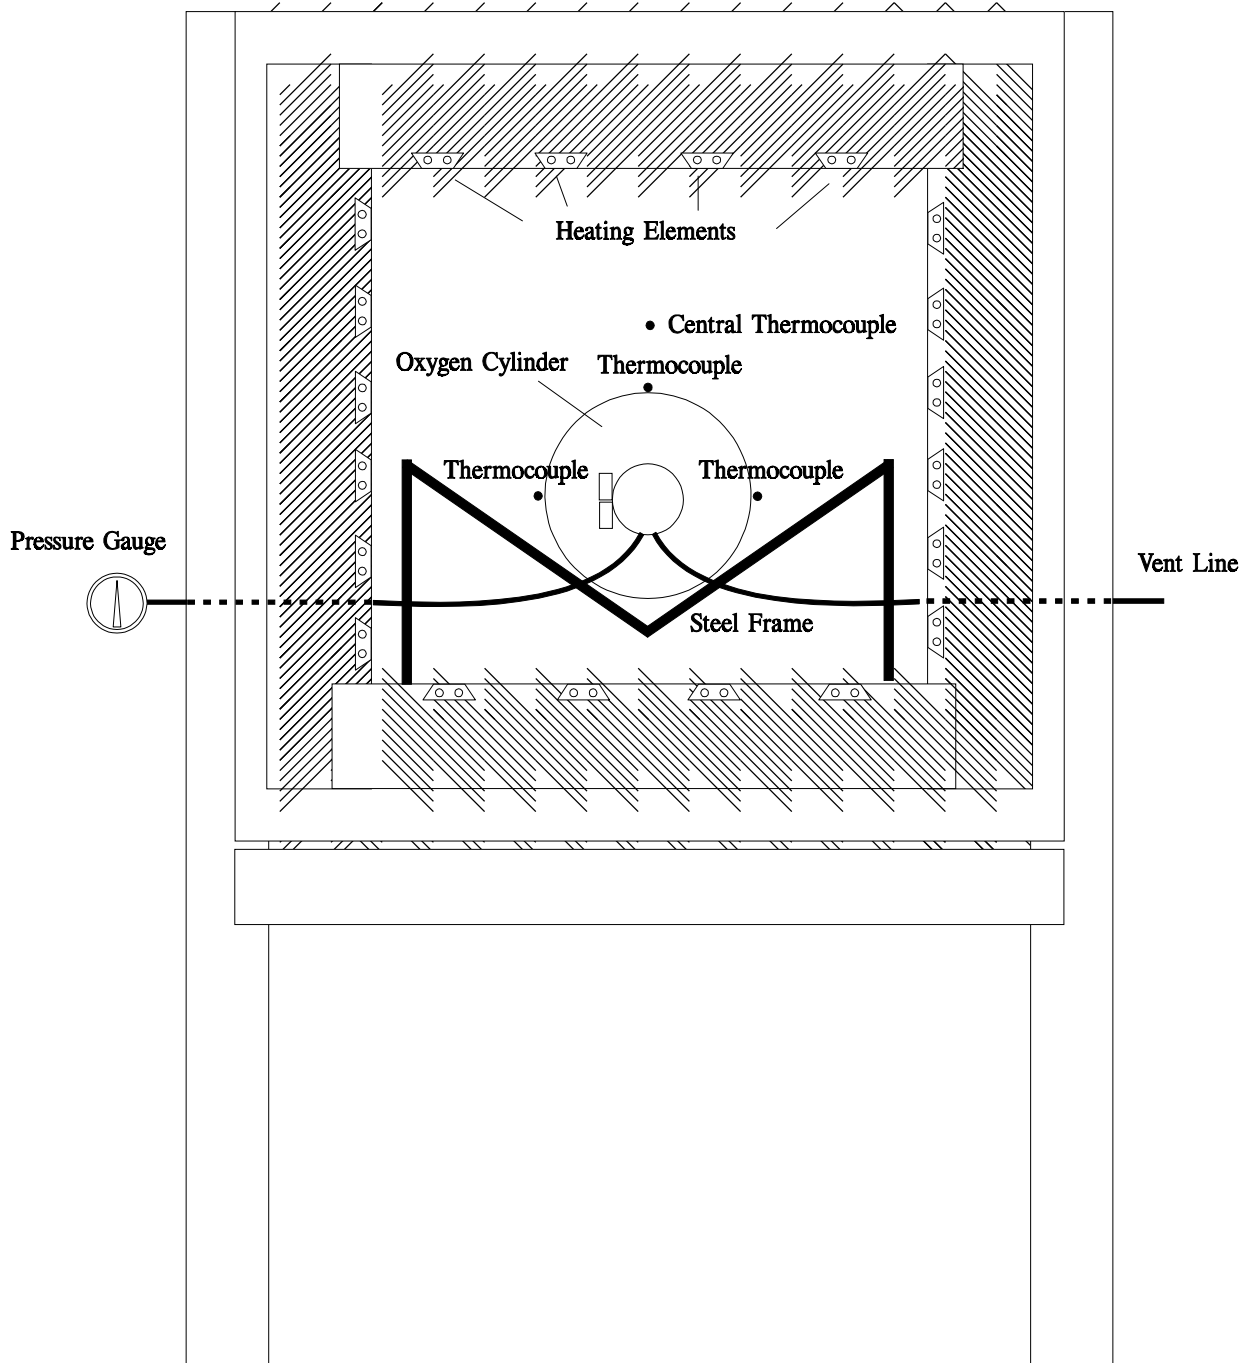
FIGURE 1. TEST FURNACE

A large, industrial-type high temperature electric box furnace was used for testing. The furnace was heated by means of coiled electric resistance-type alloy elements that are supported in hard ceramic element holders. The furnace insulation consists of a primary layer of lightweight

refractory insulating firebrick which is backed up with 2 inches of high temperature mineral fiber board. The temperature control system includes two separate zones of heating elements that are controlled independently with manual rheostat/bimetal percentage-type input controls. In addition, the overall furnace temperature is set by means of an automatic temperature control, which allowed ramping to 400°F in approximately 6 minutes. The internal dimensions of the furnace measured 37.5 by 26 by 25 inches (figure 1).

During the tests, the cylinders were attached to a steel frame that fit snugly into the test furnace to prevent cylinder movement and subsequent damage to the heating elements. The cylinder surface temperature was continuously monitored using three thermocouples attached directly to the cylinders. The furnace temperature was measured with a thermocouple located in the geometric center. A copper tube from the cylinder valve head was connected to a pressure gauge, allowing the internal pressure of the cylinder to be measured continuously during the heating process.

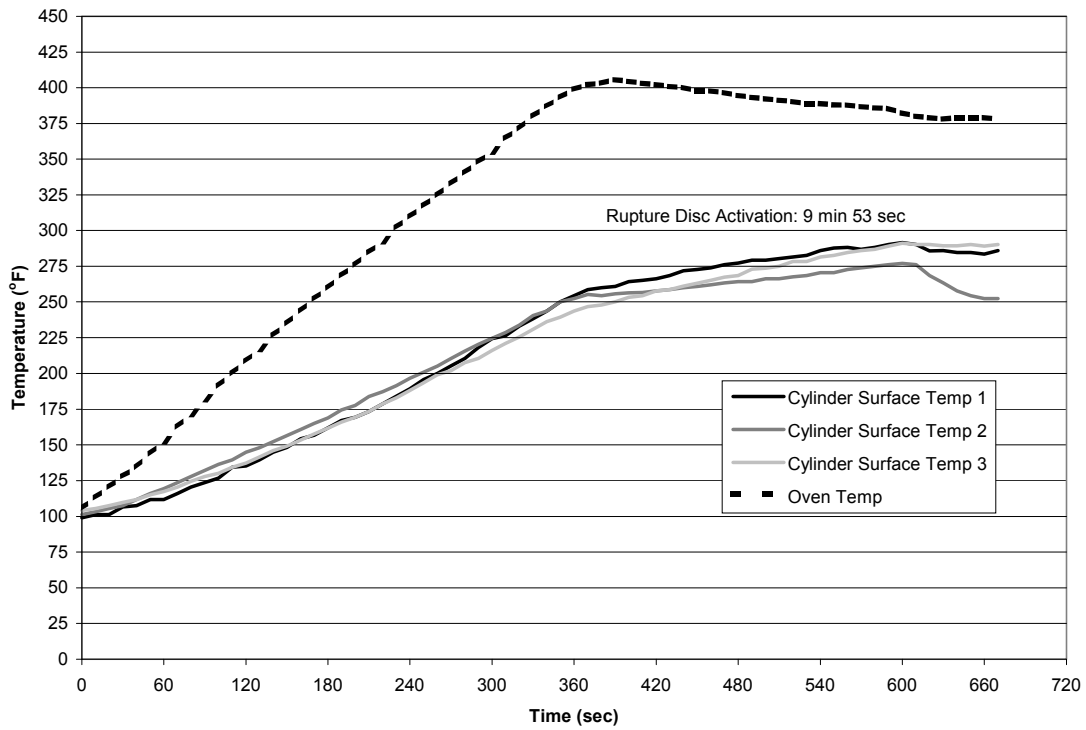
FIGURE 2. FURNACE TEST RESULTS USING A 76.5-CUBIC-FOOT CYLINDER

During the first furnace test, a 3HT-type, 76.5-cubic-foot cylinder was placed in the test frame holder. The cylinder measured 7.25 inches in diameter by 29.75 inches in length, excluding valve assembly. After the start of the test, the rupture disc activated at 9 minutes 53 seconds and required 33 seconds for the cylinder to fully evacuate. The temperature of the cylinder was 285°F, and the temperature inside the furnace was approximately 380°F at the time of release (figure 2). The cylinder internal pressure was approximately 2650 psi at the time of rupture disc activation. A second test was run under nearly identical conditions using a larger 115-cubic-foot cylinder that measured 9.00 inches by 29.56 inches. During this test, the rupture disc activated at 15 minutes 23 seconds and required 1 minute 12 seconds to fully empty. At the time of disc failure, the internal pressure was 2600 psi, and the cylinder surface temperature ranged between 300 and 320°F (figure 3). A final test was run using a small, 11-cubic-foot “walkaround” bottle that is typically used by flight attendants in the event of cabin depressurization. The cylinder was a type 3AA and measured 3.25 by 18.75 inches. A malfunction with the furnace temperature control resulted in a lengthy heating period; however, the rupture disc activated during temperature ramp-up at 17 minutes 12 seconds. The furnace temperature had reached between 350 and 370°F during release, at which point the cylinder surface temperature was between 300 and 325°F. The cylinder required only 5 seconds to fully discharge, and the pressure was observed to be approximately 2500 psi (figure 4). The average rate of release of nitrogen from the three cylinders was calculated to be approximately 2 ft³/sec.

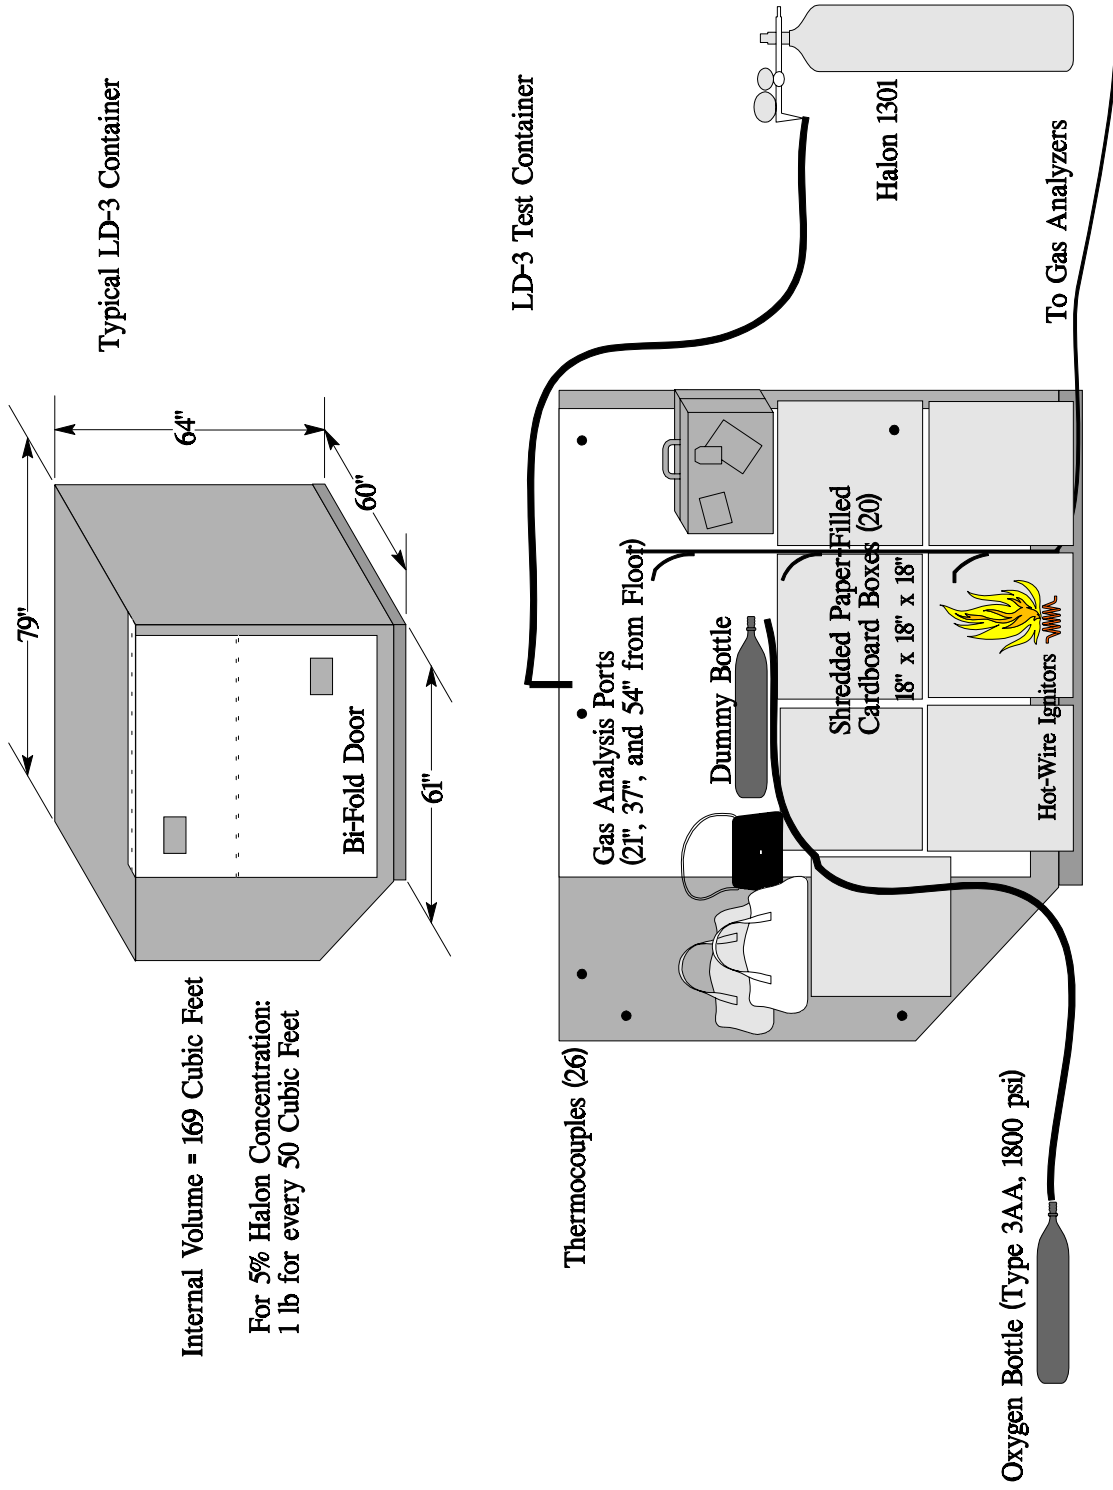
FIGURE 5. TEST 1 ARRANGEMENT IN AN LD-3 CARGO CONTAINER

In order to determine the impact of oxygen release during a fire, a steel-framed receptacle was constructed in the shape of an LD-3 container, which is typically used in the lower lobe of wide-bodied aircraft (DC-10, B-747, B-767, and L-1011). The test container had an internal volume of 169 cubic feet and could be rebuilt in the event of sidewall or ceiling damage. Sheet steel was used on most of the surfaces except for the top and front side, which was aluminum (0.63 inch thick). The fire load consisted of shredded paper-filled cardboard boxes measuring 18 by 18 by 18 inches. The boxes were loaded into the container in two tiers, each containing 9 boxes. An additional 2 boxes were loaded into the container for a total of 20. Thermocouples were placed on the four sides and ceiling of the test container. A gas sampling station contained intake ports at heights of 21, 37, and 54 inches from the floor. These lines passed through a series of filters prior to entering the gas analyzers, which continuously monitored the concentration of carbon monoxide (CO), carbon dioxide (CO₂), oxygen (O₂), and Halon 1301. A large, 1000-lb. Halon 1301 tank was available for fire suppression. A 0.375-inch diameter transfer line from the tank discharged halon from the center of the test container ceiling (figure 5).

During the first test several small rag-filled duffel bags and a large suitcase were also placed on top of the shredded paper-filled boxes (figure 5). The dummy cylinder was placed amongst this luggage which was also the area where the gaseous oxygen was discharged.

After ignition of the paper-filled fire box, the fire was allowed to develop for approximately 18 minutes, at which point the temperature in the fire box had reached 600°F, and a large amount of smoke was emanating from the edges of the container. Halon 1301 was then discharged into the LD-3 container, initially reaching a concentration of 8% at the top station (54 inches from the floor). The Halon 1301 concentration was allowed to decay until 30 minutes into the test where it had decreased to between 3.5% and 4.0%. At this point, the 11-cubic-foot oxygen cylinder was opened, but a problem with the valve prevented a rapid discharge. Instead of emptying in 5 seconds, as evidenced during the furnace test, the bottle required approximately 2 minutes to fully discharge. A review of the test data indicated the oxygen concentration inside the container rose from approximately 7% to 16% during the discharge. Slight increases in temperature were observed, but the oxygen release had little overall impact on the fire. The aluminum container ceiling did not allow flames to burn through at any time. At 60 minutes, the container was opened and the remaining fire was extinguished. Much of the original fire load was intact, as only 6 of the 20 boxes were burned, and there was no evidence of fire in and around the area of oxygen release.

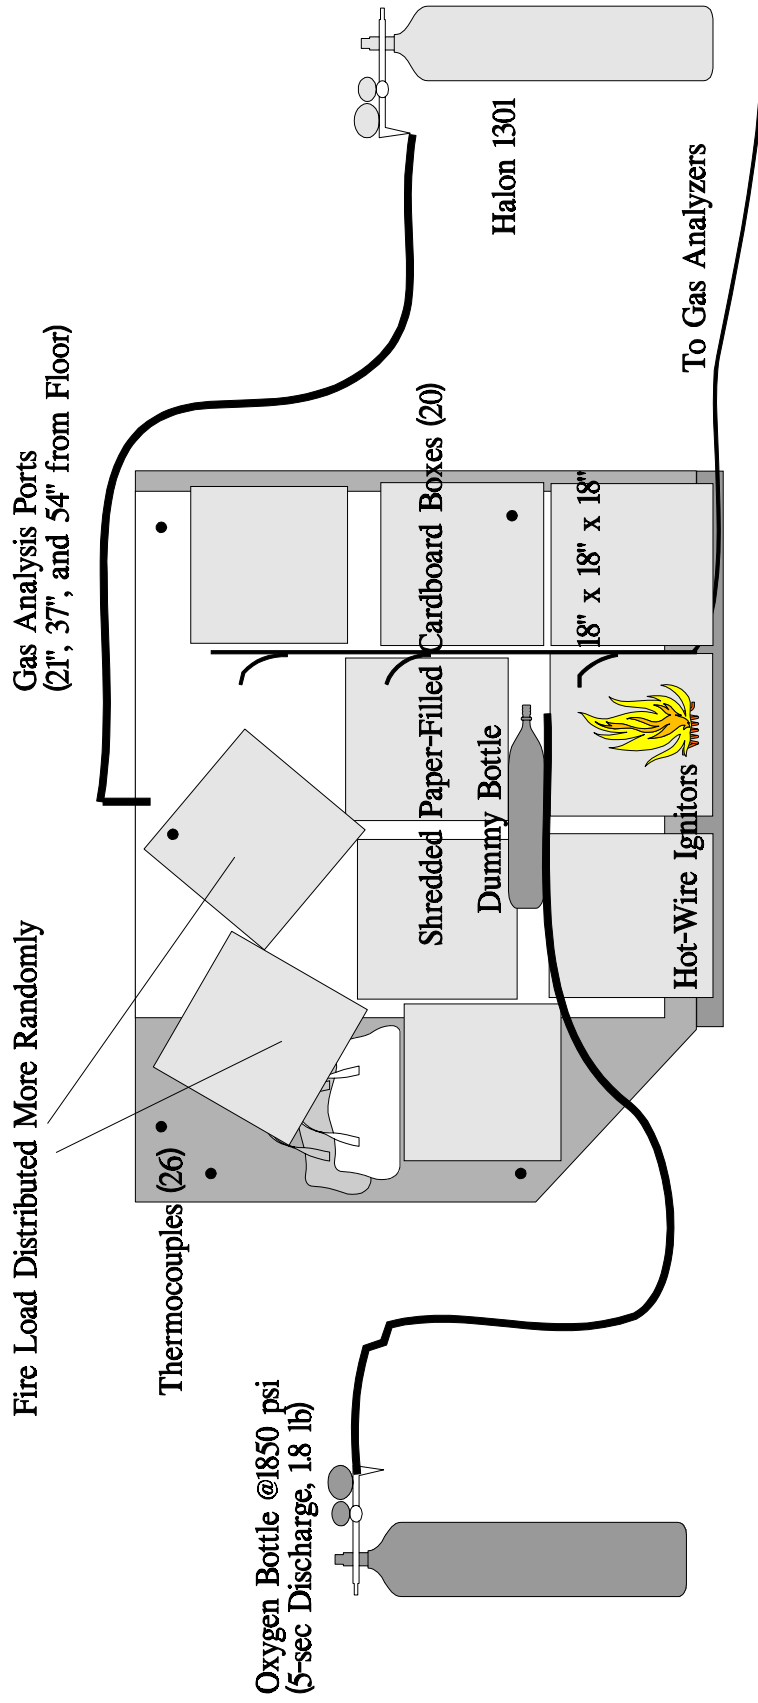
FIGURE 7. TEST 4 ARRANGEMENT IN AN LD-3 CARGO CONTAINER

Although the 11-cubic-foot oxygen release produced a severe condition inside the container, because of the short duration, it did not overcome the suppression capabilities of the Halon 1301. Since the planned test effort was to continue introducing greater but realistic oxygen quantities into the container in order to examine fire suppression capabilities of halon, twice the amount of oxygen was used in the fourth test. In an effort to expedite testing, a large welding torch oxygen cylinder was acquired and fitted with a manual on-off 90-degree valve. This allowed subsequent tests to be conducted at various discharge quantities, alleviating the need to purchase expensive cylinders of various sizes. It was predetermined that 22 cu ft of oxygen weighed 1.8 lb., so the cylinder was placed on a digital scale and the time required to release this amount from the cylinder was measured. This was observed to be 5 seconds. The execution of the test remained identical to the previous three, except for a minor deviation in the loading of the cardboard boxes, which were placed more randomly to allow for greater air circulation and better fire development (figure 7).

During the fourth test, one of the three dummy cylinder thermocouples had reached a temperature in excess of 300°F at approximately 6 minutes. Since one of the other two dummy cylinder thermocouples appeared to be malfunctioning, a determination was made to allow the test to progress a little further, since the remaining thermocouple was still well below 300°F. At

12 minutes 30 seconds into the test, the conditions were right for oxygen release, as the halon concentration was between 3% and 3.2%. Upon release, the front surface of the container was partially blown off, and flames shot out around the periphery in a violent fashion. An attempt was made to maintain the halon concentration at 3% to simulate a container inside a flooded compartment, but all of the gas analysis intake ports were clogged, so there was no way of tracking the concentration. As the test progressed, flames began to burn through the aluminum ceiling. After 21 minutes, the flames were extinguished but not before burning completely through the ceiling and part of the front side of the container, totally destroying it. A review of the thermocouple data indicated dramatic increases in temperature in the container four walls and ceiling immediately following the oxygen release.
