# **Full-Scale Tests on Rubblized Pavement Test Items at the National Airport Pavement Test Facility**

May 2010

DOT/FAA/AR-TN10/9

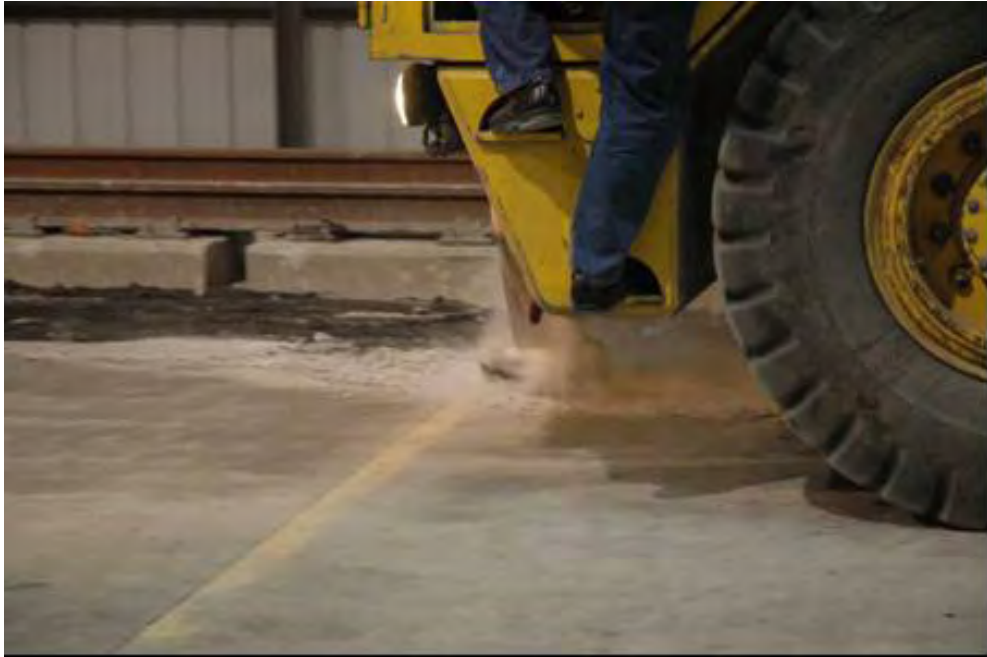
Figure 2. Rubblizing the North Traffic Lane With the Resonant Breaker

In January 2005, all the concrete slabs in the north traffic lane, including those in the transition sections, were rubblized with an RMI RB-500 resonant breaker operating at 44 Hz. In June 2005, the rubblized pavement was lightly wetted, rolled with a vibratory steel drum roller, and overlaid with 5 inches of P-401 HMA (two 2.5-inch-thick lifts). Figures 2 through 5 show, respectively, the vibrating foot of the resonant breaker, the rubblized surface being rolled, the test pavement surface after rubblization, and the test pavement surface after the overlay was applied (with the HWD equipment in position for uniformity tests).

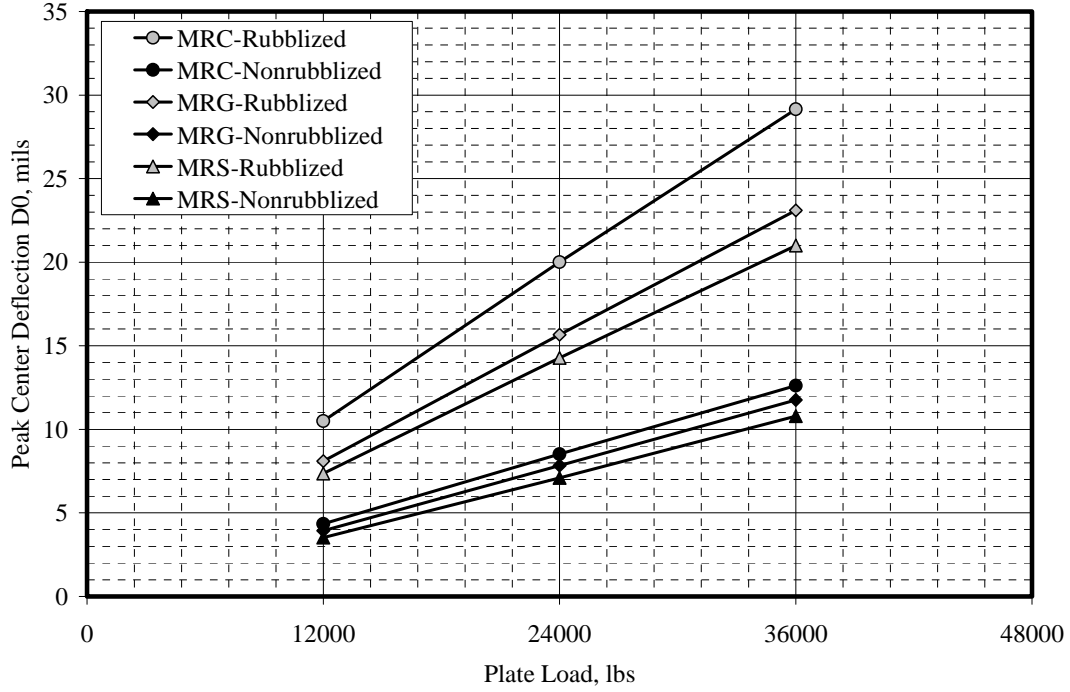
Figure 8. Mean Peak D0s From Uniformity Tests

**UNIFORMITY OF PAVEMENT STRUCTURES.** HWD tests were performed using the FAA Kuab HWD equipment on a 10-foot grid to study the uniformity of the pavement structures, see figure 5. Tests were performed with a 12-inch-diameter plate at three different load levels: 12,000, 24,000, and 36,000 lb. The results showed that the pavement structure within each test item was fairly uniform. For peak center deflection ( $D_0$ ), the coefficient of variation (COV) ranged between 20 and 25 percent. For deflection  $D_7$  (at 72-inch offset from the center of load plate, and an indicator of subgrade condition), the COVs were approximately 10 percent. Figure 8 shows that the mean  $D_0$ s for the rubblized test items were larger than the  $D_0$ s for the nonrubblized test items. Also, among the rubblized test items, MRC showed the highest deflections, followed by MRG, and then by MRS. This order was counter to expectations because MRC had a crushed aggregate subbase course and would normally be expected to be of higher stiffness than the MRG pavement built directly on the subgrade. Pretraffic measurements of subgrade strength in the test pits showed that water had migrated from the crushed aggregate subbase into the subgrade of MRC and softened approximately the top 3 inches of the subgrade. The subgrade surface in the MRC test pits had strength of approximately 4 CBR, whereas the strength 1 foot below the surface was approximately 8 CBR. The subgrade surface in the MRG and MRS test pits ranged from 7 to 8 CBR, as constructed. The order of failure, discussed in the next section, also followed the order of the HWD deflection magnitudes.

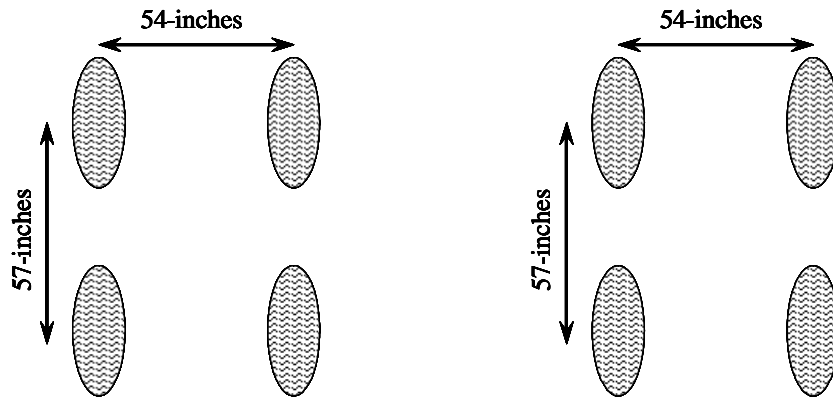
Figure 11. The Four-Wheel Landing Gear Configuration Used on Both North and South Wheel Tracks

Only four wheels were available for loading on the nonrubblized traffic lane, so traffic began with a four-wheel, dual-tandem configuration (figure 11) on both traffic lanes. The geometry was the same on both traffic lanes, with dual spacing of 54 inches and tandem spacing of

57 inches. Wheel load was set at 55,000 lb because this was the load applied to the new construction CC-2 test items and, although badly cracked at the end of trafficking, all the test items were capable of structurally supporting the loads applied up to the end of trafficking. Adding 5 inches of asphalt implied that the nonrubblized pavement would be capable of structurally supporting considerably more traffic at the same load. Calculations of the predicted life of the rubblized pavements using the assumptions of flexible pavement response and characteristics indicated that, for the initial traffic loading case, the structure on grade (MRG) might fail fairly quickly, somewhere between a few hundred and a couple thousand repetitions. The structure on stabilized base would probably last for many tens of thousands of repetitions. The standard NAPTF 66 repetitions per cycle wander pattern (figure 12) were used on both traffic lanes.

**Wheel Load = 55,000 lbs**

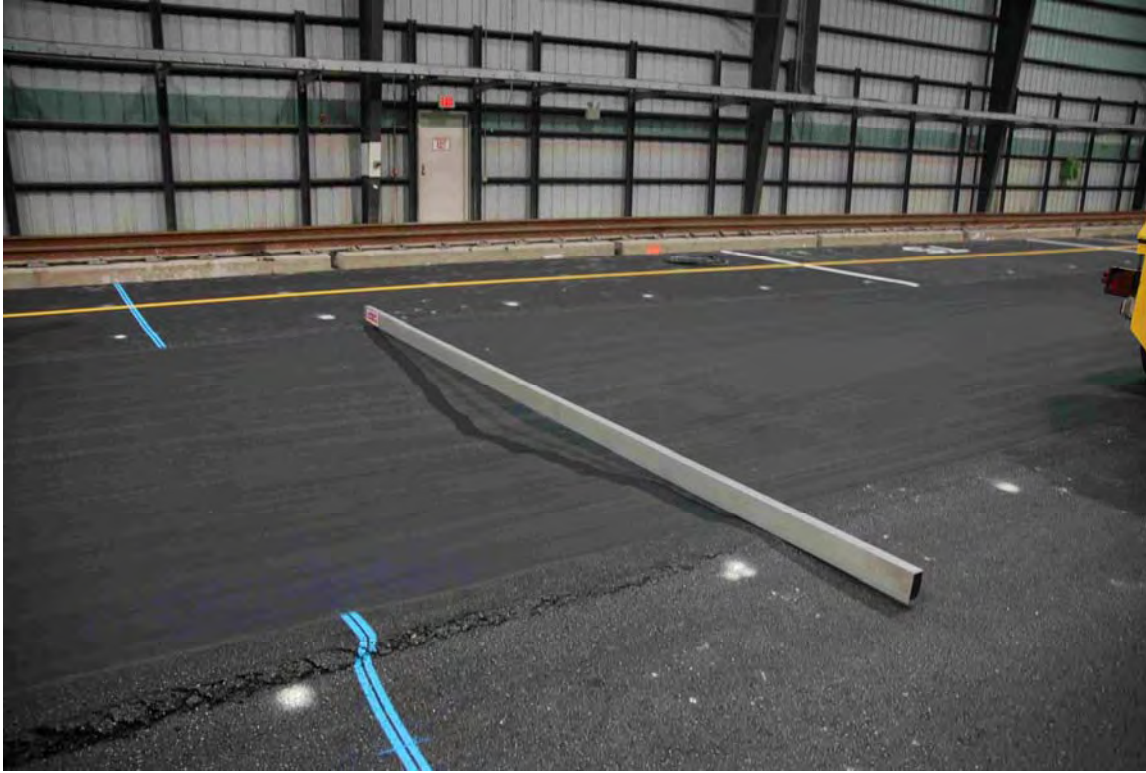
Figure 18. Pavement Failure in the East End of Rubblized Test Item MRC

The NE end of MRC was the first area of the rubblized pavements to show signs of failure (figure 18). This failure was not representative of the test item’s structural performance as a whole because one of the preoverlay test pits (for subgrade evaluation) was located where the pavement failed. A weakened support system resulted because the replaced subbase aggregate material could not be compacted to the same density as in the original construction. A depression in the pavement surface was observed at this location after about 400 load repetitions. The depression migrated longitudinally toward the east until it was about 15 feet long, but the structure continued to support the full traffic load until it appeared to be in danger of suffering complete structural collapse at 11,814 passes. The weakened area did not migrate back into the west half of the test item, and the declared structural life of MRC-NW of 14,256 passes is believed to be a true representation of the structural performance of the test item. Also, MRC-NW did not appear to be in danger of complete structural collapse as had MRC-NE. Trafficking in MRG and MRS was terminated after 25,608 passes. From visual inspection at the end of trafficking, MRG-N appeared to be suffering from structural upheaval outside the wheel track, but MRS-N did not.

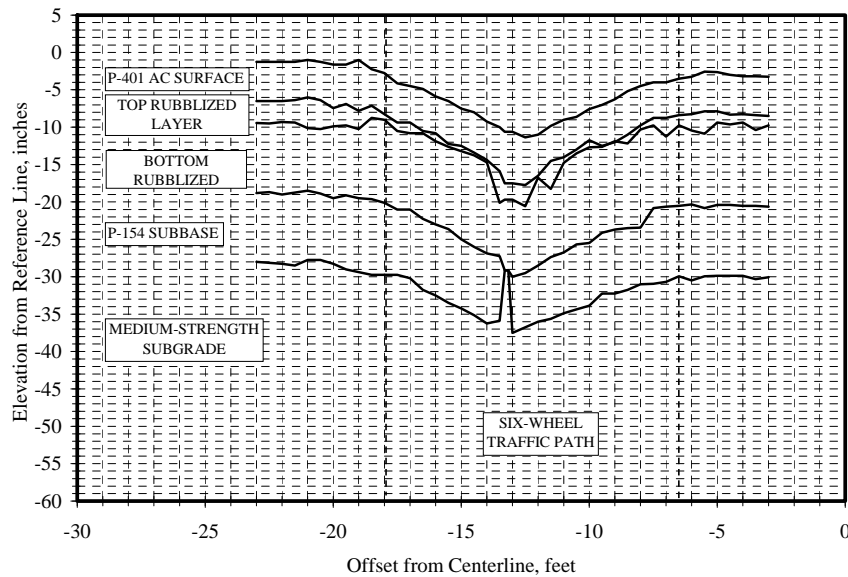
Figure 19. Pavement Layer Profiles From Trenches in Test Item MRC

When the tests were completed, the trench walls were cleaned to clearly expose the layer interfaces. The pavement layer profile measurements can be used to quantify the contribution of each component layer to the total pavement rutting and upheaval. Measurements of the pavement layer interface profiles were made relative to a horizontal string line. Figure 19 shows the layer profiles in test item MRC.

The figure shows that the HMA surface and the top rubblized layer (top 3 inches of finely rubblized material) contributed to rutting. Shear failure in the subgrade resulted in significant upheaval outside the traffic path. Subgrade penetration into the subbase was observed. Significant shoving in the HMA layer was also observed.

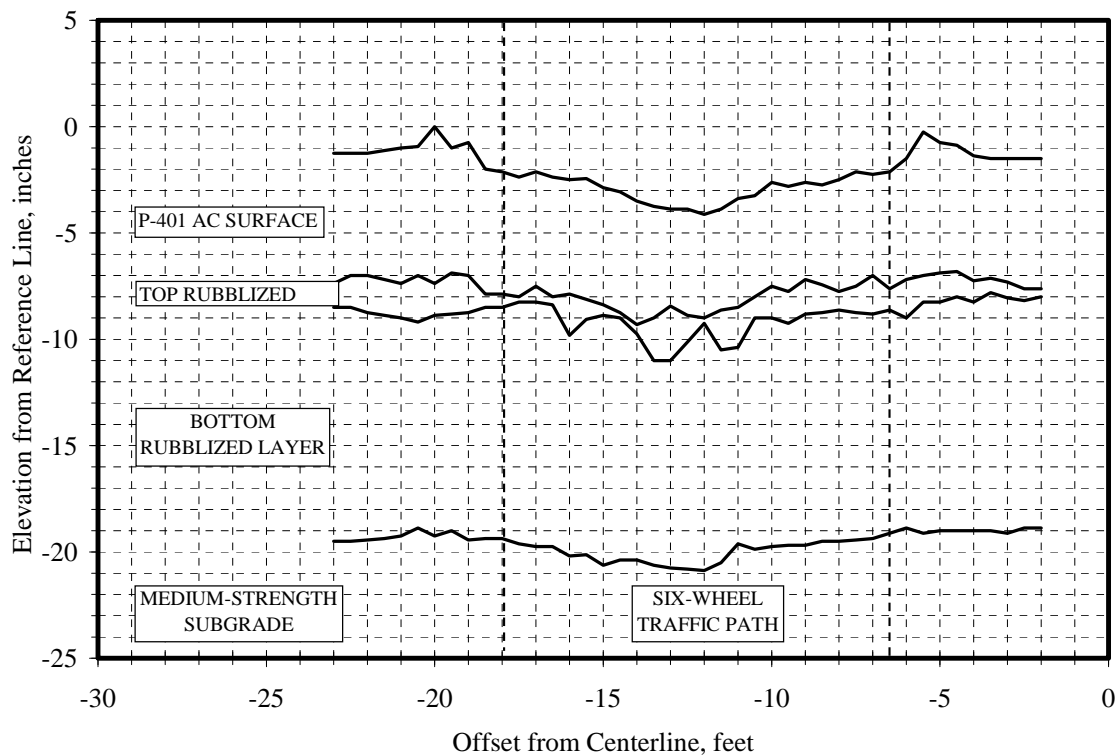
Figures 20 and 21 show the pavement layer profiles for test items MRG and MRS, respectively. The figures show that most of the rutting was contributed by the top 3 inches of the thin rubblized layer and the HMA overlay. The top 3 inches of rubblized layer are mainly composed of loose dust and stones with a top size of 1 inch. The bottom 9 inches of rubblized layer were 4 to 15 inches of tightly locked concrete pieces. A significant amount of shoving in the HMA layer was observed that resulted in significant upheaval just outside the traffic path. The subgrade in test item MRG (figure 20) showed indications of shear failure, as evidenced by the subgrade upheaval outside the traffic path.

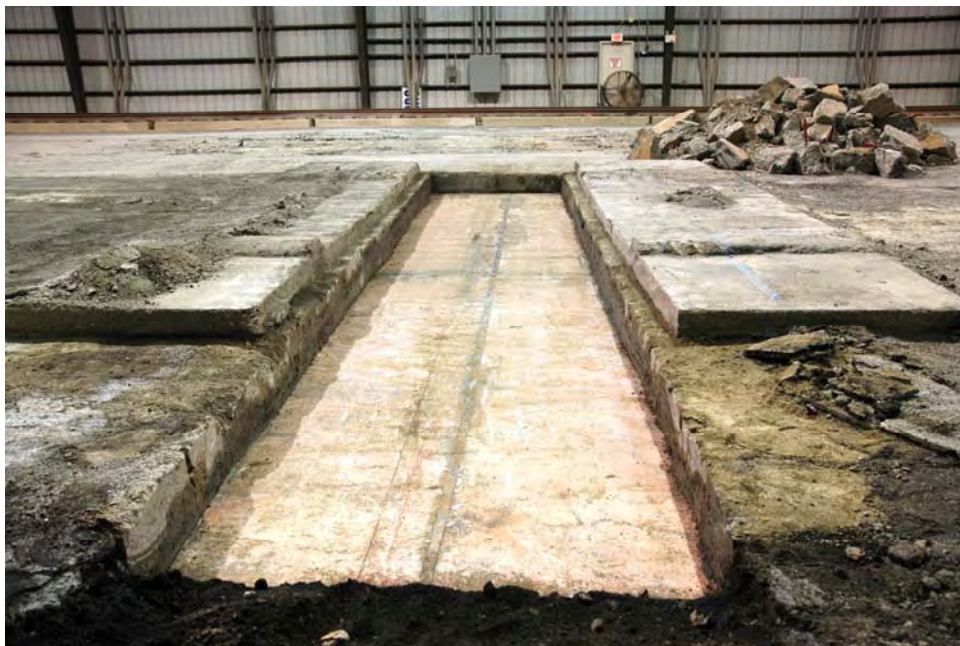
Figure 22. P-306 Econocrete Subbase in Test Item MRS

Another observation made during the trenching study was that the rubblization process did not induce any cracks in the underlying P-306 econocrete subbase layer in test item MRS (figure 22).

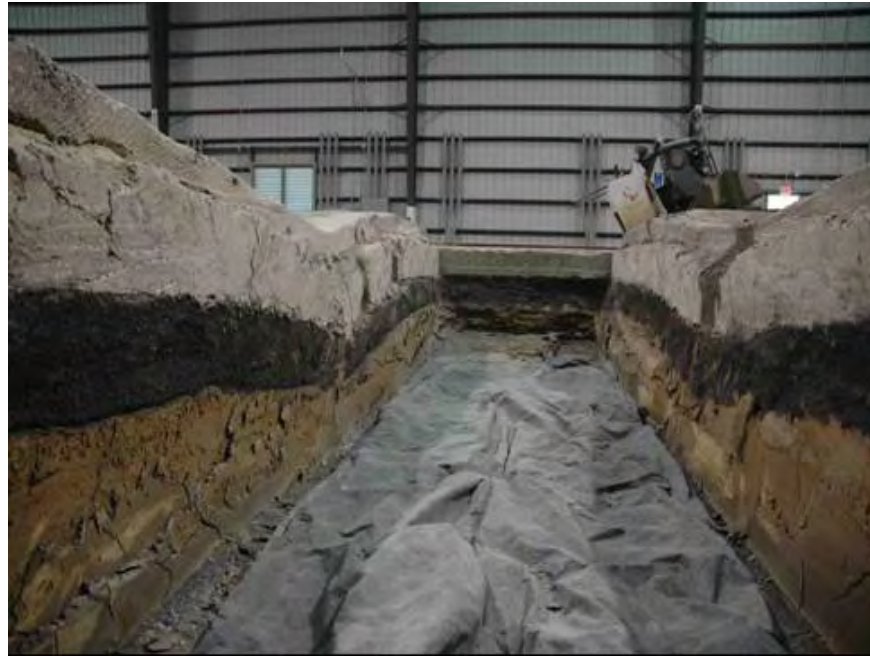
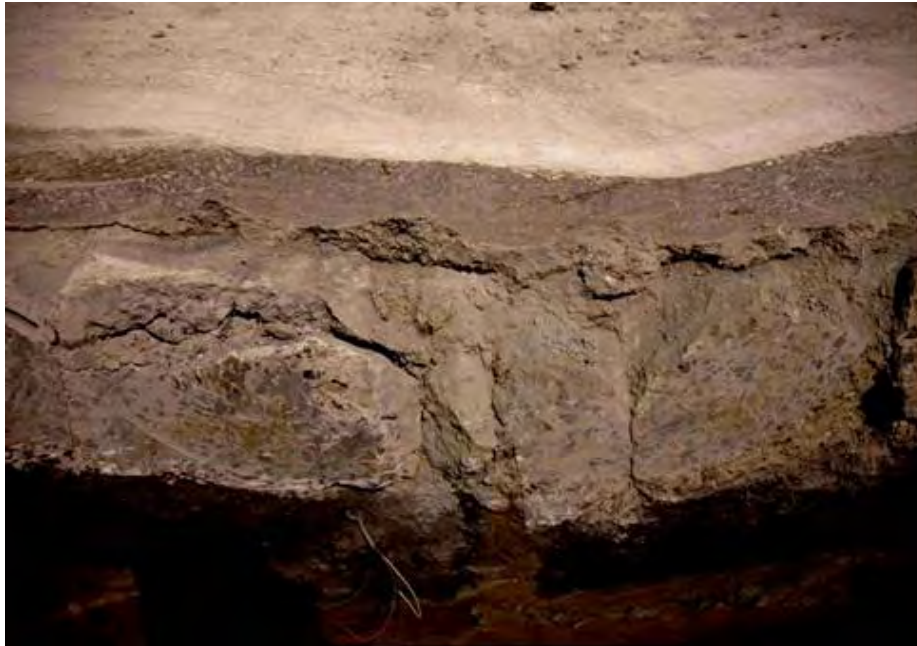
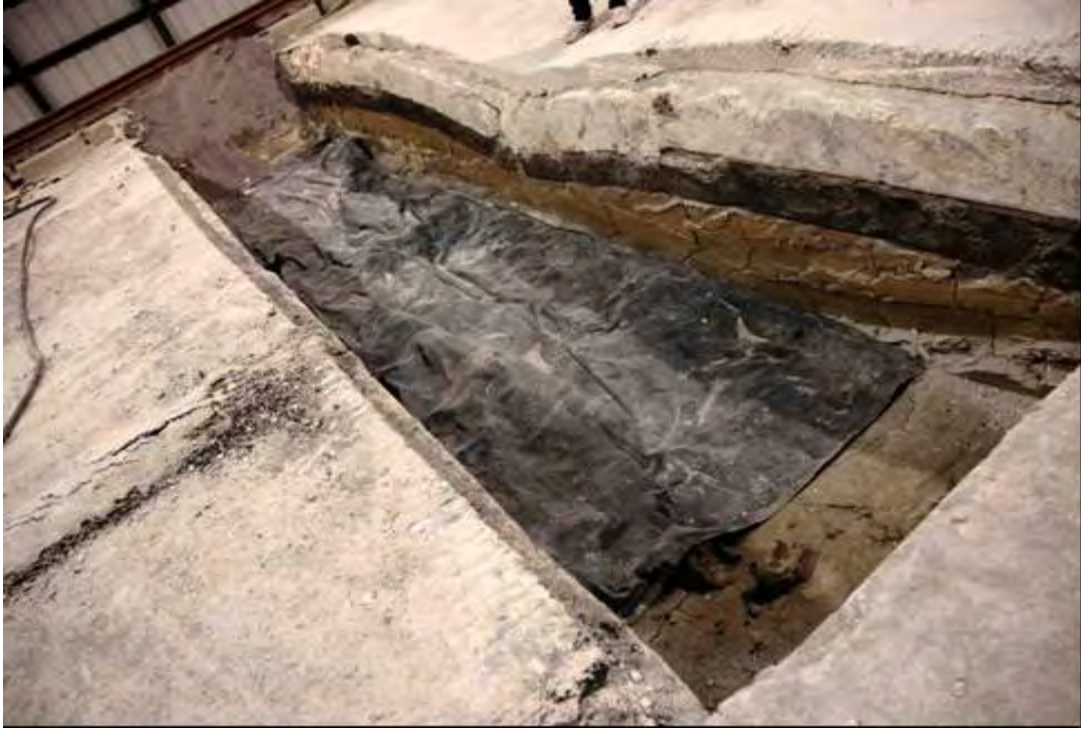
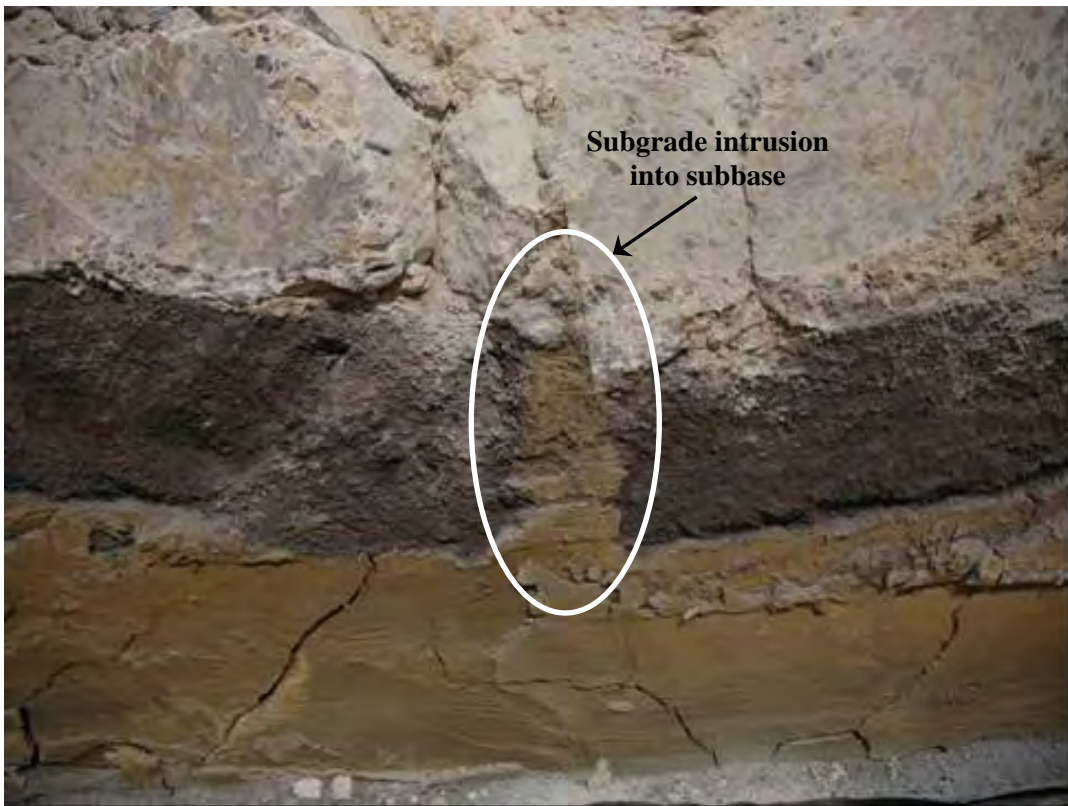
Figures 24 through 27 show the trench faces in test item MRC and close-ups of the failure zones. Figures 28 and 29 show the MRG and MRS trenches, respectively.

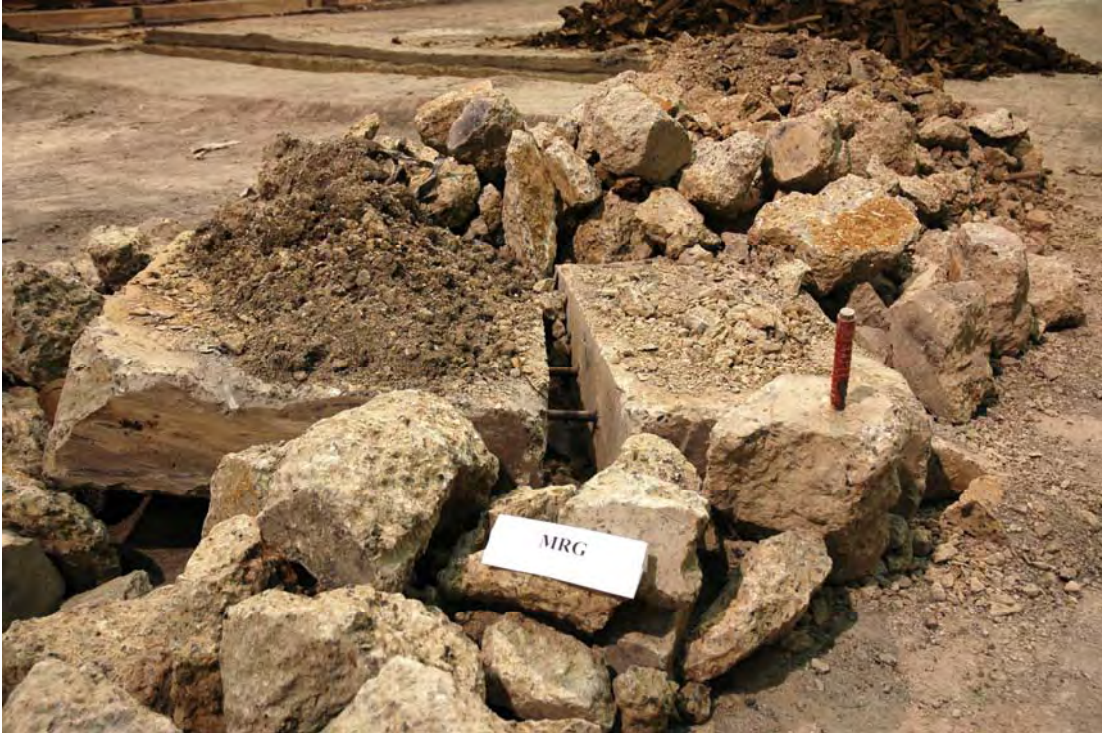
Figure 35. Rubblized Concrete Pieces Still Connected With Dowels

The increased crack width between the rubblized concrete pieces would also contribute to the increased peak surface deflections. Another factor contributing to the vertical deformation is the top 2 to 3 inches of fine material under the HWD load, where increased peak center deflections could result in lower than expected backcalculated modulus values. The HWD tests inside the traffic path were centered over an underlying dowelled longitudinal joint. During the posttraffic trench study, it was observed that the rubblization process did not debond the dowels (figure 35) from the two adjacent slabs, and the size of concrete pieces ranged from 3 to 4 feet in length and width. It is possible that this may have contributed to the higher D0s rather than the deterioration of the rubblized concrete layer. However, none of these factors significantly affected the performance of the rubblized layer, as observed from the rut depth measurements.
