Evaluation of Runway Guard Light Configurations at North Las Vegas Airport

January 2007

DOT/FAA/AR-TN06/19

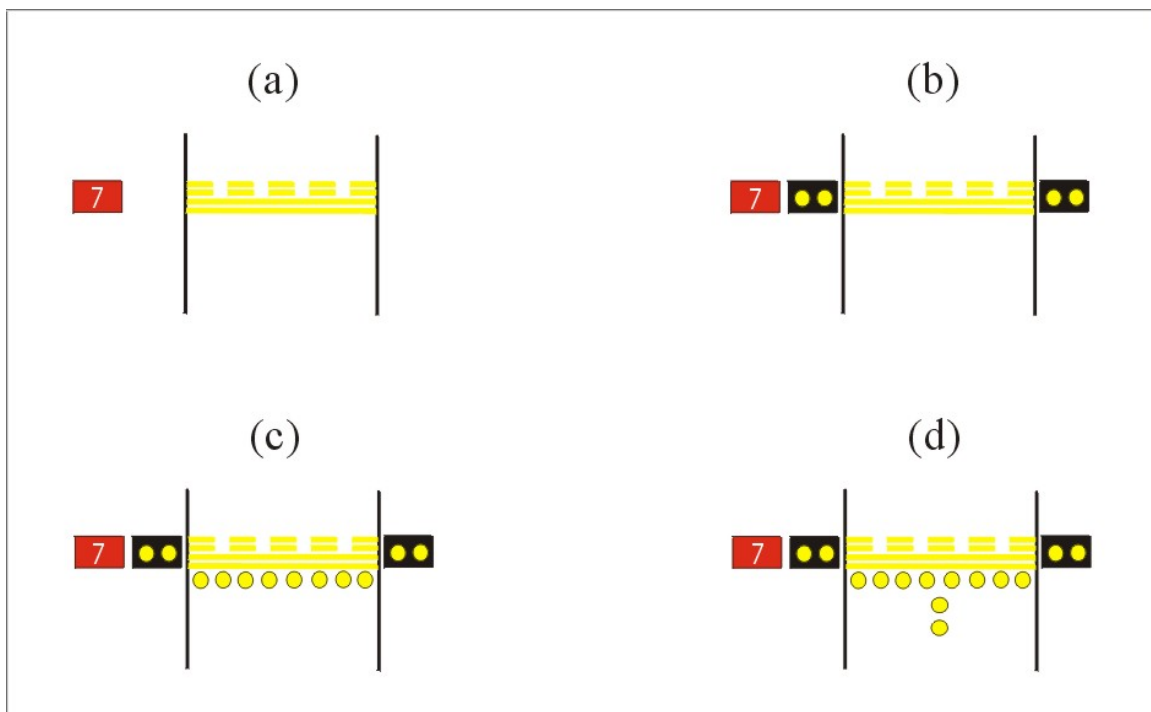
Figure 1. Evaluation Configurations

1. The basic hold position configuration includes standard painted runway hold position markings with associated L-858R mandatory instruction signs (white runway designation on a red background), see figure 1(a).
2. The basic hold position configuration with the addition of L-804 elevated runway guard lights (RGL), see figure 1(b).
3. The basic hold position configuration with the addition of elevated RGLs and L-852G in-pavement RGLs, see figure 1(c).
4. The basic hold position configuration with the addition of both elevated and in-pavement RGLs and alert zone lighting (T-configuration), see figure 1(d).

The simplest RGL system (on which the basic hold position configuration is based) consists of a pair of elevated L-804 fixtures located on each side of a taxiway, in line with the runway hold position marking. For increased conspicuity, a series of pulsing yellow in-pavement L-852G fixtures may be used in addition to the elevated L-804 fixtures, positioned equally at 8-foot spacing in front of the runway hold position marking and between the two elevated L-804 fixtures. The two configurations, when used together, offer enhanced visual cues to pilots that they are approaching the hold position marker, and that they need further clearance to proceed, thus reducing the likelihood of causing a runway incursion.

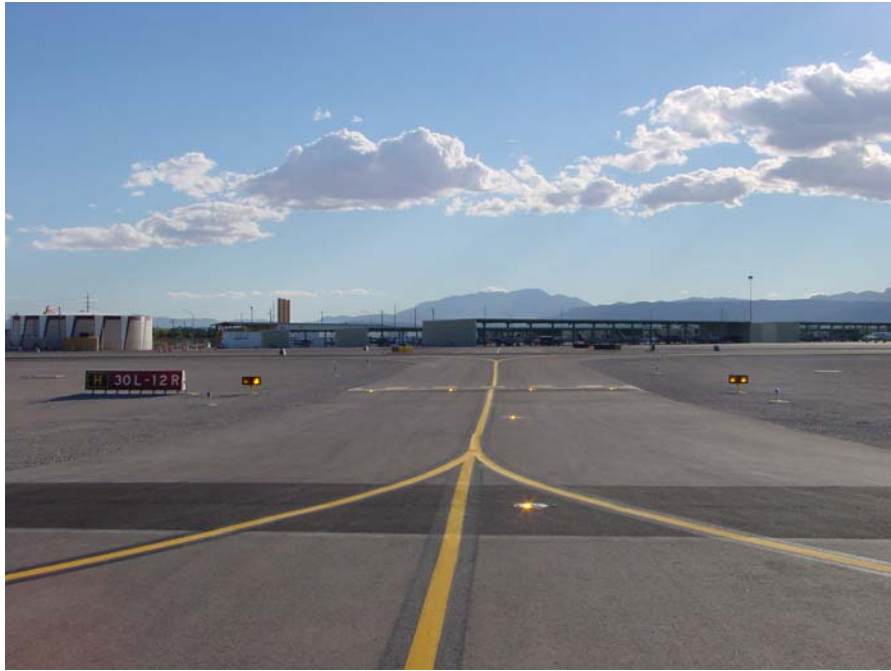
Figure A-1. Delta 1—Runway 12R-30L and Taxiway H (Northeast side)

- Delta 1—Basic Configuration with L-804 elevated RGL, L-852G in-pavement RGL, and L-852G Alert Zone Lighting (T-configuration)—Runway 12R-30L and Taxiway H (NE side) (figure A-1).
- Delta 2—Basic Configuration with L-804 elevated RGL and L-852G in-pavement RGL—Runway 12R-30L and Taxiway C (NE side) (figure A-2).
- Delta 3—Basic Configuration with L-804 elevated RGL—Runway 12L-30R and Taxiway H (SW side) (figure A-3).

This data acquisition location was the first of three approaches (identified as Delta 1, 2, and 3) to either of two runways (12R-30L and 12L-30R) from parallel taxiway D. The Delta 1 observation and data collection path was in a northerly direction along taxiway D to obtain acquisition distances for the configuration identifying the holding position at the intersection of taxiway H and runway 30L-12R (see figure 2 for illustration). The configuration at this location was comprised of standard painted runway holding position markings with associated L-858R mandatory instruction signs (white runway designation on a red background), L-804 elevated RGL, L-852G in-pavement RGLs, and L-852G alert zone lights (T-configuration).

The approach to this holding position, as well as those for the other two Delta locations, required making observations along a path primarily at right angles to the signs, lights, and markings; therefore, one would expect greater difficulty in acquiring and identifying the configuration components. This is evident when considering the relatively short distances at which the signs could be read, a result of the acute viewing angles at which observations were begun. Obviously, the signs would have been much more effective if viewed head-on initially, as is borne out at other locations (Hotel 1, Alpha 1, etc.). The elevated lights, on the other hand, provided approximately double the acquisition range during three of the four daylight and night conditions. The elevated lights were less effective during full daylight, when the yellow light could not compete with the bright Nevada sunlight. The in-pavement lights, in the T-configuration, were of only reduced effectiveness due to the physical cutoff of the lenses recessed within the fixture combined with the acute viewing angles along the approach path. The relatively narrow beam of the in-pavement lights normally restrict their utility to situations wherein they are viewed principally from angles well within the main beam.

It should be noted that during the dusk period, a pilot approaching the Delta 1 hold position faces directly into the setting sun once turning onto taxiway H. In this situation, the lighting array was more effective than the sign in identifying the critical location, and certainly more effective than the glare-masked markings.

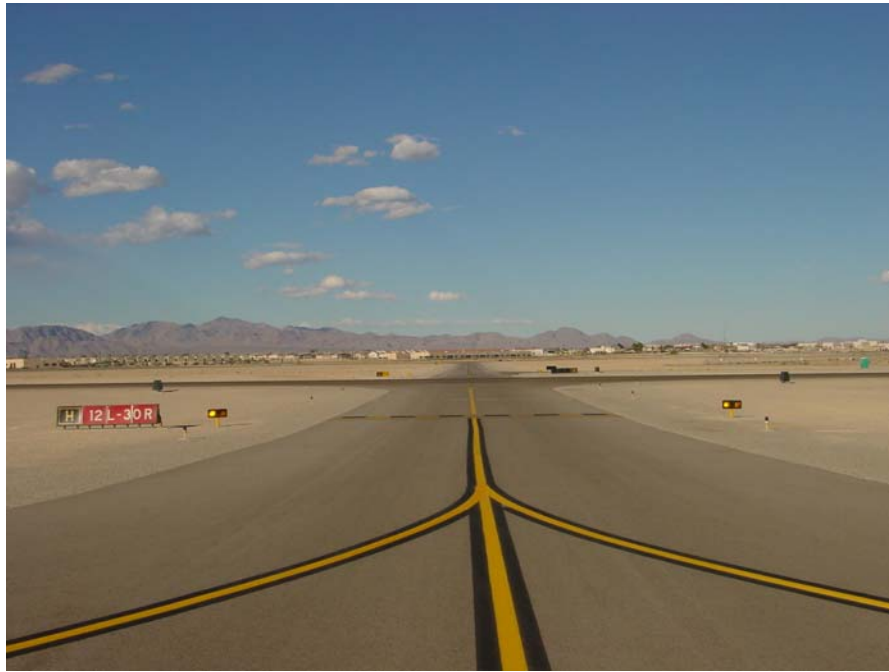
Figure A-3. Delta 3—Runway 12L-30R and Taxiway H (Southwest side)

The configuration at this location was comprised of standard painted runway holding position markings with associated L-858R mandatory instruction signs (white runway designation on a red background) and L-804 elevated RGLs.

The Delta 3 location is the last of the three Delta sites and is, once again, approached from a most acute angle along taxiway D. As expected, the lights (in this case, only elevated fixtures) are notably more effective than either the sign or markings, except during full daylight. A rather unique affect was observed during afternoon periods when the sun was in its western quadrant, shining directly on the yellow filters of the elevated lights. In this situation, both lights of the elevated RGL appeared to be illuminated, and no wig-wag effect was discernable.

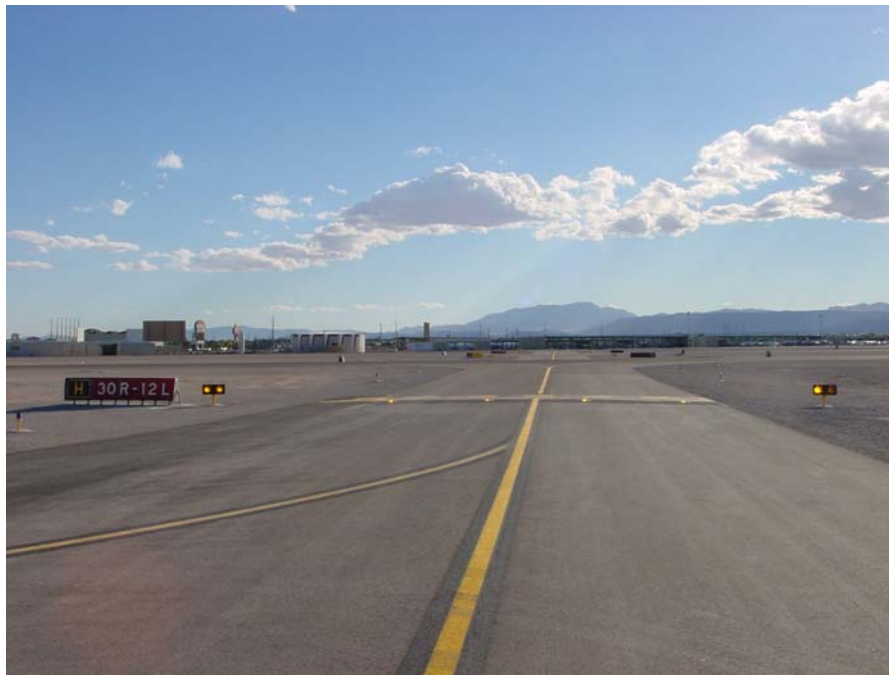
Figure A-4. Hotel 1—Runway 12L-30R and Taxiway H (Northeast side)

- Hotel 1—Basic Configuration with L-804 elevated RGL and L-852G in-pavement RGL—Runway 12L-30R and Taxiway H (NE side) (figure A-4).
- Alpha 1—Basic Configuration with L-804 elevated RGL—Runway 12L-30R and Taxiway A (E side) (figure A-5).
- Alpha 2—Basic Configuration with L-804 elevated RGL—Runway 7-25 and Taxiway F (S side) (figure A-6).
- Alpha 3—Basic Configuration with L-804 elevated RGL—Runway 12R-30L and Taxiway A (W side) (figure A-7).
- Alpha 4—Basic Configuration with L-804 elevated RGL—Runway 12L-30R and Taxiway A (W side) (figure A-8).

At this location, the approach path taken by the subject began at the intersection of taxiways A and H and proceeded directly toward the Hotel 1 hold position at the intersection with runway 30R-12L. In each instance, and under all daylight and night conditions, the subjects were able to acquire and identify the elevated lights from the turnaround point (maximum range) at taxiways A and H intersection. The in-pavement lights were also acquired at the maximum range, except during the dusk period when the setting sun was directly facing the viewer. The sign was also visible at the maximum range, but could not be read (a requirement) before reaching the somewhat closer distance shown in table 4. The markings were, as with the previous sites, effective only at close range during the day or when illuminated by the vehicle headlights after dark.
