IDAHO TRANSPORTATION DEPARTMENT

RESEARCH REPORT

Combining In-situ and Remote Sensing-Based Monitoring Methods to Improve the Efficiency and Accuracy of Landslide Monitoring Activities

RP 311

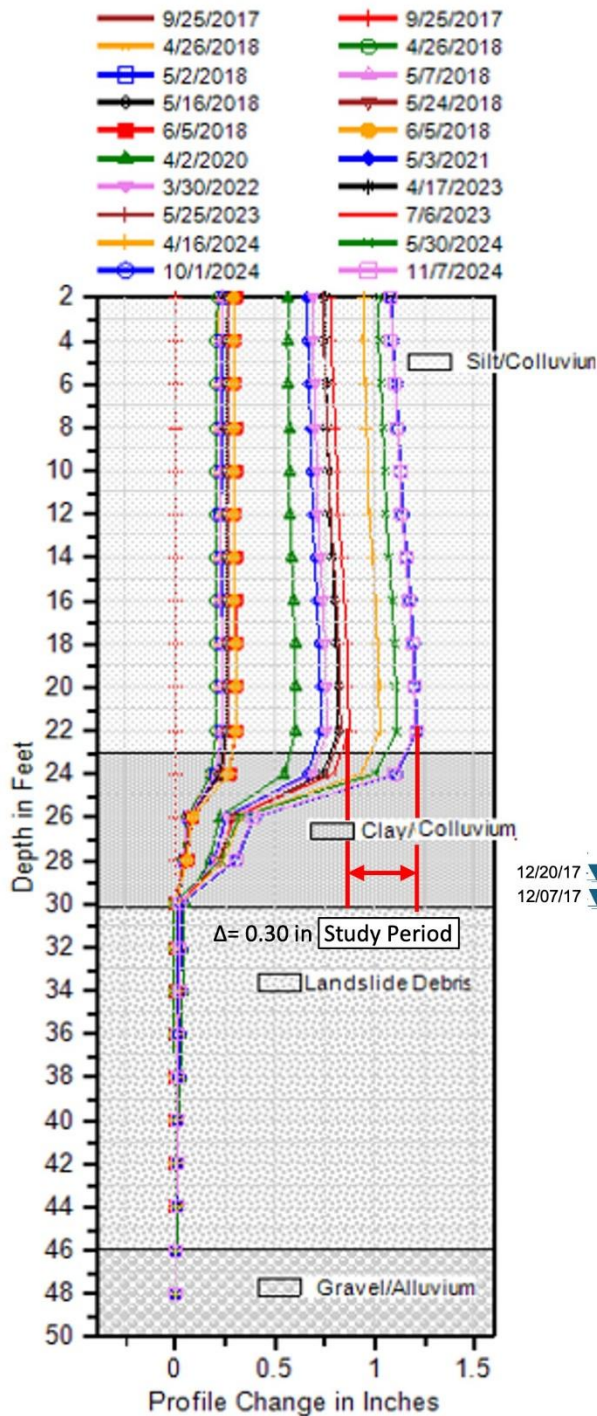
Swan Valley LT-2 A

LT-2 09/07/2017		
Elevation (ft)	Material Description	N(B/FT)
5268.0	Stiff, brown, slightly clayey SILT (ML); trace fine sand, moist (COLLUVIUM)	12
		16
		13
		12
5247.0	MEDIUM STIFF to STIFF, brown, slightly silty CLAY (CL); trace fine sand, moist (COLLUVIUM)	5
5239.8		50/4 in
	DENSE to VERY DENSE, gray, sandy GRAVEL (GW); trace clayey silt infilling, rounded to subrounded gravels up to 4" (LANDSLIDE/SLIDE DEBRIS)	CR: 41%
		CR: 29%
		CR: 10%
5224.0	MEDIUM DENSE, gray to brown sandy GRAVEL (GW); subrounded to rounded gravels (ALLUVIUM)	CR: 43%

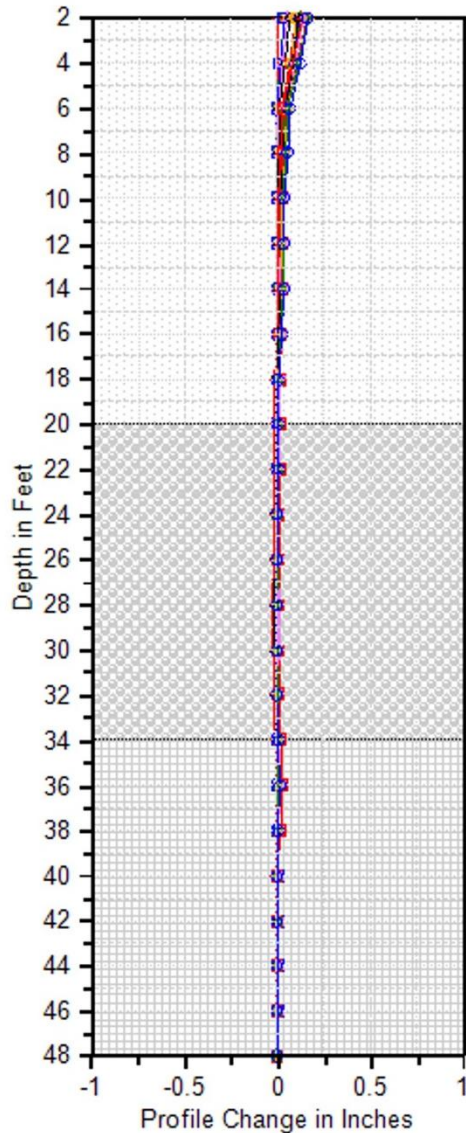
Rainey Creek LT-10 A

LT-10 09/10/2017		
Elevation	Material Description	N (Blows/ft)
5260	VERY SOFT to SOFT, brown, Clayey SILT to silty CLAY (CL-ML); trace fine sand, slightly moist to dry (EMBANKMENT FILL)	2
		5
		10
5240	DENSE to VERY DENSE, slightly clayey, silty sandy GRAVEL; angular sand-to gravel-sized rock fragments, scattered ash layers, dry (DECOMPOSED BRECCIA)	50/2 in
		50/3 in
		50/1 in
		50/1 in
5226	HARD, dark gray, slightly weathered BASALT; highly fractured fractures (40-60°), smooth to rough planar, clay infilling and secondary mineralization on fractured surfaces, dominant (SWAN VALLEY BASALT)	REC/RQD
		100/70
		100/50
Bottom of Boring: 50 ft

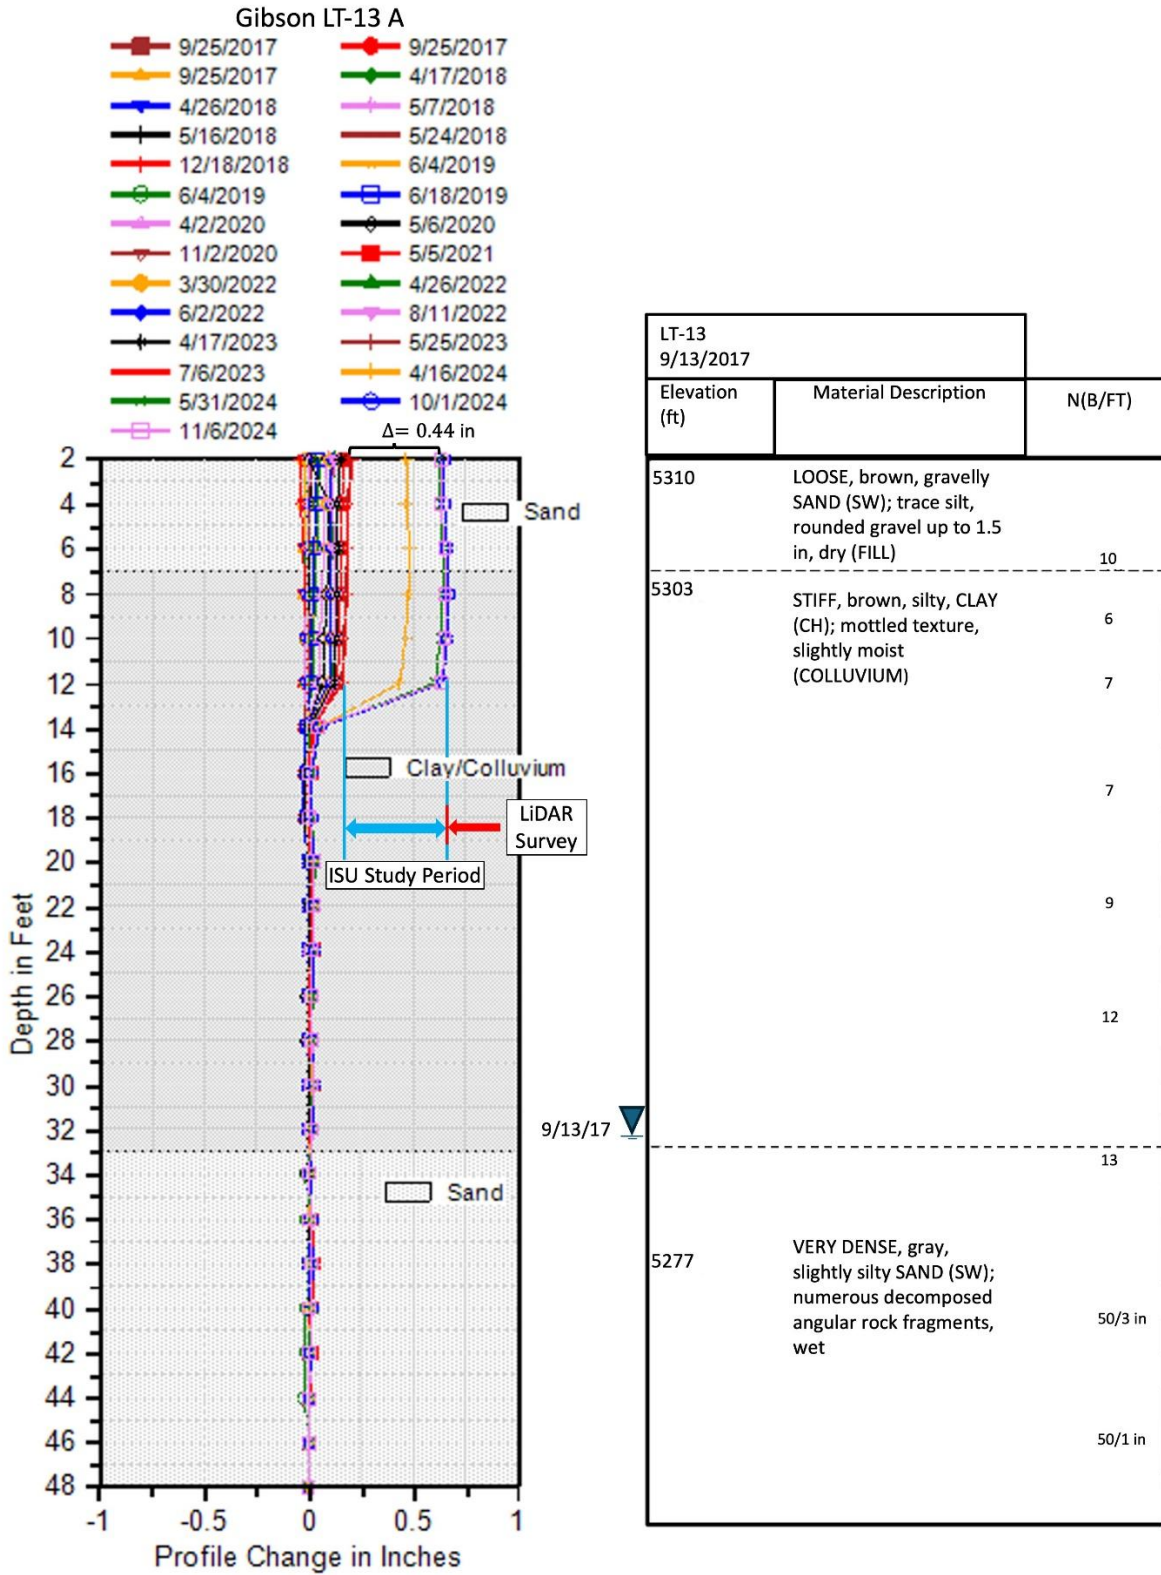
Figure 3.26 Inclinometer Displacements and Corresponding Log of Boring LT-13 in the Gibson Slide Area

Inclinometer LT-13 was installed by ITD on 13 September and first read on 25 September 2017. The lateral movement data show increased displacement during the 7-year monitoring period. The movement pattern is laterally uniform between the ground surface and a depth of 12 ft. Between 12 to 14 ft, the soil movement involves lateral shear of the inclinometer casing. Most of the slope movement occurred during the 6 July 2023 and 31 May 2024 time period (Figure 3.26). Lateral displacement at the ground surface in LT-13 was less than 0.44 in. (<2.0 cm) during the monitoring period and is below the threshold for measurable displacement in the Rainey Creek LiDAR survey (Figure 3.27).
