DOT/FAA/TC-26/16

National Airport Pavement Test Facility Construction Cycle 9

Volume 4—Cement-Treated Permeable Base Test

Final Report

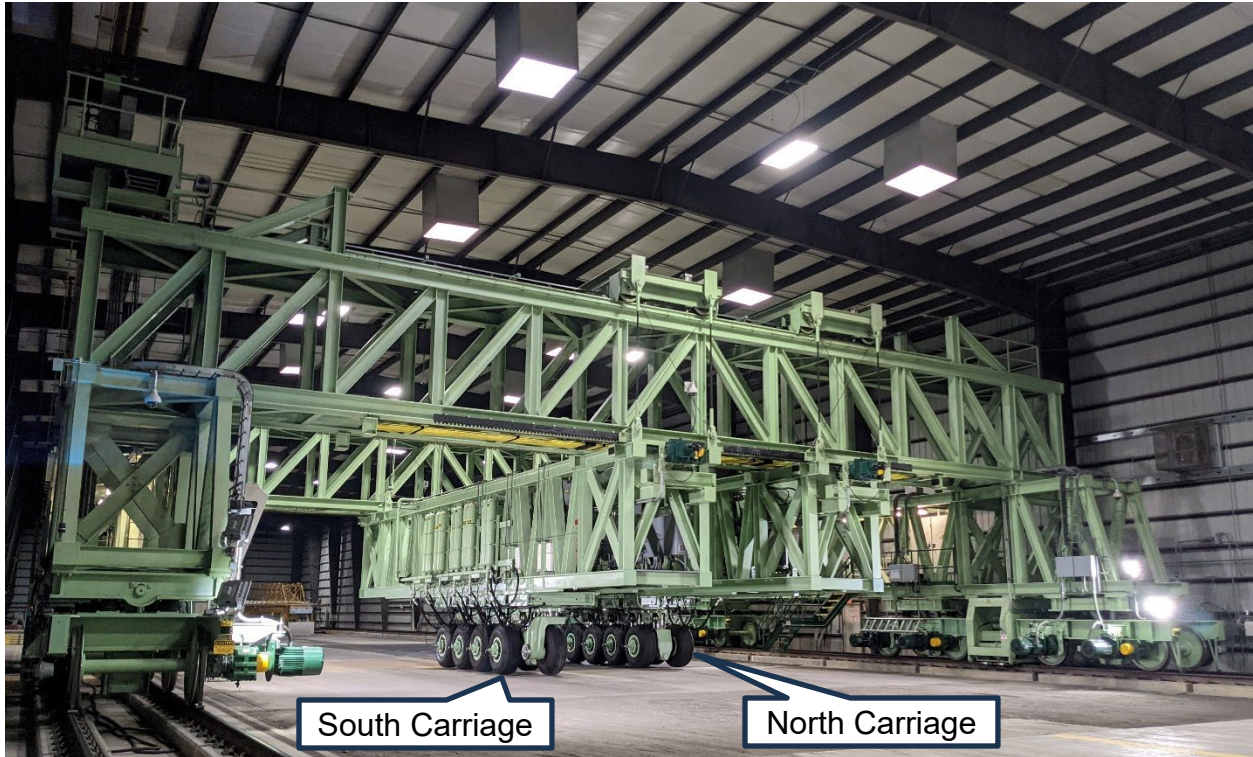
Wander Pattern. The National Airport Pavement Test Vehicle (NAPTV), depicted in Figure 1, executes a wander pattern consisting of a repeated sequence of 66 passes arranged in 9 longitudinal tracks. The lateral spacing between adjacent tracks is 10.25 in. The NAPTF wander pattern is designed to approximate a normal lateral distribution of aircraft traffic with a standard deviation from centerline equal to 30.54 in.

Figure 1. National Airport Pavement Test Vehicle

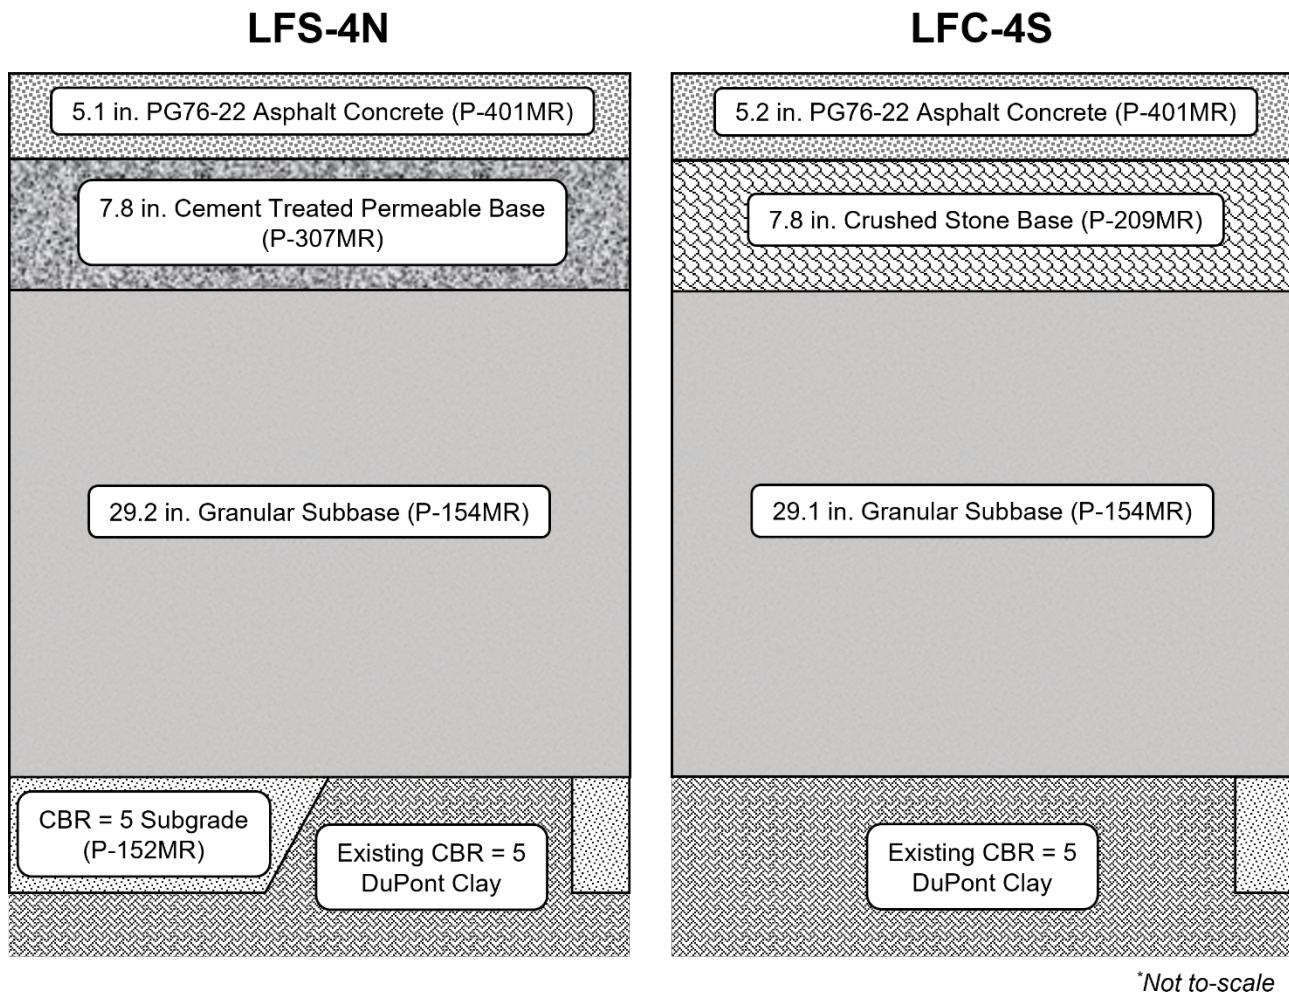
Figure 3. Pavement Structural Cross-Sections of CTPB Test Items

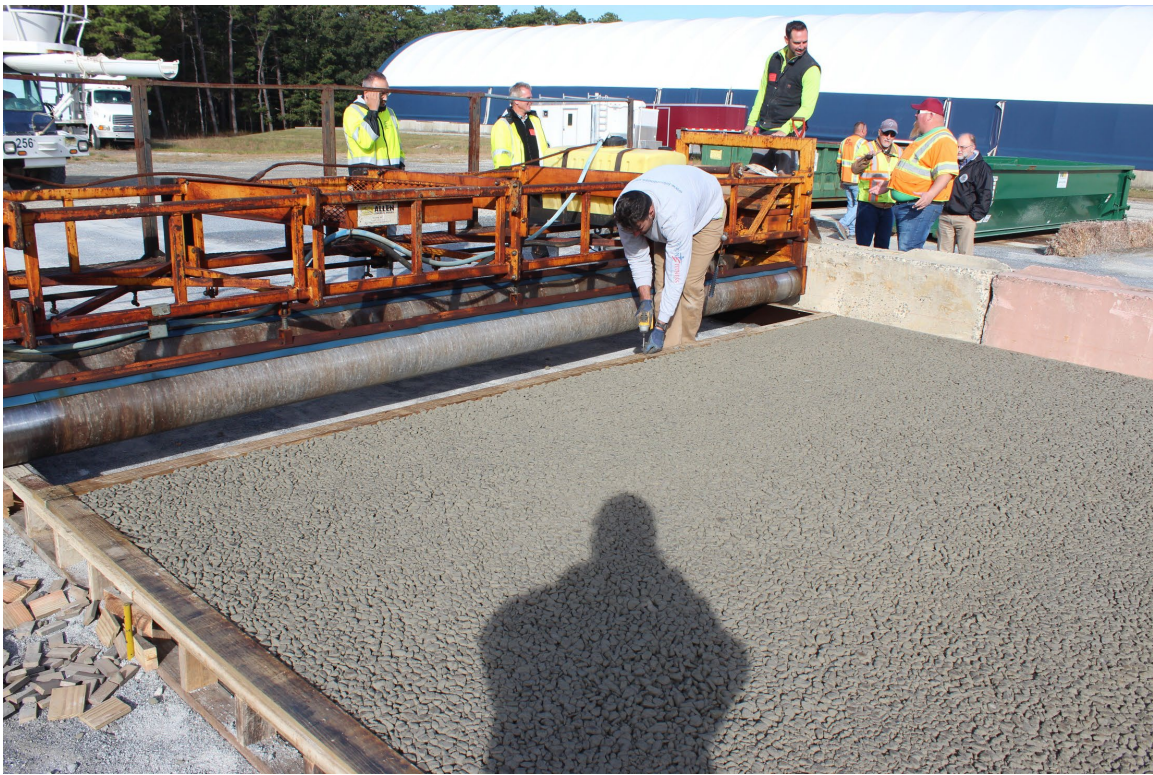
Figure 4. Removing Forms from the Third CTPB Test Strip, October 11, 2019

the form-riding triple-roller paver made six passes to bring the material flush with the top of the form.

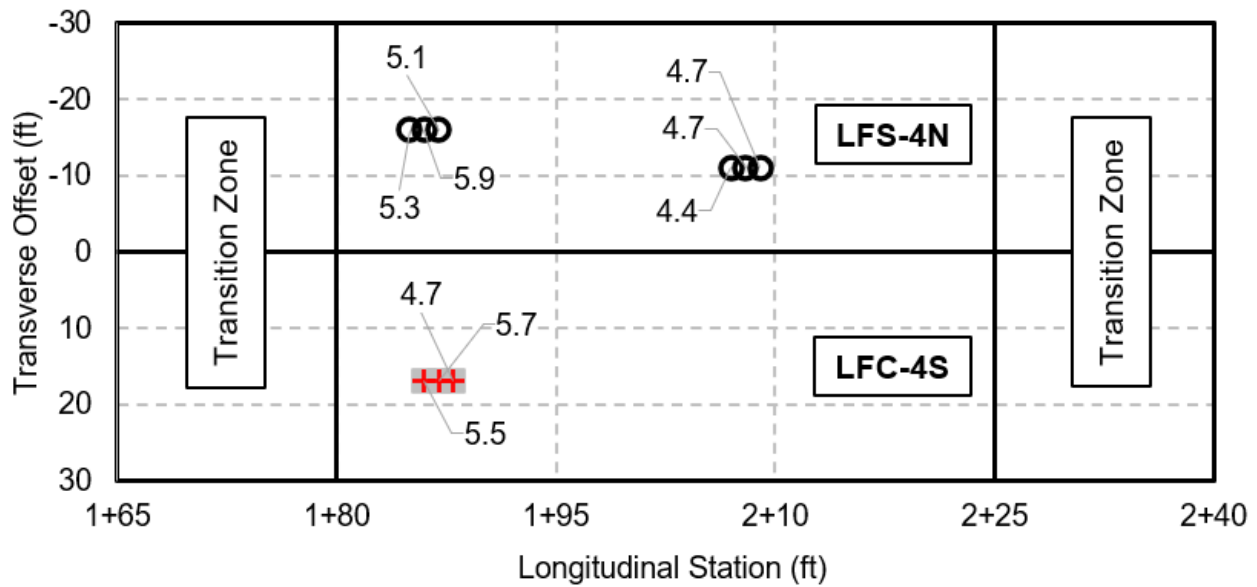
Table 3 lists material properties tested on the subgrade. Figure 5 plots in situ CBR for the CTPB test area. Subgrade CBR values were within acceptable tolerance ($\pm 1\%$ of the target CBR 5%). Figure 6 plots subgrade shear strength from vane shear tests.

Figure 5. Summary of CC9 Subgrade CBR Values in CTPB Test Items

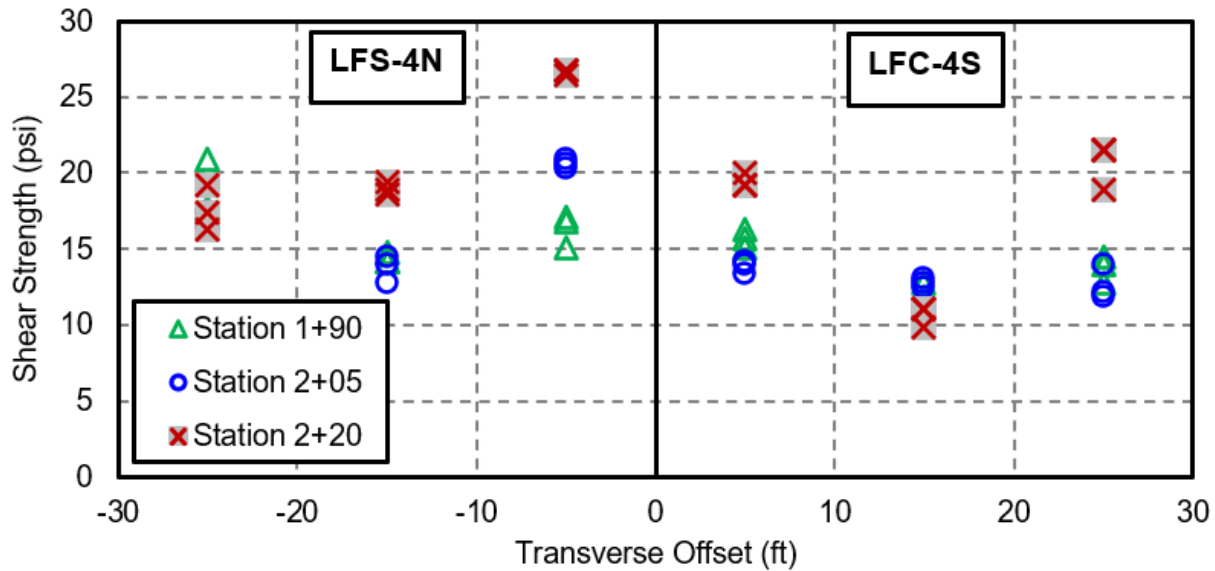
Figure 6. As-Built Subgrade Shear Strength in CTPB Test Items Measured with Vane Shear Tests

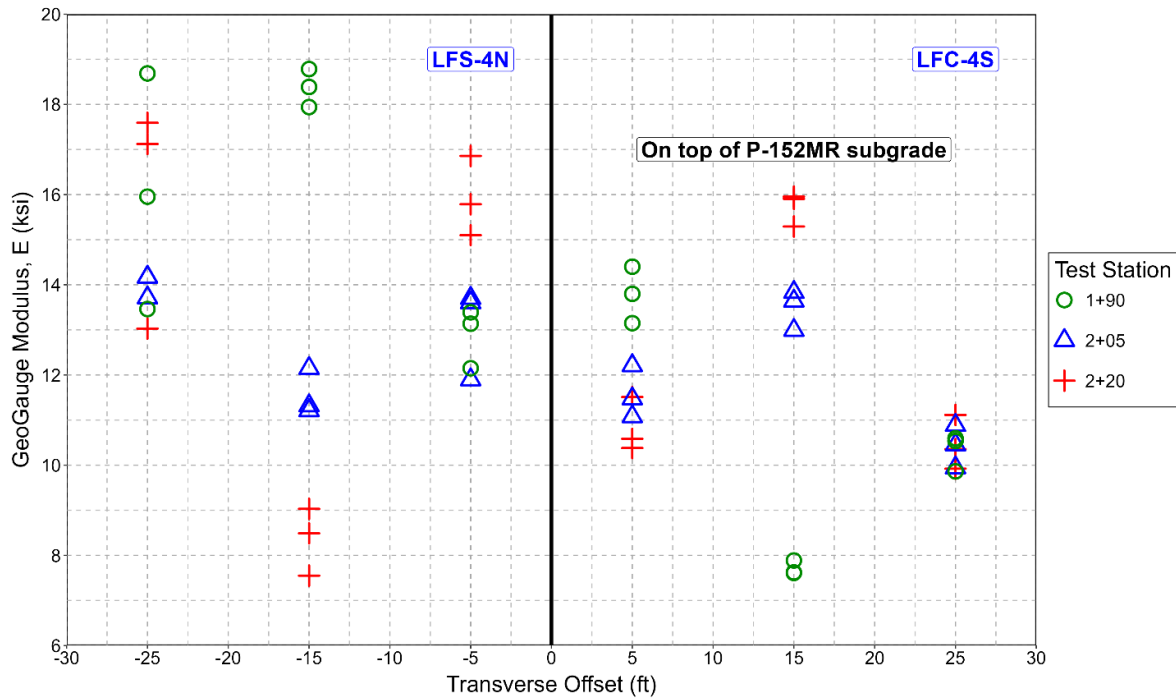
Figure 9 plots GeoGauge modulus values against transverse offset. GeoGauge moduli showed high variation for both test items. Moreover, for both test items the variation was greater at points along the center of the test item (offsets ± 15 ft) than at points along the outside offsets (± 5 ft and ± 25 ft from centerline). Considering the outside offsets only, the average geogrid modulus was significantly higher for LFS-4N than for LFC-4S.

Figure 9. As-Built Subgrade Modulus in CTPB Test Items Measured with GeoGauge

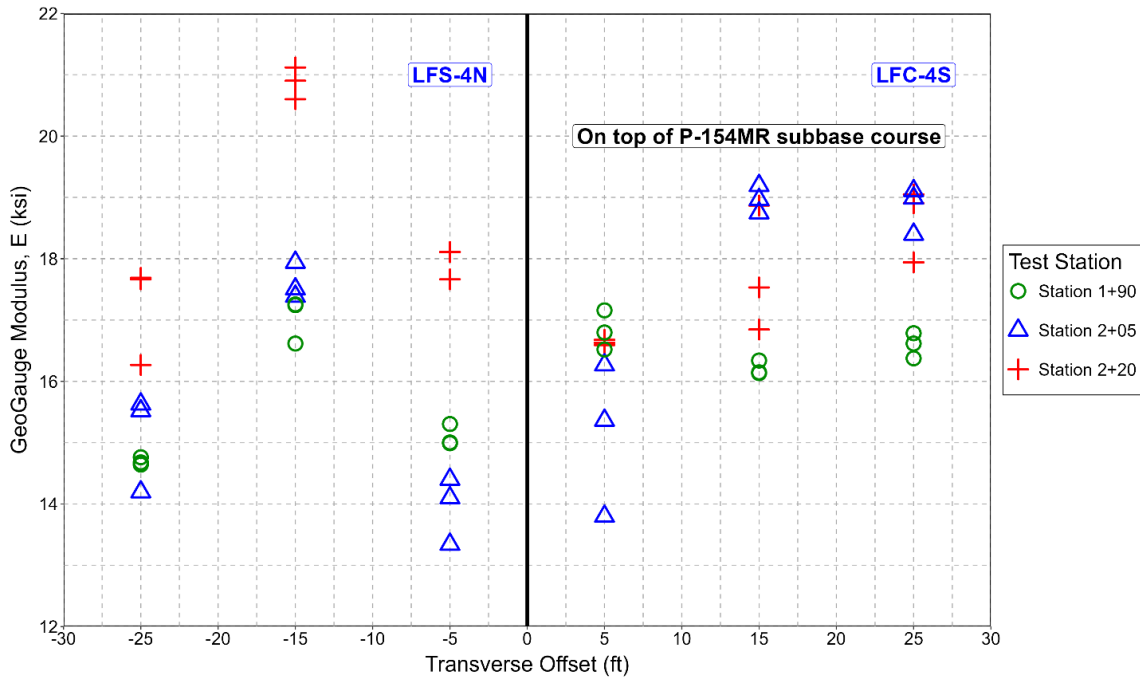
Figure 12. As-Built Subbase Modulus in Fatigue Test Items Measured with GeoGauge

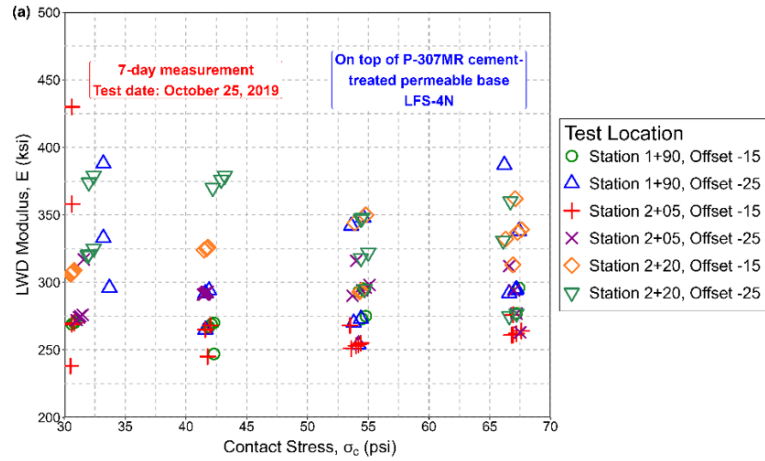
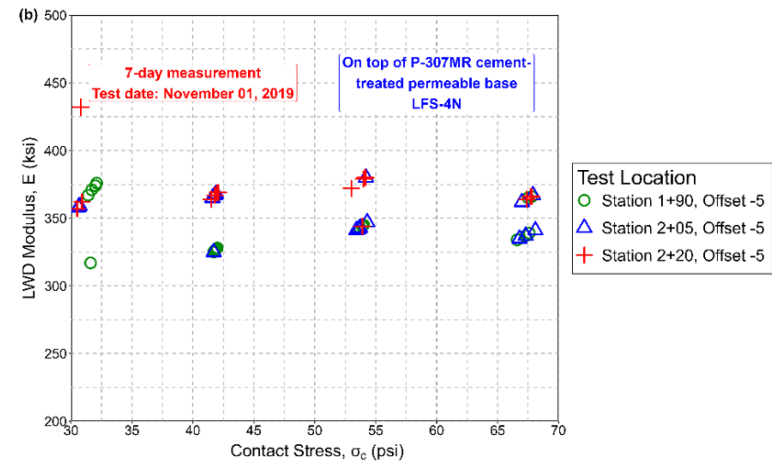
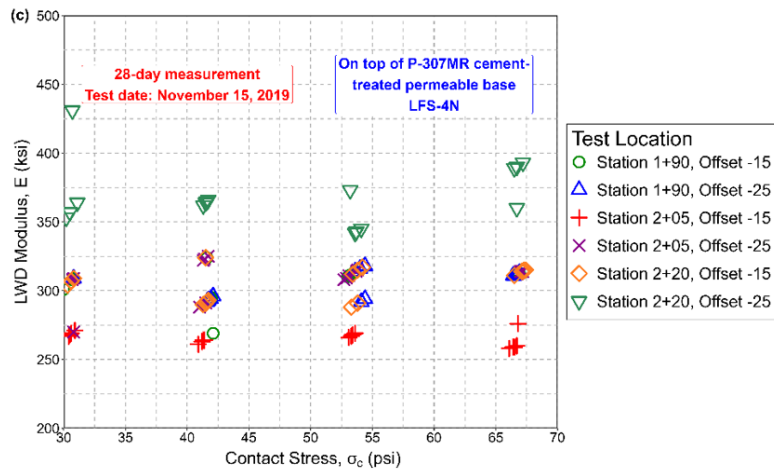
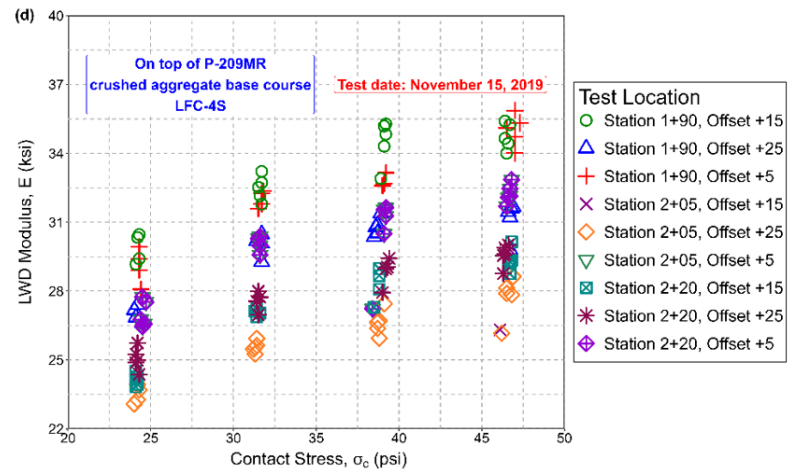
Figure 13 plots LWD field modulus at the top of the base against contact stress and LWD drop location. Figure 13(a) and (b) show the 7-day LWD moduli for the two placement lots of the CTPB. Figure 13(c) shows 28-day LWD data for the CTPB. For comparison to CTPB, Figure 13(d) shows the LWD modulus of crushed aggregate base (P-209MR) versus contact stress. In contrast to the conventional crushed aggregate bases, the CTPB shows little or no change in modulus values with respect to the contact stresses (i.e., it is neither a stress-hardening nor stress-softening material.) The LWD modulus of CTPB was approximately 10 times that of crushed aggregate base.

(a) CTPB Modulus, 7-day (1st Placement, LFS-4N)

(b) CTPB Modulus, 7-day (2nd Placement, LFS-4N)

(c) CTPB Modulus, 28-day (LFS-4N)

(d) Crushed Aggregate Base Course Modulus (LFC-4S)

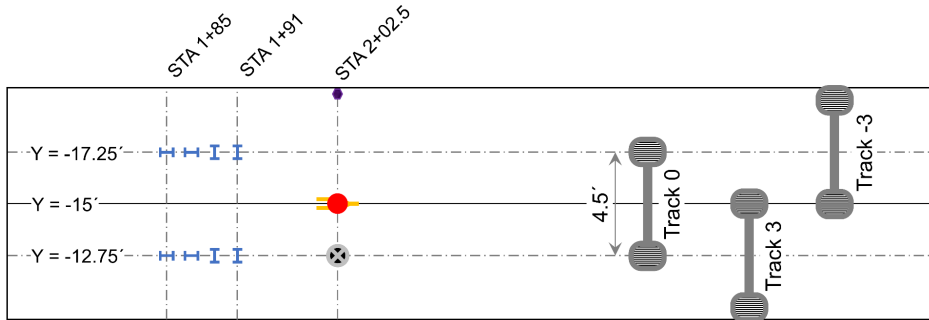
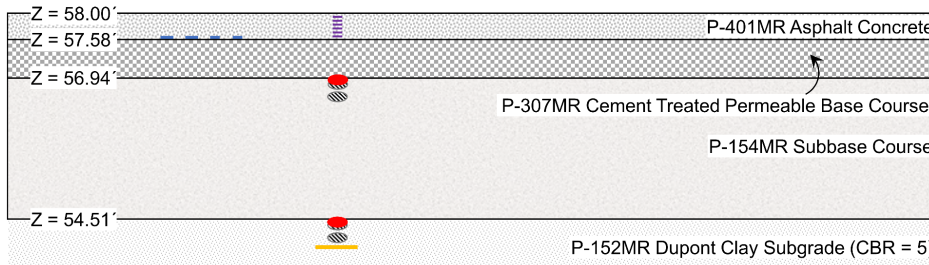
LFS-4N

Embedded sensors included asphalt strain gauges (ASGs), coil sensors (CSs), pressure cells (PCs), moisture sensors, and thermocouples. Details of the installation are found in Tomlinson et al. (2022). Figure 14 and Figure 15 show the sensor layout for the CC9 CTPB test area. Appendix A lists sensor locations for each test item.

- Longitudinal Strain Gauge
- Transverse Strain Gauge
- Pressure Cell
- Coil Sensor
- Thermocouple
- Moisture Sensor

A thermocouple tree consisting of six temperature probes was installed in the asphalt concrete layer of LFS-4N. A single moisture sensor was installed in the subgrade in each test item to monitor the influence of moisture on subgrade stress and strength under traffic.

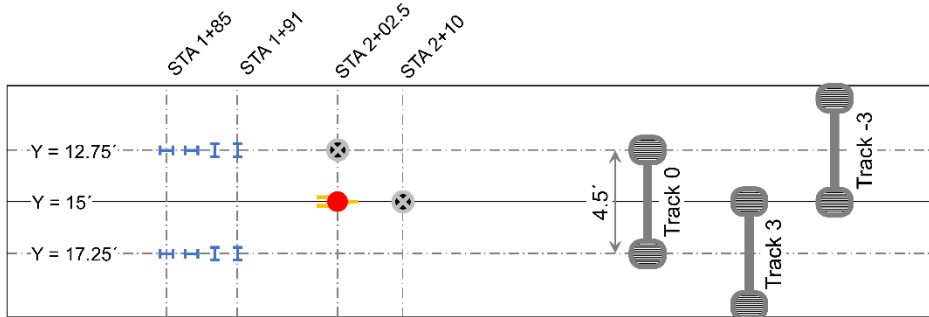
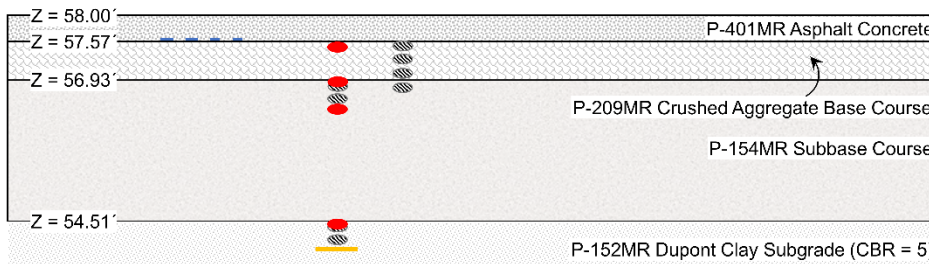
LFC-4S

- Longitudinal Strain Gauge
- Transverse Strain Gauge
- Pressure Cell
- Coil Sensor
- Bender Element
- Smart Rock
- Moisture Sensor

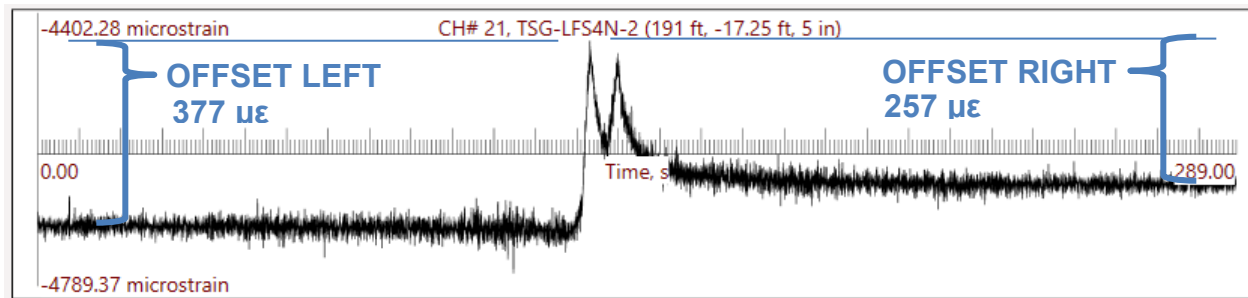
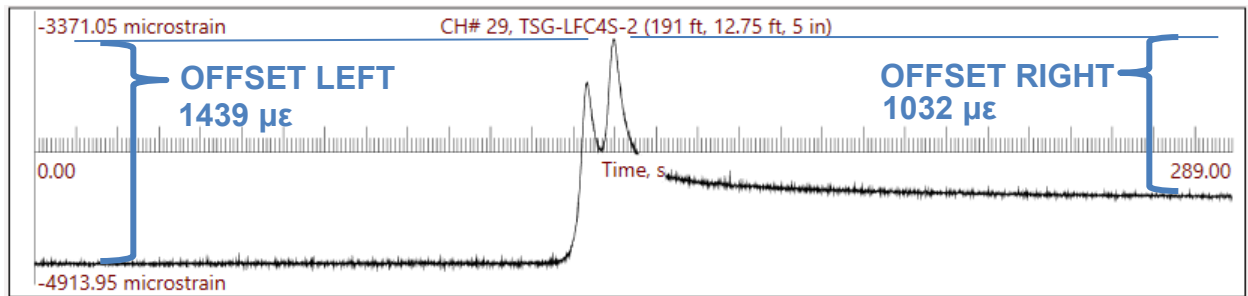
Although Table 8 shows all four transverse strain gauges (TSGs) in LFS-4N as operational, the responses from these sensors were generally noisier than those from the four TSGs in LFC-4S (see Figure 16). The response from both sets of TSGs was characterized by a significant difference between the starting and ending strain (the unrecovered part). Therefore, the magnitude of peak asphalt strain depends on whether it is calculated with reference to the starting strain value (offset left) or ending strain value (offset right) for the pass. Figure 16 and Figure 17 show examples of ASG slow-roll test data. In Figure 17, the peak strains are relative to the “offset right” and may be considered to represent recovered strain. Figure 17 shows the general trend where, as expected, increasing wheel load and decreasing vehicle speed both correspond to increasing peak tensile strain in the bottom of the asphalt layer. For the same load conditions, the strain magnitudes are much lower for LFS-4N (on CTPB) than for LFC-3S (standard base). In contrast to LFC-4S (Figure 17(b)), LFS-4N showed little or no sensitivity of the asphalt peak strain to vehicle speed, especially at higher wheel loads (Figure 17(d)).

Figure 16. Slow-Roll TSG Responses (2D gear, 36,000 lb/wheel, 5 mph), Test Conducted November 17, 2022

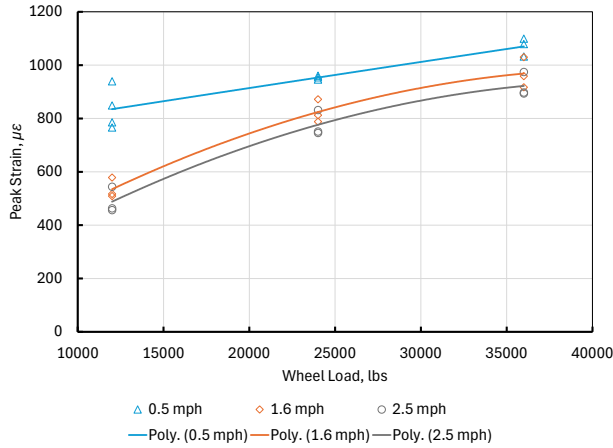
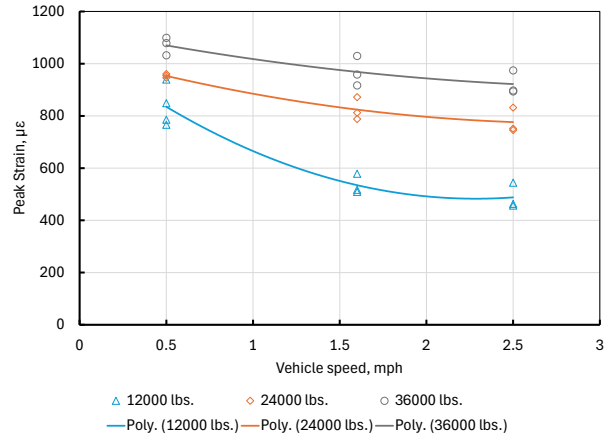
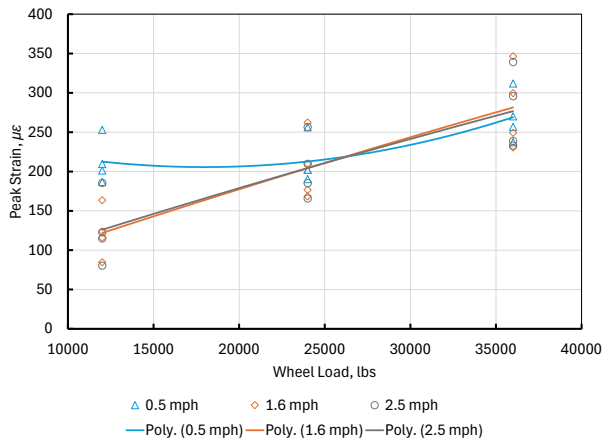
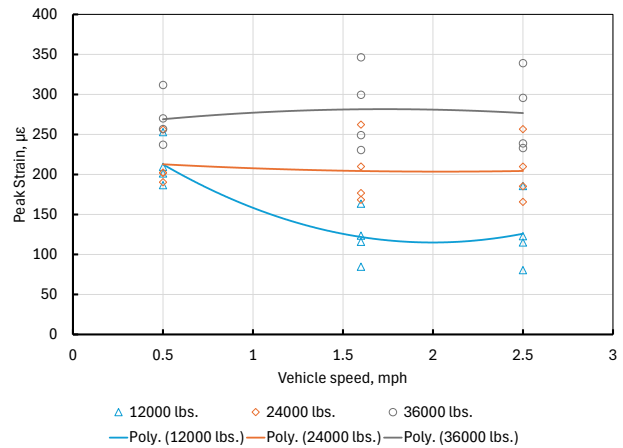
(a) LFC-4S – TSG Strain versus Wheel Load

(b) LFC-4S – TSG Strain versus Vehicle Speed

(c) LFS-4N – TSG Strain versus Wheel Load

(d) LFS-4N – TSG Strain versus Vehicle Speed

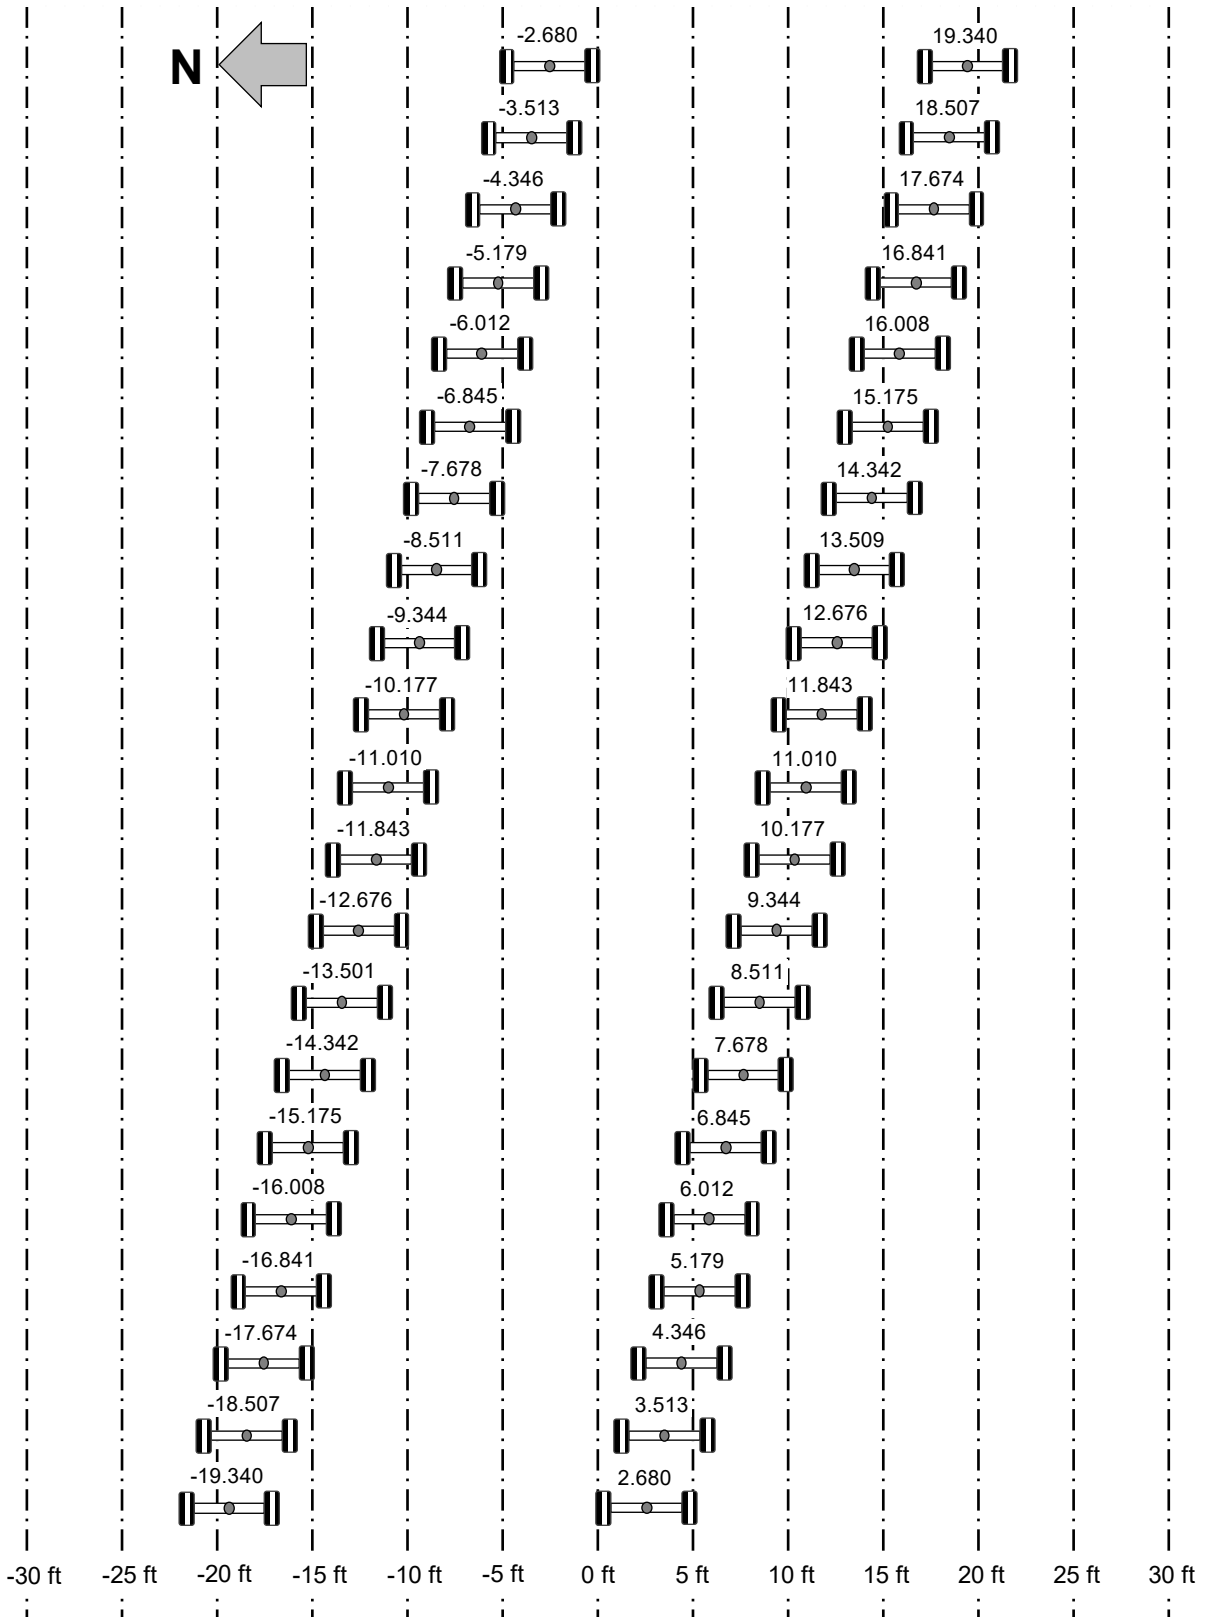
Figure 18. Carriage Positions for Each Pass of Proof Roll

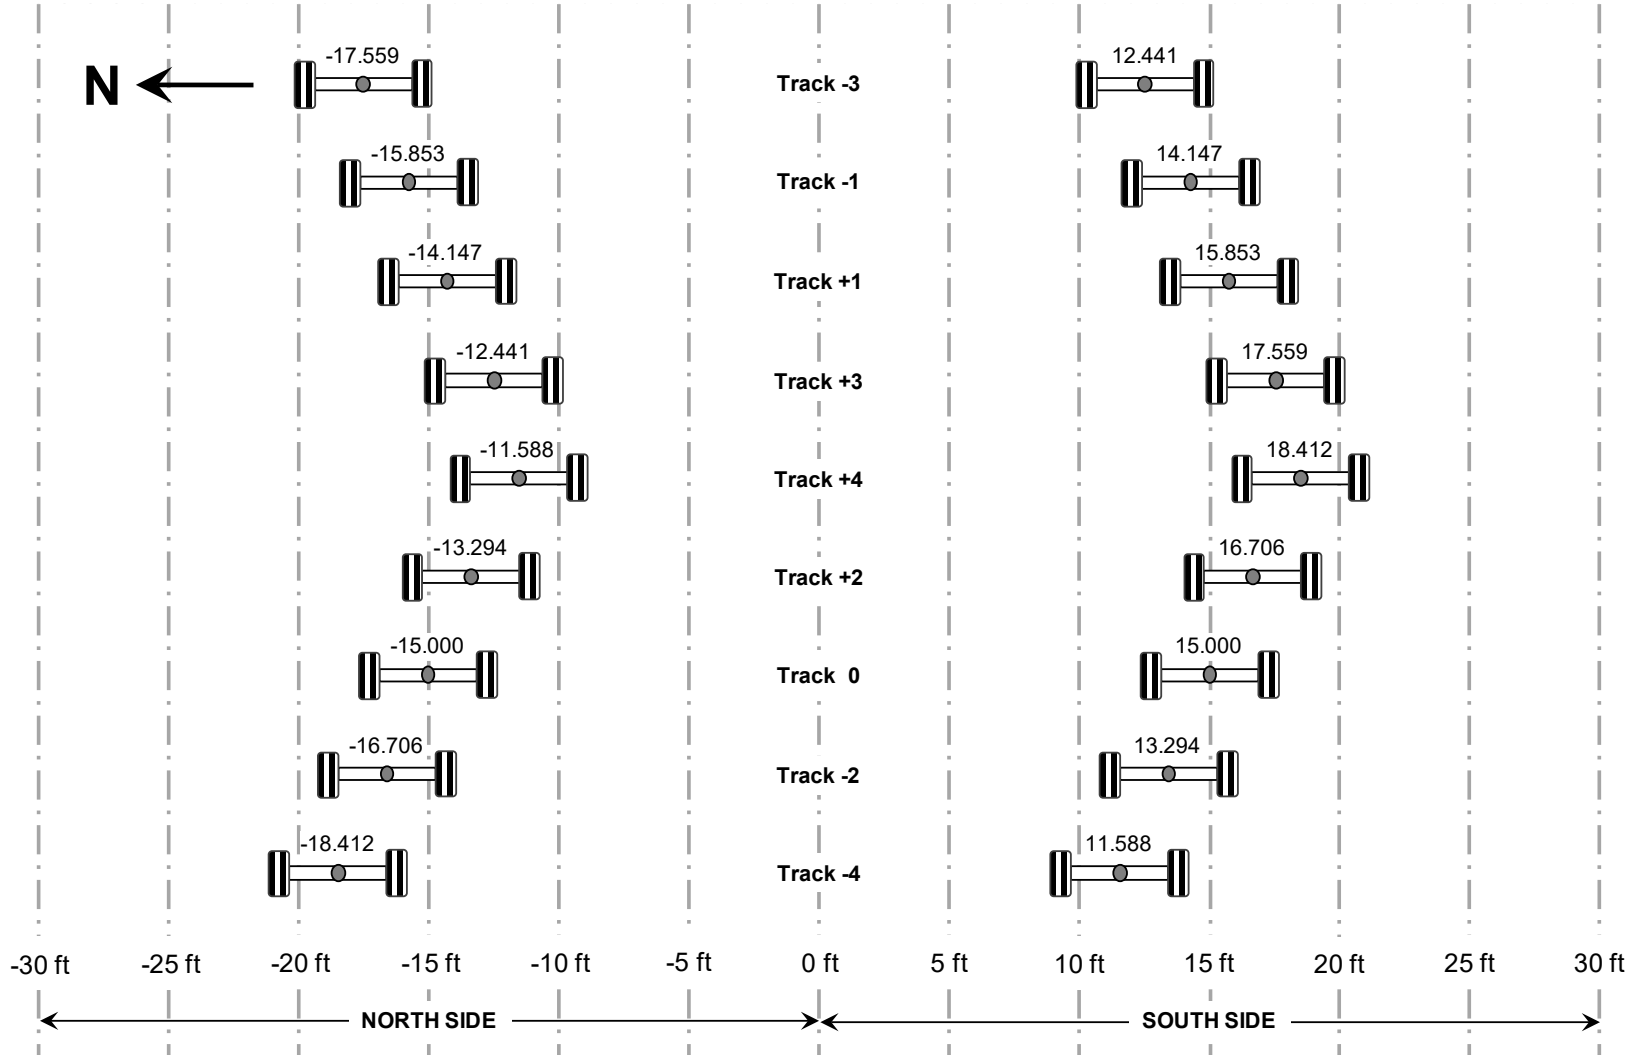
Figure 19. Construction Cycle 9 Traffic Wander Wheel Tracks

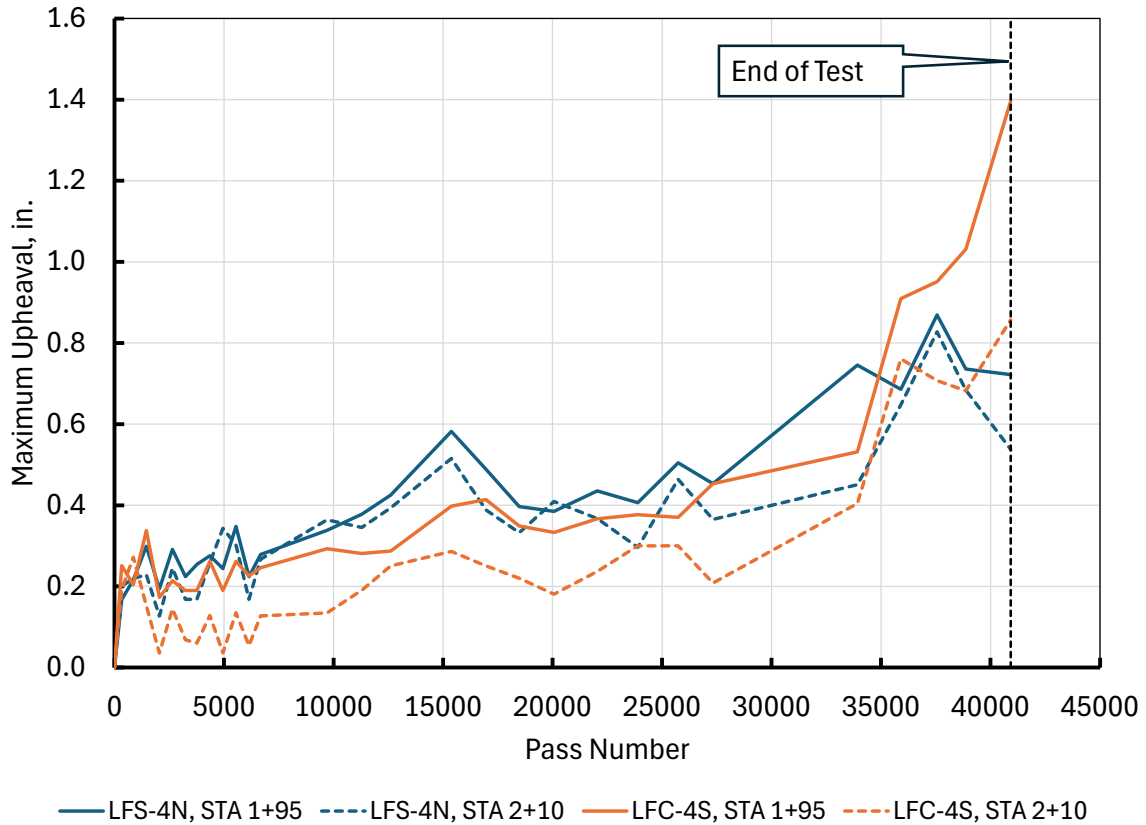
Surface upheaval outside of the trafficked area greater than approximately 1 in. is a key indicator of structural failure (Section 4.2.2). Figure 20 plots the development of upheaval in both test items at two stations, STA 1+95 and STA 2+10. In Figure 20, the maximum upheavals were

computed from transverse profile data using a software procedure called Virtual Upheaval Calculator (VUC). VUC computed upheaval relative to a baseline (pre-traffic) profile, where both profiles (current and baseline) were extracted from three-dimensional laser surveys of the pavement surface (Section 4.2.4.6). Details of the VUC procedure are found in Mazzotta et al. (2024).

Figure 20. Maximum Upheaval from VUC in CTPB Test Items

Appendix B lists the surface upheaval data for the CTPB test items. As shown in Figure 20, test item LFC-4S failed according to the technical criterion (i) in Section 4.2.2, passing the 1-in. threshold at STA 1+95 after approximately 38,000 passes. Test item LFS-4N did not fail according to this criterion. However, Figure 20 shows that for most of the test, the upheaval in LFS-4N tracked closely with LFC-4S, and the final upheaval (~ 0.8 in.) near the failure criterion. Complicating the analysis, small variations in computed upheaval (less than about 0.25 in.) may be due to nonstructural factors including lateral displacement of the asphalt surface material under wandered traffic, surface macrotexture, and inherent limitations of the VUC procedure, and do not necessarily reflect true structural layer damage. Figure 21 shows the extent of deformation in test item LFS-4N at the end of the test.

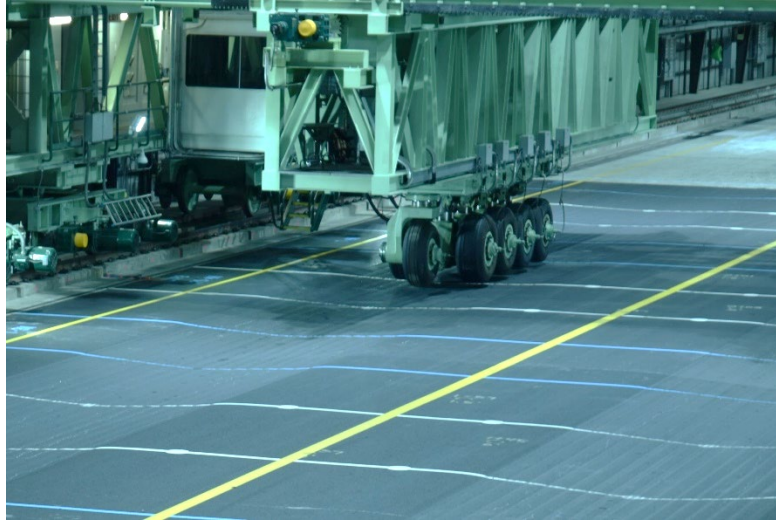
Figure 21. Deformed Surface of the CTPB Test Item After 40,920 Passes (November 3, 2022)

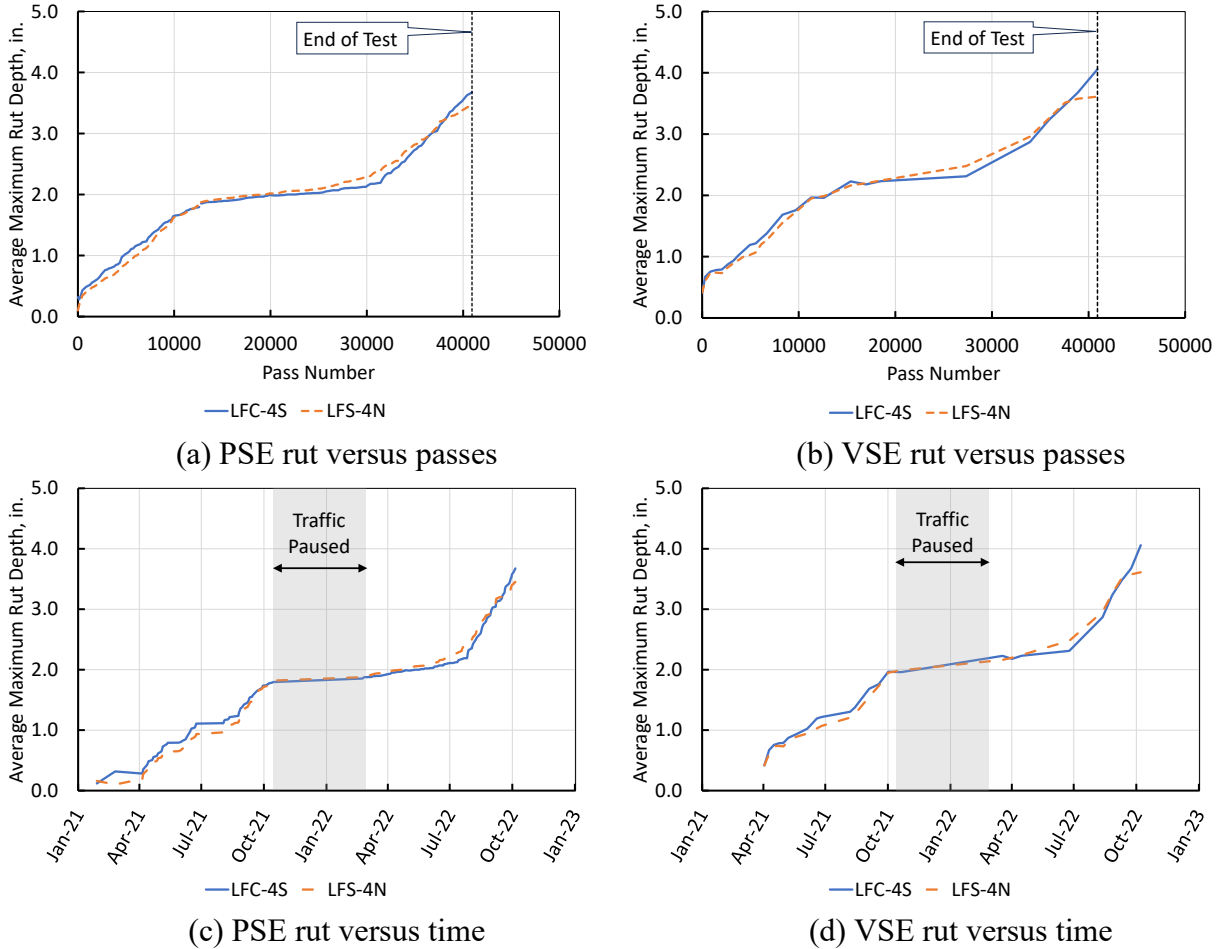
Another key measure of structural performance is straightedge rutting. CC9 rut depths were (a) measured physically using a 16-ft physical straightedge (PSE), and (b) computed from transverse profile data using a 16-ft virtual straightedge (VSE) computer program. The transverse profiles were extracted from three-dimensional laser surveys (Section 4.2.4.6). For comparison, Figure 22 plots both types of rut data against traffic passes and against time for the two CTPB test items. Mazzotta et al. (2024) gives a full description of the rut depth determination. Mazzotta et al. (2024) noted that “typically, the VSE values are higher than PSE, which is reasonable since the straightedge operator must physically search for the maximum rut depth location and may not find it, while the VSE program can find the absolute maximum rut depth location automatically.” Note that both PSE and VSE rut depths are determined from the current profile geometry alone and, unlike computed upheaval values, are not relative to a baseline condition. Thus, straightedge rut depths at the start of the test are small but nonzero, reflecting the fact that the initial transverse profiles were not perfectly flat. Figure 22 shows very little difference in rut accumulation between the two test items. The CTPB did not improve rutting performance compared to the standard base. Figure 22(a) and (b) appear to show a three-phase progression of rutting: initial rutting up to 12,500 passes, followed by an extended period of stability, then the beginning of failure. However, a closer look at Figure 22(c) and Figure 22(d) suggests that the periods of significant rutting are associated with higher ambient temperatures in the NAPTF during the summer months.

Figure 22. Straightedge Rut Depth in CTPB Test Items
(Values plotted are averages of rut depths determined at STA 1+95 and STA 2+10.)

Figure 40 compares the PSE rut depth for CC9 LFS-4N (CTPB) from Figure 22(a) with the corresponding rut depth for test item LFS-6N (ATPB) in CC7. Rutting rates were comparable, with both test items reaching a surface rut depth of approximately 2 in. after 23,000 passes, although the initial rate of rutting in the ATPB section (first 2,500 passes) was much higher. Figure 41 compares the CD trends for CC9 test items from Figure 23 with the CD trend for CC7 test item LFS-6N. Surface cracking in the ATPB test item was much more extensive than in either CC9 LFS-4N (CTPB) or LFC-4S (control). This result is explained by the much lower temperatures at which CC7 was tested, which increases the propensity for cracking (see above).

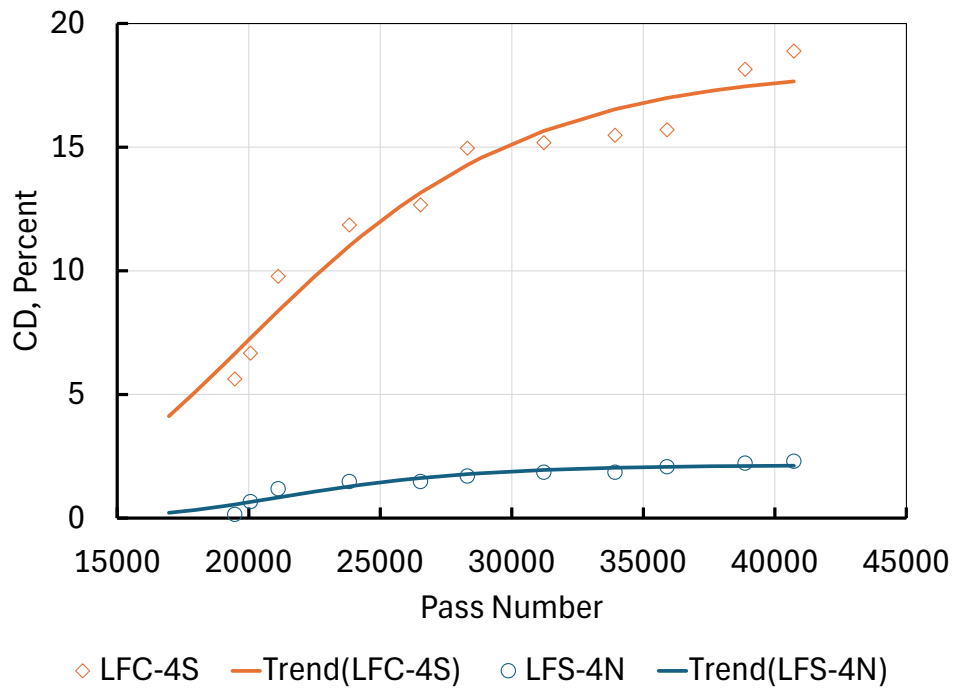
Figure 23. Variation of Crack Densities with Traffic in Test Items LFS-4N and LFC-4S

Figure 23 shows that crack growth was much higher in LFC-4S (control) than in LFS-4N (CTPB). The logistical model (Equation 3) that fits the available CD data has a mathematical upper bound represented by the parameter a . However, this does not mean that even larger values of CD would not be possible with additional traffic. Due to the definition of CD and the fact that the trafficked area of the test item covered approximately 12 ft of the 30-ft width, the natural upper limit of CD is about 12/30, or 40% (assuming that every 1-ft square in the traffic area has a visible crack). As shown in Section 6, CD values approaching 35% were observed in CC7 test items.

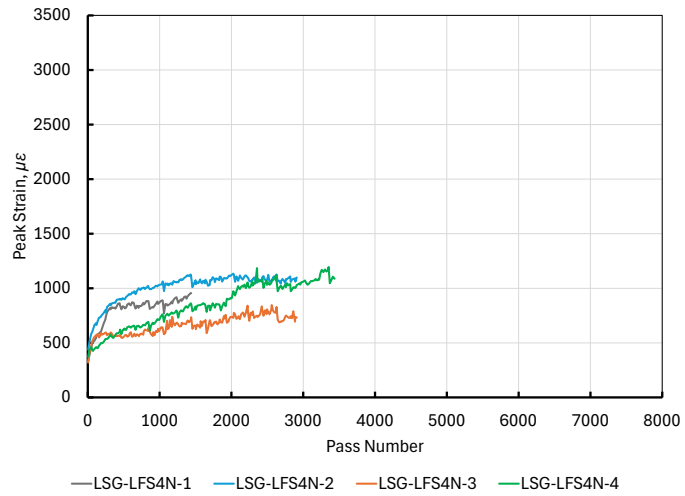
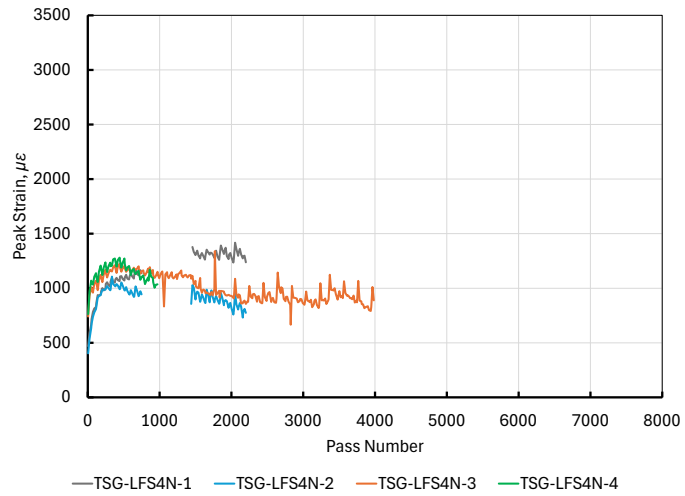
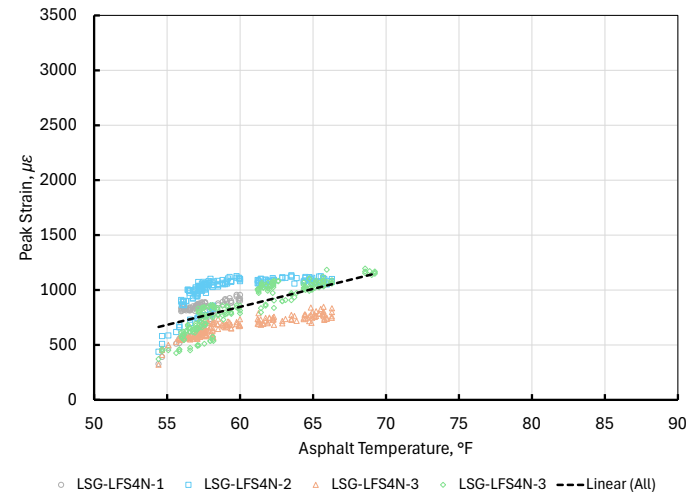
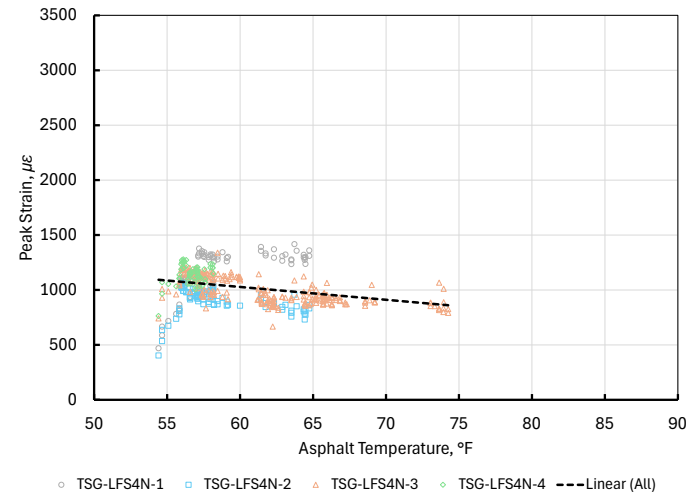
Figure 24 and Figure 25 plot peak load-induced tensile strains from the start of the test up to 8,000 passes, at which point most of the sensors had failed due to large surface deformations. Graphs (a) and (c) show peak strain versus passes for longitudinal strain gauges (LSGs) and TSGs respectively, while graphs (b) and (d) plot peak strain against asphalt temperature. All temperature readings were taken at T-LFS-4N-6 and represent the hourly reading closest to the timestamp on the strain gage reading. For both test items, the peak longitudinal strain magnitude increased with increasing asphalt temperature, as expected. However, peak transverse strains did not show a strong correlation with temperature, even showing a weak negative trend in LFS-4N, as shown in Figure 24(d)

Figure 24. Peak Tensile Strains at the Bottom of the Asphalt Layer, Test Item LFS-4N

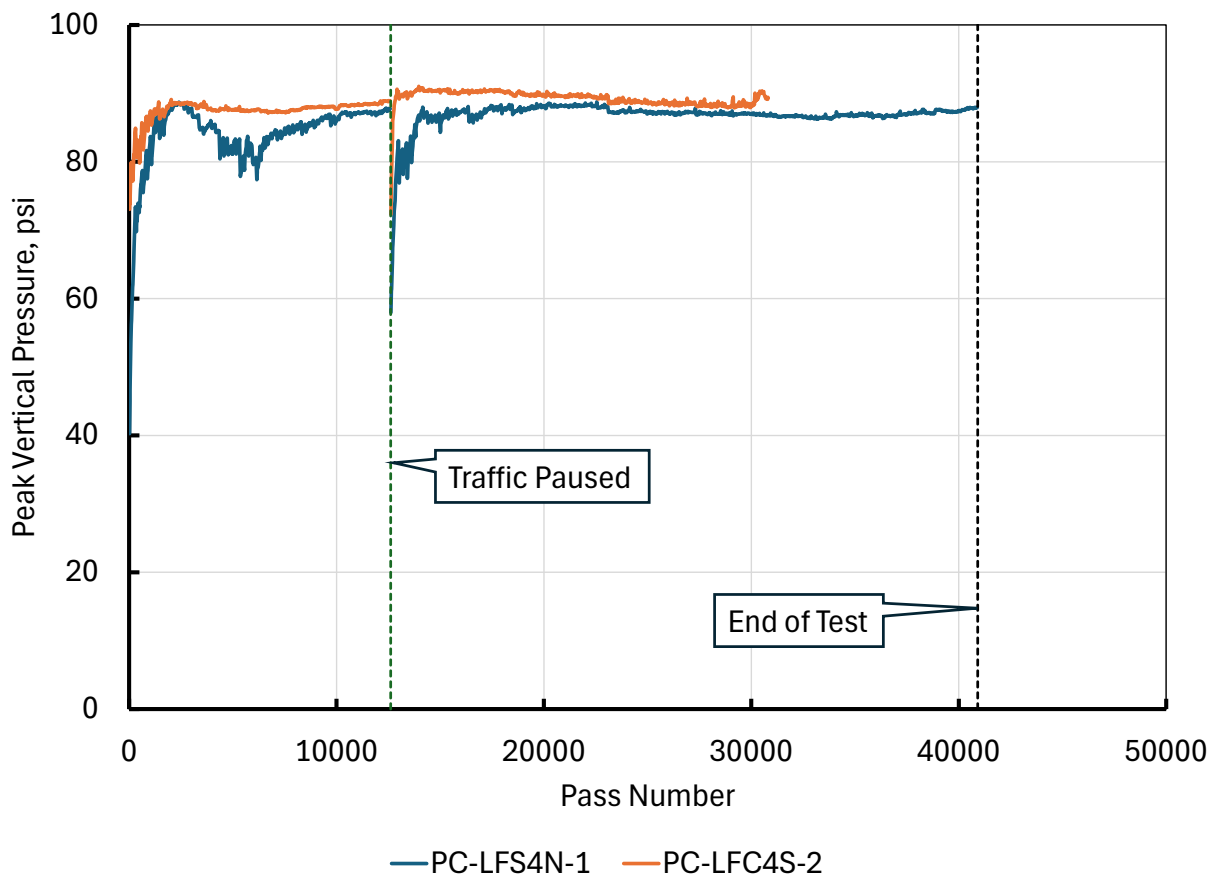
PC-LFC4S-2 failed after 30,000 passes due to repeated stress above its rated limit. PCs had a standard rating of 58.0 psi but could read up to 1.5 times their rated pressure (87 psi) per the manufacturer's specification. Throughout the test, PC-LFS4-1 operated just at the limit of its real capacity. However, PC-LFC4S-2 repeatedly exceeded its capacity under load, with the result that peak stresses were repeatedly cut off (Figure 28). Hence, the maximum values shown in Figure 25 may be considered unreliable, and true peak pressures for LFC-4S are higher than those shown.

Figure 26. Pressure Cell Peak Response (top of P-154 granular subbase) for CTPB Test Items
