DOT/FAA/TC-26/16

National Airport Pavement Test Facility Construction Cycle 9

Volume 4—Cement-Treated Permeable Base Test

Final Report

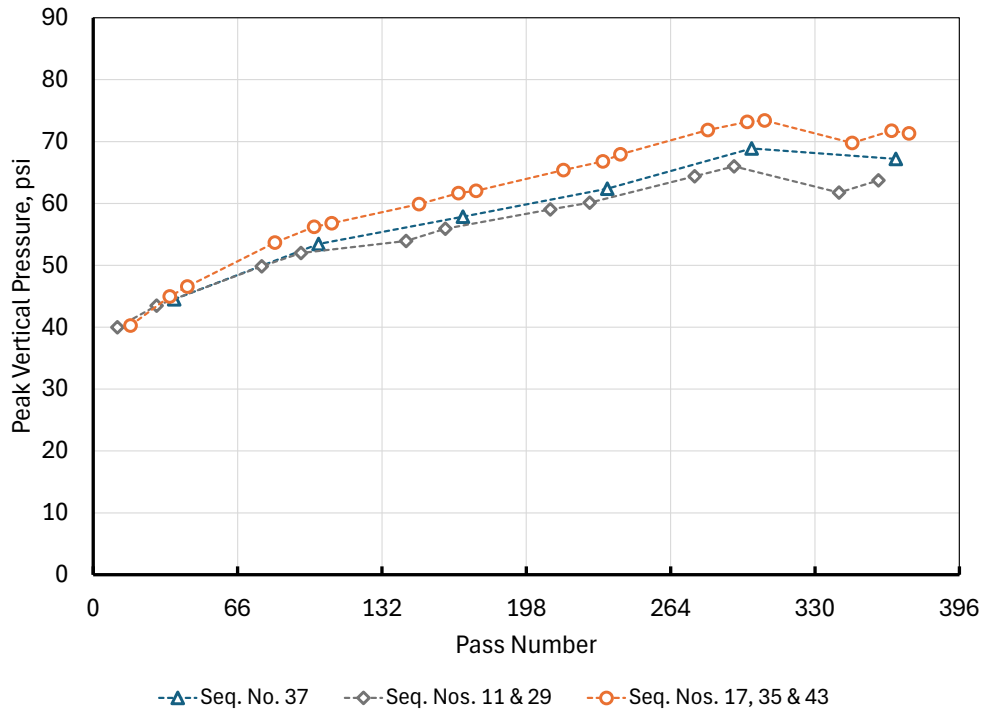
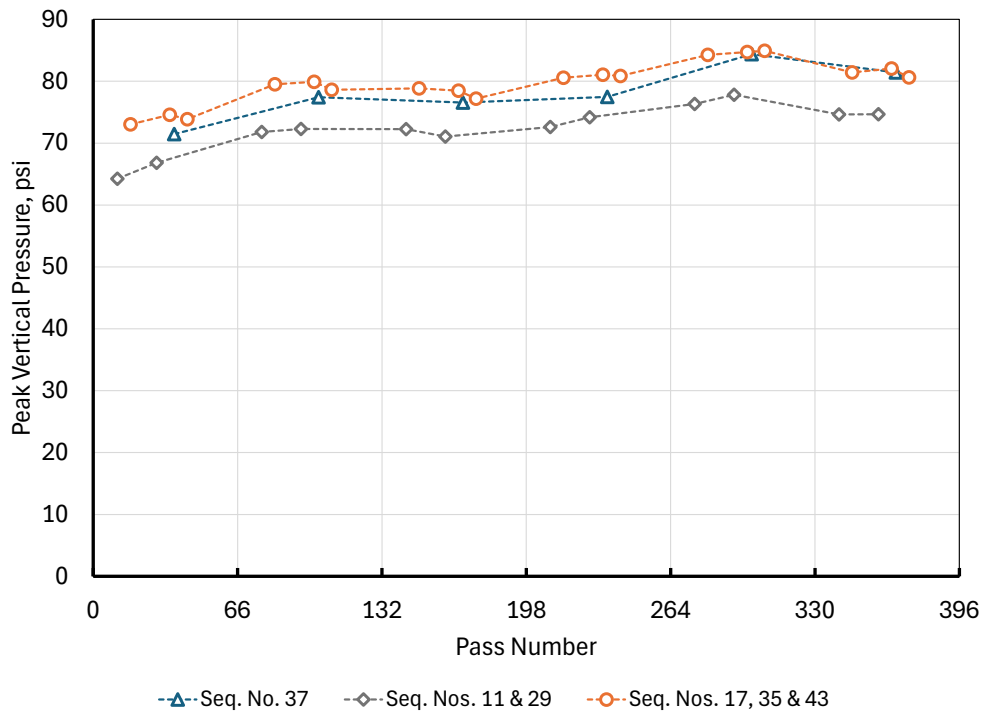
Figure 27. Pressure Cell Peak Response (top of P-154 subbase) for Critical Tracks +3 and -3, First 6 Wander Pattern Repetitions

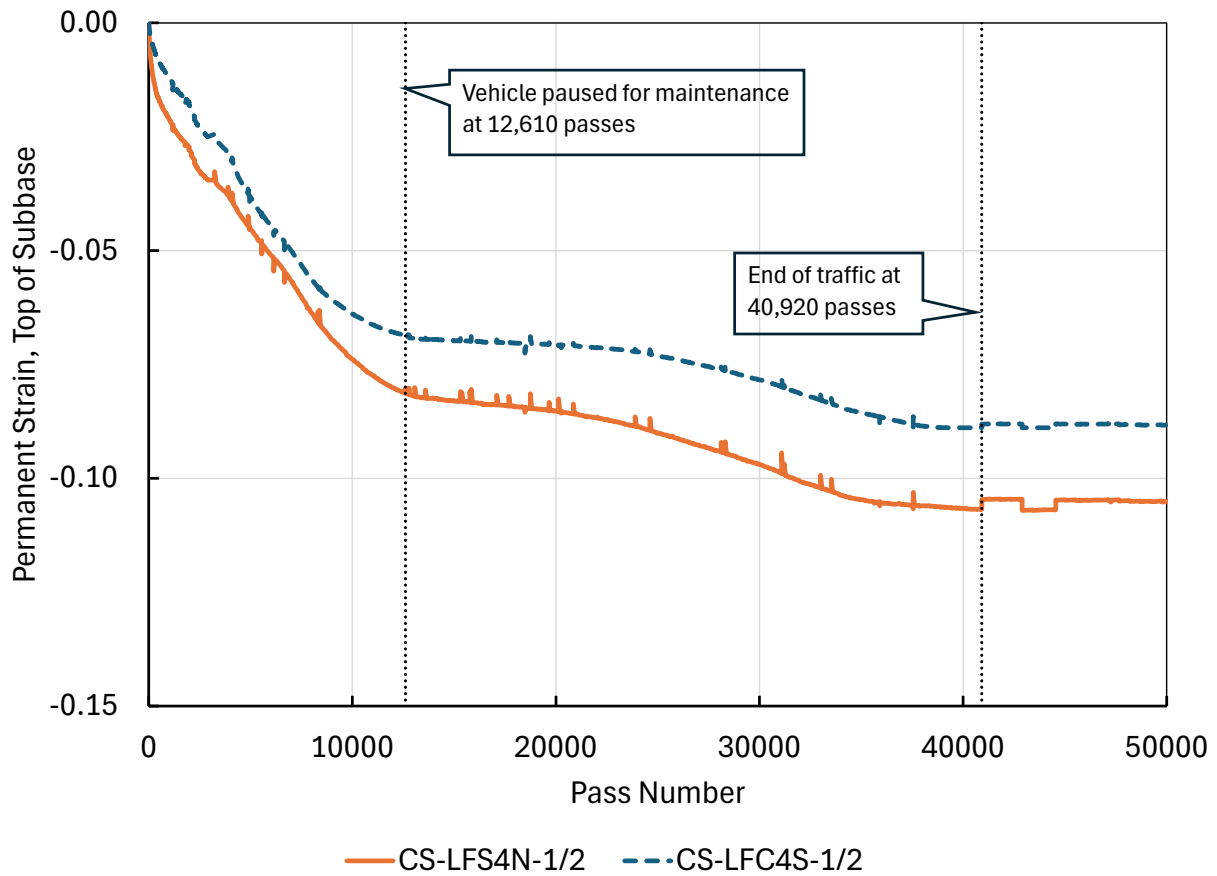
the test, accumulated permanent strain in the CTPB test item subbase material was 20% to 30% higher than in the control test item.

Figure 29. Permanent Strain at CS Location, top of P-154MR Subbase

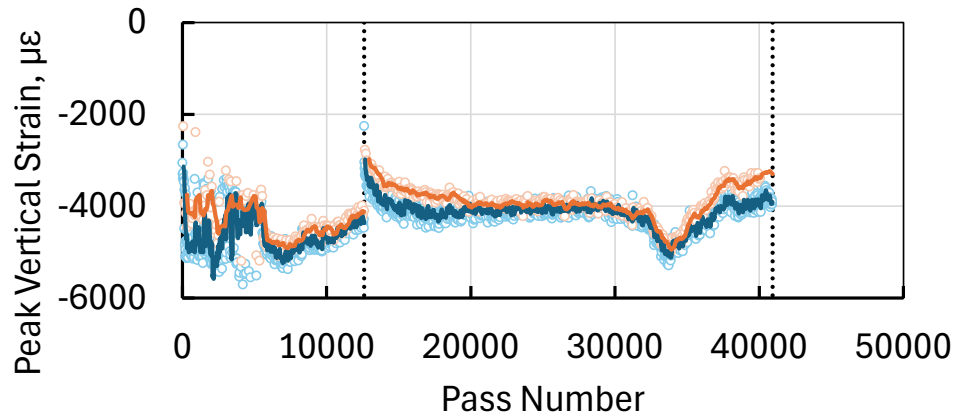
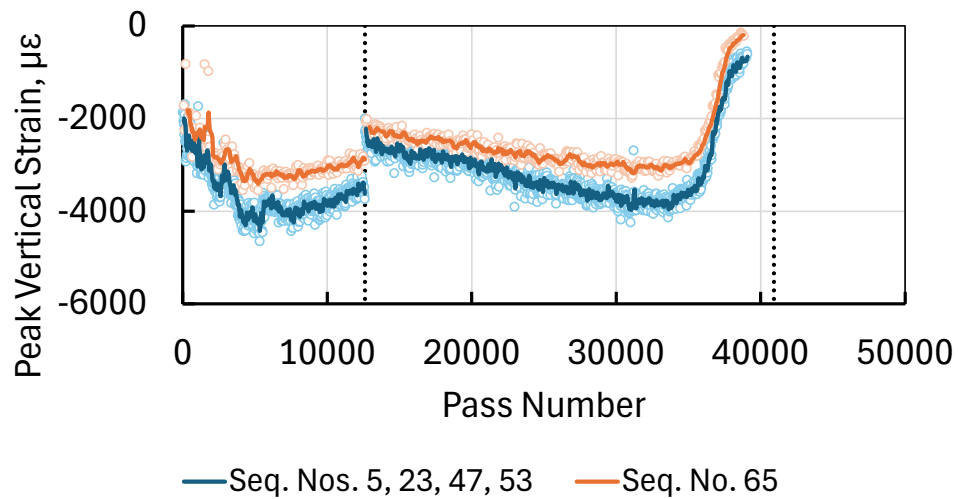
Figure 30 plots peak vertical compressive strain at the top of the granular subbase against traffic. Similar to the trend for permanent (unloaded) strain, load-induced compressive strains in the LFS-4N subbase were higher than those in the LFC-4S. For CS pairs at the top of the subgrade, the critical track for peak strain was track 0. However, as described in Section 5.2.2, the peak response is also affected by the lateral position of the previous pass, due to particle rearrangement in the unbound layers. Referring to the wander pattern (Section 4.2.1), all W→E passes on track 0 were preceded by a pass on track -2, except for those in sequence number 65, which were preceded by track -1. This explains why the peak strain responses fell into two groups as shown in Figure 30.

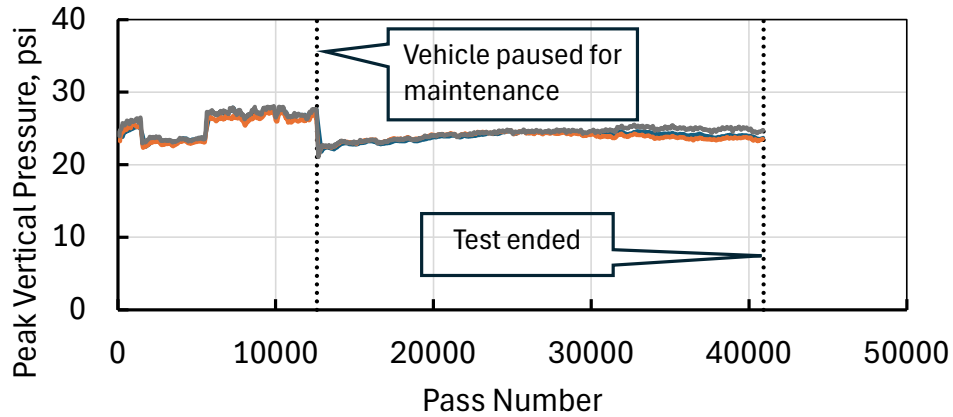
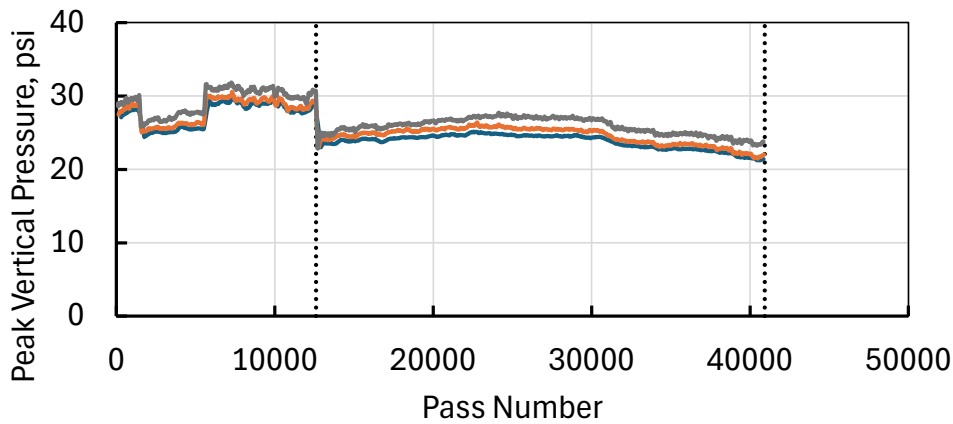
Figure 31 shows peak top-of-subgrade, load-induced vertical stress versus number of passes. Vertical stresses in the subgrade remained relatively stable throughout the test. Abrupt changes in the PC reading from LFC-4S in Figure 31 (at passes 1,452; 5,544; and following the pause at pass 12,610) were probably due to sensor malfunction.

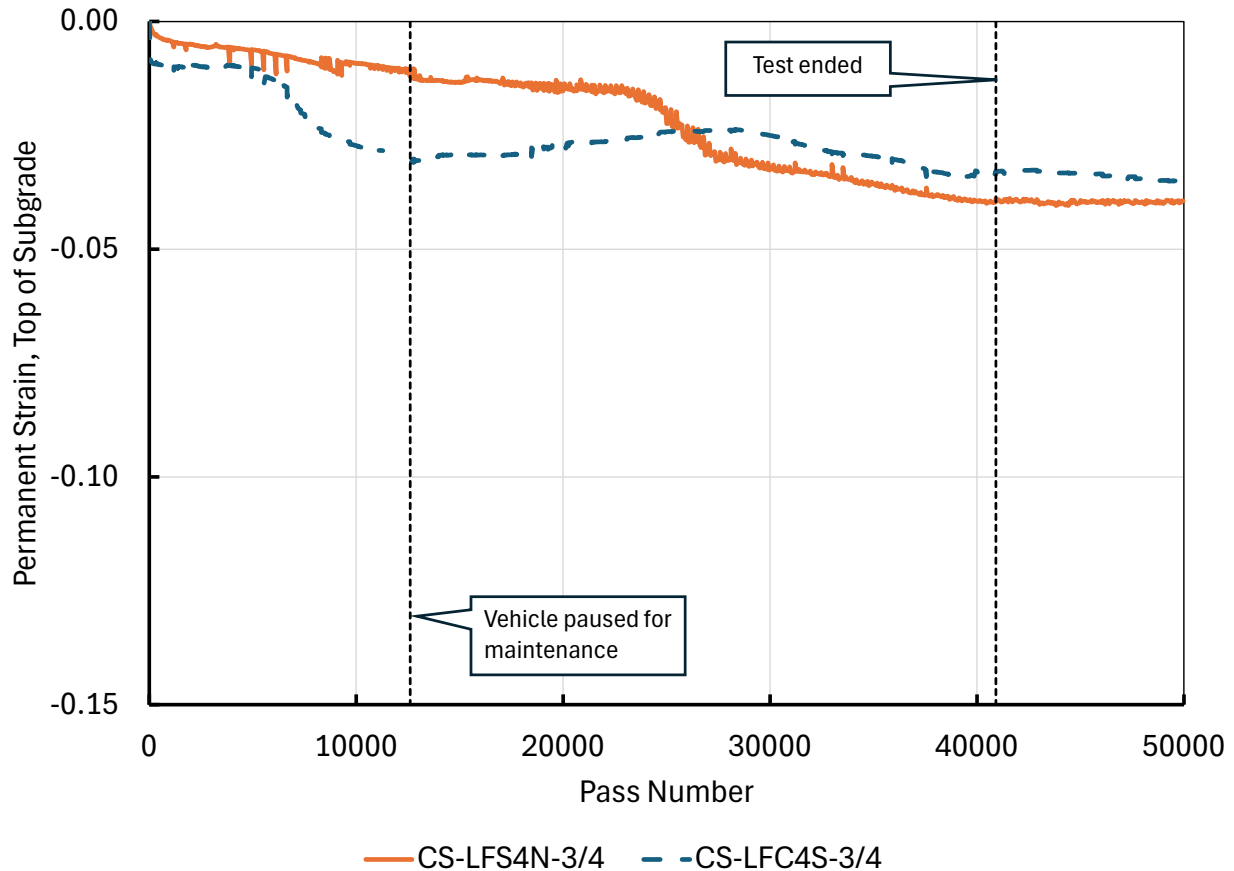
Figure 32 plots permanent vertical strain at the top of the subgrade against the number of passes. As with Figure 25, the permanent strain was computed as the ratio of unloaded deformation in the CS pair at the end of each completed wander pattern to the nominal coil separation distance (75 mm, approximately 3 in.). While both test items showed final permanent strain of the top of the subgrade of approximately 0.04, their paths to that point were clearly different. CS-LFC-4S-3/4 seems to show an initial large deformation under traffic, followed by a period of recovery after the pause in traffic. Some of this recovery may be only apparent, due to distortion or rotation of the CS pair. CS-LFS-4N-3/4 shows a significant increase in permanent deformation after approximately 23,500 passes, and no recovery.

Figure 32. Permanent Strain at Coil Sensor Location, Top of Subgrade

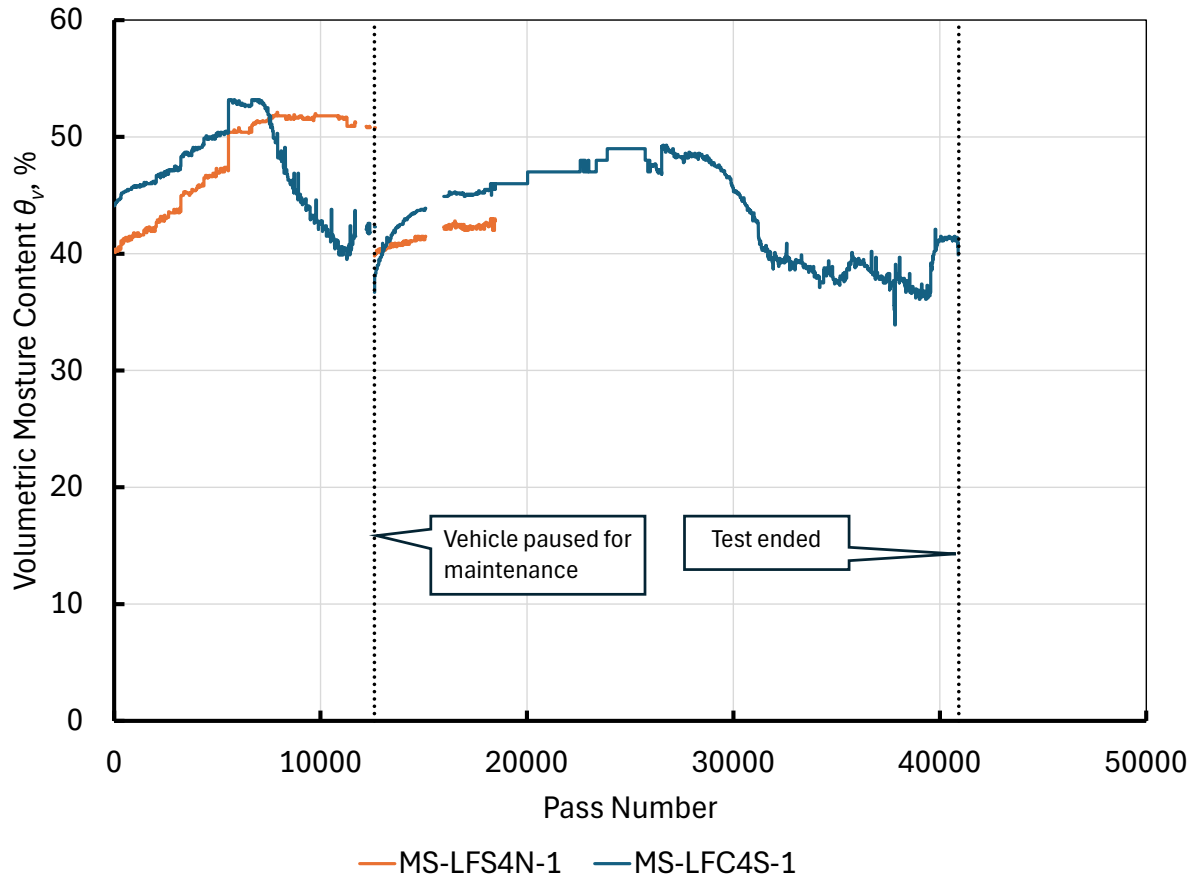
Subgrade moisture content θ_v was monitored closely during the test. Figure 34 plots subgrade θ_v against traffic for both test items. As shown in Figure 34, after about pass 18,500, MS-LFS-4N-1 started to behave erratically, and readings after that point were considered unreliable. In Figure 34, the value of θ_v associated with a pass number is the hourly value closest in time to the pass (nearest 30 minutes). Initially, θ_v increased with traffic for both test items. The LFS-4N subgrade exhibited a steep drop in θ_v during the 5-month pause when traffic was removed, behavior that was not reflected as strongly in LFC-4S.

Figure 34. Change in Subgrade θ_v with Traffic

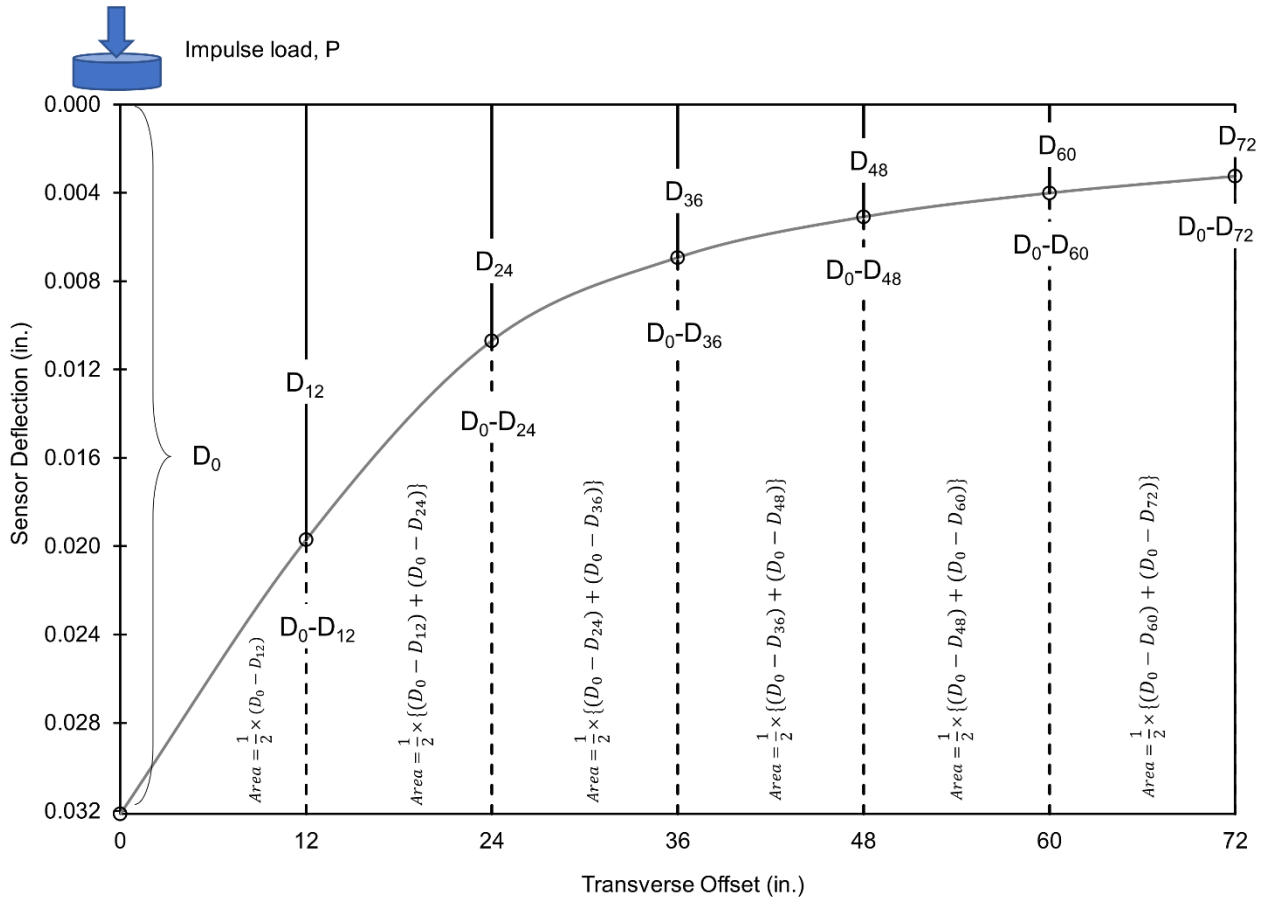
$$AUPP = \frac{1}{2} \times \{11D_0 - 2(D_{12} + D_{24} + D_{36} + D_{48} + D_{60}) - D_{72}\} \quad (4)$$

Figure 35. Sample HWD Deflection Basin

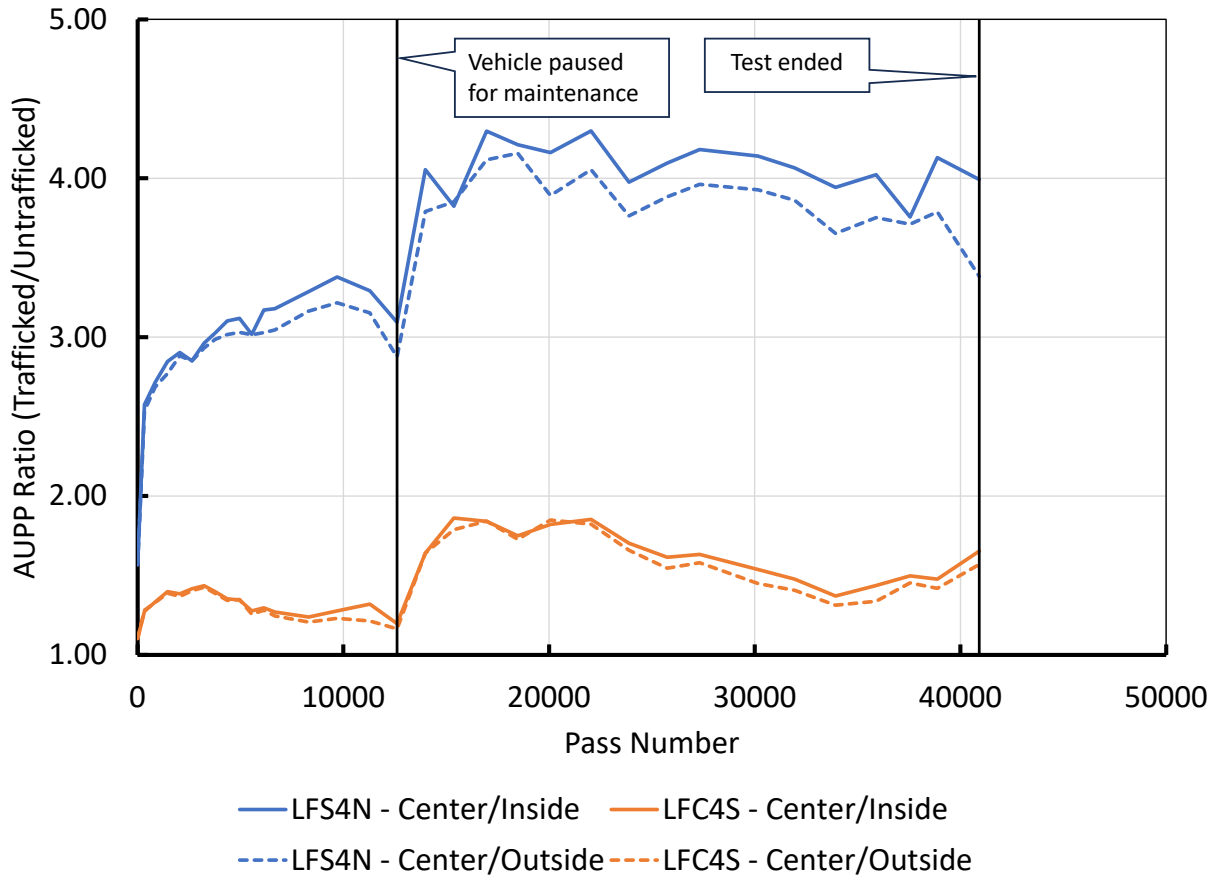
Figure 36 plots the ratio $AUPP_{Traffic}/AUPP_{Untrafficked}$ versus pass number for the two CTPB test items. As expected, the AUPP ratios were consistently above one, but they did not consistently increase with traffic (as might have been expected). Rather, both test items saw a sharp increase in AUPP ratio after the start of traffic, which stabilized after several thousand passes. There was little correlation between AUPP ratio and additional traffic. AUPP ratios in test item LFS-4N (CTPB) were consistently much higher than those in LFC-4S (control).

Figure 36. Variation of Area Under Pavement Profile Ratios Between Trafficked and Non-Trafficked Areas of CTPB Test Items
(Plotted values represent averages of the two drop locations (STA 1+95 and STA 2+10) within each test item.)

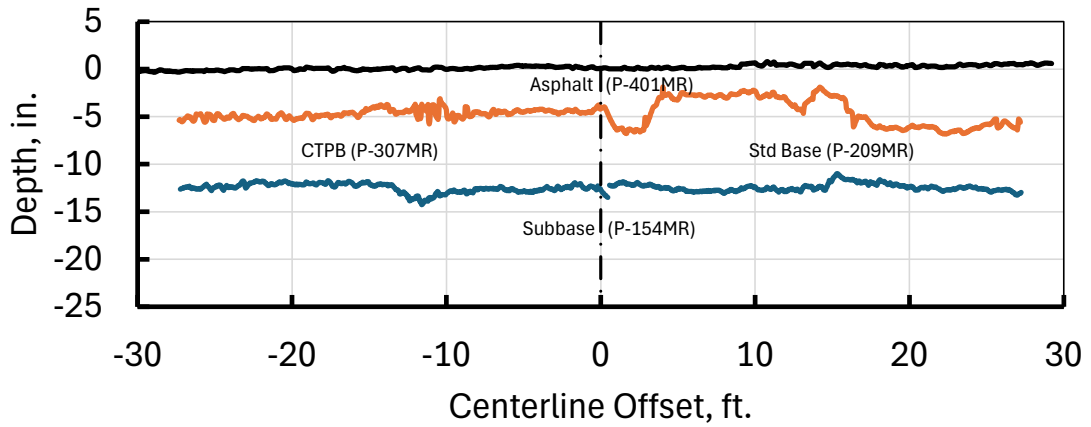
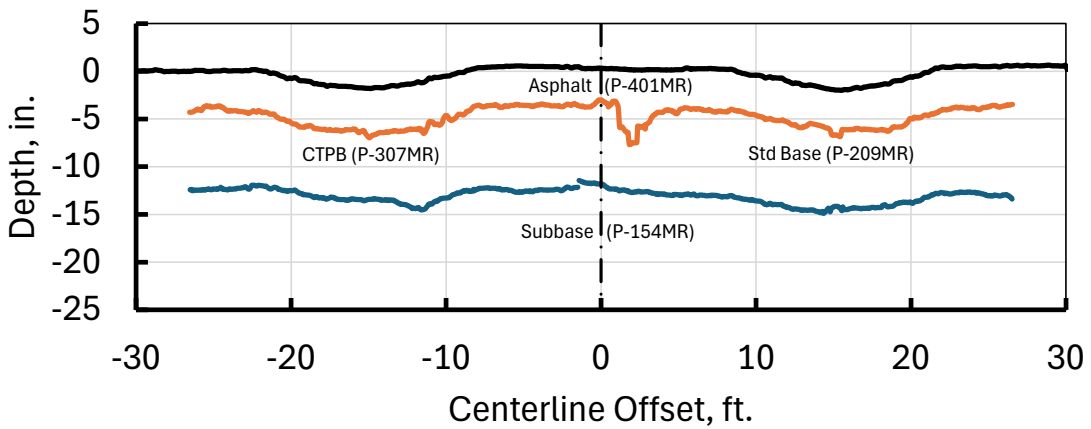
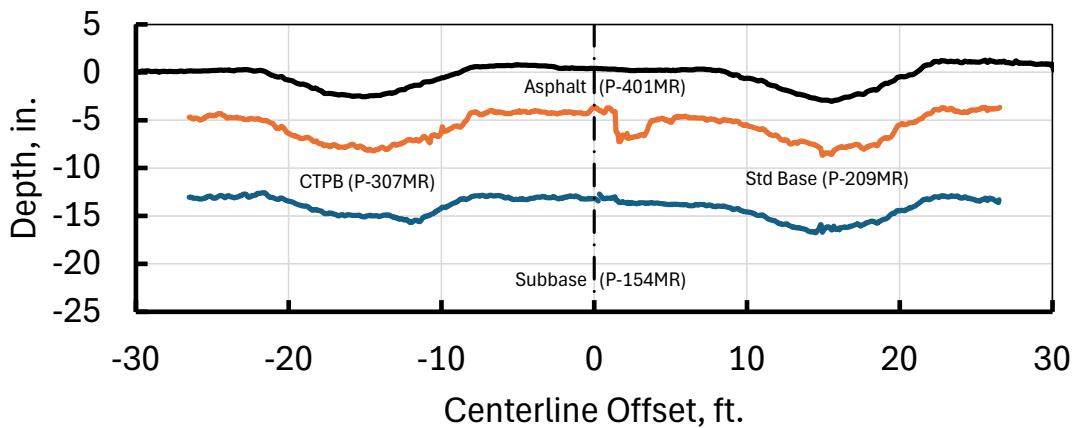
Figure 37 shows the evolution of the combined GPR/surface transverse profiles for the CTPB test area. Figure 38 shows the final GPR-based longitudinal centerline profiles (excluding the surface profile). Transverse profiles clearly show the progression of permanent deformation, with limited rutting occurring in upper structural layers for both test items. The asphalt layers in both test items, and the aggregate base (P-209MR) in LFC-4S, maintained their thickness throughout the test. The trafficked areas of the CTPB layer in LFS- 4N experienced some thinning, which could indicate material breakdown under traffic of the CTPB layer. However, from Figure 37 it can be inferred that most permanent deformation took place in the subbase and/or subgrade.

Figure 37. Transverse Profiles, STA 2+10, Laser Profile + GPR (900 MHz Antenna)

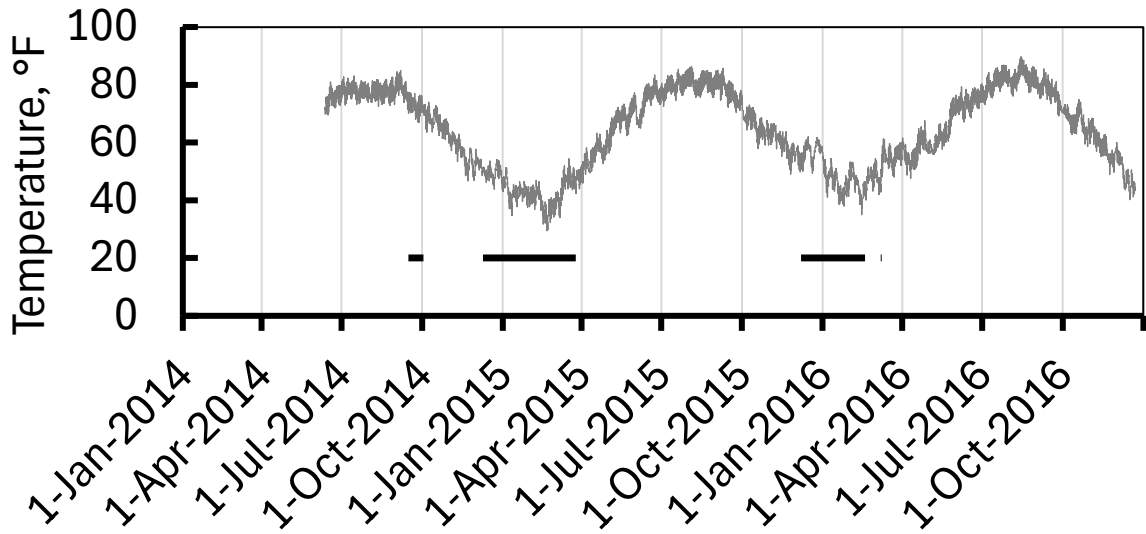
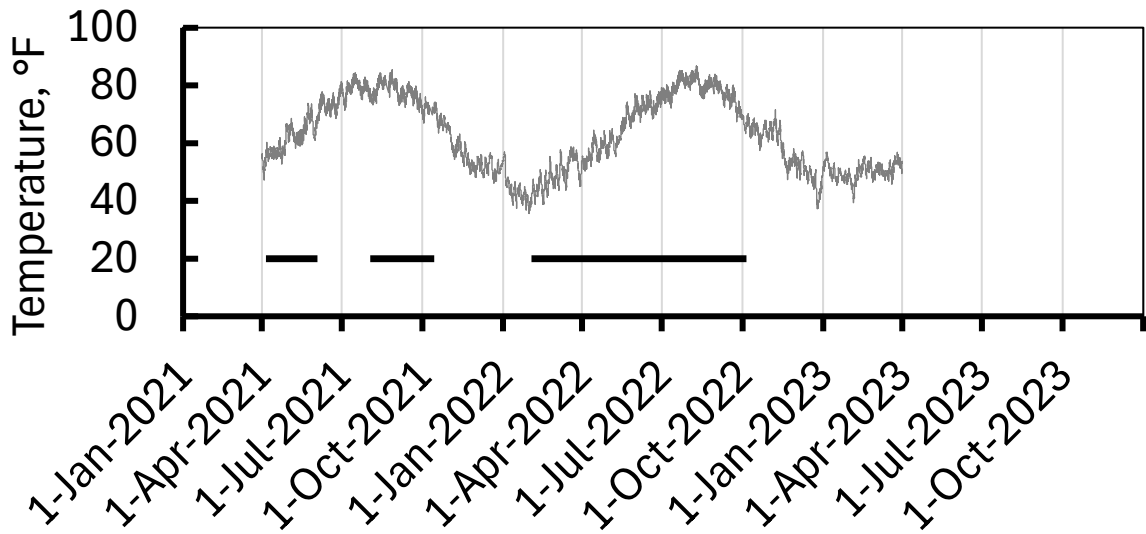
(a) CC7 ATPB Test Timeline

(b) CC9 CTPB Test Timeline

Other CC9 monitoring procedures were paralleled in CC7. In both tests, one PC was placed at the top of the subgrade to monitor vertical load-induced stress. At regular intervals, engineers measured straightedge rut depth and conducted visual surveys following ASTM D5340 (ASTM, 2020).

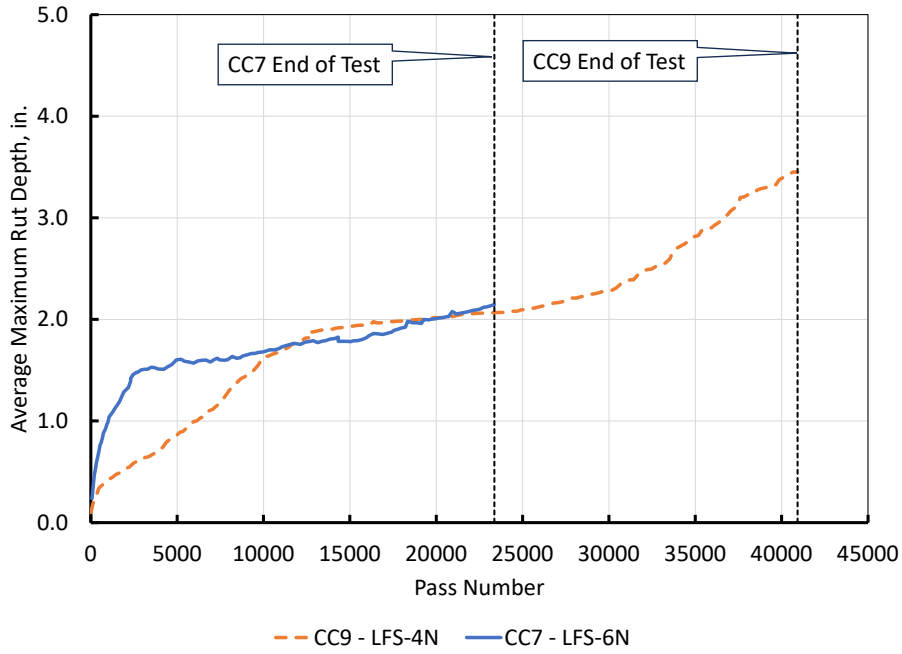
Figure 40 compares the PSE rut depth for CC9 LFS-4N (CTPB) from Figure 22(a) with the corresponding rut depth for test item LFS-6N (ATPB) in CC7. Rutting rates were comparable, with both test items reaching a surface rut depth of approximately 2 in. after 23,000 passes, although the initial rate of rutting in the ATPB section (first 2,500 passes) was much higher. Figure 41 compares the CD trends for CC9 test items from Figure 23 with the CD trend for CC7 test item LFS-6N. Surface cracking in the ATPB test item was much more extensive than in either CC9 LFS-4N (CTPB) or LFC-4S (control). This result is explained by the much lower temperatures at which CC7 was tested, which increases the propensity for cracking (see above).

Figure 40. Physical Straightedge Maximum Rut Depth Versus Cumulative Passes for CC7 and CC9 Stabilized Permeable Base Test Items

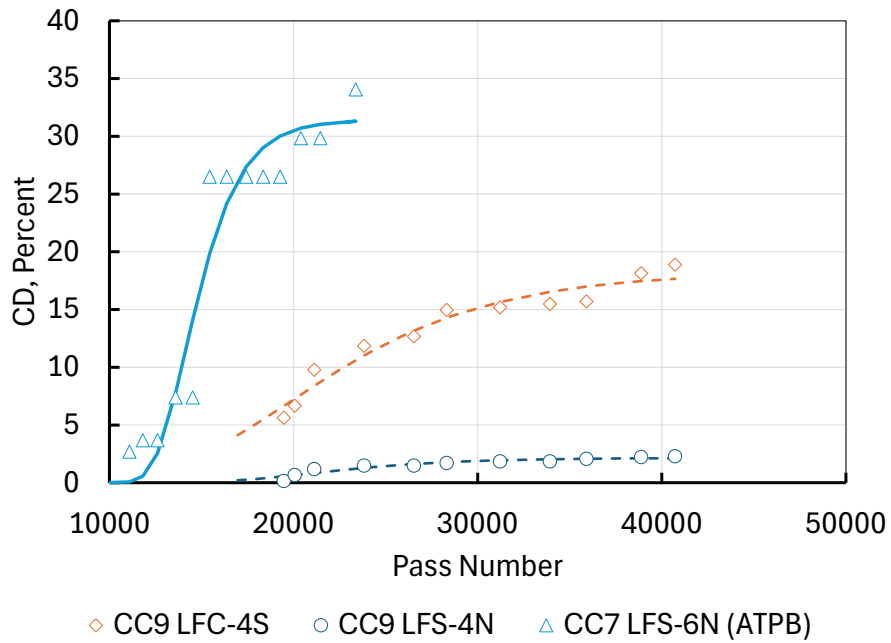
Figure 41. Crack Density Versus Cumulative Passes for CC7 and CC9 Stabilized Permeable Base Test Items

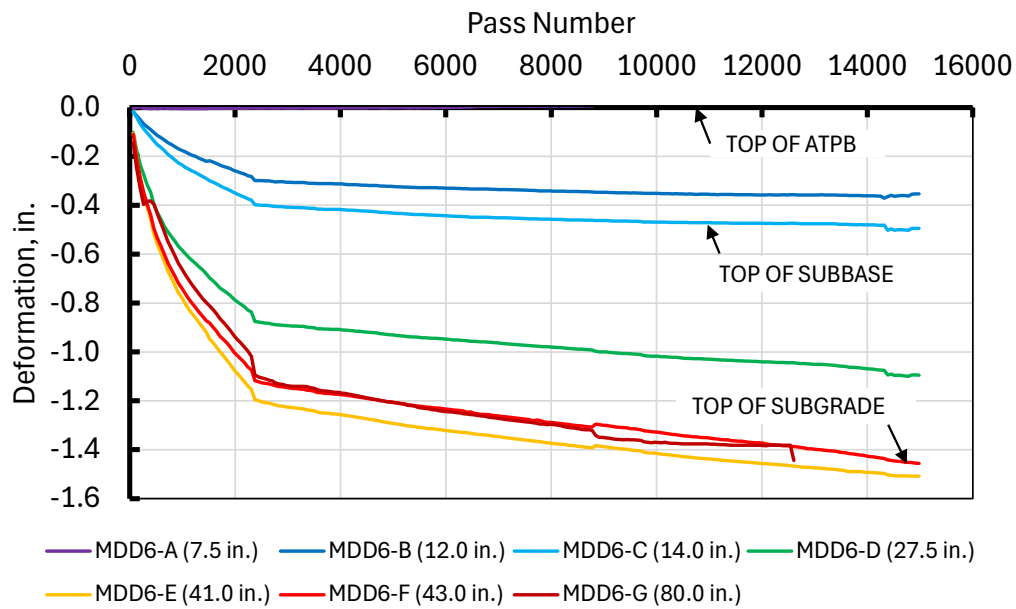
Post-traffic investigations of CC7 LFS-6N conducted in 2017 included opening a transverse trench through the test item, which confirmed the above results. From physical inspection of the trench, the investigators concluded that that 27% of total rutting was contributed by the ATPB, 73% by the subbase, and zero by the asphalt or subgrade layers (Li & Yin, 2018). Comparing Figure 44 with the GPR deformation profiles for CC9 LFS-4N in Section 5.3.2, the rut contributed by ATPB appears to be somewhat less than that estimated for CTPB (Table 18). However, the results for CTPB are preliminary and must be confirmed by trench investigations.

Figure 42. Permanent Deformation in CC7 ATPB Test Item LFS-6N from MDD
(The vertical axis shows the total deformation of the structure above the MDD component.
Numbers in parentheses are the nominal depths below the surface elevation.)

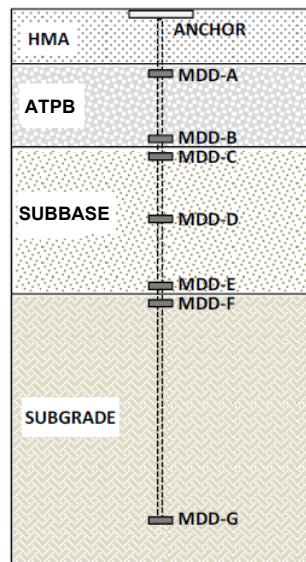
Figure 43. Locations of CC7 MDD Components Relative to Layer Boundaries (ATPB test item)

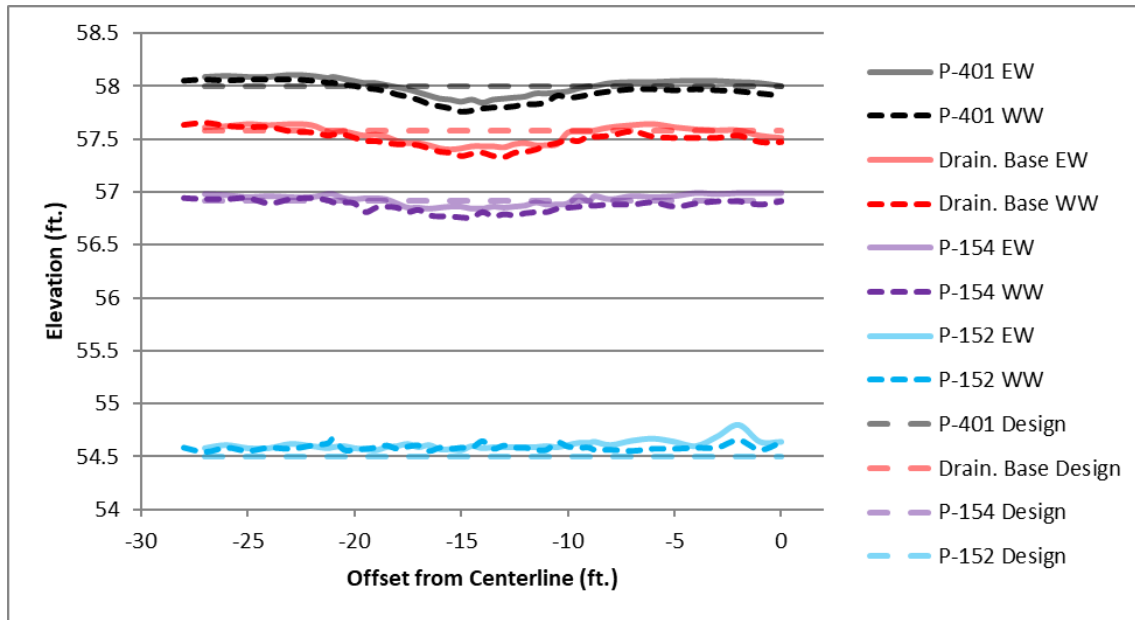
Figure 44. Pavement Layer Profiles from Post-Traffic Trench, CC7 Test Item LFS-6N (Li & Yin, 2018)
(EW and WW refer to the east wall and west wall of the trench, respectively.)
