Final Report

**Debris Accumulation at Bridge Crossings:  
Laboratory and Field Studies**

FHWA/IN/JTRP-2003/10

School of Civil Engineering  
Purdue University

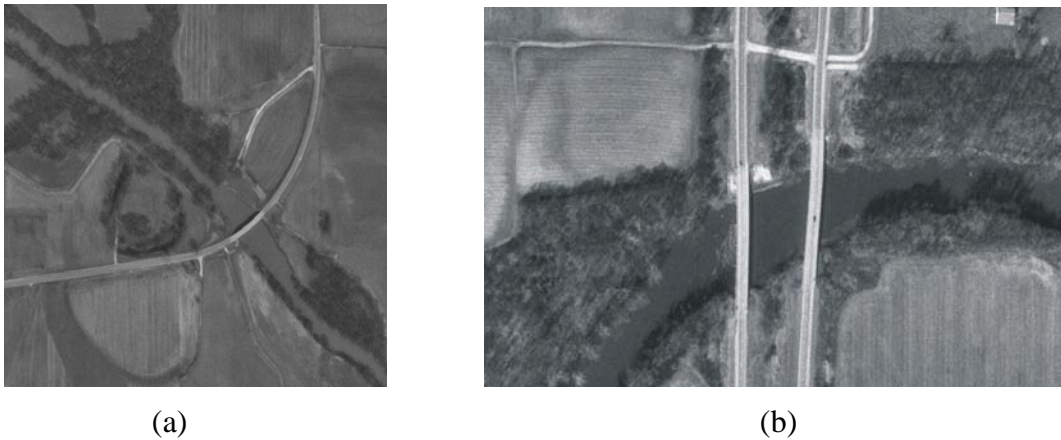
**Figure 1.1: Sites with chronic and severe debris accumulation problems in Indiana, a) SR59 south crossing of the Eel River (flowing from top left to bottom right), b) SR63 crossing of the Vermilion River (flowing from bottom left to bottom right)— source: USGS aerial photographs from <http://TerraServer-USA.com>**

The SR 59 south crossing of the Eel River in Clay County provides an example of a bridge crossing in Indiana where substantial debris accumulation poses a chronic problem (Fig. 1.1a). In Fig. 1.2a, the site is shown when it has been cleared of debris, while Fig. 1.2b shows the extensive debris accumulation that can be expected after only a single season. Apparent in the photograph of the cleared site, the mid-stream sand bar or ‘island’ that has developed around one of the piers, may be relevant, as will be argued later. Under high-flow conditions, this bar is submergent. Another Indiana site where debris accumulation requires continual attention from INDOT is the southbound SR63 bridge over the Vermilion River (Fig. 1.1b, where the debris pile can even be seen). This occurs at the beginning of pronounced bend in the river, towards the inner bank. At both of these sites, the problem is of such magnitude that INDOT has installed structures, debris deflectors (the vertical cylindrical structures in Fig.1.2), intended to guide the woody debris through the bridge opening between the piers.

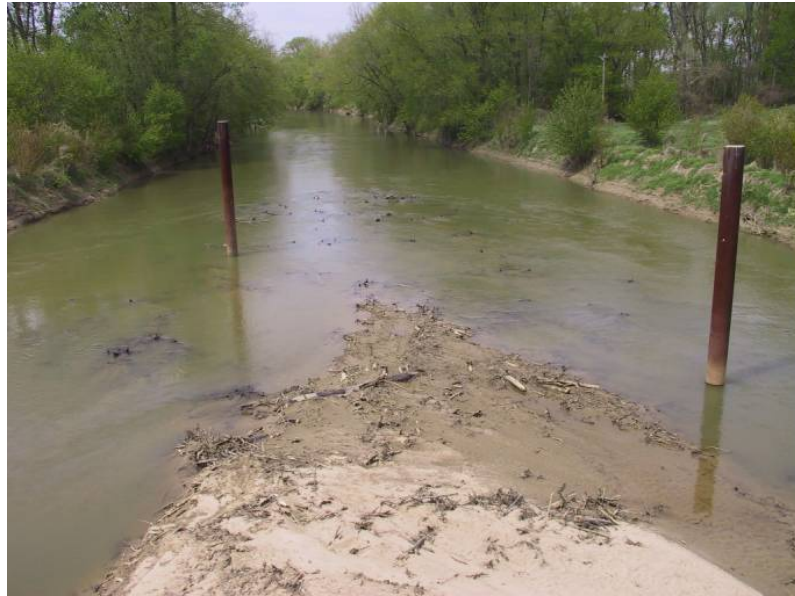
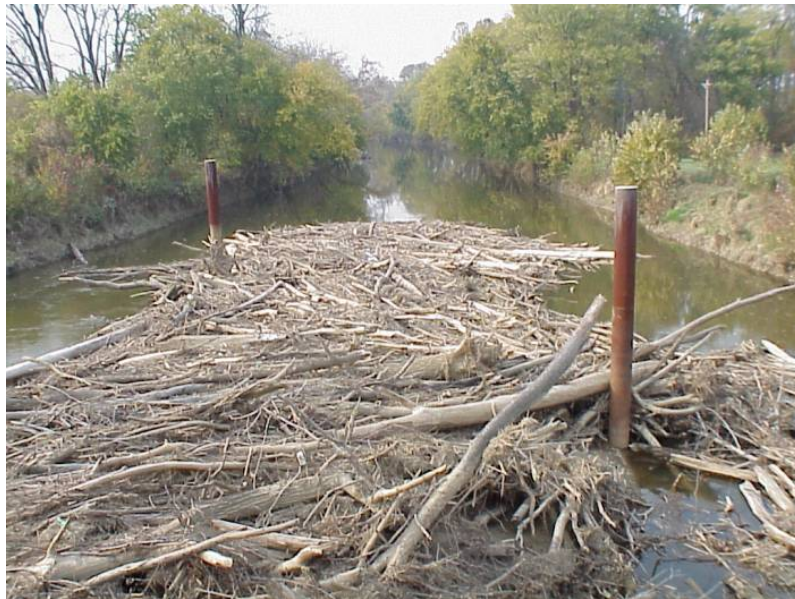
**Figure 1.2: View of the Eel River site from bridge deck in upstream direction: a) site cleared of debris (April 2001), b) site with debris pile after a major flow event (August 2000); cylindrical vertical structures are debris deflectors**

Experiments with two types of countermeasures were also conducted. One type of countermeasures is modeled after those in the field, namely, a vertical cylinder installed as a debris ‘deflector’ directly upstream of the model pier. As seen in Fig. 1.2b, the effectiveness of such debris deflectors in the field has been dubious. An alternative countermeasure consisting of submerged groin-like structures was also tested. Both countermeasures were tested with and without a model sandbar present, and at two different velocities but essentially at constant depth.

The significant expansion as the bridge is approached requires further discussion. The photograph of the site cleared of debris (Fig. 1.2a) shows clearly a sand bar in midstream, which, from the results of the laboratory study, may play an important role in debris accumulation. Fig. 4.1 shows the site bridge plan prepared for the bridge construction, and a nascent sand bar can be seen, indicating that the beginning of a sand bar already existed before the bridge construction. Apparently, because the expansion results in lower velocities, and hence lower sediment-transporting capacities, sediment deposition has occurred, such that the nascent sand bar has grown substantially, at the same time, possibly also being slightly displaced downstream.

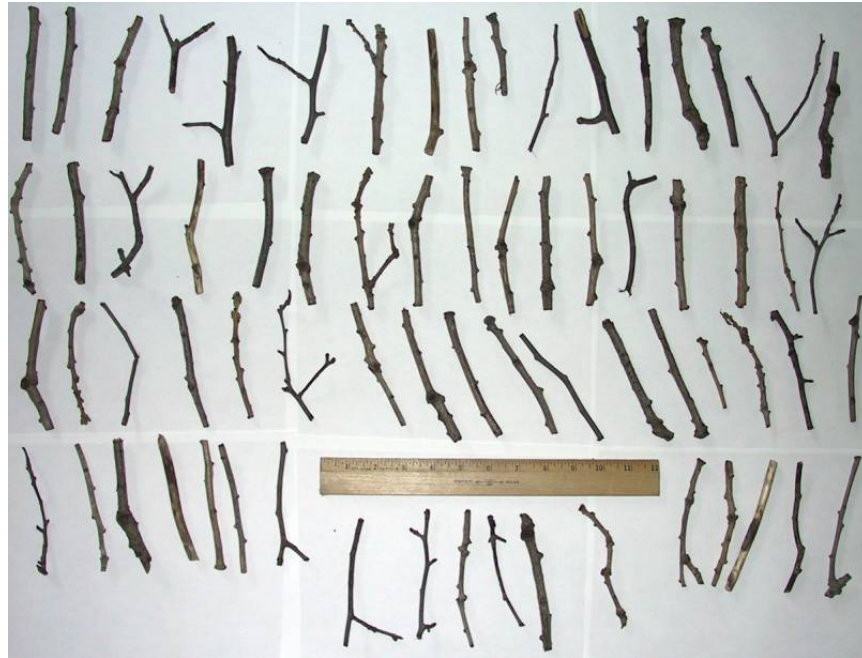
**Figure 2.1: Twigs used as model logs**

the average diameter of the largest circle that could be inscribed at each point on the ‘skeleton’ of the twig respectively,. The mean length and diameter defined in this manner were 4.55 in (11.6 cm) and 0.23 in (0.58 cm).

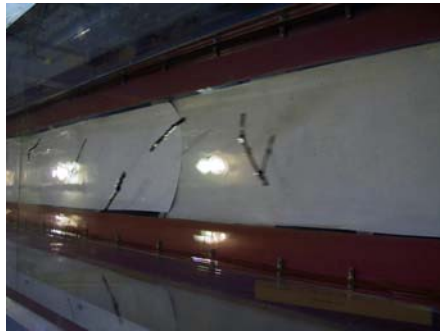
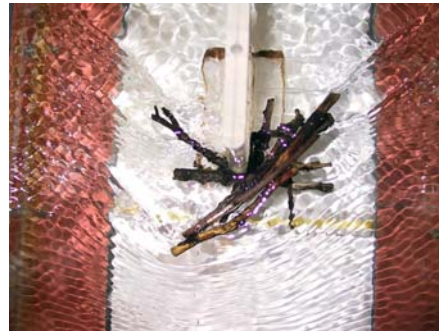
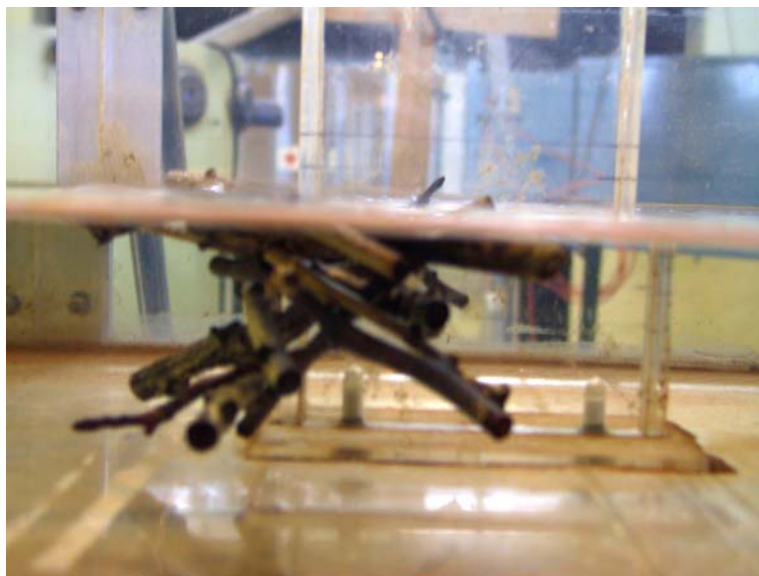
A photograph of model logs (twigs), upstream of the pier section, traveling downstream (to the left) is shown in Fig. 3.1a. In spite of the logs being introduced with their longest dimension approximately aligned with the flow, they do not necessarily maintain this orientation, often rotating significantly as they move downstream. A plan-view photograph of a stable debris pile at the model pier is shown in Fig. 3.1b, while the corresponding side view is given in Fig. 3.1c. In this particular run (at a shallow depth of  $\gg 5$  cm), the pile consists of a large number (at least 6) of twigs, with the pile almost extending through the entire water column, and at least one twig touching the bottom of the channel.

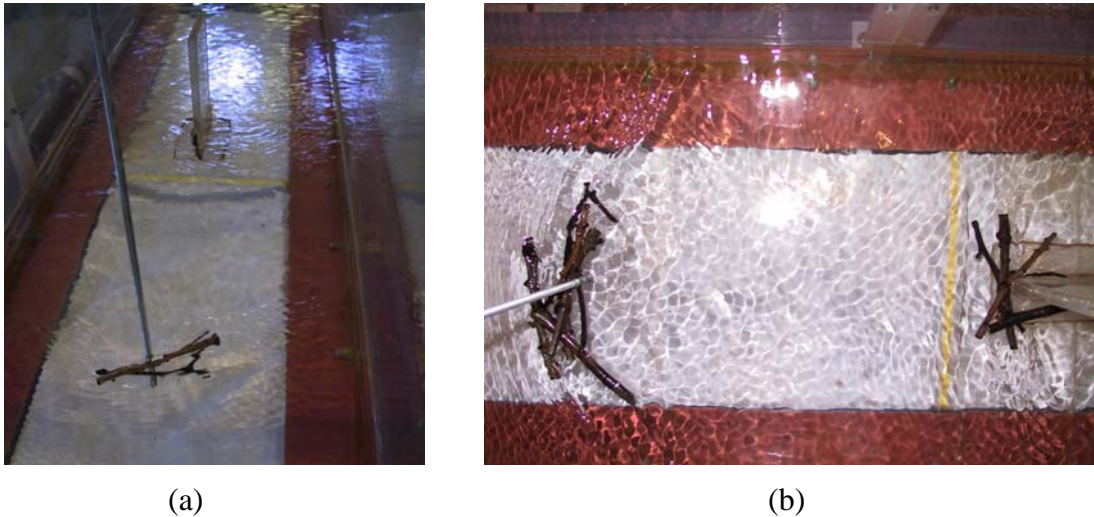
**Figure 3.2:** Case with deflector installed upstream of model pier, a) perspective view looking downstream, b) top view with debris accumulated at both deflector and pier

The first experiments with a deflector were also conducted in this series. The deflector, modeled with a ¼” threaded rod, was installed 15” (corresponding, assuming a length scale ratio of 48, to 60-ft in the field) directly upstream of the pier. Fig. 3.2 shows photographs taken of cases with the deflector in place, again all at the smaller depth. In the large majority of the runs, the debris pile developed at the deflector, with very few or no logs at the pier. Logs can however still be trapped at the pier (Fig. 3.2b).

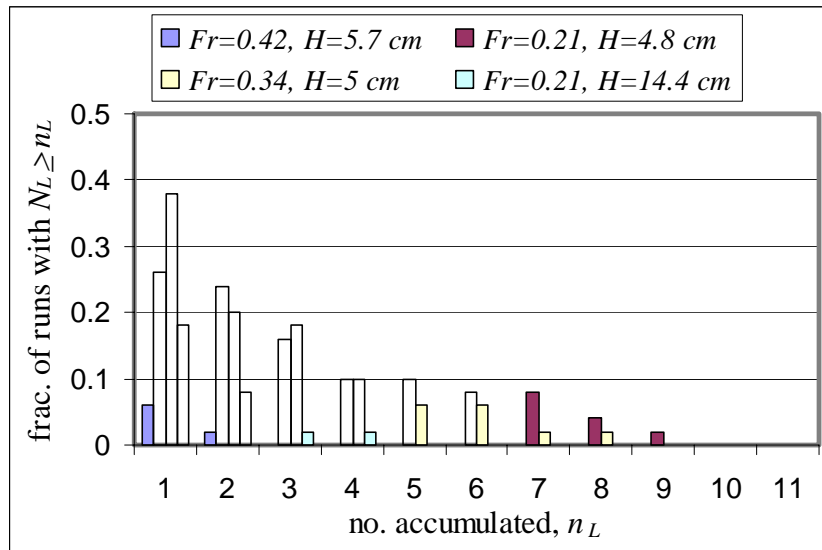
**Figure 3.3: Distribution of experimental runs with number of logs accumulated for cases where dowels are used as model logs**

These experiments continued along the lines of the Series B experiments, but refined the definition of a debris pile and pile stability. Consider first the results shown in Fig. 3.3 of experiments with wooden dowels in which, on the one hand, the depths were kept approximately constant,  $\gg 5$  cm, but the velocity and hence the Froude number,  $Fr$ , was varied, and on the other hand,  $Fr$ , was kept constant at 0.21 and two depths were studied. On the  $x$ -axis is plotted the number of model logs,  $n_L$ , remaining at the pier after 15 minutes, whereas on the  $y$ -axis is plotted the fraction of runs in which the actual number of logs,  $N_L$ , is greater than or equal to  $n_L$ . Fig. 3.3 therefore is interpreted as showing the distribution of  $N_L$  treated as a discrete random variable. At the highest velocity ( $Fr = 0.42$ , corresponding to a velocity of 1 fps or 31 cm/s), very few logs were trapped (only in 0.06 of the 50-runs was any log trapped, and in none of the runs were there more than 2 trapped logs observed). According to the definition of a debris pile used previously, i.e., a minimum of 3 trapped logs, no debris pile developed for this particular case. As might be intuitively expected, if the depth is kept (approximately) constant and the velocity (and hence  $Fr$ ) decreases, then the likelihood of debris (dowels) accumulating at the model pier increases. Interestingly, both of the lower-velocity cases resulted in quite similar distributions, so it seems that, below a certain velocity, the velocity may cease to have any significant influence. This was already seen though less clearly in the results of the Series A experiments. Whether this is a scaling effect which would not occur at full scale is less clear.

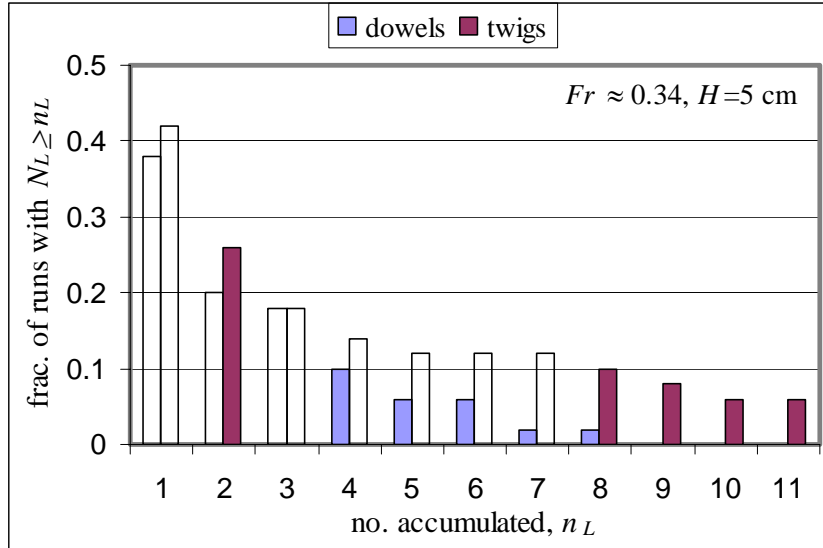
**Figure 3.4: Comparison of distribution of accumulated model logs in cases with dowels and with twigs as model logs**

Fig. 3.4 shows results illustrating the difference when using dowels and using twigs as model logs for given velocity (the case with the twigs had a slightly higher velocity, 25.5 cm/s, compared to 24 cm/s for the case with the dowels) and depth. For small values of  $n_L (\leq 3)$ , the distribution are perhaps surprisingly similar; only at larger values of  $n_L$  do they diverge. Thus, the primary difference between dowels and twigs would seem to be that larger accumulations are much more stable when twigs are used, and so are observed more frequently. Since the flow conditions are for practical purposes identical, the difference is attributed to the difference in physical characteristics, namely the much rougher surface texture of the twigs as well as their occasional branching features.

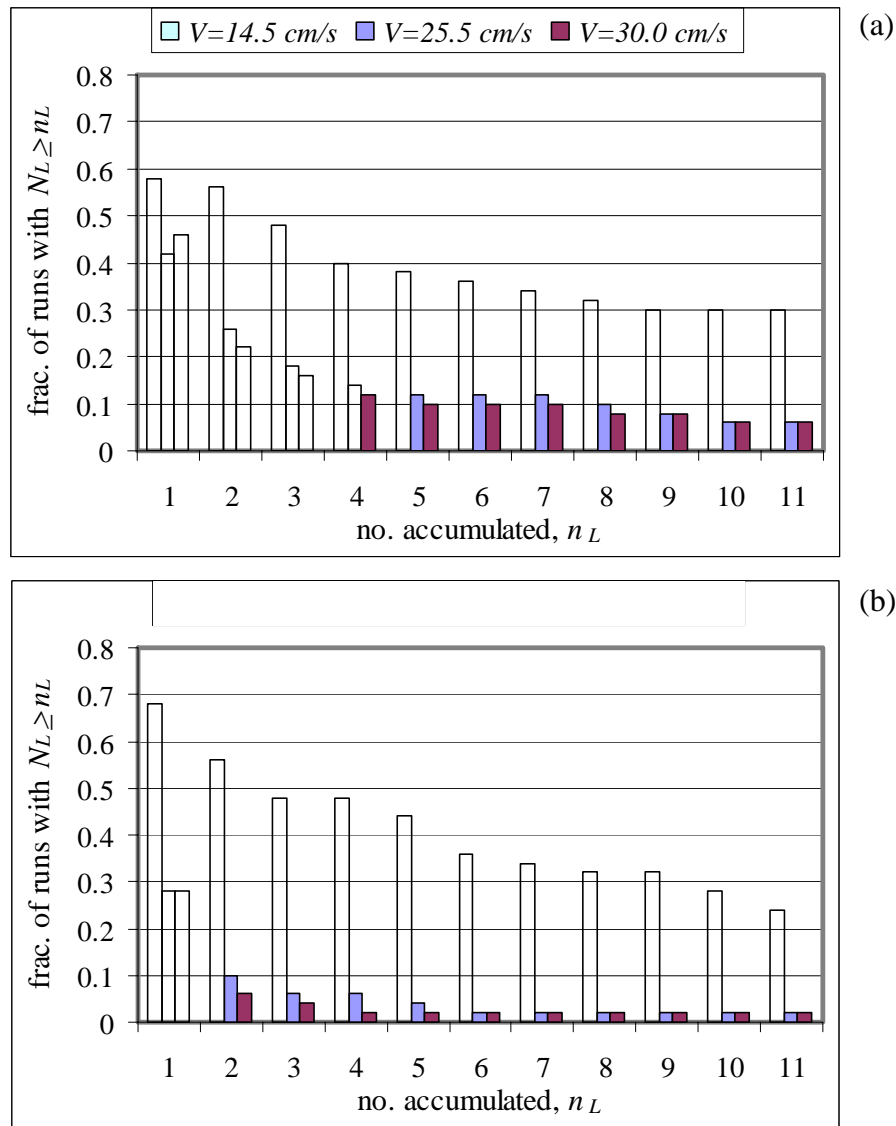
**Figure 3.5: Effect of velocity on distribution of number of accumulated logs at approximately constant depth, a)  $H \gg 5$  cm, b)  $H \gg 15$  cm**

For those cases where twigs are used as model logs, the effect of velocity at constant depth or of depth at constant velocity is considered in Figs. 3.5 and 3.6. In the former case, the distributions at both depths studied exhibit quite similar features (Fig. 3.5). As seen before with the dowel as model logs, there is a strong effect of velocity, in that the case with the lowest velocity ( $V \gg 15$  cm/s, i.e.,  $Fr \gg 0.13$  or  $0.21$  depending on the depth) shows a markedly higher probability of occurrence of large debris accumulation. Somewhat different from the case of the dowel logs, the difference between the cases of the two highest velocities is relatively small. The effect of depth can be inferred from Fig. 3.5, but is made clearer in Fig. 3.6, where the results for two depths are compared at each of three velocities. At the lowest velocity ( $V \gg 15$  cm/s), the effect of depth is weak or non-existent. At the two other higher velocities ( $V \gg 24$  cm/s or  $V \gg 30$  cm/s), however, a much more noticeable effect of depth is observed. If as before a debris pile is defined as containing 3 or more logs, then the differences seen in Fig. 3.6 between the two depths at the two higher velocities would be statistically significant at the 5% level. The variation of the probability of occurrence of a debris pile with either velocity or depth is therefore not necessarily monotonic. Above a certain velocity, the effect of velocity may be negligible, while below a certain velocity, the effect of depth may be negligible.

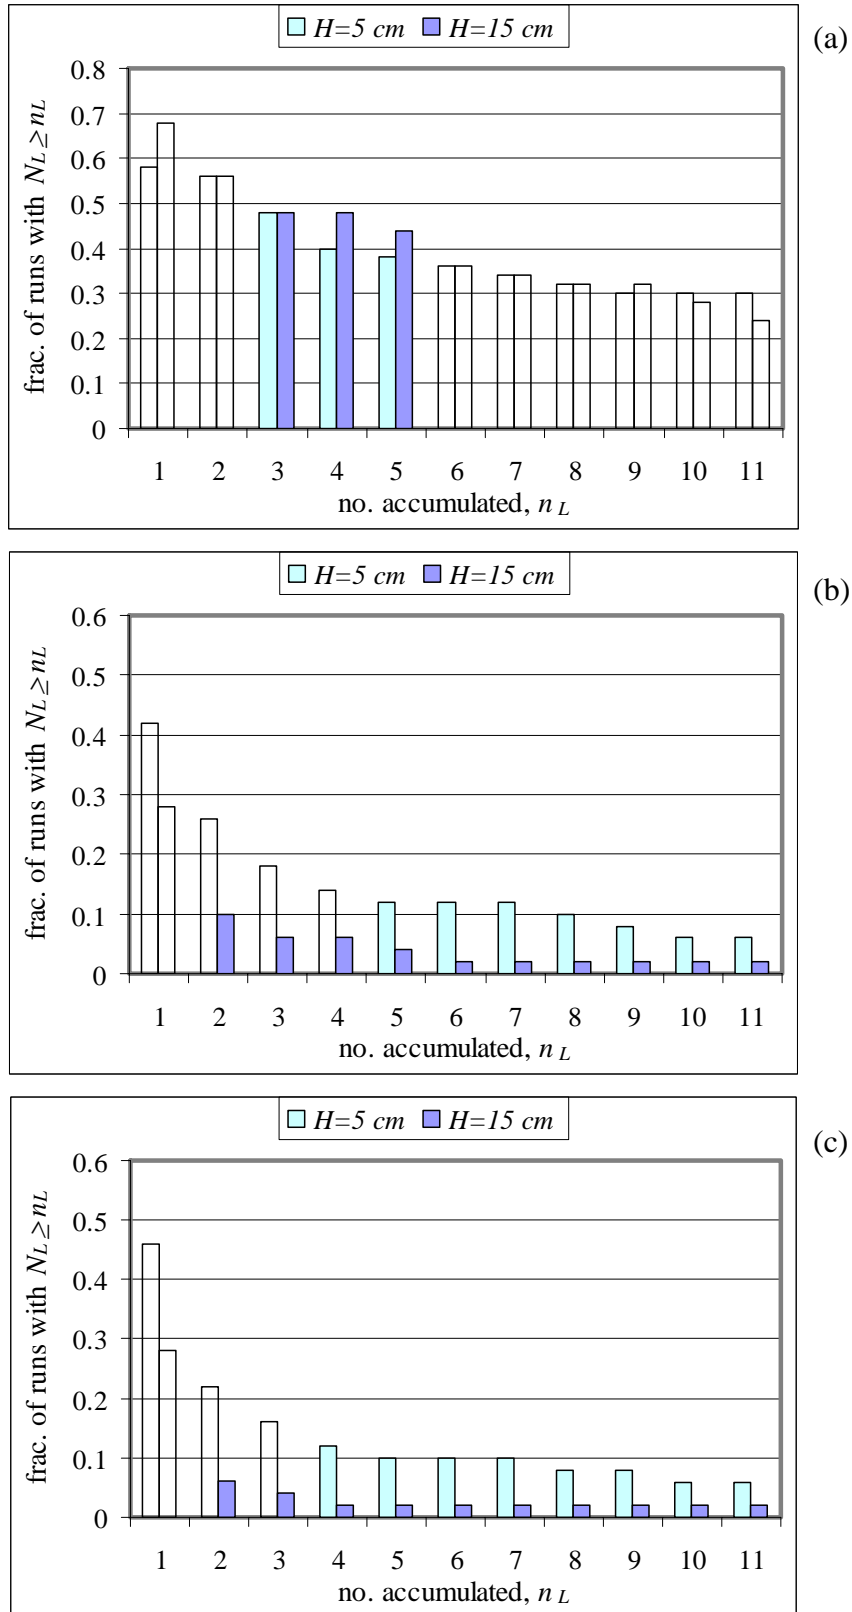
Figure 3.6: Distribution of accumulated logs at two different depths with velocity approximately constant, a)  $V \gg 15\text{ cm/s}$ , b)  $V \gg 25\text{ cm/s}$ , c)  $V \gg 30\text{ cm/s}$

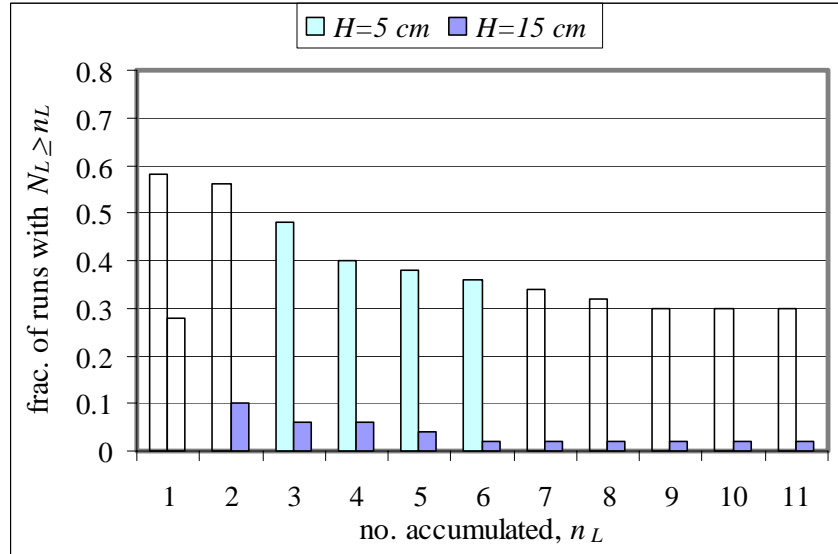
**Figure 3.7: Effect of depth on distribution of runs with debris piles at constant Froude number,  $Fr \gg 0.2$ .**

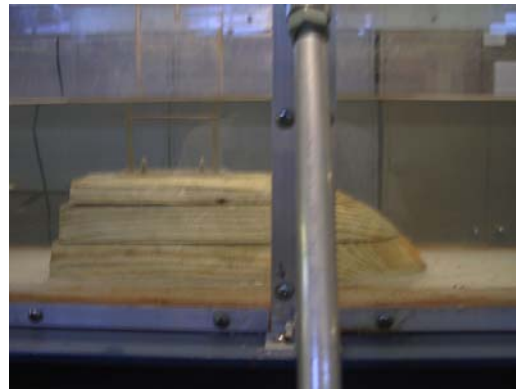
**Figure 3.8: Model sand bar in laboratory channel, a) perspective view downstream, b) sideview (flow is from right to left)**

A possible criticism can be leveled at comparisons between experiments in which the flow is approximately uniform (and so the depth is everywhere the same) in that extraneous effects due to the flow upstream of the pier, such as the strength of secondary currents, may influence results. Further, it was pointed out in Chapter 1 that the mid-stream sand bar may play a significant role in debris accumulation (see Fig. 1.2, and also Diehl, 1997). For both these reasons, experiments with a model sand bar (Series D) were motivated. Results for cases with and without a sand bar, but under the *same* upstream flow conditions, could then be more meaningfully compared. The model sand bar had rather exaggerated dimensions, and no attempt was made to make it geometrically similar to that at the Eel River site. It is  $\approx 40$  cm in total length, and  $\approx 11$  cm in total height, with streamlined upstream and side faces but a vertical downstream face. Pictures of the model sand bar are given in Chapter 3 (Fig. 3.8).

This series of experiments was performed with a simulated sand bar in the channel. The submerged sandbar is shown in Fig. 3.8. Two experiments were performed with this configuration, with a single depth corresponding to the larger depth of the previous experiments, i.e.,  $H \gg 15$  cm, but at two upstream velocities, again approximately equal to those used in the previous experiments without the simulated sand bar. In the case with  $V = 15.9$  cm/s, only 25 runs were performed, in part because such a large proportion of the runs resulted in large debris accumulations. As discussed in Sec. 2.3, this configuration avoids possible extraneous upstream effects because the upstream flow should be for practical purposes identical—only the section with the pier on top of the bar and its immediate vicinity differs from the cases studied without the sand bar.

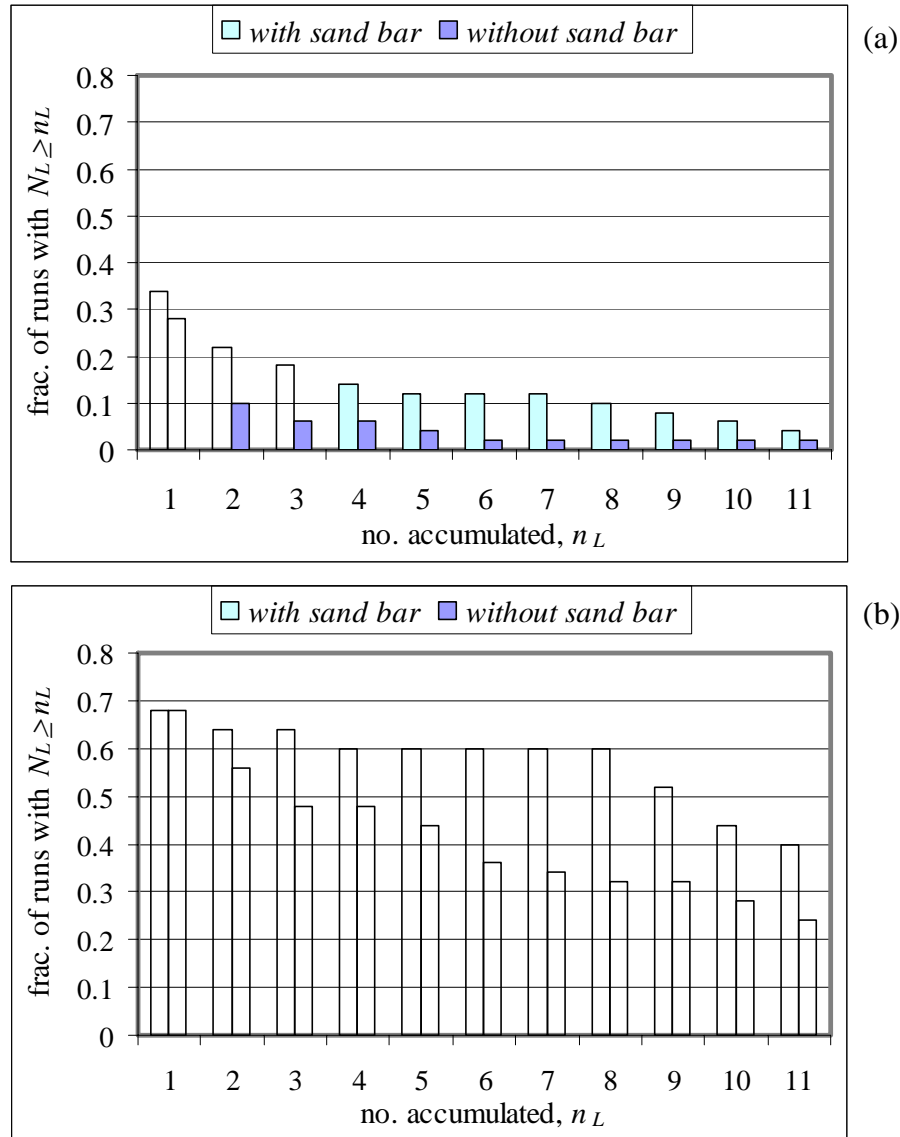
Figure 3.9: Effect of the presence of a sand bar on the distribution of runs with a debris pile, a)  $V \approx 25$  cm/s, b)  $V \approx 15$  cm/s.

While the above suggests the strong influence of the sand bar, the precise mechanism or even the physical characteristic of the sand bar most important in this regard is less certain. From our previous experiments, smaller depths would seem to be associated with debris accumulation. In the neighborhood of the pier installed on the simulated sand bar, the depth is certainly locally smaller than in the main flow, and so the hypothesis can be advanced that this aspect of the sand bar is decisive. Without a precise physical mechanism causing this tendency, the hypothesis is primarily based on a statistical correlation, and so should be viewed cautiously.

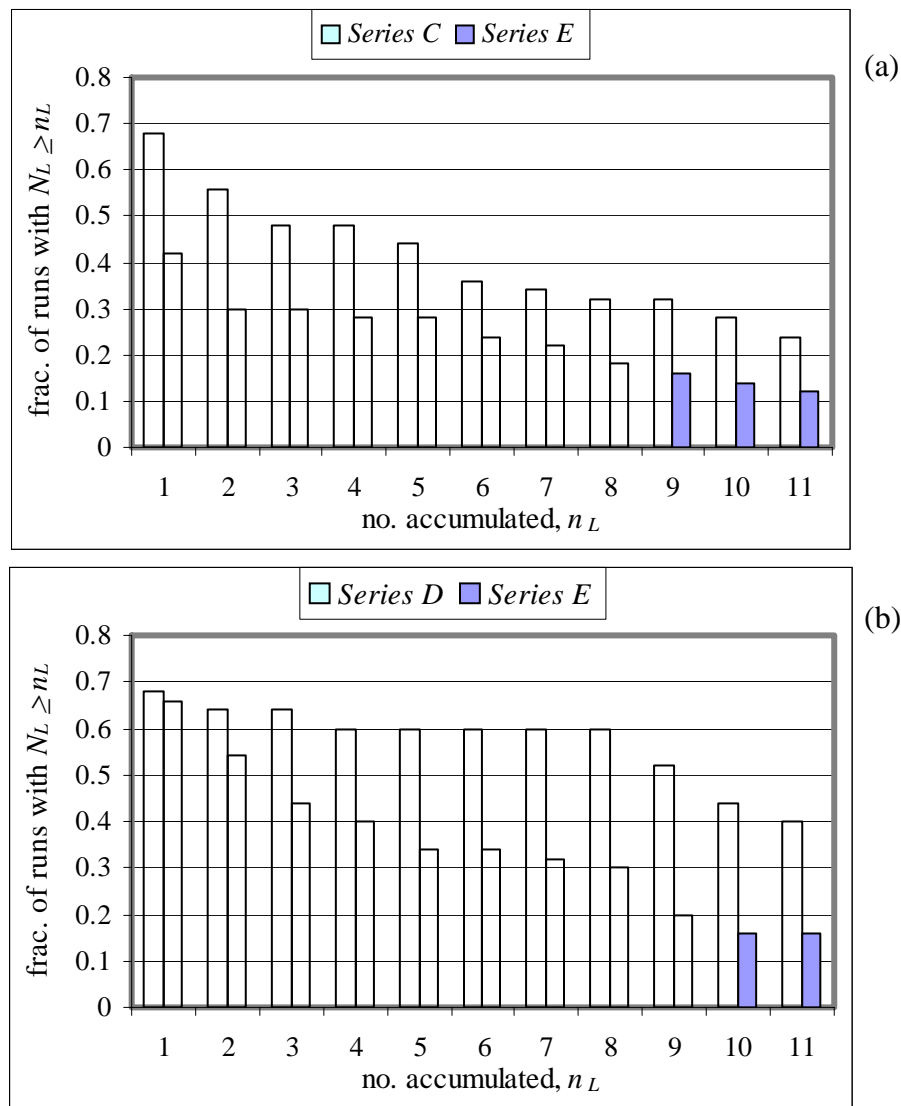
**Figure 3.11: Comparison of Series E experimental results with results from earlier series, a) case with no sandbar, b) case with sandbar (in both cases, discharge was 0.32 cfs, and upstream depth was  $\approx 16$  cm)**

Before results involving deflectors are presented, results from series E are compared to those from earlier series with comparable experimental conditions. Fig. 3.11 shows two cases, one with and one without the model sandbar. Differences are evident, and may be indicative of the statistical variation that is associated with such results when experiments are performed by different individuals. For the case without the sandbar, the discharges were the same, but there was a slight difference in depth (the Series E flow was 1.3 cm deeper), while for the case with the sandbar, the number of runs in Series D was 25 compared to 50 in Series E. Qualitative trends tend to be preserved, however—in both cases, there is evidence that the presence of the sandbar is associated with greater likelihood of debris accumulation. For greater consistency, comparisons in the following will therefore be made only between Series E experiments since these were performed by the same individual.

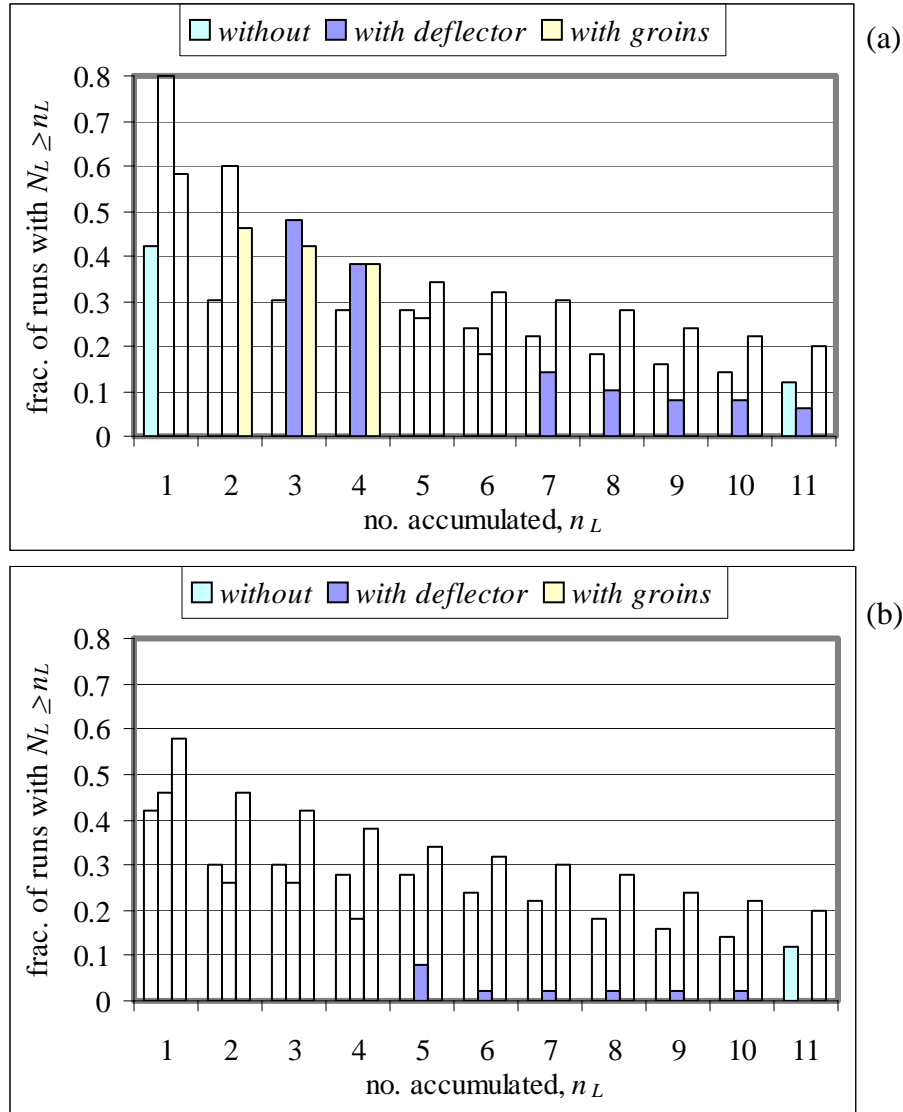
**Fig. 3.12: Effect of countermeasures on likelihood of debris accumulation, a) considering total number of logs accumulated at both pier and deflector, b) the same as in (a), but considering only the number of logs accumulated at the pier.**

Results for experiments without a model sandbar at a discharge of 0.32 cfs (this corresponds to an upstream velocity of 0.46 fps and an upstream Froude number,  $Fr = 0.11$ ) are shown in Fig. 3.12. For experiments with deflectors, a further problem arises in defining the number of logs accumulated in that a model log may be trapped either at a pier or at the deflector. The total number of logs accumulated, whether at the deflector or the pier, might be considered the most relevant statistic because logs trapped at either deflector or pier can develop into a debris pile and are therefore cause for concern. Nevertheless, it should be recognized that this total number may lead to quite different distribution than, for example, the number accumulated at the pier; Fig. 3.12 shows both. When the total number is used, a much larger likelihood of debris

accumulation is observed for small  $n_L$  because logs can be trapped at either deflector or pier. For large  $n_L$ , however, the presence of the deflector does tend to reduce the likelihood of debris accumulation. The results of Fig. 3.12a also indicate that the effectiveness of the alternative countermeasure is rather doubtful since the likelihood of debris accumulation is uniformly higher for all  $n_L$  compared to the reference case. Fig. 3.12b replots the results of Fig. 3.12a, except that, in the case with deflector installed, the number of logs accumulated at the pier (not the total number) is considered. In this representation, it is clearer that the presence of the deflector reduces the debris accumulation at the pier, though this may be due to accumulation at the deflector.

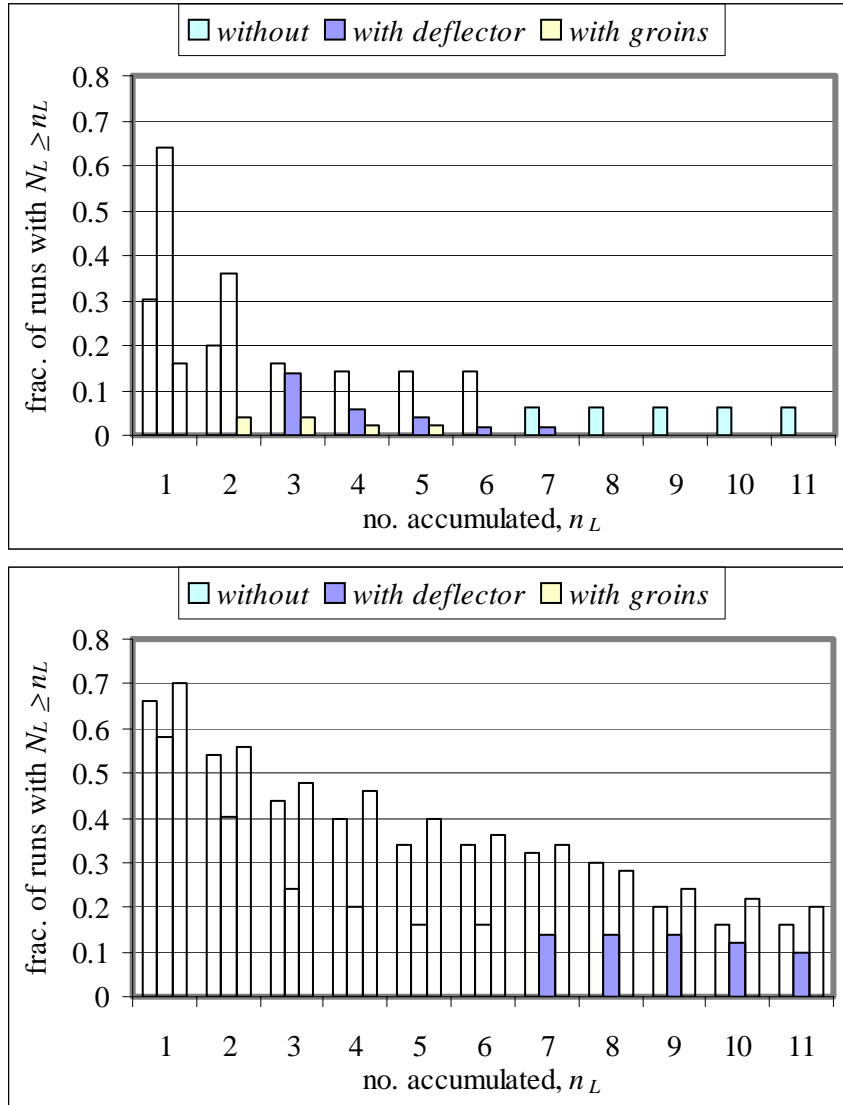
Fig. 3.13: Case when a model sandbar is present, a) higher discharge case, ( $Q = 0.5$  cfs,  $V = 22$  cm/s), b) lower discharge case ( $Q = 0.32$  cfs,  $V = 14$  cm/s)

The case where a sandbar is present is examined in Fig. 3.13 at two different discharges (and hence two different approach velocities). Here, in the case where a deflector is present, the total number of logs accumulated is taken. At the higher discharge ( $Q = 0.5$  cfs,  $V = 22$  cm/s), the submerged groin structures appear to be quite effective, inhibiting to a large degree even small debris accumulations. At the lower discharge ( $Q = 0.32$  cfs,  $V = 14$  cm/s), however, the effectiveness is considerably reduced, consistent with the result already seen in the absence of a sandbar. The results would suggest that the presence of a deflector does reduce the likelihood of debris accumulation, though possibly not sufficient to prevent the development of large piles. For the lower-discharge case with deflector installed, a debris pile developed with over 30 logs at the deflector in one run, while in another run, a debris pile with over 20 logs accumulated *at the pier*.

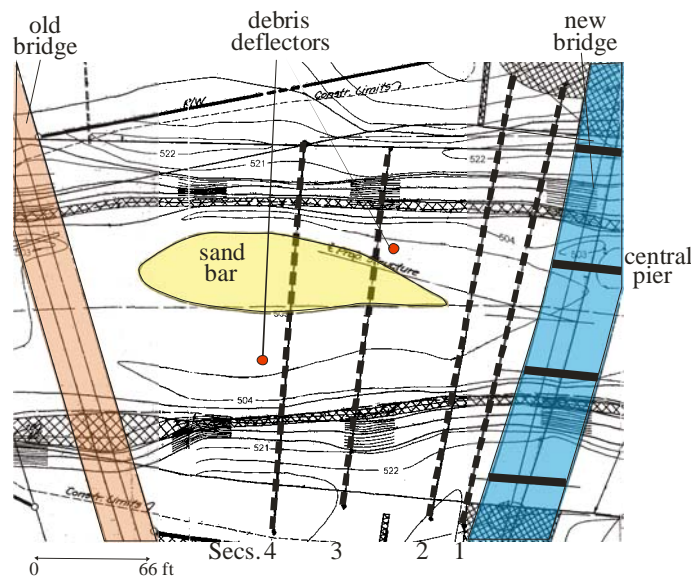
**Figure 4.1: (1985 design) Bridge plan, showing topography of stream at that time, nascent sand bar, old and new bridges, debris deflectors, and sections surveyed in 2002 (heavy dashed lines)**

The surveyed cross-sections (Cross-section 1 is closest to the bridge) are compared with the corresponding cross-sections taken from the design bridge plan, dated 1985. Two differences between the 1985 bridge-plan and the current (2002) cross-sections are striking: i) the width of the channel, and ii) the growth of the sand bar. The first indicates that, if there had been an expansion before the bridge construction, it was likely to have been much less pronounced than is the current expansion. The widening seems to have been a deliberate design choice to increase the bridge clear opening and therefore to be able to pass a larger discharge at a lower water surface elevation, since instructions on the plans are given to clear an area substantially wider than the original channel. The second shows a marked growth, in excess of 4 ft, in the highest elevation of the sand bar, and also a displacement of the highest points somewhat to the left (looking downstream) and downstream. Lateral as well as longitudinal (in the streamwise direction) growth may have also occurred, but a definite conclusion is more difficult to arrive at, due to the possible displacement. The sediment deposition that caused this sand bar growth is, as was noted above, mainly attributed to the lower velocities resulting from the expansion, but it may also have been enhanced by the debris accumulation. In this way, sedimentation and debris accumulation may be self-reinforcing processes.

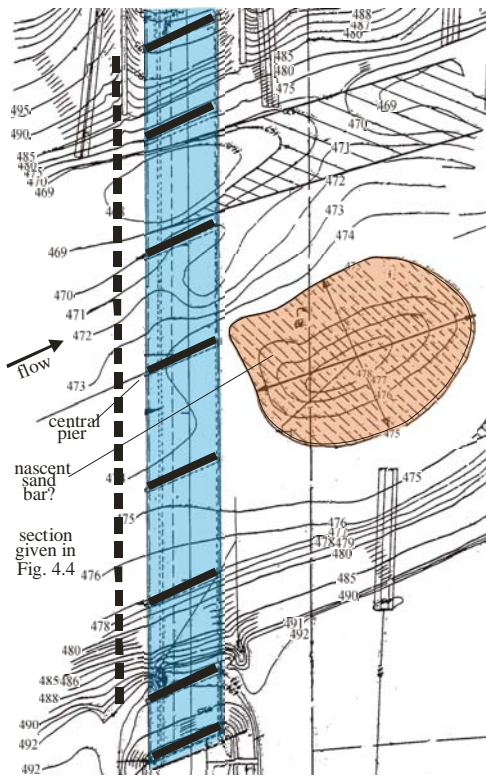
**Fig. 4.3: Channel geometry in the vicinity of the SR63 southbound crossing of the Big Vermilion River, taken from the bridge plans developed for the construction of new (northbound) bridge**

Fig. 4.3, adapted from the 1968 bridge plan for the new bridge, shows the stream topography in the immediate vicinity of the southbound bridge. Interestingly, a bar-like feature is found, though, *downstream* of the southbound bridge, along with specific instructions that this should be cleared to elev. 475 ft (similar instructions were also given to clear the thalweg region just downstream of the bridge to elev. 469 ft, hatched in Fig. 4.3). A cross-section just upstream of the southbound bridge (the location is shown in Fig. 4.3 as a heavy dashed line) based on the 1968 design plan is shown in Fig. 4.4a (as before, this is plotted looking downstream). It is fairly typical of cross-sections at a river bend, with the thalweg region towards the outer part of the bend (left looking downstream). A quite steep outer bank may be indicative of some stream instability. A feature of particular interest is a very mild ‘shoulder’ or terrace beginning at  $\approx 175$  ft in Fig. 4.4a, which is  $\approx 5$  ft higher than the channel thalweg elevation. This is the region, towards the *inner* part of the bend, where debris accumulation predominantly occurs. As noted in the literature review, laboratory and field observations indicate that, in the absence of bridges and piers, debris deposition and hence accumulation tend to occur towards the *outer* part of a bend. On the other hand, the observations at the Vermilion R. site are consistent with the hypothesis suggested by the present laboratory study that a smaller local depth increases the potential for debris accumulation. Figs. 4.4b,c are upstream cross-sections based on flood analyses (Flood Insurance Study, Cayuga, 1980), performed in 1979, i.e.,  $\approx 10$  years after the bridge construction. Secs. 1 and 2 are  $\approx 150$  ft and 2200 ft upstream of the southbound bridge. The beginning of a shoulder feature might possibly be seen at a lateral coordinate of  $\approx 2250$  ft (note that this coordinate system is not the same as that used in Fig. 4.4a) in Sec. 1, closer to the bridge and the bend. Well away from the bridge and the bend, Sec. 2 (Fig. 4.4c) exhibits little if any sign of a shoulder feature. It may be relevant that the Vermilion R. also goes through another bend, similar to that at the SR63 crossing, about 4000 ft upstream of the SR63 crossing.

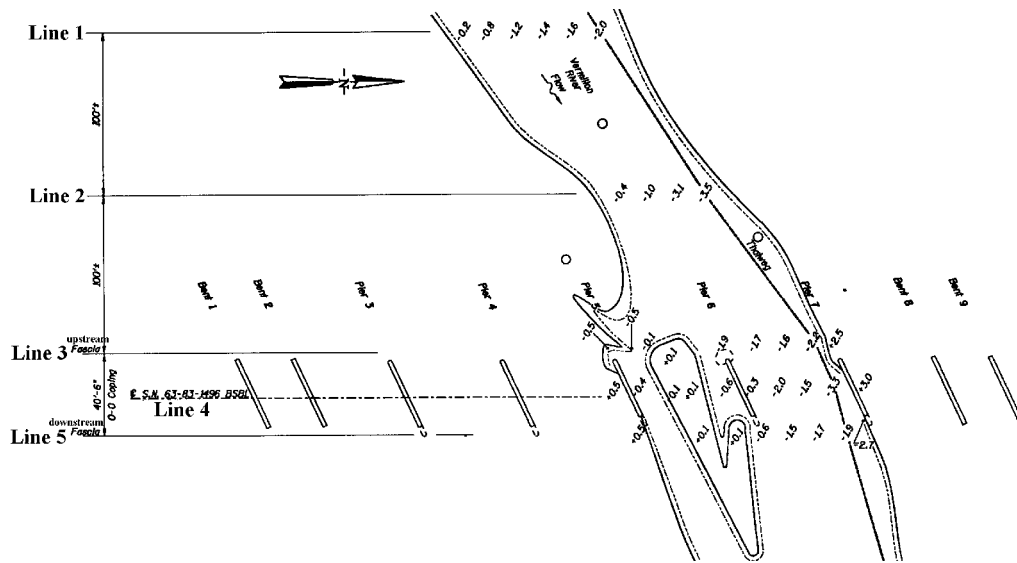
**Figure 4.5: Bathymetric data for the Vermilion River at the SR63 southbound bridge obtained during underwater bridge inspection study (adapted from Collins Engineers, 2001)**

Three debris deflectors, identical in form to those at Eel River, are also installed in a similar geometric arrangement, all in the ‘shoulder’ region of the cross-sections, at the Vermilion R. site. As in the case at the Eel River site, the performance of the debris deflectors as deflectors is doubtful in view of the chronic debris accumulation.

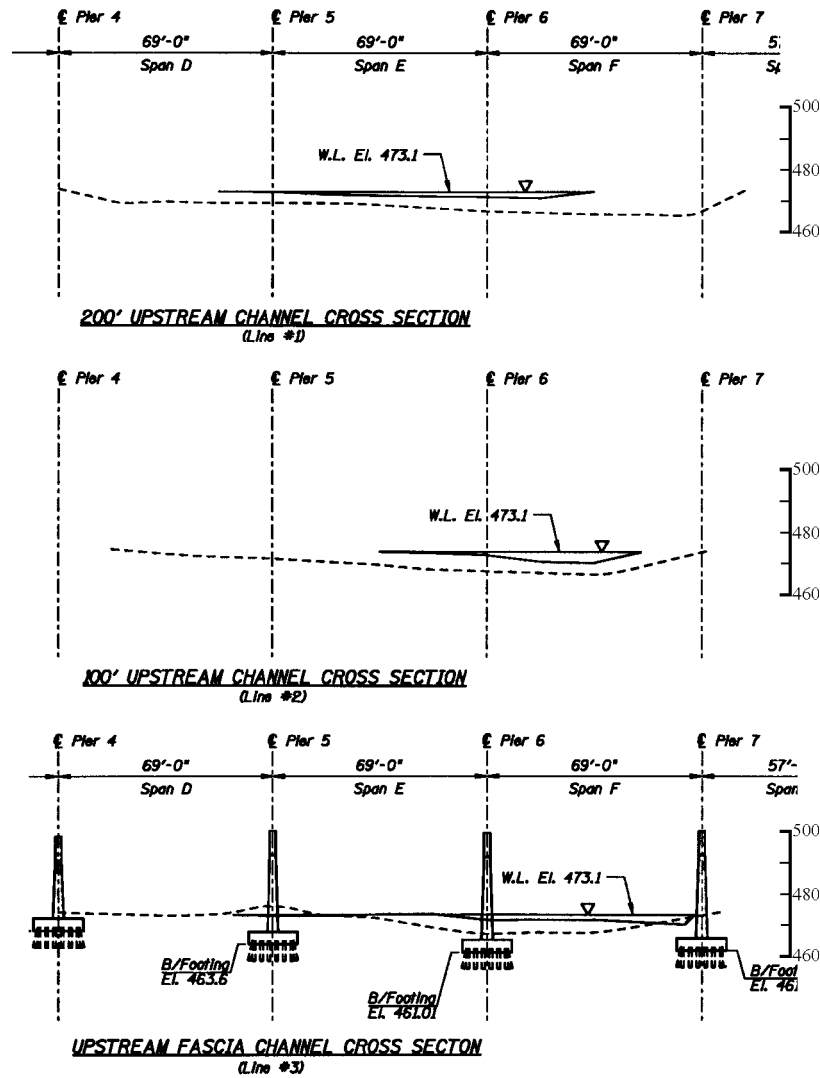
Figure 4.6: Bed elevations at three upstream sections at the SR63 Vermilion River site (adapted from Collins Engineers, 2001)

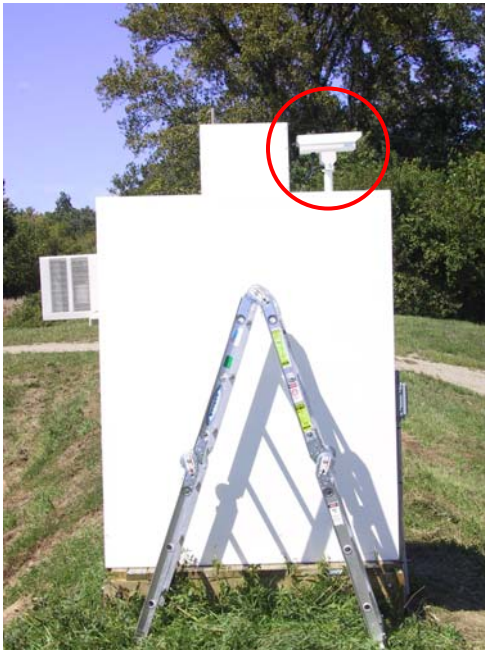
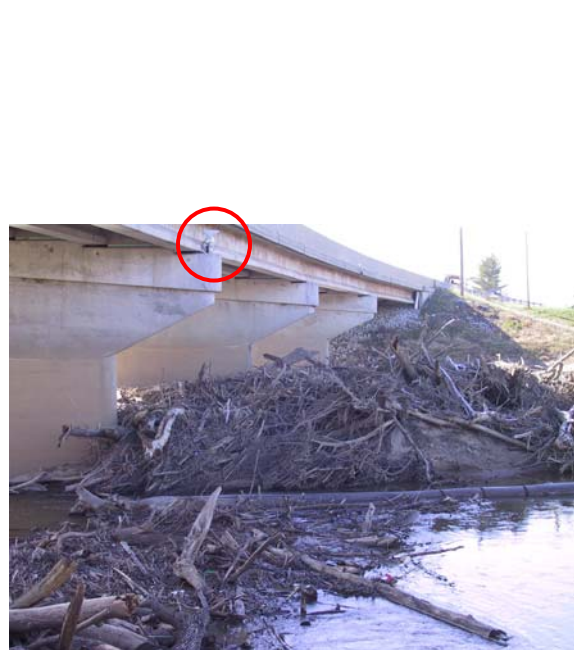
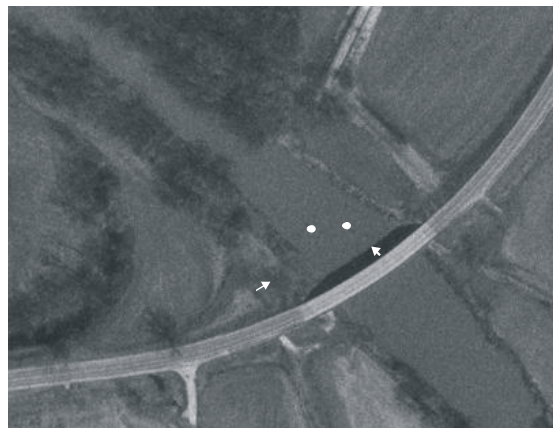
**Figure 4.7: SR59 site, a) camera (circled) mounted on top of fiberglass enclosure located on right bank, b) camera mounted on bridge pier, c) plan view indicating location and view of cameras (arrows) and location of debris deflectors (solid circles)**

The Eel River site was instrumented first for various reasons, including its more dramatic debris accumulation, its simpler channel geometry more directly related to the laboratory study, and a greater ease in setting up the instrumentation because of specific site layout. Two cameras were used, one installed on a bridge pier with a view upstream, and the second, installed on the bank atop the fiberglass enclosure, from the side, almost

at right angles to the bridge camera, with a view of the bridge and the piers (Fig. 4.7). The cameras were Wattec (Model WAT-902HS) with black and white 1/2" CCD, specially chosen for its high sensitivity (according to specifications, with a minimum required illumination of 0.00015 lux), fitted with Tokina 6-15 mm auto iris lens with motorized zoom and focusing. The cameras were housed in a Pelco outdoor camera housing with mount. The camera on the bridge pier, because it was not easily accessible once it was mounted, also had a pan/tilt/zoom mechanism that could be controlled from a unit within the instru

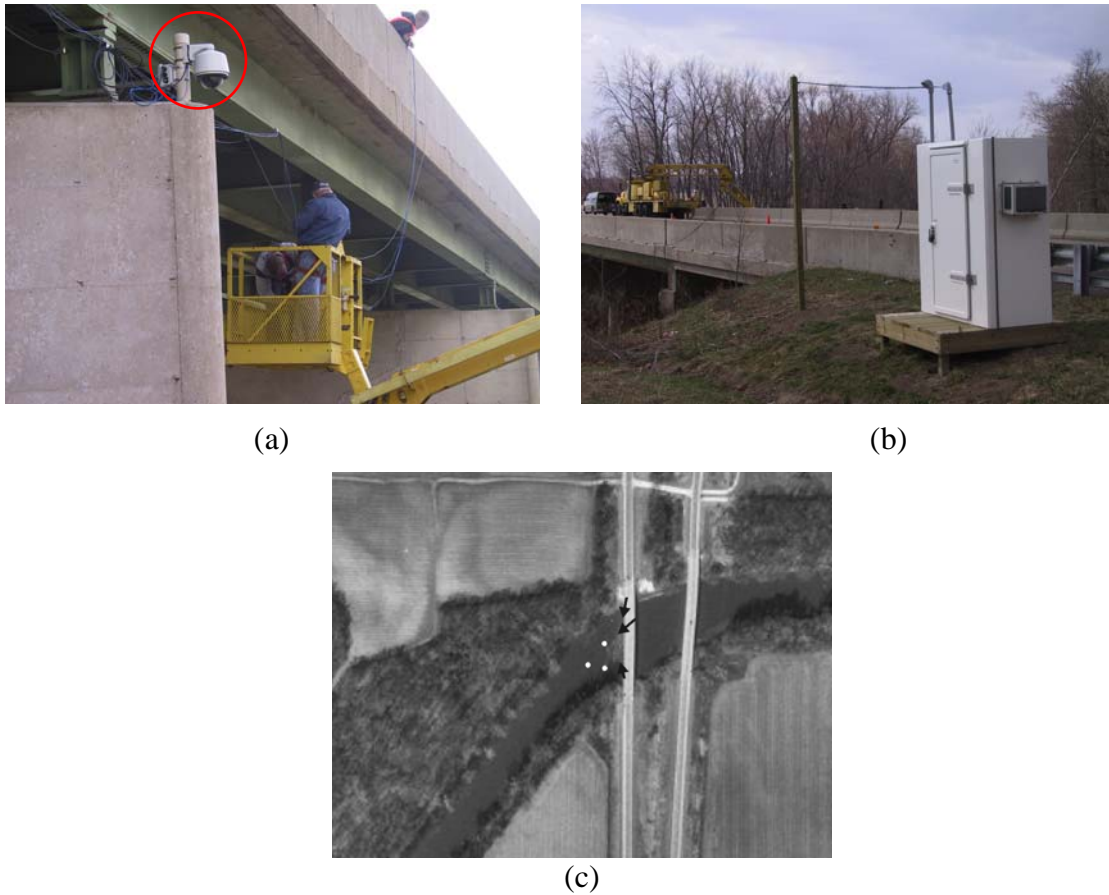
**Figure 4.8: SR63 site, a) one of the dome cameras (circled) mounted on a pier at the SR63 site, b) instrument enclosure on the other (downstream) side of the southbound bridge, c) approximate location of debris deflectors (solid circles) and angle of view of pier-mounted cameras (arrows)**

from lower-level signal/video cables. Voltage drops and possible signal losses in long cable runs may need to be considered. Security against vandalism should also be considered not only in running cables, but also in the placement of equipment in general.
