Final Report

**Debris Accumulation at Bridge Crossings:  
Laboratory and Field Studies**

FHWA/IN/JTRP-2003/10

School of Civil Engineering  
Purdue University

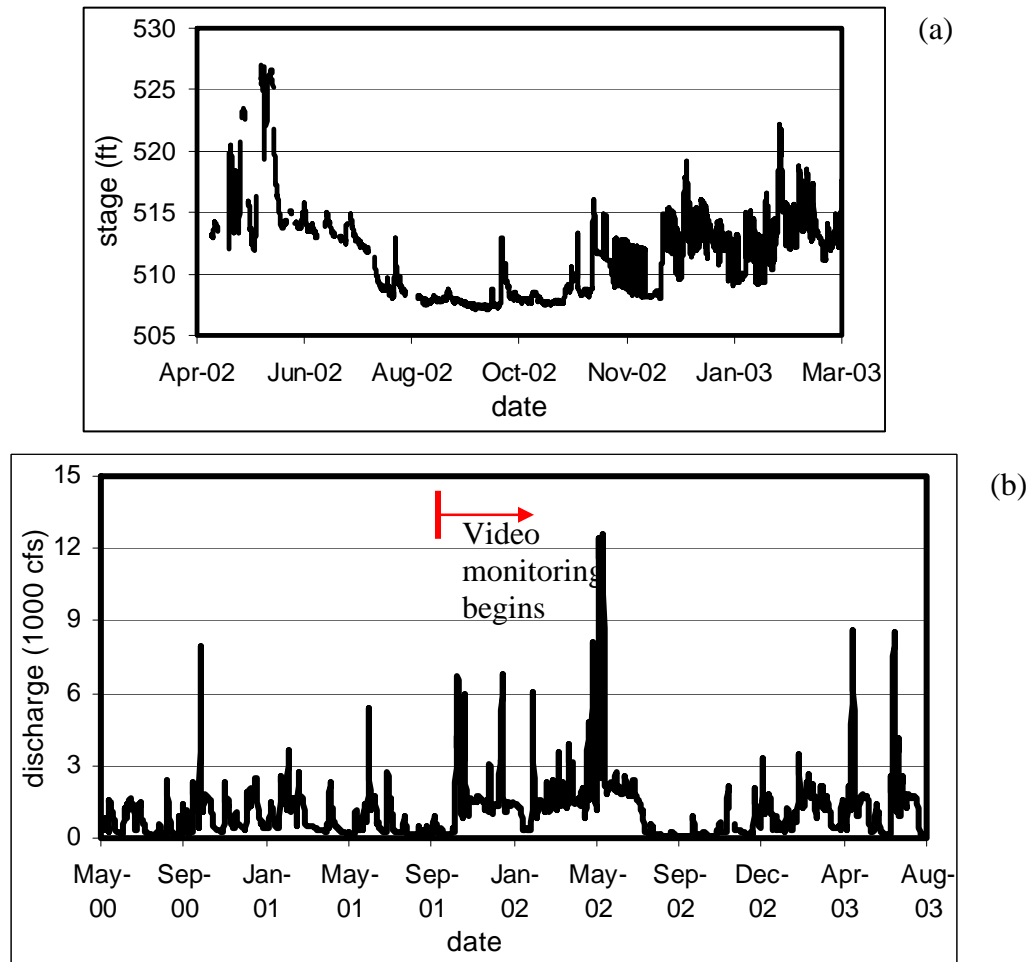
**Figure 5.2:** a) stage recorded at SR59 site, b) discharge at Bowling Green USGS stream gaging site, over the course of the project period

As noted in the previous chapter, the nearest USGS stream gaging site is located at Bowling Green, over 20 river miles upstream of the site. The stage recorder at the site, in continuous operation since 4/02 (it was installed earlier but needed further adjustment), can on occasion operate erratically (as will be seen shortly), and so the Bowling Green data will be used where necessary as an alternative consistent surrogate for the purposes of identifying major flow events that might be transporting large woody debris through the research site. Fig. 5.1 compares the stage measured at the site by the stage recorder with the stage at the USGS Bowling Green station (elevation datums are different, so the stages are not absolutely comparable). The stage at the SR59 site is generally consistent with that reported at Bowling Green, with there being a small difference in phase, the peak in the SR59 site occurring  $\approx 6$  hours after the peak at the Bowling Green site.

the bridge low concrete is at 529.3 ft and the average high-water elevation is 521.7 ft (bridge plan, file: 59-11-6778). The discharge reported at the USGS Bowling Green station is shown in Fig. 5.2b, and, unlike the stage record, covers the entire project period. Video monitoring began with one camera on 9/12/01, and with both cameras on 11/20/01. A large flow event is indeed recorded at Bowling Green in May 02, which is consistent with the stage measured at the SR59 site; on the other hand, while there is discharge peak occurring in Feb. 03, it is not particularly large, and so the peak in stage at that time is likely overstated in Fig. 5.2a.

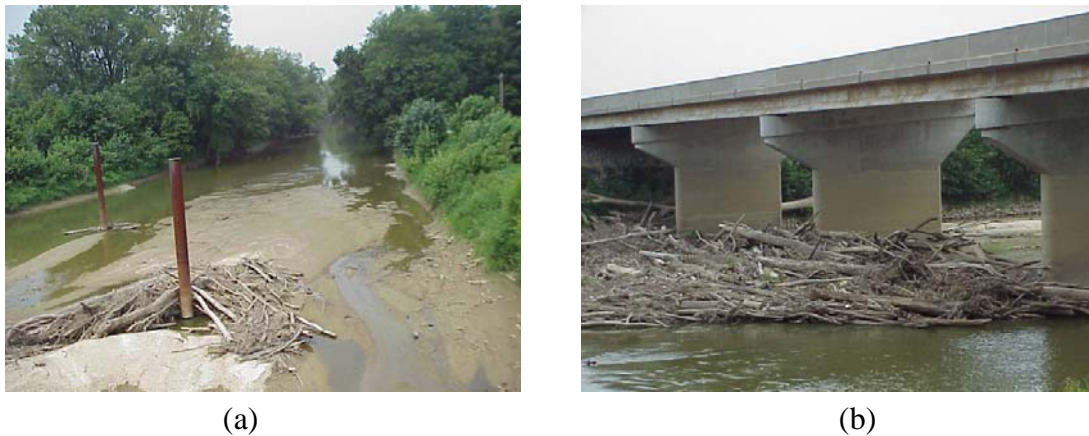
**Figure 5.3: Site photographs from Aug. 17, 2000: a) view upstream of debris deflectors, b) view of piers on the left side (looking downstream) of river**

dual from before this period. On the subsequent site visit, on 10/26/2000, a dramatic increase in accumulation is evident (Fig. 5.4), both upstream of the deflectors as well as at the bridge. In the intervening time between the two visits, one large event (discharge,  $Q \gg 8000$  cfs, where discharge will always refer to that reported at the Bowling Green station, with a water surface elevation at the SR59 site estimated to be  $Z \gg 525$  ft) can be identified at the Bowling Green station about two weeks before the second site visit. Two relatively minor events ( $Q \gg 2000$  cfs, with estimated  $Z \gg 515$  ft at the SR59) did also occur in that period, but the very substantial increase in the observed debris accumulation is most likely attributable to the *single* larger flow event. It is somewhat debatable whether the presence of already existing accumulation might have caused or at least exacerbated the ultimate accumulation.

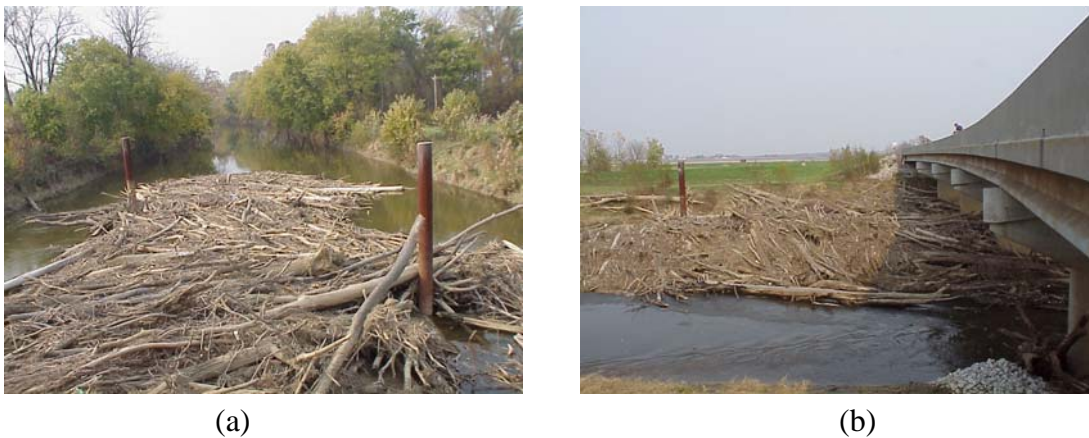
**Figure 5.4: Site photographs from Oct. 26, 2000: a) view upstream of deflectors (same as Fig. 1.2a), b) view of piers on left side (looking downstream) of river**

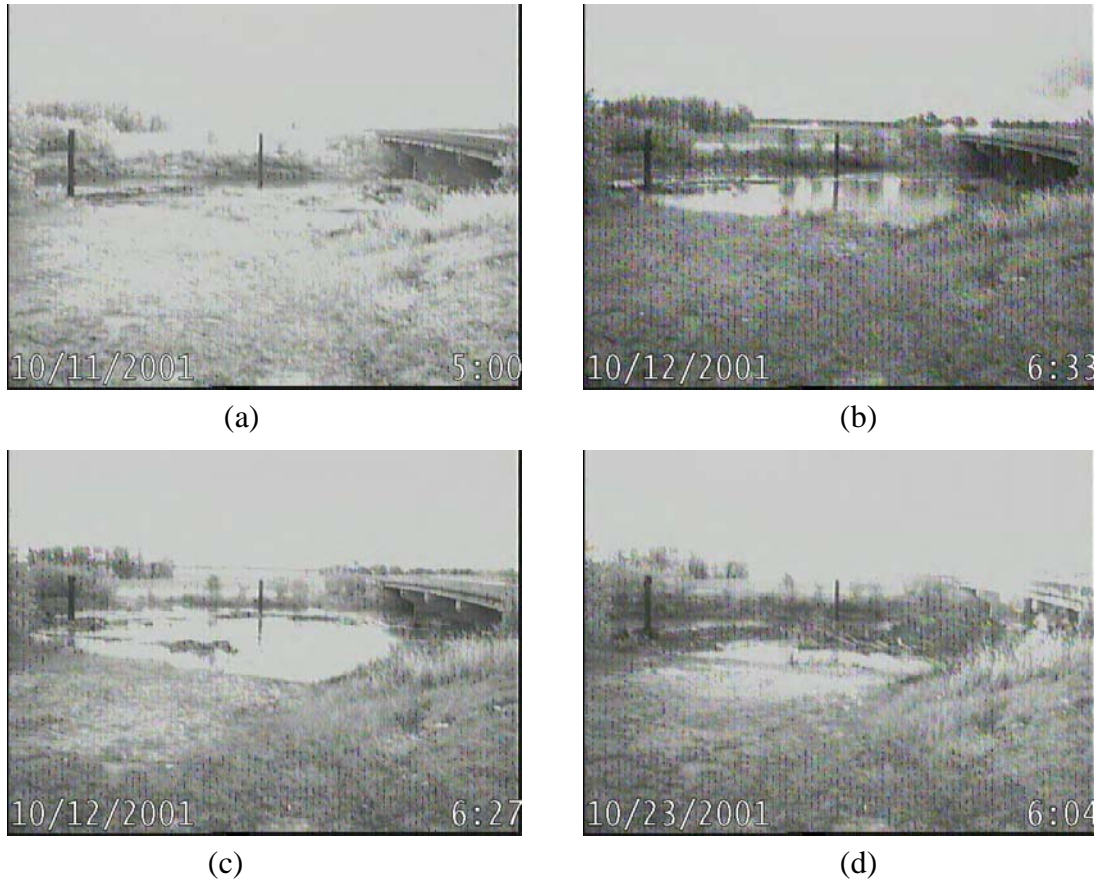
**Figure 5.5: Images of the first recorded significant flow event at the SR59 site, a) before the event, sand bar unsubmerged, b) during the event but before any significant debris movement, c) the first significant debris movement, d) after the event, sand bar again unsubmerged**

significant debris at the site; in comparison with Fig. 5.5a, the debris pile is seen to extend from the piers in a thick mat to the nearer debris deflector, only thinning out towards the more upstream deflector.

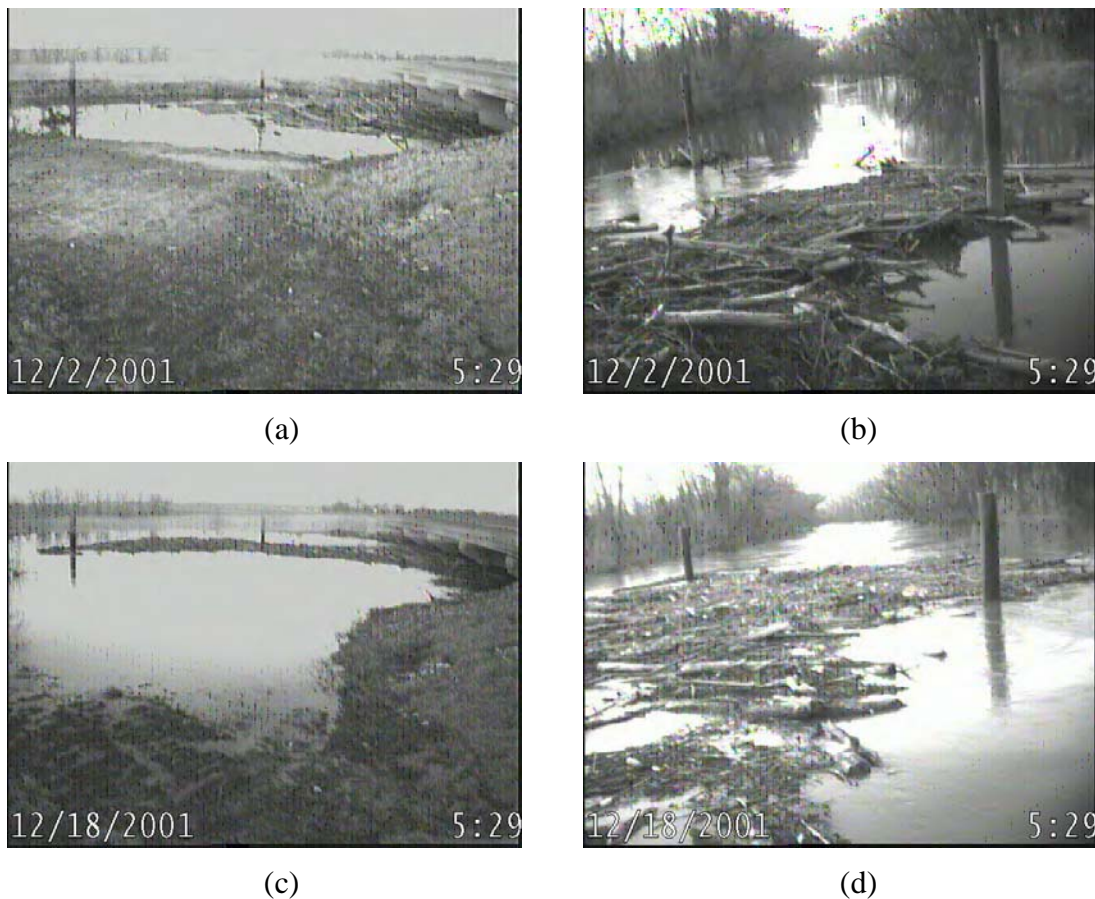
**Figure 5.6: Images from two-camera system, (a) and (b) (relatively) low-water at site on 12/2/21, (c) and (d) high water at the site on 12/18/21, from the bank camera and bridge camera respectively**

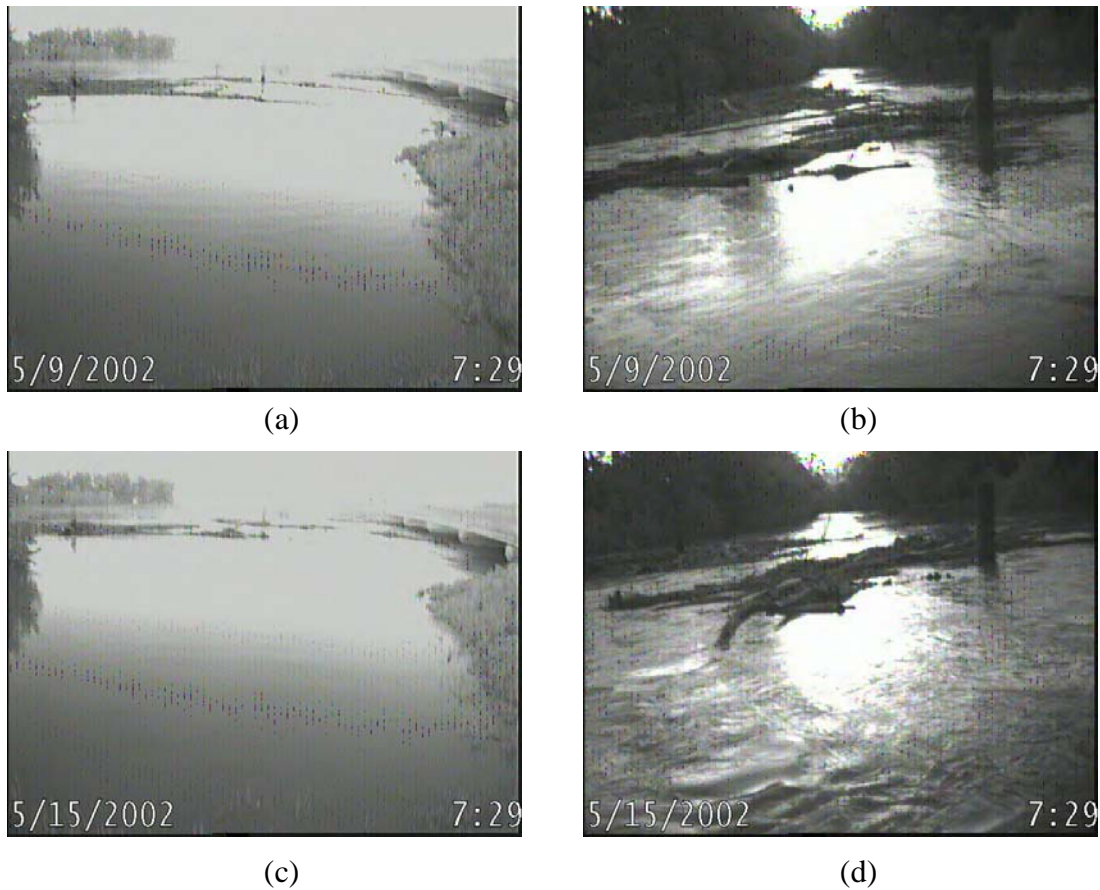
**Figure 5.7: Side- and upstream-views during the two largest flow events during the project period, (a) and (b) on 5/9/2002, (c) and (d) on 5/15/2002.**

the bridge plan). Fig. 5.7 shows that the stage is noticeably higher than in previous figures (the water surface almost reached the top of the levee on which the instrument enclosure was placed), but also that the debris accumulation seems to have been reduced, compared to the images seen previously. Although this could imply that the disaggregation process observed in the laboratory may also be significant in the field at least under certain circumstances, care should be exercised in interpreting what is seen at the water surface—as will be seen shortly, it is possible that some large part of the pile may be submerged. Indeed, underwater bridge inspection has often found submerged accumulated debris at piers (Collins Engineers, 1994, 2001).

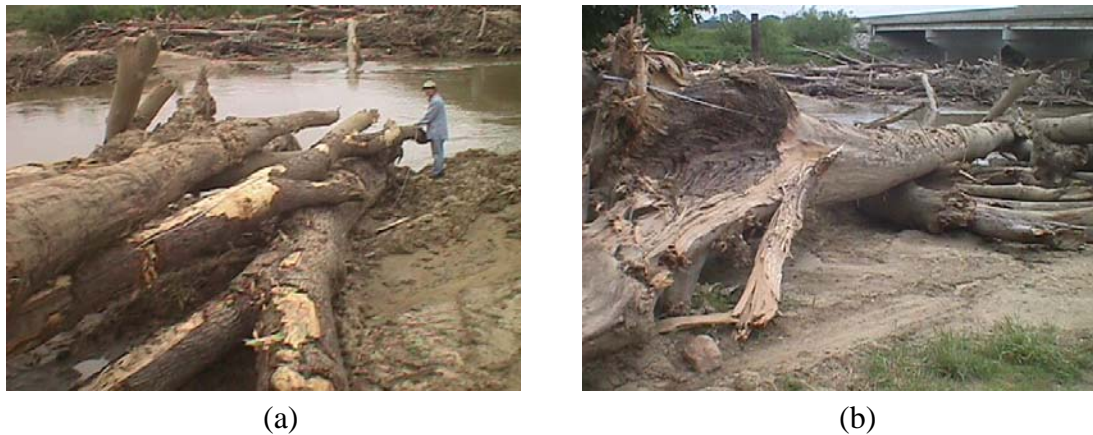
**Figure 5.9: Logs taken from debris pile: a) 42-ft log being measured, b) longest log (length, 67.7 ft) measured**

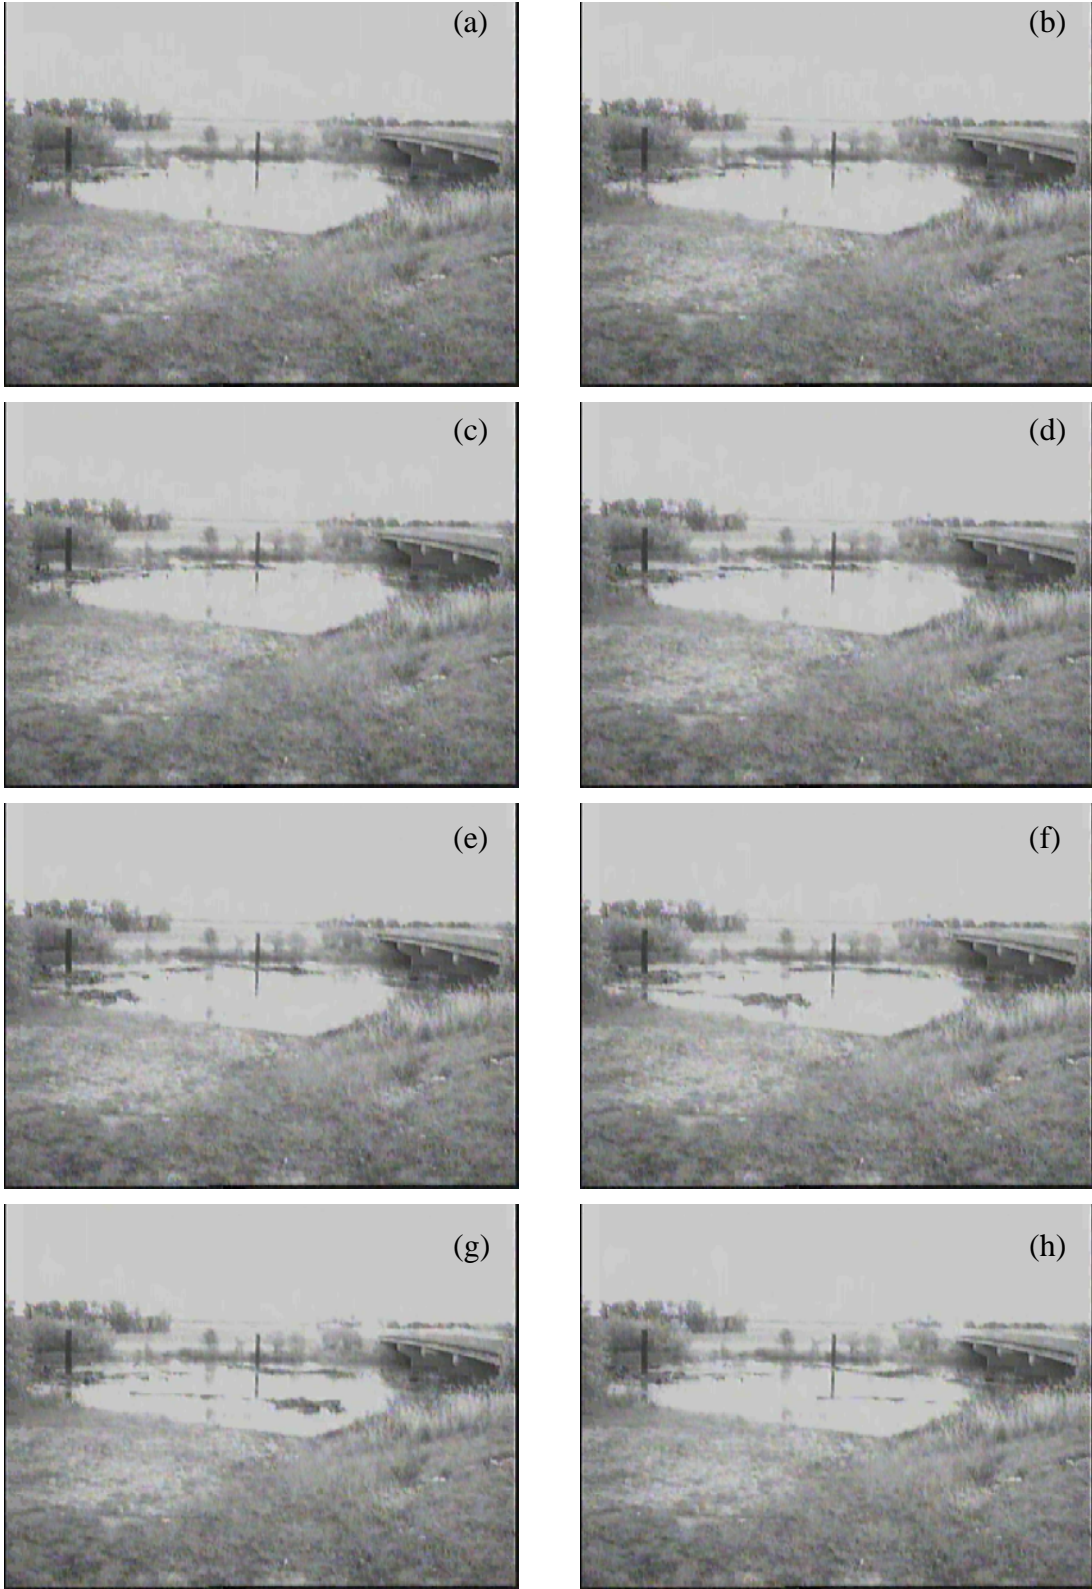
**Figure 5.10: Sequence of images showing movement of floating woody debris (a)-(h) images are taken every 10 seconds**

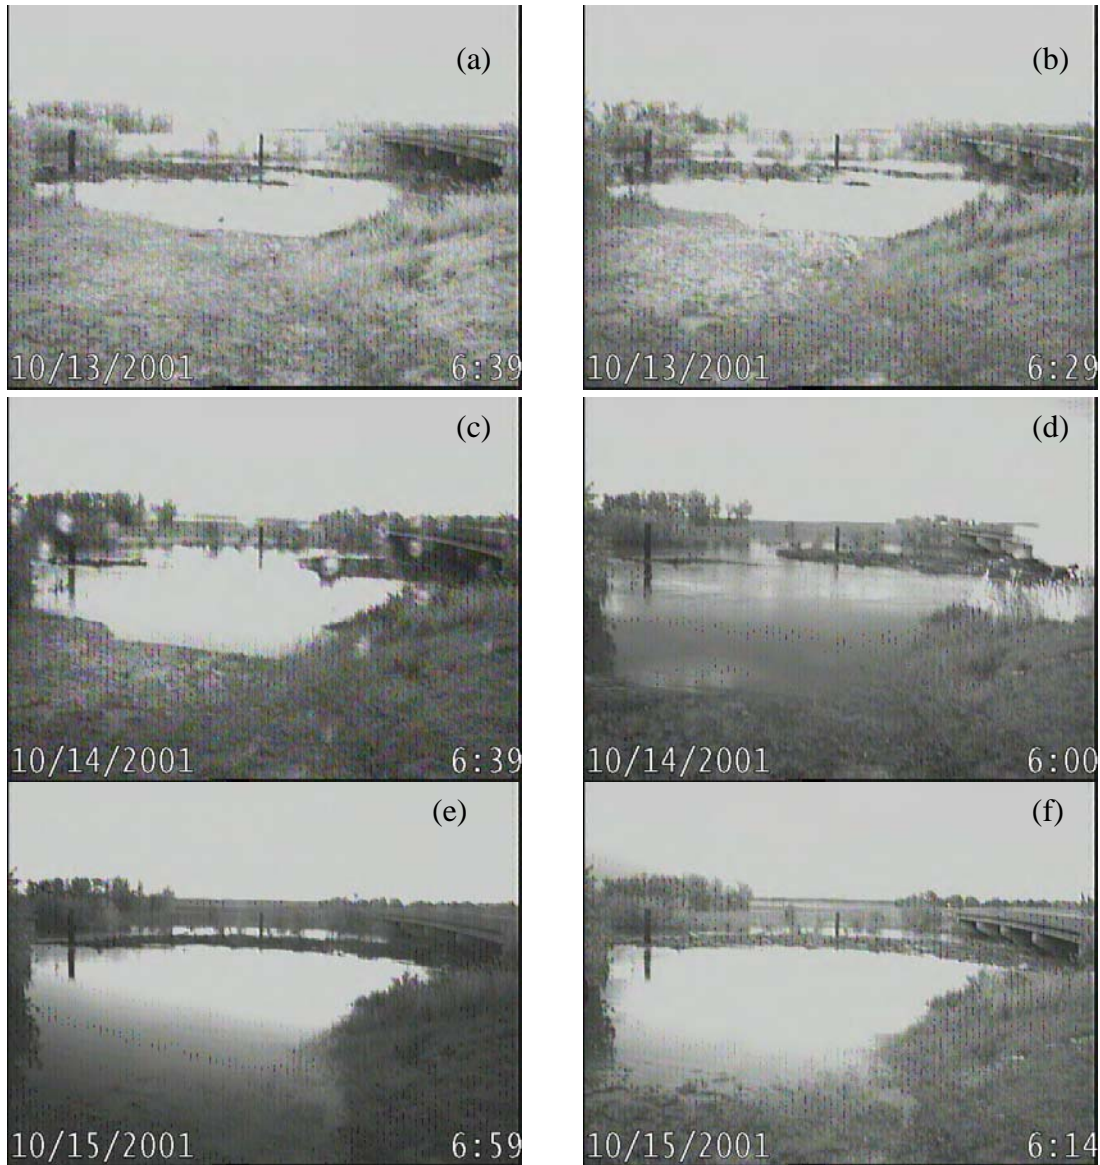
**Figure 5.11: a) and b) debris pile established at deflectors, c) debris pile now found at bridge, d), e), and f) slow growth of debris pile over two days**

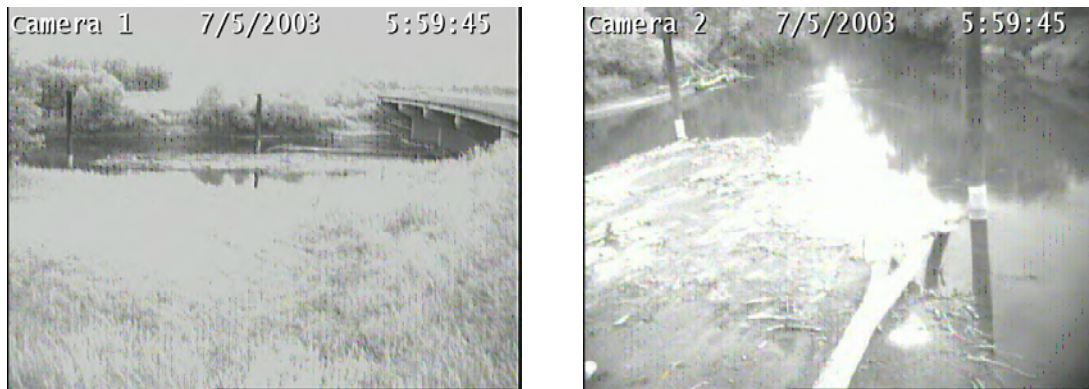
**Figure 5.12: Images taken at the SR59 site on 5 July 2003.**

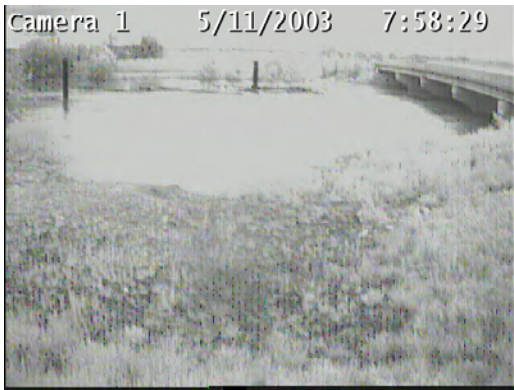
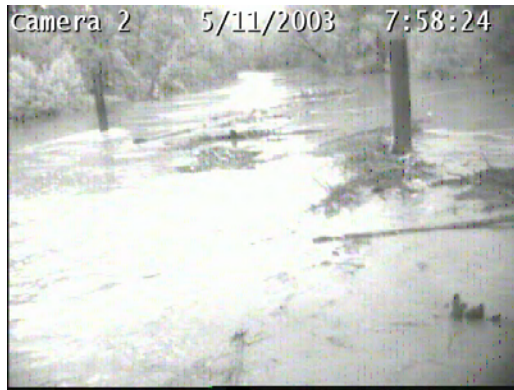
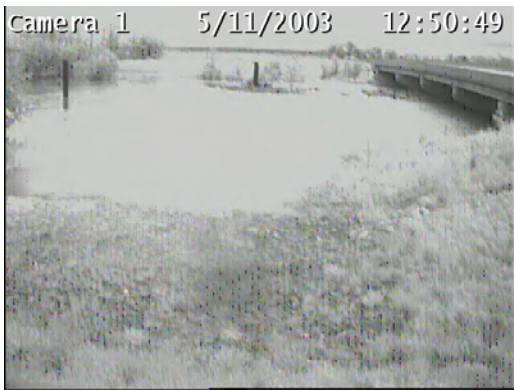
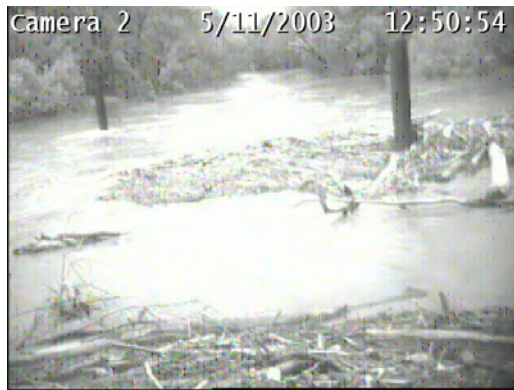
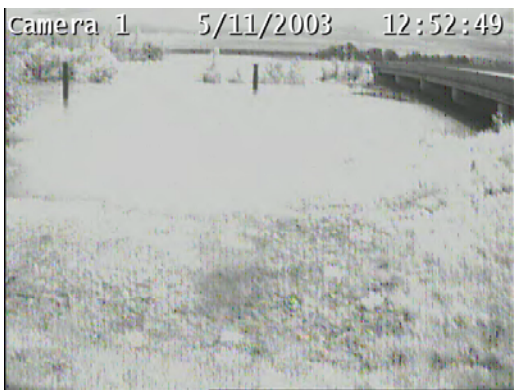
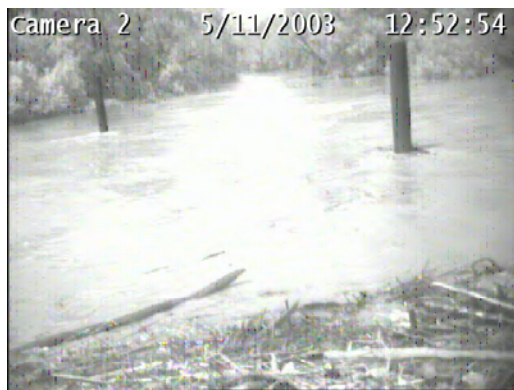
Figure 5.13: Debris transport, accumulation and disaggregation during the May 2003 flow event

- **Debris motion and size**
  - As noted previously in the literature, logs do tend to travel singly rather than in a clump or large aggregations of material.
