Evaluation of Retro-Reflective Beads to Increase Airport Surface Marking Conspicuity

May 2010

DOT/FAA/AR-TN10/10

U.S. Department of Transportation
Federal Aviation Administration

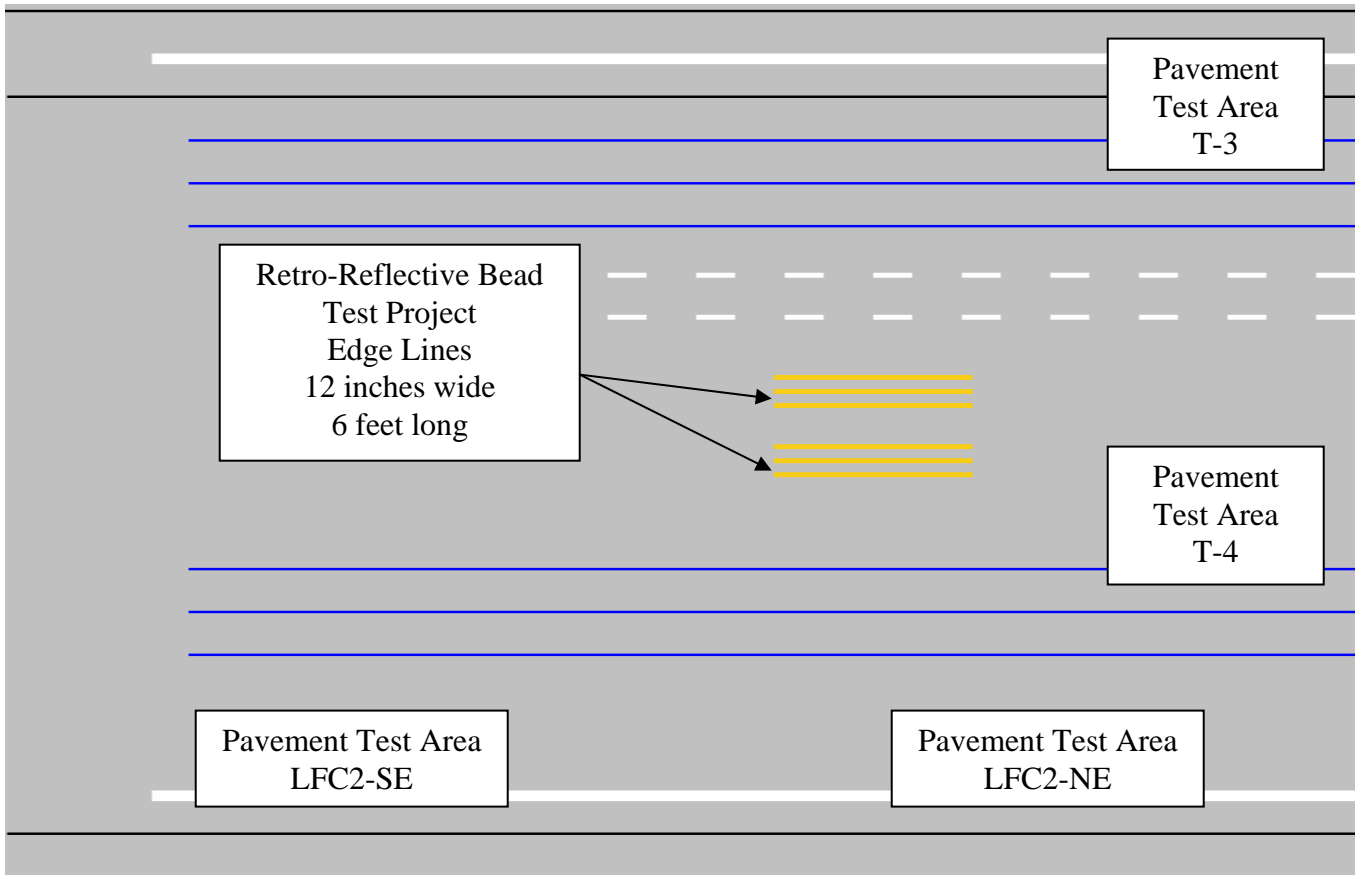
Figure 2. Test Site One Inside the FAA William J. Hughes Technical Center NAPTF

Test Site One was located inside the FAA William J. Hughes Technical Center NAPTF. This fully enclosed instrumented test track is 900' long by 60' wide and is designed to accelerate the wear on runway materials from aircraft operations to determine useful life of various materials. During this retro-reflective bead project, the National Airport Pavement Test Vehicle (NAPTV), as shown in figure 1, was configured to simulate the taxi loading of a Boeing 747 and 777 aircraft. Using this site added the benefit of providing accelerated operations and provided wear data from two different aircraft.

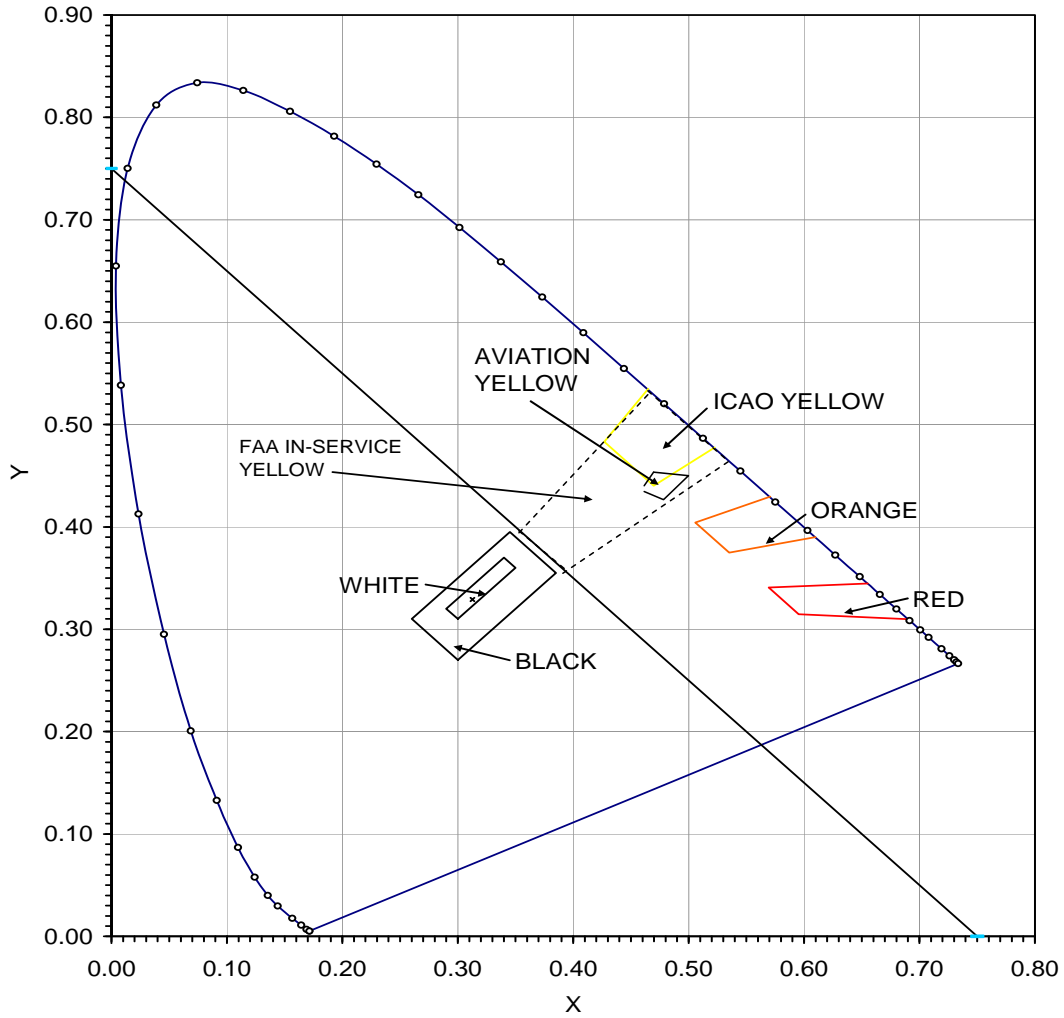
Figure 14. Sample CIE Standard Illuminant D₆₅ Color Chart

Color readings were taken with a Spectro Guide, which produces three coordinates (Y = depth, x = width, and y = height) for its readouts. The standard coordinate system CIE 1931 XYZ color space, created by the International Commission on Illumination (CIE), was used. The readings obtained were compared to the color coordinate boundaries for FAA in-service yellow. The boundaries of FAA in-service yellow are not the same as aviation yellow. The region for FAA in-service yellow is documented in appendix A of reference 2, "Development of Methods for Determining Airport Pavement Marking Effectiveness." The readings were also charted on the CIE standard illuminant D₆₅ chromaticity chart, as shown in figure 14. This chart has been modified to address the FAA in-service yellow used on airports. Color readings were collected after the initial application of the paint marking material and continued monthly thereafter for 1 year. Figure 15 shows chromaticity readings being taken.

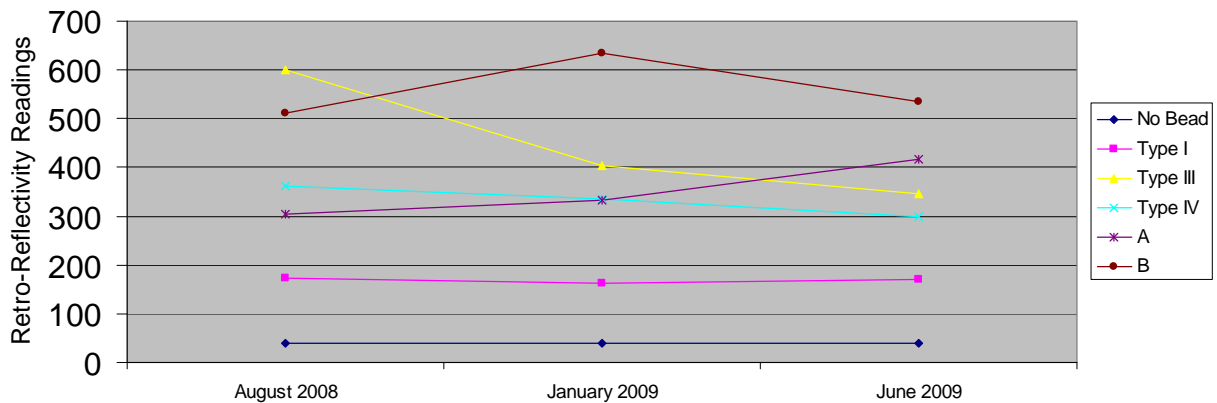
Figure 30. Average Retro-Reflectivity Readings of Test Markings on Aged PCC
