JOINT TRANSPORTATION RESEARCH PROGRAM

INDIANA DEPARTMENT OF TRANSPORTATION
AND PURDUE UNIVERSITY

Case Studies Documenting Lessons Learned and Identifying Opportunities for Maintenance of Traffic (MOT) Improvements

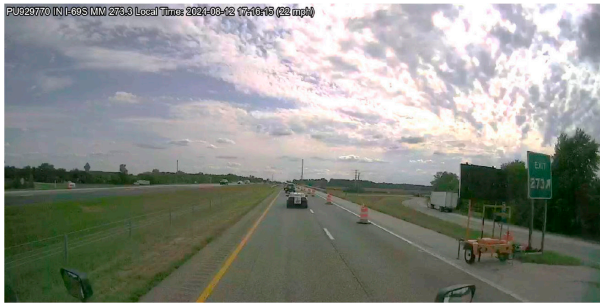
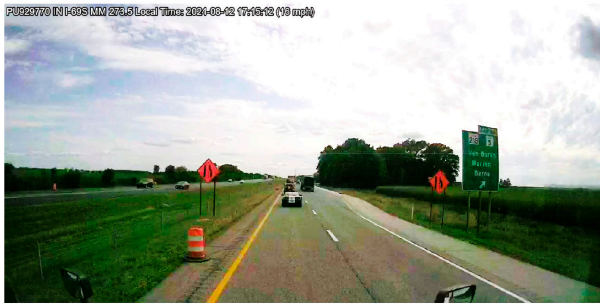
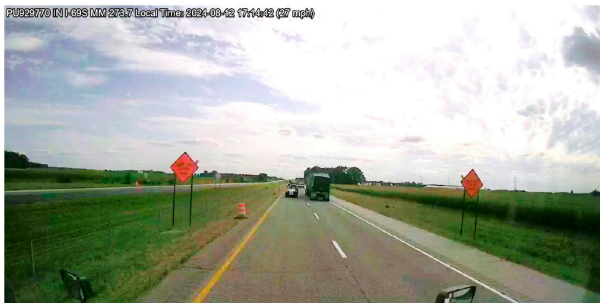
Figure 1.1 Dash Camera Images Along I-69 in Indiana Verifying MUTCD Work Zone Design.

Metadata associated with the image provide valuable context for the images. At the top of the image shown in Figure 1.1a, the following metadata attributes are visibly encoded on the image overlay:

(a) Arrow Board at Merge Point

(b) "LANE ENDS MERGE LEFT" Sign 1,000 ft in Advance of Merge Point

(c) "RIGHT LANE CLOSED AHEAD" Sign 2,500 ft in Advance of Merge Point

Comparing Figure 1.1b and Figure 1.1c, the MM changes to 273.5 and 273.7, the time to 17:15:12 and 17:14:42, and the speed to 16 and 27 mph, respectively. The visible side mirrors in the lower left and right corner also provide evidence that these images were captured from a commercial truck. These dash camera images from Figure 1.1 can be used to identify Manual on Uniform Traffic Control Devices (MUTCD) traffic control devices such as signs and markings. A subject matter expert can then cross-reference the images with standard agency practices. Figure 1.2 is adapted from the Federal Highway Administration's (2023) MUTCD to illustrate the practices transportation agencies typically follow for sign placements near an interchange entrance ramp. In this simple example, one can see the arrow board in Figure 1.1a, two orange W4-1 signs in Figure 1.1b, and two orange W20-5 signs in Figure 1.1c align with the configuration recommended in Figure 1.2.

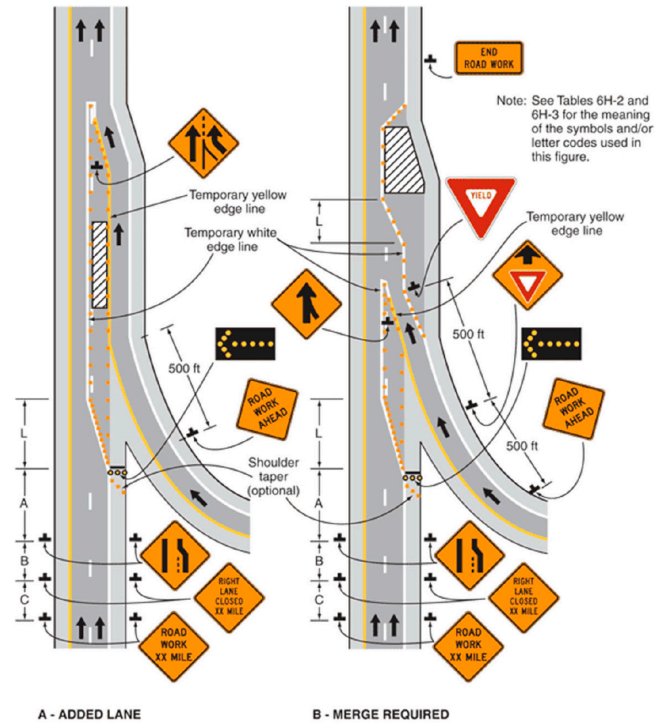
Figure 1.2 MUTCD Typical Application 44: Work in the Vicinity of an Entrance Ramp.

Typical Application 44

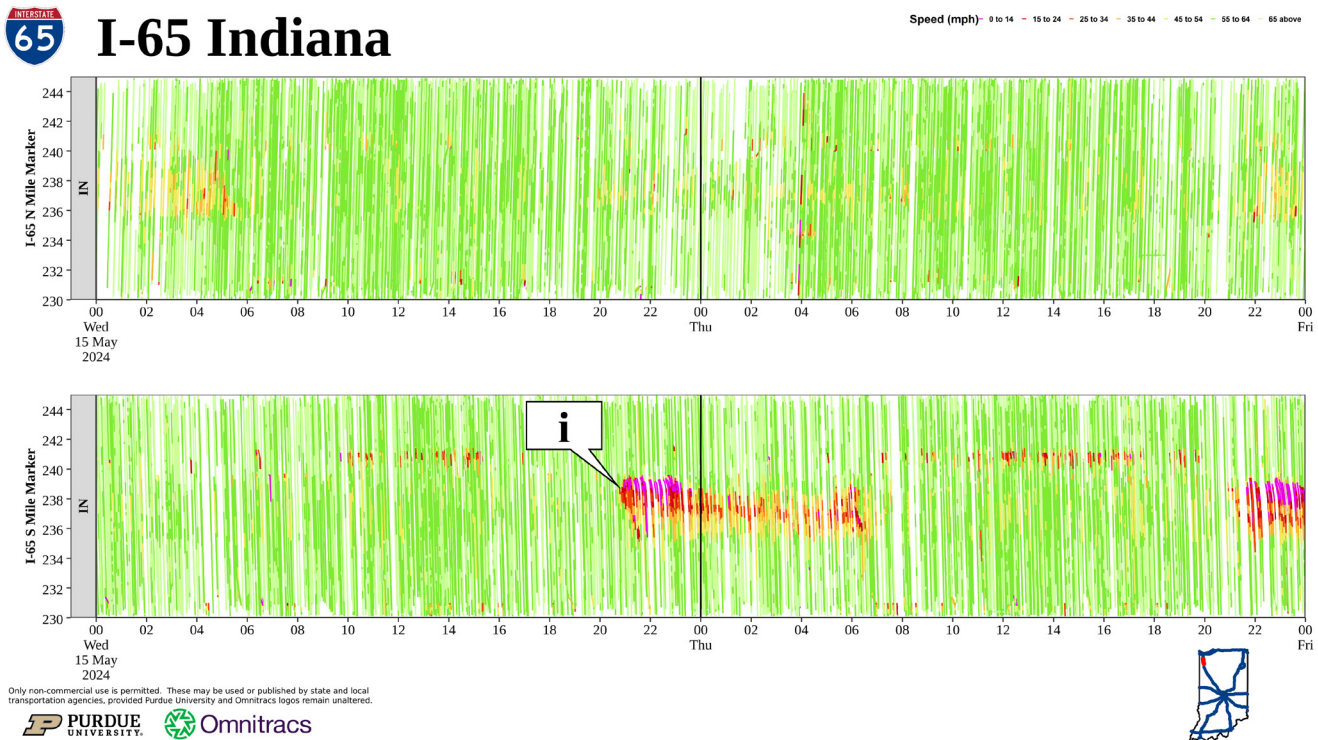
Figure 2.1 Traffic Speed Heatmap for a Section of I-65 in Indiana From MM 230 to MM 245 on Wednesday, May 15, 2024 and Thursday, May 16, 2024.

section of I-65 with Callout i showing the congestion from the queuing due to the single lane closure. The specific work involved a material transfer vehicle needing to be on the travel lane side of the temporary concrete barrier to transfer the material over the wall (Figure 2.2). Due to this, the vehicle incurred on the single travel lane (Callout ii) for the southbound direction requiring passing vehicles to utilize the shoulder to traverse around the ongoing work (Callout i). Due to the limit width of the inside shoulder, the potential for run-off-the-road crashes can increase, especially for semitrucks.

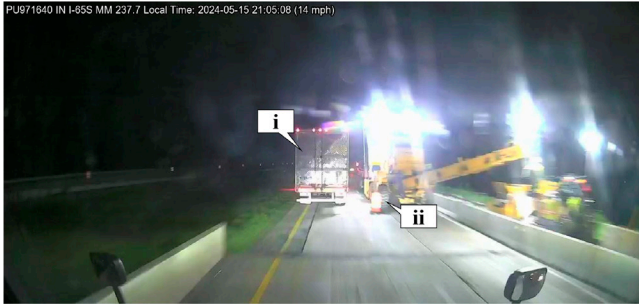
Figure 2.2 Dash Camera Image Showing a Semitruck Driving on the Shoulder Through a Work Zone During a Material Transfer Operation.

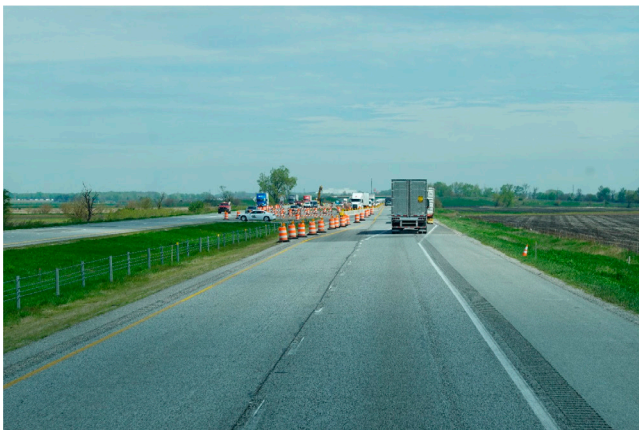
This case study shows a work zone where a double lane shift to the right is present at the start of the work area. Figure 2.3 shows a potential issue where the trajectory of the lane shift leads the vehicles in the right lane to the edge of the pavement.

Figure 2.3 A Double Lane Shift Inside of a Work Zone.

The opportunity here is to discuss with MOT designers to increase the length of the taper and allow for a longer taper so that there are fewer sharp curves, especially when a shoulder is narrow with little room for correction.

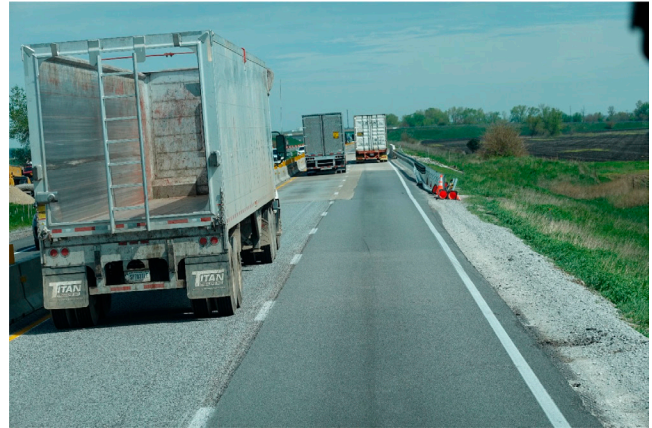
Figure 2.3 shows a damaged guardrail and tire tracks in the aggregate next to the roadway, likely due to a run-off-the-road crash.

Figure 2.4 A Damaged Guardrail.

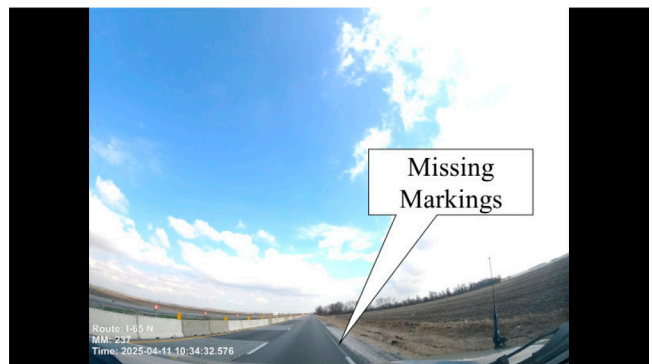
This case study shows a work zone along I-65 where some of the right edge line pavement markings line are missing, as shown in Figure 2.5. Furthermore, Figure 2.6 shows inconsistent pavement markings for the right edge line, which also varies the available lane widths. With the shoulder width already being narrow, the need to have pavement markings and for them to be consistent along with consistent lane widths is paramount.

Figure 2.5 Dash Camera Image Showing Right No Right Edge Line Pavement Markings.

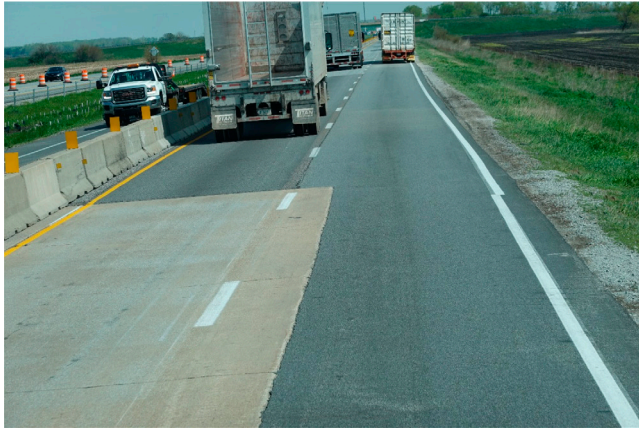
Figure 2.6 Image Showing Inconsistent Right Edge Line Pavement Markings and Inconsistent Lane Widths.

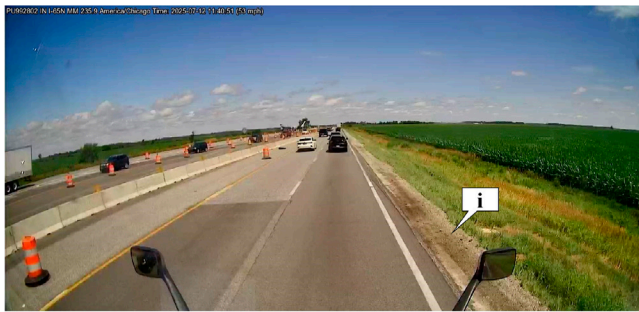
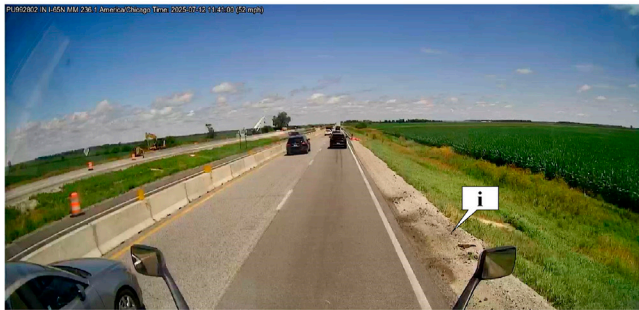
With the close proximity of the edge line to the shoulder along this section of I-65 through the work zone, there were a substantial number of vehicles, particularly trucks, with tires

Figure 2.7 Dash Camera Images Along Northbound I-65.

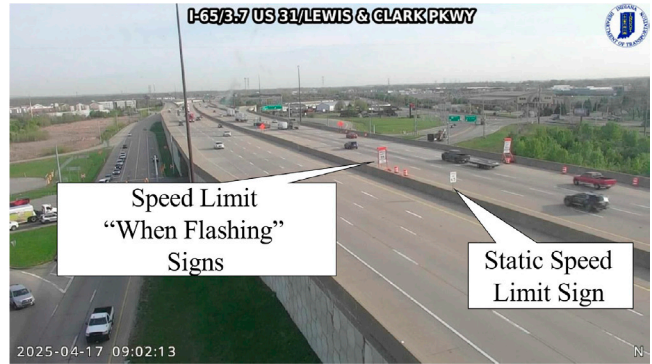
Figure 2.8 ITS Camera Image Along I-65 at MM 3.7 Showing a Variable Work Zone Speed Limit Trailer in Close Proximity to a Static Speed Limit Sign.

an intelligent transportation system (ITS) camera image where a static speed limit sign is approximately 50 ft upstream of a temporary work zone “When Flashing” speed limit trailer. While this is within the standard of the MUTCD (FHWA, 2023) and the Indiana Manual on Uniform Traffic Control Devices (IMUTCD; INDOT, 2025), this setup can be confusing to motorists if it is within quick succession, like shown.

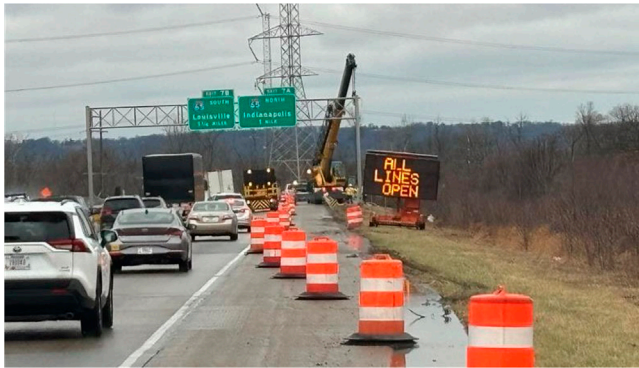
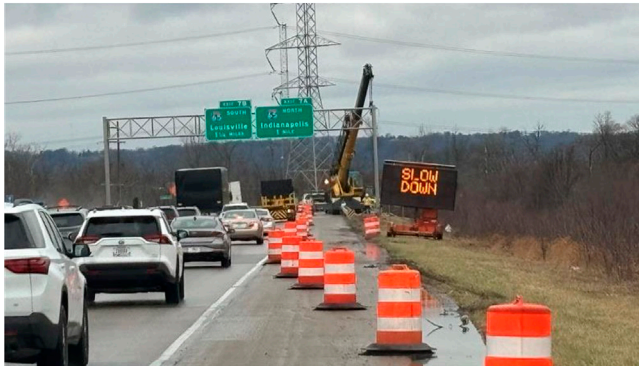
Figure 2.10 Several Images of a Work Zone With a PCMS Sign Showing “ALL LINES OPEN.”

This case study shows a temporary work zone for shoulder work, requiring intermittent right lane closures along a two-lane section of Interstate 265 (I-265). The potential issues include the misspelt portable changeable message (PCMS) saying “ALL LINES OPEN” instead of “ALL LANES OPEN,” as shown in Figure 2.10a. Furthermore, Figure 2.10a and Figure 2.10b demonstrate incorrectly displayed messages as the truck-mounted attenuator (TMA) truck is in the right lane, therefore closing the lane from travel. The message should then be displaying “RIGHT LANE CLOSED.”

The opportunity here is to discuss with MOT contractors to make sure that, not only are the PCMS messages spelt correctly, but to also make sure the correct message is being displayed.

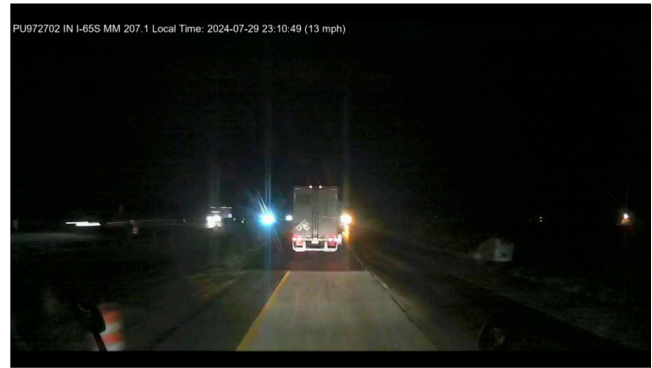
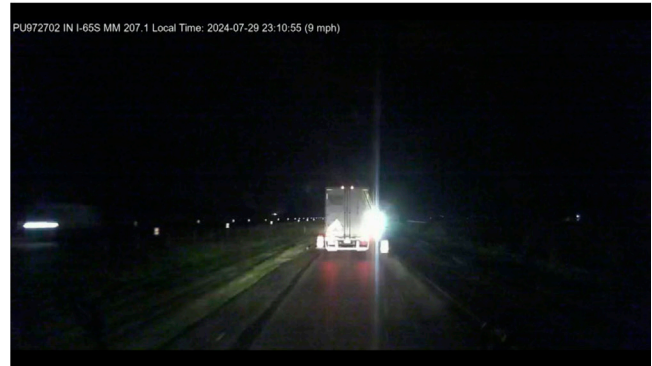
Figure 2.11 Dash Camera Images Showing a Recently Constructed Shoulder With No Pavement Markings and Narrow Lanes.

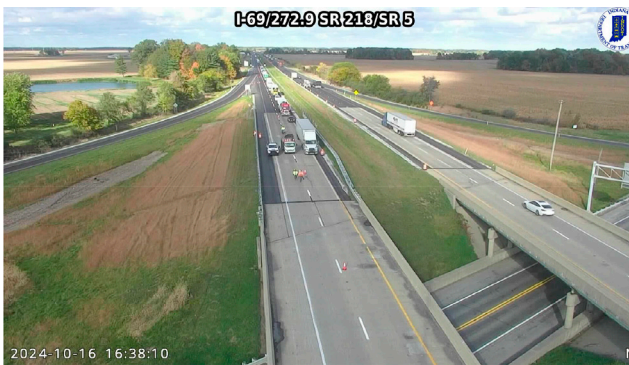
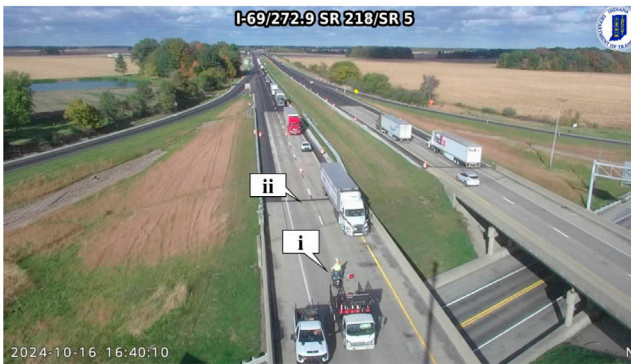
This case study shows a moving work crew putting down centerline pavement markings during the daytime along I-69. Figure 2.12 shows a traffic speed heatmap with Callout i showing the moving congestion in the southbound direction. In Figure 2.13, both images show that traffic is being pushed

Figure 2.13 ITS Camera Images Showing a Moving Work Convoy Putting Down Pavement Markings.

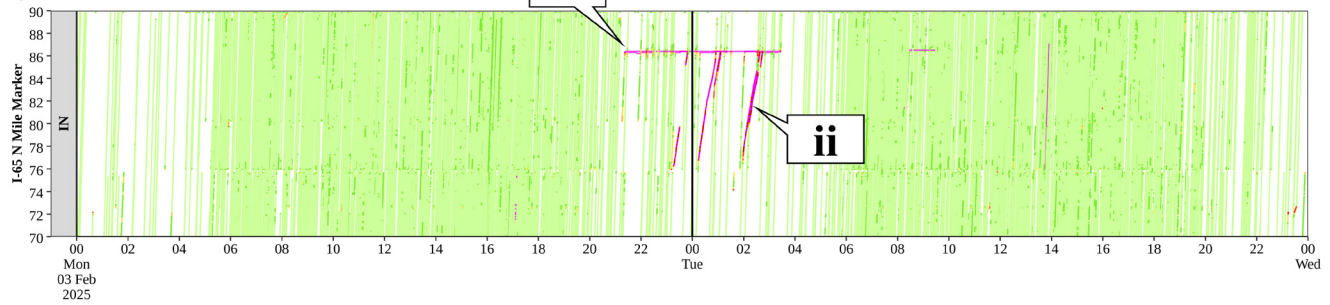
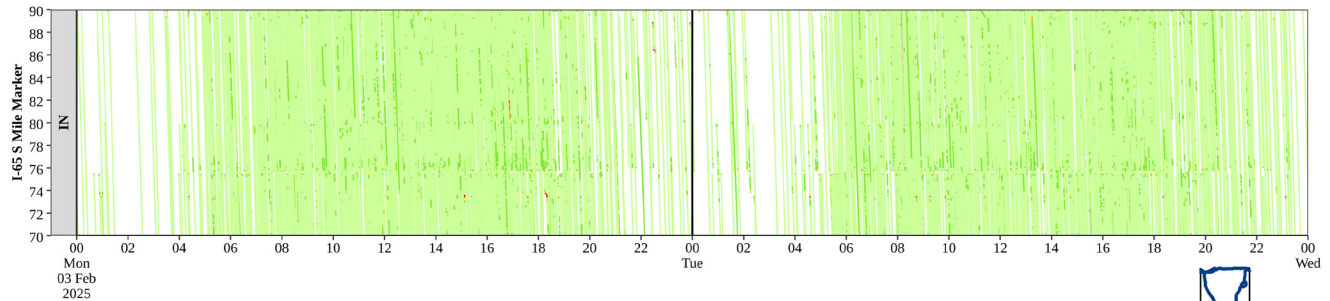
Figure 2.14 Traffic Speed Heatmap for a Section of I-65 in Indiana From MM 70 to MM 90 on Monday, February 3, 2025 and Tuesday, February 4, 2025.

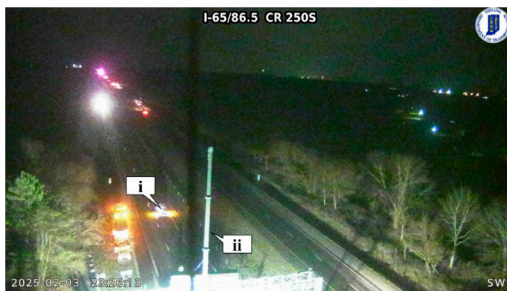
Figure 2.15 ITS Camera Image Along I-65 Near Mile Marker 86.5 Showing a DMS Sign Being Installed.

the sign to be placed overhead of the lanes. Figure 2.16 shows a social media post that states that an incident has cleared around 2:39 a.m. but does not specify what it was. In this situation, the details do not appear to have been communicated

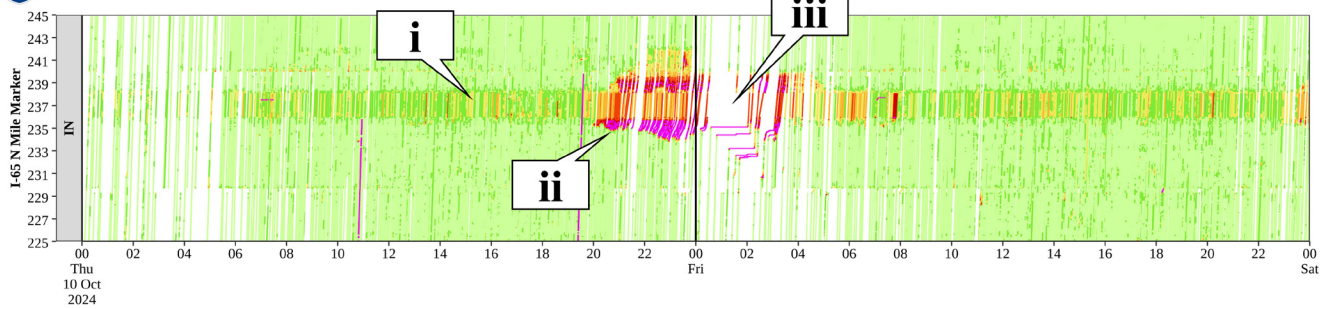
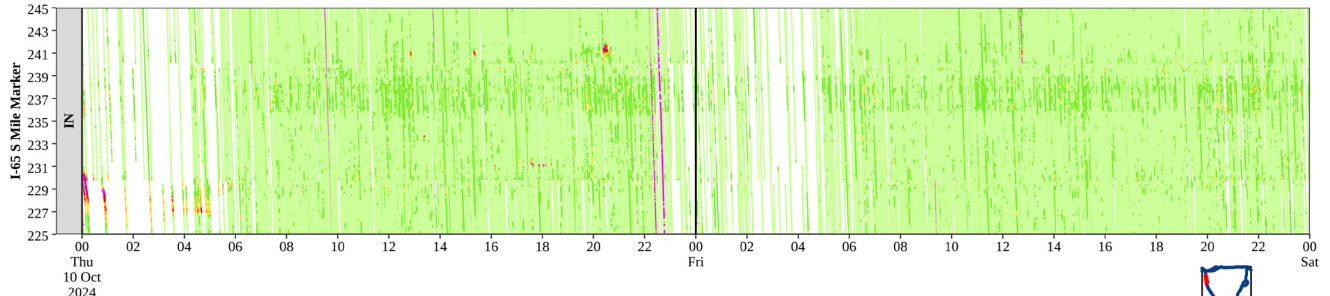
This case study shows a heatmap along I-65 with an overnight work operation. During the daytime, the northbound direction has a bifurcated crossover for one of the lanes meaning that one lane of northbound traffic crosses over the median and runs on the southbound side of I-65. The heatmap in Figure 2.17 shows the bifurcated section between MM 236 and MM 238 by Callout i.

Figure 2.17 Traffic Speed Heatmap for a Section of I-65 in Indiana From MM 225 to MM 245 on Thursday, October 10, 2024 and Friday, October 11, 2024.

Callout ii is the queuing from the start of the right lane closure, with all the traffic using the bifurcated crossover lane. Callout iii shows no traffic in the northbound direction of the nonbifurcated side due to the full closure of that lane. Figure 2.18 shows a dash camera image of a semitruck approaching the stopped queue with no advanced warning. This can potentially lead to

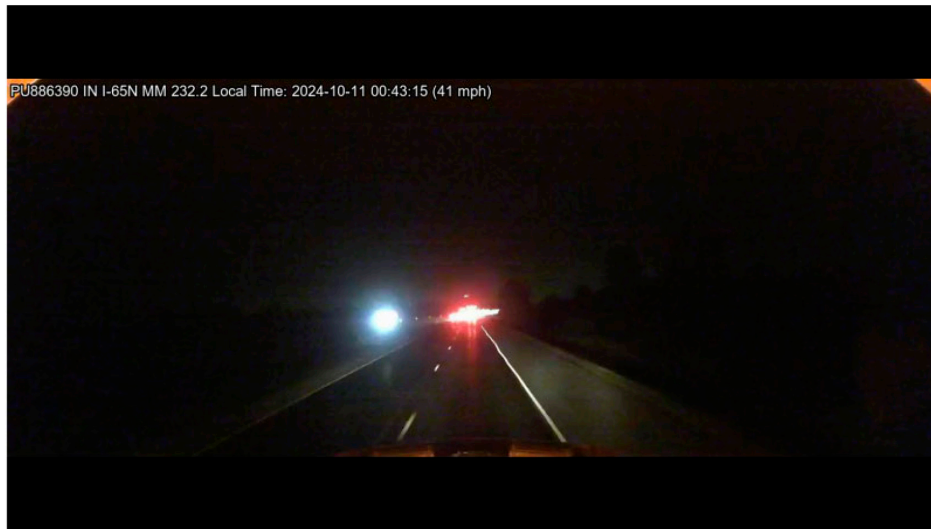
Figure 2.18 Dash Camera Image Showing a Semitruck Approaching a Stopped Queue With No Advanced Warning.

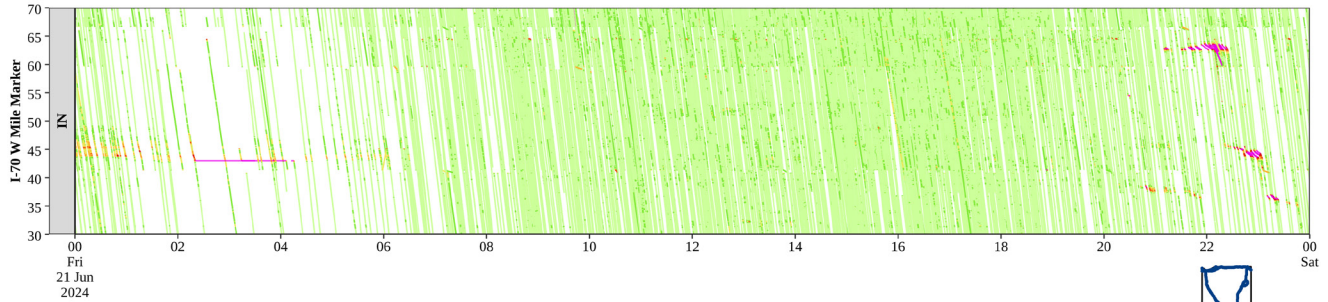
Figure 2.19 Traffic Speed Heatmap for a Section of I-70 in Indiana from MM 30 to MM 70 on Friday, June 21, 2024.

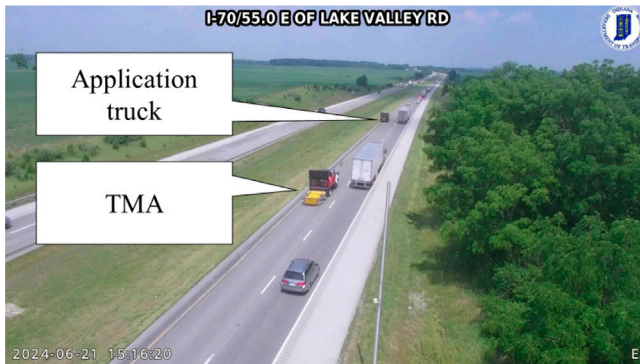
Figure 2.20 ITS Camera Image Showing a Moving Work Convoying in the Left Lane of I-70.

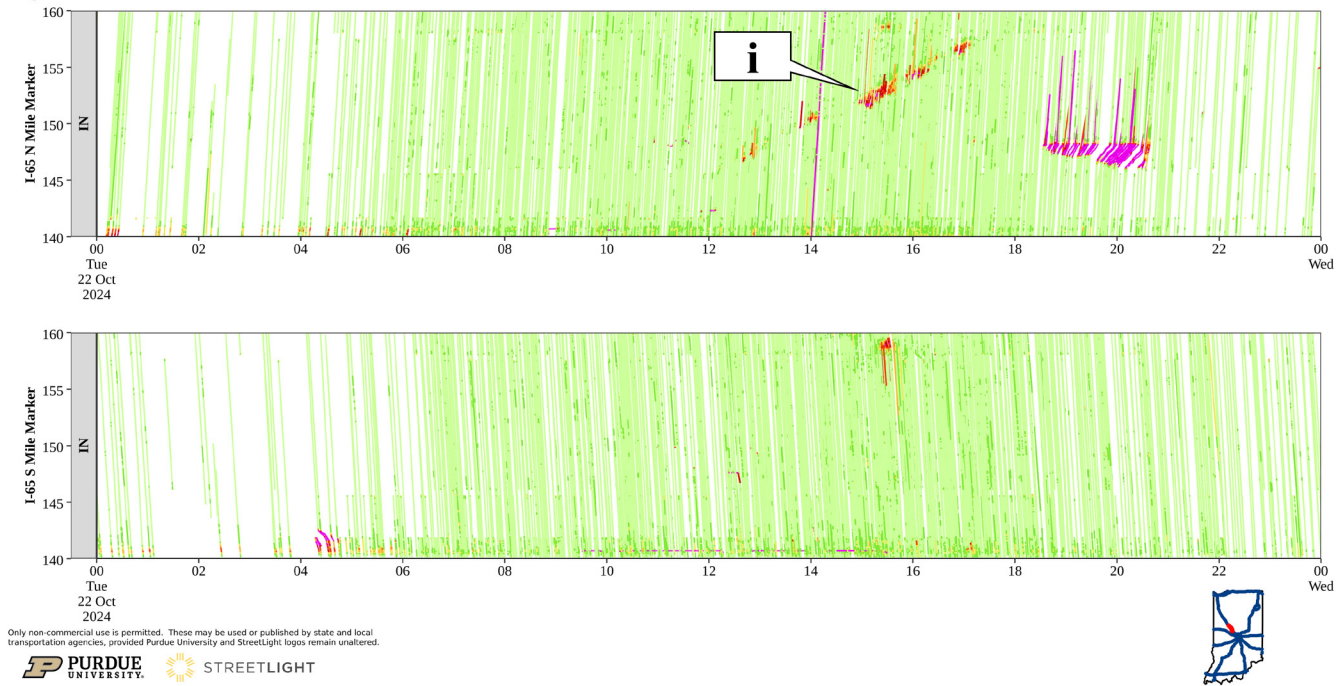
Figure 2.21 Traffic Speed Heatmap for a Section of I-65 in Indiana From MM 140 to MM 160 on Tuesday, October 22, 2024.

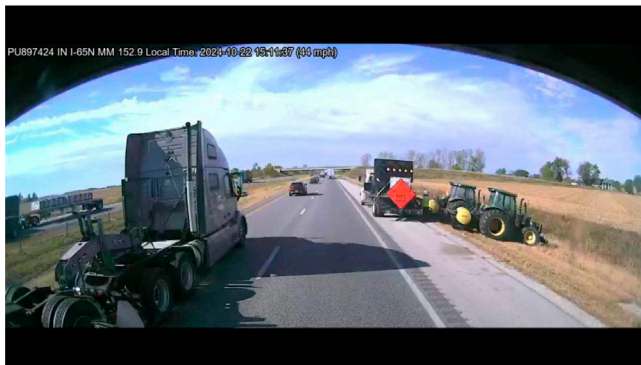
Figure 2.22 Dash Camera Image Showing a Semitruck Traveling by a Work Convoy on the Outside Shoulder.

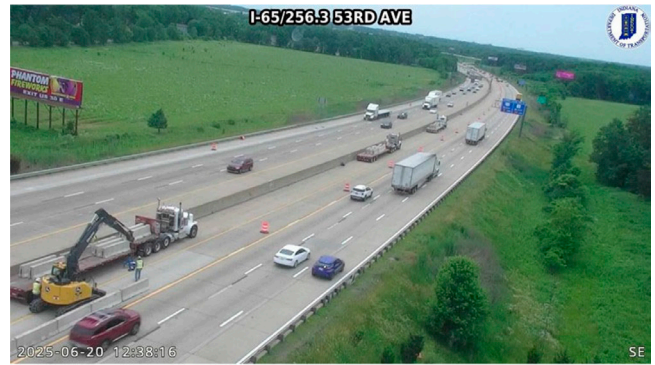
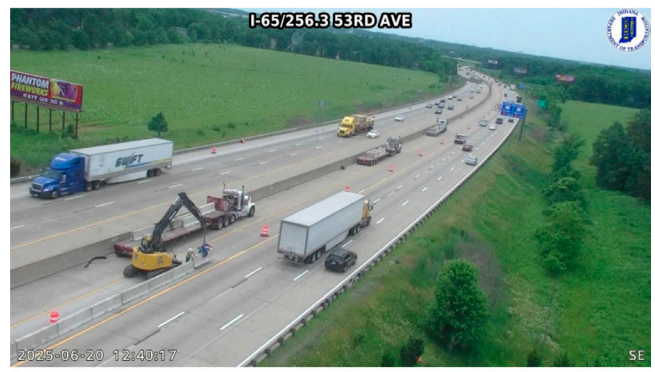
the daytime on a Friday afternoon along a busy stretch of interstate. Figure 2.23 shows two ITS camera images of the concrete barriers being placed next to the live traffic. Normally, the cross section includes three travel lanes with an inside shoulder of 14 ft and outside shoulder of 10 ft. The MOT for this section continues the three travel lanes but has no shoulders on either side. Because of this, vehicles are not able to take evasive actions on shoulders, if needed, and if a vehicle breaks down, has a fire, or is in a crash, there is no relief to go onto either shoulder. The potential issue can arise if any incident occurs and no relief area is provided.

Figure 2.23 ITS Camera Images Along I-65 Near MM 256.3 on June 20, 2025 Showing the Installation of Temporary Concrete Barriers Next to Live Traffic.

The opportunity from this case study is to work with INDOT and contractors to define the best practice for this type of installation.

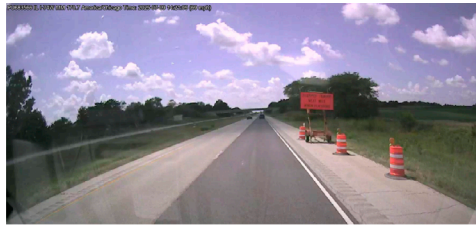
ChatGPT: No
Orange sign says 'Workers Ahead Next Mile' with 3 barrels on the shoulder. No taper or lane closure visible.

Gemini: Yes
Orange barrels and a "Road Work Ahead" sign are on the right shoulder.

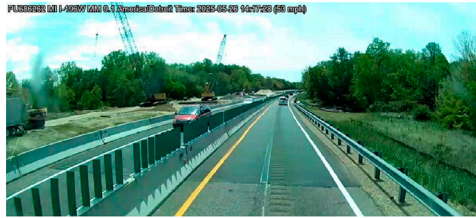
(c)

ChatGPT: Yes
Concrete barriers line both sides of the lane, and construction equipment is visible on the left. Speed is reduced, indicating a work zone.

Gemini: No
Construction is on the opposite side of the highway, not affecting travel.

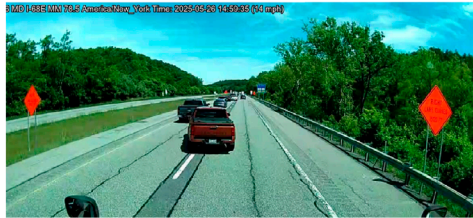
ChatGPT: Approaching
Two orange warning signs on each side of the highway state "Right Lane Closed 1500 FT"; driver is not yet in the construction zone, but it is imminent.

Gemini: Yes
"RIGHT LANE CLOSED AHEAD" sign is posted and traffic is slow.
