**Structures Research
Report 2026/
P0260410-P0260749**

Deliverable 6: Final Report

Bond Performance of Post-tensioning Tendons with Corrosion Inhibitor

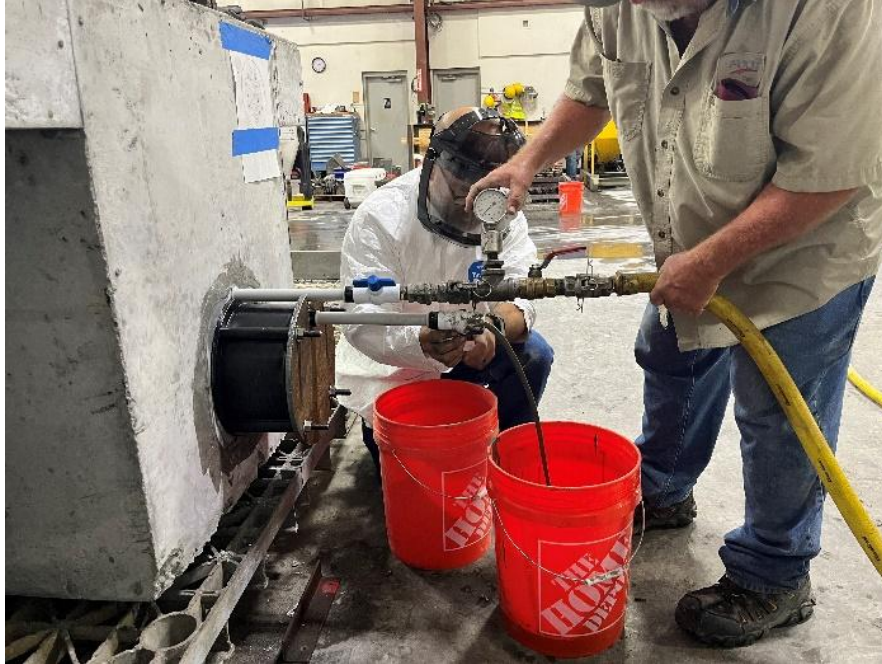
Figure 6.16. Grout injection at PT live end of beam S19-M-U

Similar to the grout injection process in the previous beams, the grout was injected at a constant pressure of approximately 15 psi, and the remaining three grout ports - one at the live end and two at the dead end were monitored visually with their valves open until grout discharge occurred. Grout injection was stopped once approximately 1 gallon of grout had been discharged from each grout port (except the injection port), after which all valves were closed.

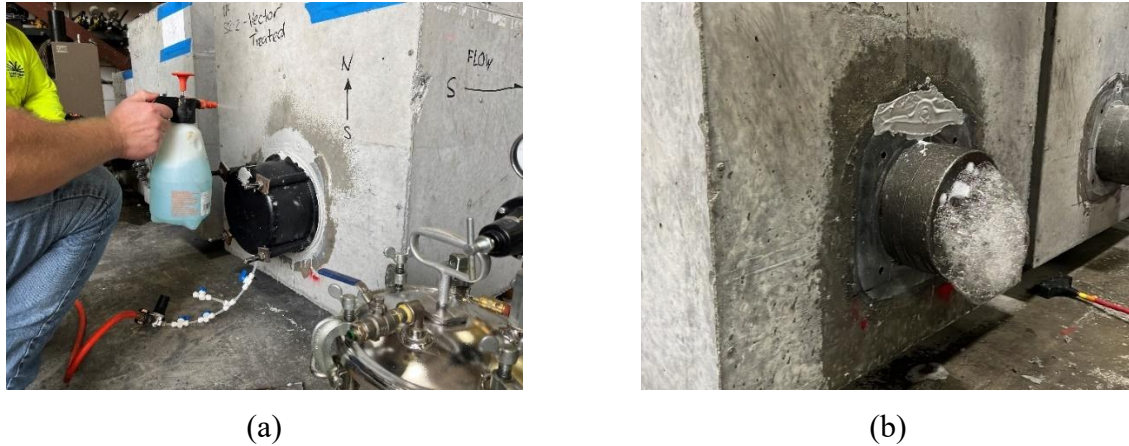
Figure 8.4. Air flow tests on S12-P-T beam: (a) Checking for leaks at the bearing plate-concrete joint at PT live end; (b) Bubbles confirming air flow at the PT dead end.

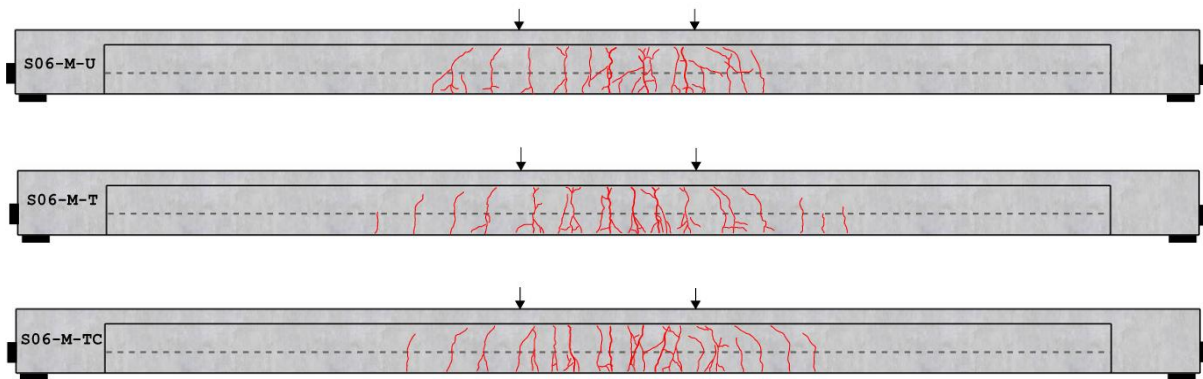
Figure 9.6. Final crack map after flexural testing of S06 beams.

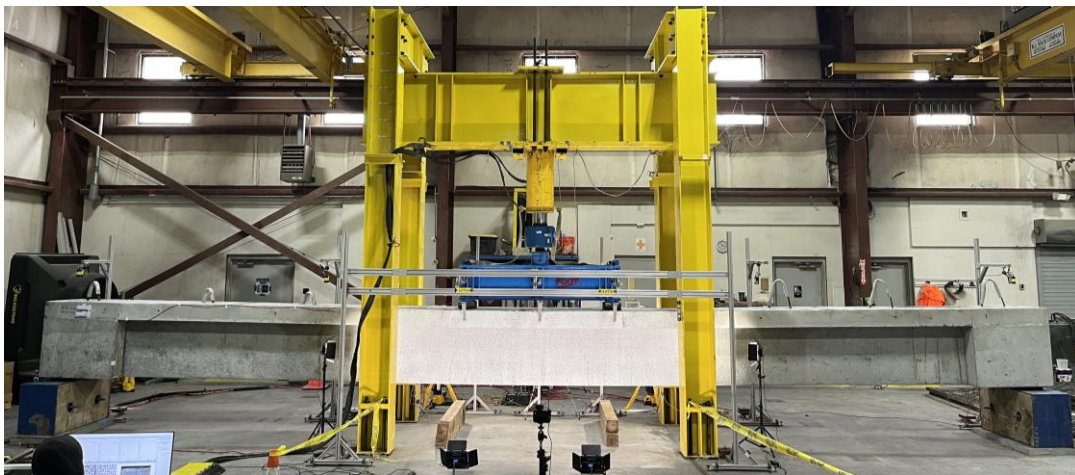
Figure 9.7. Flexural testing of S12-P-T beam

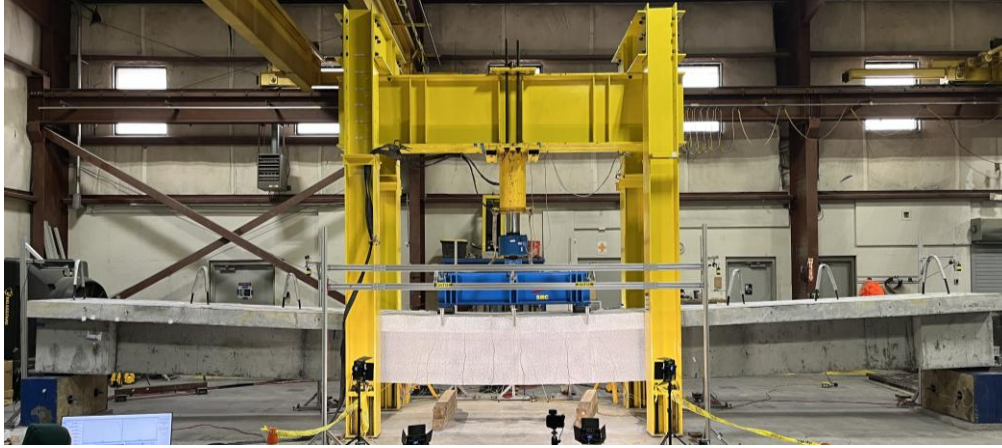
Figure 9.11. Flexural testing of S19-M-T test beam.
