GEORGIA DOT RESEARCH PROJECT 21-04

**PRAGMATIC PRECAST/PRESTRESSED
GIRDER ACCEPTANCE CRITERIA**

July 2025

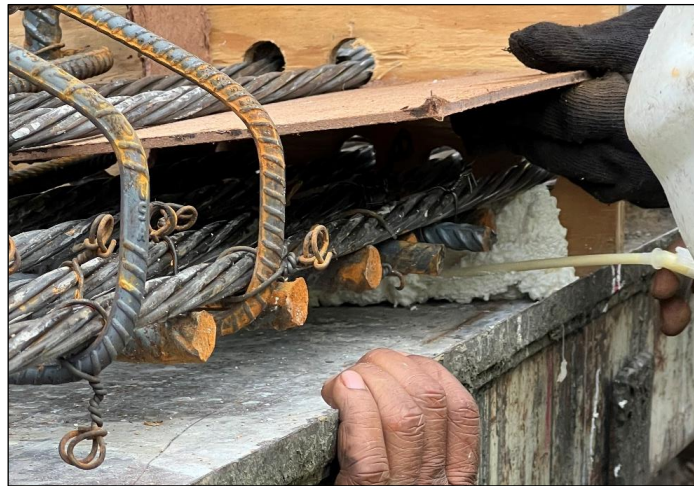
Figure 5. Photo. Typical bearing area block out.

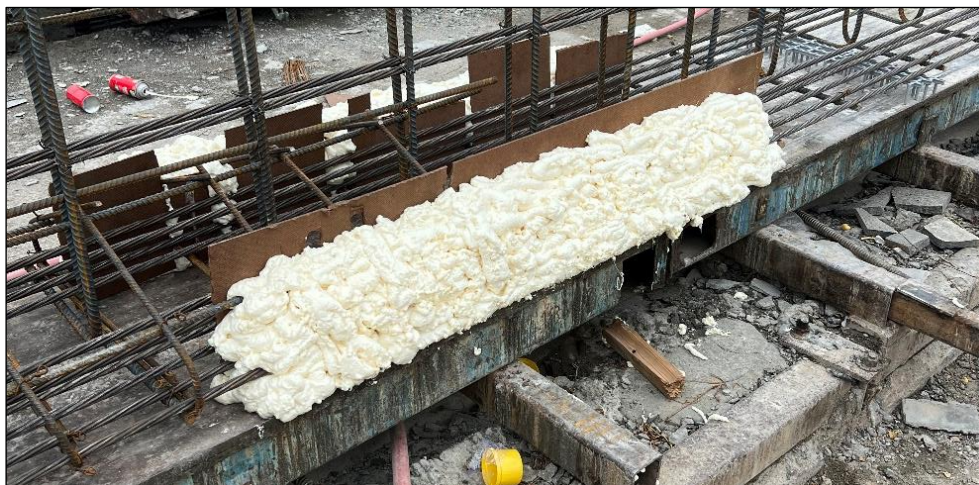
Figure 6. Photo. Typical bottom flange block out.

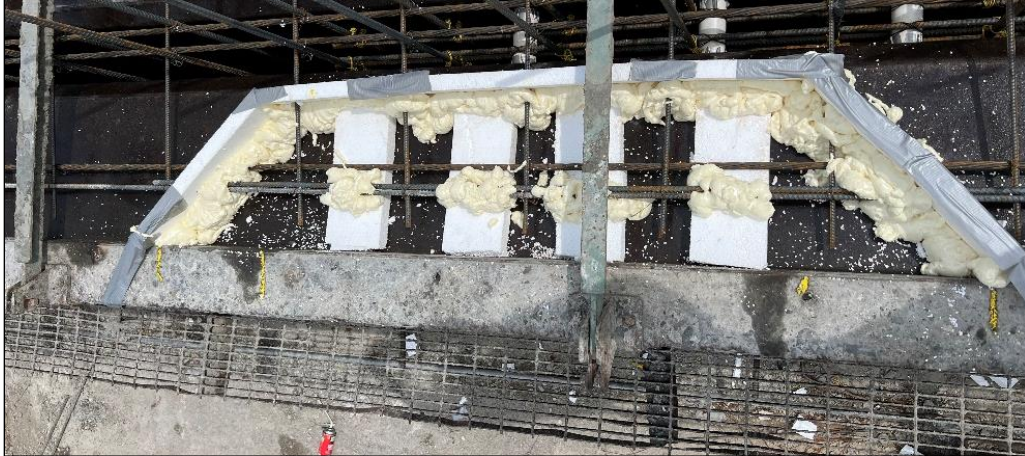
Figure 7. Photo. Typical top flange block out.

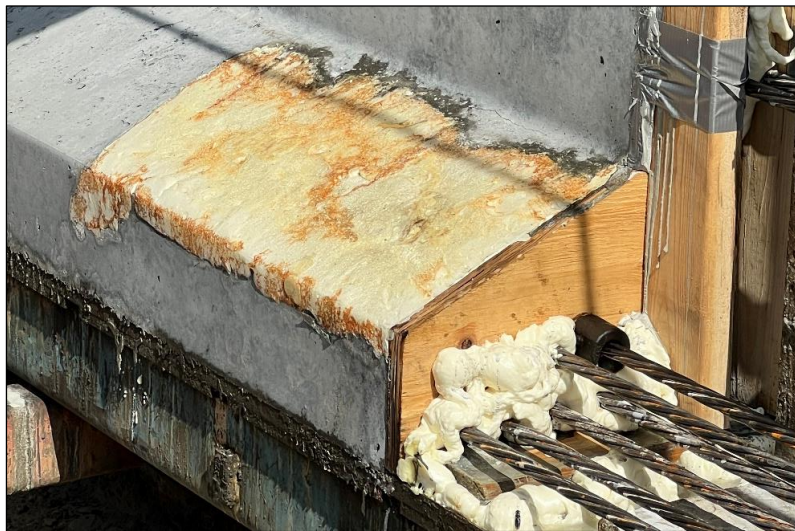
Figure 8. Photo. Typical bottom flange block out after formwork removal (end view).

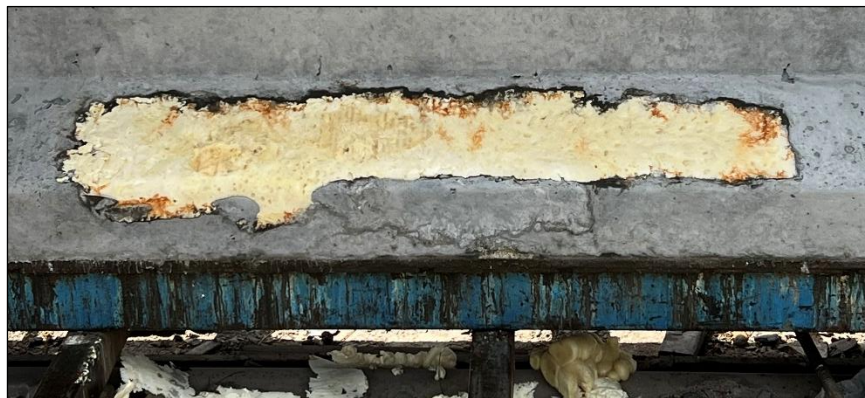
Figure 9. Photo. Typical bottom flange block out after formwork removal (top view).

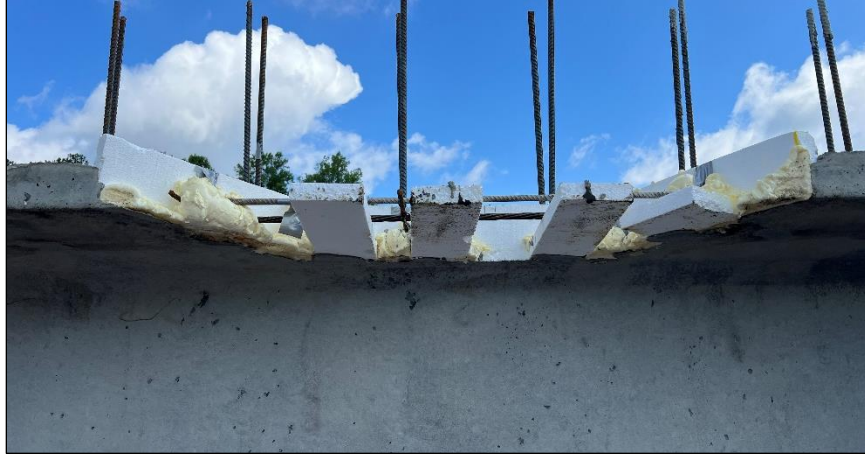
Figure 10. Photo. Typical top flange block out after formwork removal.

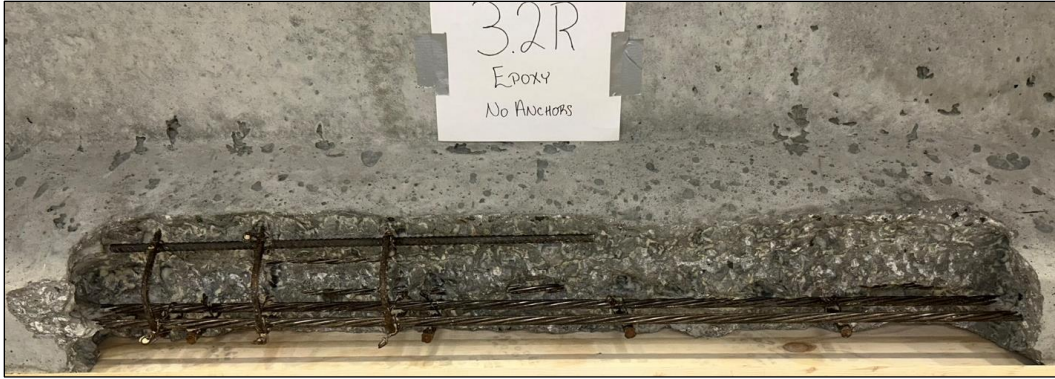
The removal of spray foam was facilitated using steel wire brushes attached to a cordless hammer driver-drill. Spray foam was removed until the concrete surface was visible. Then, the bottom flange repair surface was chipped with a rotary hammer tool to obtain a 0.25-in. amplitude surface (see figure 13).

Figure 13. Photo. Spray foam block out in girder repair section after preparation.

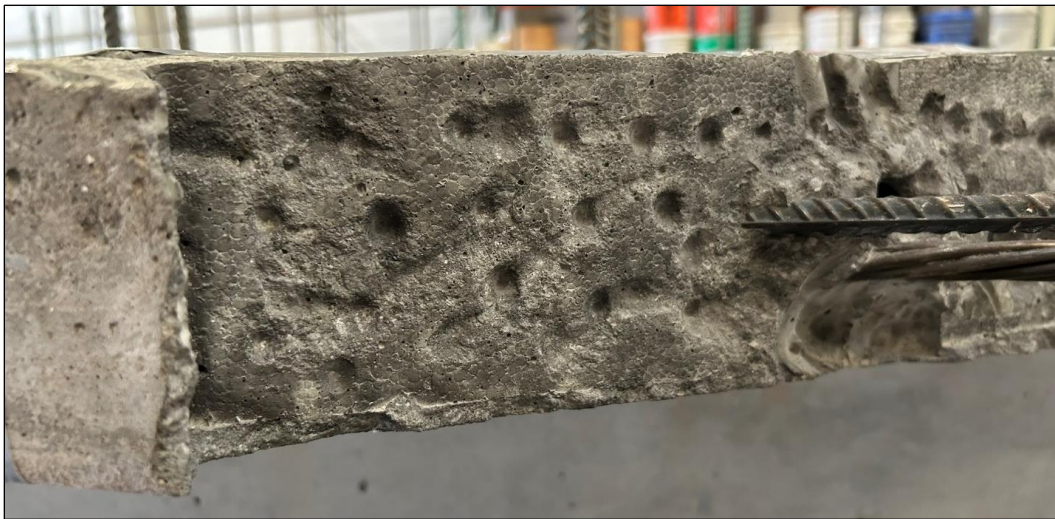
For the top flanges, the block outs were removed at SCP, and the surface of the repair areas was roughened at 0.25-in. amplitude as well (see figure 14).

Figure 14. Photo. Top flange repair surface preparation.

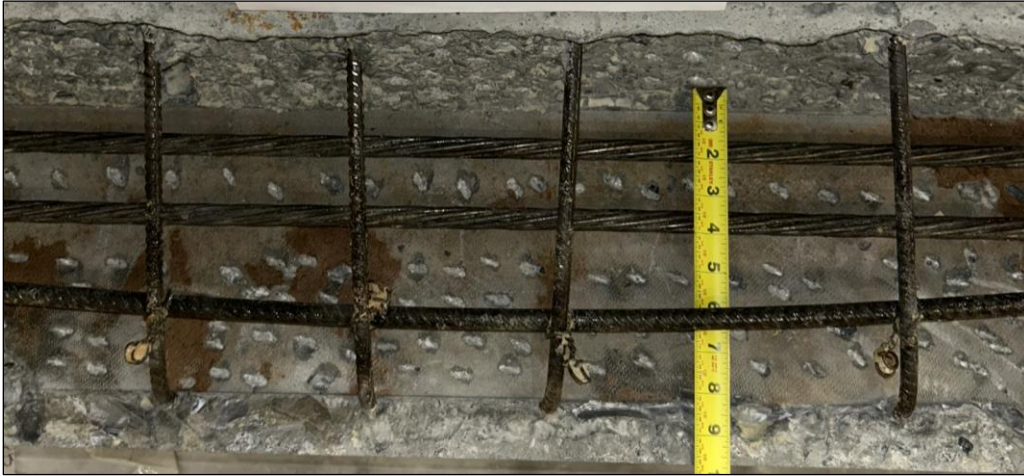
surface was roughened to a 0.25-in. amplitude to improve the shear friction between the existing concrete surface and the new concrete surface that was placed as the repair (see figure 15).

Figure 15. Photo. Roughened 0.25-in. amplitude surface.

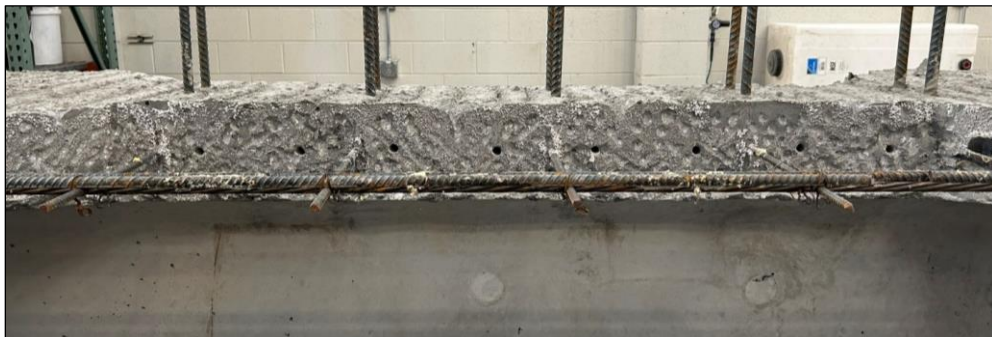
The c-bars were bent using a rebar bender. To install the bars into the girder, 0.5-in.-diameter holes ranging from 3- to 4-in. deep were drilled into the top flange web section (see figure 17). Where possible, the holes were spaced at approximately 6 in.

Figure 17. Photo. Drilled holes for c-bars.

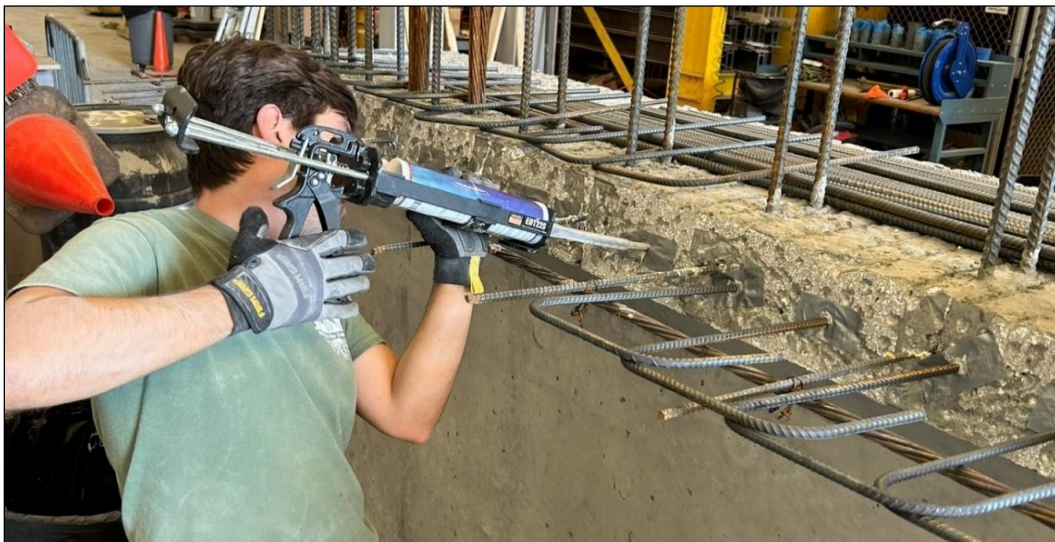
To install the c-bars, the two-part epoxy was inserted into the hole and filled about halfway. Then the c-bars were pushed in and held in place by one person, while another person secured it in its final position with rebar ties (see figure 18 and figure 19). The next step was to create formwork that matched the existing flange shape (see figure 20). A gap found between the angled portion of the formwork and where the top flange bevels into the web was filled using 0.25-in. foam weather stripping. The bottom of the formwork was secured in place with the use of sandbags to avoid any accidental movement of the formwork.

Figure 18. Photo. Insertion of two-part Unitex Pro-Poxy 300 into cleaned drilled holes.

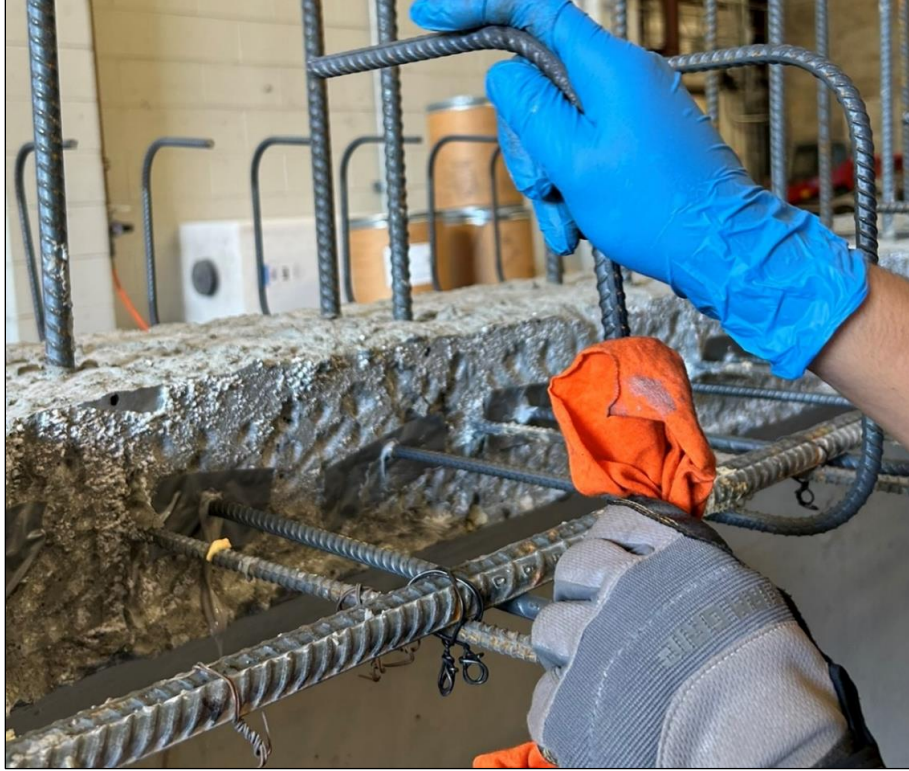
Figure 19. Photo. C-bar installation.

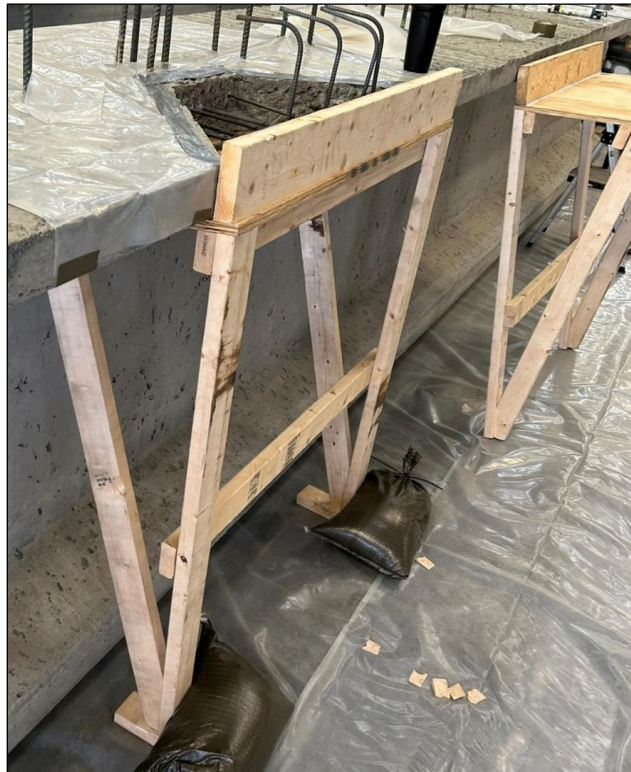
Figure 20. Photo. Top flange repair formwork.

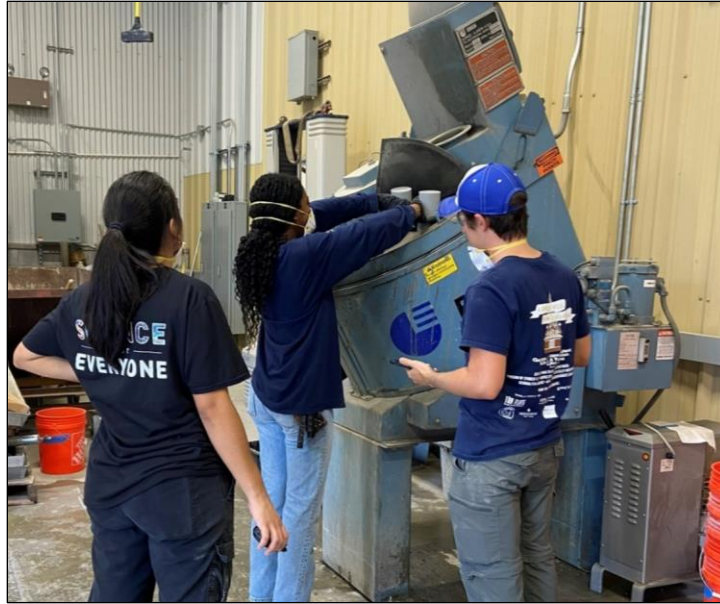
Each batch was 2 ft³ and mixed using an Eirich R08W concrete mixer (see figure 21). The mix design for the three girders with top flange repairs is provided in appendix D. The mix design procedure consisted of mixing the coarse and fine aggregate together for 2 min, adding the cement and mixing for another 1–2 min, and adding the water with admixtures and mixing for approximately 3–4 min. The mix time after adding the water varied depending on the desired slump for the mix.

Figure 21. Photo. Concrete mixing 2-ft³ batches with Eirich mixer.

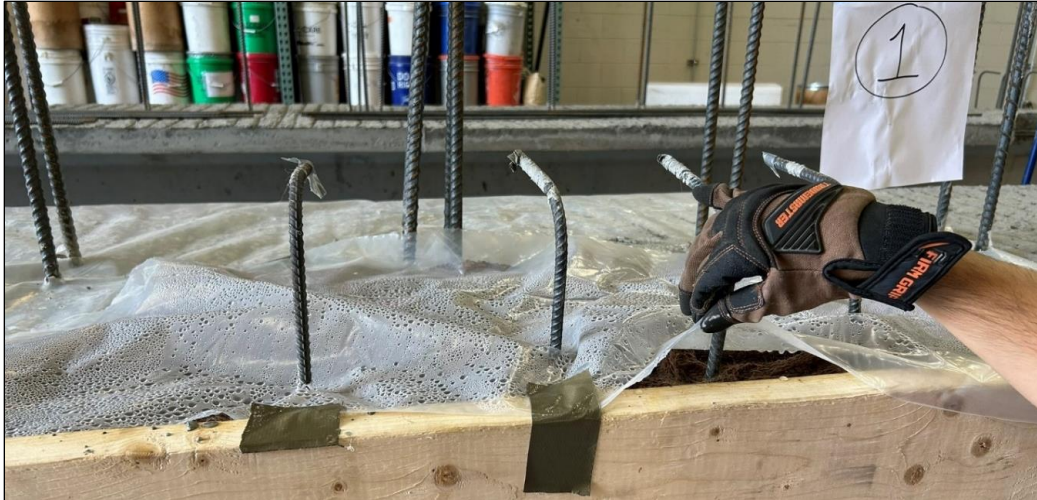
After the grooves were created on the repair surface, damp burlap was placed to cover the fresh concrete. A layer of polyurethane plastic was placed to cover the burlap. These two steps ensured the fresh concrete repair cured in moist curing conditions (see figure 24). The top flange repairs were demolded 48 h after the cast (see figure 25).

Figure 24. Photo. Concrete curing conditions for top flange repair.

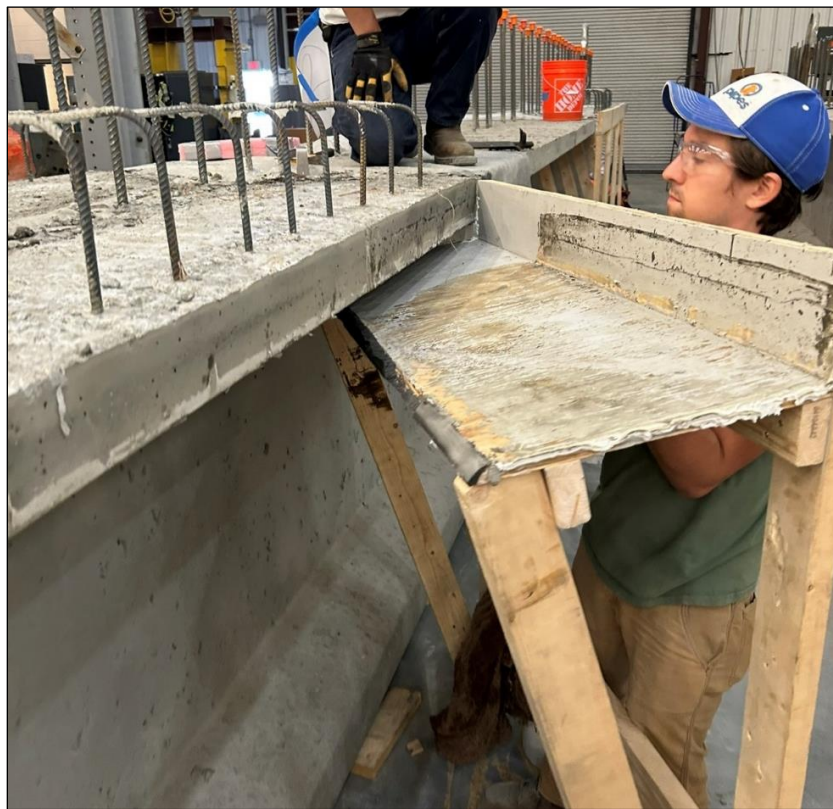
Figure 25. Photo. Demolding of top flange repair.

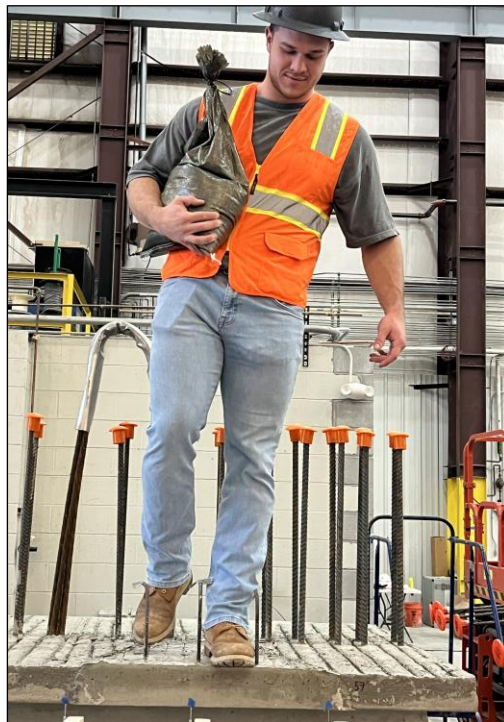
The serviceability of the repair was verified to confirm whether the deflection was consistent across the repairs under the expected construction loads. A 250-lb point load and a 50-psf distributed load were used for this testing based on general guidelines from a GDOT bridge engineer. The point load was recreated with a person's weight plus a sandbag (see figure 26). The distributed load was recreated using 40-lb and 60-lb sandbags (see

Figure 26. Photo. Point load of 250 lb on the top flange.

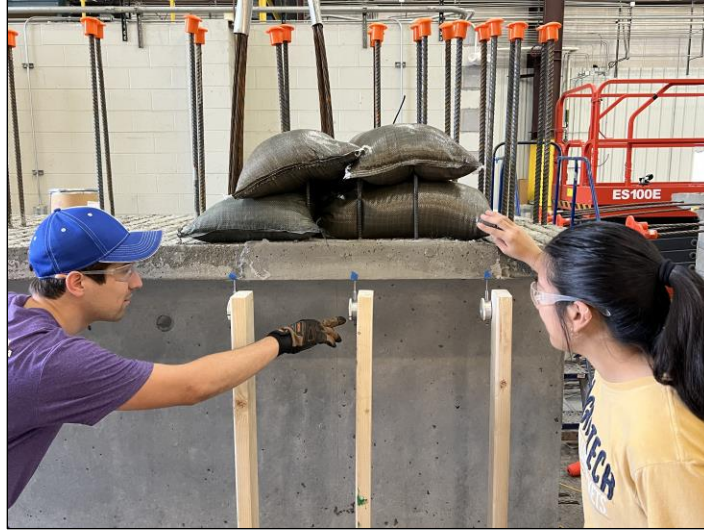
figure 27). Deflections were measured using dial gauges attached to 2-in. × 4-in. posts. These posts were spaced uniformly across the length of each repair, and the number of posts varied based on the length of the repair. The posts were secured in place using sandbags (see figure 28).

Figure 27. Photo. Distributed load of 50 psf on the top flange.

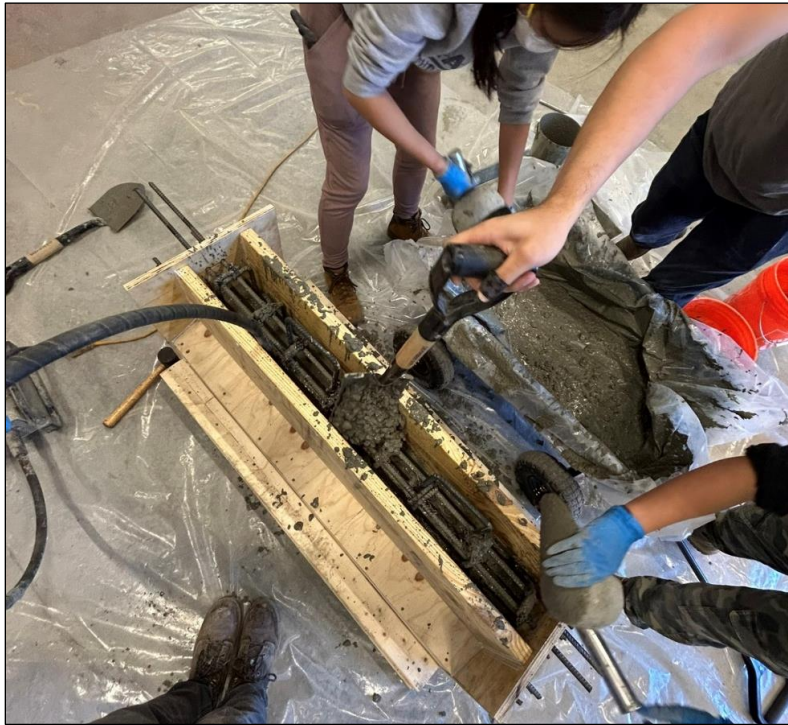
The dimensions of the mini girders were 4 ft long, 18 in. tall, and 12 in. wide on the bottom. The web portion was 6 in. thick, like that of a BT-54 girder. Number 4 reinforcing bars represented the 0.6-in.-diameter prestressing strands. Figure 30 through figure 39 illustrate the mini-girder construction and repairs.

Figure 30. Photo. Mini girder construction using the same concrete mix as used in the full-size BT-54 girders.

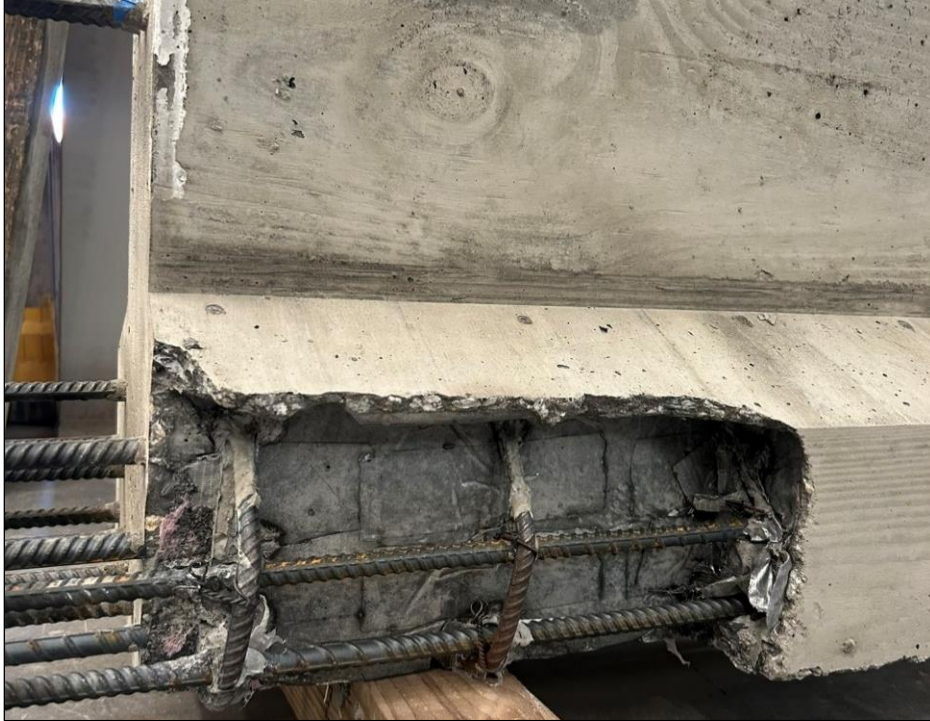
Figure 31. Photo. Mini girder nonconformance representing conditions comparable to repair 3.1RTF.

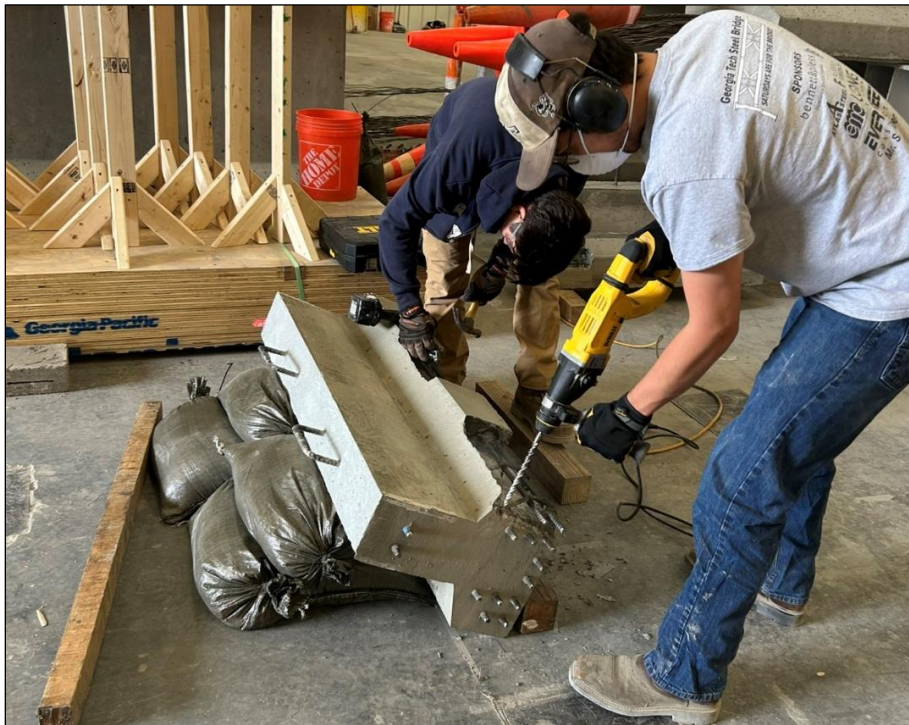
Figure 32. Photo. Chip hammer practice.

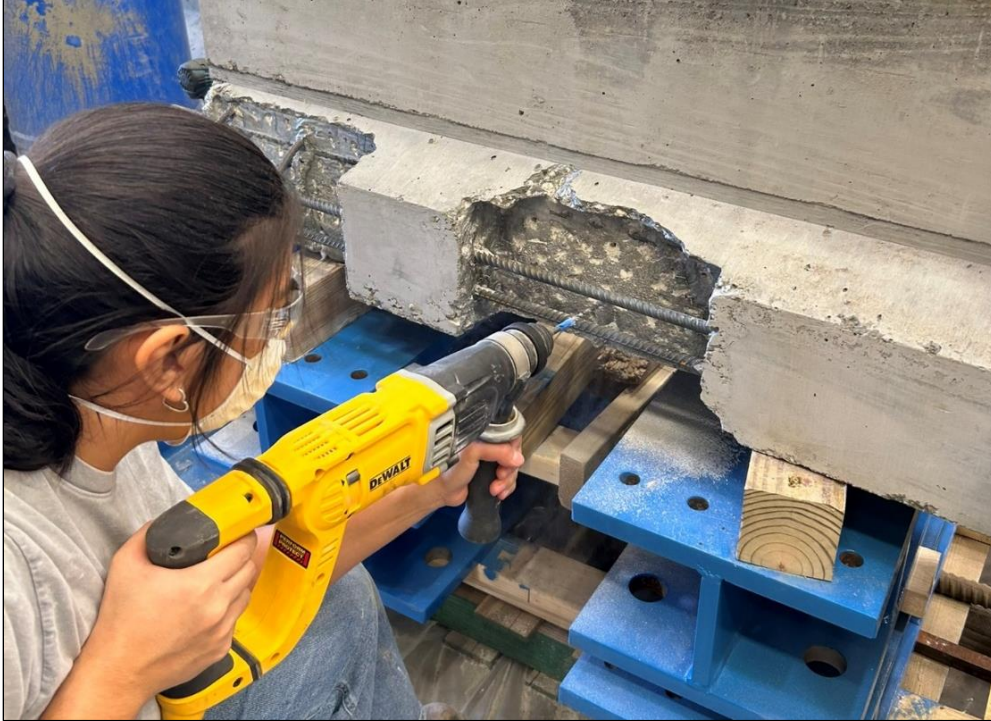
Figure 33. Photo. Practice hammer-drilling pilot holes for concrete anchors between closely spaced reinforcement.

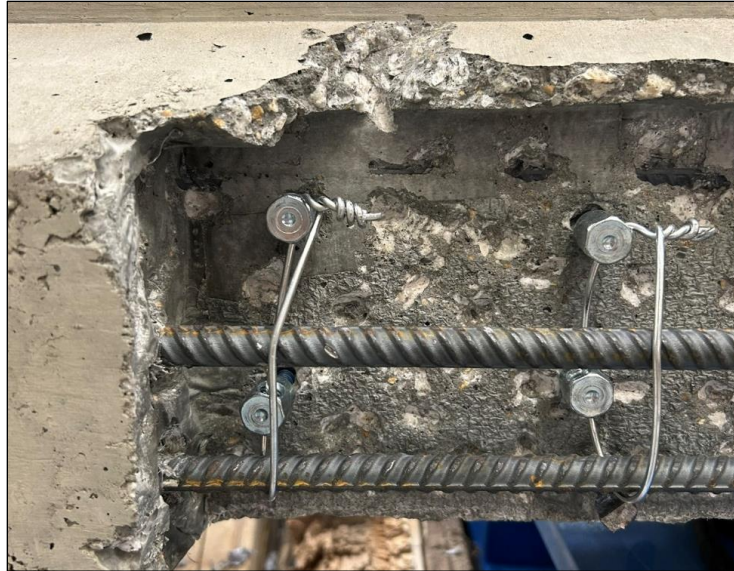
Figure 35. Photo. Practice installation of 12-gauge wire fed through the concrete anchor holes on longitudinal reinforcement.

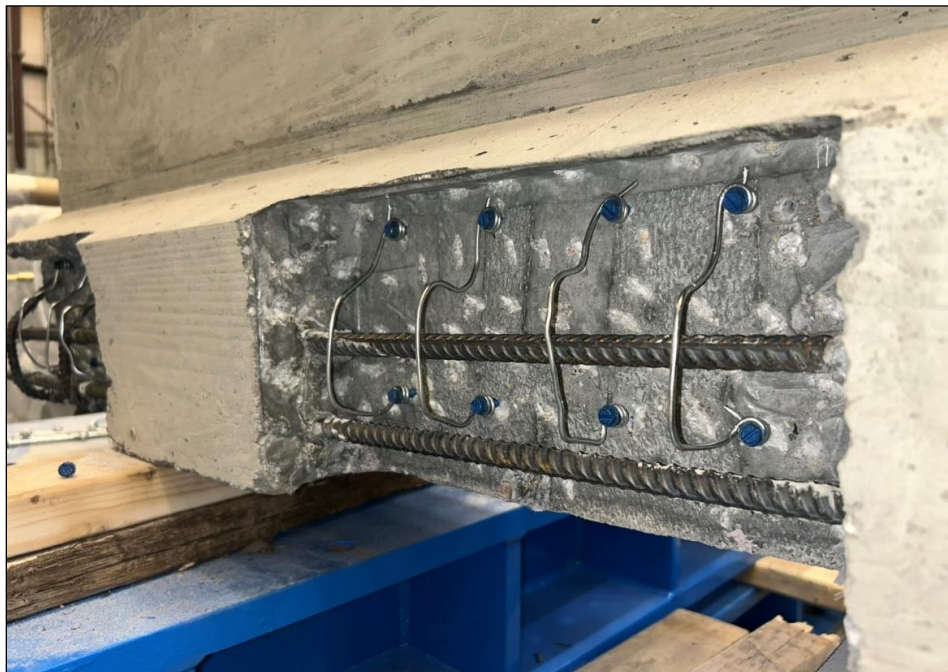
Figure 36. Photo. A 12-gauge wire installation studied as an alternate to reinforcing bars originally recommended by MNL-137.

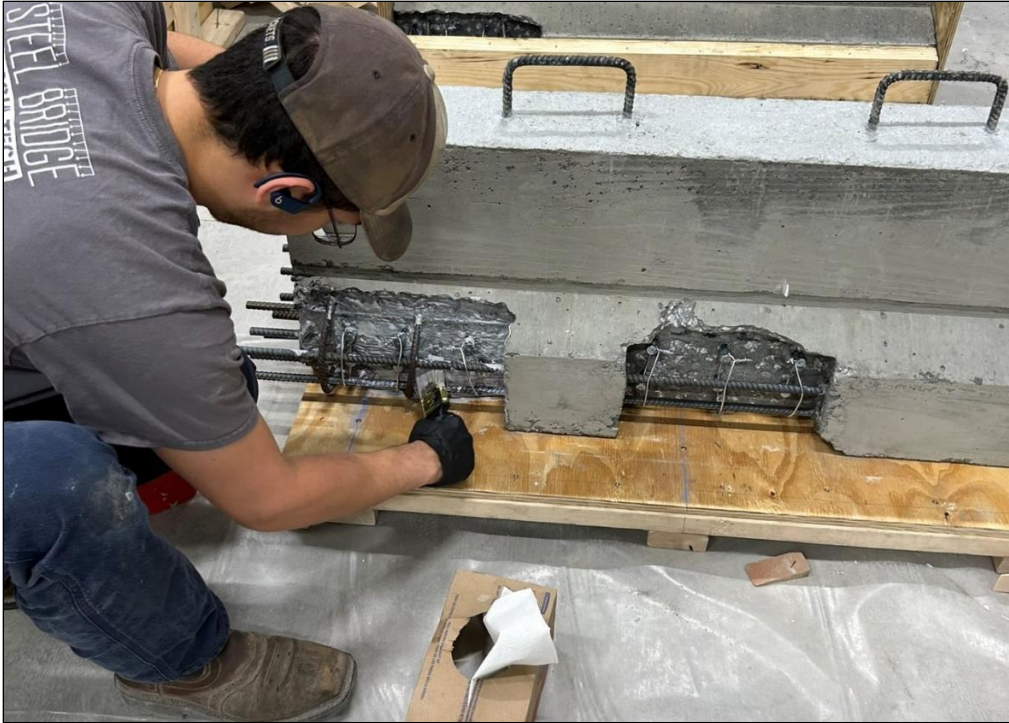
Figure 37. Photo. Installation of the epoxy bonding agent.

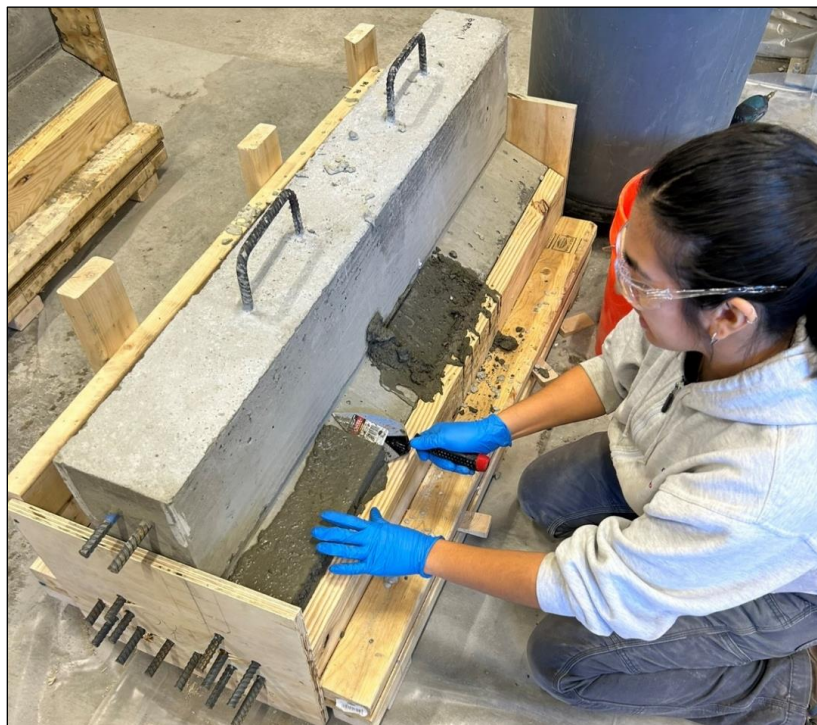
Figure 38. Photo. Finishing the SCC repair surface with a trowel for Mini Girder 1.

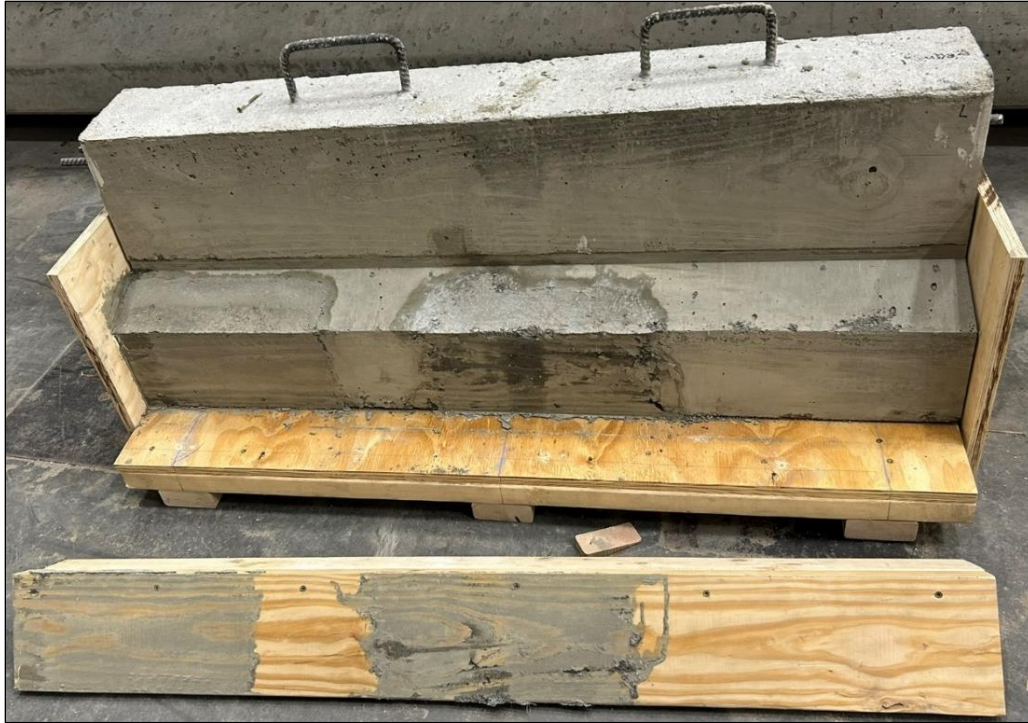
Figure 39. Photo. Bottom flange repair on Mini Girder 1 using the SCC mix.

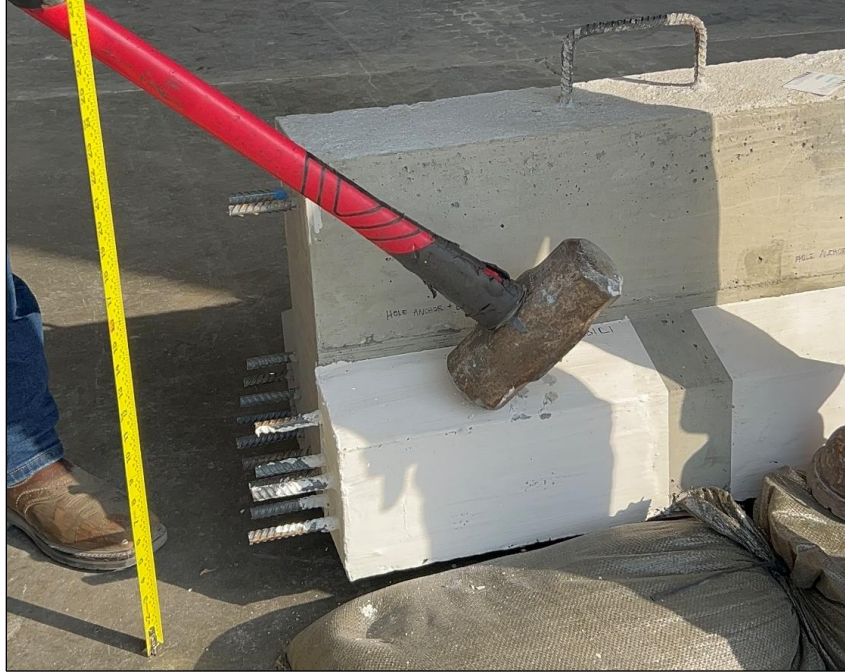
Nineteen days after the repair, the mini girder bottom flange repairs were tested by impact with a 16-lb sledgehammer. Each patch was struck three times, with the sledgehammer being dropped from different heights. A measuring tape was used to help locate the height of each sledgehammer drop. Figure 40 shows a sledgehammer drop test on a mini girder patch with anchors. For all mini girder repairs, minimal surface chipping (see figure 41) was noted after the height-controlled sledgehammer drops.

Figure 40. Photo. Strength and efficacy test of 12-gauge wire reinforcement and concrete anchors by striking with a 16-lb sledgehammer.

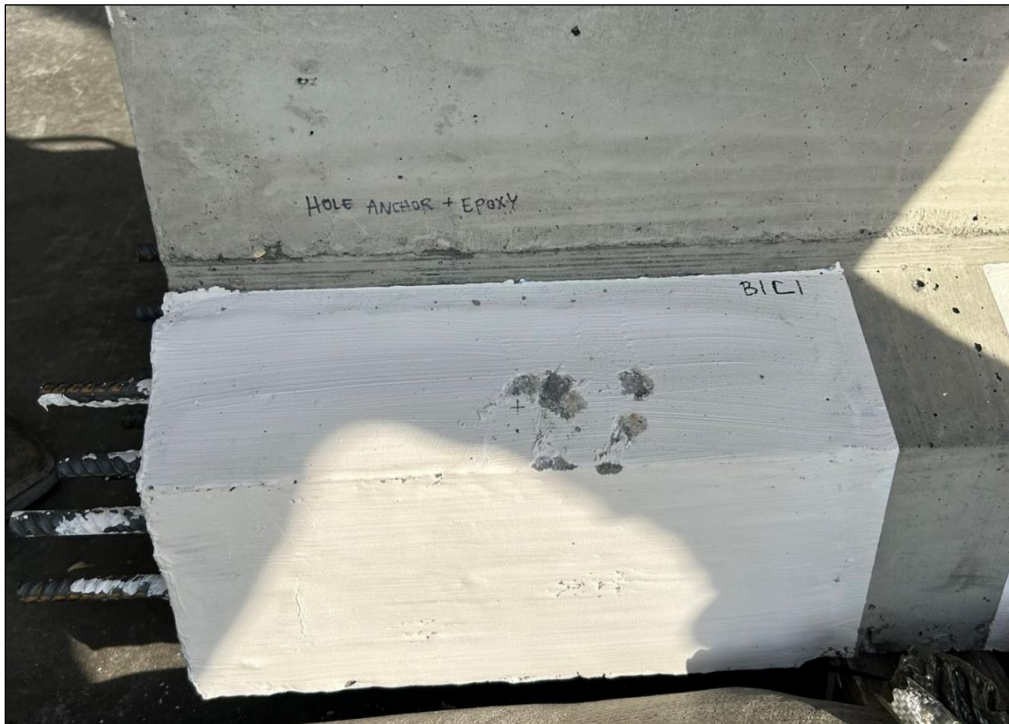
Figure 41. Photo. Minimal surface chipping after sledgehammer impact. The sledgehammer did not crack or dislodge the patch.

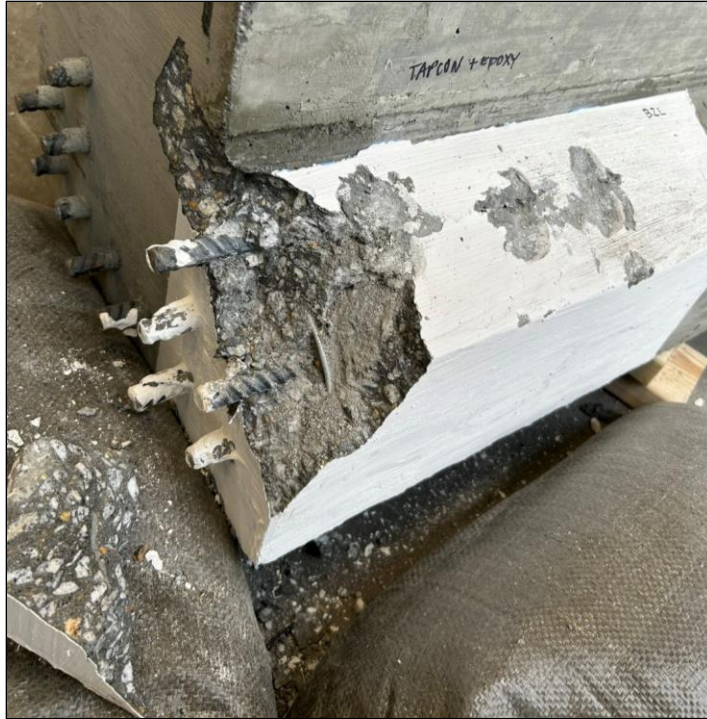
After the height-controlled sledgehammer drops were completed, more intense sledgehammer impacts were conducted on the mini girder patches. During these impacts, corners of the edge repairs broke off (see figure 42), indicating that the patch did not dislodge from the mini girder. The corner spalling allowed viewing of the SCC cross-section and confirmed proper consolidation of the repair concrete.

Figure 42. Photo. Intense sledgehammering removed corner concrete and demonstrated good consolidation of concrete around the reinforcement and 12-gauge wires.

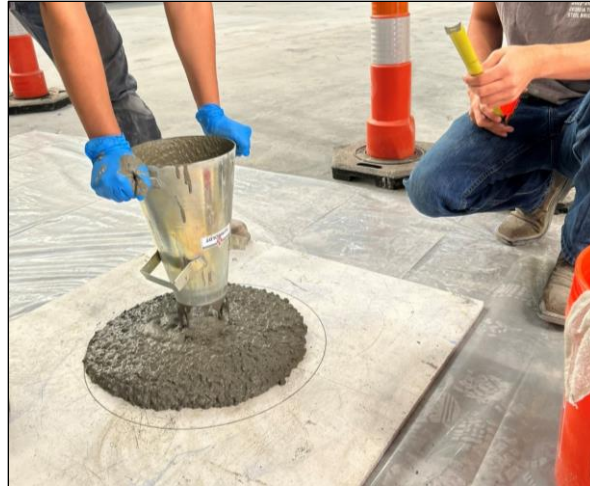
Three trial batches were conducted to test the flowability and compressive strength of the mix. The mini girders were then repaired with SCC. For every batch of SCC, an inverted slump cone test was performed to check the spread of the mix (see figure 43). The procedure in ASTM C1611 was followed for these tests.⁽¹⁸⁾ Concrete cylinders (4 in. × 8 in.) were cast for each batch of SCC used in the bottom flange repairs. Cylinders (3 in. × 6 in.) were also cast for one batch to compare the concrete compressive strength difference given by the two cylinder sizes. Concrete compressive strength data are provided in appendix F for all SCC batches. GDOT Research Project 2042 on SCC and the associated thesis were key references for SCC design mixes, sampling procedures, and other items related to SCC.⁽¹⁹⁾

Figure 43. Photo. Inverse slump cone test for the SCC mix.

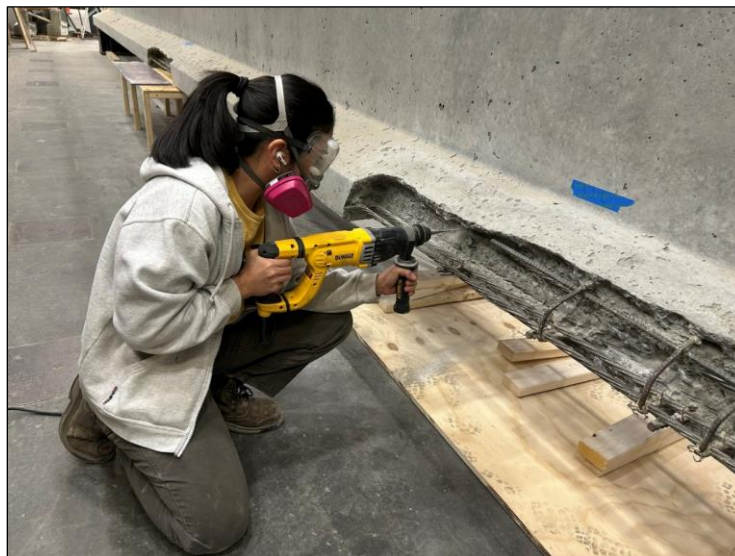
After the surfaces of the repair areas were cleaned and chipped, pilot holes were drilled for the stainless steel Tapcon concrete screw anchors. The Tapcon dimensions were 0.25 in. diameter \times 1.75 in. long. Per the manufacturer installation instructions, 0.1875-in.-diameter pilot holes were drilled. The holes were drilled with the use of a rotary hammer drill (see figure 44).

Figure 44. Photo. Drilling pilot holes for stainless steel Tapcon concrete anchors.

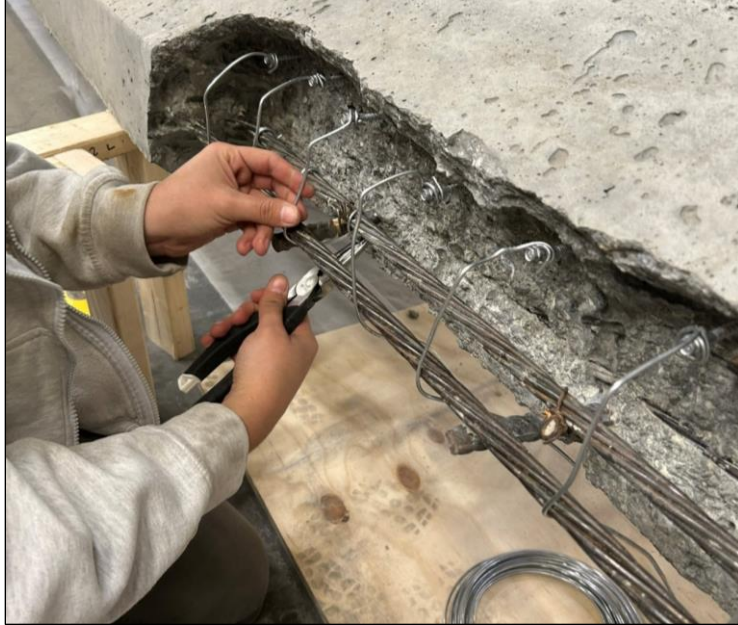
At times, it was difficult to install the Tapcon past a 1-in. depth. Some Tapcon would strip and not anchor correctly; those that did not anchor correctly were removed and replaced with a new Tapcon. After the Tapcon were installed, the 12-gauge galvanized wire was installed (see figure 45). This galvanized wire provided anchorage for the new bottom flange concrete. One end of the wire was coiled three times around the Tapcon, and the other end of the wire was coiled twice around an interior prestressed strand. This was done using a pair of pliers and wire cutters. Some areas of the bottom flange repairs had doghouse bars, and others did not. The use of Tapcon and wire anchors was focused in areas where there was little to no existing reinforcement. Figure 46 shows a repair case where the Tapcon and wire anchors were only installed on about half of the repair length.

Figure 45. Photo. Installing 12-gauge galvanized wire.

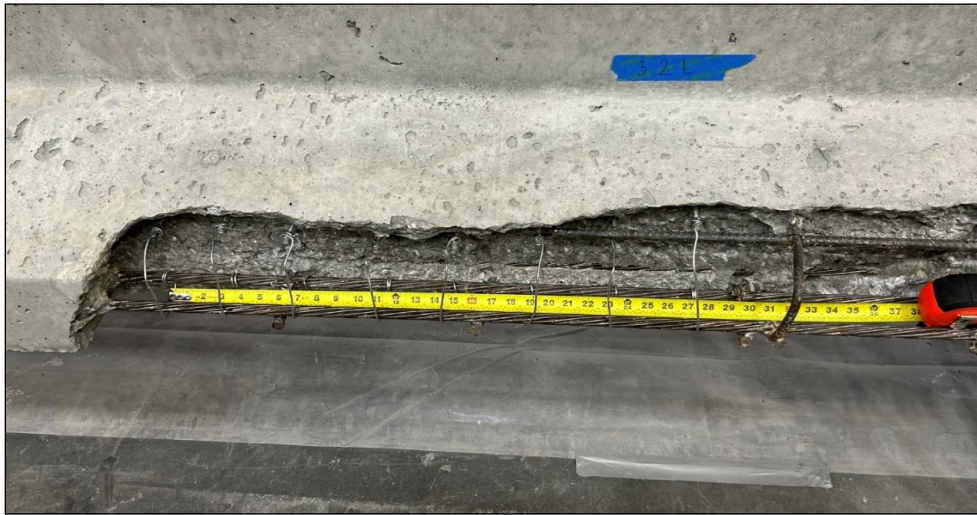
Figure 46. Photo. Post-installed steel anchors and wire in a bottom flange repair.

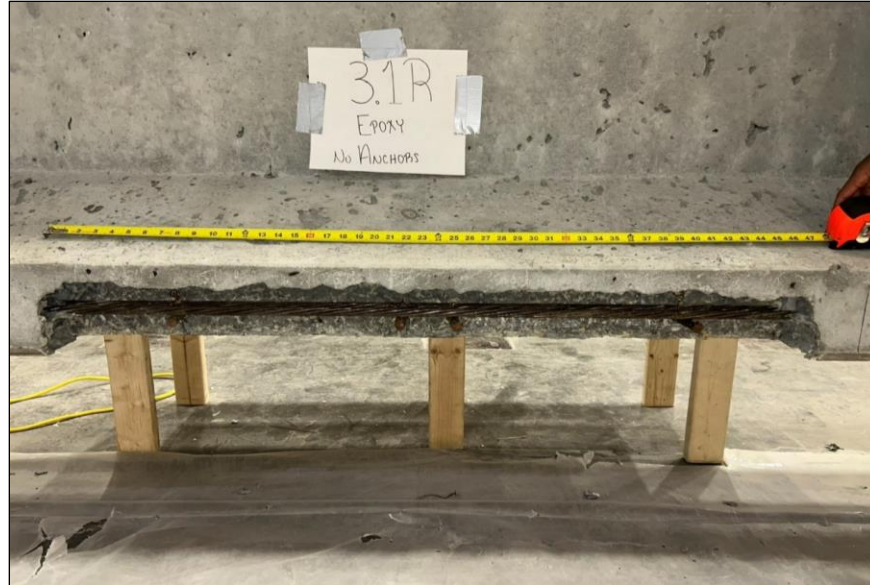
For the second bottom flange repair method, repairs with only epoxy bonding agent (i.e., no post-installed anchors) were constructed. The repairs with and without anchors were almost identical. Two 52-in.-long repairs were made using only the epoxy bonding agent with the concrete replacement (see figure 47 and figure 48).

Figure 47. Photo. Bottom flange repair 3.1RBF with no post-installed anchors.

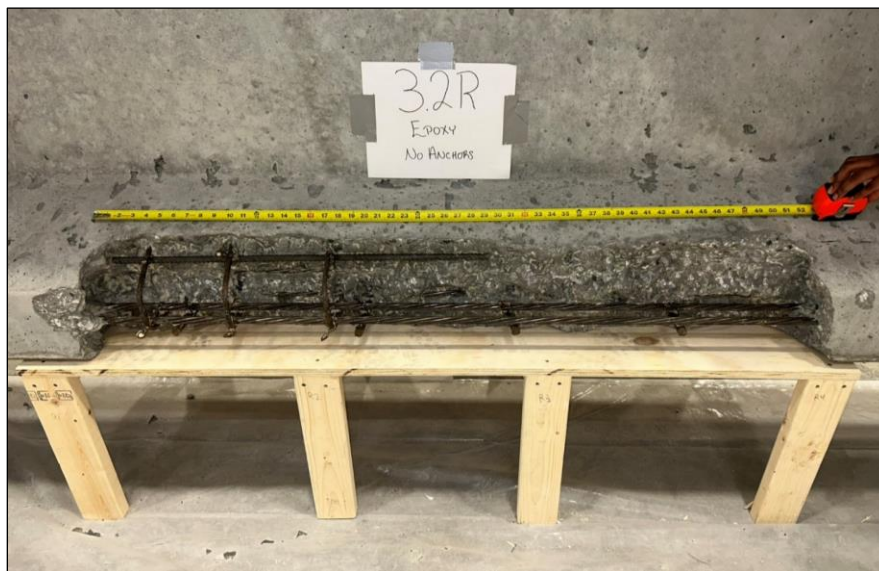
Figure 48. Photo. Bottom flange repair 3.2RBF with no post-installed anchors.

For the bottom flange repairs, especially repair 3.1RBF, implementing the concrete replacement was difficult because there was no access point from above to pour the concrete. A takeaway from practicing on the mini-girder repairs was the need for the formwork to be removed and installed again in a quick turnaround time, particularly in cases where epoxy bonding agent was applied. Therefore, formwork for each of the bottom

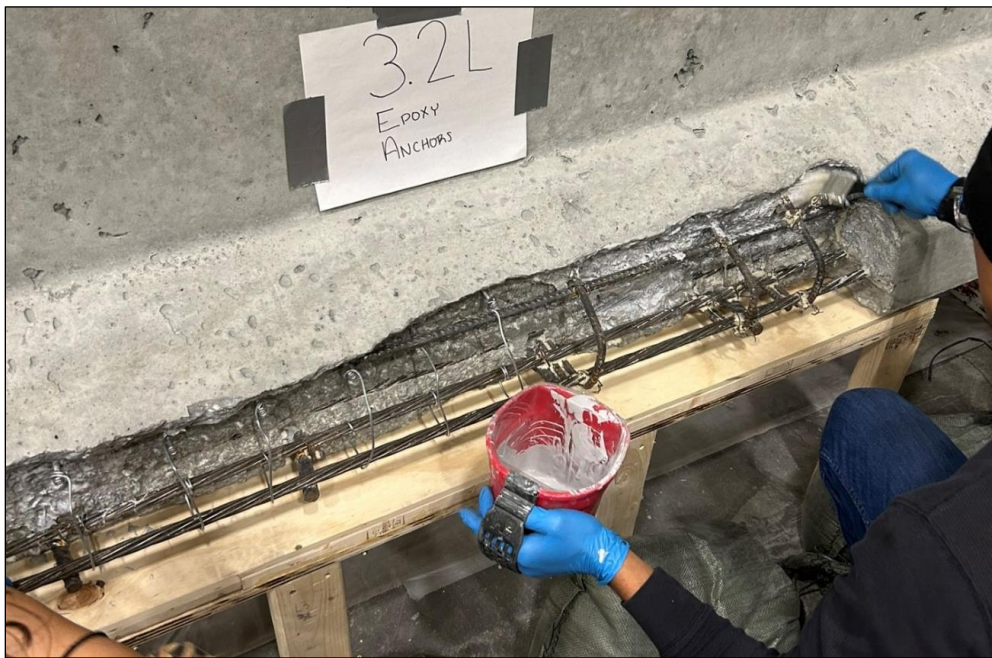
Figure 49. Photo. Coating a bottom flange repair with Sikadur-32 epoxy.

flange repairs was custom-made for each repair. For Girder 3, epoxy bonding agent was used on all the repairs. The bonding agent was mixed as the water was added to the concrete mix. Then, it was layered on the target repair area simultaneous to the performance of the flow test for each SCC concrete batch. The epoxy bonding agent was applied with a 2-in. nylon brush, avoiding the reinforcement as much as possible during the application. Figure 49 shows the two-part epoxy bonding agent application.

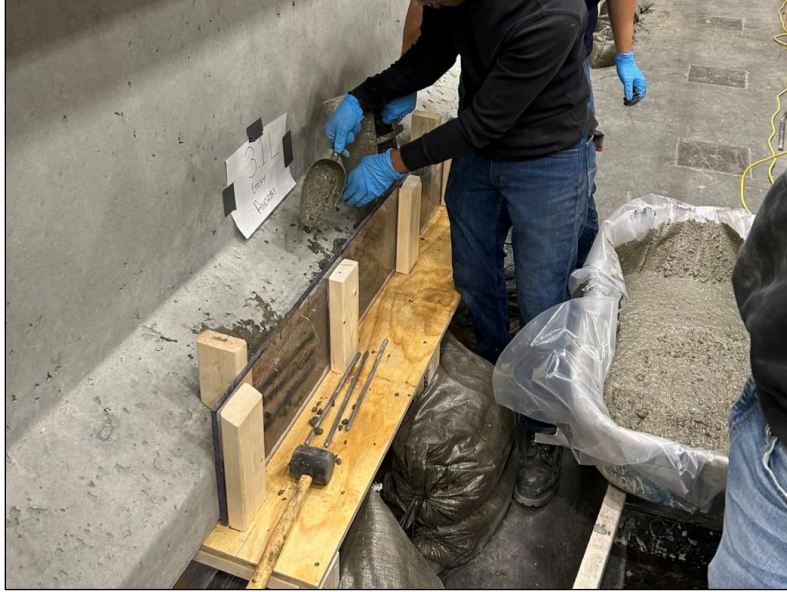
Figure 50. Photo. Placing concrete through the exposed top of a repair with polycarbonate formwork for viewing.

Upon completion of the two-part epoxy bonding agent application, the formwork was reassembled. Two kinds of concrete pouring holes were included in the formwork: top pour and chimney. The top pouring hole was where the top of the repair was exposed and concrete was able to flow into the repair (see figure 50). Another lesson learned from repair of the mini girders was that confirmation was needed on whether the concrete was filling the repair void adequately. To permit viewing of the concrete installation, clear polycarbonate sheets were used for formwork (see figure 50).
