GEORGIA DOT RESEARCH PROJECT 21-04

**PRAGMATIC PRECAST/PRESTRESSED
GIRDER ACCEPTANCE CRITERIA**

July 2025

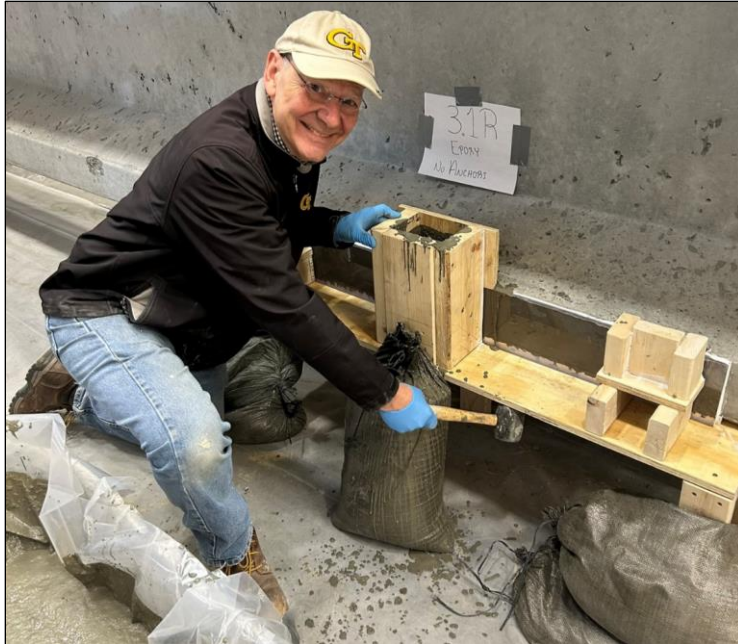
Figure 51. Photo. Vibrating the formwork with a rubber mallet.

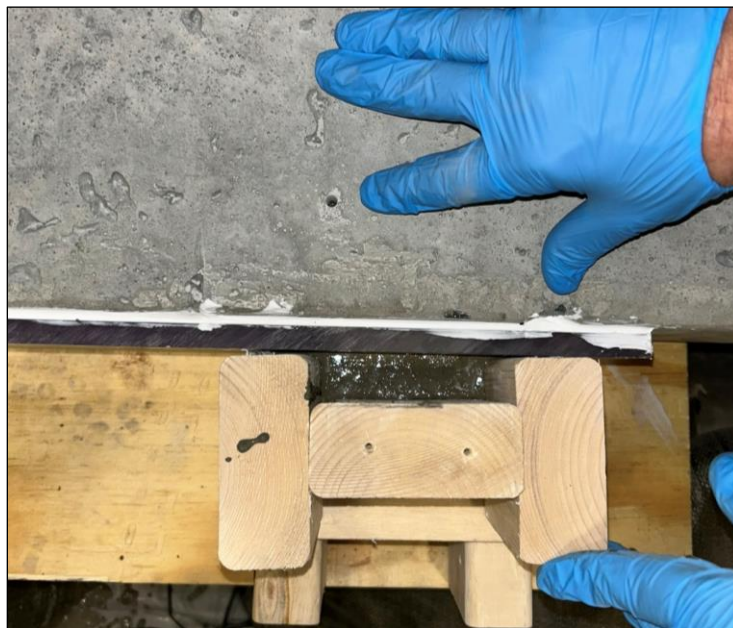
Figure 52. Photo. SCC flowing out of the air vent and through the drilled hole, indicating complete concrete replacement in the repair.

The second type of pouring hole practiced was the chimney, as suggested by MNL-137 Chapter 4, Section C.⁽¹⁾ In this process, SCC was poured into a “chimney.” As the repair void was filled, an exit/vent hole would allow air to escape, ensuring the concrete filled the void completely and no air was entrapped. However, this method required more patience than the top pouring hole because the flow of SCC varied by batch. Thus, steel rods were used to help the concrete flow through the chimney. Rubber mallets were also used to vibrate the forms and help the concrete flow easier (see figure 51). The air vent consisted of $\frac{3}{16}$ -in. holes drilled through the top surface of the bottom flange (see figure 52).

When the concrete was visible through the drilled hole and flowed out of the air vent, it was confirmed that the repair void was filled. The clear polycarbonate formwork sections allowed for easy inspection of the fresh concrete repair. Some repairs were able to be

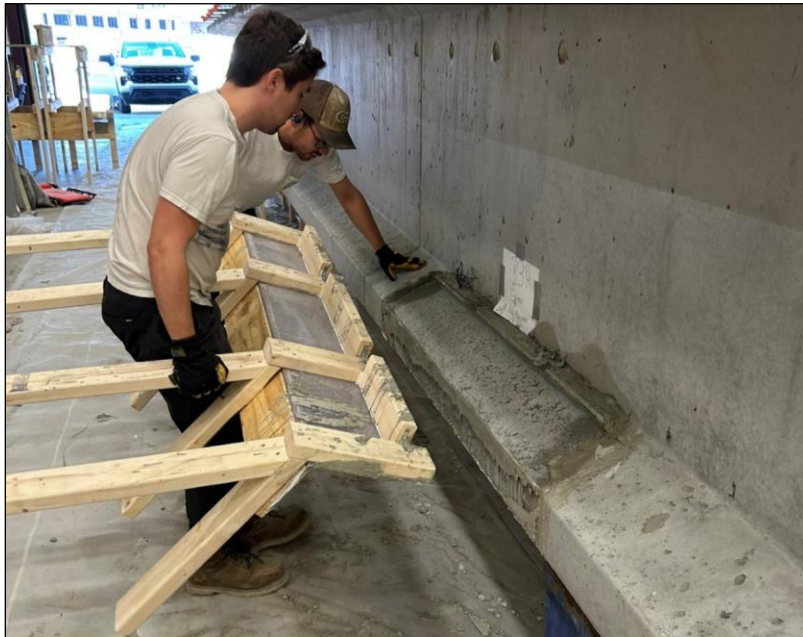
Figure 53. Photo. Demolding of repair 3.3RBF.

finished on the top surface after 30 min, but others were not accessible. Because only a small part of the top surface was exposed, damp burlap was not used to cover these repairs. Typically, after a day of curing, the formwork was removed from these repairs. Figure 53 shows the process of removing formwork from repair 3.3RBF.

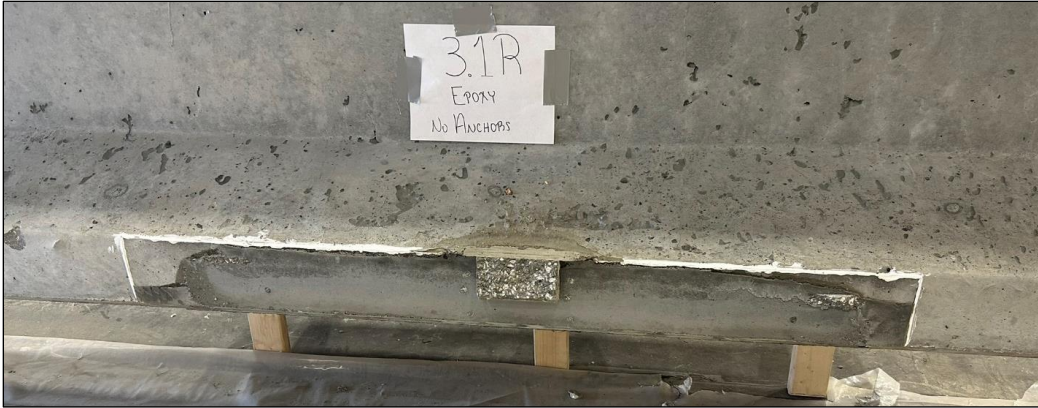
Figure 54. Photo. Repair 3.1RBF with a chimney pouring hole after demolding.

It was more difficult to remove the formwork on the repairs with a chimney due to the leftover concrete that was in the chimney and air vents. Therefore, more force (e.g., use of hammers) was employed to remove this formwork. Figure 54 shows repair 3.1RBF, a repair with a chimney pouring hole, after the formwork was removed. The center concrete bulge was later reduced with a chisel.

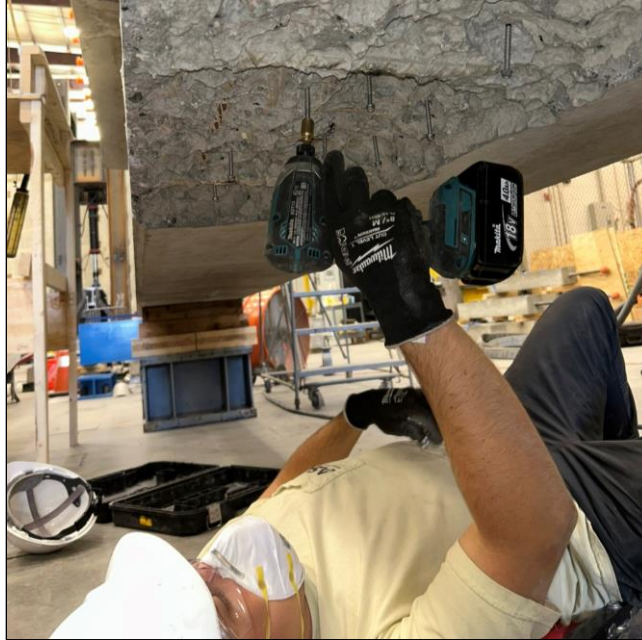
Figure 55. Photo. Installing stainless steel Tapcon into the congested repair.

The third repair method consisted of only post-installed steel anchors and no epoxy bonding agent. This type of repair was used only in Girder 4 repair 4.3L. Epoxy bonding agent did not seem practical to use in this repair due to its large surface area, shallow depth, and inconvenient location. Placing a layer of epoxy coating and then speedily installing and securing the formwork would have been difficult because this repair is directly on the bottom of the girder. No exposed reinforcement was available to anchor the repair concrete, so post-installed anchors were necessary. MNL-137 suggests anchoring concrete repairs that are located above traffic to reinforcement.⁽¹⁾ However, the location of this repair region was heavily congested with a full row of prestressed strands on the bottom of the flange. This left little to no access for large reinforcement bars to be drilled and anchored into the girder safely without hitting any of the prestressing strands. Instead of the larger bars, stainless steel Tapcon and 12-gauge galvanized wire were placed in an approximate 6-in. × 4-in. grid. Three rows of eight Tapcon were installed, with at least 1 inch of depth. The girder was required to be lifted off the ground to install these anchors. Figure 55 shows the process of installing the Tapcon with an impact driver.

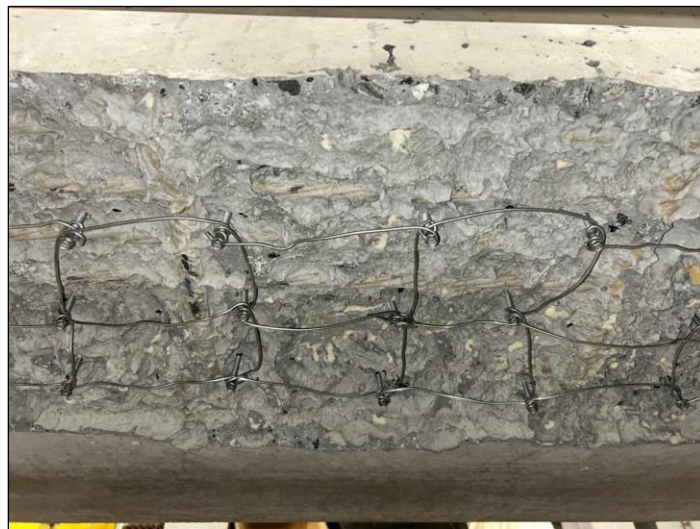
Figure 56. Photo. Stainless steel Tapcon and galvanized wire grid.

Similar to the Method 1 bottom flange repairs, some anchors that did not anchor in tightly enough were removed and replaced with a new anchor. After all the anchors were secured, 12-gauge galvanized wire was coiled around each Tapcon, forming a grid (see figure 56). A pair of pliers was helpful in this process.

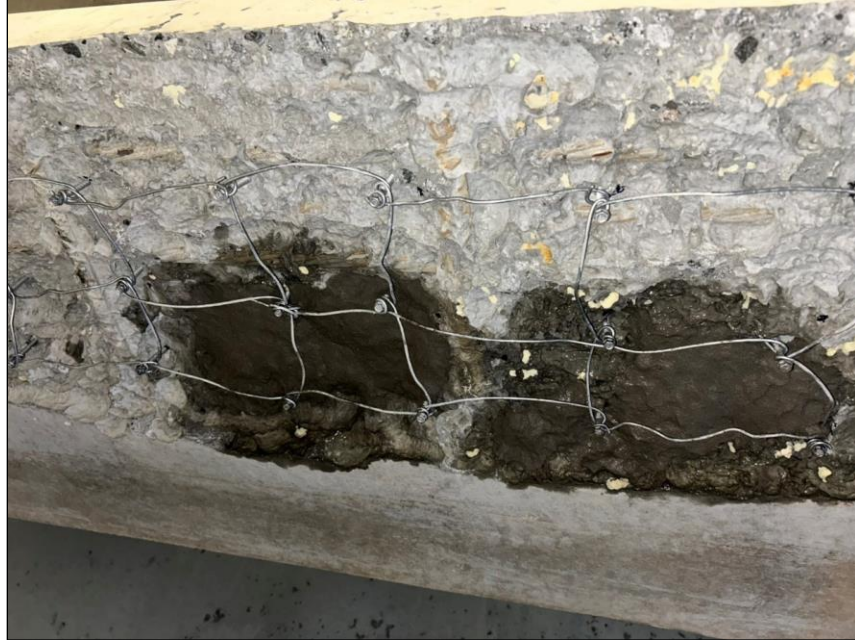
Figure 57. Photo. SikaEmaco 425 Gel Patch non-sag concrete repair mortar on repair 4.3LBF.

Aside from SCC, a small trial of SikaEmaco 425 Gel Patch mortar was performed on repair 4.3LBF. This quick-setting non-sag concrete repair mortar was mixed according to the manufacturer's instructions and placed in small (maximum 2-in.) lifts onto the overhead repair. The surface of the concrete repair was dampened with a spray bottle to help the mortar adhere. However, upon placing the mortar, it would slowly detach from the overhead surface. To mitigate this, thinner 1-in. patty-like lifts were placed. These smaller lifts needed to be thoroughly molded into the crevices of the overhead surface to prevent them from detaching and falling. With a workability of only 20–30 min, it was difficult to fill a decent portion of the repair. Therefore, only a small section of repair 4.3LBF contained this type of concrete repair mortar (see figure 57).

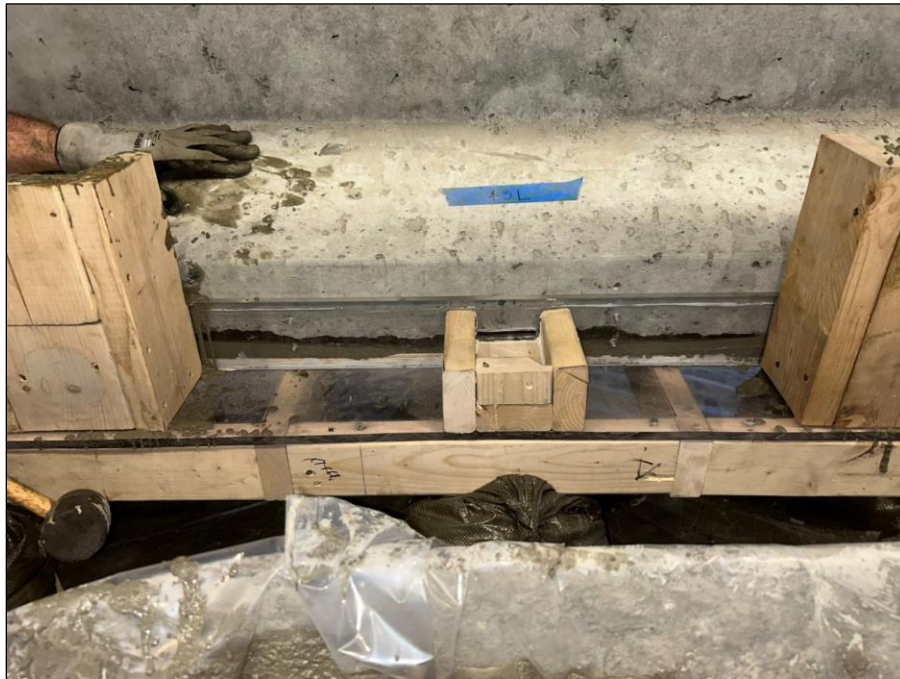
Figure 58. Photo. Repair 4.3LBF during concrete casting.

The remaining void on repair 4.3LBF was filled with SCC. The formwork consisted of two chimneys to pour concrete into due to the large size of the repair. The one air vent for this repair was located on the midspan of the repair. The casting procedure was the same as the previous bottom flange repairs, except no epoxy bonding agent was applied. A rubber mallet was used to help spread the concrete throughout the void. Figure 58 shows repair 4.3LBF during the concrete casting.

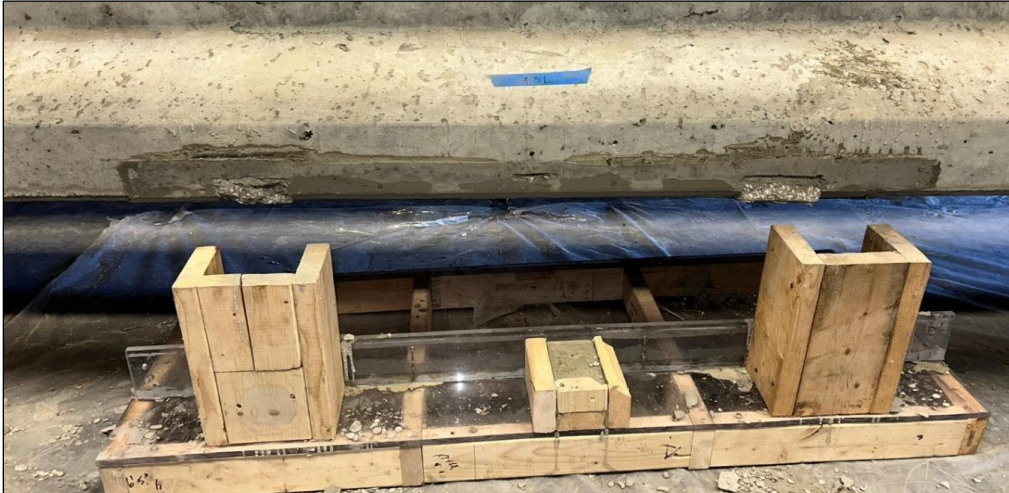
Figure 59. Photo. Repair 4.3LBF after demolding.

was removed the next day. Once again, hammers and extra force were needed to remove these forms due to the extra concrete held in the chimneys. Figure 59 shows repair 4.3LBF after demolding.

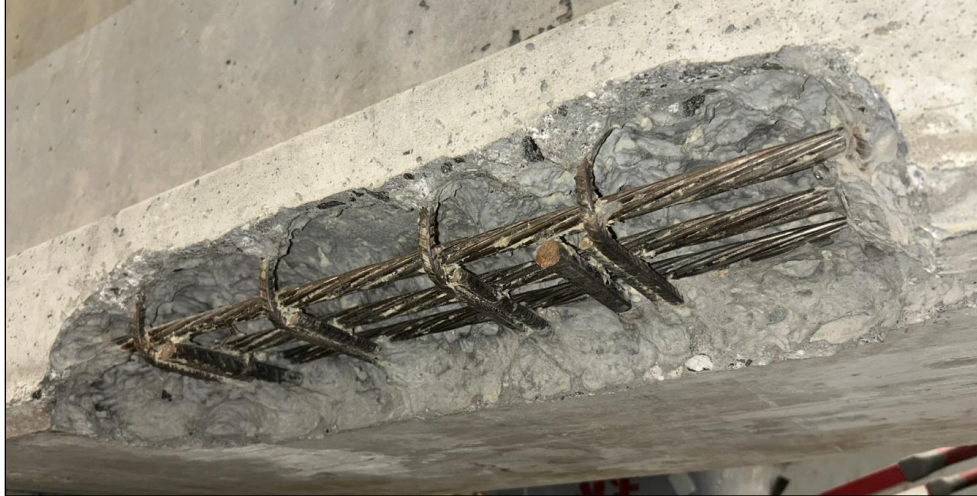
Figure 60. Photo. Repair 4.2RBZ with rebar congestion.

The fourth type of bottom flange repair used no post-installed anchors and no epoxy bonding agent. This type of repair was implemented in repair areas where heavy congestion did not allow any installation of anchors or bonding agents, notably the end zones of the girders and also on strand retensioning repair areas and bearing zone areas, which are discussed in later sections. Repair 4.2RBZ on Girder 4 is shown in figure 60.

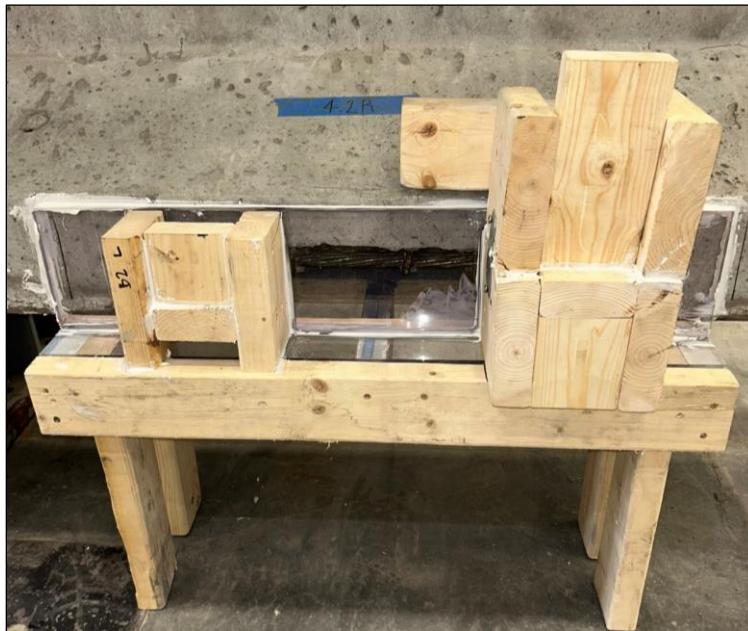
Figure 61. Photo. Formwork with one chimney for repair 4.2RBZ.

Because repair 4.2RBZ had no access point from above, the chimney method was used to fill this repair. The formwork was the same as in the previous repairs, but it only had one chimney and one air vent due to the smaller size of the repair (see figure 61).

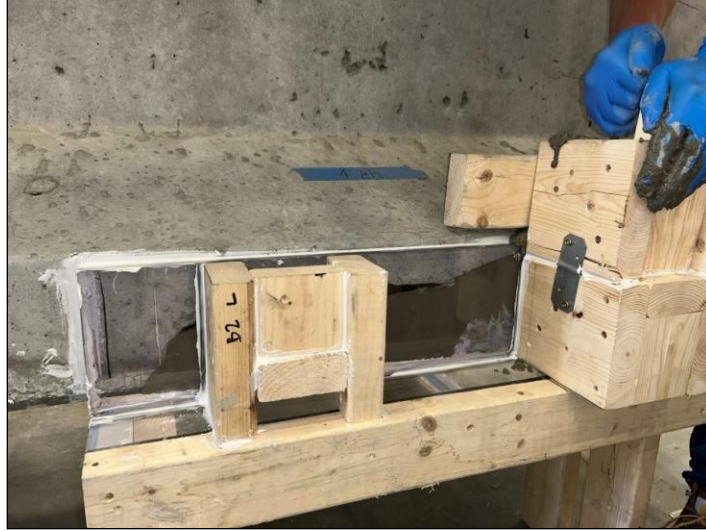
Figure 62. Photo. SCC flowing through the chimney formwork in repair 4.2RBZ.

After the formwork was placed and the edges were caulked, the SCC was poured. This repair again demonstrated the usefulness of having the clear polycarbonate formwork to visually confirm the success of the SCC placement (see figure 62). Pouring continued until concrete flowed out of the air vent slot. Sandbags were placed to keep the formwork stable (see figure 63).

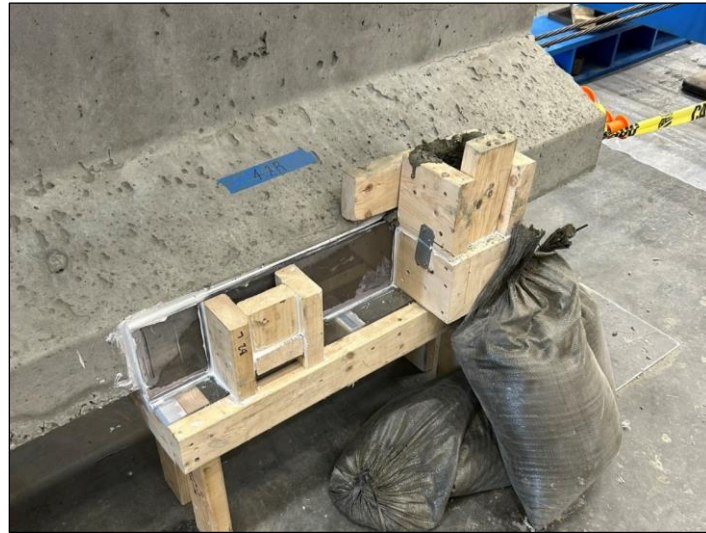
Figure 63. Photo. Sandbags keeping the formwork stable after SCC replacement of the repair void.

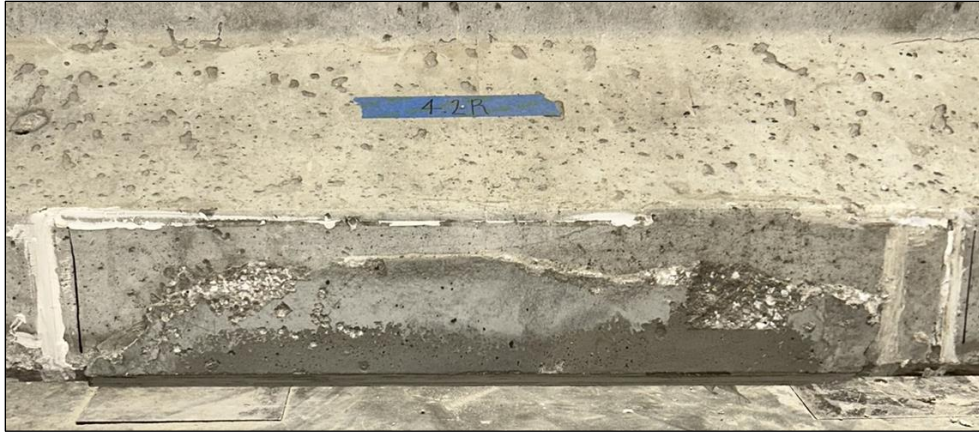
Figure 64. Photo. Repair 4.2RBZ after demolding.

No burlap or plastic sheeting was used to cover the chimney hole. The formwork was removed the next day with the help of hammers. Figure 64 shows the result of this repair after demolding.

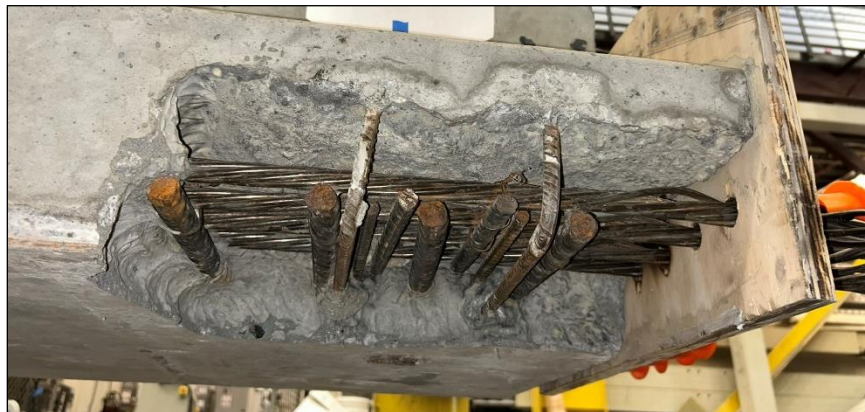
Figure 65. Photo. A nonconformity in the transfer region of Girder 1 before repair.

Nonconformities in the transfer region were simulated in two girders. Figure 65 and figure 66 show a nonconformity impacting four bottom strands in Girder 1 before and after repair, respectively.

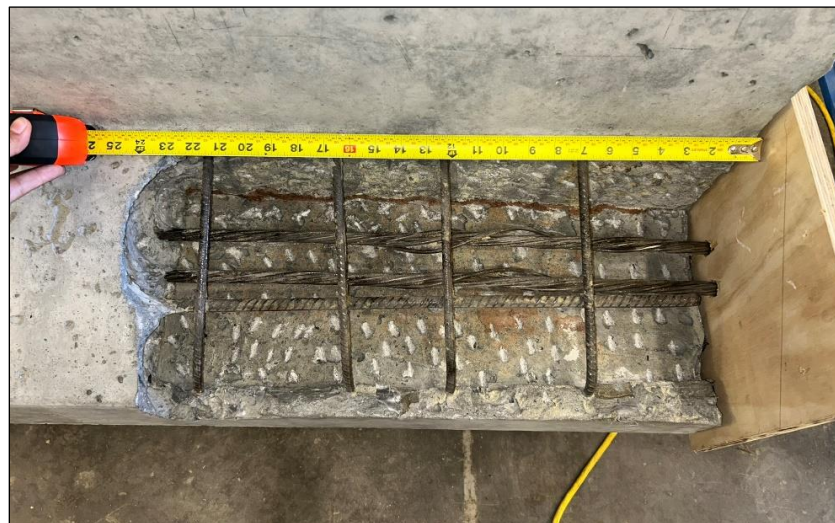
Figure 67. Photo. A nonconformity in the transfer region of Girder 4 before repair.

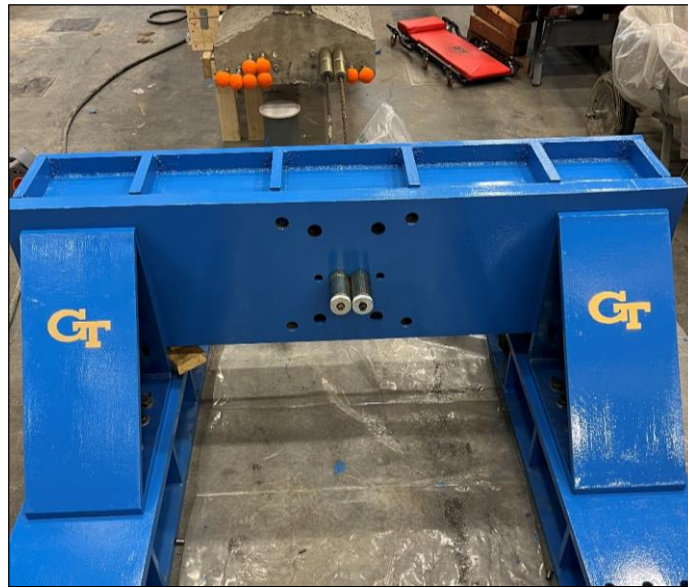
Figure 69. Photo. Dead end abutment anchored to the strong floor.

The dead end of the girder was anchored in place with an abutment bolted to the strong floor (see figure 69). The girder end was placed as close as possible to the abutment to reduce the length of strand between the end of the girder and the abutment. This would help limit stretch in the strands and girder movement on its supports toward the live end. Strand stretching on the dead end proved to be a challenge when retensioning the strands.

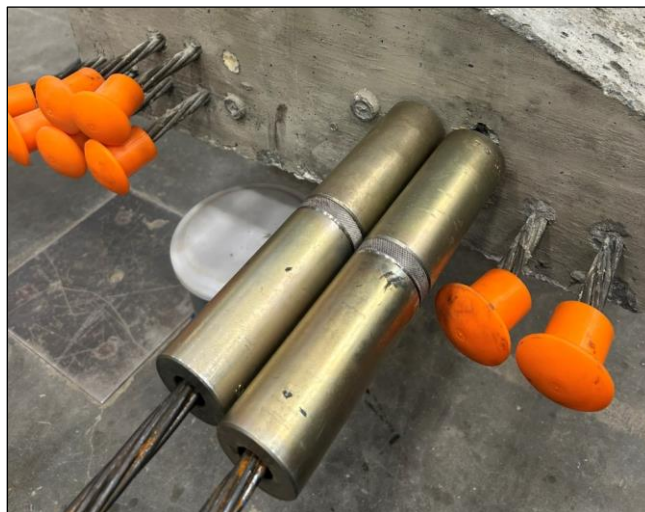
Figure 70. Photo. Splice chucks used to extend strands through the abutment.

Strands on the dead end passed through the abutment and were locked in place using strand chucks. At the time of initial detensioning in the precast plant, some of the strands “birdcaged” and could not be used further without trimming off the expanded section and using a splice chuck to connect another section of undamaged strand (see figure 70). The splice chucks were provided by General Technologies, Incorporated.

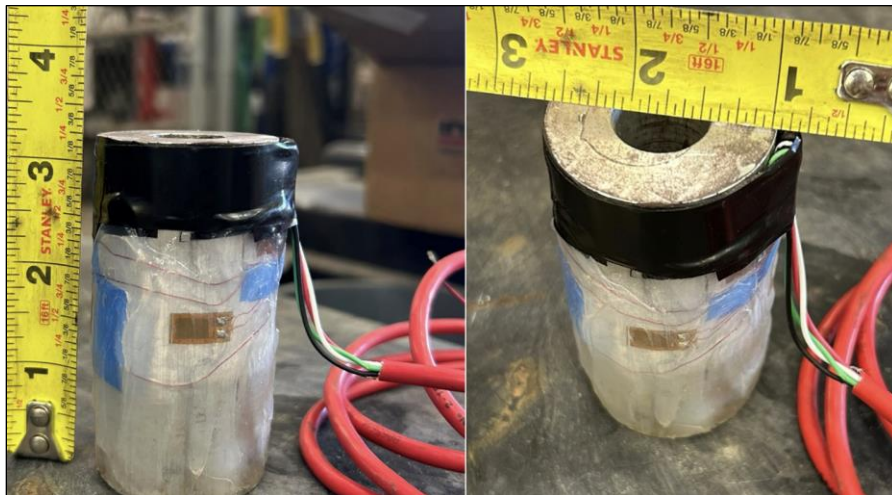
Figure 71. Photo. Load cells.

The live end was prepared in a similar manner; splice chucks were used to attach an additional length of strand such that the strand could be passed through the abutment, a load cell, strand chuck, center hole jack, and final strand chuck. The load cells were manufactured to record tension in the strands (see figure 71). The load cells were aluminum cylinders of 1.75 in. diameter and 3.50 in. length, with a center hole of 0.75 in. diameter. The Micro-Measurements CEA-13-250UWA-350 strain gauges were applied to the surface of the cylinders in a full bridge configuration. The load cells were calibrated on a Satec Systems 67-kip capacity compression testing machine by recording strains at given loads, plotting a graph, and then determining an equation for the resulting line.

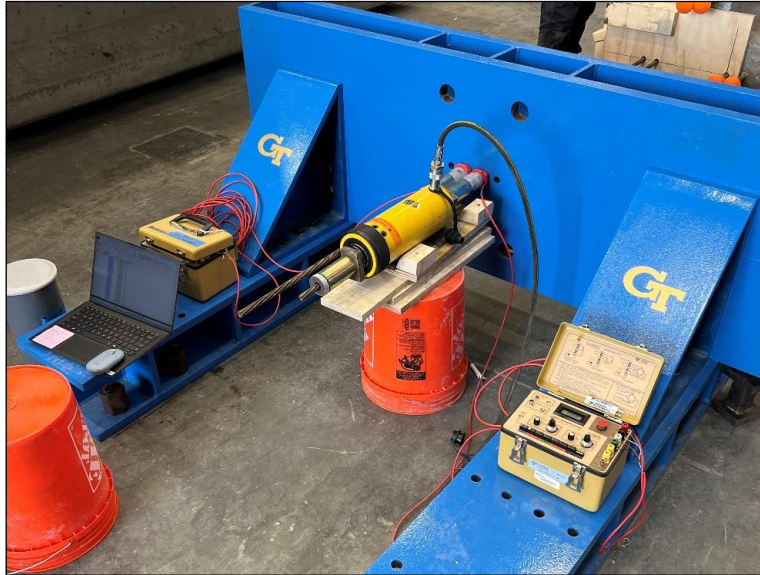
Figure 72. Photo. Live end configuration with load cells and a center hole jack.

The individual load cells were connected to a Vishay Measurements SB-10 switch and balance unit (SBU) such that multiple load cells could be monitored concurrently. The SBU was then connected to a Vishay Measurements P-3500 strain indicator from which strains were read and compared to the known calibration curve for each load cell. Figure 72 shows the setup on the live end of the girder with load cells connected to P-3500 strain indicators.

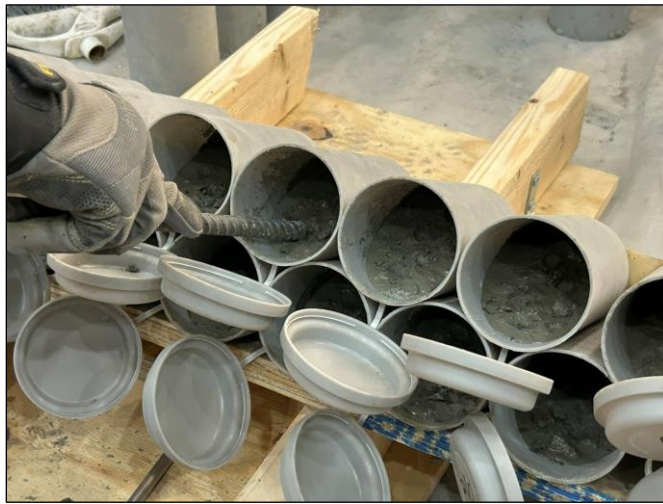
Figure 75. Photo. Roughening the surfaces of the bottom half slant shear cylinders, which were cast at a 30-degree angle.

bond the fresh SCC mix made to the girder concrete mix. The slant shear cylinders were cast following ASTM C882.⁽²⁰⁾ The bottom half of the cylinder was cast with top flange repair concrete batches because it best matched the strength of the existing girder concrete. These bottom halves were left to cure at a 30-degree angle on a custom wooden form. To match the 0.25-in. amplitude of the repair surface, the surface of these bottom half cylinders was roughened using a #4 piece of rebar (see figure 75).

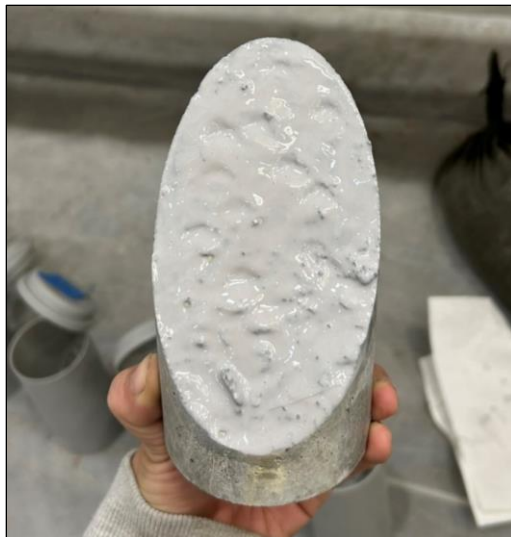
Figure 76. Photo. Sikadur-32 coat on angled surface of slant shear cylinders.

The bottom halves of these cylinders were left to cure in the fog room until a future SCC casting. The day before the SCC casting, 10 bottom half cylinders were taken out of the fog room to allow the surface to dry before applying the Sikadur-32 epoxy coat on half of these the next day. Before completing the top half of the cylinder with SCC mix, a coat of Sikadur-32 was brushed on the 30-degree angled surface of five of the slant shear cylinders (see figure 76).

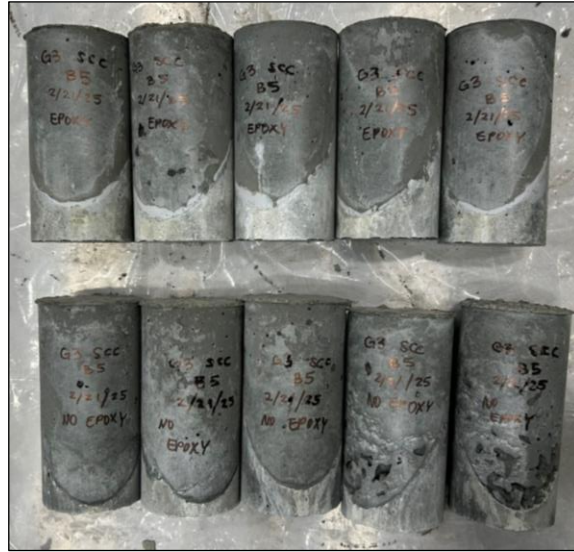
Figure 77. Photo. Demolded slant shear cylinders.

Only 5 of the 10 slant shear cylinder bottoms had a Sikadur-32 layer. Thus, results from slant shear tests with epoxy and without epoxy could be compared to see which performs best. The bottom half of the cylinder was then placed back into a 3-in. \times 6-in. cylinder mold. After approximately 92 days, the mold was filled with the SCC repair mix to complete the full cylinder. The slant shear cylinders were left to cure upright on a level surface upon completion. After 1 day, the 10 specimens were demolded and placed in the fog room until the SCC reached 28-day strength (see figure 77). The slant shear cylinders were tested following ASTM C39.⁽¹⁶⁾

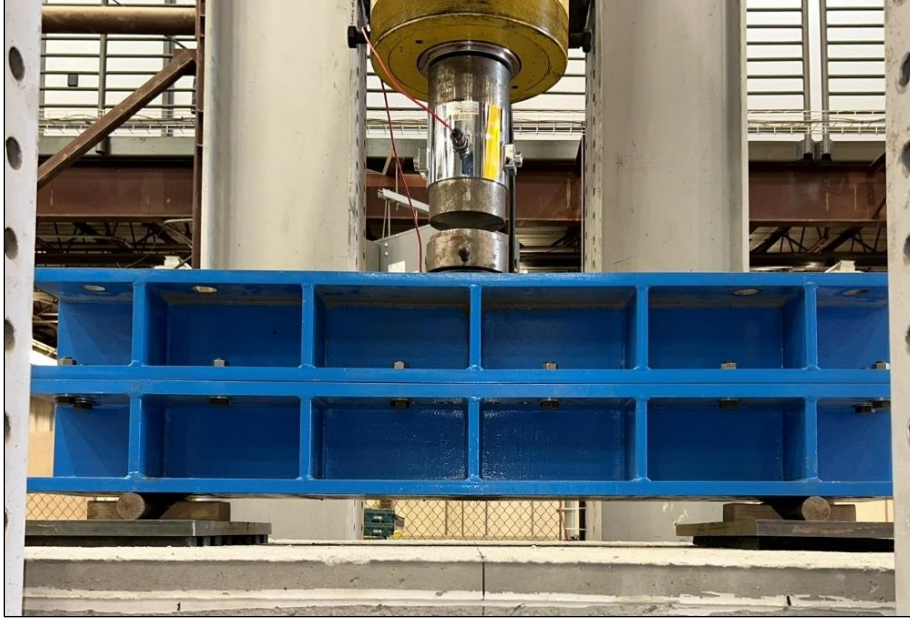
Figure 78. Photo. General spreader girder configuration.

Each girder was placed into the testing frame via a crane and a roller. A spreader girder was used to transfer load from the actuator to the girder specimen. The spreader girder was chosen to conduct three- and four-point testing. Rollers 12 in. long \times 2 in. diameter were placed 4 ft apart to support the spreader girder, with a 12-in. \times 24-in. steel plate under each roller and an elastomeric rubber pad between the steel plate and the girder top surface. An overall view of the spreader girder is shown in figure 78.

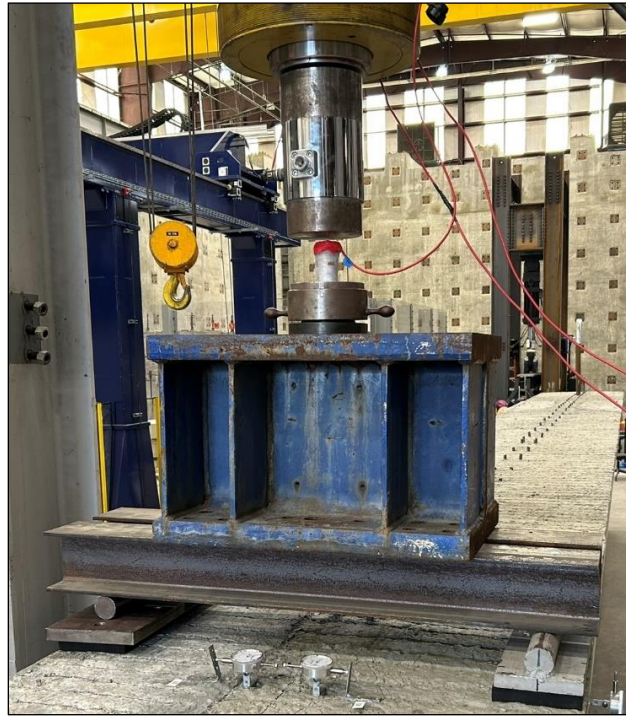
Figure 80. Photo. Top flange test setup.

The top flange test setup consisted of two 46-in.-long W5 × 16 steel shapes spanning across the top flanges with pin and roller supports, which rested on elastomeric bearing pads. The pins for the pin and roller were 2 in. in diameter, resting on a 1-in. plate and 1-in. bearing

pads. The two $W5 \times 16$ shapes were spaced 7 in. apart. On top of the two girders was a 16-in.-deep steel blue pedestal girder to transfer the force from the actuator to the girders. The pin and roller pin supports were centered 3 in. from the edges of the top flange.

For the top flange tests (Tests 1.2.F, 1.3.F, and 1.4.F), a new setup was used (see figure 80).

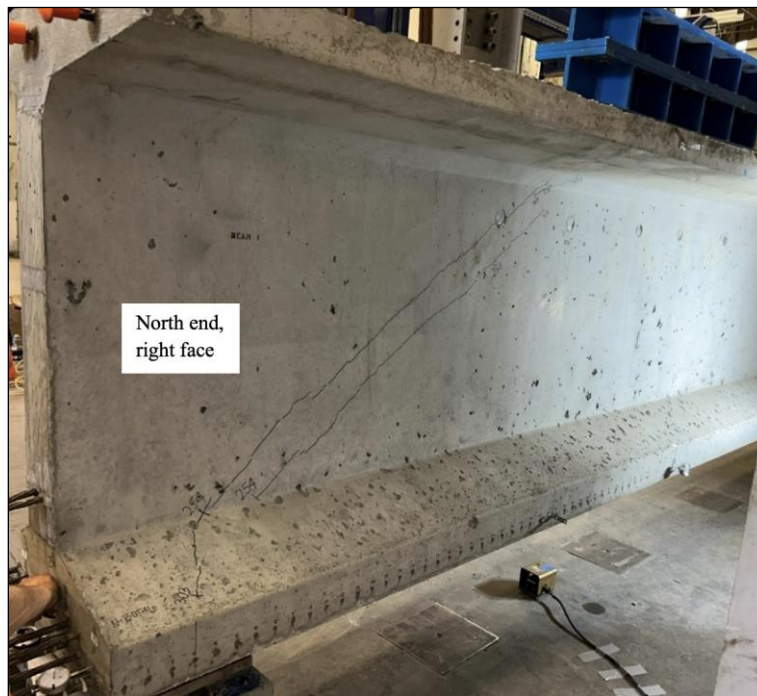
Figure 83. Photo. Test 1.1.S (repair 1.1LBZ) initial shear cracks on the original, nonrepaired girder side (right face of girder pictured). Note that the diagonal cracks orient to a location over the center of the end support.

For each load step, when the load was reached, the pump valves were closed and a brief pause was taken for safety reasons prior to collecting gauge readings. The first diagonal shear cracks occurred at 254 kip (see figure 82 and figure 83). The shear crack width measured 0.00394–0.00591 in. The strut width was 5 in, and the strut angle was between 34 and 35 degrees. Gauge readings were recorded, and no damage was seen in repair 1.1LBZ.

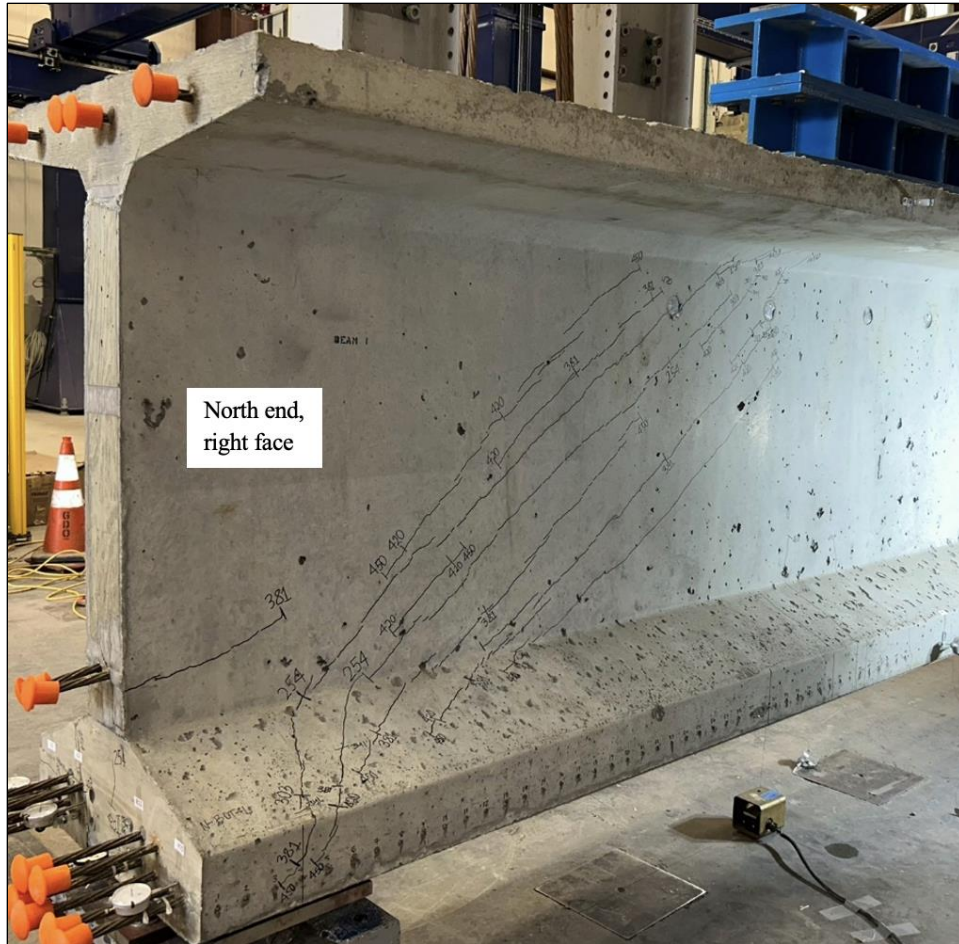
Figure 87. Photo. Test 1.1.S (repair 1.1LBZ) overall crack pattern on original, nonrepaired girder side at 450 kip (right face of girder pictured).

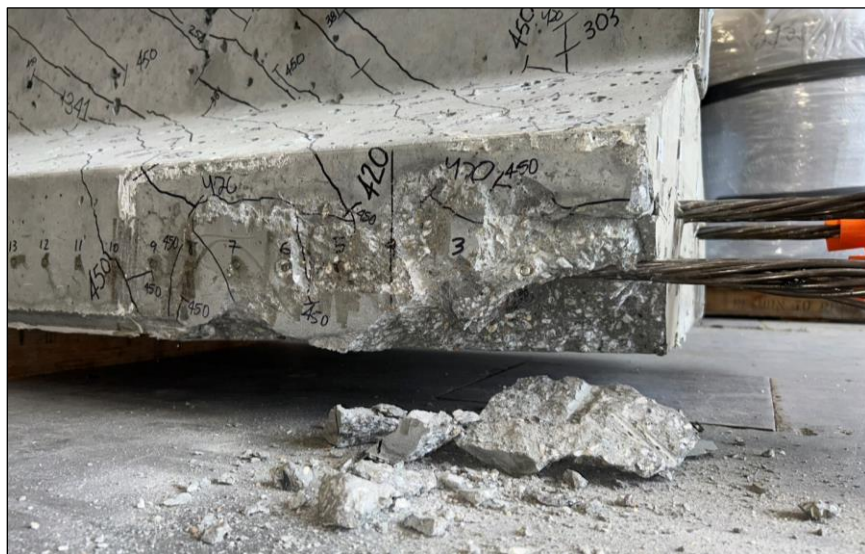
Figure 88. Photo. Test 1.1.S (repair 1.1LBZ) residual strength test using a sledgehammer.

An overall crack pattern from this shear test is shown in figure 86 and figure 87. A residual strength test was done on repair 1.1LBZ. A 16-lb sledgehammer was used to strike the repair approximately 10 times. The only damage observed was pieces of the repair breaking away. Figure 88 shows the aftermath of the residual strength test on repair 1.1LBZ.

Slight separation of the repair concrete from the original concrete is evident in the photos of the repairs at maximum loads and after residual testing (see figure 85 through figure 88), as cracks formed around the perimeter of the bearing zone repair. It is suspected that bond slip in strand LS2 was exacerbated due to being at the border of the repair.

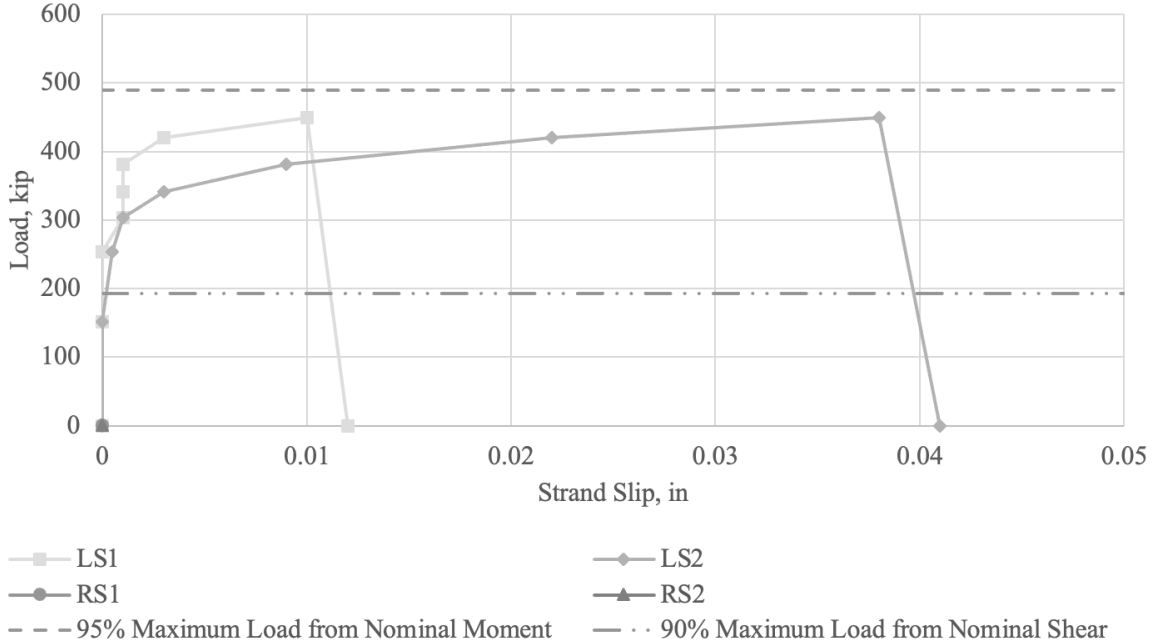
Figure 91. Graph. Test 1.1.S (repair 1.1LBZ) load-strand slip plot.

maximum. As repair 1.1LBZ detached from the girder, additional strand slip was induced, resulting in a loss of stress in the strand at maximum load.

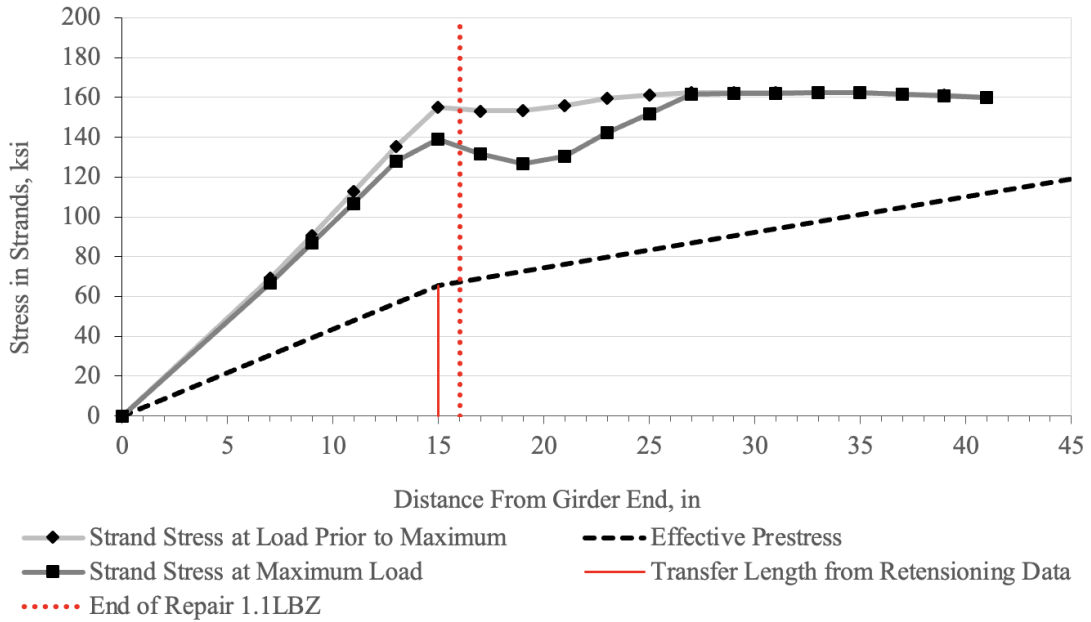
Figure 92. Graph. Test 1.1.S (repair 1.1LBZ) CSS plot: Strand stress vs. distance from girder end.

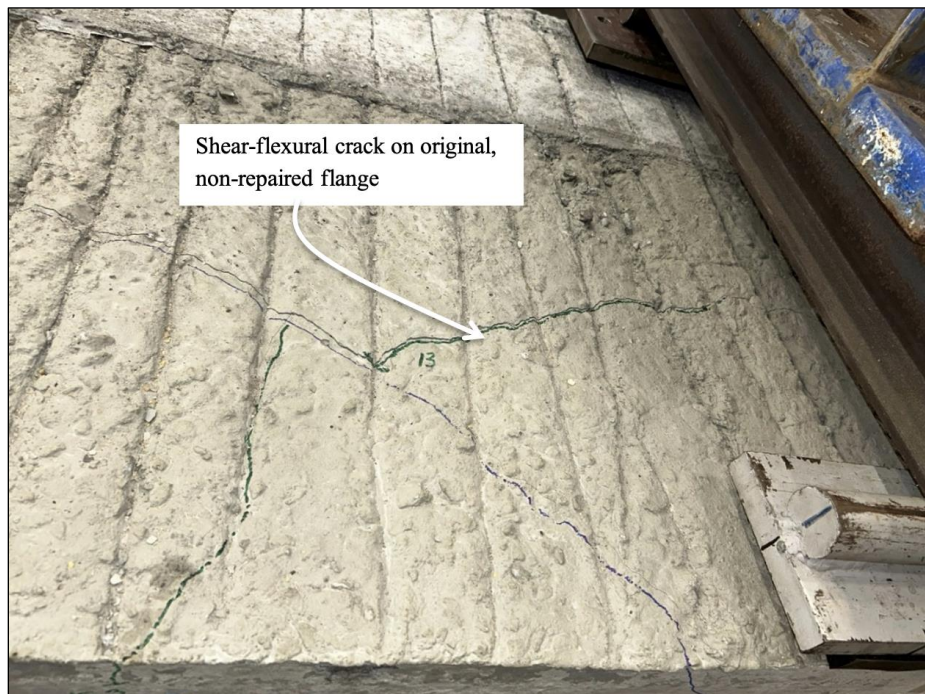
Figure 99. Photo. Test 1.3.F (repair 1.2LTF) shear-flexural cracks at 13.5 kip (right face of girder pictured, north end).

During the loading process, after a load is stopped and the valves are shut on the manual hydraulic pump, the pressure decreases, and the load drops each time. In this test, no cracks were seen in the 5-, 10-, or 15-kip load increments. After loading to 15 kip, the pressure dropped the load to 10 kip. Loading was started again to attempt to load the top flanges to the next interval of 20 kip; however, the original top flange cracked at 13.5 kip while reloading. The crack width was 0.0197–0.0236 in. The shear-flexural cracks are shown in figure 98 and figure 99.

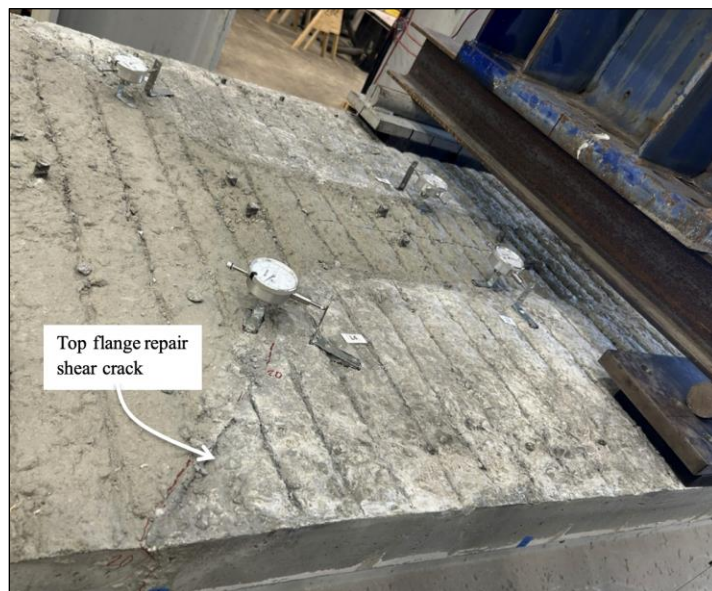
Figure 105. Photo. Test 1.4.F (repair 1.3RTF, 1.3LTF) top flange shear cracks at 20 kip (left face of girder pictured).

The load was then increased to 20 kip. The previous right-side face crack remained the same, and the L2 crack increased to 0.00984 in. wide. Cracks near the R4 gauge and near the L4 gauge were seen, both measuring 0.00394 in. Figure 105 shows the initial L4 crack.

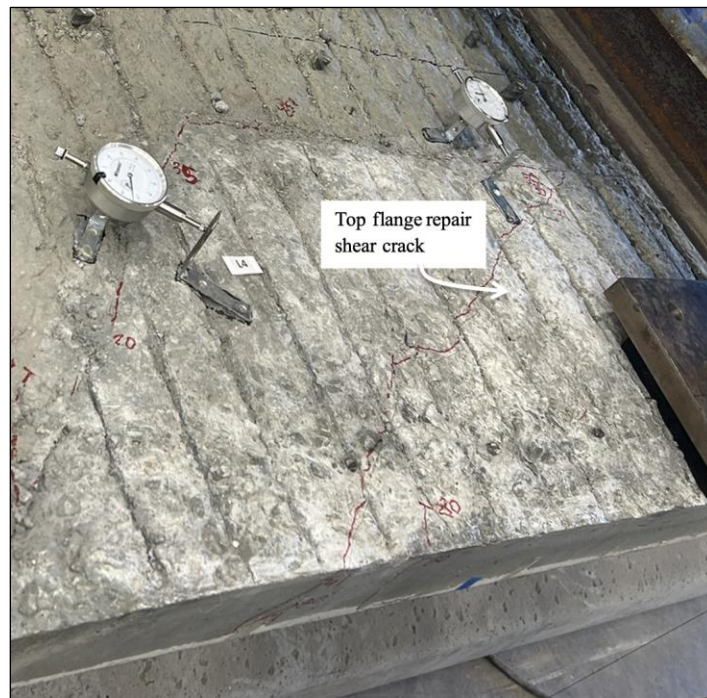
Figure 106. Photo. Test 1.4.F (repair 1.3RTF, 1.3LTF) top flange shear crack on repair 1.3LTF.

The load was then increased to 71 kip. Punching shear cracks formed on both repairs, appearing to propagate from the top flange test setup supports. These two cracks measured 0.00984 in. wide. The left flexural crack measured 0.0177 in., the right-side face crack now measured 0.0177 in., and the L2 crack measured 0.0118 in. The other cracks remained the same in width. The punching shear crack on the left side repair is shown in figure 106.

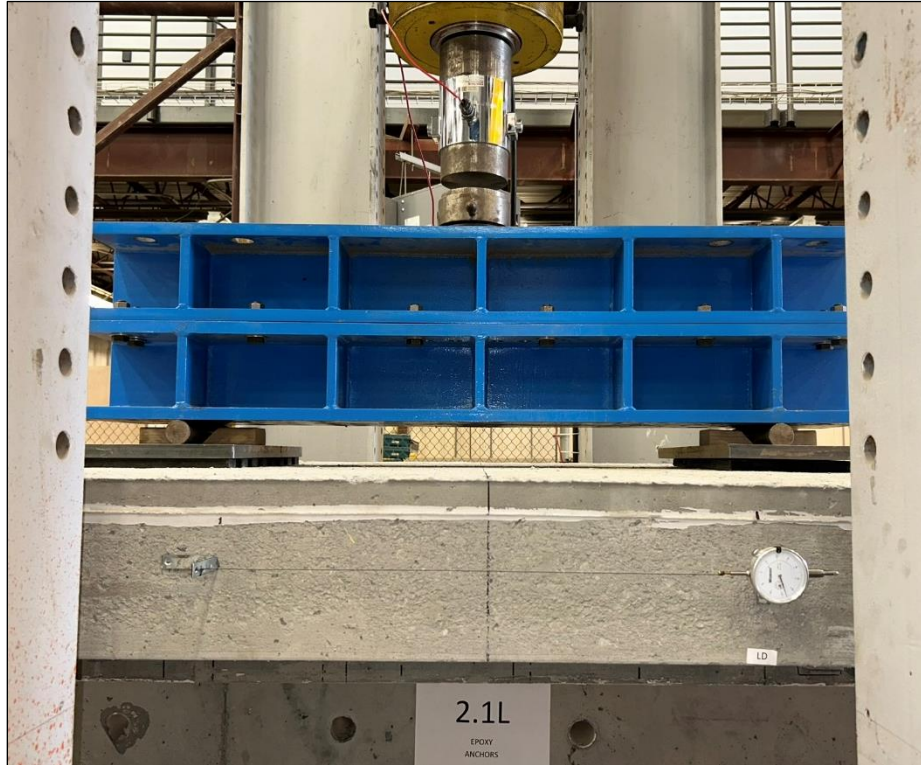
Figure 108. Photo. Test 2.1.S (repair 2.1RTF, 2.1LTF) spreader beam with two rollers spaced 4 ft apart and 51 in. long.

used in a four-point bending test configuration, where the “point” loads were spaced 4 ft apart to match the AASHTO HS-93 truck load wheel spacing (see figure 108).

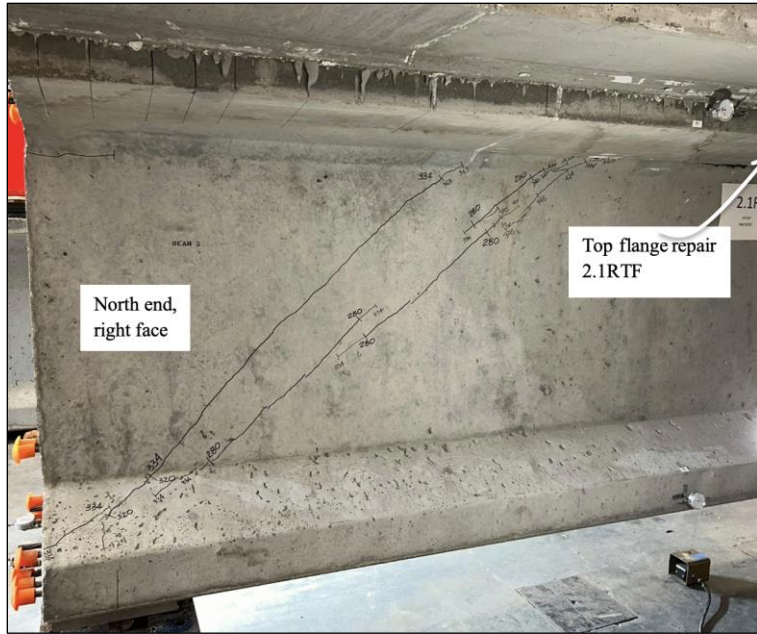
Figure 109. Photo. Test 2.1.S (repair 2.1RTF, 2.1LTF) shear cracks to the left of repair 2.1RTF (right face of girder pictured).

The load was applied in steps. When either the desired load was reached or a significant crack developed, the pump valves were closed and a brief pause was taken prior to collecting gauge readings. Cracking was first heard and observed at a load of 280 kip. The crack angle was between 35 and 36 degrees from the horizontal. The strut configuration matches that discussed in the commentary for AASHTO Section 5.6.3 Strut-and-Tie Method.⁽²³⁾ The apparent width of the compression strut narrowed as the strut approached the bulb. Gauge readings were recorded, and no damage was seen in repairs 2.1RTF or 2.1LTF, nor in any other top flange repairs on the girder. Shear cracks are shown in figure 109 and figure 110, and end cracking in figure 111.

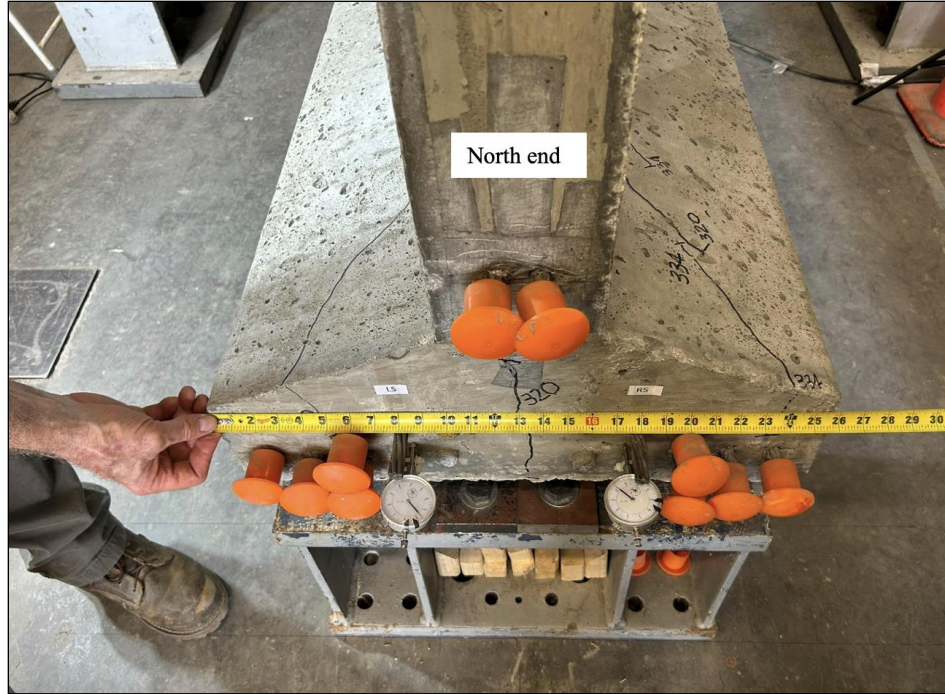
Figure 111. Photo. Test 2.1.S (repair 2.1RTF, 2.1LTF) north end cross-section cracks extending past center of bearing, prompting strand slip failure.
