GEORGIA DOT RESEARCH PROJECT 21-04

**PRAGMATIC PRECAST/PRESTRESSED
GIRDER ACCEPTANCE CRITERIA**

July 2025

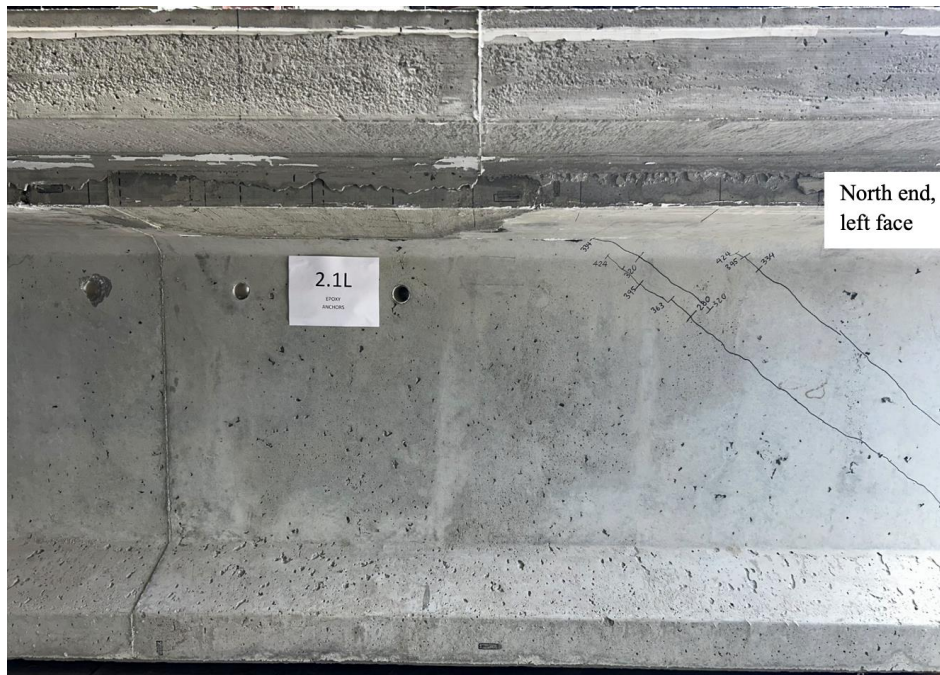
Figure 113. Photo. Test 2.1.S (repair 2.1RTF, 2.1LTF) final shear cracks not spreading to top flange repair 2.3LTF at 424 kip (left face of girder pictured).

Loading continued to the maximum load of 424 kip. The shear crack width now measured 0.0177 in. Strand slip measured 0.017 in., which was past the slip failure threshold of 0.01 in. Loading was stopped at this point due to strand slip failure and to not prematurely fail the girder before the other tests were conducted. The final shear crack pattern is shown in figure 112 and figure 113. No separation of the repair concrete from the original concrete occurred in any repair. No signs of cracking, debonding, interface shear, or failure in top flange repairs 2.1RTF and 2.1LTF were observed.

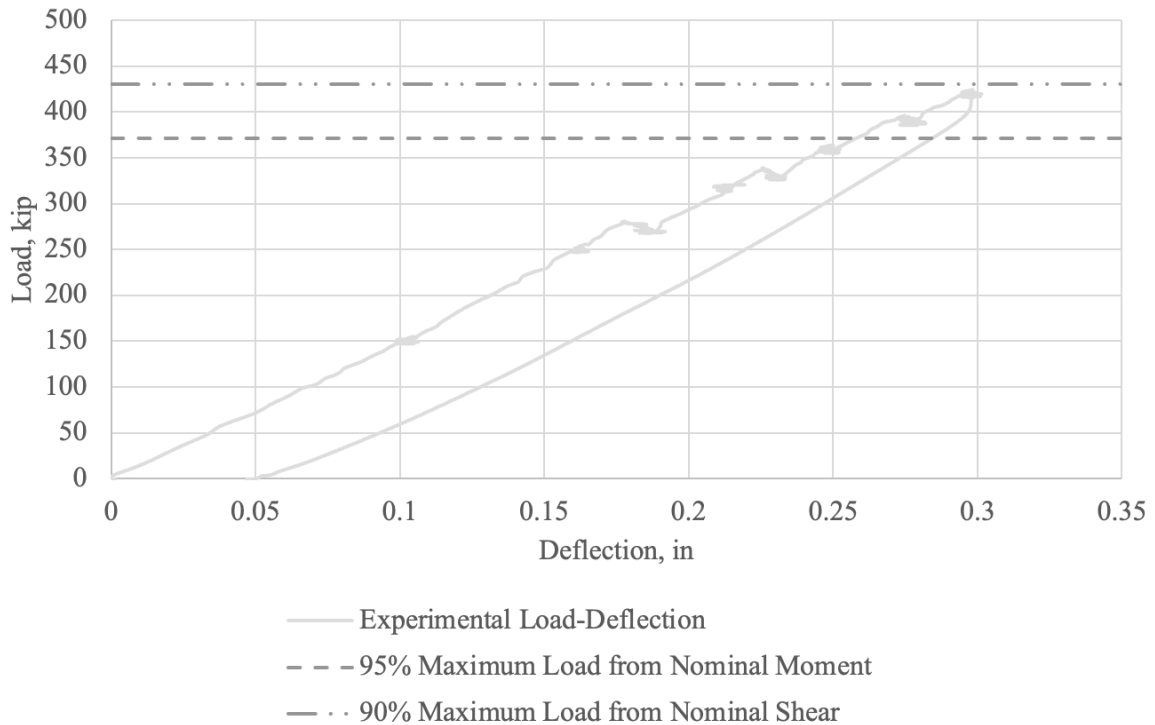
Figure 114. Graph. Test 2.1.S (repair 2.1RTF, 2.1LTF) load-deflection plot.

As seen in the load-deflection plot for Test 2.1.S (repair 2.1RTF, 2.1LTF) (see figure 114), the girder was tested past its elastic point (cracking), resulting in a nonlinear deformation after unloading due to the cracked girder section. The finding of this shear test was that the girder sustained a load within 89 percent of the maximum load based on the nominal shear capacity (the dashed-dotted line in figure 114). This suggests that top flange repairs 2.1RTF and 2.1LTF did not negatively impact the shear capacity of the nonconforming girder. The girder performed well past its service load conditions.

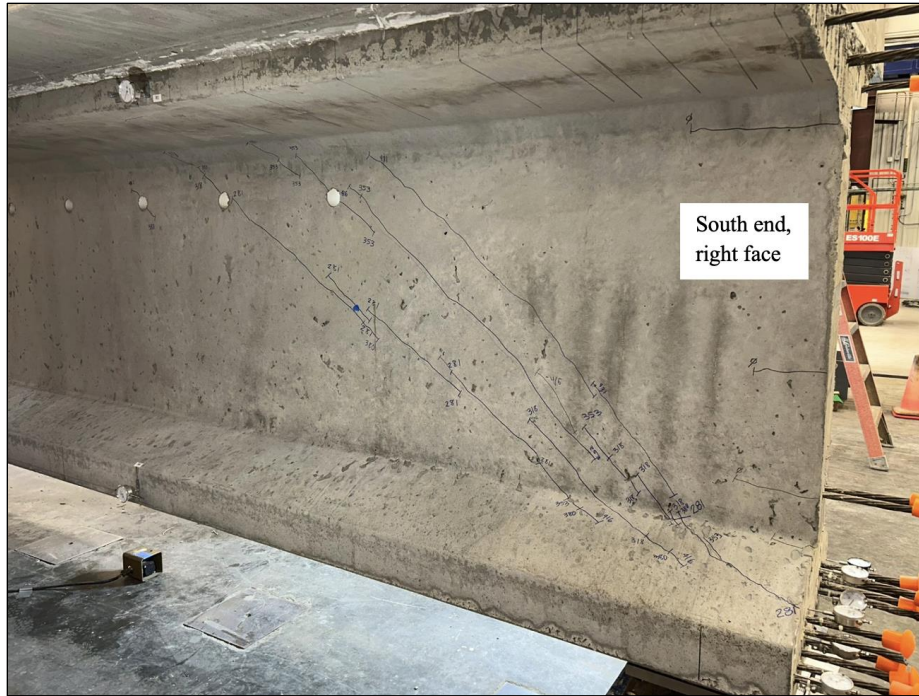
Figure 117. Photo. Test 2.2.S (repair 2.2LTF) initial shear cracks on original, nonrepaired face (right face of girder pictured).

As the girder was loaded in steps, the first shear cracks were seen and heard at a load of 281 kip (see figure 117 and figure 118), along with end zone cracking (see figure 119). The shear crack width measured 0.00591 in. The strut width was 10–10.5 in. The strut angle was between 29 and 33 degrees. Gauge readings were taken, and no damage was seen in repair 2.2LTF or any other top flange repairs.

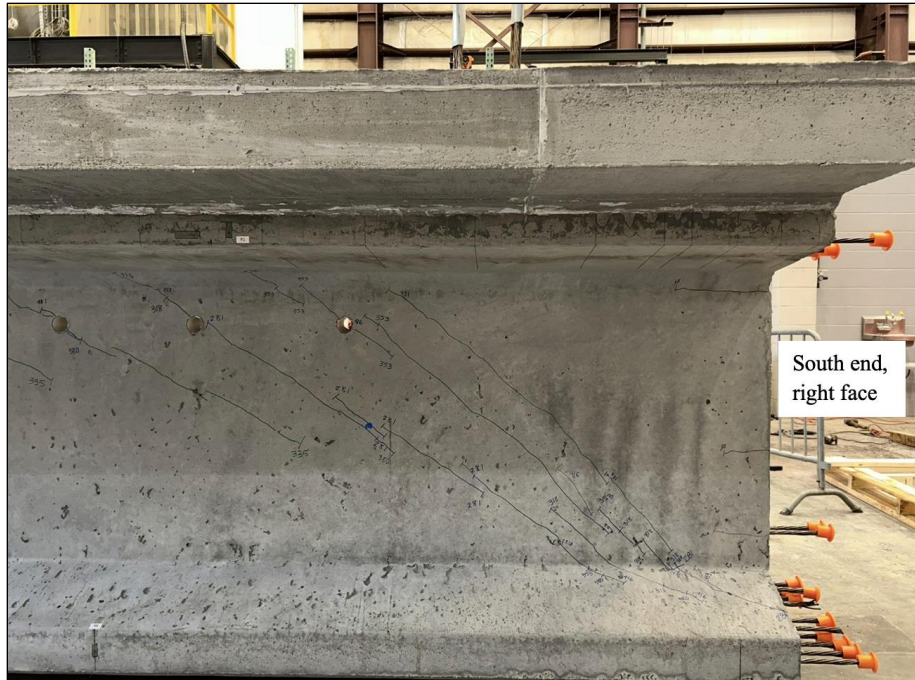
Figure 121. Photo. Test 2.2.S (repair 2.2LTF) final shear cracks on nonrepaired, original face at 424 kip (right face of girder pictured).

The final shear crack pattern of Test 2.2.S (repair 2.2LTF) is shown in figure 121 and figure 122. As these overall figures of the repairs at maximum loads show, no separation of the repair concrete from the original concrete occurred in any repair. Diagonal shear cracks were directed at the repair zone; yet, the authors observed no diagonal cracking at the edges of the BT-54 flange or in the cast-in-place deck. No signs of cracking, debonding, interface shear, or failure in top flange repair 2.2LTF were observed.

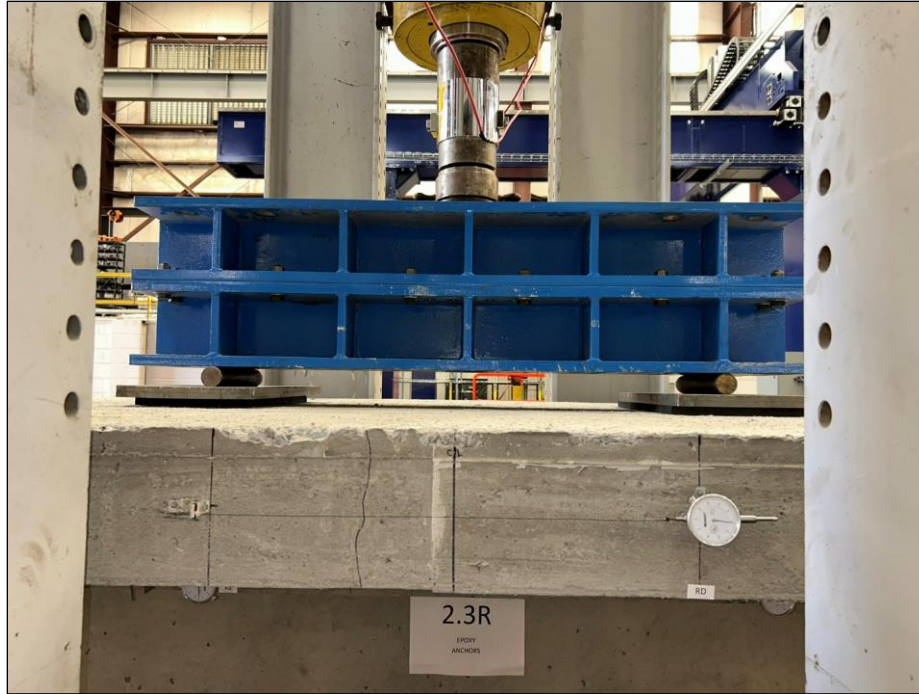
Figure 126. Photo. Test 2.3.F (repair 2.3LTF) spreader beam four-point bending configuration near midspan, simulating a two-axle truck load to create maximum tensile stress in the top flange.

The last test on Girder 2, Test 2.3.F, was a flexural, moment capacity test at midspan. This test was designed to observe the performance of top flange repair 2.3LTF by centering the load point over the repair and maximizing the tensile stress experienced by it. The load point location was 263 in. from the center of bearing of the south end of the girder. Theoretical calculations for Girder 2 can be found in appendix H. The girder supports were placed 7 in. from each end. The spreader beam was used in a four-point bending test configuration test (see figure 126). Dial gauges were placed on the bottom flange at the level of the bottom strands and 4 in. below the top of the deck to measure top and bottom strain to enable calculation of girder curvature.

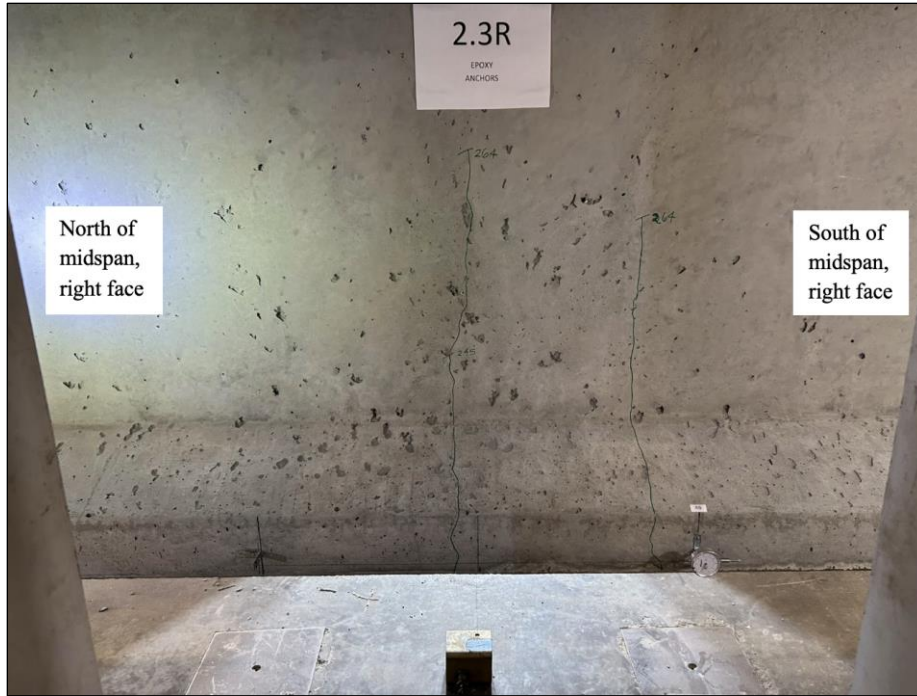
Figure 127. Photo. Test 2.3.F (repair 2.3LTF) flexural cracks at 264 kip (right face of girder pictured).

Flexural cracking in the bottom flange occurred at 245 kip, and Figure 127 shows the cracking at 264 kip. At a load of 335 kip, a new shear crack patterned around the tie-down transport holes, near the south end of the girder where the second test took place. Figure 128 and figure 129 show this shear crack pattern that occurred during the midspan loading of Girder 2.

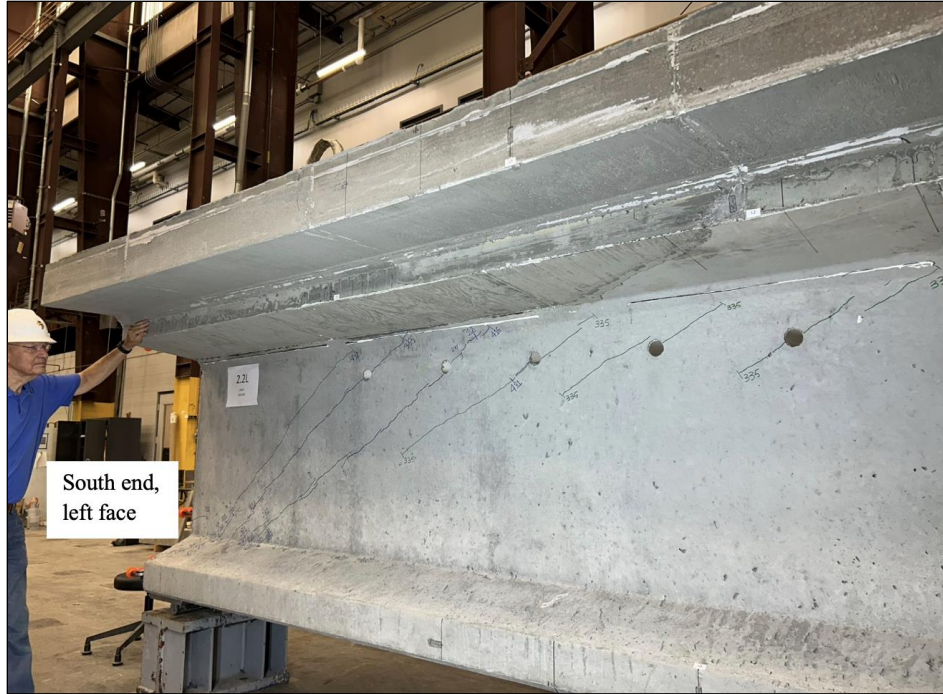
Figure 129. Photo. Test 2.3.F (repair 2.3LTF) shear cracks through tie-down holes toward the midspan of the girder at a 335-kip flexural load, repaired face with longest top flange repair of 126 in. (left face of girder pictured).

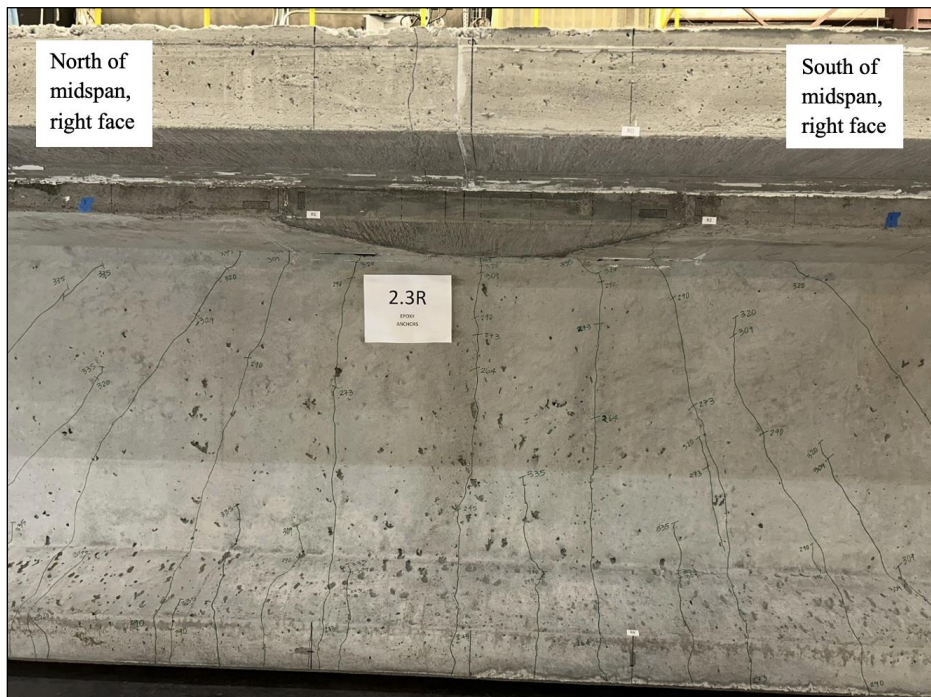
Figure 130. Photo. Test 2.3.F (repair 2.3LTF) final flexural and shear-flexural cracks on repaired face at 341 kip. Cracks did not extend into top flange repair 2.3RTF (right face of girder pictured).

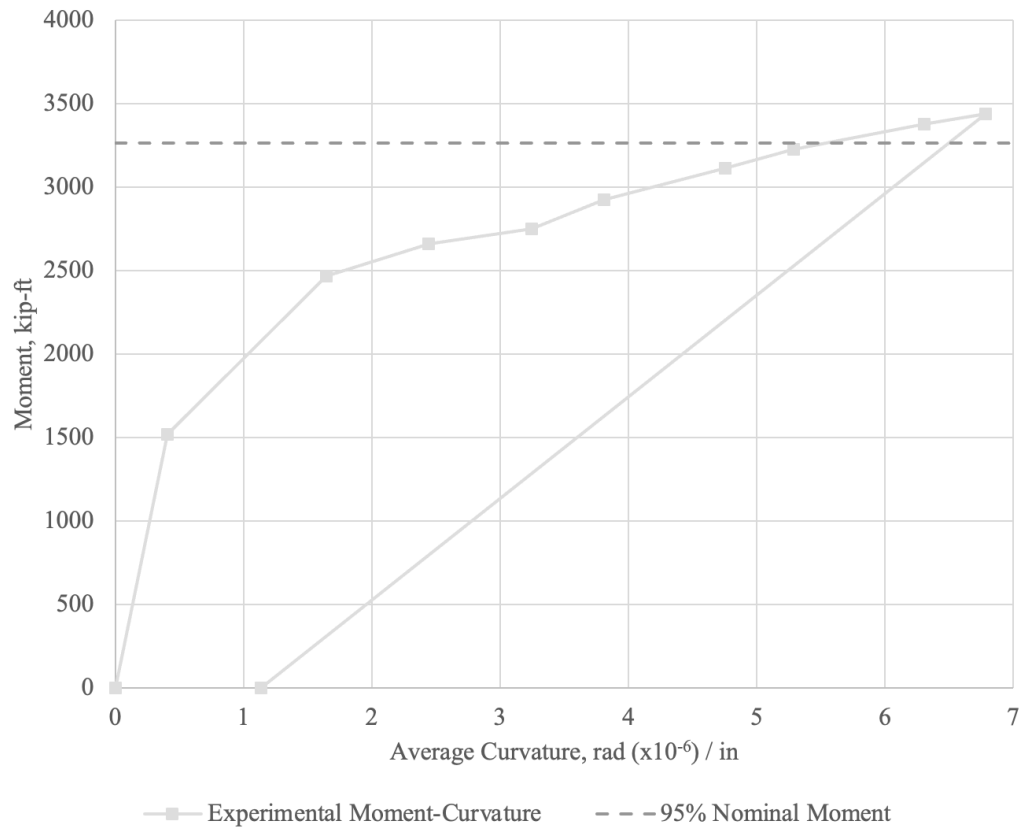
Figure 133. Graph. Test 2.3.F (repair 2.3LTF) moment-curvature plot.

The moment-curvature plot for Test 2.3.F (repair 2.3LTF) (see figure 133) shows the experimental values obtained from this test. Nonlinear behavior is exhibited after the girder cracked at approximately 2,470 kip-ft. Based on this plot, the repaired girder exceeded 95 percent of the nominal moment capacity. This suggests that top flange repair 2.3LTF did not negatively impact the capacity of the nonconforming girder.

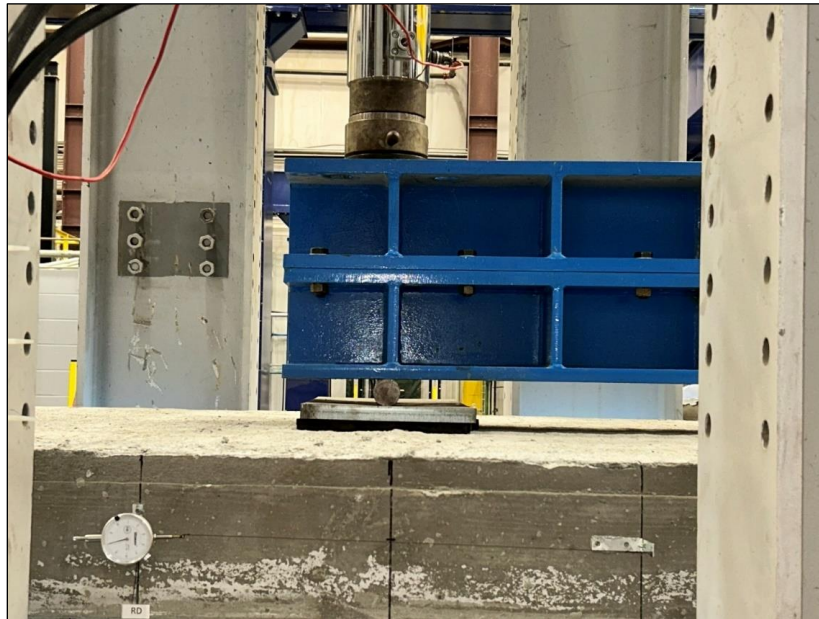
Figure 134. Photo. Test 3.1.S (repair 3.1RBF, 3.1LBF) spreader beam configuration with the hydraulic ram located directly above the load point closest to the north girder bearing.

The first test on Girder 3, Test 3.1.S, was designed to maximize the compression force in the diagonal strut to observe the performance of repairs 3.1RBF and 3.1LBF under this loading. The load point location was 94.75 in. from the center of bearing of the north end of the girder. This distance is referred to as “x1” in the appendix I calculations ($a/d = 1.55$). The spreader beam was used in a three-point bending test configuration, where only one end of the spreader beam was used to transfer load. This configuration also maintained the distance from the deck surface to the base of the load cell, alleviating the need to adjust the test setup. The spreader beam configuration for this test is shown in figure 134.

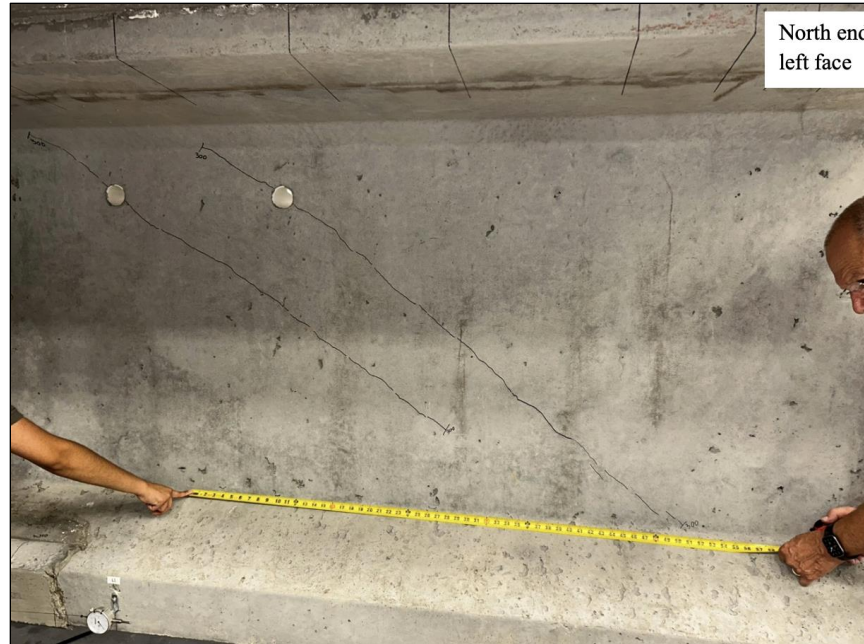
Figure 135. Photo. Test 3.1.S (repair 3.1RBF, 3.1LBF) initial shear cracks (left face of girder pictured).

Upon loading, two diagonal shear cracks were seen at a load of 300 kip. The shear crack width measured 0.00787 in. The strut width was between 9 and 11 in. The crack angles were between 37 and 40 degrees (see figure 135 and figure 136).

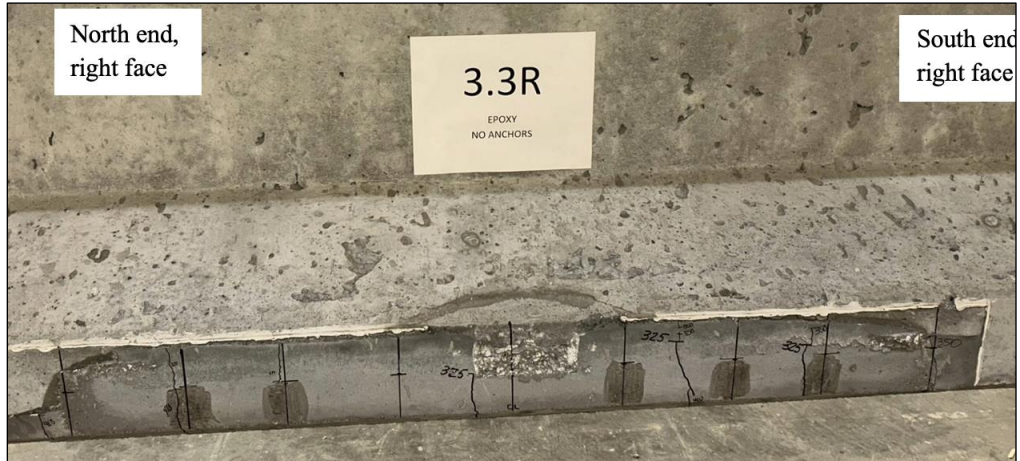
Figure 137. Photo. Test 3.1.S (repair 3.1RBF, 3.1LBF) flexural cracking on midspan repairs at 325 kip (right face of girder pictured).

Gauge readings were recorded, and flexural cracks were seen in repairs 3.3RTF and 3.3LTF at the quarter points. These cracks measured 0.00394–0.00591 in. wide. Flexural cracks occurred at a 325-kip load (see figure 137 and figure 138).

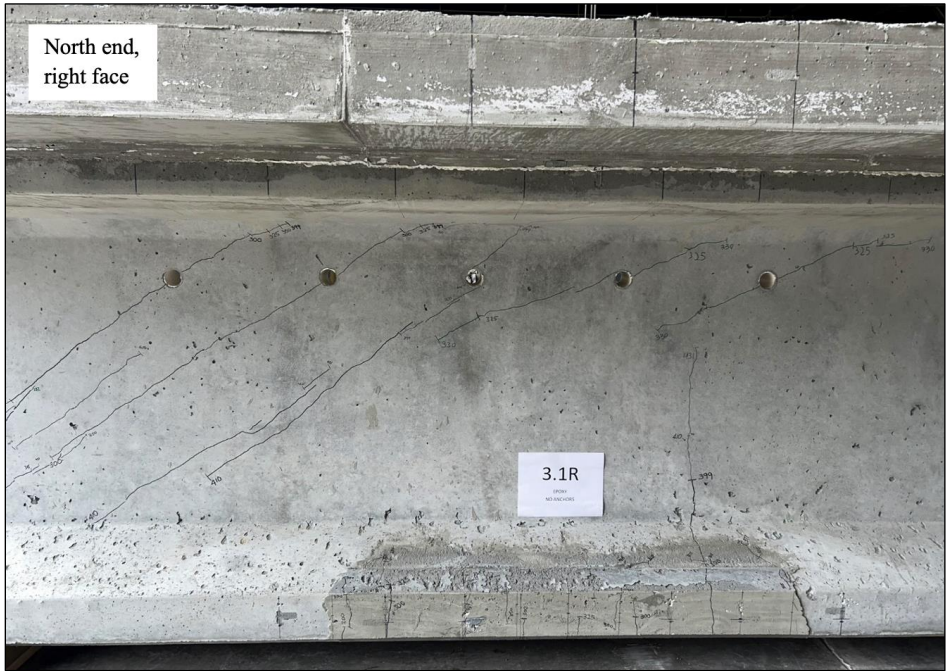
Figure 141. Photo. Test 3.1.S (repair 3.1RBF, 3.1LBF) final crack pattern at 431 kip (right face of girder pictured).

The final crack pattern is shown in figure 141 and figure 142. As these overall figures of the repairs at maximum loads show, no separation of the repair concrete from the original concrete occurred in any repair even though significant cracking occurred in the repair. Crack widths were uniform through the lengths of the repairs, showing that there was no debonding of the prestressing strand. No signs of interface shear cracking or failure of the bottom flange repairs 3.1RBF and 3.1LBF were observed.

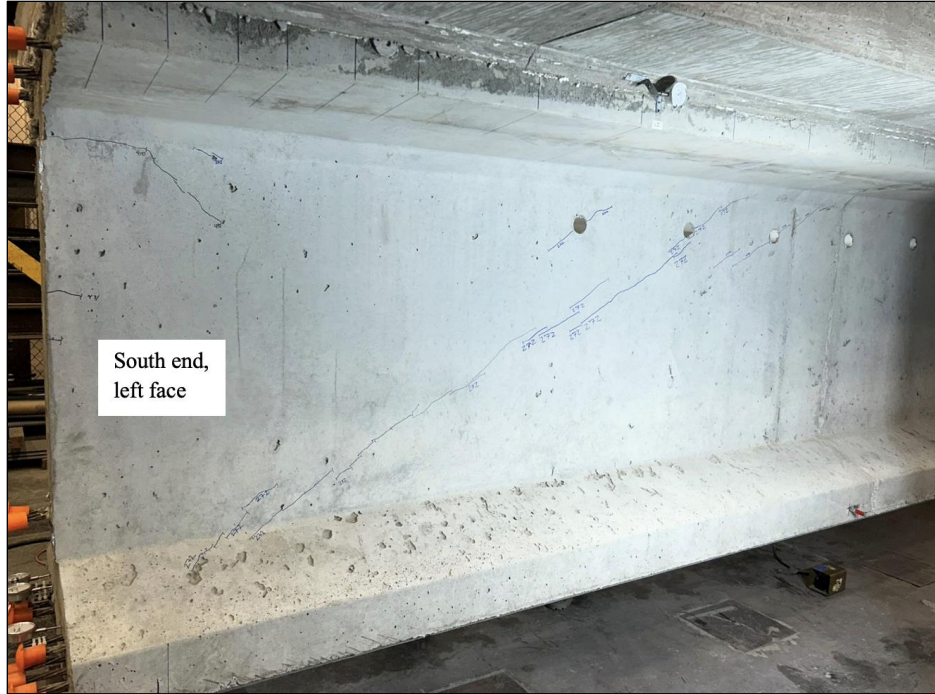
Figure 147. Photo. Test 3.2.S (repair 3.2RBF) initial shear cracks on nonrepaired, original girder face at 272 kip (left face of girder pictured).

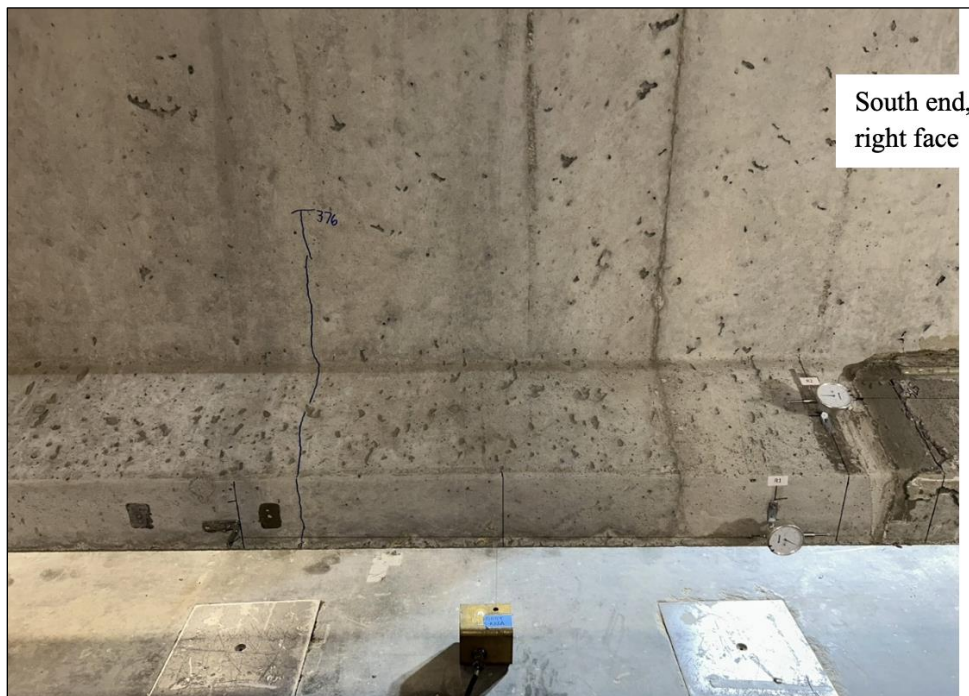
Figure 148. Photo. Test 3.2.S (repair 3.2RBF) flexural cracks toward the midspan, to the left of repair 3.2RBF at 376 kip (right face of girder pictured).

Flexural cracks also formed on repair 3.2RBF, which were 0.00394 in. wide. Flexural cracking increased at 376 kip (see figure 148 and figure 149).

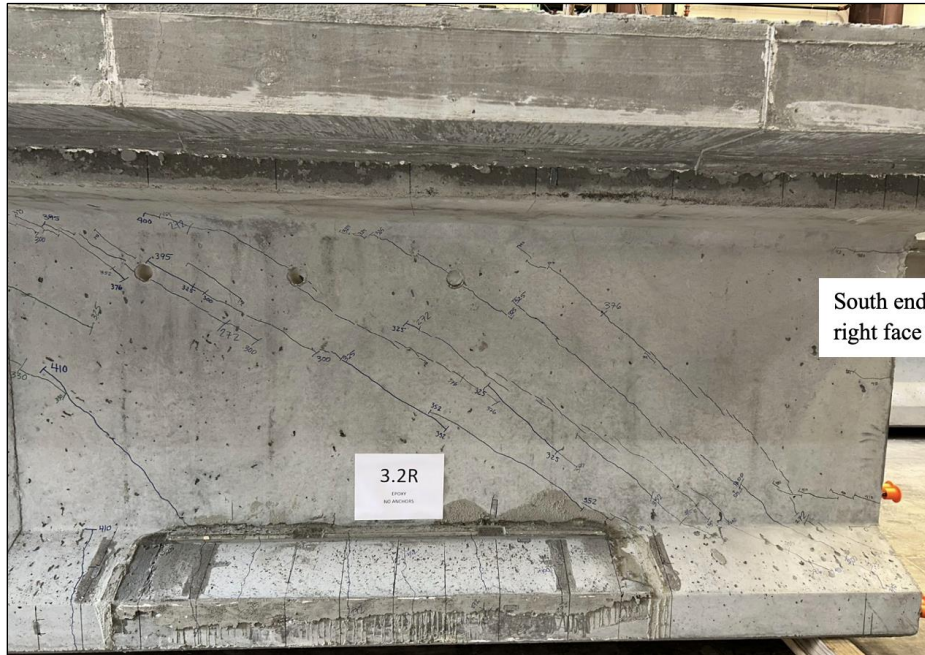
Figure 152. Photo. Test 3.2.S (repair 3.2RBF) final shear cracks on repaired face of the girder at 410 kip (right face of girder pictured).

The final shear crack pattern of both sides of the girder is shown in figure 152 and figure 153. Note the width of the compression struts on each side of the girder and that the center of compression is beyond the center of bearing of the girder. The horizontal component of the compression force in the web was resisted by the tensile forces in the strands across the bottom flange. Because the center of tension in the left and right sides of the bulb was eccentric to the center of compression in the web, transverse tensile forces in

the bottom flange developed; these tensile forces resulted in the end zone cracking, the decrease in bond capacity of the strands, and the resulting bond-slip.

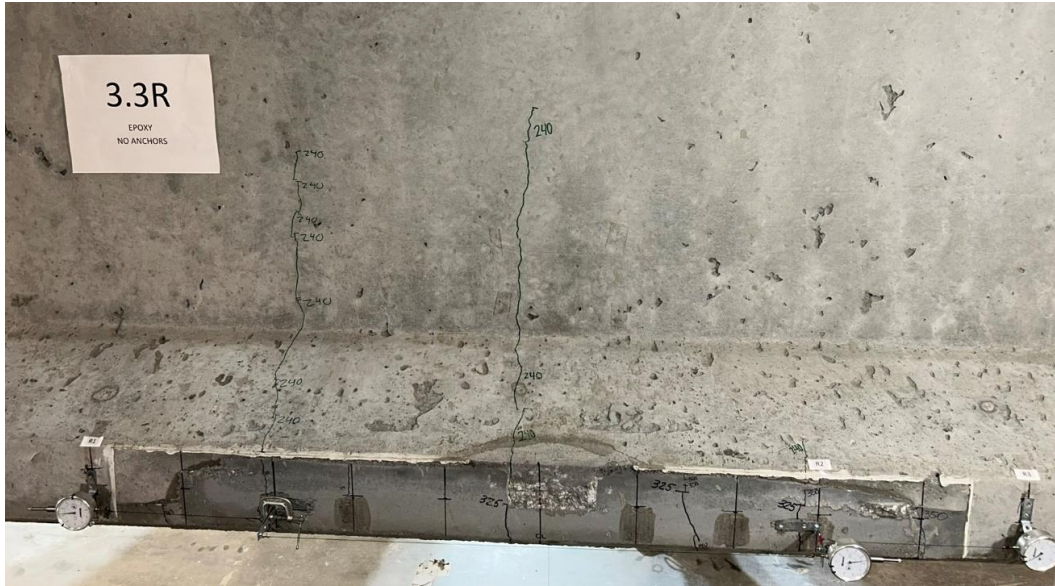
Figure 157. Photo. Test 3.3.F (repair 3.3RBF, 3.3LBF) initial flexural cracks at 240 kip (right face of girder pictured).

and seen. These new flexural cracks measured 0.0787 in. wide. Figure 157 and figure 158 show the flexural cracks on the right and left sides of the girder, respectively.

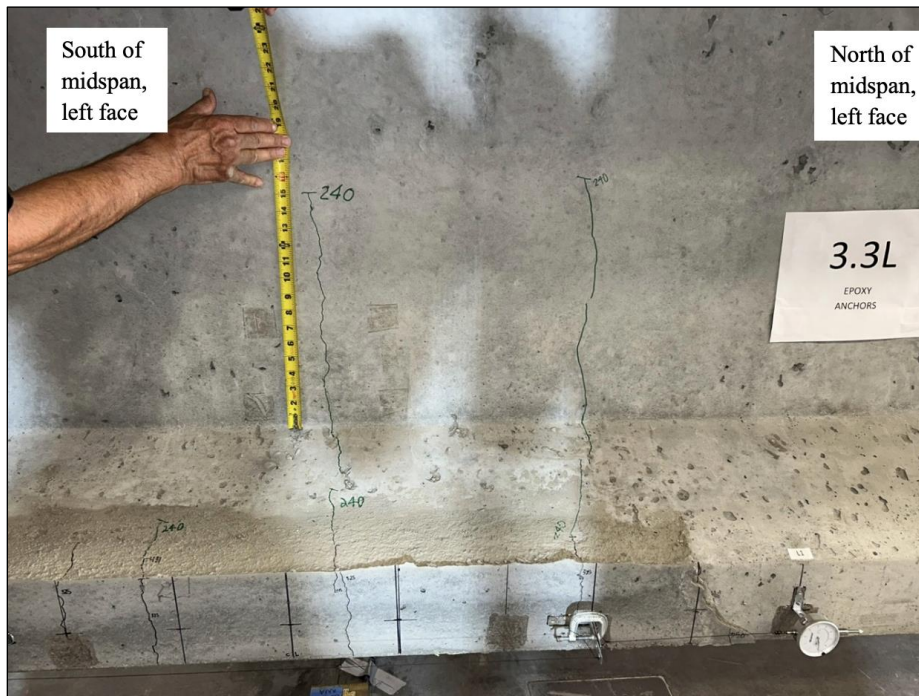
Figure 158. Photo. Test 3.3.F (repair 3.3RBF, 3.3LBF) initial flexural cracks extending 15 in. from the top of the bulb at 240 kip (left face of girder pictured).

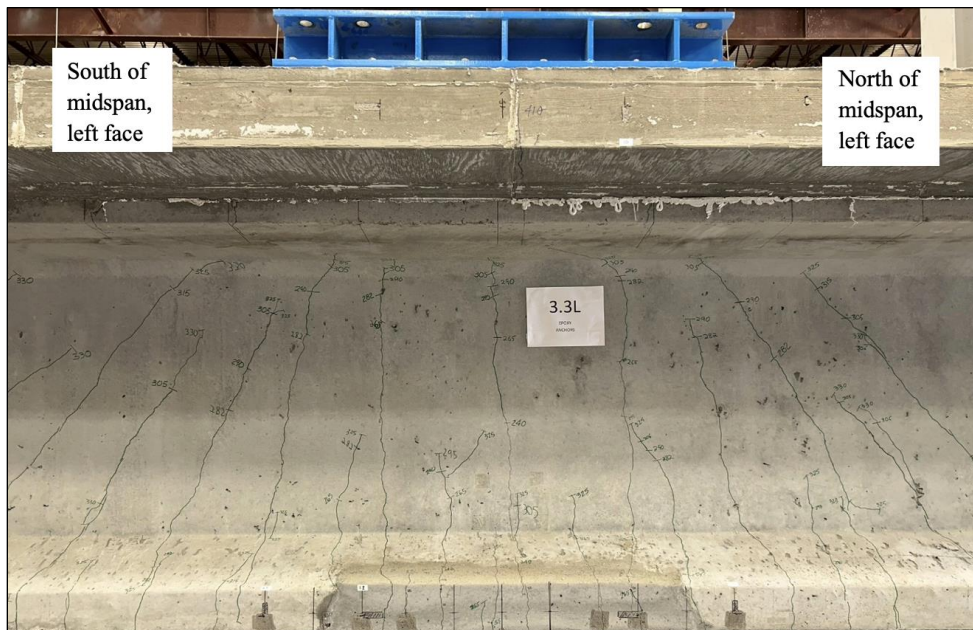
Figure 159. Photo. Test 3.3.F (repair 3.3RBF, 3.3LBF) overall crack pattern at the final load of 330 kip. Extensive flexural cracks occurred in the bottom flange repair (left face of girder pictured).

As the overall figures of the repairs at maximum loads show (see figure 159 and figure 160), no separation of the repair concrete from the original concrete occurred in any repair, even though significant cracking in the repair was evident. Crack widths were uniform through the lengths of the repairs, showing that there was no debonding of the prestressing strand and that there probably was excellent bond between the repair and the original concrete at the interior side of the original concrete. If there were separation, the exterior strains as shown by cracking would vary significantly.

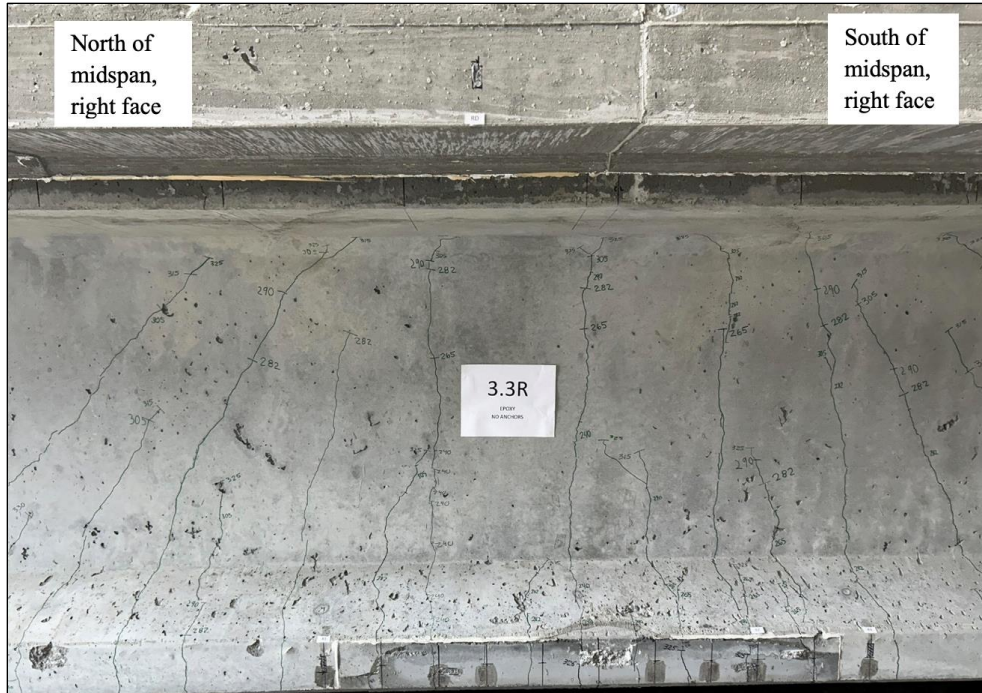
Figure 160. Photo. Test 3.3.F (repair 3.3RBF, 3.3LBF) overall crack pattern at the final load of 330 kip. Extensive flexural cracks occurred in the bottom flange repair (right face of girder pictured).

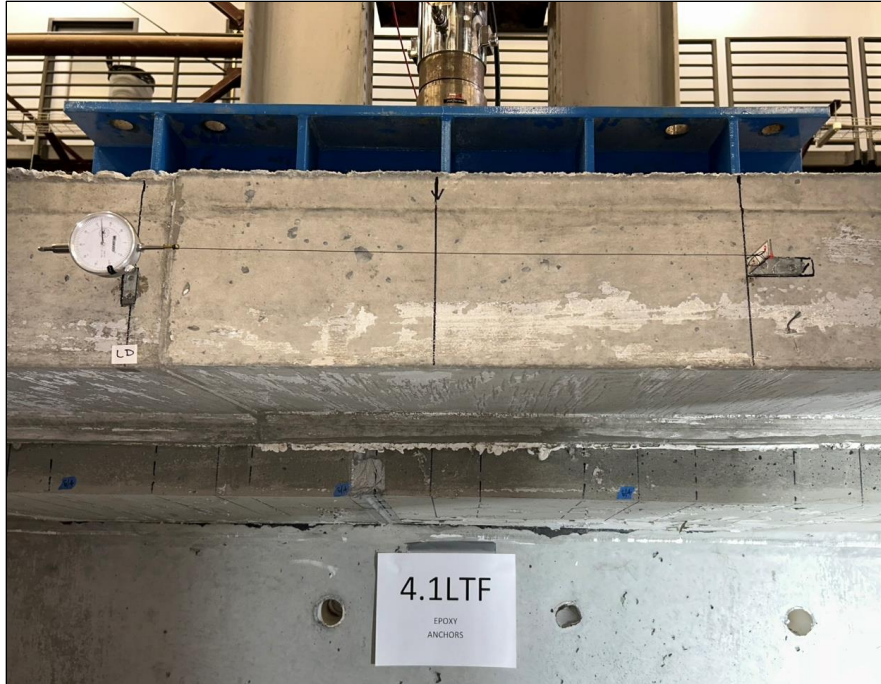
Figure 163. Photo. Test 4.1.S (repair 4.1LBZ, 4.1RTF, 4.1LTF, 4.4LTF) general test setup (left face of girder pictured).

The first test on Girder 4, Test 4.1.S, was designed to observe the bearing zone repair performance by focusing the center of the compression strut on the repair and evaluating the behavior of the repair under this high load. This test was also designed to observe the performance of top flange repairs 4.1RTF and 4.1LTF by centering the load point over these repairs and maximizing the tensile stress experienced by them. The load point location was 113 in. from the center of bearing of the north end of the girder. This distance is referred to as “ x_1 ” in the appendix J calculations ($a/d = 1.85$). The spreader beam was used in a four-point bending test configuration, which was identical to the spreader beam setup for the shear tests on Test 2.1.S (see figure 163).

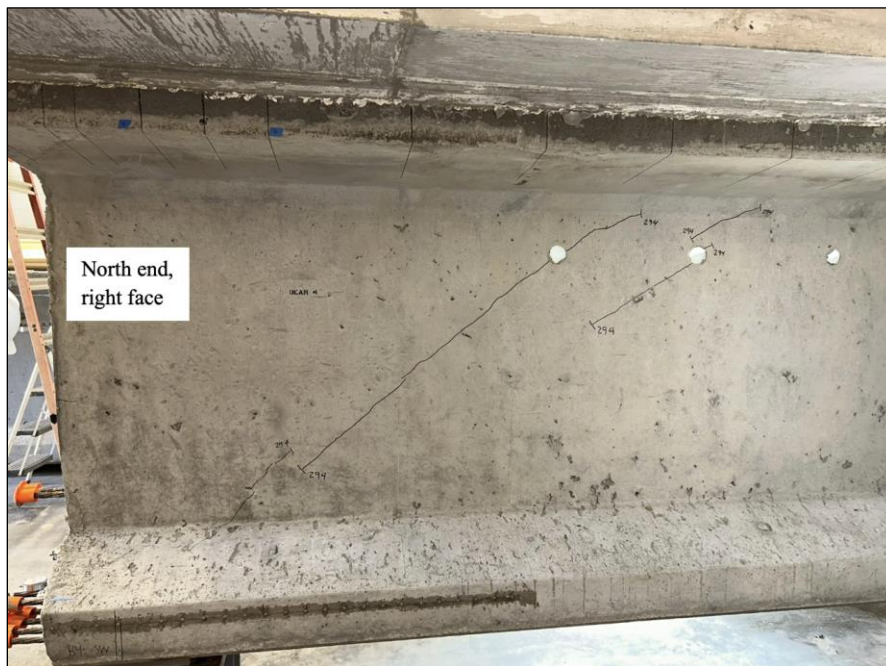
Figure 164. Photo. Test 4.1.S (repair 4.1LBZ, 4.1RTF, 4.1LTF, 4.4LTF) initial shear cracks on original, nonrepaired face at 294 kip (right face of girder pictured).

At a load of 294 kip, two diagonal shear cracks were seen. The shear crack width measured 0.00787 in. The strut width was 9.5–10 in. The crack angles were between 37 and 39 degrees (see figure 164 and figure 165).

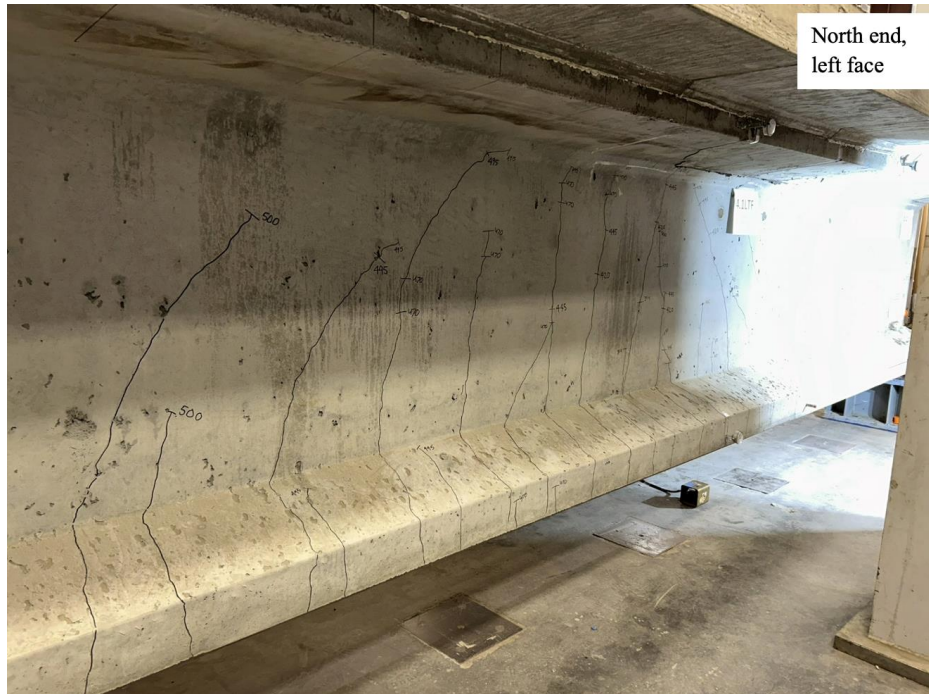
Figure 168. Photo. Test 4.1.S (repair 4.1LBZ, 4.1RTF, 4.1LTF, 4.4LTF) flexural and shear-flexural cracks around the innermost spreader beam support, not extending into repair 4.1LTF at 500 kip (left face of girder pictured).

At a load of 394 kip, flexural cracks propagated directly below the load point from the bottom of the girder up toward the spreader beam pin support. They continued to spread up the web after each load step, and their final width measured 0.00787 in. At a load of 470 kip, shear-flexural cracks formed. They formed on both sides of the innermost support of the spreader beam and continued to spread after each load step, with a similar length between them. Their final width measured 0.0256 in. Figure 167 and figure 168 show the flexural and shear-flexural cracks at the final load of 500 kip.

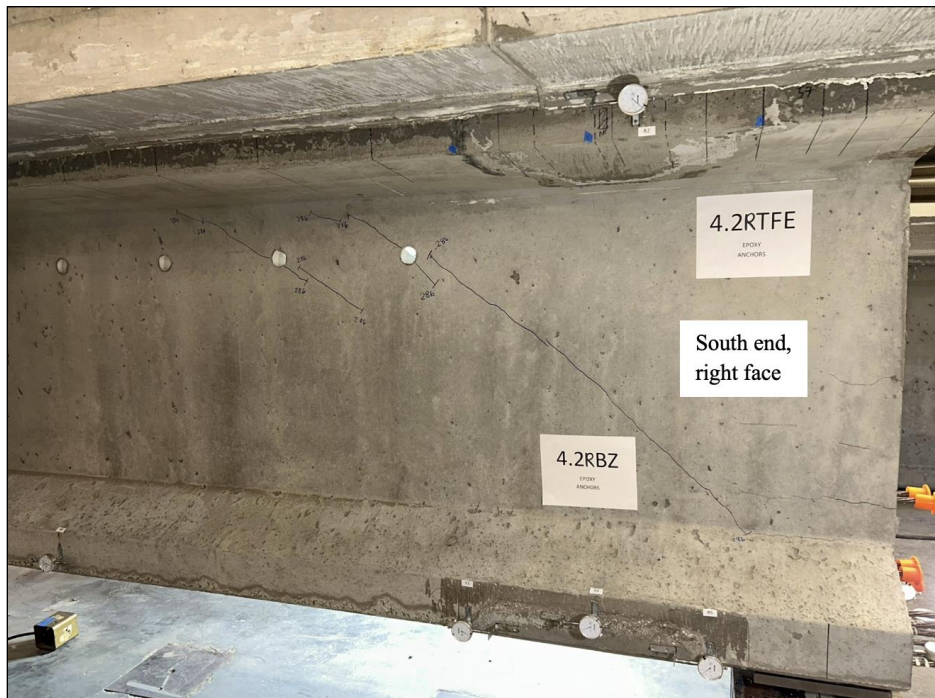
Figure 175. Photo. Test 4.2.S (repair 4.2RBZ, 4.2RTFE, 4.2RTF, 4.2LTF) initial shear cracks on repaired face at 286 kip (right face of girder pictured).

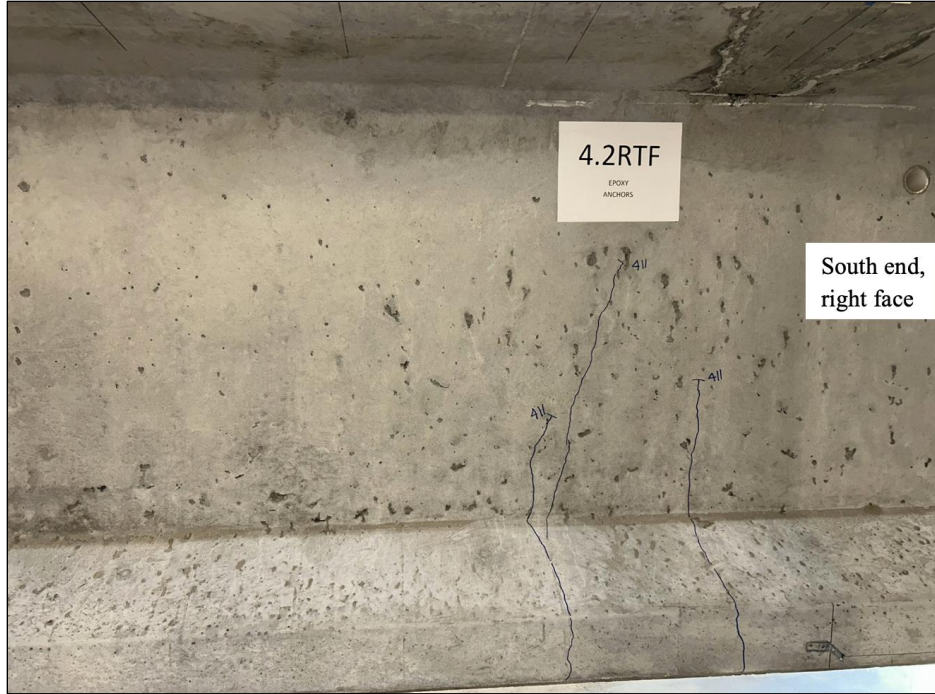
Figure 179. Photo. Test 4.2.S (repair 4.2RBZ, 4.2RTFE, 4.2RTF, 4.2LTF) initial flexural and shear-flexural cracks at 411 kip (right face of girder pictured).

At a load of 411 kip, the first flexural and shear-flexural cracks were seen under the innermost spreader beam support from the bottom flange up the web (see figure 179).

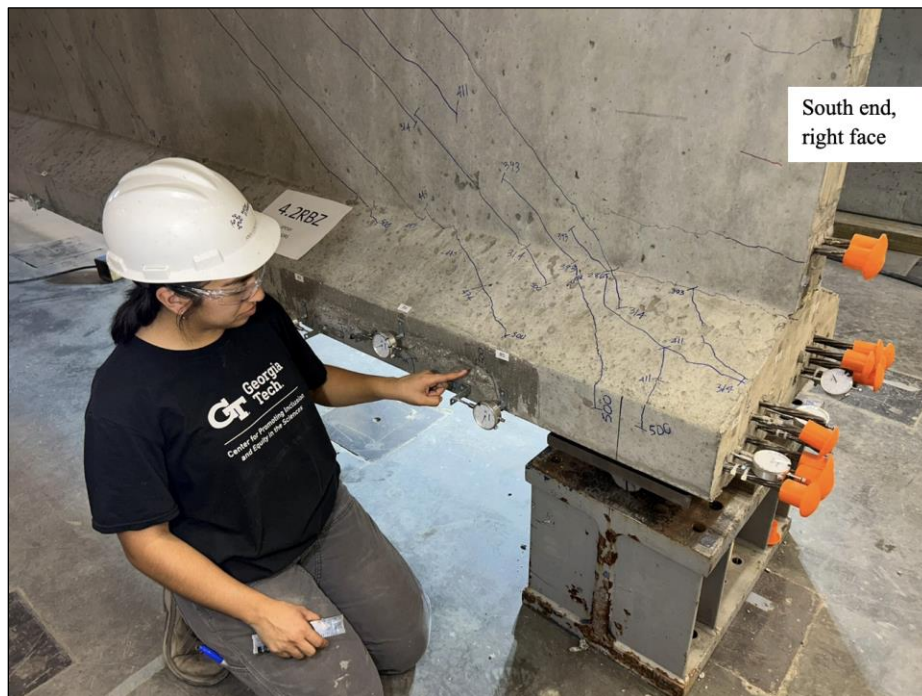
Figure 180. Photo. Test 4.2.S (repair 4.2RBZ, 4.2RTFE, 4.2RTF, 4.2LTF) perimeter cracks at 500 kip with a 0.006-in. repair interface crack measured in dial gauge R5, the outermost strand on the right side, and a strand slip of 0.027 in. measured in dial gauge RS1 (right face of girder pictured).

The girder was loaded to a final load of 500 kip. The test was ended at this load due to a strand slip of 0.0275 in. occurring in strand LS, which exceeds the set strand slip limit of 0.01 in. of this project. Some cracks on the perimeter of repair 4.2RBZ were noted, with a maximum of 0.006 in. of separation measured in dial gauge R5. Figure 180 shows one of the researchers pointing at the location of maximum repair detachment for repair 4.2RBZ.

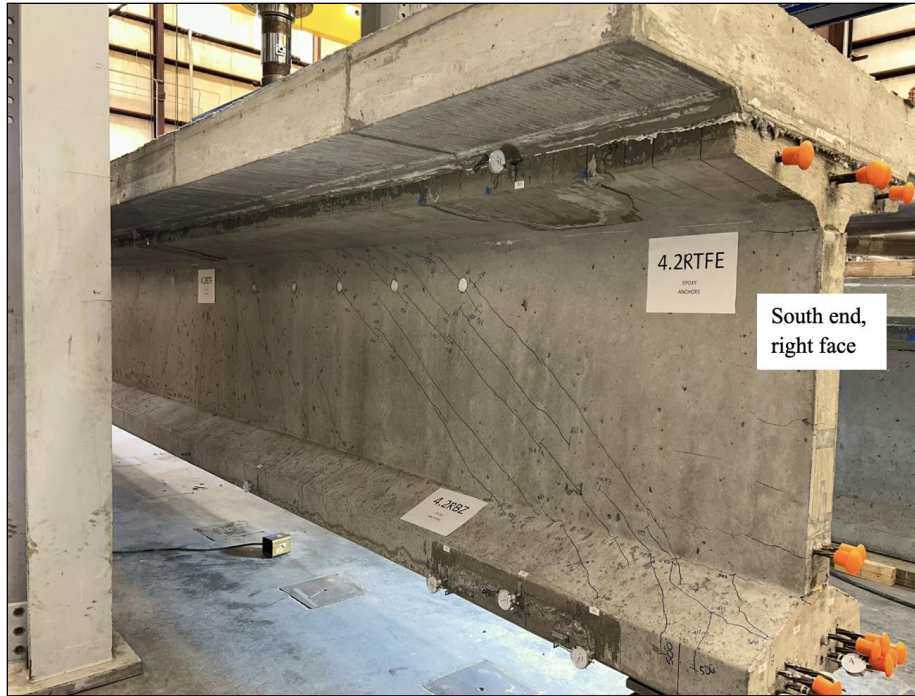
Figure 181. Photo. Test 4.2.S (repair 4.2RBZ, 4.2RTFE, 4.2RTF, 4.2LTF) final shear cracks on top and bottom flange repaired face at 500 kip (right face of girder pictured).

The final shear crack pattern is shown in figure 181 and figure 182. Notably, the compression strut did not pass through repair 4.2LBZ. Also, the crack patterns on each face of the girder were very similar.

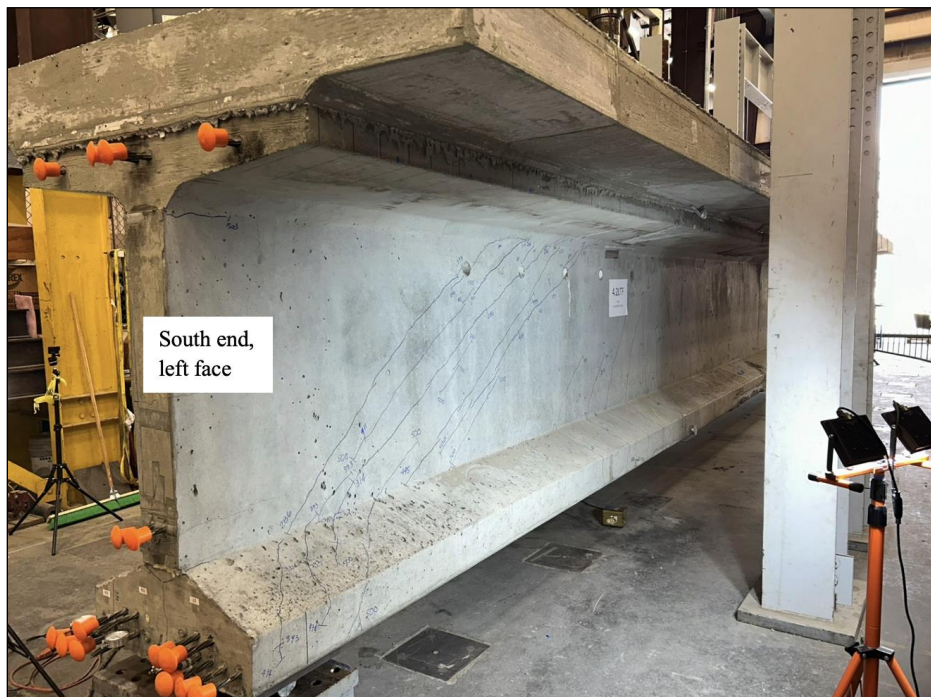
Figure 182. Photo. Test 4.2.S (repair 4.2RBZ, 4.2RTFE, 4.2RTF, 4.2LTF) final shear cracks on top flange repaired face at 500 kip (left face of girder pictured).

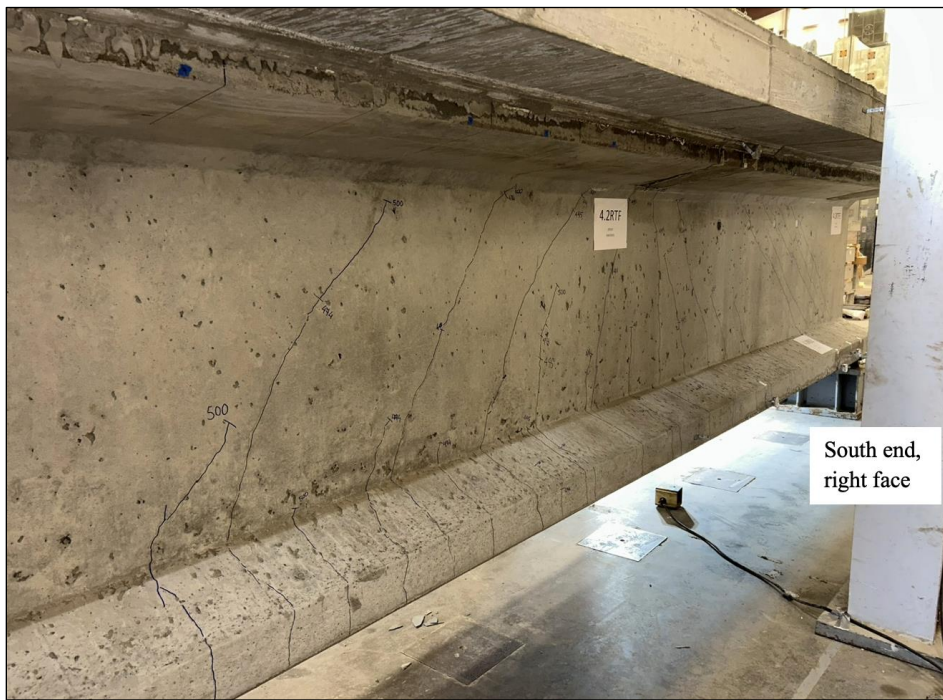
Figure 183. Photo. Test 4.2.S (repair 4.2RBZ, 4.2RTFE, 4.2RTF, 4.2LTF) flexural and shear-flexural cracks around the innermost spreader beam support, extending slightly into repair 4.2RTF at 500 kip (right face of girder pictured).
