GEORGIA DOT RESEARCH PROJECT 21-04

**PRAGMATIC PRECAST/PRESTRESSED
GIRDER ACCEPTANCE CRITERIA**

July 2025

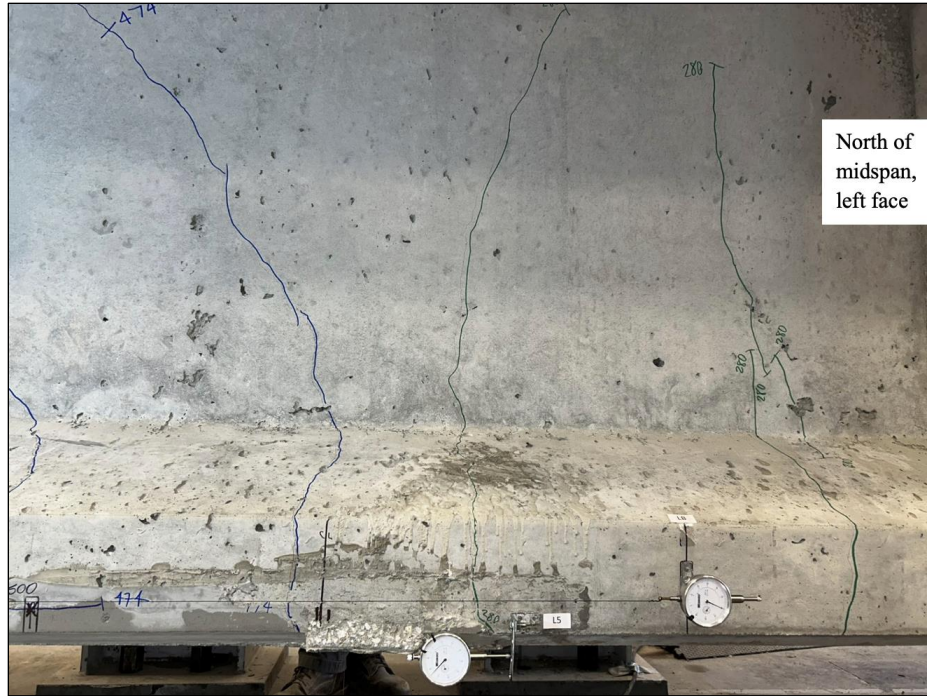
Figure 189. Photo. Test 4.3.F (repair 4.3LBF, 4.3LTF) initial flexural and shear-flexural cracks at 280 kip (left face of girder pictured).

The first flexural and shear-flexural cracks occurred at a load of 280 kip (see figure 189, right side). They measured 0.00984–0.0138 in. wide.

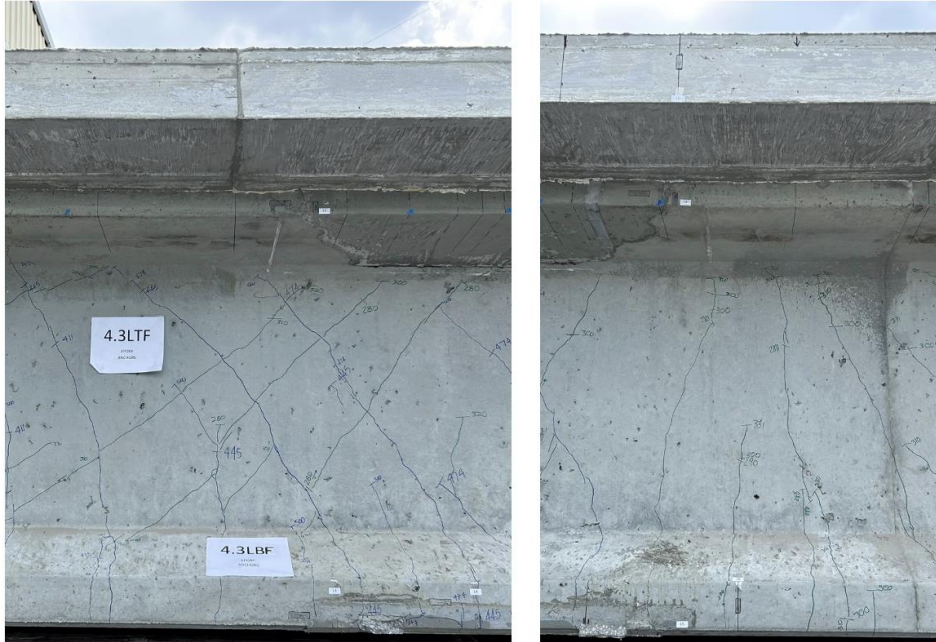
Figure 191. Photo. Test 4.3.F (repair 4.3LBF, 4.3LTF) final overall crack pattern on the top and bottom flange repaired girder face after the final load of 331 kip (left face of girder pictured).

The final flexural and shear-flexural crack pattern on Test 4.3.F (repair 4.3LBF, 4.3LTF) is shown in figure 191. The shear-flexural cracks did not extend into repair 4.3LTF but did extend on the opposite girder face of the repair (right face; figure 192). The maximum crack width for flexural cracks was 0.0177 in. and for shear-flexural cracks was 0.0276 in.

As the overall figures of the repairs at maximum loads show (see figure 190, figure 191, and figure 192), no separation of the top flange repair concrete from the original concrete occurred. Some separation was heard when conducting a hammer sounding test on bottom flange repair 4.3LBF. Given that this bottom flange repair is shallow and had no exposed reinforcement to anchor to, it was difficult for the repair to sustain such high tensile stress at the bottom of the beam near midspan. Crack widths were uniform through the lengths of the repairs, showing that there was no debonding of the prestressing strand.

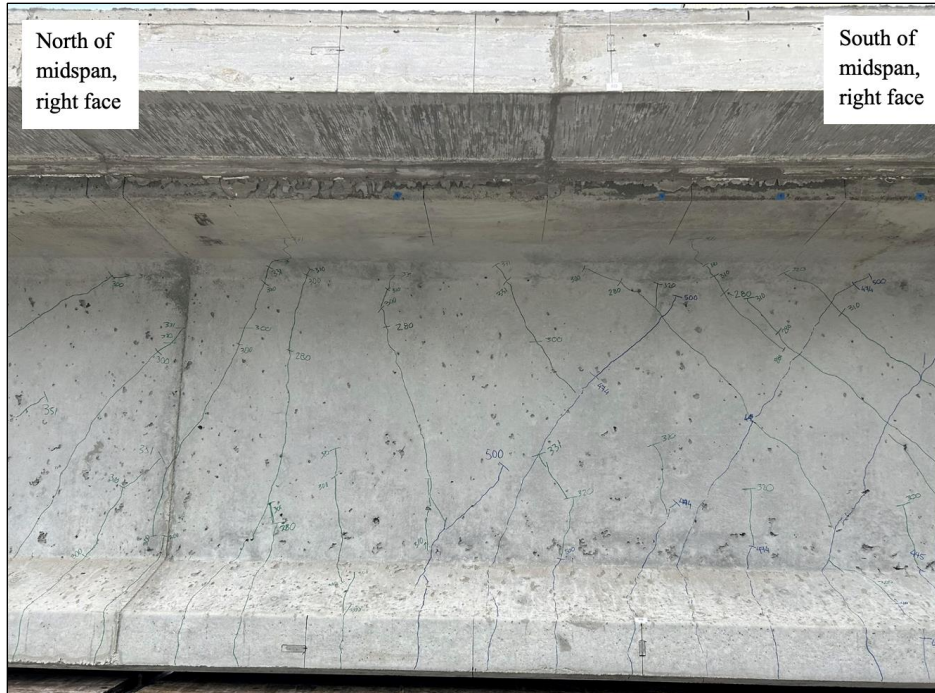
Figure 192. Photo. Test 4.3.F (repair 4.3LBF, 4.3LTF) final overall crack pattern on original, nonrepaired girder face after the final load of 331 kip (right face of girder pictured).

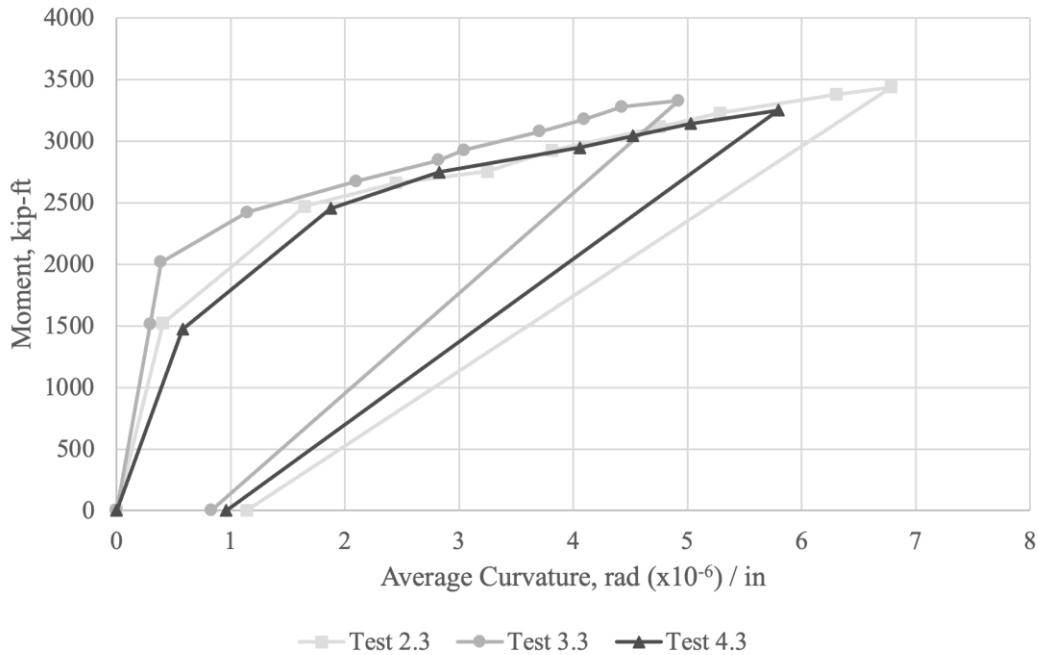
Figure 195. Graph. Combined moment-curvature plots for flexural tests.

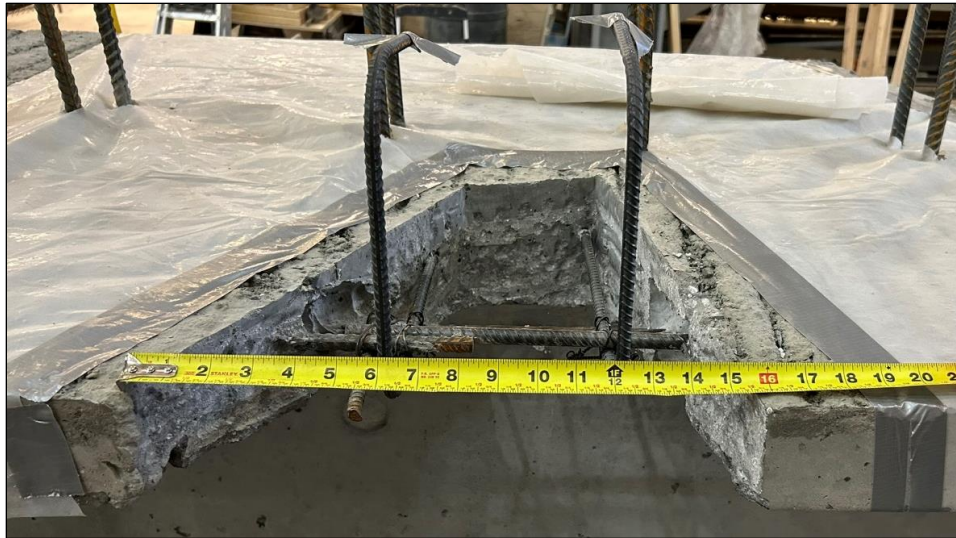
Figure 1. Top flange nonconformity not located at the end of the girder.

1. Top flange nonconformities accepted with repairs:
 - a. Top flange nonconformity not located at the end of the girder (Figure 1).

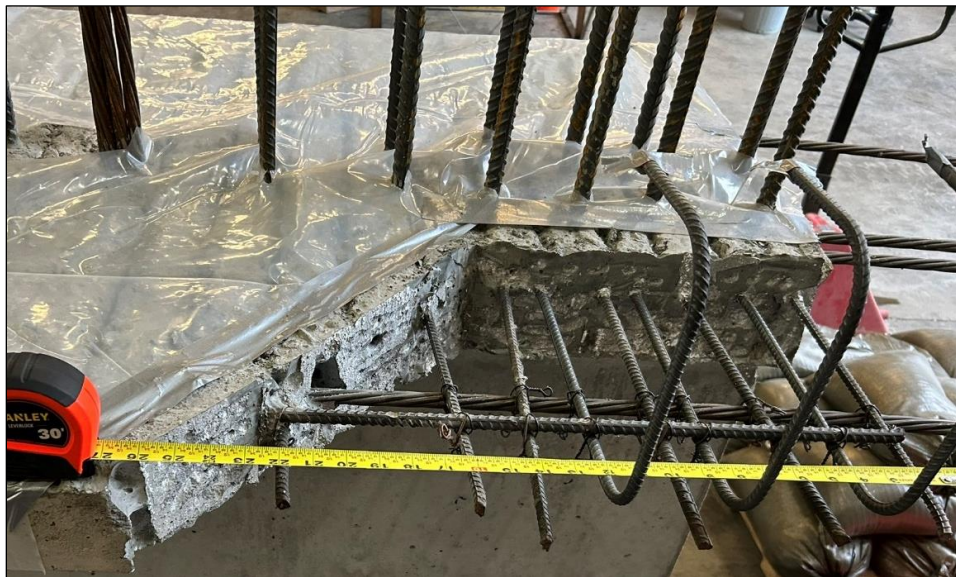
Figure 2. Top flange nonconformity located at the end of the girder.

- a.
 - b. Top flange nonconformity located at the end of the girder (Figure 2).

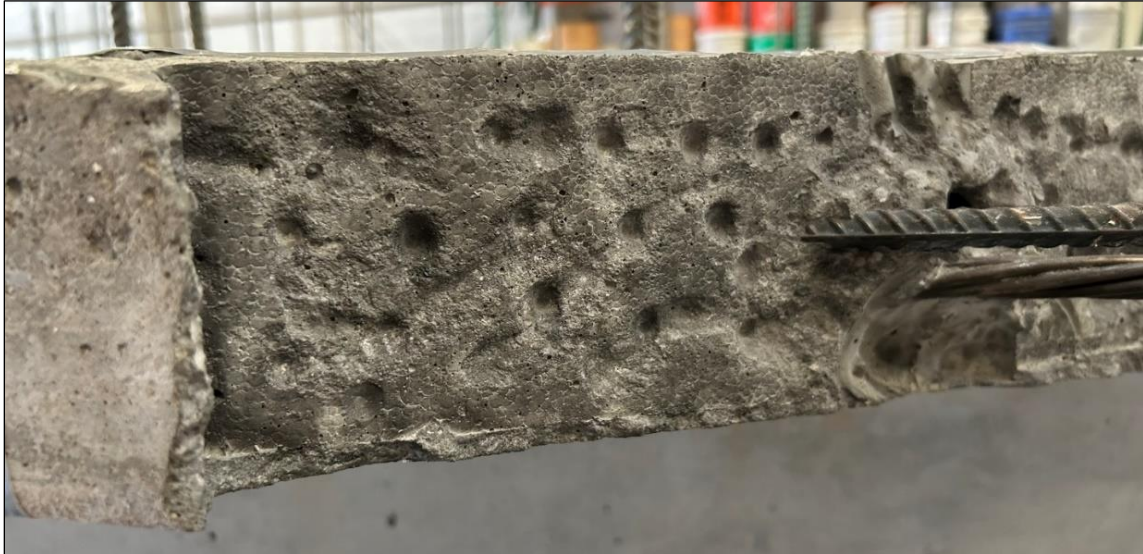
Figure 3. Top flange 0.25-in. amplitude chipped surface.

2. Top flange repair procedure accepted:
 - a. If a cracked concrete section is being retained by prestressed or non-prestressed steel reinforcement, carefully remove the loose segment of concrete to expose a sound concrete surface. If non-prestressed steel reinforcement is partially exposed, clear a 1-in. area around the reinforcement, if possible.
 - b. Chip the sound concrete surface to a 0.25-in. amplitude (Figure 3).

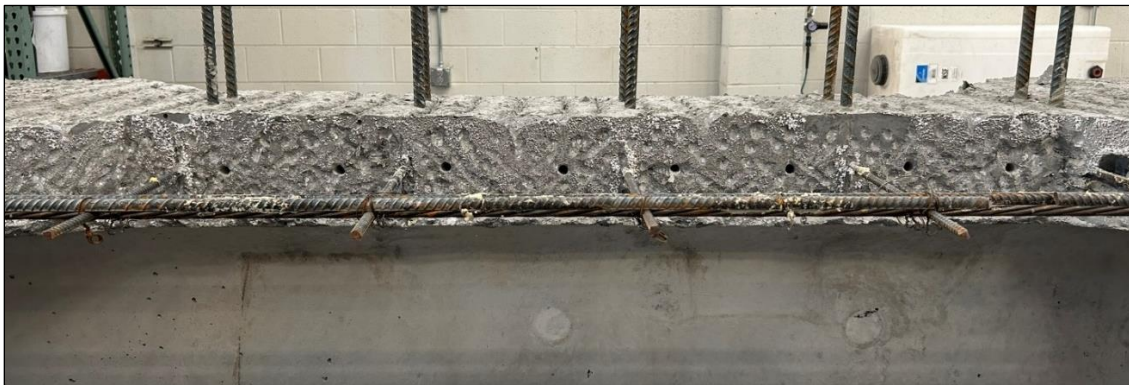
Figure 4. Drilled holes for c-bars.

- c. Drill holes (spaced approximately 6 in. on center; Figure 4) using a 0.25-in. diameter masonry drill bit with a hammer drill to a depth specified by an epoxy resin chosen from the GDOT Qualified Products List. Thoroughly clean all loose debris, dust, and laitance from the concrete surface to be repaired. Remove dust from the drilled holes using compressed air, ensuring the epoxy resin manufacturer specifications are met.

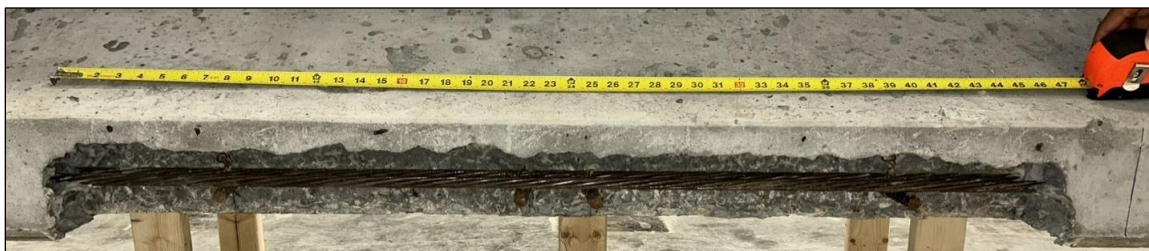
Figure 7. Bottom flange nonconformity requiring a chimney formwork for concrete replacement.

- b. Bottom flange nonconformity with prestressing strands and non-prestressed reinforcement exposed, requiring a chimney formwork for concrete replacement (Figure 7).

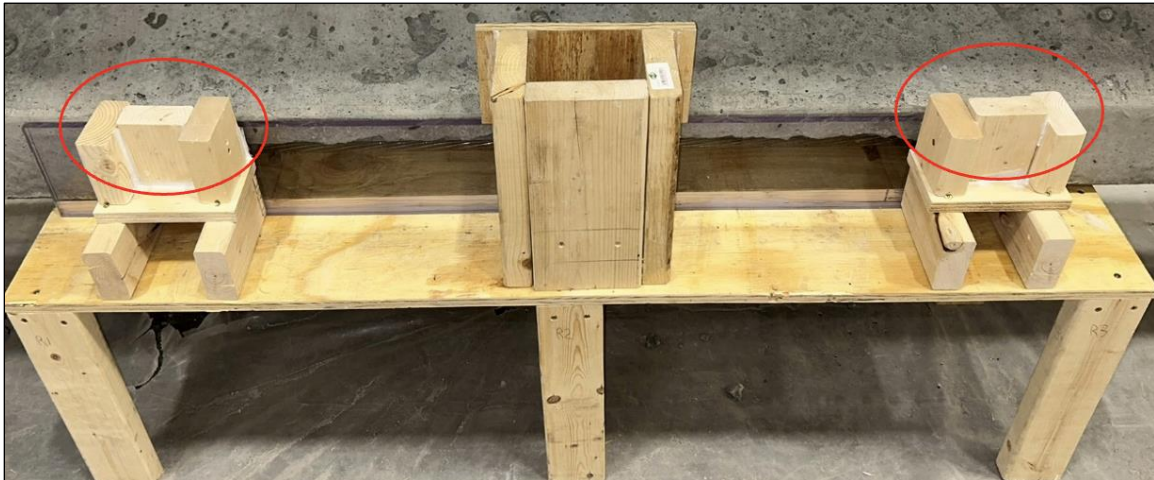
Figure 8. Chimney formwork example.

Use formwork that fits the existing, conforming bottom flange shape to produce a uniform, conforming prestressed girder section. If a chimney formwork is required for concrete replacement, size the chimney (dashed circle, Figure 8) to allow proper flow of self-consolidating concrete (SCC) into the formwork. Figure 8 shows an example of a chimney formwork with air vent holes (solid circle, Figure 8), as well as a clear polycarbonate sheet to allow inspection of proper flow of SCC.

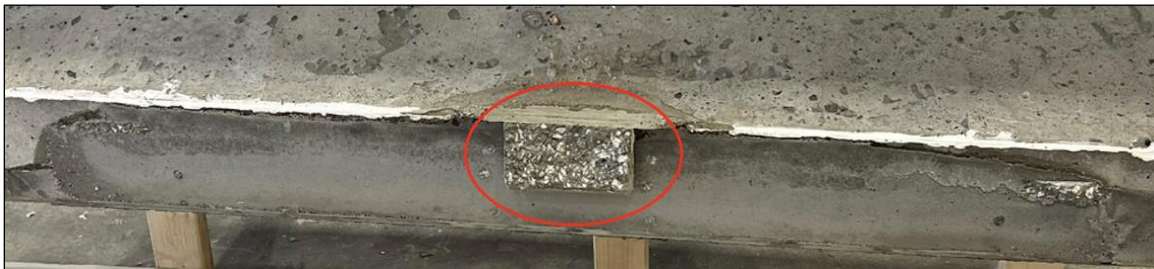
Figure 9. Imperfection due to chimney opening.

Upon removing the formwork, an imperfection will remain at the base of the chimney opening (circle, Figure 9) that will require proper finishing to achieve a smooth surface that matches the girder surface.

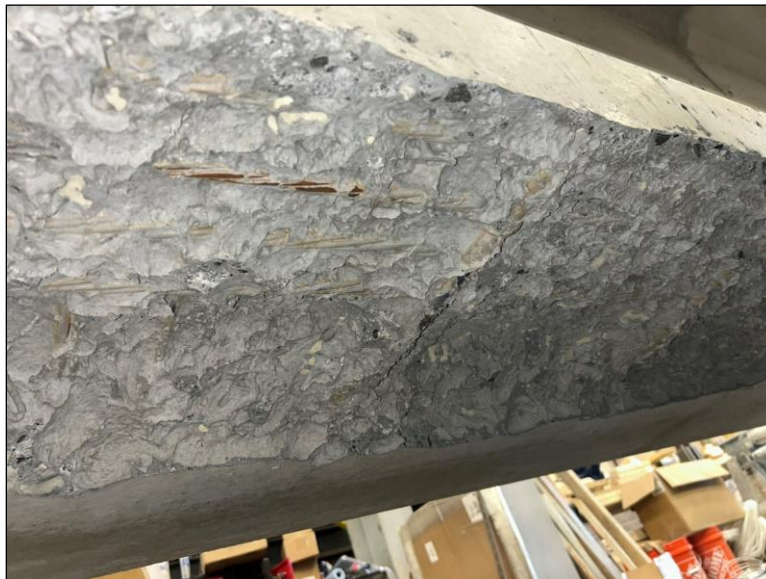
Figure 12. Bottom flange nonconformity with no exposed reinforcement.

- b. End nonconformity with loss of prestressing force, located in the bearing zone (Figure 11).
- c. Shallow nonconformity with no steel reinforcement exposed, located at the bottom of the girder (Figure 12).
