EFFECT OF THERMAL RADIATION ON THE INTEGRITY OF PRESSURIZED AIRCRAFT EVACUATION SLIDES AND SLIDE MATERIALS

FEDERAL AVIATION ADMINISTRATION

MARCH 1981

1. Report No. FAA-CT-81-28		2. Government Accession No.		3. Recipient's Catalog No.	
4. Title and Subtitle EFFECT OF THERMAL RADIATION ON THE INTEGRITY OF PRESSURIZED AIRCRAFT EVACUATION SLIDES AND SLIDE MATERIALS				5. Report Date March 1981

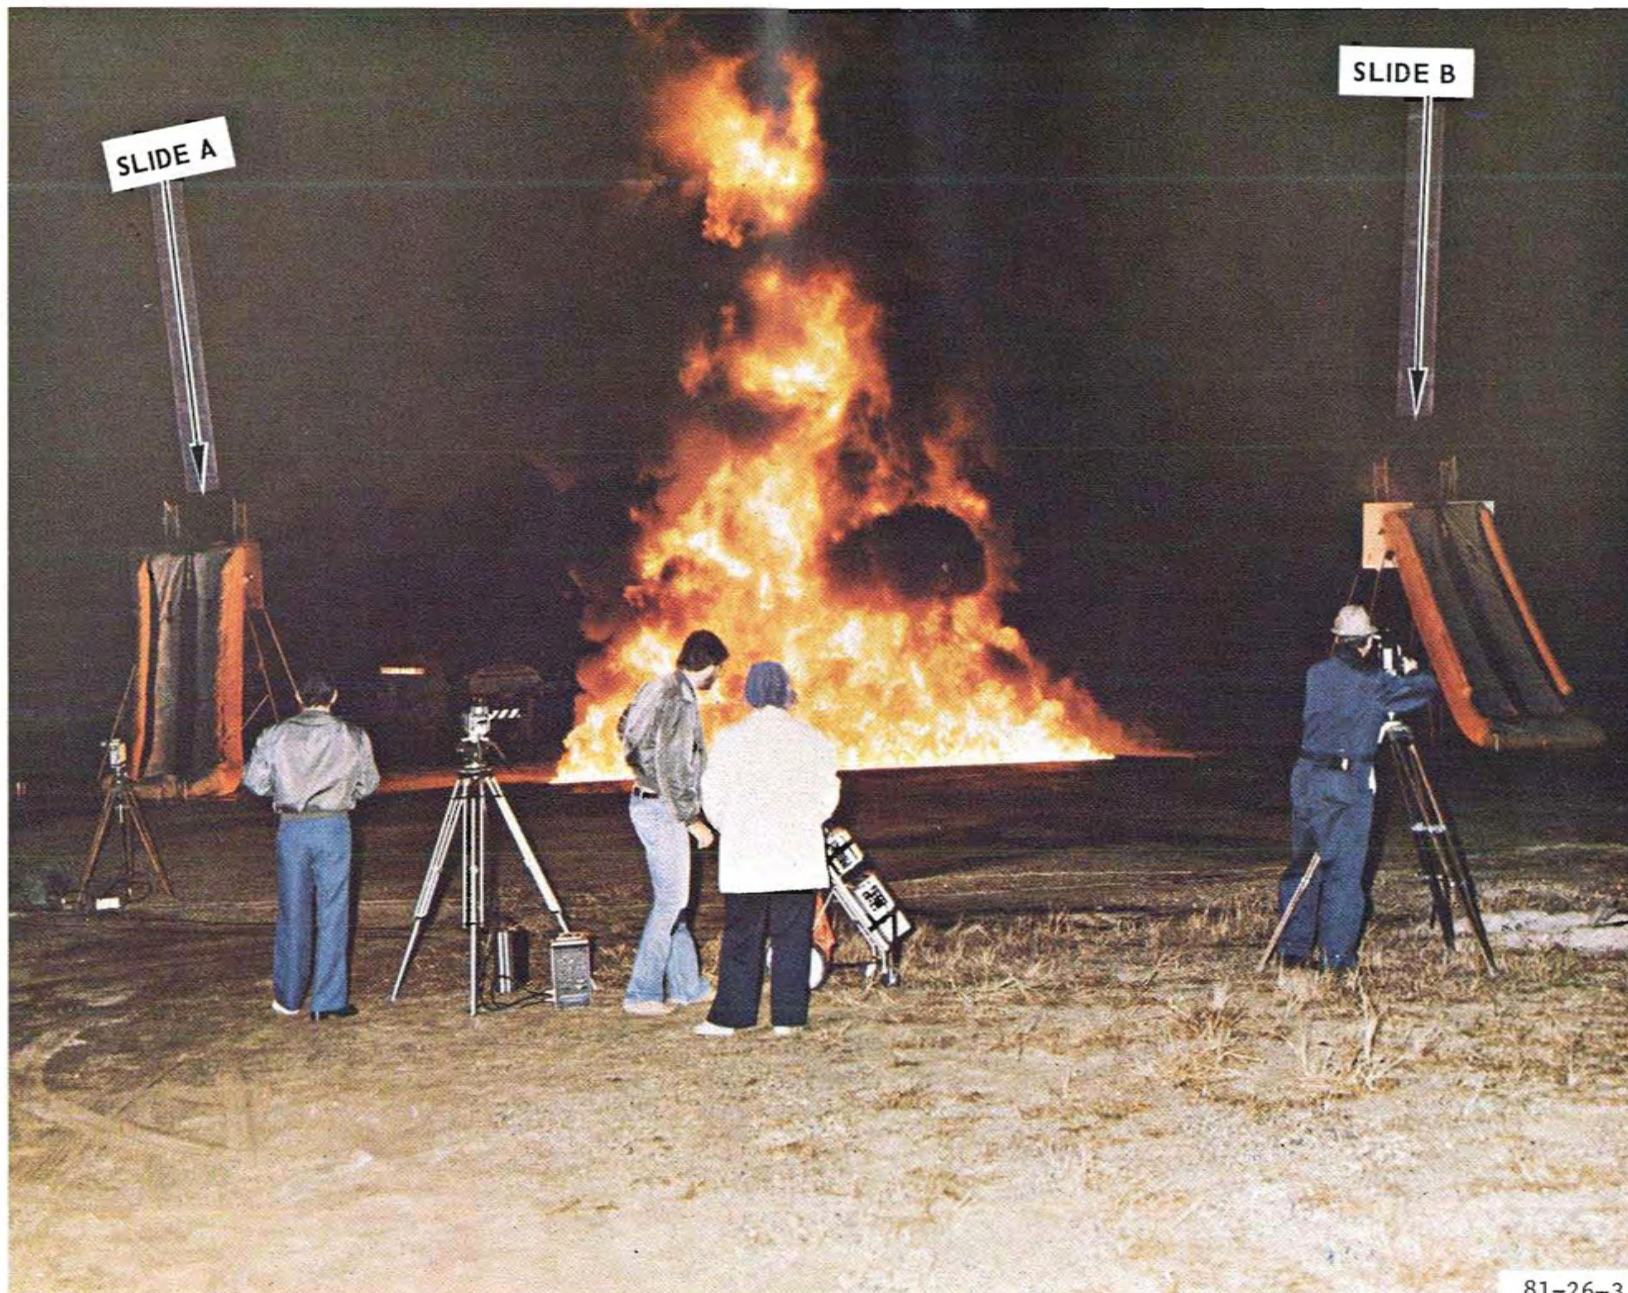
FIGURE 4. FULL-SCALE FIRE TEST SET-UP; TEST 5

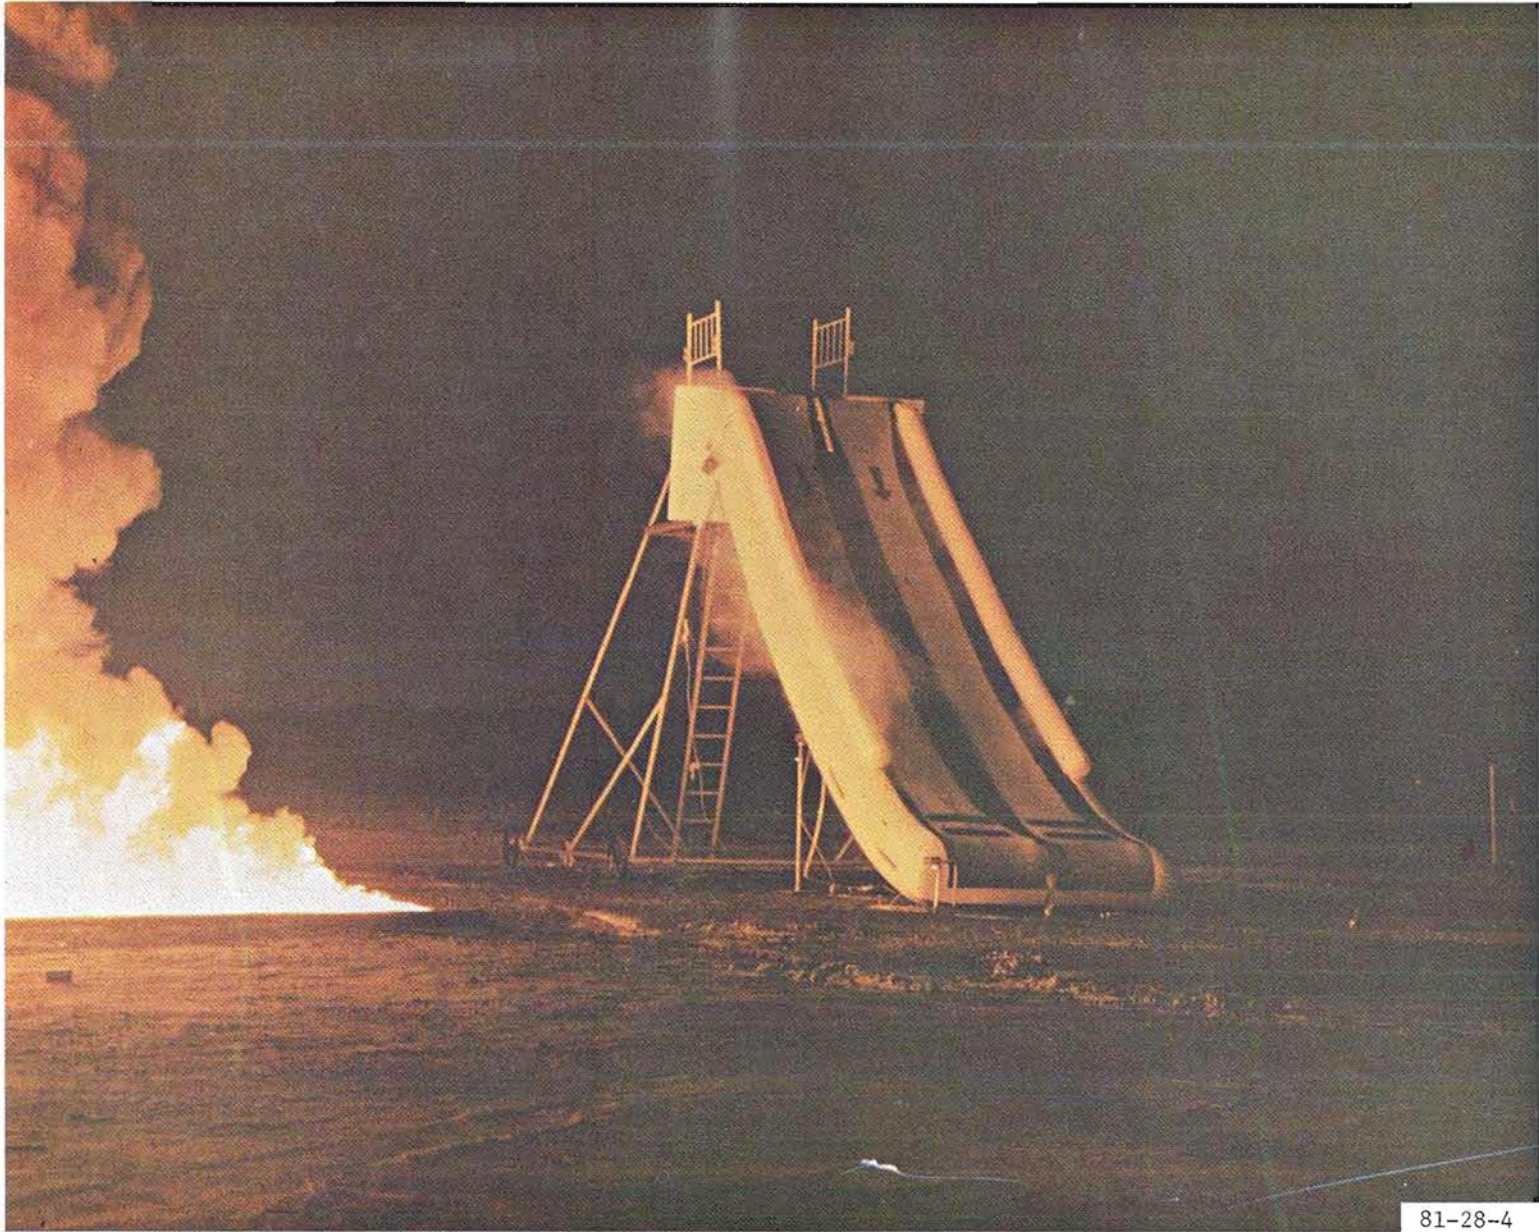
FIGURE 5. URETHANE NYLON SLIDE SMOKING DURING TEST; TEST 3B

At 27 seconds into the test and a peak pressure of 3.0 psig, slide "B" began to leak pressure from a nonseam area near the center of the tube facing the fire (see figure 5). At 52 seconds, slide "B," after having leaked down to 0.38 psig, blew out. The heat flux levels recorded by the medium height calorimeter were practically identical to those measured for slide "A" at the same location (see figure B-2).

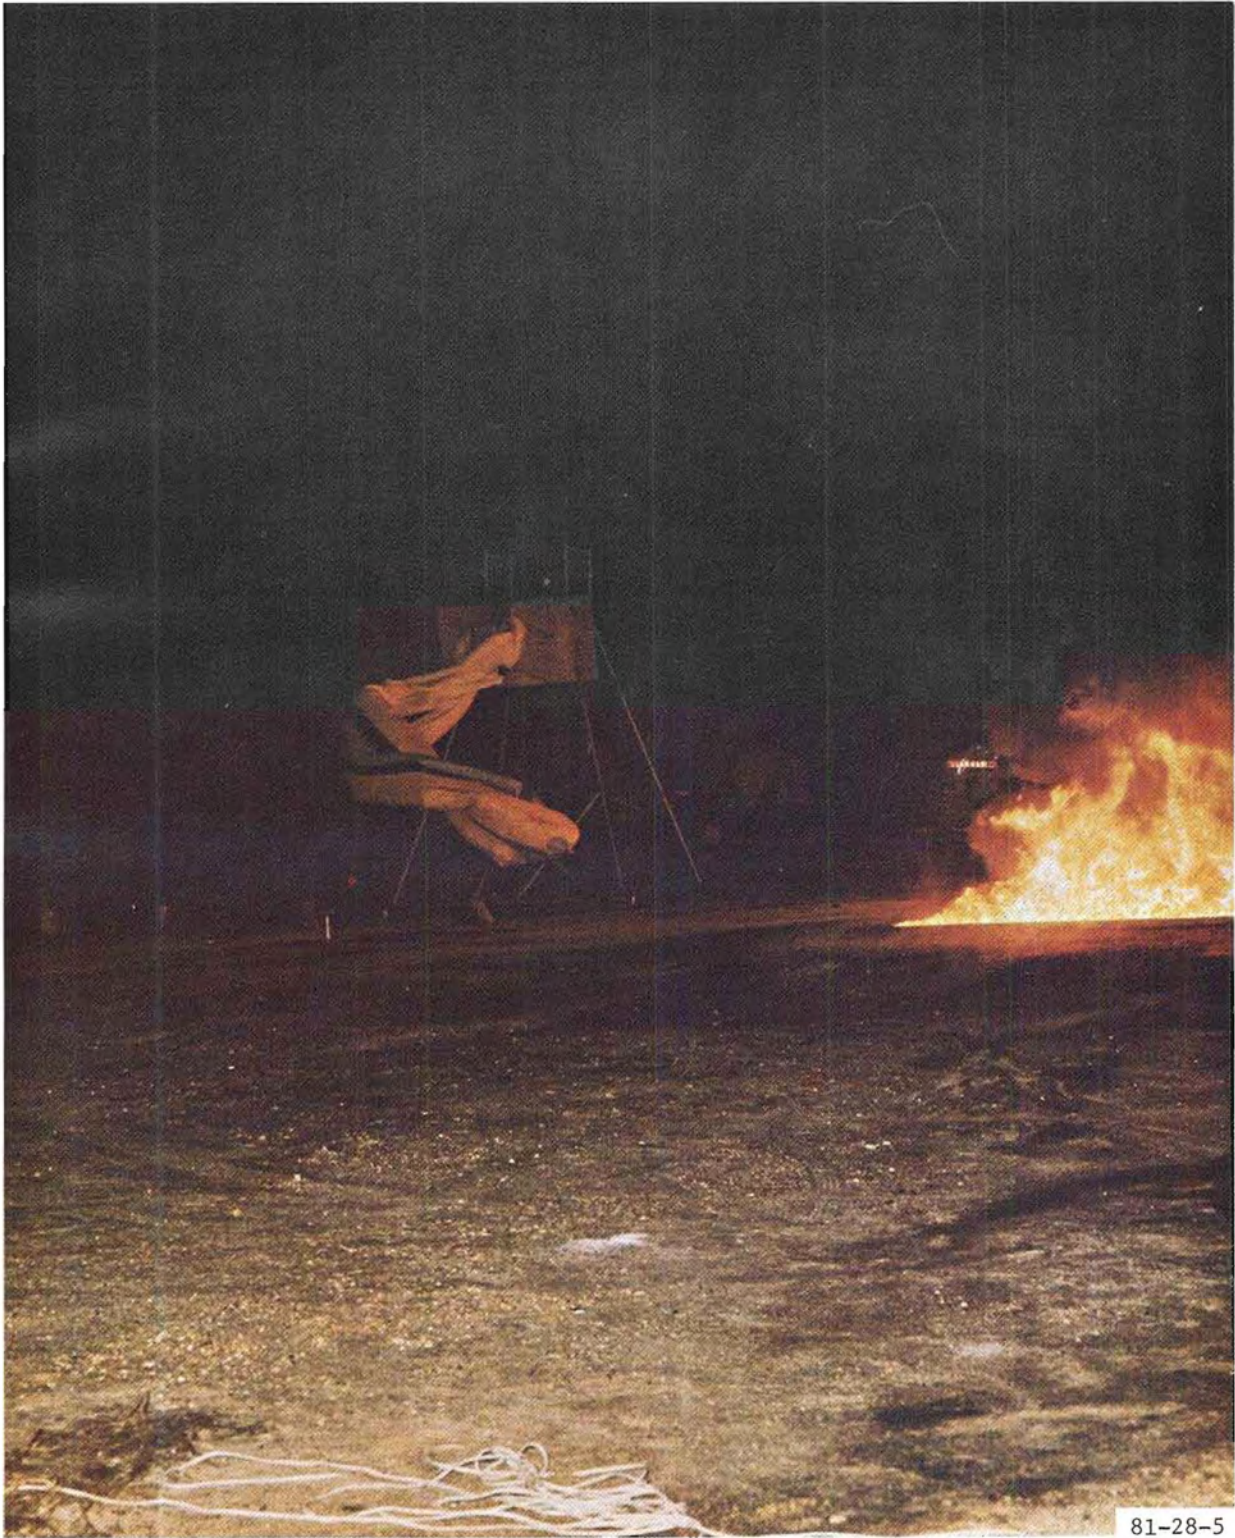
FIGURE 6. CATASTROPHIC FAILURE OF URETHANE NYLON SLIDE; TEST 8A

At 84 seconds into the test, slide "A" blew out catastrophically (see figure 6) at a seam approximately 2 feet below the aspirator on the tube facing the fire. The pressure had increased to 4.1 psig at the point of failure.

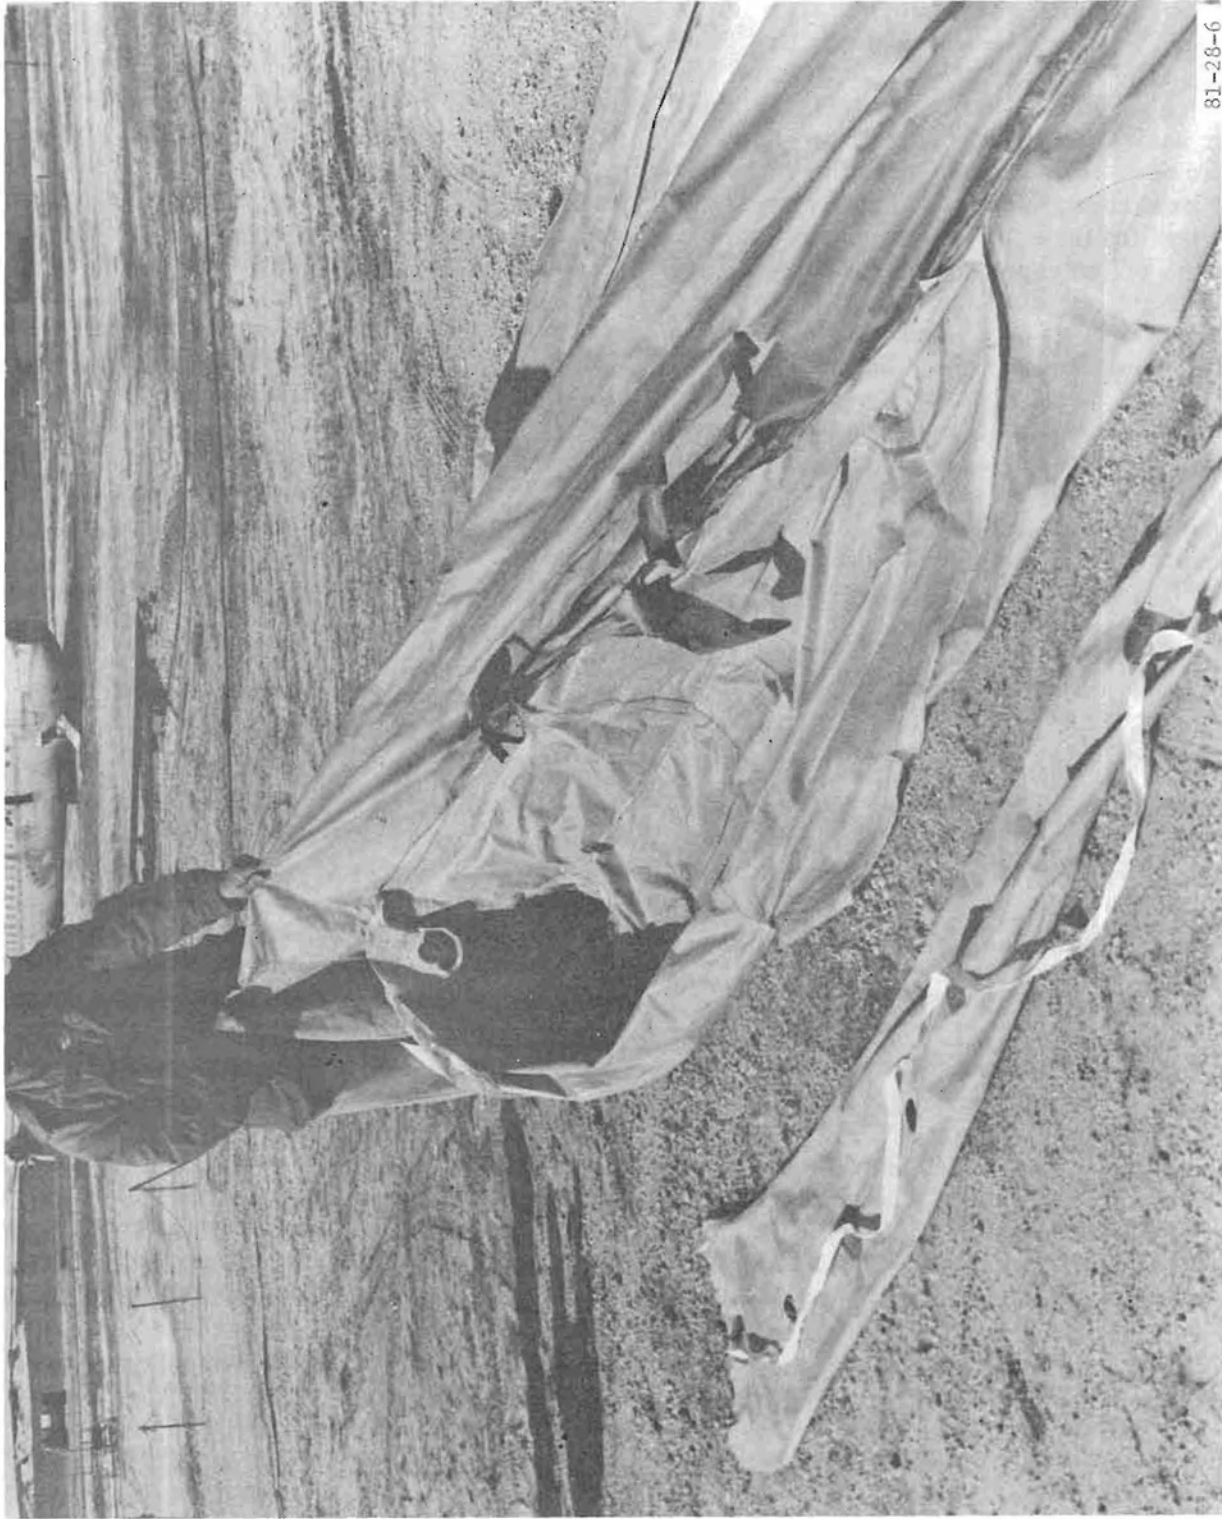
FIGURE 7. NEOPRENE NYLON SEAM FAILURE; TEST 11

At 58 seconds into the test, the upper chamber blew out catastrophically on a seam area facing the fire near the base of the slide. The blowout shifted the base of the slide approximately 3 feet further away from the fire pit. Also at 58 seconds, the lower chamber began losing pressure, perhaps from the shock caused by failure of the upper chamber. The loss of pressure was very gradual (figure B-9) in contrast to the experiences of previous tests. By 206 seconds, the lower chamber had leaked down from a peak pressure of 3.75 psig at 58 seconds to 3.25 psig, and blew out catastrophically on a seam area near the base of the slide (see figure 7). The medium height calorimeter recorded the peak heat flux and the highest average heat flux, 1.4 Btu/ft²-sec and 1.16 Btu/ft²-sec, respectively. It was estimated that the heat flux near the base of the slide dropped approximately 0.3 Btu/ft²-sec after failure of the upper chamber.

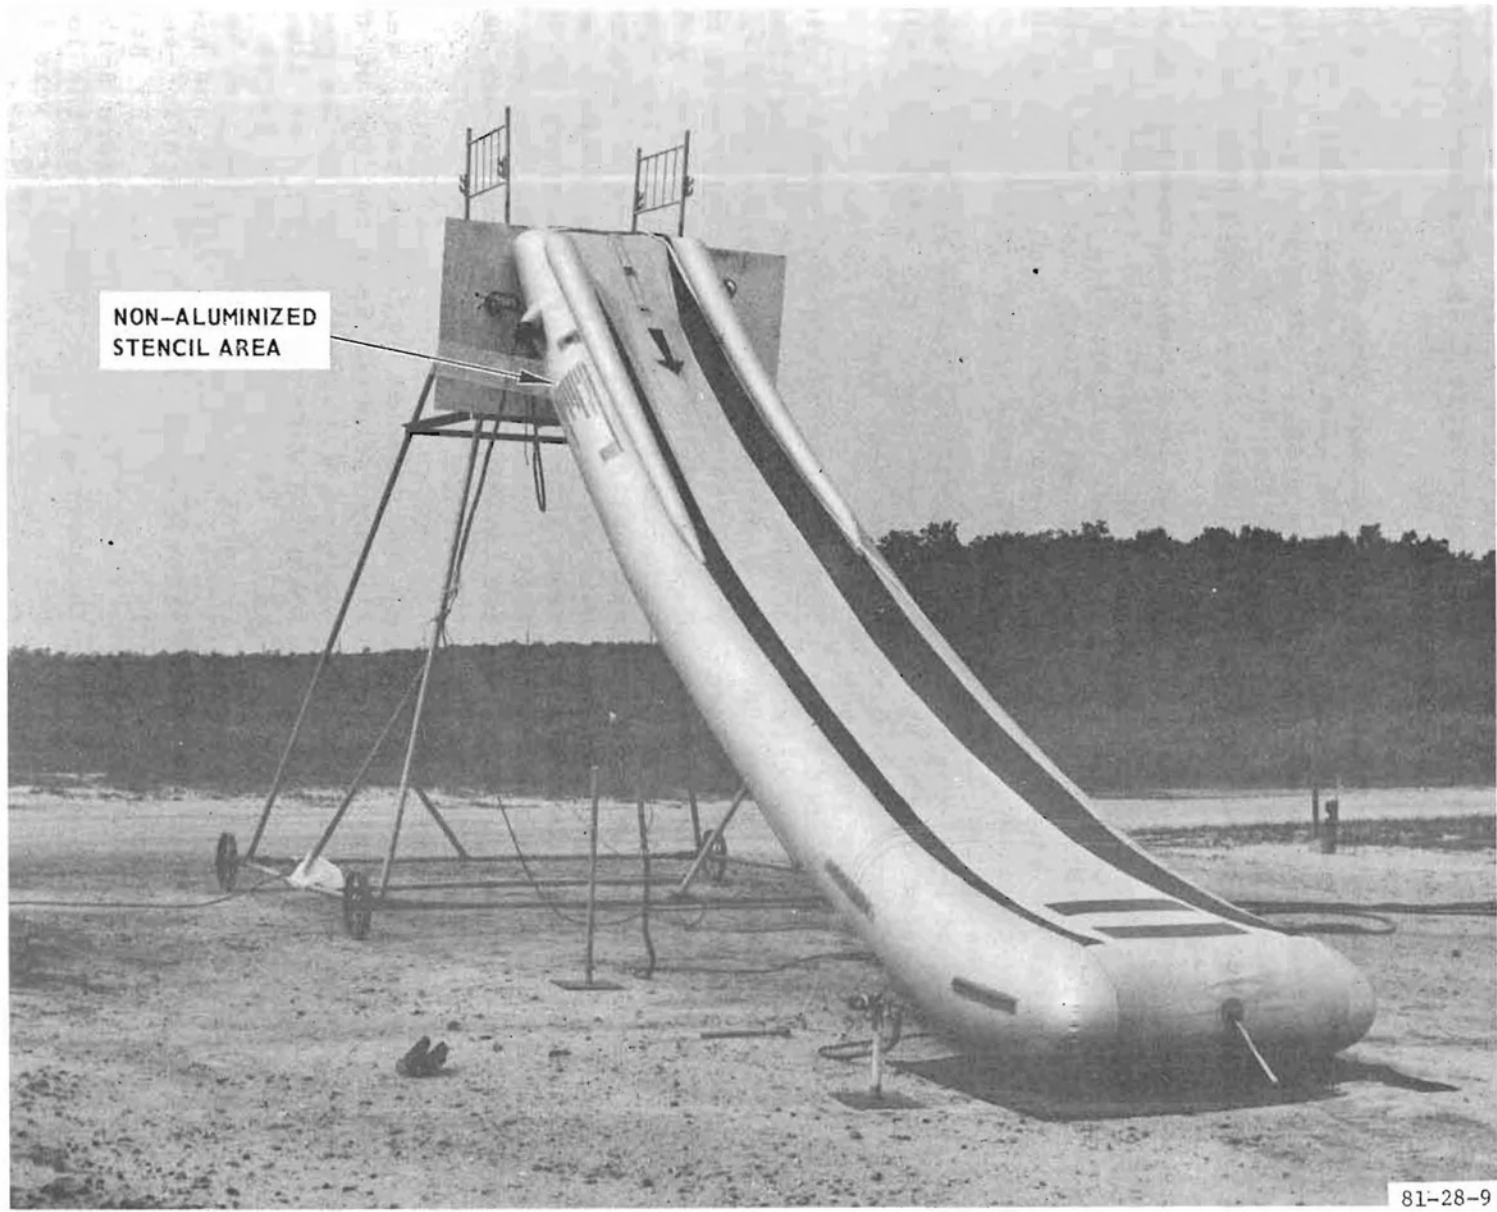
FIGURE 10. ALUMINIZED URETHANE NYLON WITH STENCILING SHOWING; TEST 16B

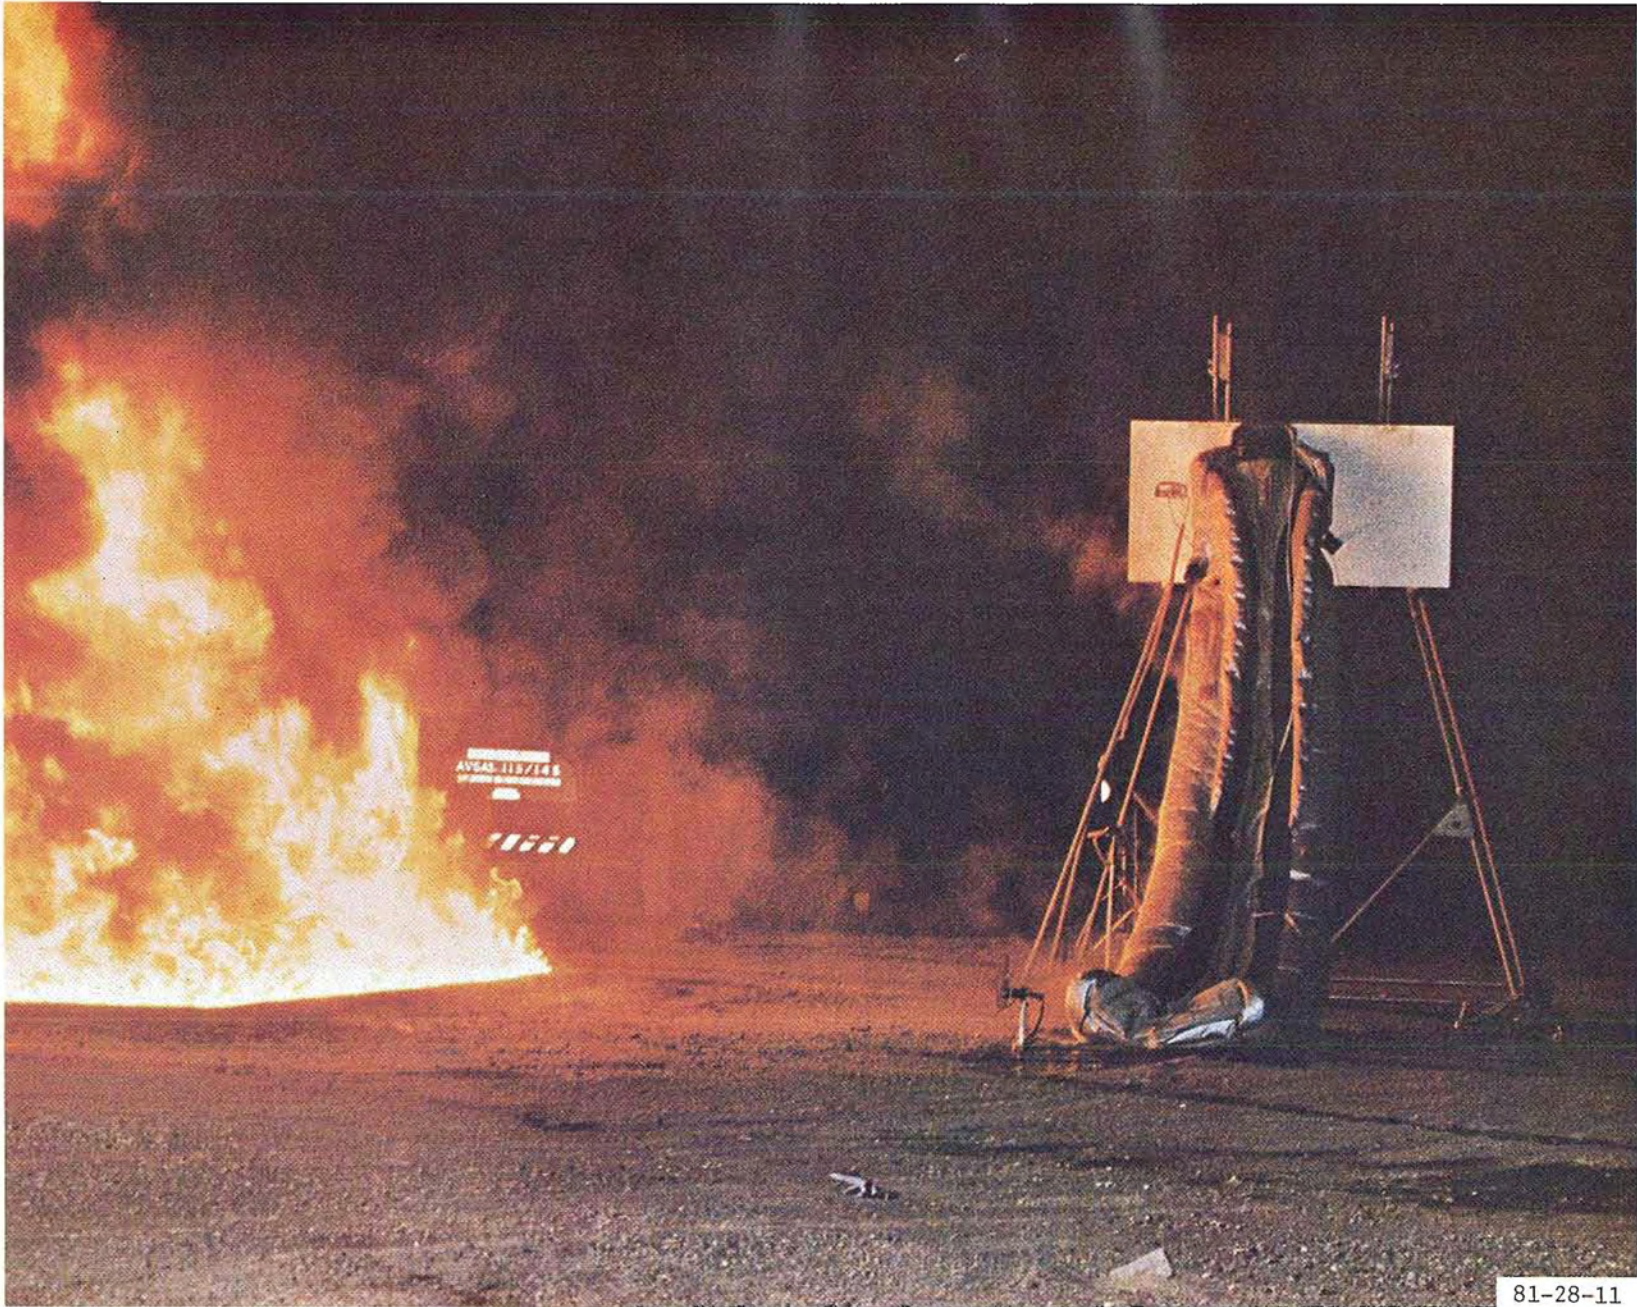
FIGURE 12. ALUMINIZED URETHANE NYLON SLIDE FAILURE DURING TEST; TEST 16B

The aluminized slide did not begin leaking pressure until 64 seconds into the test, exactly two times as long as the uncoated slide. The initial leakage which was gradual (figure B-13) was from a seam above the aspirator on the tube facing the fire. At 71 seconds, a more rapid leakage occurred from the non-aluminized, nonseam stenciled area below the aspirator facing the fire (see figure 12). By 80 seconds, slide "B" had leaked down to 0.25 psig. As shown in figure B-12, the heat flux levels impinging on the aluminized slide ("B") were higher than on the unprotected slide ("A"). Thus, one might surmise that, notwithstanding the unprotected stenciled area, had the aluminized slide been subjected to precisely the same radiation as the unprotected slide, the improvement would have been even greater. Again, wind conditions caused the fire to bend slightly toward the top of slide "B," producing a higher heat flux.

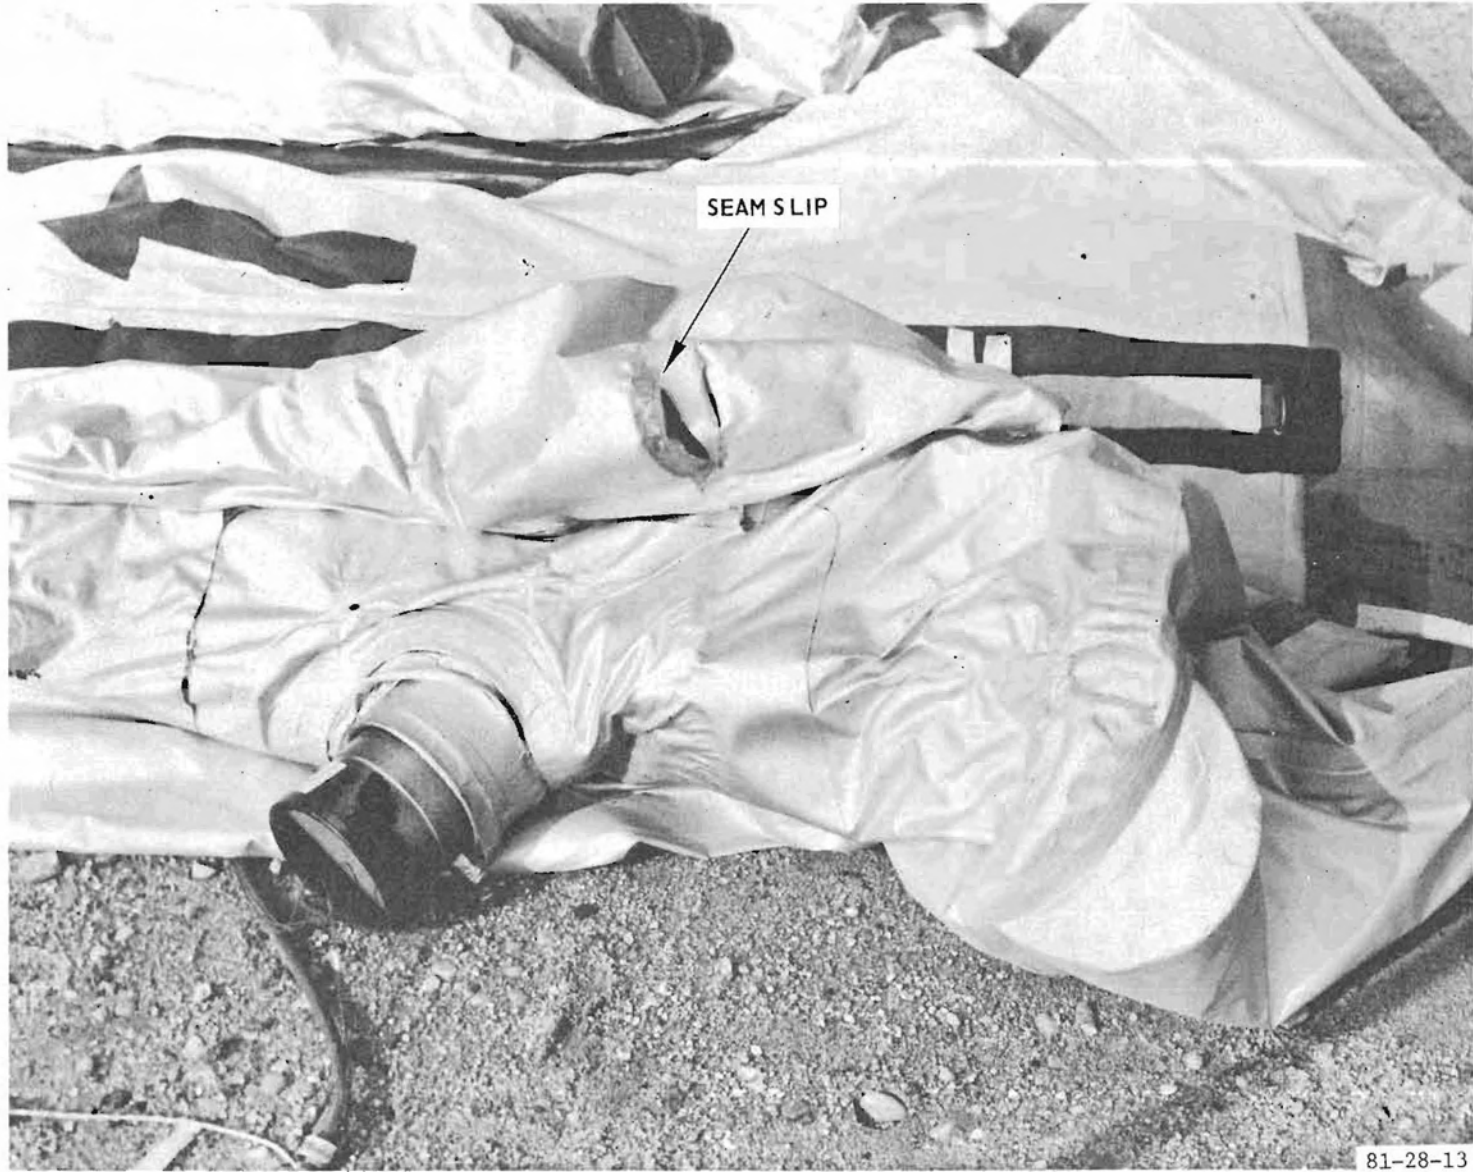
FIGURE 14. ALUMINIZED URETHANE NYLON SEAM SLIPPAGE; TEST 19

At 58 seconds into the test, seam slippage occurred near the top of the slide on a rounded corner of the upper retaining tube ("armrest") (see figure 14). The slide visually began to collapse at 85 seconds. The peak heat fluxes for the low, medium, and high calorimeters were 1.75 Btu/ft²-sec, 1.65 Btu/ft²-sec, and 1.25 Btu/ft²-sec, respectively (figure B-15). The average heat fluxes for the low, medium, and high calorimeters were 1.2 Btu/ft²-sec, 1.22 Btu/ft²-sec, and 0.85 Btu/ft²-sec, respectively (refer to appendix B-15). This test indicated that seam failure limited the potential heat resistance improvements provided by an aluminized coating applied to a
