1. Report No. FHWA/IN/JTRP-2004/37		2. Government Accession No.		3. Recipient's Catalog No.	
4. Title and Subtitle Performance Metrics for Freeway Sensors				5. Report Date December 2004

6. Performing Organization Code	
7. Author(s) Christos D. Achillides and Darcy M. Bullock				8. Performing Organization Report No.	
9. Performing Organization Name and Address Joint Transportation Research Program 550 Stadium Mall Drive Purdue University West Lafayette, IN 47907				10. Work Unit No.

11. Contract or Grant No. SPR-2713	
12. Sponsoring Agency Name and Address Indiana Department of Transportation State Office Building 100 North Senate Avenue Indianapolis, IN 46204				13. Type of Report and Period Covered Final Report

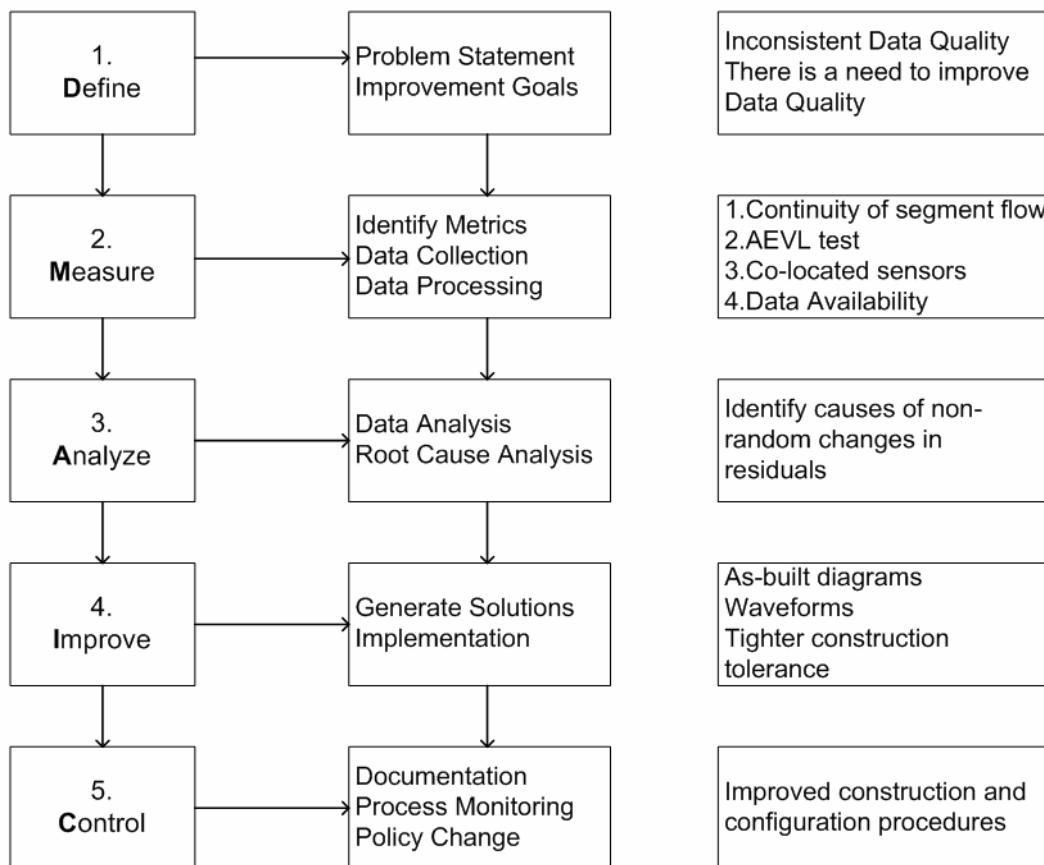
Figure 1-1: DMAIC Performance Improvement Model

A structured methodology for executing Six Sigma project activities is the Define, Measure, Analyze, Improve and Control process, abbreviated DMAIC (1, 2, 3). Many of the preliminary theory and discovery steps of this model have been addressed in this project. Figure 1-1 illustrates the steps of the DMAIC performance improvement model, which can be applied by any transportation agency to improve quality control of their traffic network data (4).

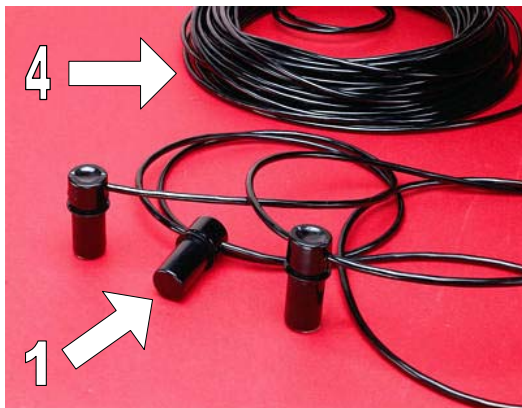
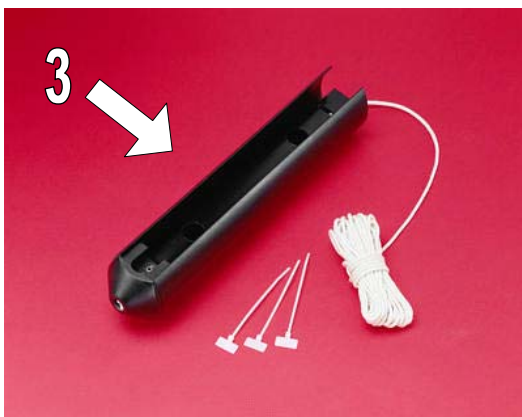
Figure 2-1 shows the main components of the microloop vehicle detection system.

a) Model 702 non-invasive microloop probe

b) Front panel of Canoga 944E Traffic Monitoring card

c) Model 702 installation kit and carriers

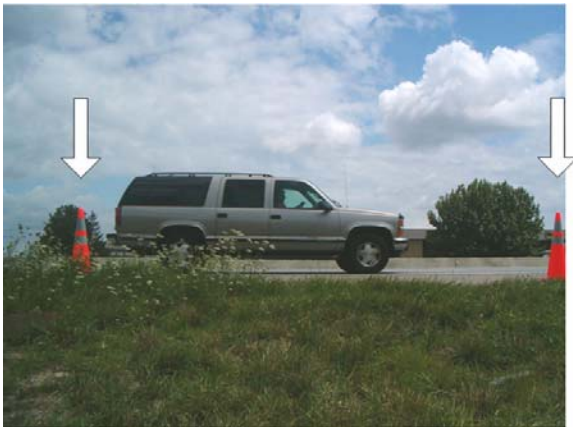
Figure 2-3 depicts an example of a detection zone defined by microloops on a test site located on I-465 (Indianapolis).

a) Microloop detection zone

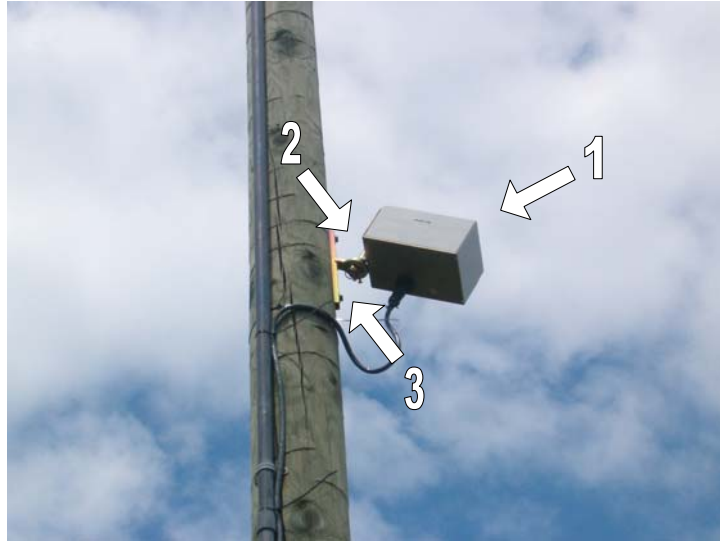
1. RTMS sensor
2. Ball joint mounting bracket
3. Connector kit

a) Radar Traffic Microwave Sensor (RTMS)

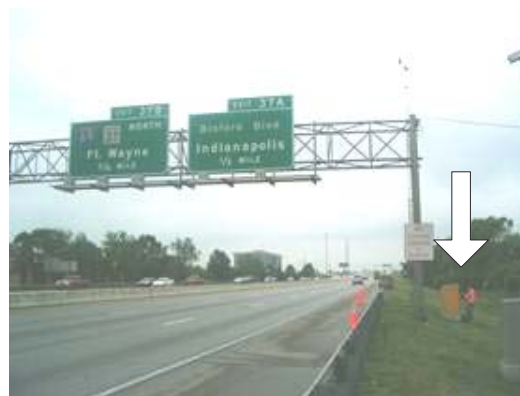
b) Site Photo

The test site is located on the eastbound direction of I-465, at Mile Post (M.P.) 36.2 as shown in Figure 4-1. The selection of the test site was made based on two criteria:

Figure 4-1: Study site

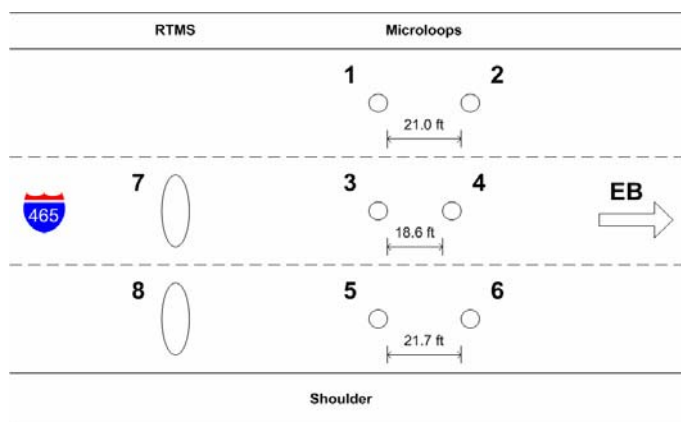
Figure 4-2: Configuration of microloops and RTMS with initial detector spacing

feet), and the detector spacing in lanes 1 and 3 (21.0 and 21.7 feet, respectively). This inconsistency will be discussed in more detail in Chapter 5.

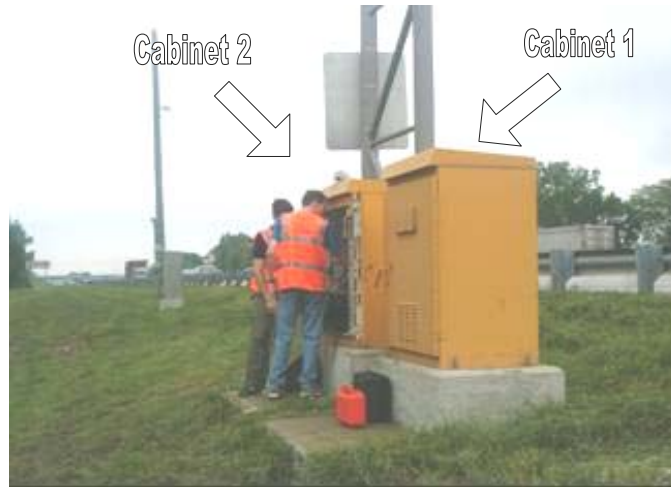
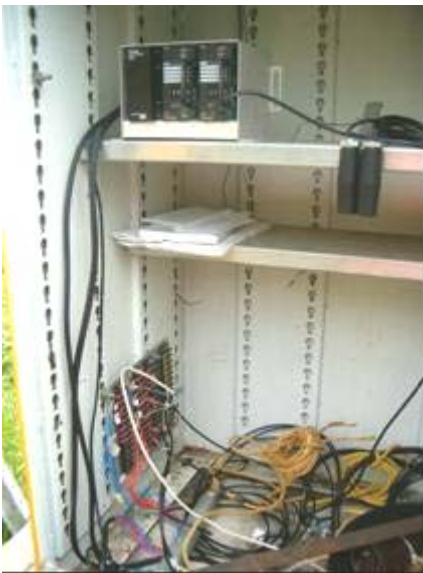
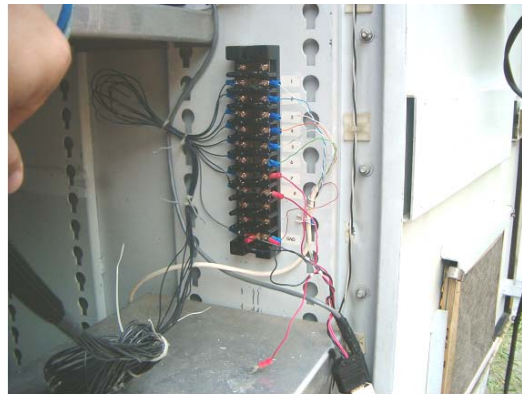
At the location, the equipment was located in two closely spaced cabinets as shown in Figure 4-3a and b. For the both technologies, the wires routed through the conduits and were lead to the second cabinet where they terminated to the terminal strip. Therefore, we had two options for providing data; a) directly over a serial bus and b) by “contact outputs” that simulate loop detector outputs from the traffic controller (Autoscope 2020) input files as depicted in Figure 4-3b and Figure 4-3c. Both options were applied for the two technologies. However, for this second option

a) Cabinets photo

b) Loop output in cabinet 1

c) Autoscope input in cabinet 2

Figure 4-3: Wires from cabinet 1 to cabinet 2

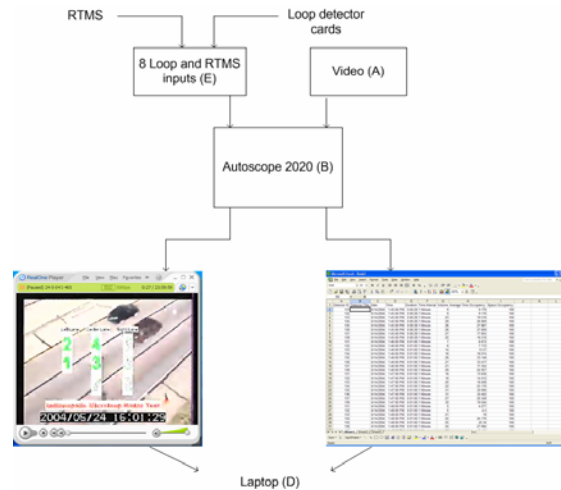
In cabinet 1, only the Canoga traffic monitoring cards were placed together with a second laptop to upload the collected data.

a) Photo of the equipment in the cabinet

b) Block Diagram

Figure 4-4: Equipment used for the evaluation

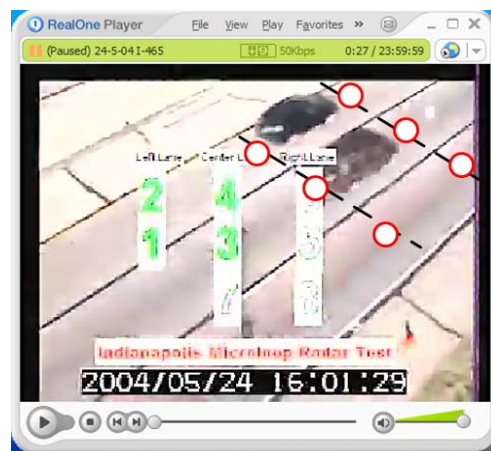
Figure 4-5 presents a screen capture of the video overlay of detector status with the approximate location of microloops (indicated by the small white circles). In the screen capture we can notice that channels 1, 2, 3 and 4 are ON (indicated by the green numbers) as there are two vehicles at this time on lanes 1 and 2, respectively.

Figure 4-5: Screen capture of the video overlay of detector status with approximate location of microloops shown (Channels 1, 2, 3 and 4 are ON)

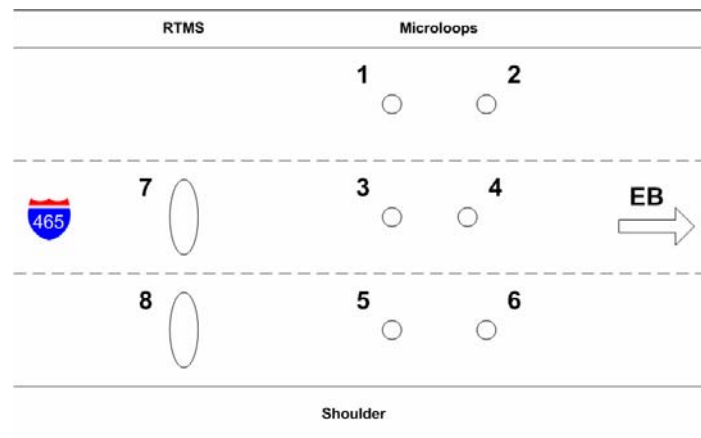
A time sequence example of vehicle detection for the test site, shown schematically in Figure 4-6, is depicted in Figure 4-7. On the video overlay shown, there are eight numbers representing the microloops and RTMS sensors at the site location, as follows:

- Numbers 1 and 2 correspond the leading and lagging microloops, respectively, in the left lane (Lane 1)
- Numbers 3 and 4 correspond the leading and lagging microloops, respectively, in the center lane (Lane 2)
- Numbers 5 and 6 correspond the leading and lagging microloops, respectively, in the right lane (Lane 3)
- Numbers 7 represents the RTMS sensor in the center lane (Lane 2)
- Numbers 8 represents the RTMS sensor in the right lane (Lane 3)

Figure 4-6: Site configuration

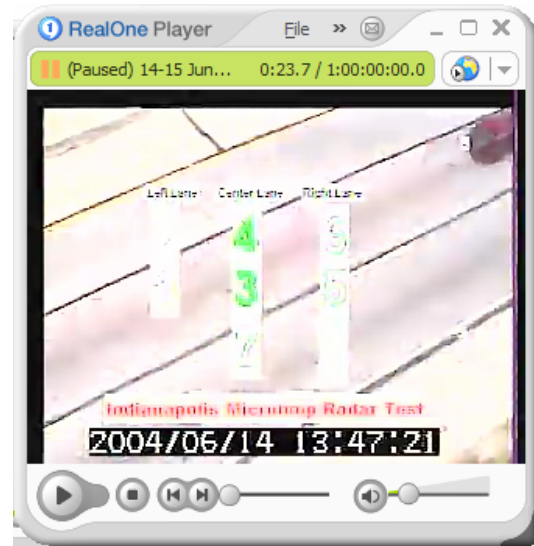
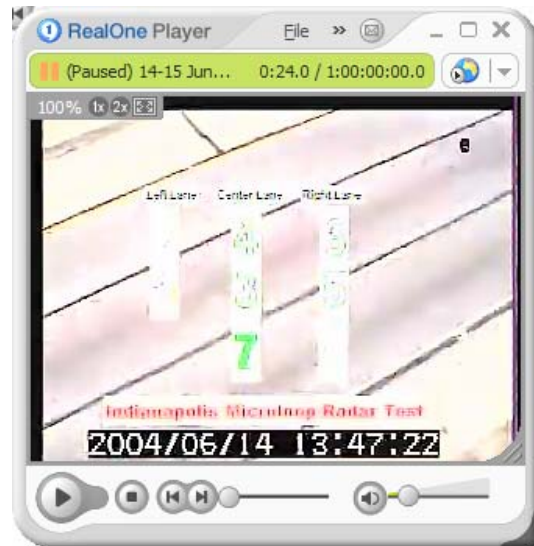
At the time that the vehicle passes over the lead detector, number 3 turns “ON” ,indicating a vehicle detection in lane 2 (Figure 4-7a). As the vehicle continues its way, number 4 turns “ON” to indicate that the vehicle passes over the lag detector of lane 2, as well (Figure 4-7b). A few hundreds of seconds later, number 3 turns “OFF”, resulting that the vehicle is not within the detection zone of the leading microloop any more (Figure 4-7c). However, the vehicle is still in the detection zone of the lagging microloop. Finally, as shown in Figure 4-7d, the vehicle gets out of the detection zone of the lagging detector, and at the same time, the RTMS sensor indicates that another vehicle (not shown in the figure) is detected and is expected to pass over the microloops in the next few seconds.

a) Channel 3 is ON and channel 4 is OFF

b) Both channel 3 and channel 4 are ON

c) Channel 3 is OFF and channel 4 is ON

d) Both channel 3 and channel 4 are OFF

Figure 4-7: Example of vehicle detection on channel 3 and 4 in lane

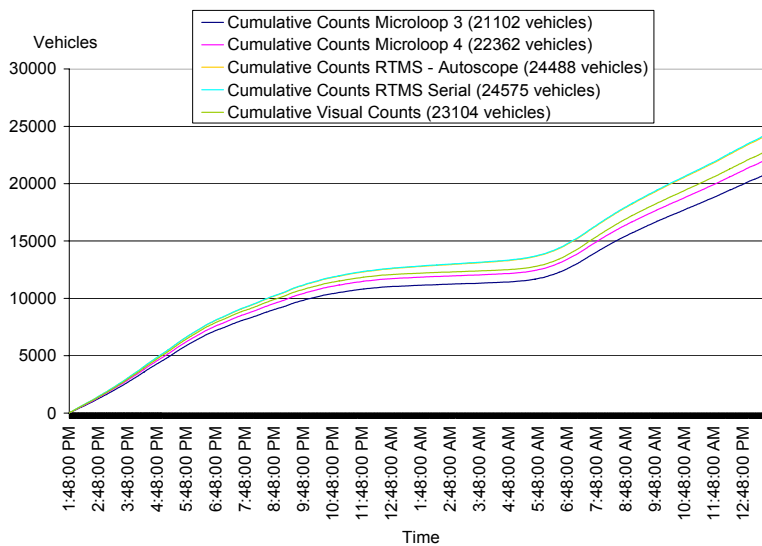
For instance, after the data collection of June 14-15, 2004, it was observed that for the center lane (lane 2) there were significant discrepancies concerning the vehicle counts between RTMS, microloop and visual counts. Figure 4-8 illustrates that the results between microloops 3 and 4 were different by more than 1200 vehicles for the particular day.

Figure 4-8: Cumulative microloop (Autoscope), RTMS (Autoscope and Serial) and visual counts for Lane 2, on I-465 at M.P. 36.2 on June 14-15, 2004

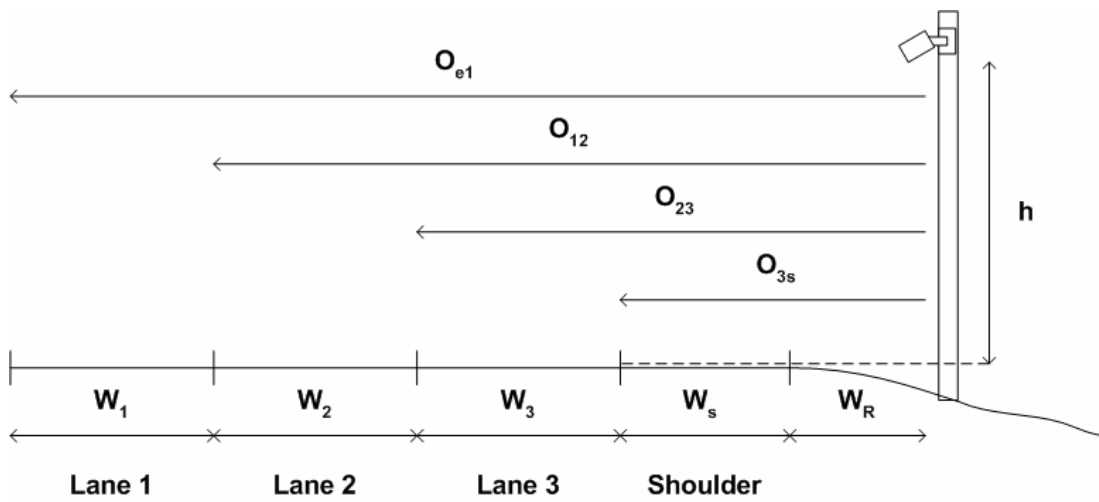
Figure 4-12: RTMS Offsets

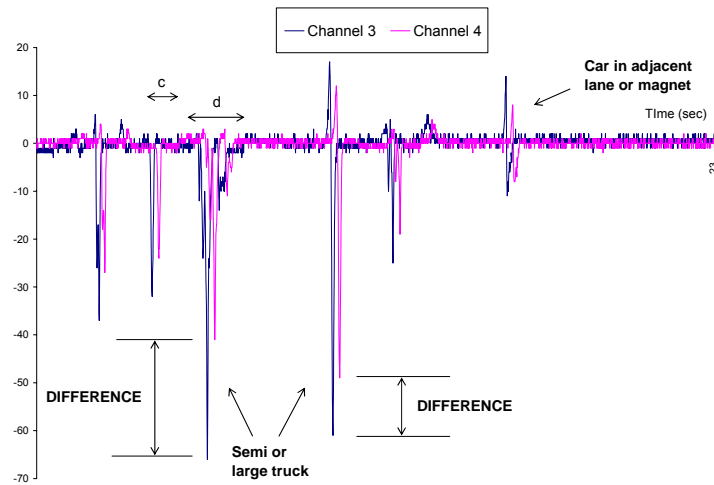
In contrast, the waveform analysis of lane 2 indicated that there were large amplitude differences between the leading and the lagging microloop as illustrated in Figure 5-3. Several hypotheses were considered to explain this fact. The most reasonable explanations were that either a

drainage tile was present under the surface of the pavement affecting the performance of the microloops, or the probe depths were inconsistent.

Figure 5-3: Microloop waveforms in Lane 2 at I-465 EB M.P. 36.2

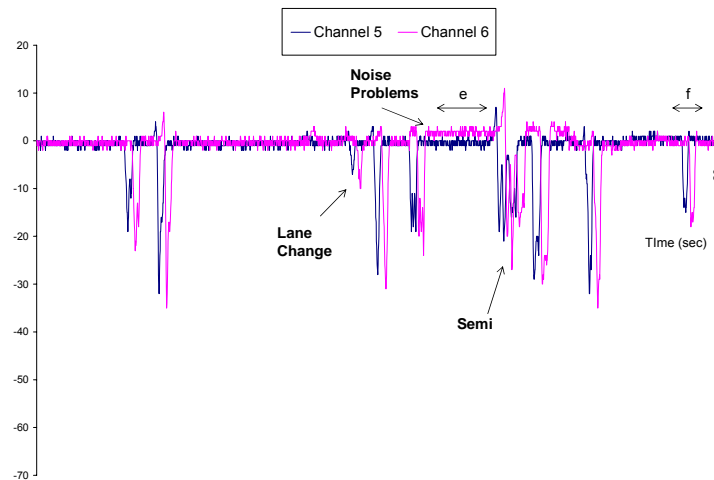
The waveform analysis for lane 3, depicted in Figure 5-4, did not show any important indications, except for some noise problems probably because of the presence of a class-9 vehicle.

Figure 5-4: Microloop waveforms in Lane 3 at I-465 EB M.P. 36.2
