FHWA/IN/JTRP-2004/6

**EVALUATION OF SURFACE (TOP DOWN) LONGITUDINAL
WHEEL PATH CRACKING**

Joint Transportation Research Program
Project No. C-36-31P
File No. 2-11-16
SPR-2788

Purdue University
West Lafayette, Indiana
September 2004

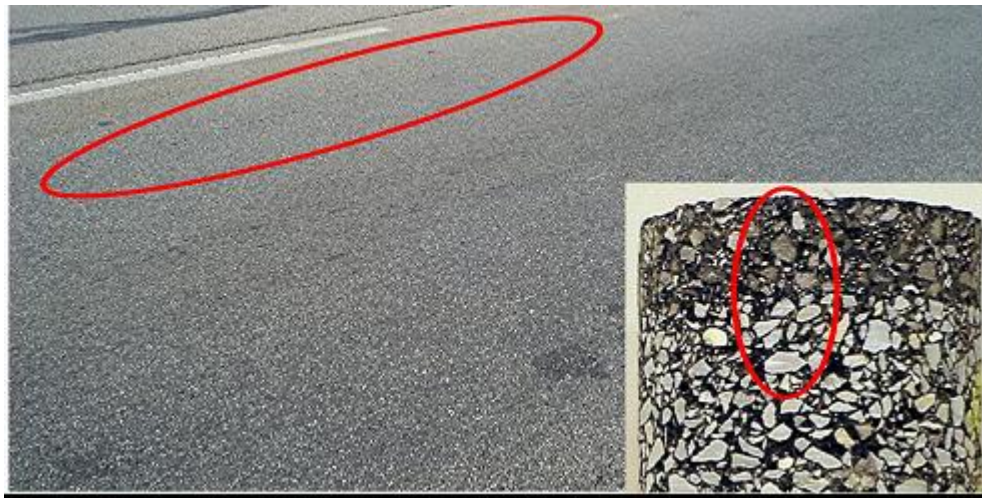
Figure 1: Surface cracked major interstate highway (I-65 North) in Indiana.

Surface-initiated longitudinal wheel path cracking in asphalt pavements, Figure 1, has been reported as a widespread mode of failure in asphalt concrete pavements. It is a phenomenon that has recently attracted a large amount of interest and very few theories have been presented so far that fully explain the phenomenon of the top-down cracking mechanism. Studies performed by various researchers have shown that the existing design and evaluation methods that use average conditions are inadequate for predicting this type of surface cracking. The mechanisms controlling surface cracking are related to the fracture properties of the asphalt mixture loaded by traffic and climate. Work in recent years has suggested several theories for understanding these mechanisms. However, additional studies of in-situ pavements are needed to develop a complete understanding of the top-down cracking phenomenon to develop better rehabilitation guides for these pavements.

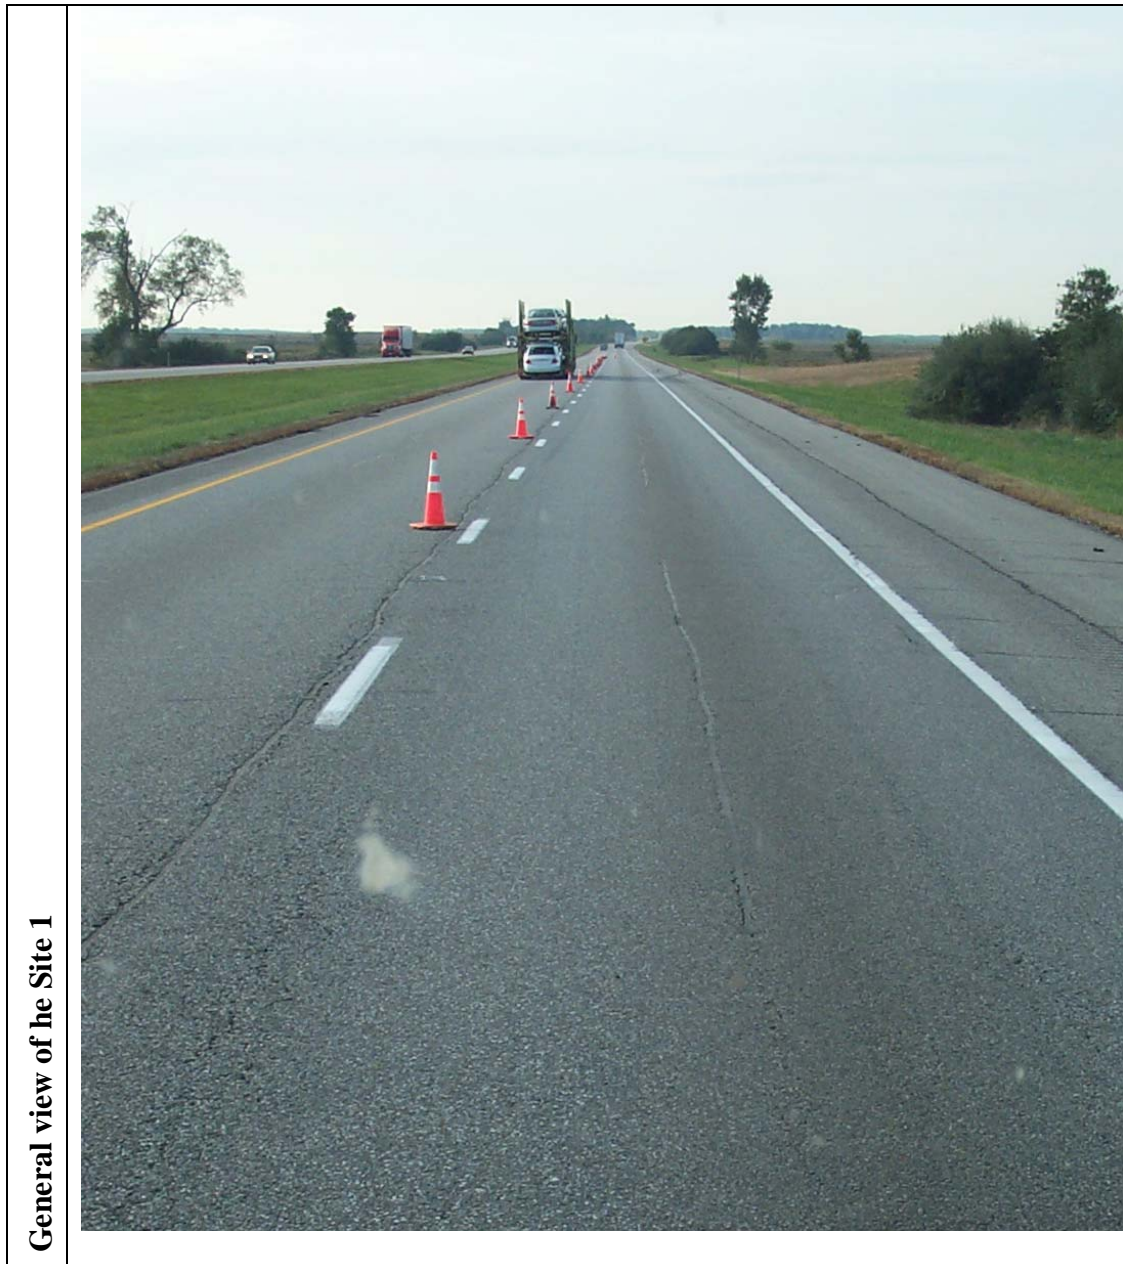
Figure 10: Site 1, I-65 North of Lafayette.

For Site 1 the centerline cracking may be caused by segregation by the auger gear box in the center of the paver screed. The gear box may cause segregation as the mix is transported from the tunnel to the augers. The wheel path cracking may also be initiated from the areas of segregated mix, although in this case it seems to be less likely; see Figure 10.

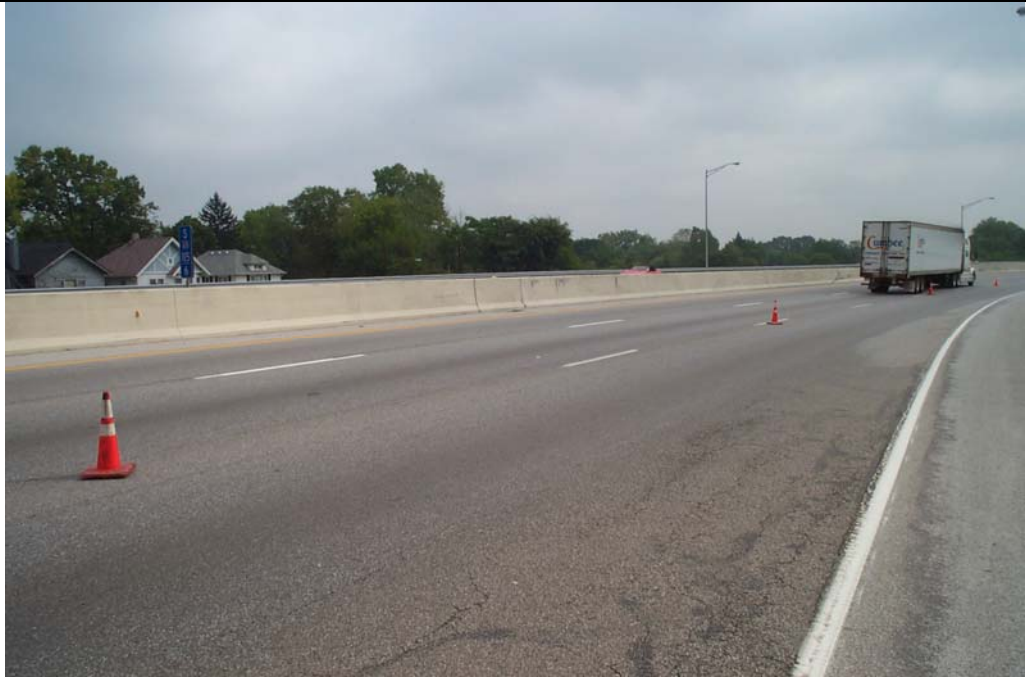
Figure 11 (a): General view of he Site 2

For Site 2 the outside wheel path cracking may also be initiated by segregation caused by screed extensions and edges of tunnel similarly as described for Site 3 above. In this case the weak area of the pavement is 0.5 meters outside of the wheel path which is consistent with the wider paving lane width of 4 meters; see Figure 11 (a).

Based on literature review, top-down cracks may initiate from the segregated areas in the pavement, which exhibit weaker material properties. Based on the visual survey, none of the sites seem to have exhibited load-end segregation as Figure 10, Figure 11 (a), and Figure 11 (b) show. Load-end segregation manifests itself as coarser and more open mat texture repeating about 25 to 30 meter intervals. However, this finding was not verified by laboratory testing.

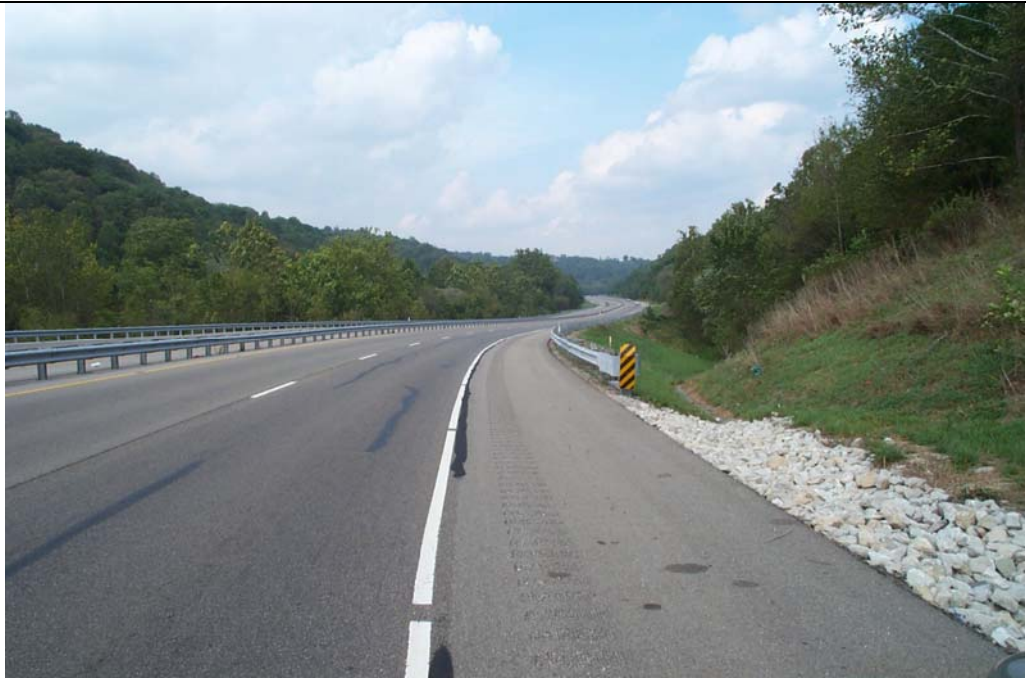
Figure 11 (b): General view of he Site 3

Longitudinal surface cracking in Site 3 was systematically located in the left wheel path area with some symmetrical cracking in the right wheel path; see Figure 11 (b). This may indicate some longitudinal mix segregation caused by screed extensions in the paver. The width of the paving lane is approximately 3.5 meters, which means that screed extensions were used to cover the entire paving width with one paver pass. The screed extensions can cause segregation of the mix depending on the specifics of the screed used and segregation tendency of the mix.

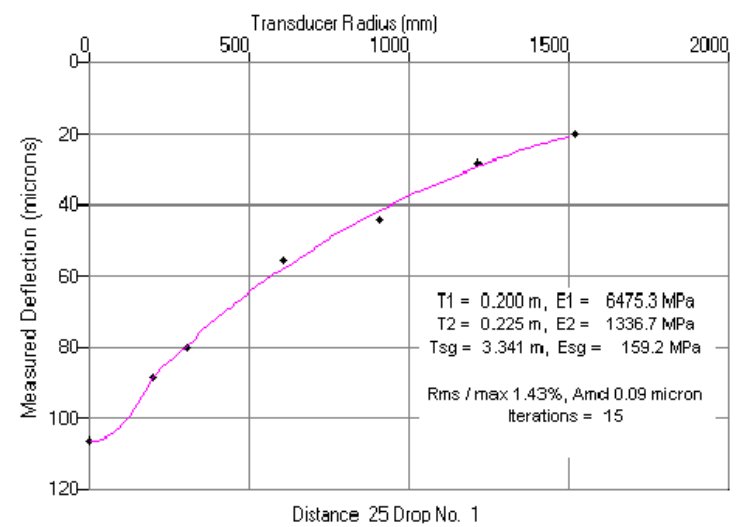
Figure 19: Example of fitted and measured FWD bowls, Site 3 US-421 Madison.

In the equations, the partial derivatives are estimated numerically, by elastic layer analysis. The deflection analysis provides the measured deflection bowl and the resulting fitted back-calculated bowl. A typical result is illustrated in Figure 19.

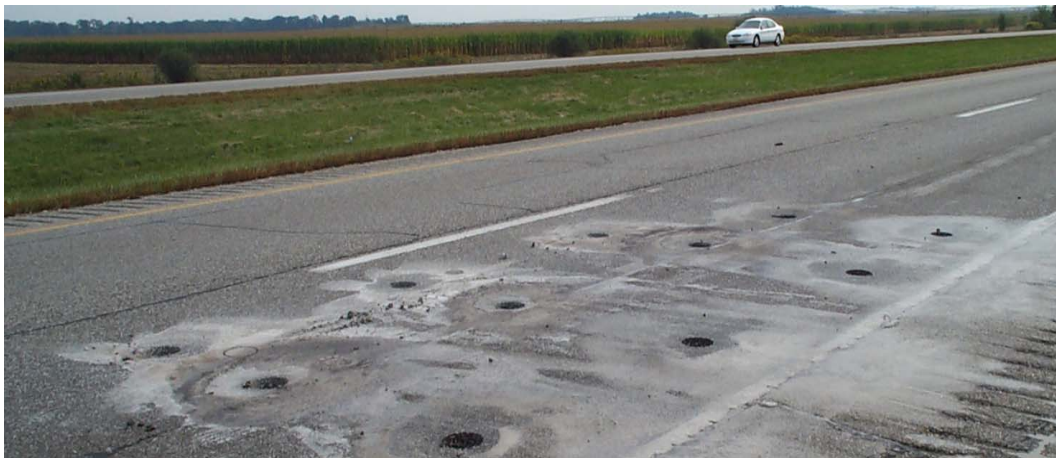
Figure 20: Coring locations in the pavement, Site 1.

The coring locations, mile posts, and exact distances between cores for the three sites are mapped in the distress data sheets presented in Appendix A. Figure 20 shows the coring location for Site 1 (I-65 North of Lafayette).

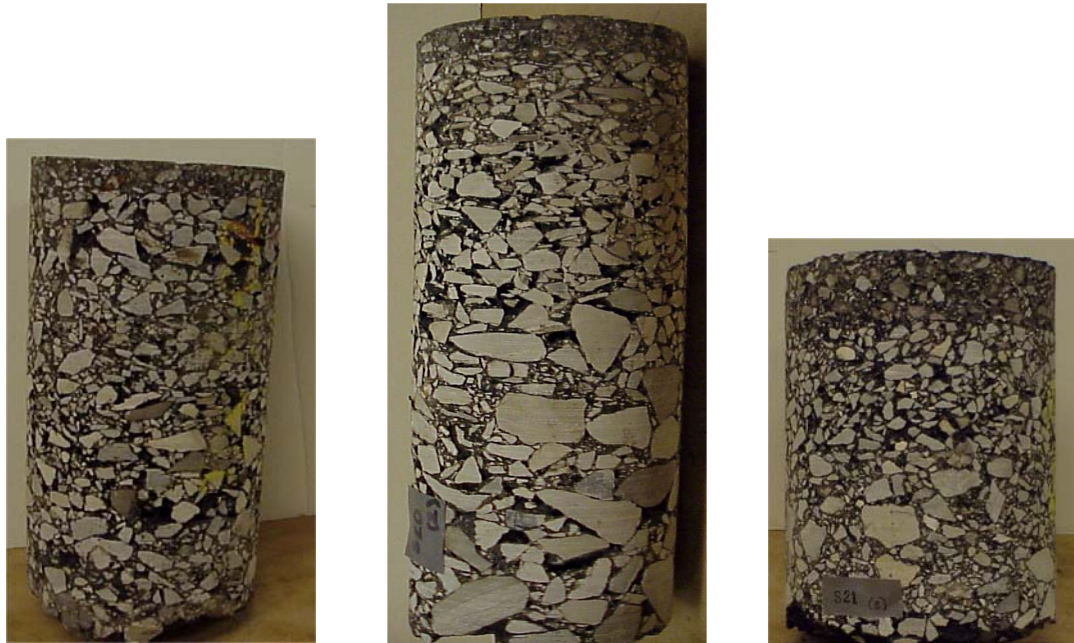
Site 1: Core height 300 mm Site 2: Core height 430 mm Site 3: Core height 200 mm

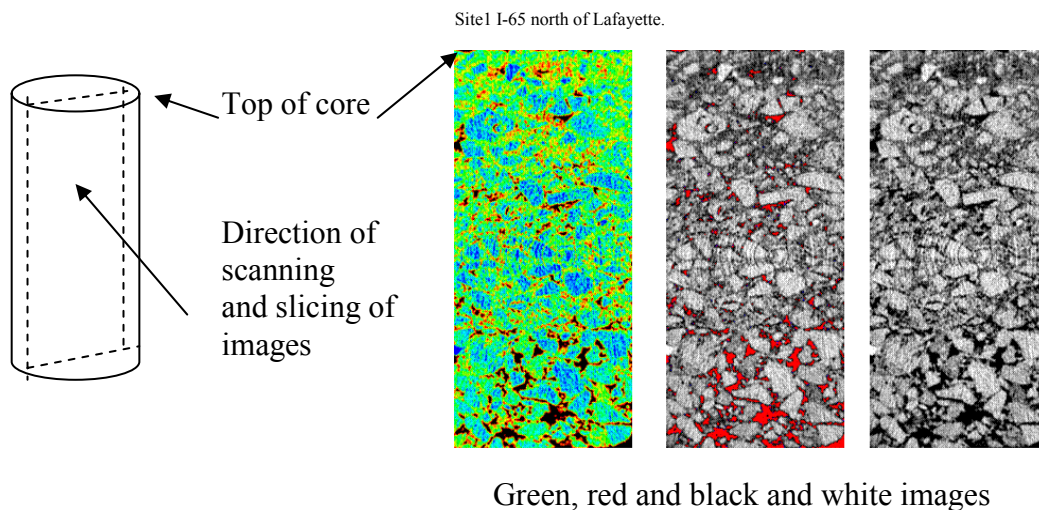
Figure 27. Scanning of Cores.

A cross-sectional picture of the cores was reconstructed from the scanned image. The 3-D picture was then sliced into 184 slices for Site1 and Site3, and 186 slices for Site 2, to investigate crack propagation inside the core. Figure 27 shows the same scanned slice in three different color combinations, green, red and black & white. The ID of the core shown in Figure 27 is S16 (1) and it is from Site1 I-65 north of Lafayette. No visible cracks can be detected inside the core.

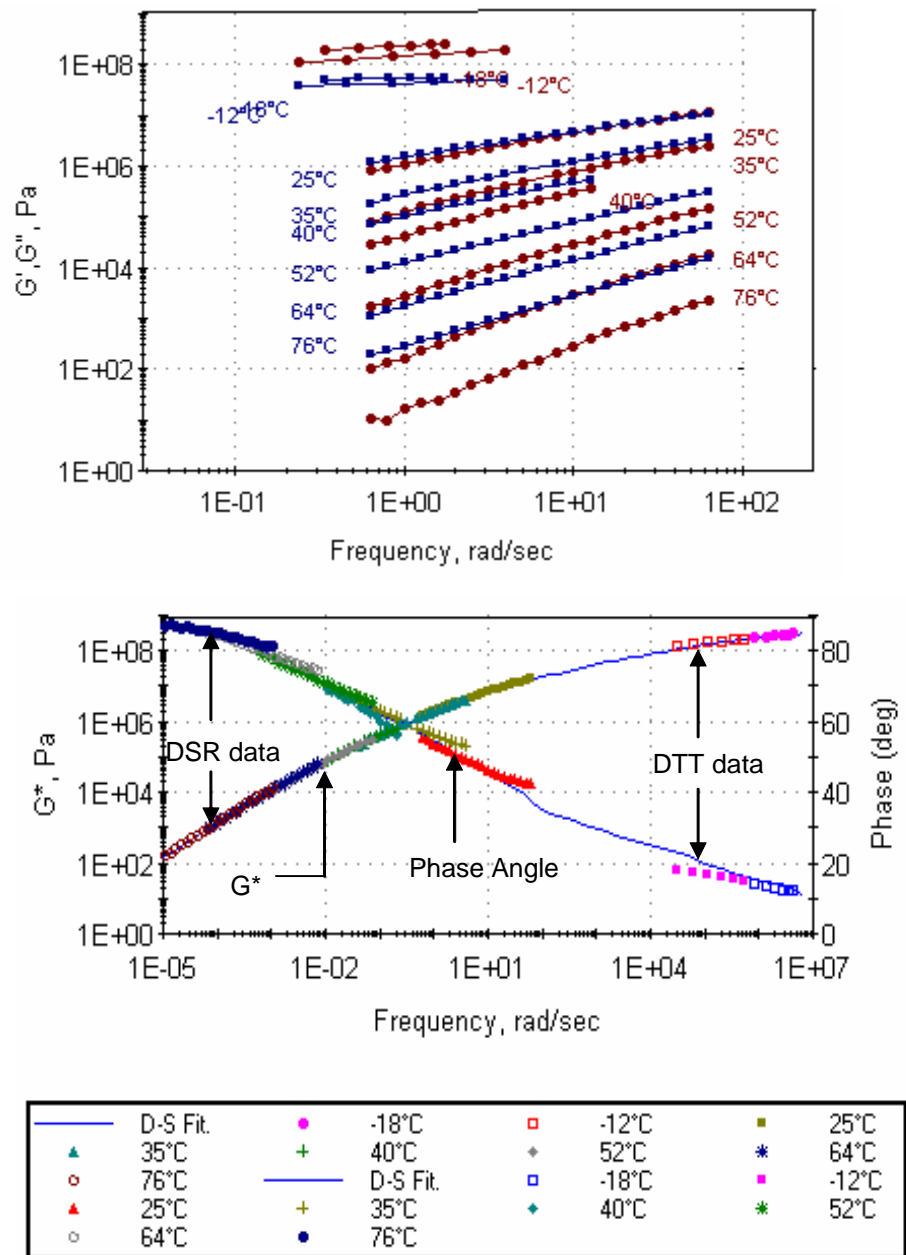
Figure 35: Master curve for shear complex modulus $|G^*|$, Site1.

Figure 35 shows the constructed master curve for Site 1; Figure 36 shows Site 2; and Figure 37 shows the master curve for Site 3. In each figure the first figure (a) presents the raw data or measured data without the shifting for storage modulus G' and loss modulus G'' . In each figure the second figure (b) shows the shifted data for the shear complex modulus $|G^*|$ as a function of reduced frequency (angular velocity in radians per second). The figures also show the measured and shifted phase angle as a function of reduced frequency. As the frequency decreases the phase angle approaches 90° indicating pure viscous material behavior.

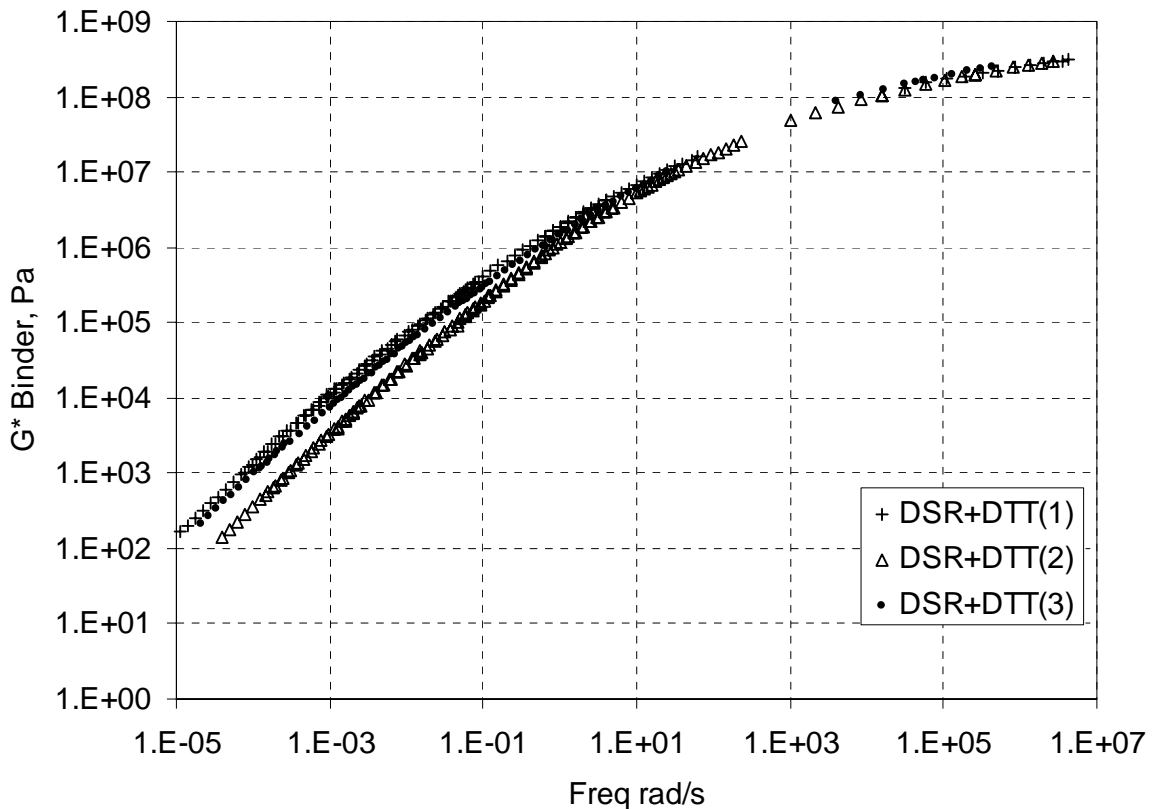
Figure 38: Comparison of binder shear stiffness $|G^*|$ master curves.

From the DSR data it was estimated that the high temperature performance grade for Site 1 binder was PG 82, for Site 2 PG 76, and for Site 3 PG 82. Thus, Site 1 had aged three PG grades while Site 2 and 3 had aged two PG grades.

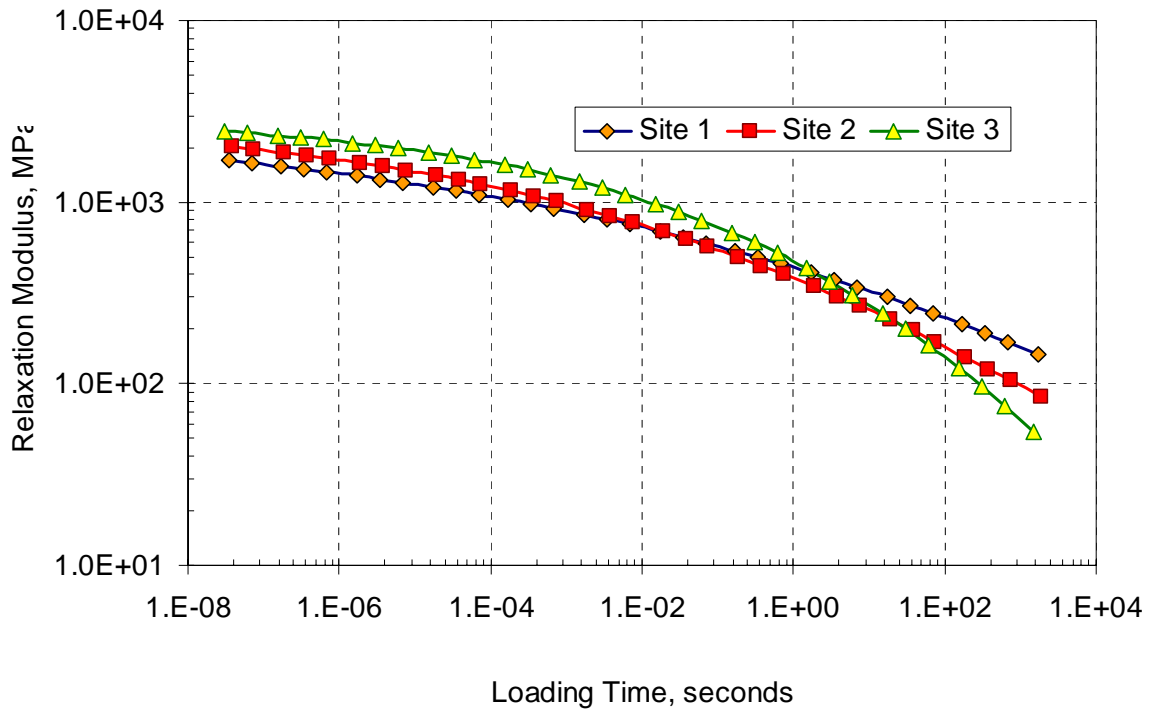
Figure 39: Relaxation modulus $E(t)$ master curve, $T_{ref} = -12^{\circ}\text{C}$.

The parameters used enable construction of the master curves as illustrated in Figure 39 from which it can be observed that the curvature results in a lower stiffness at longer loading times. The flatter slopes of Sites 1 and 2 are more indicative of oxidized materials as would be expected when considering the relative ages of the sites. The binder in Site 3 has significantly better relaxation properties (e.g. slope of master curve at loading time at approximately 60 seconds on this plot – equivalent to an m-value for a binder being considered for a -22 grade) at the conditions associated with thermal cracking. In addition, at the loading time of 60 seconds Site 3 has the lowest relaxation modulus with Site 1 having the highest which is consistent with the age of Site 3 and Site 1. Site 2 had been in service one year more than Site 1 but the binder in the mix had slightly better relaxation properties compared to Site 1. These findings are in agreement with the critical cracking temperature calculations, as expected.
