FHWA/IN/JTRP-2001/10-I-2

**FATIGUE BEHAVIOR OF BEAM DIAPHRAGM CONNECTIONS
WITH INTERMITTENT FILLET WELDS**

PART I, VOLUME 2: LABORATORY FATIGUE EVALUATION

Purdue University
School of Civil Engineering

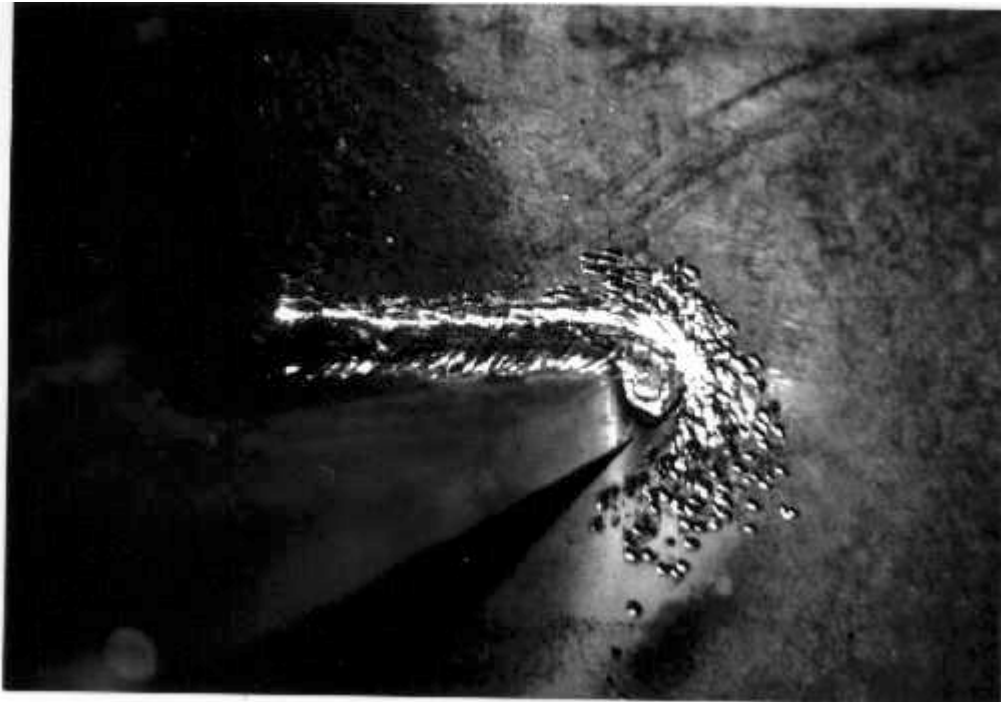
Figure 4.10 Photograph of the peened bottom flange weld area

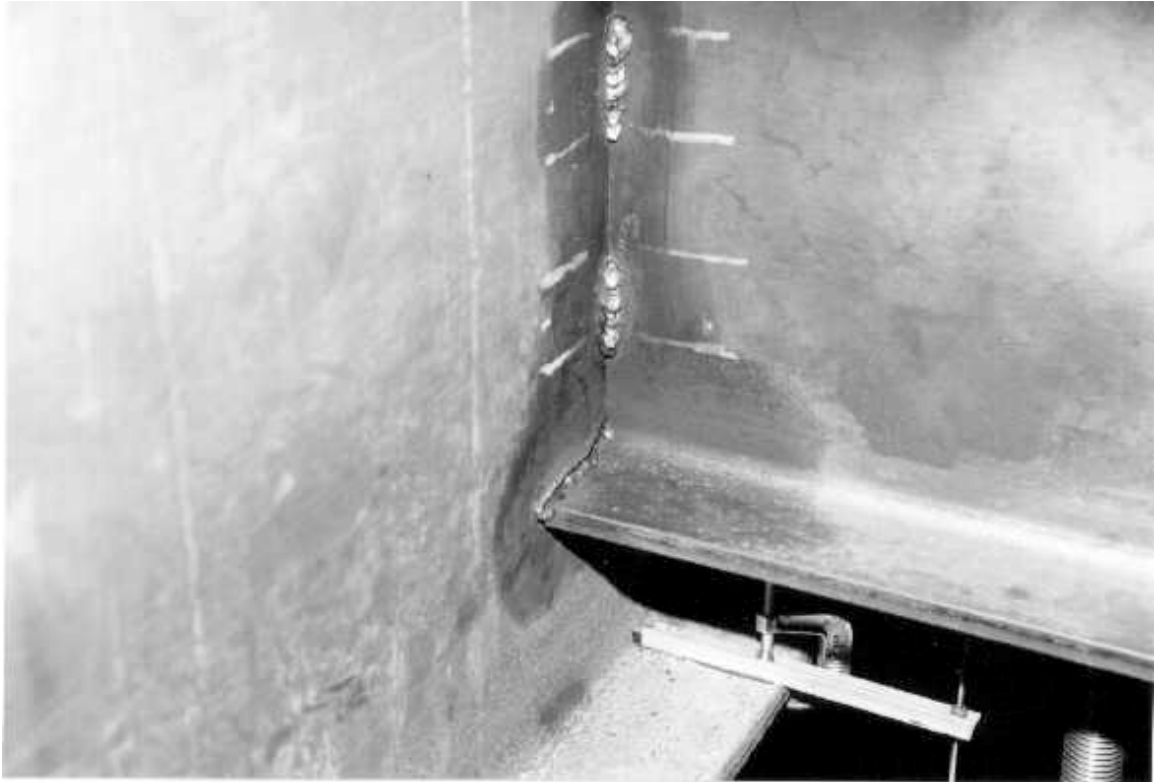
Figure 4.33 Typical fractured bottom weld in nonstaggered diaphragm tests

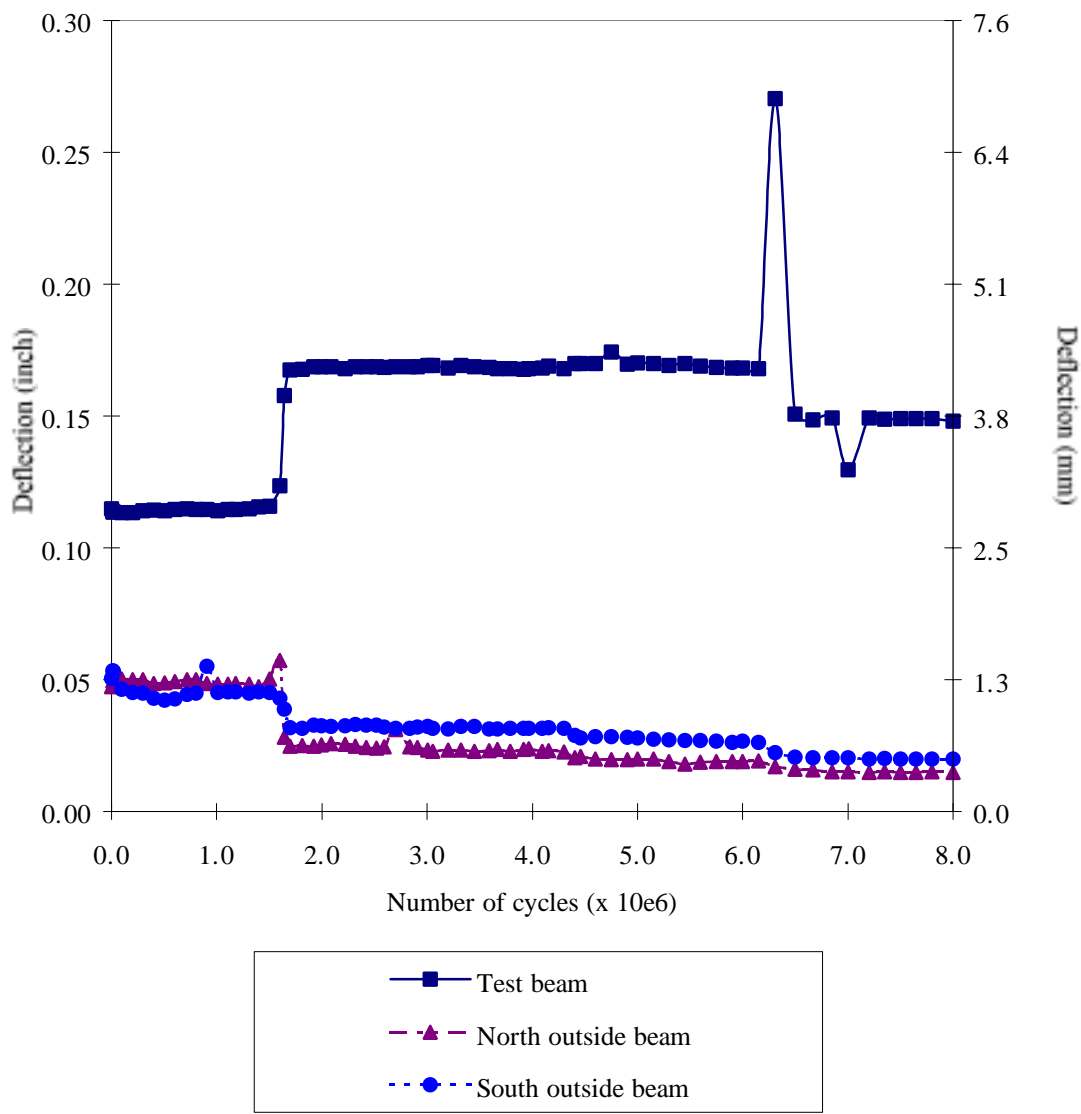
Figure D.1 Deflection measurements for NS-NR(30)

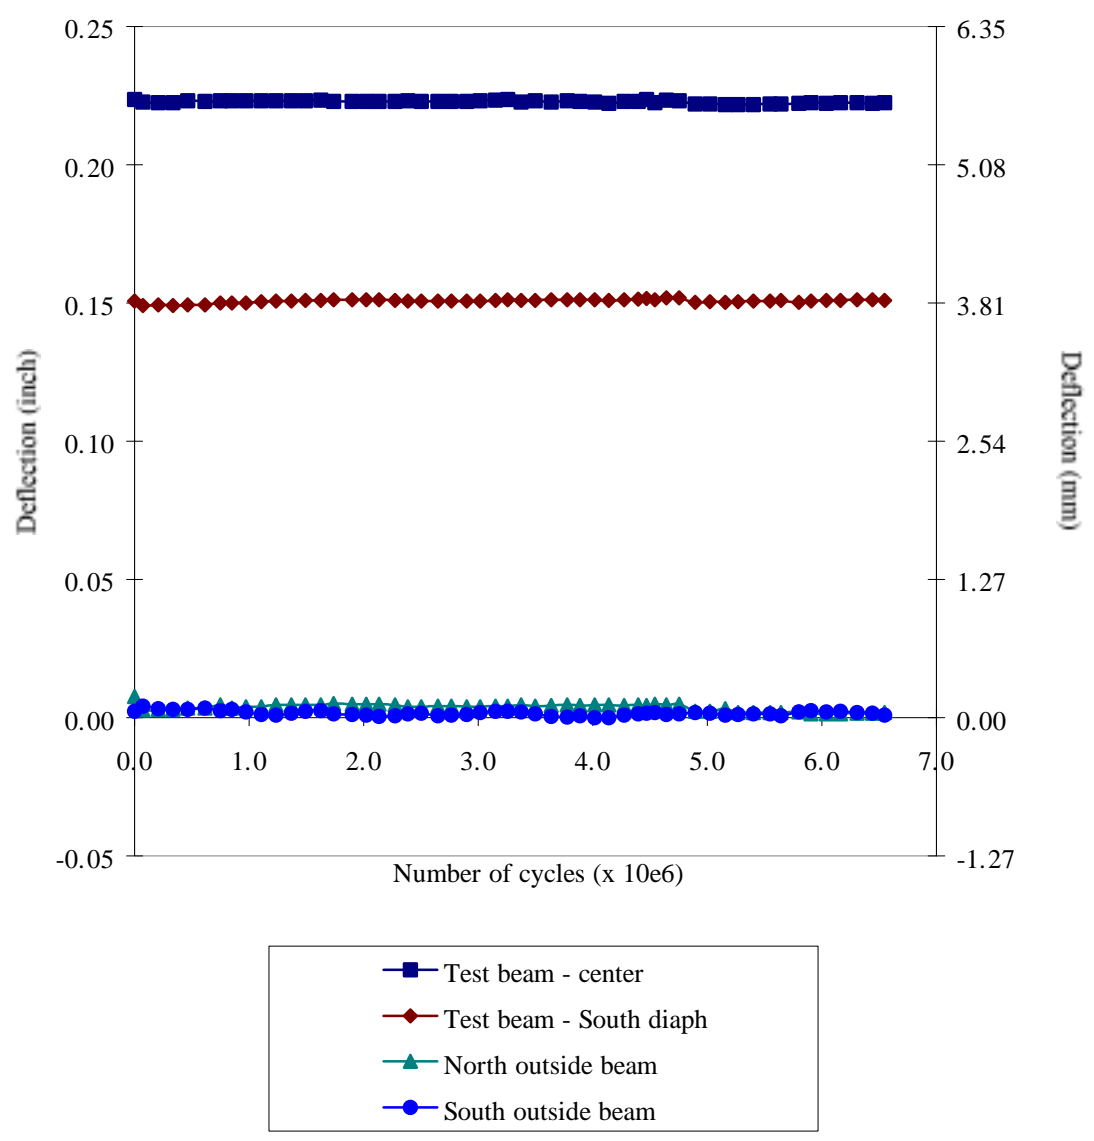
Figure D.22 Deflection measurements for SL-NR(45)
