FHWA/IN/JTRP-2001/22

**EVALUATION OF SELECTED VIDEO
DETECTION SYSTEMS AT SIGNALIZED
INTERSECTIONS**

**Jeromy Grenard
Darcy Bullock
Andrzej P. Tarko**

School of Civil Engineering
Purdue University

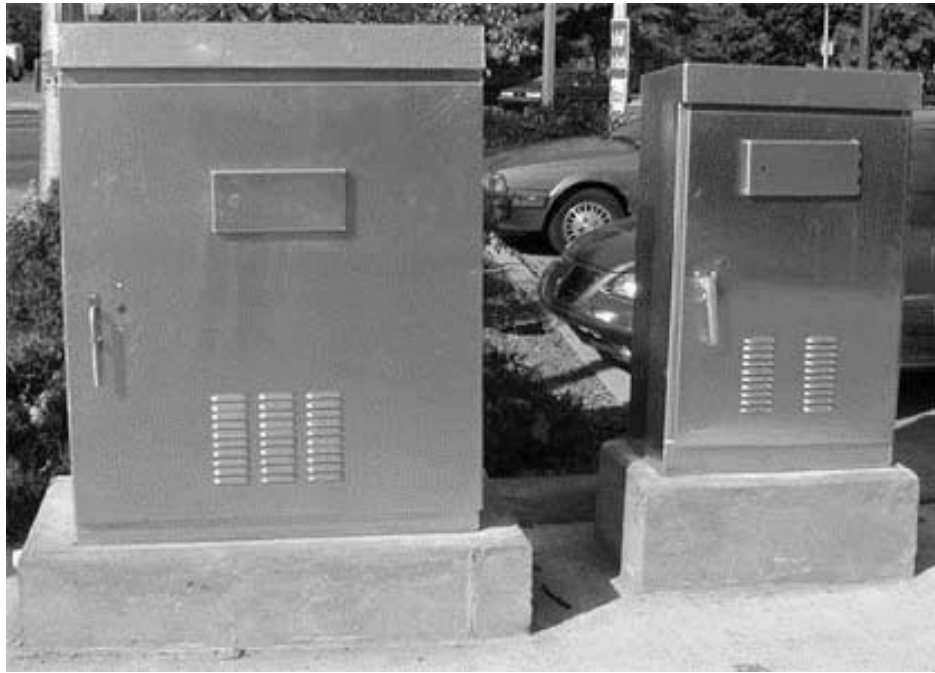
Figure 3-7: INDOT and Purdue Cabinets

The INDOT traffic cabinet, shown in Figure 3-7 and Figure 3-8, at the location of the test bed contains the normal equipment that one would find at a fully actuated intersection. The only difference that exists can be found on the back panel of the cabinet, which is “tapped” with optically isolated modules for research purposes. This in no way affects the control at the intersection. It merely allows for the vehicular calls placed on all detectors, and the signal states that result from the control of the controller to be replicated inside the lab. The wires that are connected to the back panel of the INDOT cabinet are fed through

The purpose of the Purdue University Traffic Cabinet, shown in Figure 3-7 and Figure 3-9, is to house the fiber video transmitters, shown in Figure 3-11 as NW05 – NW08, and the Controller Interface Devices (CIDs), shown in Figure 3-12 as NW01 and NW02, that recognize the states of detectors and signals coming from the INDOT cabinet. The devices labeled NW01 provide the "brains" of the device, and are linked to a high speed Ethernet link. The devices labeled NW02 are the optically isolated interface modules connected to the INDOT cabinet, NW03. The purpose of the Traffic Signal Interface Board is to read the signals coming from the back panel of the INDOT cabinet. The fiber video transmitters (Figure 3-11, CIVL 05 – CIVL08) turn the video camera signals into a form that can be sent through fiber optic cables into the lab.

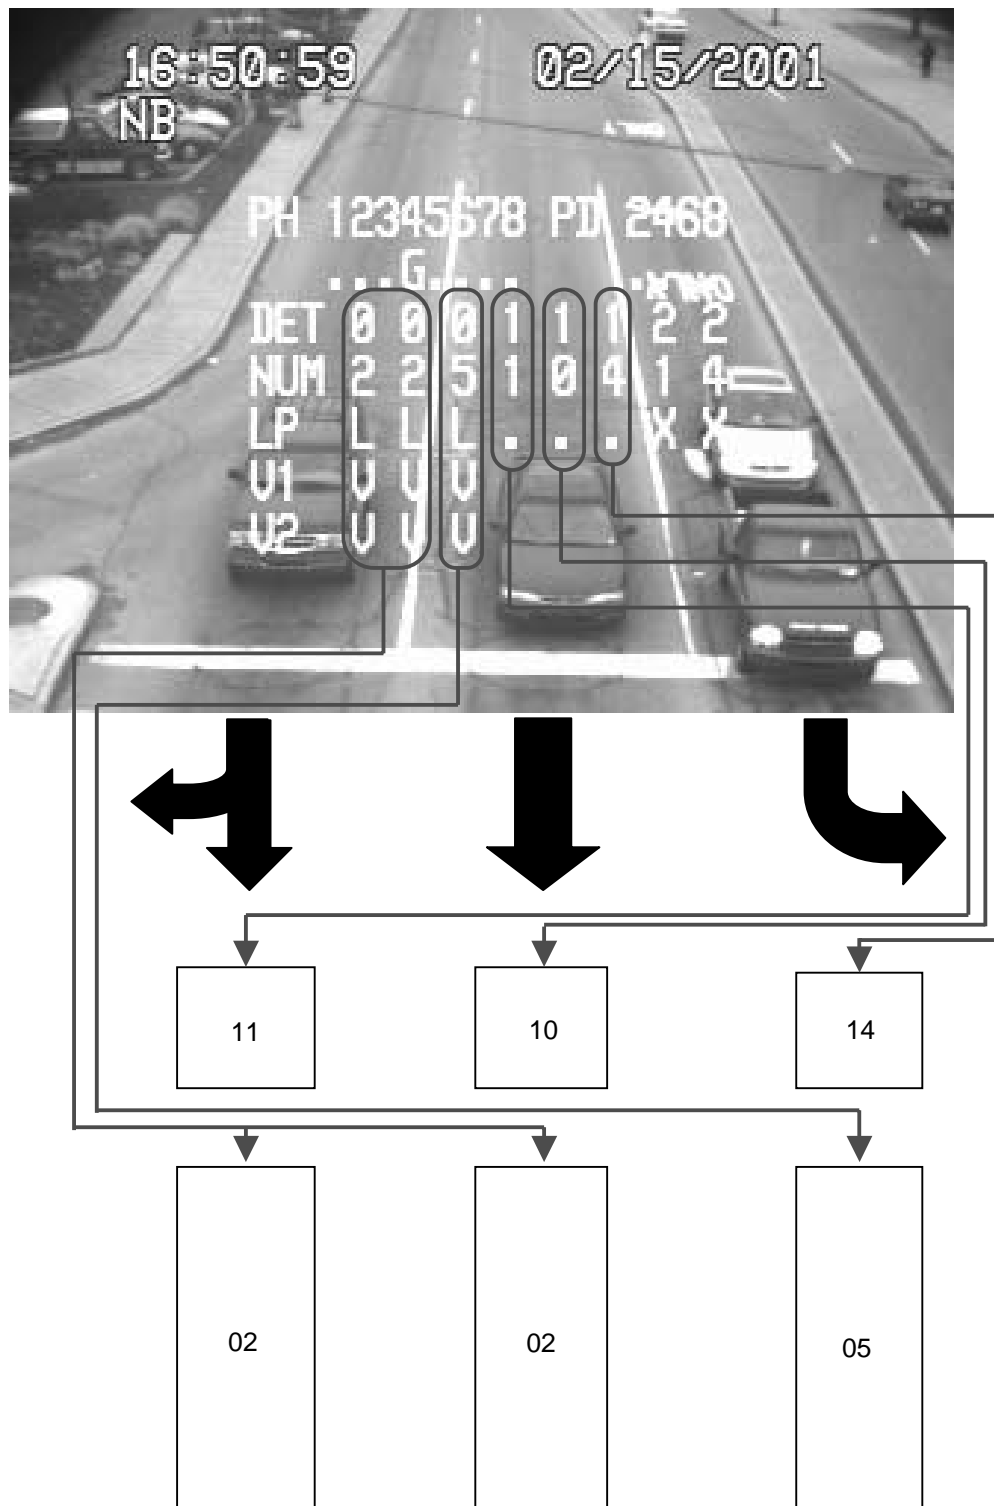
Figure 3-23: Relation of Text Overlay to Detector Layout

When examining Figure 3-23, one can see which detector numbers on the text overlay correspond to which detection zones on the lanes. There are two lanes that have a detection zone number of 02. The inductive loops in these two lanes have been wired together with an OR expression, because they serve the same traffic movements. The detection zone numbers shown here have been applied to both the inductive loops and the video detectors.

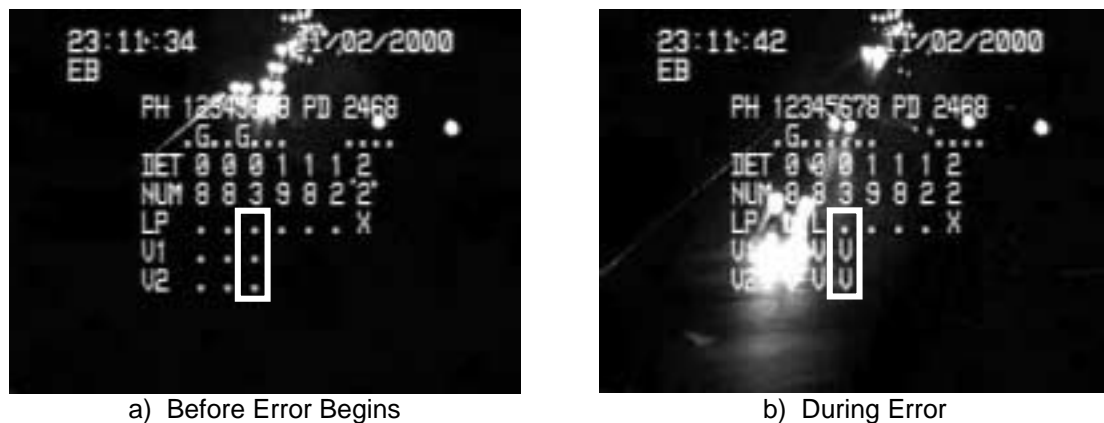
Figure 4-2 shows the negative effect that headlight glare can have on video detection performance. In this case, a vehicle has pulled into the through lane approach, and is awaiting the green signal. The headlights from the vehicle are shining into the area that has been defined as the video detection area for the left turn lane. For this reason, both video detectors indicate a vehicle's presence in the left turn lane, when in reality there is none.

Figure 4-2: Example Screen Capture of L0V1 Discrepancy Caused by Headlight Glare in Left Turn Lane (Systems 1 & 2, Before Recalibration)

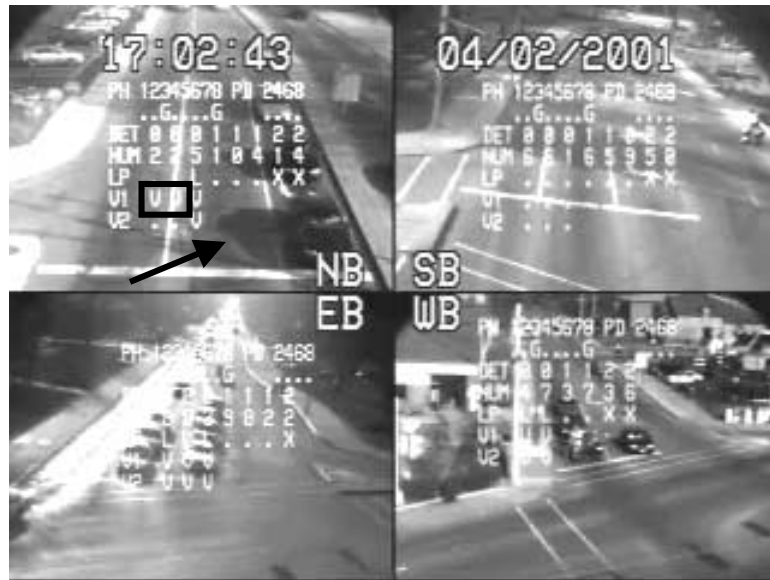
Figure 4-4 illustrates the negative effect that shadows can have on video detection. In this figure, the shadows from the vehicles in the left turn lane are causing Video Detection System 1 to indicate the presence of a vehicle. Again, this would cause an efficiency problem for intersections that are operating at mid-to-full capacity.

Figure 4-4: Example Screen Capture of L0V1 Error Caused by Vehicle Shadows (Northbound Through Lane, System 1, After Calibration)

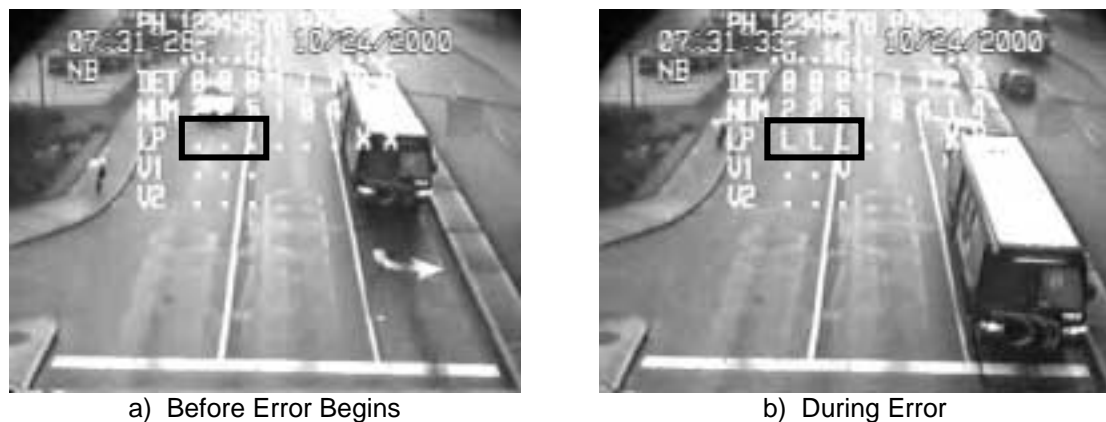
Figure 4-5 illustrates the fact that L1V0 errors are not always a fault of the video detectors. In this figure, a bus has pulled into the turn lane, and is awaiting the green signal. For certain reasons, perhaps too high of a sensitivity setting on the inductive loop detectors, the inductive loops in the through lanes are indicating the presence of a vehicle when, in reality, there is none present. It is through the use of the video with text overlay that these times can be ascertained.

Figure 4-5: Example Screen Captures of L1V0 Error Caused by Inductive Loops (Before Recalibration, System 1)

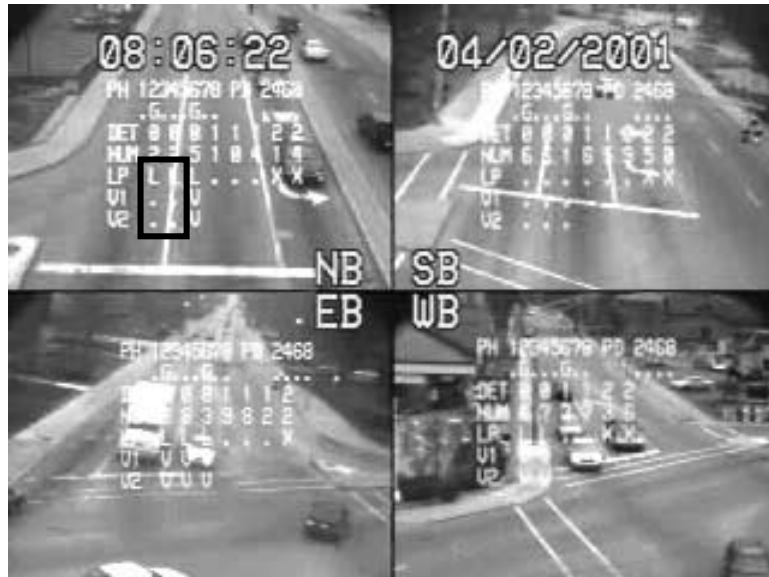
Figure 4-7, illustrates the same purpose that Figure 4-5 did. Either the inductive loop detectors in the northbound through lanes are too sensitive, and are registering the presence of vehicles in the northbound left turn lane, or they are faulty detectors.

Figure 4-7: Example Screen Capture of L1V0 Error Caused by Loops (Northbound Through Lanes, After Recalibration)

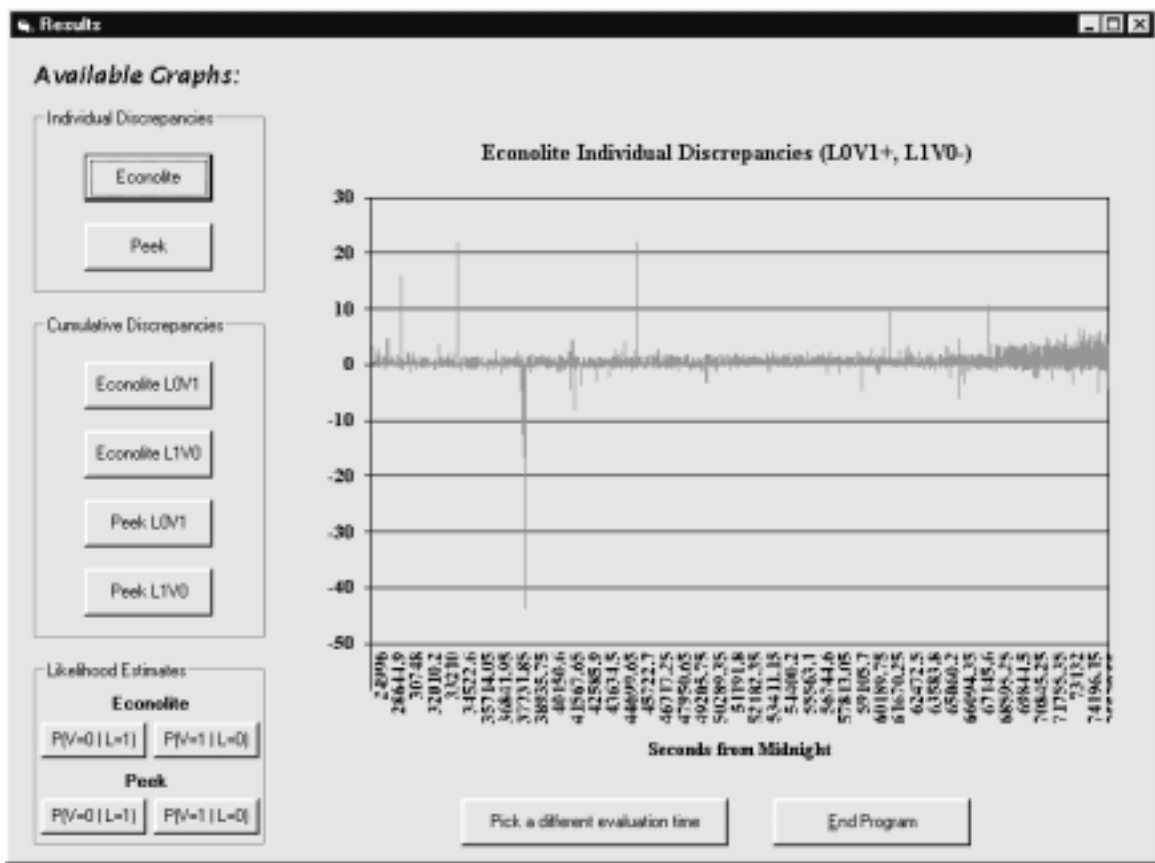
Figure 5-7: Example of Individual Discrepancies Graph

discrepancy graphs is that they can sometimes mask potential problems because of the magnitude of the Y-axis scale. They are also very unforgiving in the sense that if there is one large error, and the rest of the performance is good, the magnitude of the Y-axis scale is deceiving. In other words, these graphs should only be used for a quick overview of the data. It should never be taken as the last word without further investigation.

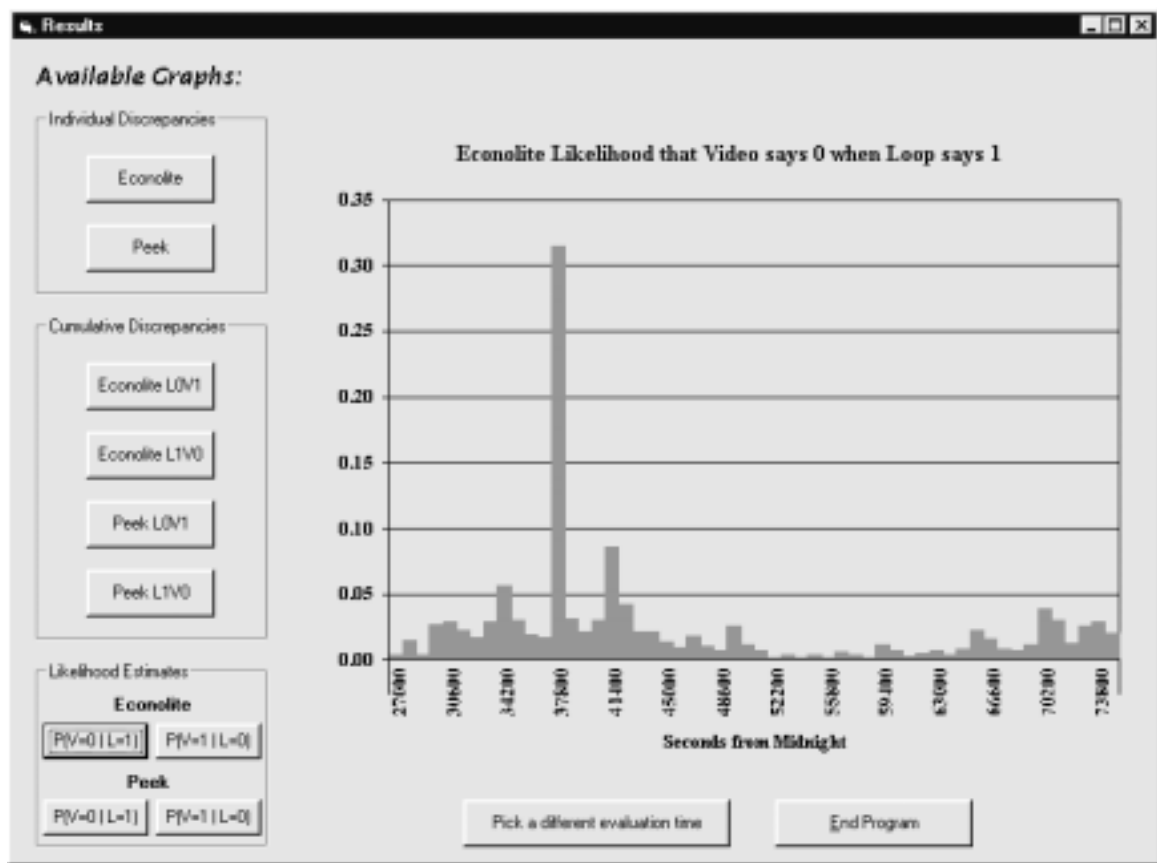
Figure 5-9: Example of Likelihood Estimate Graph

The purpose of these graphs is to have a graphical representation of the probability that a certain type of discrepancy is taking place. An example of the Likelihood Estimates graph can be seen in Figure 5-9. The values used to populate these graphs are calculated using the equations given in Chapter 4.

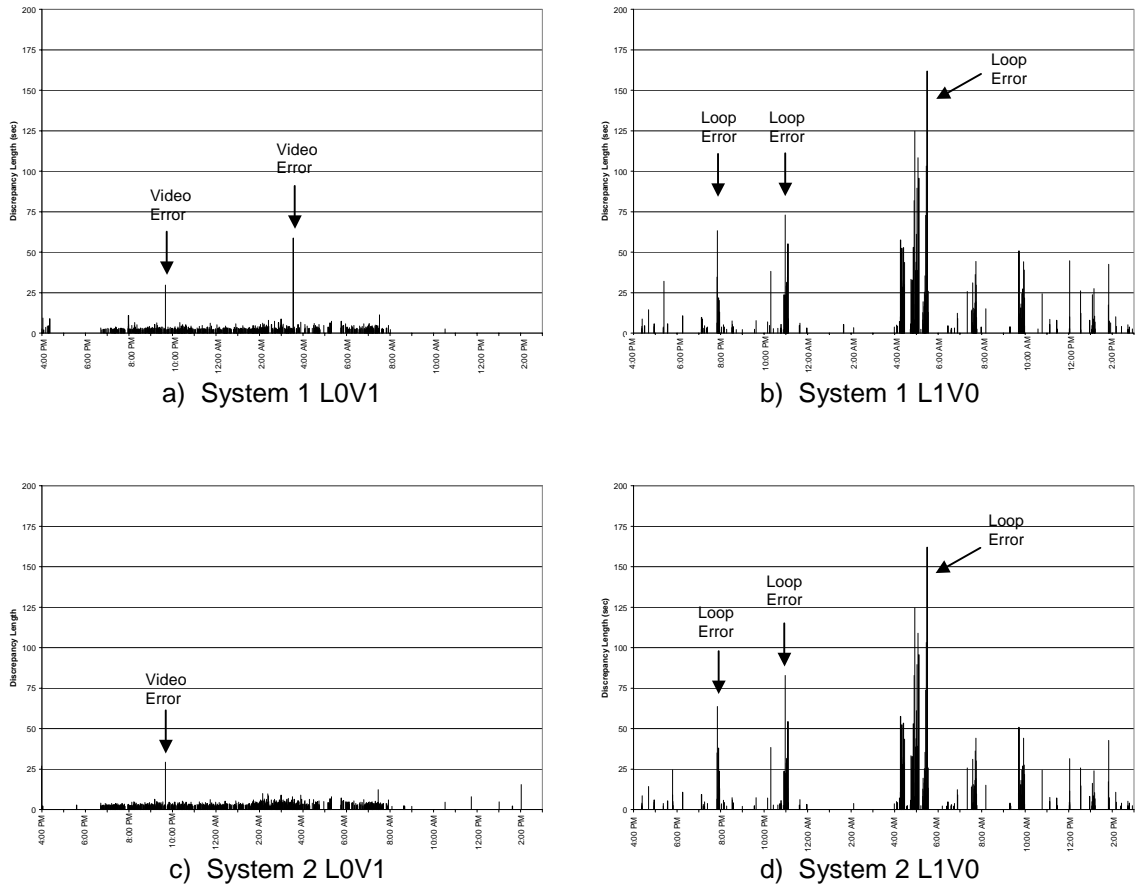
Most discrepancies are caused by the video detectors, but one can see in Figure 6-2 that there are several times when the inductive loops register a call when there is no vehicle present, and thus cause L1V0 errors. This is sometimes caused by faulty inductive loops, and sometimes by oversensitive loops registering a call because of a large vehicle in an adjacent lane served by another phase.

Figure 6-2: Phase 2, Blanking Band = 2 sec., February 23 & 24, 2001, Rain

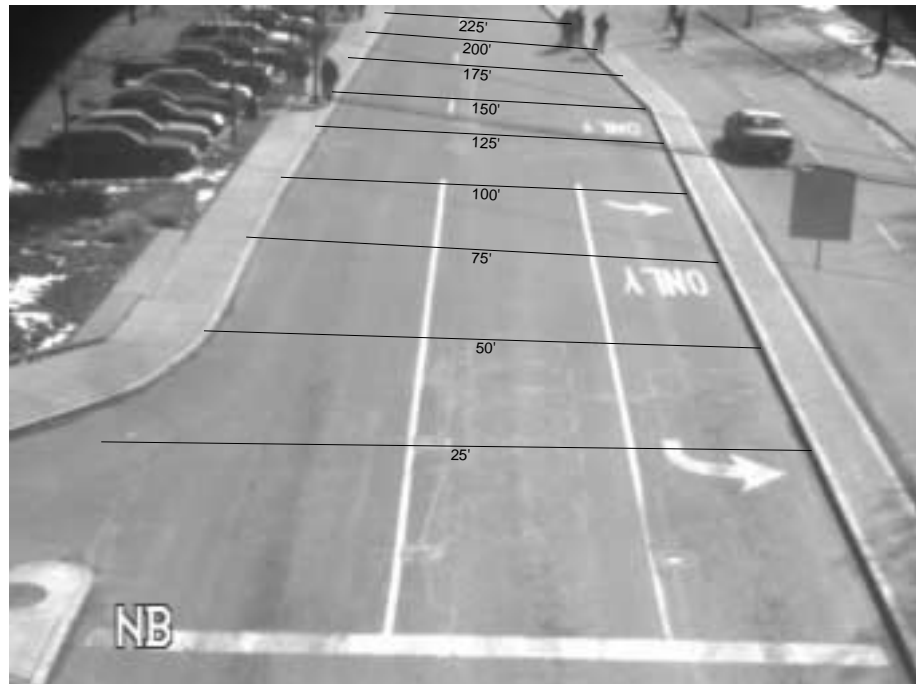
from the stop bar (approximately 50 ft), with no outliers. One can see that before the recalibration, the detection distances were further from the stop bar, and more spread out. After the recalibration, the detection distances moved closer to the stop bar, and the spread of the detections was less. It should be noted that the Autoscope 2004 unit has a feature called “Night Reflections.” The purpose of this feature is to reduce the effect that vehicle headlight glare has on vehicle detection. This feature was not enabled before the recalibration, but was enabled during the recalibration.

Figure 6-29: Distances from Stop Bar on Northbound Approach

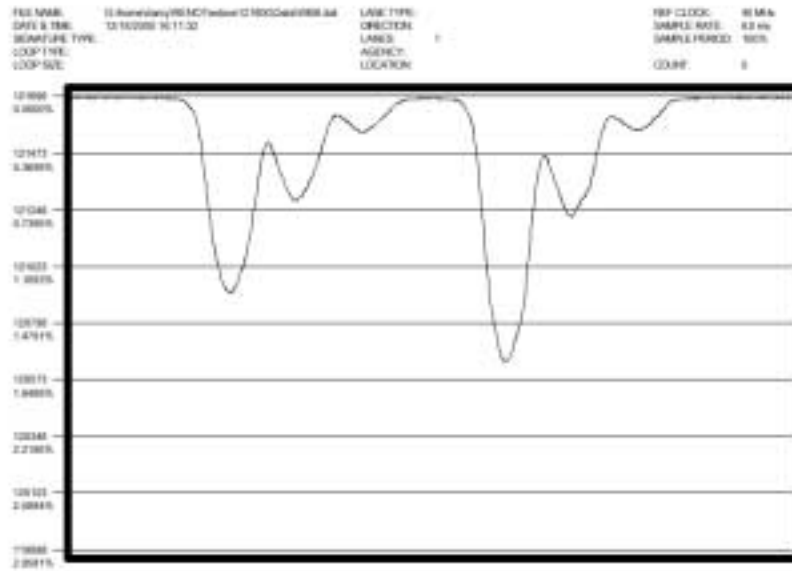
Figure A-13: Signature of two vehicles proceeding across west bound through movement moving off loop due to snow cover.

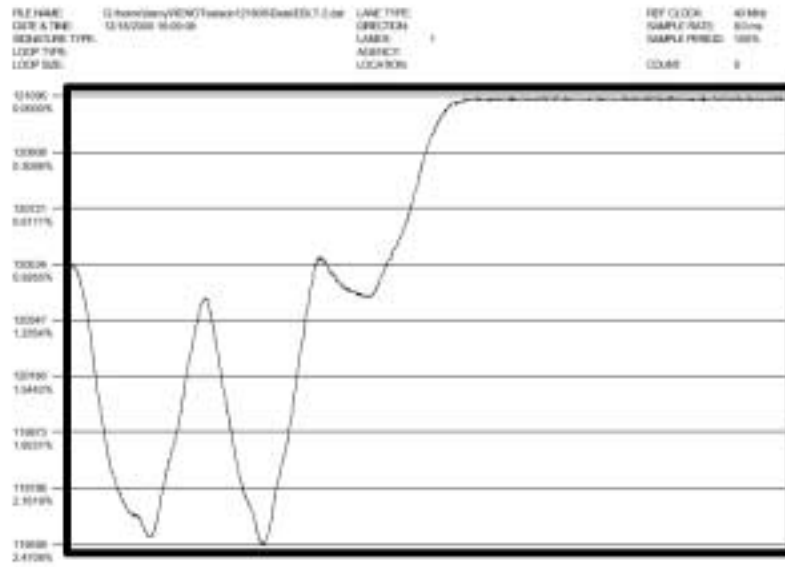
Figure A-15: Signature of one vehicle proceeding across loops in east bound left turn pocket, but turning before completely traversing the last loop
