## **Lateral Load Effect on Railway Tapered Roller Bearing Performance**

A Report on Research Sponsored by  
University Transportation Center for Railway Safety (UTCRS)  
University of Texas Rio Grande Valley (UTRGV)

December 2025

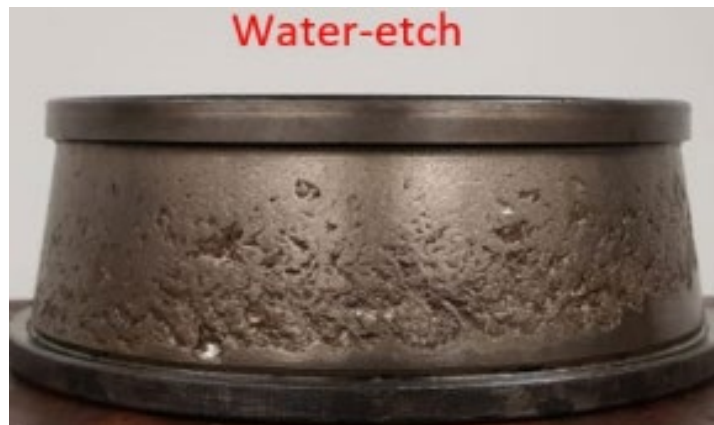
Lubricant contamination most commonly occurs when moisture mixes with the bearing grease. This form of contamination, often referred to as water-etching, is frequently observed in field applications. Moisture interaction with the grease causes lubricant degradation and leads to raceway corrosion. As a result, etch marks appear along the raceways. Under continuous operation, this type of defect can propagate, accelerating bearing degradation. Figure 4 shows water-etch damage on a cone raceway.

Figure 4. Water-etch damage on a cone raceway of a tapered roller bearing [3]
