JRC2011-56091

**PRELIMINARY RESULTS OF THE TRESPASS PREVENTION RESEARCH STUDY IN WEST
PALM BEACH, FLORIDA**

**Marco daSilva
and Anya Carroll**

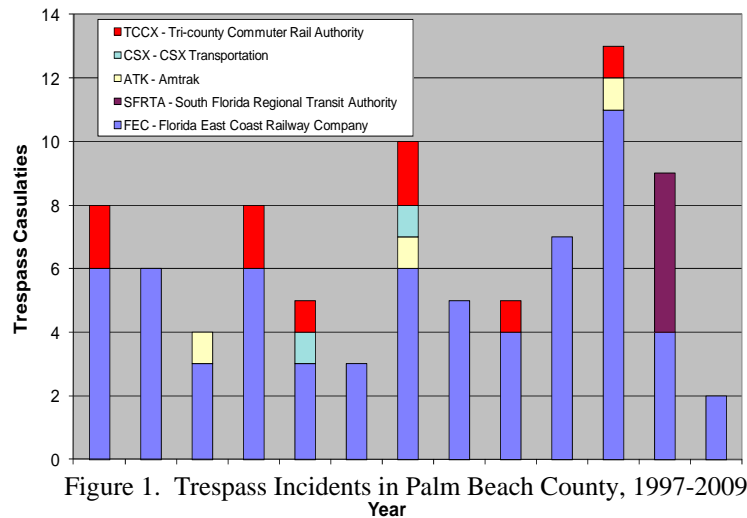
Figure 1. Trespass Incidents in Palm Beach County, 1997-2009

The SFRTA’s TriRail service, which is a commuter rail operation between Miami and West Palm Beach, was originally selected for this research study that began in July 2009. SFRTA experienced a record number of casualties in 2008 with regard to trespass events in Palm Beach County, as shown in Figure 1 [1]. It should be noted that it was operated as the Tri-County Commuter Rail Authority (TCCX) before 2008. A 1 ½ to 1 ¾ mile stretch of ROW from 45th Street and Okeechobee Boulevard in the city of West Palm Beach, FL, was the focus of four of the 5 fatalities in the county in 2008.

The FRA incident data related to trespass, although very important, does not currently provide enough information as to exact location of trespass incidents to yield any accurate determination of trespass location. Currently, this data is only reported at the county level, as shown in Figure 1. Additionally, since trespass casualties are relatively rare (SFRTA experienced 4 fatal casualties in 2008 along the study area), surrogate measures of safety need to be considered for analysis. Examples of surrogate measures include violation data reported by local law enforcement, locomotive crew observations, and video recording of specific locations. Although the research staff has requested and received some law enforcement and locomotive crew observation data, the bulk of the analysis to date has focused on locomotive video data supplied by SFRTA.

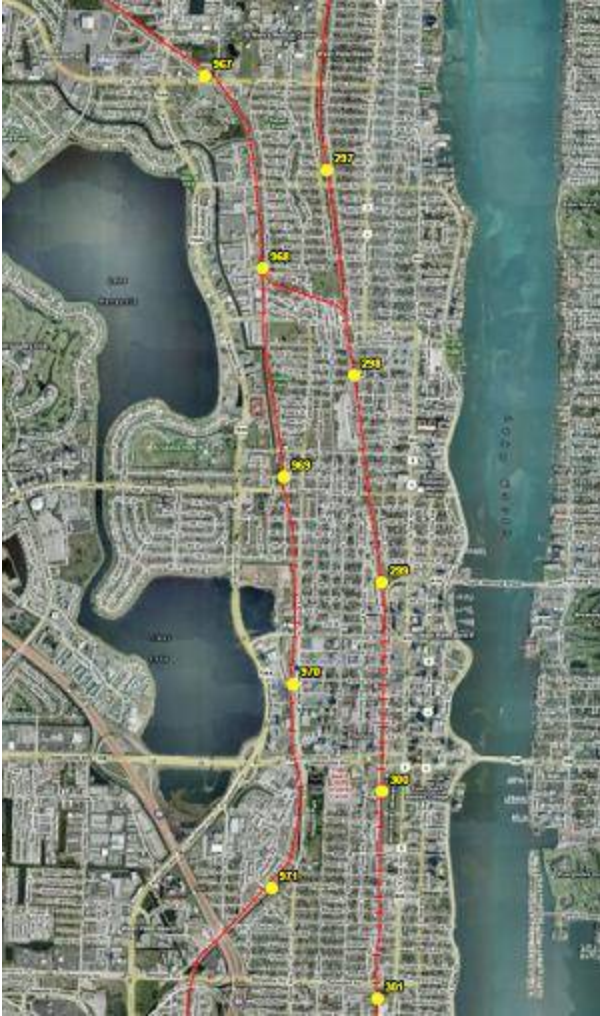
Figure 2. West Palm Beach Study Area (SFRTA TriRail line on left, FEC line on right)

The original scope of the TPRS was only in relation to trespass concerns along the SFRTA operations within West Palm Beach, Florida. Upon initial review of incident data and site visits, the scope was later expanded to all rail lines in the West Palm Beach, Florida area to include the FEC, which owns and operates a freight-only line on a separate ROW to the East of the SFRTA line within West Palm Beach. As shown in Figure 1, FEC also has a major problem with trespassing on its ROW within the study area. In fact, there were more trespass casualties reported by FEC than by all other operations combined, except for 2008 where SFRTA experienced the most. A map of the two rail lines within the study area is shown in Figure 2. It should be noted that the SFRTA line is all double-tracked and equipped with four-quadrant and pedestrian gates at all crossings in the study area. Additionally, the ROW is owned by Florida DOT and operated by CSX, which runs freight trains on the line. Amtrak also runs passenger service over the same line. FEC uses its line, composed of both single-track and double-track segments throughout the study area, for freight operations.

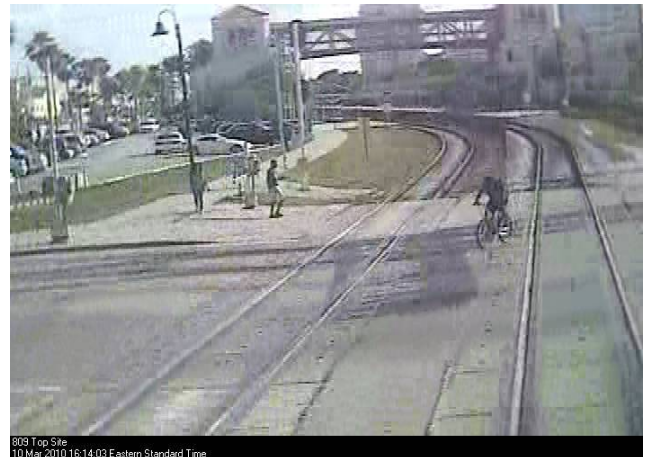
Figure 3. Grade Crossing Trespass Event

A trespass event was defined as an event involving a person or cyclist on the railroad ROW identified via analysis of the video data. Trespass events were further classified into two sub-types: at grade crossings, and on the ROW. Trespassing at a grade-crossing was defined as a person occupying the crossing while the grade crossing gates were in the down position, which follows the same definition of a trespasser at a gated crossing as defined by the FRA [5]. As already mentioned, the SFRTA line in the study area is double-tracked and all crossings are equipped with four-quadrant and pedestrian gates. An example of this type of event is shown in Figure 3, which shows a pedestrian and a cyclist violating the down gates at the Banyan Boulevard crossing after the train has passed (this view is from the rear cab-car). The other trespass type, trespassing on the ROW, was used to capture all non-grade crossing trespassing. An example of this type of event is shown in Figure 4, which shows two trespassers on the ROW.

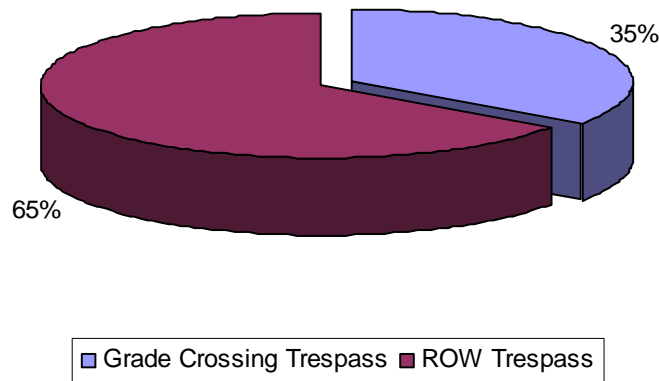
Figure 5. Trespass Event Location, SFRTA Locomotive Video Data

A total of 176 trespass events involving 230 trespassers were identified through the review of the set of 613 trips. This averaged out to about 0.3 trespass events per trip, or 1 trespass event every 3.5 trips. A total of 60 of the 176 events involved trespassing at a crossing either before or after a train while the gates were in the down position. The remaining 116 events involved trespassers along the ROW at non-crossing locations. Figure 5 shows the distribution of each type of trespass event.

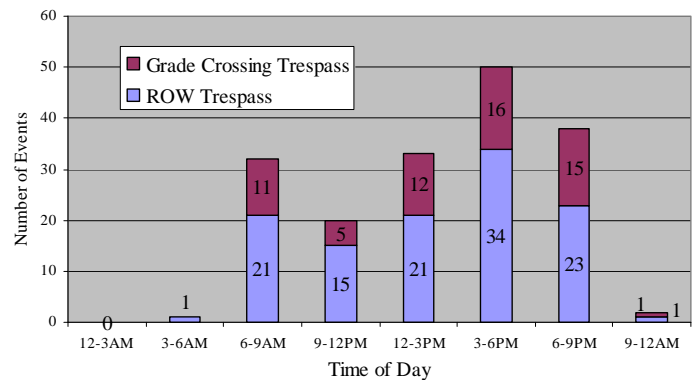
Figure 6. Trespass Events by Time of Day

Figure 6 shows the breakdown of trespass events by time of day. Overall, about 70 percent of the trespass events occurred after 12PM. The data also reveals that the highest number of trespass events on the SFRTA line within the study area occurred during the 3PM to 6PM time period, regardless of event type. It should be noted, that of the 50 weekday trips by the SFRTA line, a total of 22 trips pass through the study area in the morning hours and 28 in the afternoon and evening hours. Additional data analysis will focus on normalizing this data per train frequency.

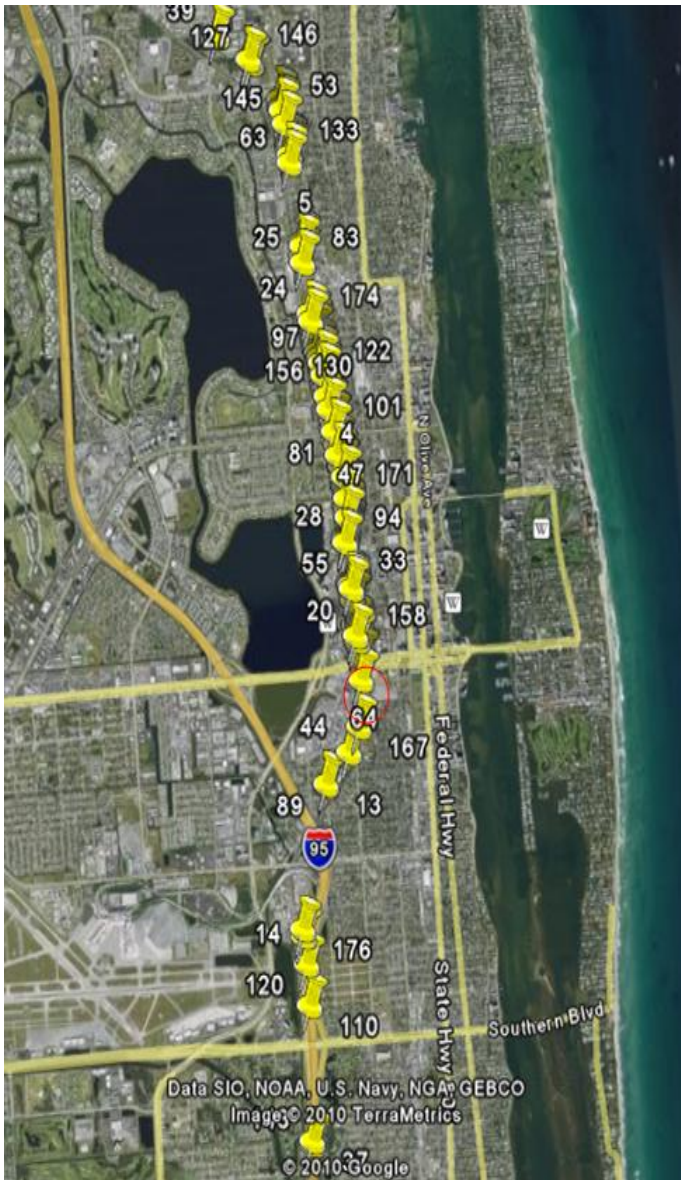
Figure 7. Location of Trespass Events on SFRTA Line

Figure 7 shows the locations of all 176 trespass events. The numbers on the graphic identify each event as listed in the data base created by the Volpe Center research team. Although it can be easily seen that the trespass problem is present almost everywhere along the line, it is difficult to determine specific trouble spots at this level of detail. Figure 8 displays the zoomed-in area identified by the red circle within Figure 7, which covers the south approach to the West Palm Beach station. A total of 13 out of the 116 ROW trespass events were recorded at that location alone. Additionally, 12 of the 13 events at this location involved a trespasser crossing over the track, which amounts to almost 40

percent of the 31 ROW events involving trespassers crossing the tracks at non-grade crossing locations in the study area.

The main objective of the analysis of the SFRTA locomotive video data was to help identify and quantify the trespass problem. All of the trespass data were plotted on a geobrowser to visually depict trespass events along the SFRTA study area.

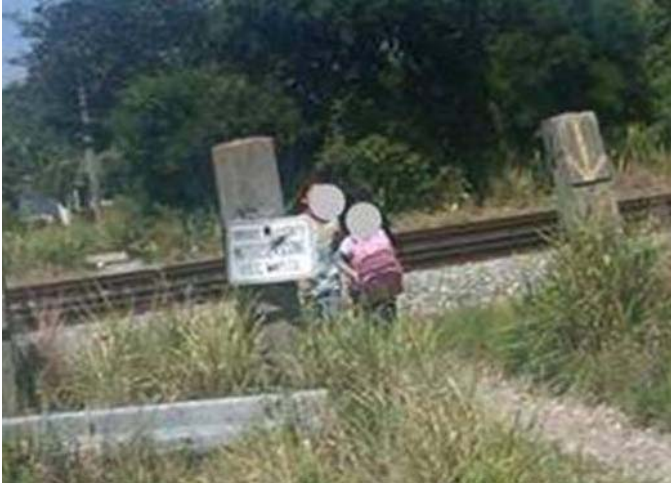
Figure 9. FEC ROW Trespass Event Example

Unlike SFRTA, no locomotive video data was available from FEC. However, the research team performed multiple site visits to known trouble spots all along the ROW within the study area and catalogued a total of 32 locations where there was evidence of trespass (observed trespassing, worn paths, and breaks in fencing). Additionally, data from the Palm Beach County School District Police, which has yet to be analyzed, will provide more information as to where and why there is a significant trespass issue particularly towards the north end of the city. The research team observed many instances in that general area involving children with backpacks trespassing across the FEC tracks. Figure 9 shows an example of such an event observed by the research team during a site visit in April 2010. During that same visit at that same location, the research team observed fifteen trespassers in less than 30 minutes. Most of the trespassers were children or teenagers crossing over the tracks. The research team engaged in discussions with the Palm Beach County School District to ascertain the underlying cause of this issue, which may have to do with the catchment area of the local schools (the geographic area from which students are eligible to attend a local school) and substantial distance between grade crossings in that area.
