Field Study to Determine Salt Usage Efficiency and Transport to the Surrounding Environment on Two Pavement Types

Final Report

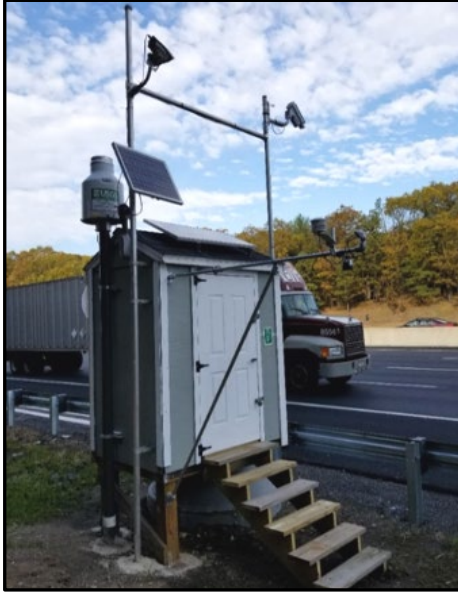
Figure 2.3: Close up view of existing highway instrumentation station

WEATHER DATA COLLECTED
1. Air Temperature
2. Snow Depth
3. Precipitation (Ice, Water, Snow)
4. Wind Speed & Direction

ENVIRONMENTAL DATA COLLECTED
1. Runoff Flow
2. Water Temperature
3. Specific Conductance (Salinity)

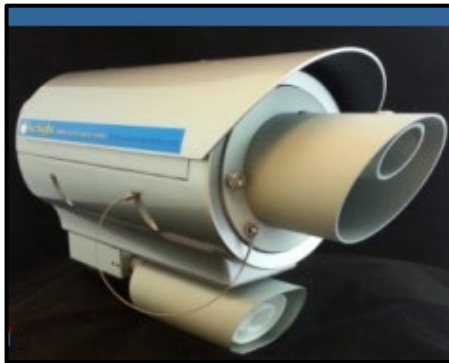
Figure 2.4: Existing non-contact road surface condition sensor at existing highway instrumentation stations - IceSight-2020E

DATA COLLECTED
1. Air Temperature
2. Relative Humidity
3. Pavement Surface Temperature
4. Surface Conditions
5. Estimate of Friction (Grip)

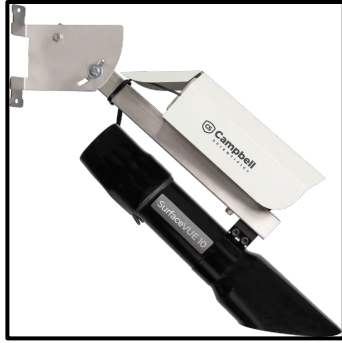
DATA COLLECTED
1. Air Temperature
2. Relative Humidity
3. Pavement Surface Temperature
4. Surface Conditions
5. Estimate of Friction (Grip)
6. Water & Ice Layer Thickness

Figure 2.5: New non-contact road surface condition sensor installed at existing highway instrumentation stations – Surfacevue10

For this project, the USGS acquired and installed an additional non-contact sensor (shown in Figure 2.5) called the Surfacevue10. The Surfacevue10 provides measurements of air temperature, relative humidity, pavement temperature, surface condition, estimate of friction (grip), and water/ice layer thickness. According to the USGS, this non-contact sensor provides more reliable data than the existing IceSight-2020E non-contact sensor.

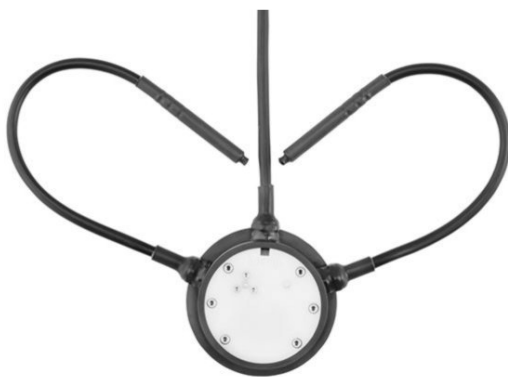
DATA COLLECTED
1. Road Surface Temperature
2. Temperature at Depth (5cm/30cm)
3. Water Film Height
4. Freezing Temperature of De-icing Materials
5. Road Condition
6. Friction
7. Ice Percentage
8. Salt Concentration

Figure 2.6: First invasive sensor installed – Passive Lufft IRS31PRO-UMB

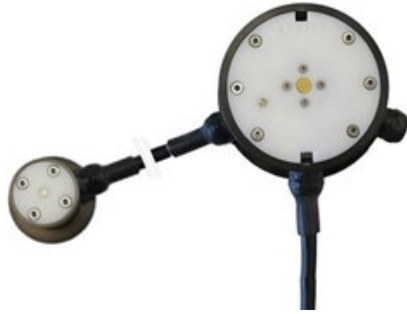
DATA COLLECTED
1. Freezing point temperatures: Measured independently from de-icing materials

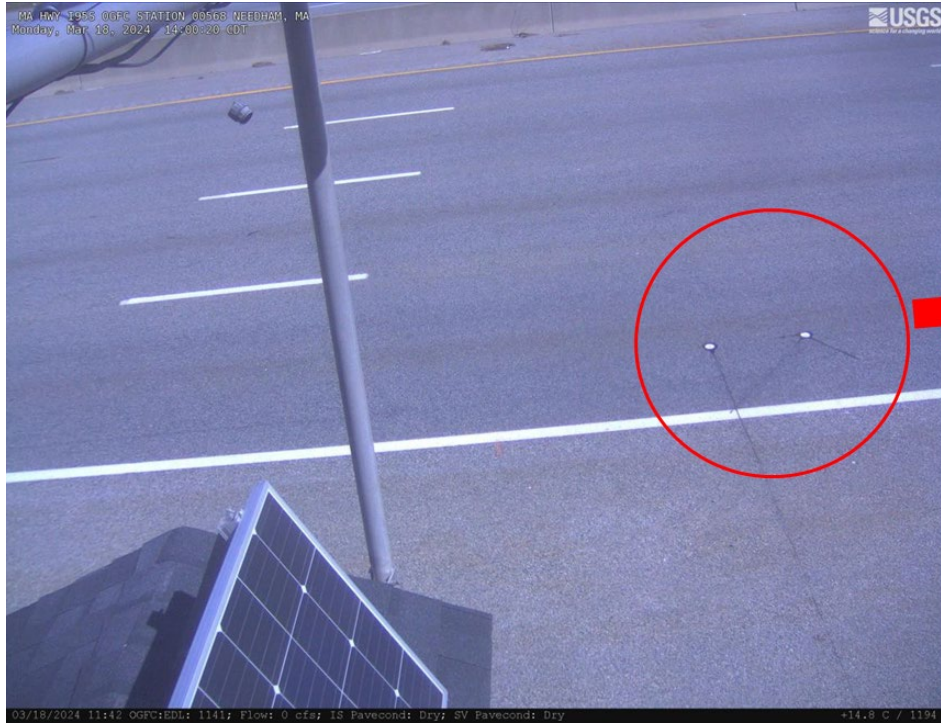
Figure 2.12: View of sensors from weather station – OGFC

the camera view for each station) for DG and OGFC pavement surfaces respectively. In these figures, the arrow indicates both the direction of traffic and the location of the other set of sensors that is not visible in the camera view.

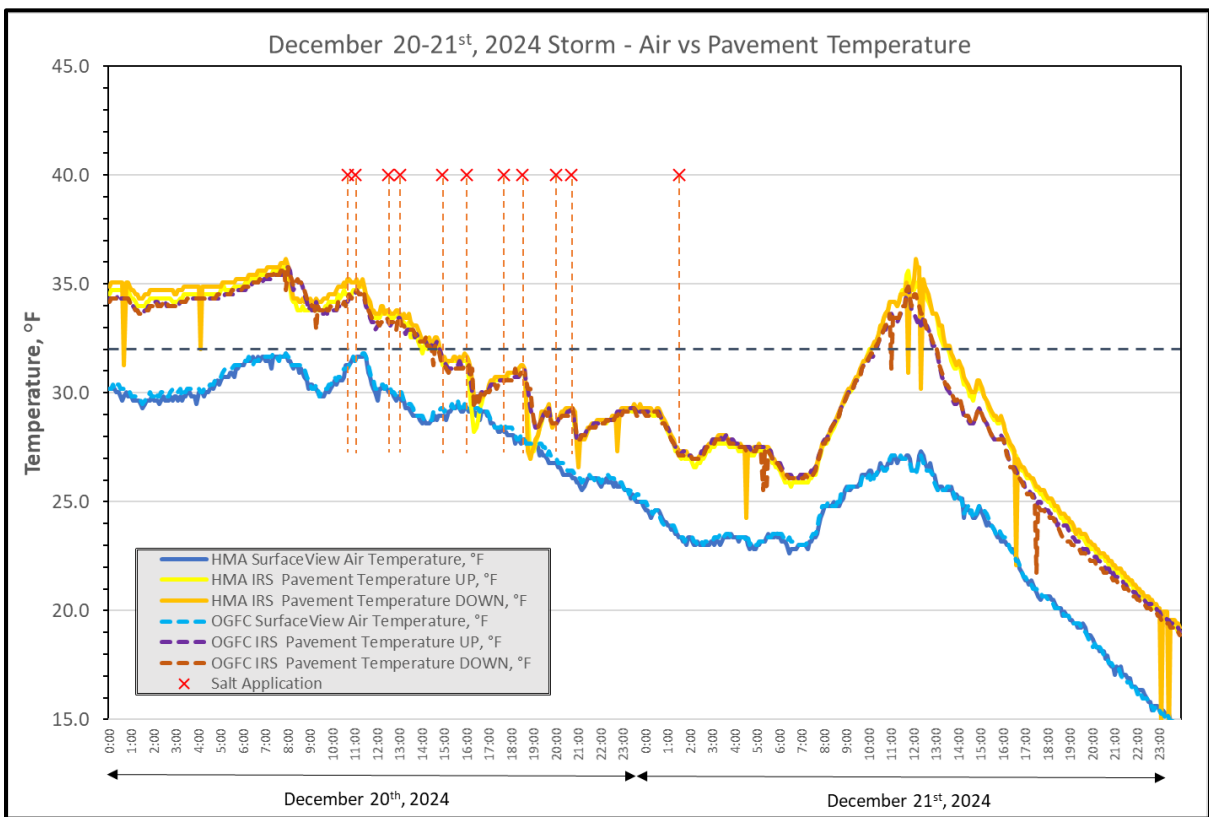
Figures 4.1 and 4.2 show a comparison of air temperature measured by the SurfaceVue10 (non-contact) and the imbedded pavement invasive sensors (IRS) for both DG and OGFC pavement types with respect to salt application. As it can be seen, the air temperature measured by the SurfaceVue10 generally trended colder than pavement temperature measured by the invasive sensors regardless of pavement type.

Figure 4.1: Temperature by sensor type - Air versus Pavement (2024)

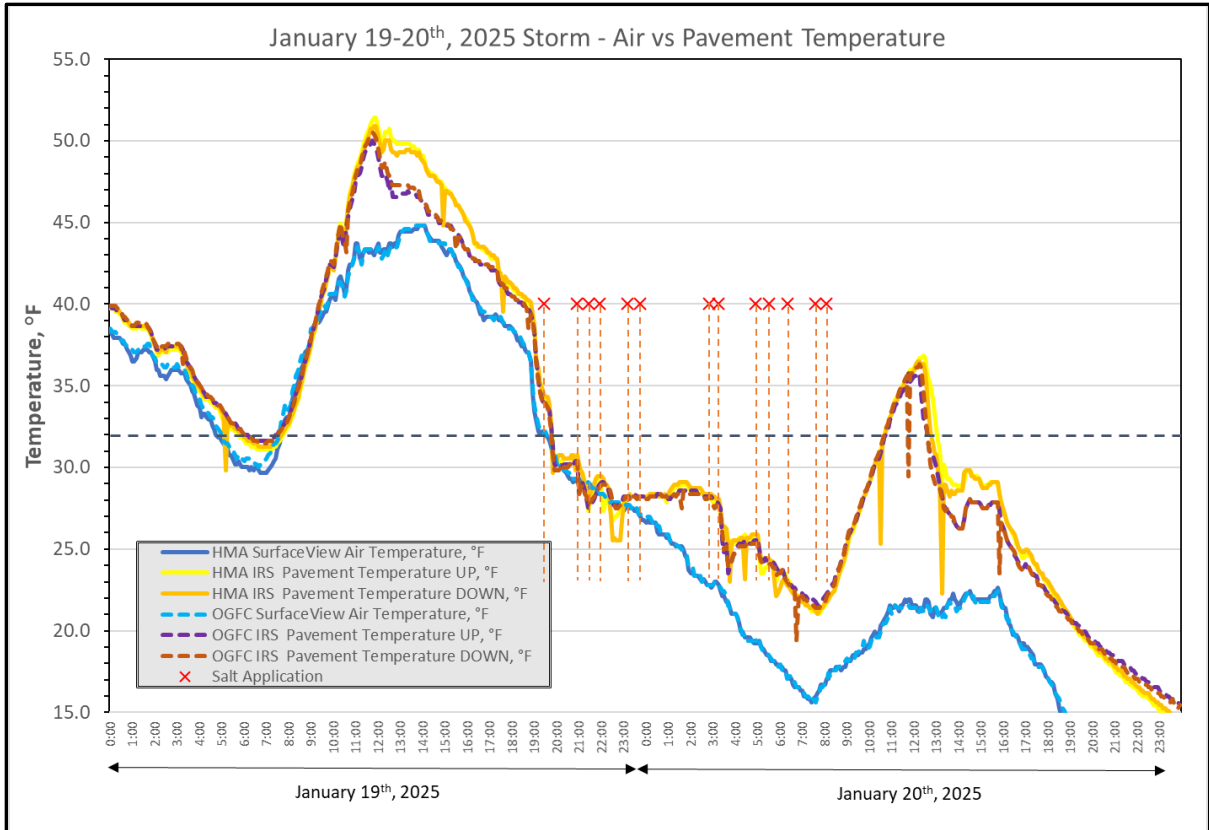
Figure 4.2: Temperature by sensor type - Air versus Pavement (2025)

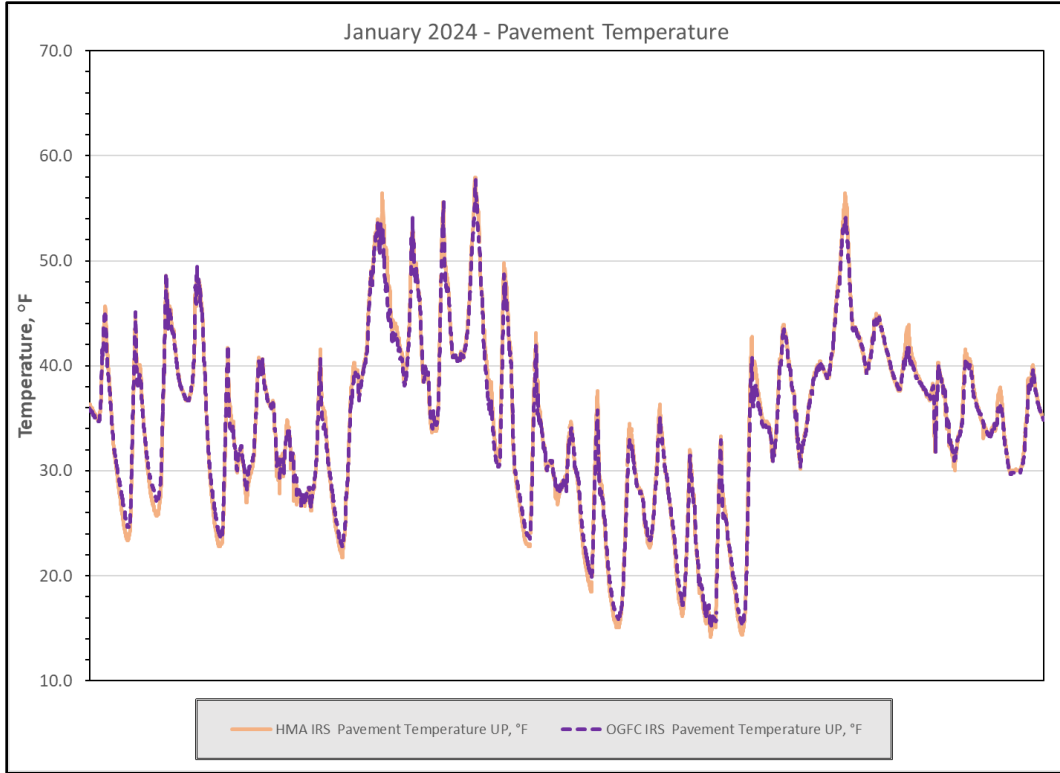
Figure 4.3 shows a comparison of pavement surface temperature from the invasive sensors (IRS) for both DG and OGFC pavement types. The temperature was similar between both the DG and OGFC mixture types. No data indicated one pavement type was freezing faster than the other, as surface temperature data was generally the same. Analysis of other storm data on different dates provided similar results.

Figure 4.3: Surface temperature – Dense graded vs. OGFC

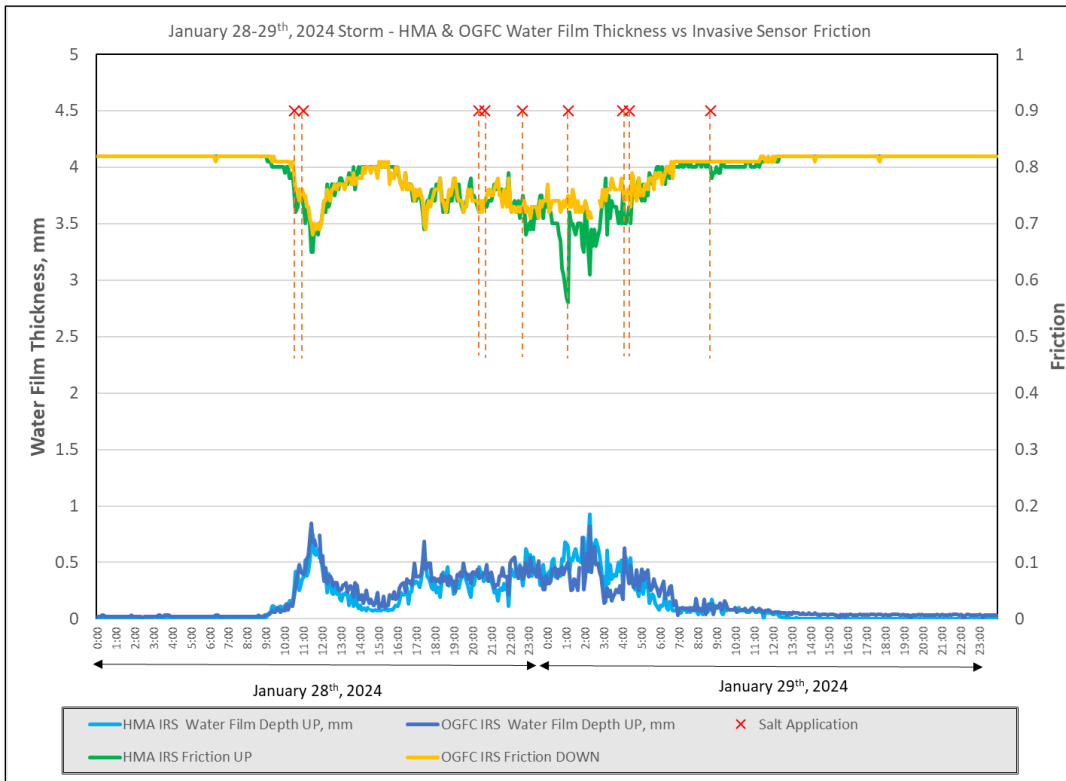
Figures 4.4 and 4.5 show a comparison of water film thickness versus invasive sensor (IRS) friction by pavement surface type. Friction was only of concern when moisture, or water film, was present at the sensor in the pavement. If the pavement were dry, there would be less potential for reduced friction or an icing condition. The data indicated that the friction characteristics of the DG and OGFC pavement types were similar with respect to salt application, and that the water film experienced on both was similar. In Figure 4.5, the incomplete areas, or gaps, in the friction data were common. In consulting with USGS, these gaps occur when the freezing point estimated by the IRS sensor return an unrealistic value. This could be due to build-up of contaminants on the sensor surface. The unrealistic value of freezing point then affects the calculation of friction, which is based on freezing point. USGS applied filters to the data stream to remove such unrealistic data, and thus these data gaps appear.

Figure 4.4: Water film thickness versus invasive sensor friction (2024)

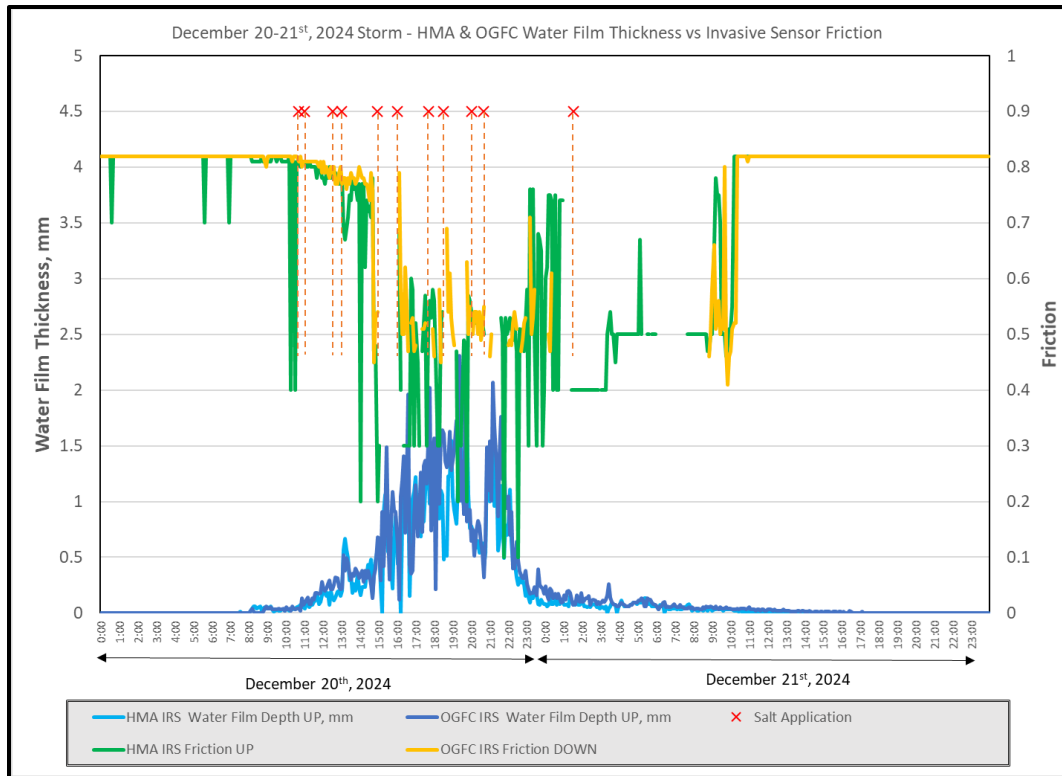
Figure 4.5: Water film thickness versus invasive sensor friction (2025)

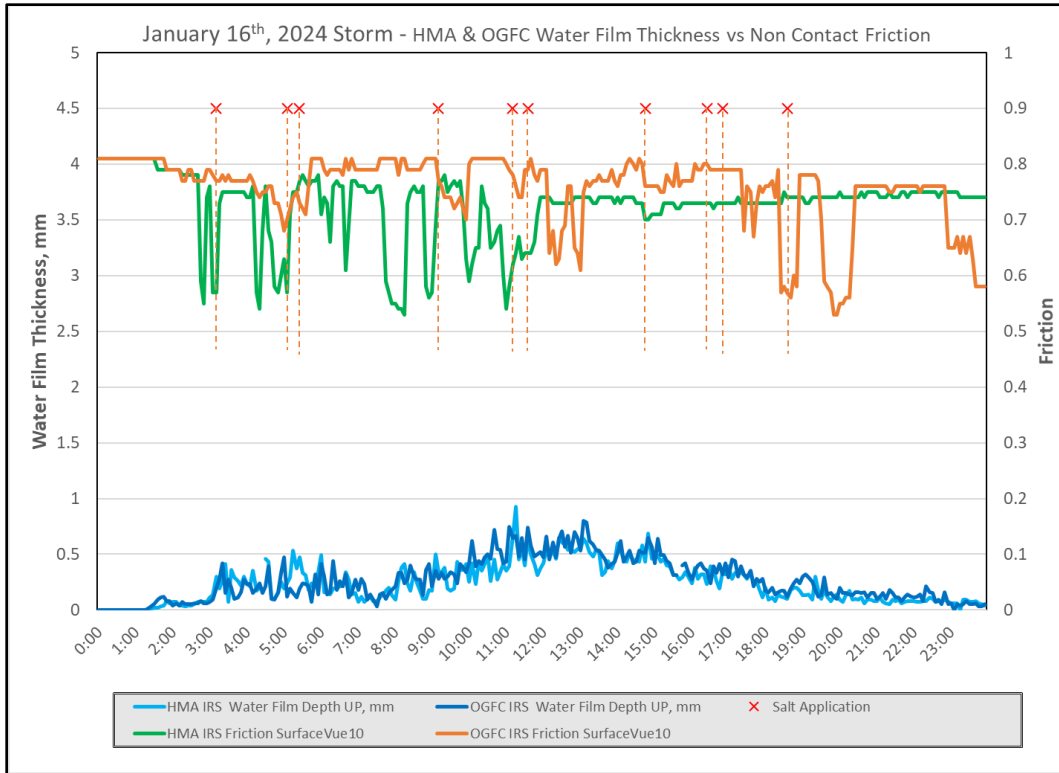
Because of the data gaps observed in the invasive sensor friction data, the friction value obtained by the non-contact SurfaceVue10 were plotted similarly versus water film thickness. As shown in Figures 4.6 and 4.7. The data showed agreement with the invasive sensor friction data. The friction characteristics of the DG and OGFC pavement types with respect to salt application were similar.

Figure 4.6: Water film thickness versus non-contact sensor friction (2024)

The data presented in Figures 4.1 through 4.7 show examples of the common trends in the data that was observed after analysis of the indicated storms in Tables 4.1 and 4.2. The winters of 2023-2024 and 2024-2025 were less harsh than historically anticipated for the region, thus yielding limited data to analyze. The original research scope proposed collecting data over three winters, but the invasive sensors were not able to be installed until fall 2023. This eliminated one winter from the study.

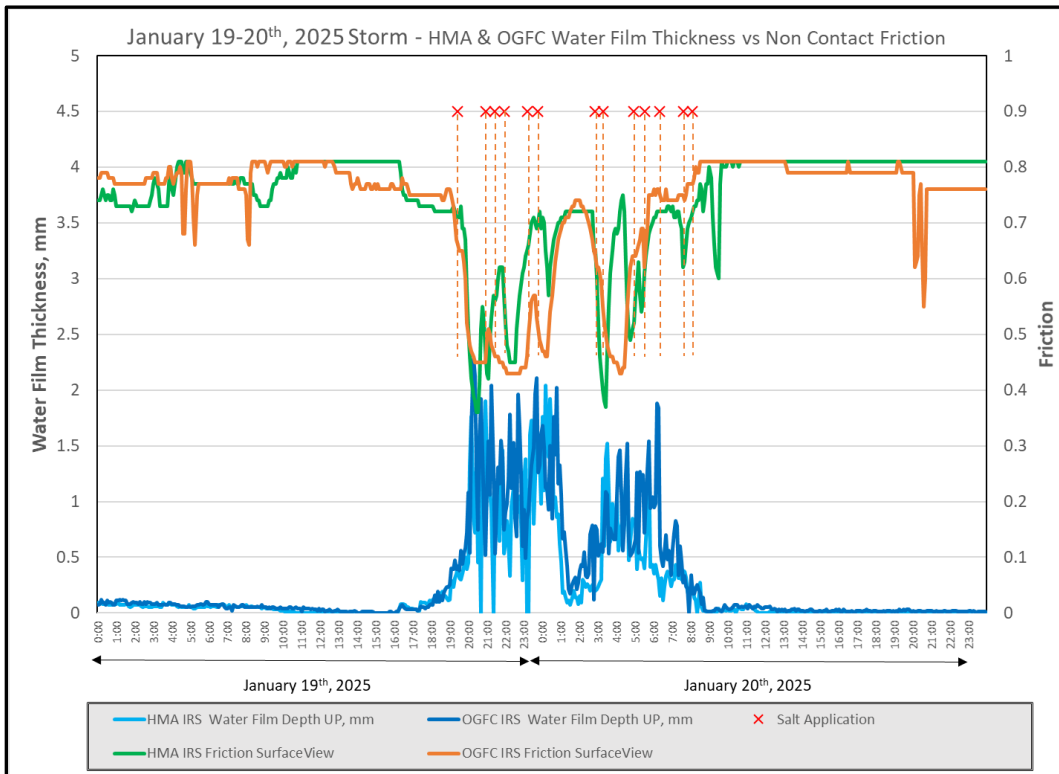
Figure 4.7: Water film thickness versus non-contact sensor friction (2025)
