Demonstrating the Use of Small Uncrewed Aircraft Systems (Drones) Capabilities and Data for Iowa Transportation and Infrastructure Work

Pilot Project No. 1 – Use of Small Uncrewed Aircraft Systems for Hairline Crack Detection on Bridge Deck

Task Report | May 2025

IOWA STATE UNIVERSITY
Institute for Transportation

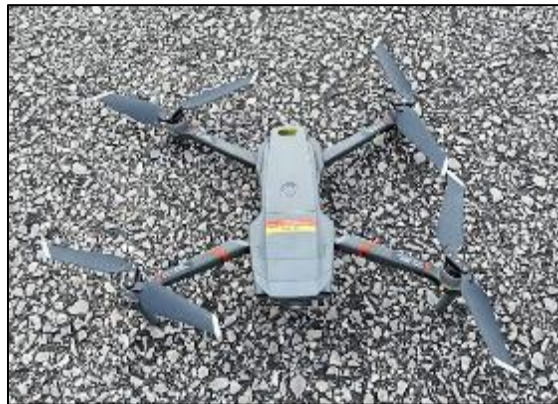
Figure 2. DJI Mavic 2 Enterprise Advance sUAS

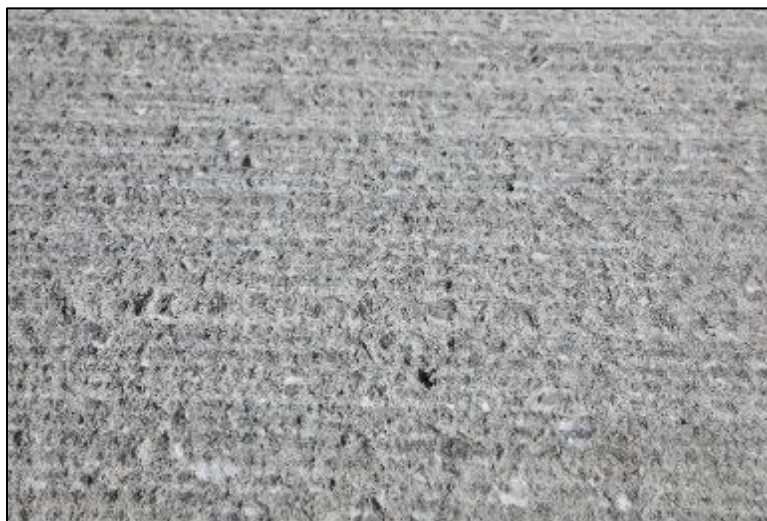
Figure 4. Milled surface of Unit 2

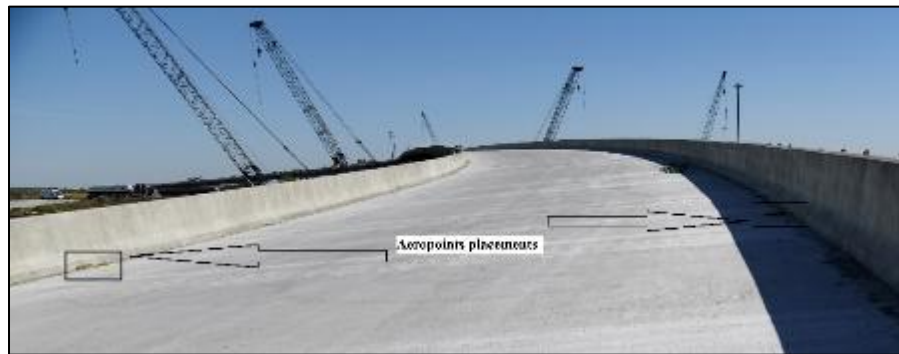
Figure 8. Placement of AeroPoints GCPs on the ground

With the preflight planning complete, the team ensured that the bridge section was free of obstacles and ready for operation. The research team placed 10 GPS-enabled Propeller AeroPoints GCPs at intervals along both sides of the bridge in the longitudinal direction, as shown in Figure 8. The AeroPoints automatically collected highly accurate GPS data that were uploaded to Propeller’s cloud server and used for sUAS data processing to improve merged imagery outputs. For the initial few flight operations, an M2EA Real-Time Kinematics (RTK) module was used for better geo-positioning and stability using Networked Transport of RTCM via Internet Protocol (NTRIP). However, each time the sUAS and its remote controller were shut down and restarted for a battery change, the RTK module had issues connecting to the NTRIP server, so onboard GPS was used for position in the later flights.

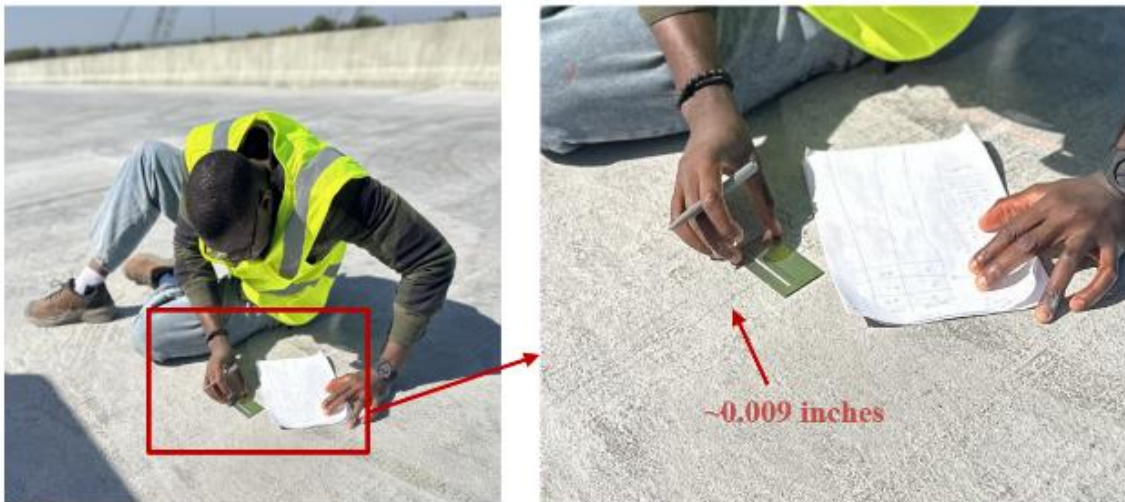
Figure 15. Ongoing measurement of observed hairline cracks

Before takeoff, the team performed a quick manual inspection of the bridge deck, identifying the locations of crack distresses to be marked and measured. Figure 15 shows a team member measuring a hairline crack using a crack gauge. Observing these cracks helped create ground truth data samples used for visibility analysis in later sections. The main data were collected at 15 ft (4.6 m) AGL, and additional data were collected at 35 ft (10.7 m) AGL. Data collection for the remaining Unit 1 sections at 15 ft (4.6 m) AGL was completed using seven separate manual flights. Figure 16 illustrates the combined paths of the seven missions.

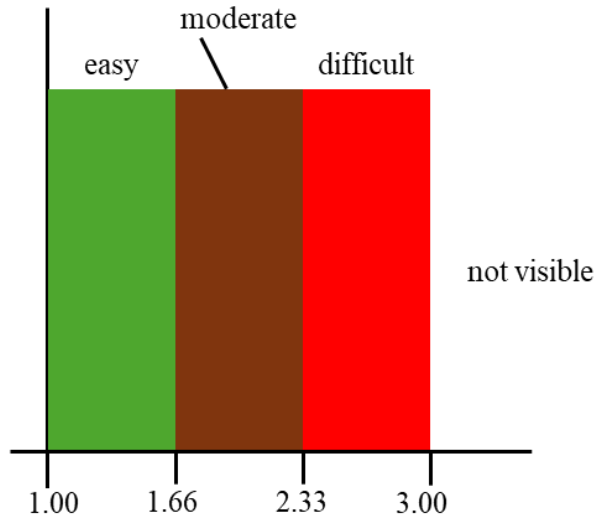
Figure 22. Final level of detection bounding range

The reviewers’ labels were aggregated, weighted, and compared for further analysis. Since the reviewers were knowledgeable about cracks but had no prior knowledge of the exact crack locations in the bounded marks, their deductions were assigned more weight. The final aggregate score was defuzzified using the numerical range illustrated in Figure 22. Table 2 shows the final weighted detection level for each crack sample and the combined similarity counts of the reviewers (4) and the sUAS team (1).

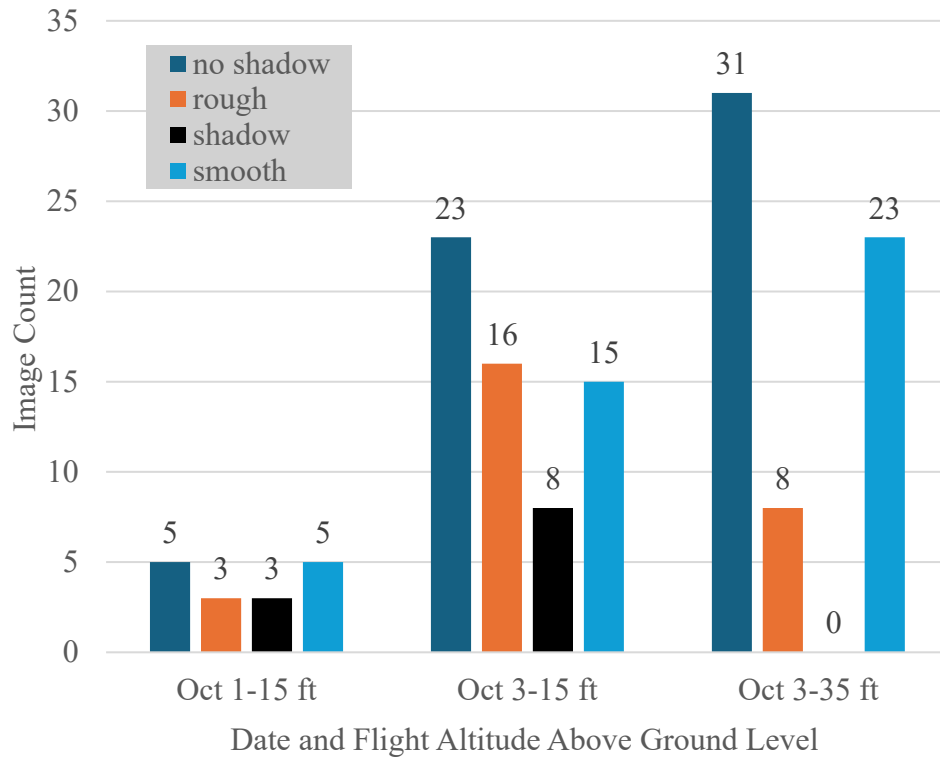
Figure 23. Counts of image classification clusters

the rough-no-shadow class, underscoring the ability of the fine resolution data obtained by the 15 ft (4.6 m) AGL orthophotos to capture the detailed texture of the concrete surface.

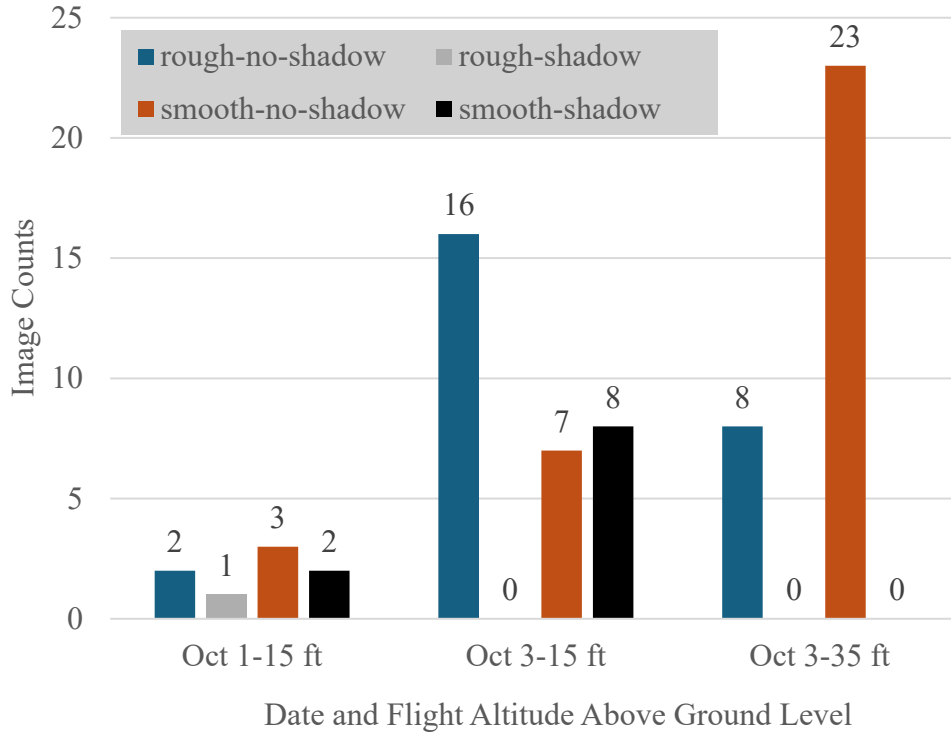
Figure 24. Counts of combined image classification clusters

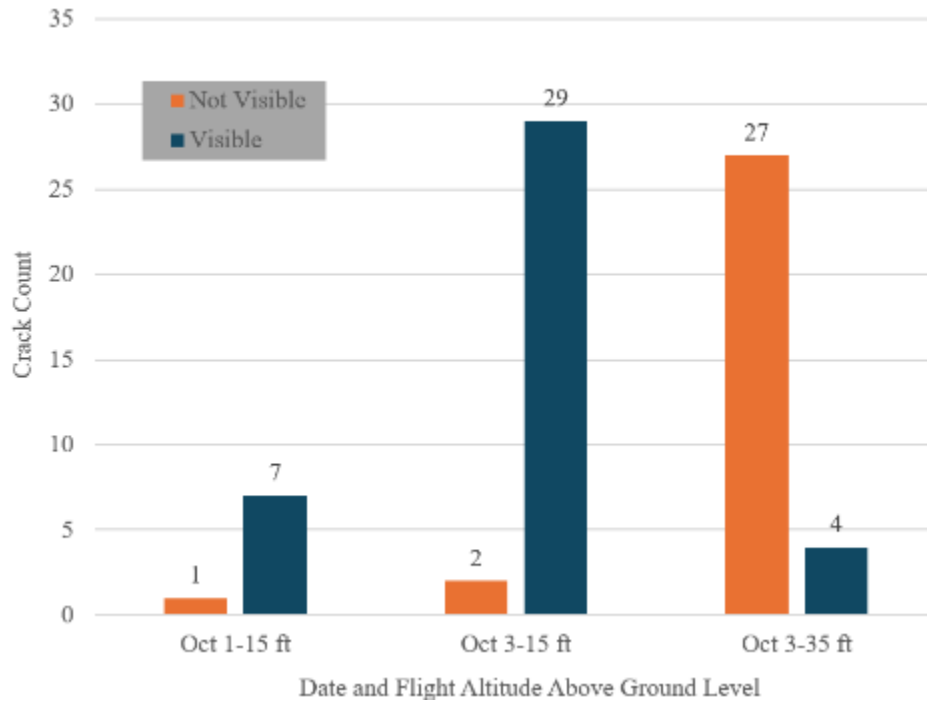
Figure 25. Visible and not-visible hairline cracks from exported RGB orthophoto images at 15 ft (4.6 m) and 35 ft (10.7 m) flight altitude

Since the sUAS was flown at 15 ft (4.6 m) AGL on both inspection days and at 35 ft (10.7 m) AGL on only the second inspection day, the complete dataset of 39 ground truth cracks is available for the 15 ft (4.6 m) AGL orthophotos, while only 31 cracks are available for the 35 ft (10.7 m) AGL orthophotos. Figure 25 illustrates the number of detected or visible hairline cracks in the orthophoto images based on the reviewers' aggregation, grouped by collection date and sUAS flight altitude. The research team concluded that hairline crack detection is more challenging in 0.066 in./pixel (1.67 mm/pixel) orthophotos collected at 35 ft (10.7 m) AGL due to their smoothness and lower resolution. Only 4 of the 31 available cracks were detected.

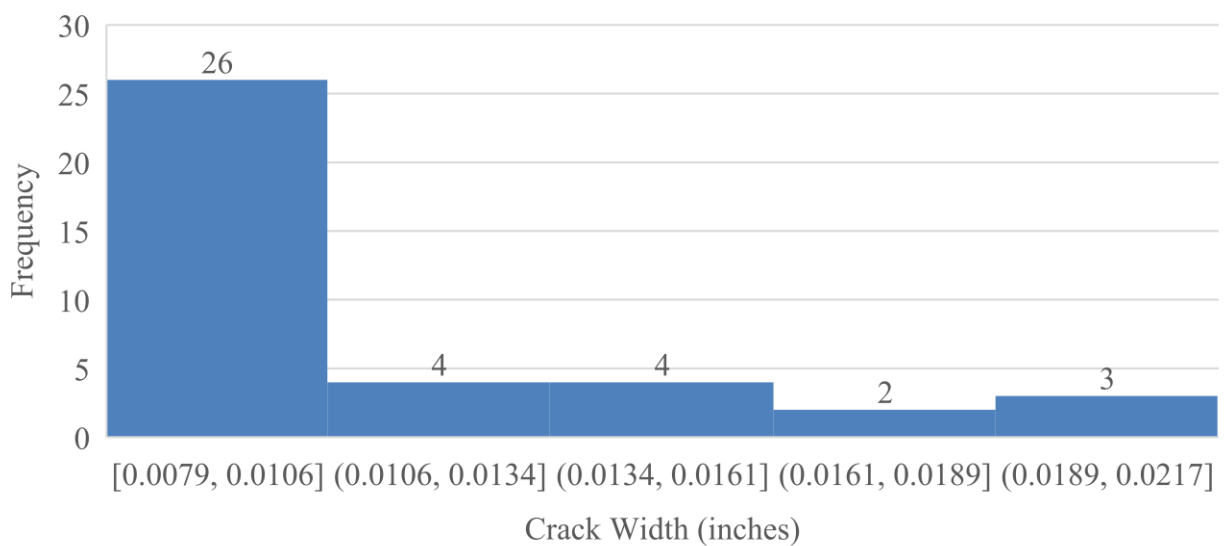
Figure 26. Histogram plot of measured crack widths

Figure 26 shows a histogram of the distribution of the measured crack widths, while Table 3 summarizes the descriptive statistics of the crack widths. Based on the histogram plotted in Figure 26, approximately 66.67% of the ground truth samples have crack widths between 0.0079 and 0.0106 in (0.2 and 0.3 mm), further highlighting the significant number of fine/hairline cracks.

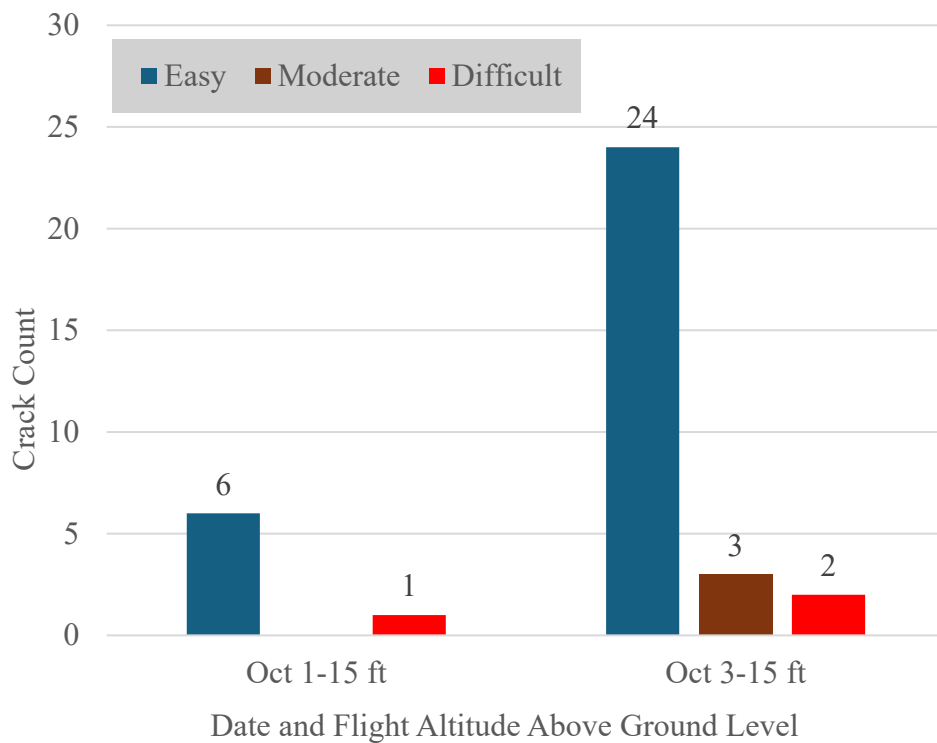
Figure 27. Visible cracks level of detection

Given the greater detection success for the 15 ft (4.6 m) AGL images, the final attributed labels for the 15 ft (4.6 m) AGL crack images were further analyzed to identify factors influencing hairline crack detection in orthophoto images. Figure 27 provides an overview of detection levels for all images with visible cracks. The detected cracks from the first-day images were classified as easy (6) or difficult (1), while the majority (24 out of 29) of the detected cracks in the second-day images were classified as easy.

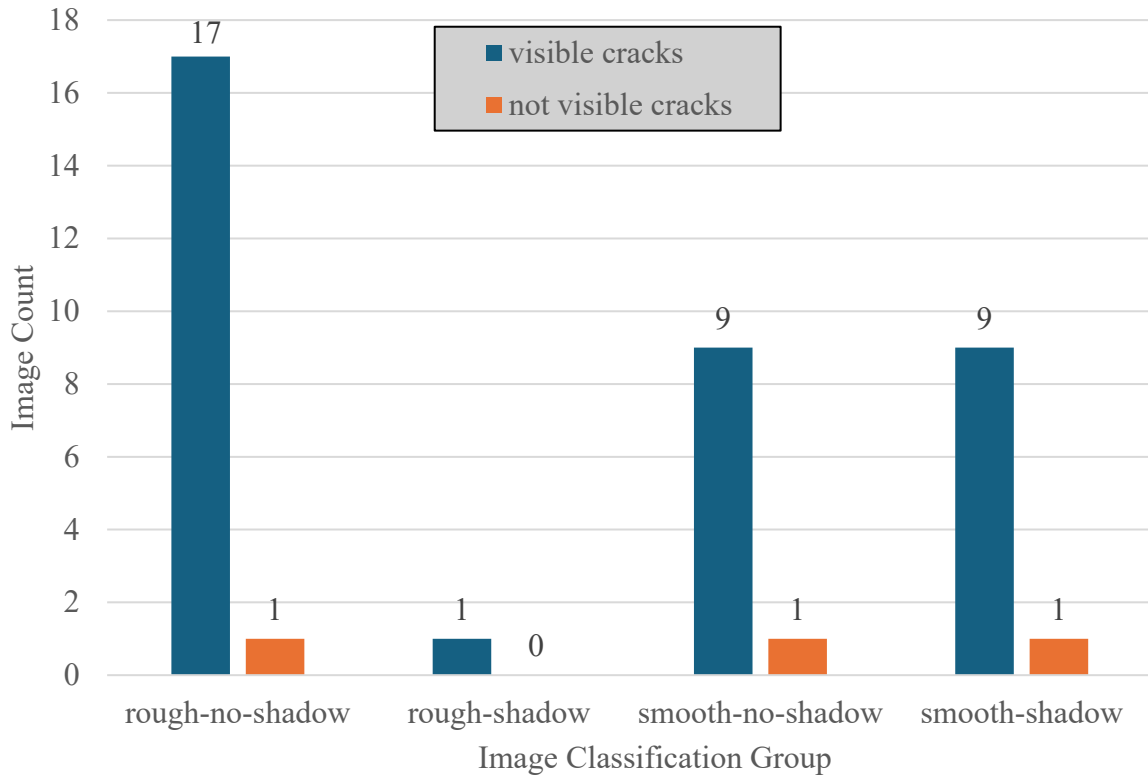
Figure 28. Visibility counts across combined image clusters for 15 ft (4.6 m) AGL data

Figure 28 illustrates the visibility counts across the four image classes, as first categorized in Figure 23. Even though the total number of images in each image class varies, one can generalize that the hairline cracks are visible across different classes. Since there was only one image classified as rough-shadow, it is premature to include that class under the stated generalization. Further comparison at the image classification level and the associated crack widths are shown in Figure 29 through Figure 32, with the conclusions summarized for each figure.

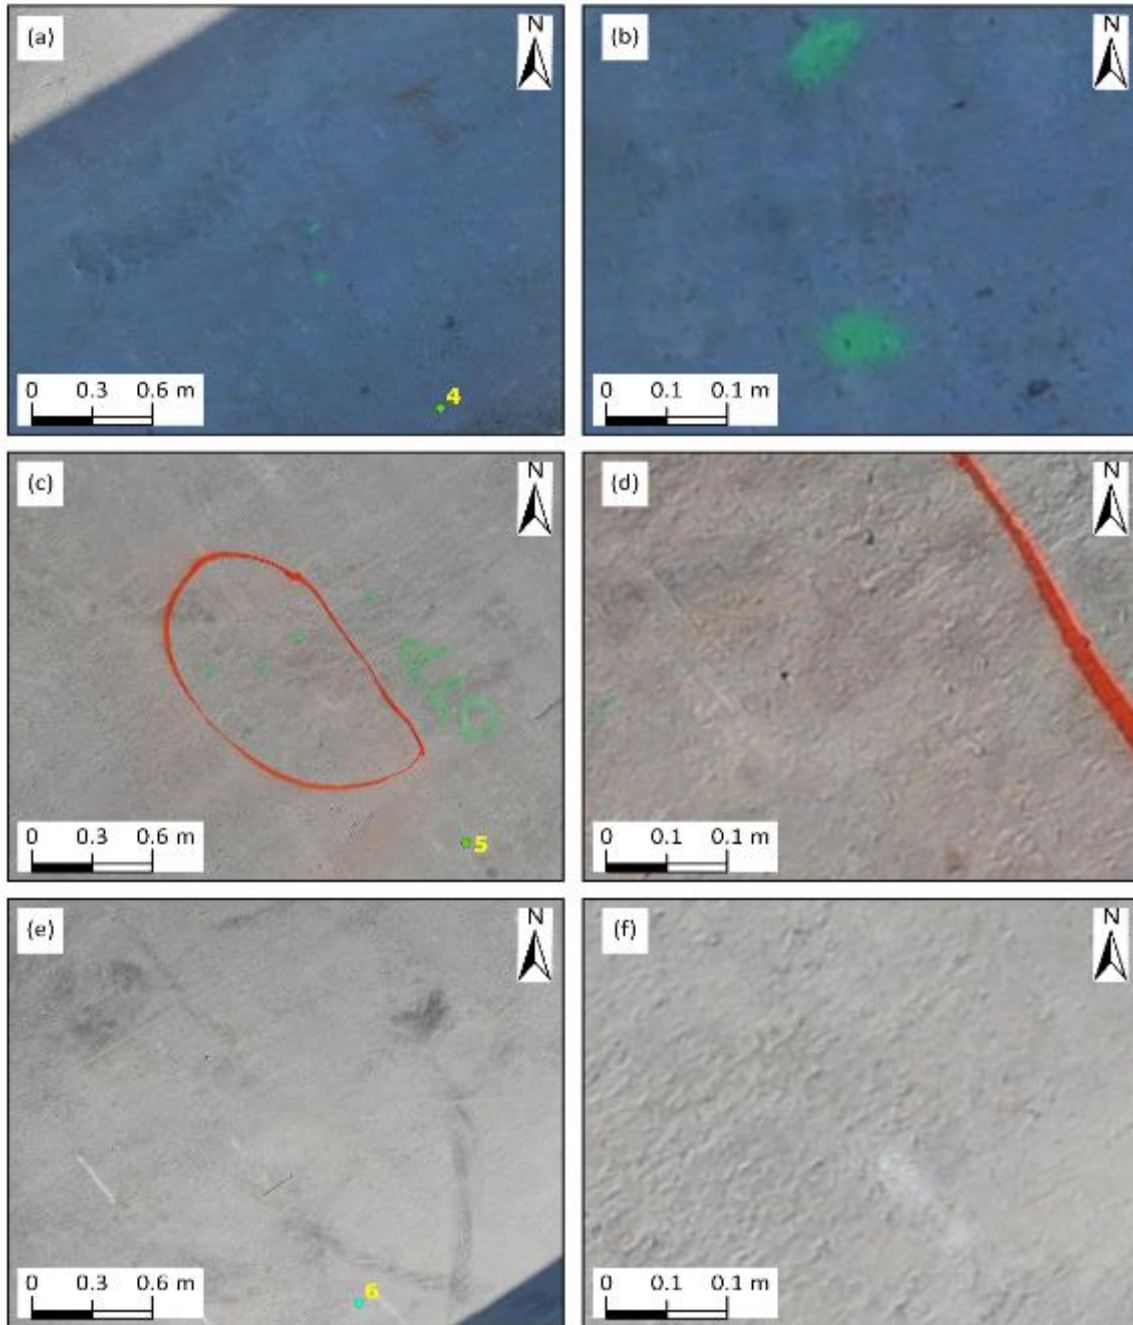
Figure 33. Cracks 1 through 3 at 0.032 in. (0.81 mm) GSD (1:30 zoom level on left and 1:5 zoom level on right)

Figure 34. Cracks 4 through 6 at 0.032 in. (0.81 mm) GSD (1:30 zoom level on left and 1:5 zoom level on right)

Figure 35. Cracks 7 and 8 at 0.032 in. (0.81 mm) GSD (1:30 zoom level on left and 1:5 zoom level on right)

Figure 36. Cracks 1 through 3 at 0.035 in. (0.88 mm) GSD (1:30 zoom level on left and 1:5 zoom level on right)

Figure 37. Cracks 4 through 6 at 0.035 in. (0.88 mm) GSD (1:30 zoom level on left and 1:5 zoom level on right)

Figure 38. Cracks 7 through 9 at 0.035 in. (0.88 mm) GSD (1:30 zoom level on left and 1:5 zoom level on right)

Sample images cropped from the 15 ft (4.6 m) AGL orthophotos are shown in Figure 33 through Figure 38, with the images on the left side of each figure showing a marked hairline region at a scale of 1:30 and the images on the right side of each figure showing a zoomed-in section of each region at a scale of 1:5.

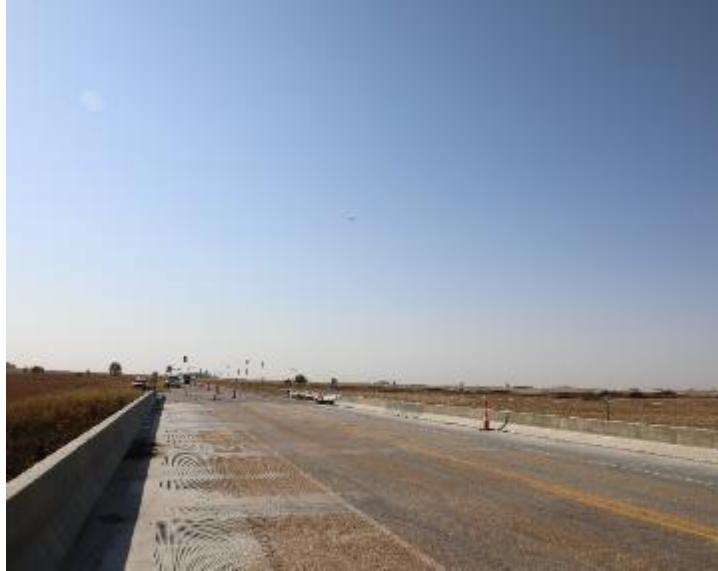
Figure 45. sUAS in automatic flight mode at 40 ft (12.2 m) AGL

While the longitudinally grooved bridge deck presented a challenge in distinguishing cracks from the grooved surface, particularly when cracks were aligned parallel to the grooves, transverse and angled cracks were easier to detect. After completing crack sampling and positioning six AeroPoints, full-lane closure was arranged and cones were removed from the median line to prepare for the first automatic mission flight at 40 ft AGL. Since the bridge is located outside controlled airspace, no flight approval was required. Figure 45 captures the flight in progress, which followed a longitudinal flight path with side and front overlaps ranging from 70% to 80%. Figure 45 illustrates the automatic flight path at a 40 ft altitude.

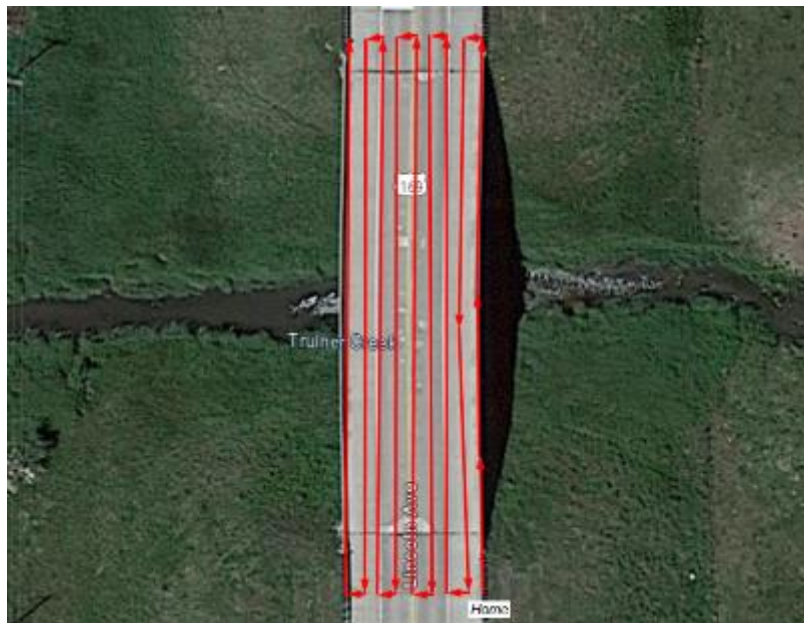
Figure 46. Manual mission flight at 15 ft (4.6 m) AGL

The research team completed the 40 ft AGL flight in four minutes, and traffic flow resumed in one of the two lanes. Over the closed lane, the research team manually flew the sUAS at an altitude of 15 ft AGL, ensuring necessary overlap while following a longitudinal flight path similar to that of the automatic mission. Figure 46 illustrates the 15 ft manual flight path, and Figure 47 shows the remote pilot, a zoomed-in image of the sUAS in the air, and a passing vehicle in the open lane.

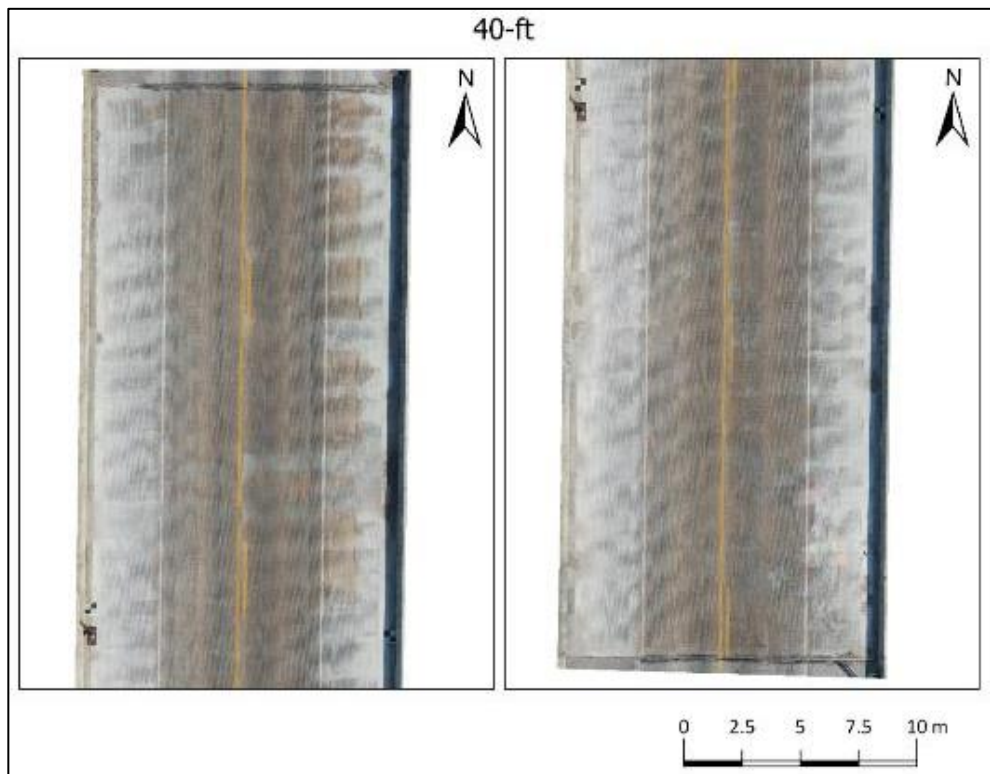
Figure 49. Processed orthophotos from sUAS data collected at 40 ft (12.2 m) AGL

Section	Images	Capture Time (mins)	Time Required (mins)				GSD (in. (mm))	
			Alignment	Depth Maps	Model	Ortho		Total
15 ft	789	45	39	340	137	136	652	0.033 (0.85)
40 ft	79	4	3	30	30	25	88	0.079 (2.02)
