**Final Report on Phase I**

# **ALTERNATE METHODS OF STABILIZING DEGRADING STREAM CHANNELS IN WESTERN IOWA**

**ISU-ERI-Ames-81047  
Project 1421**

**Iowa DOT HR-208**

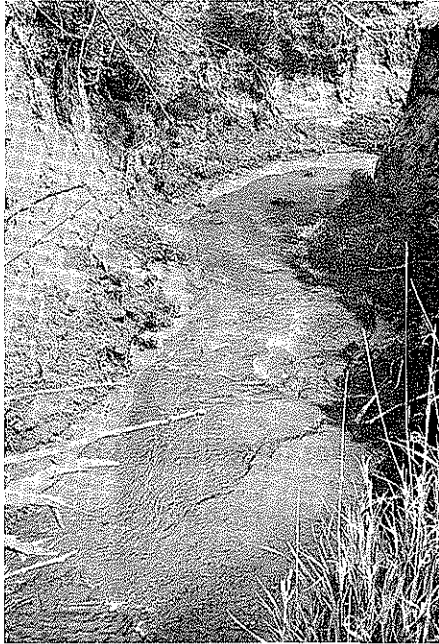
Plate 1. An example of a degrading stream in Monona County. Note the blocks of soil sliding down the channel sides.

Since the beginning of channel straightening at the turn of the century, the streams of western Iowa have degraded 1.5 to 5 times their original depth. This vertical degradation (Plate 1) is often accompanied by increases in channel widths of 2 to 4 times the original widths. The deepening and widening of these streams has jeopardized the structural safety of many bridges by undercutting footings or pile caps (Plate 2), exposing considerable length of piling (Plate 3), and removing soil beneath and adjacent to abutments (Plate 4).

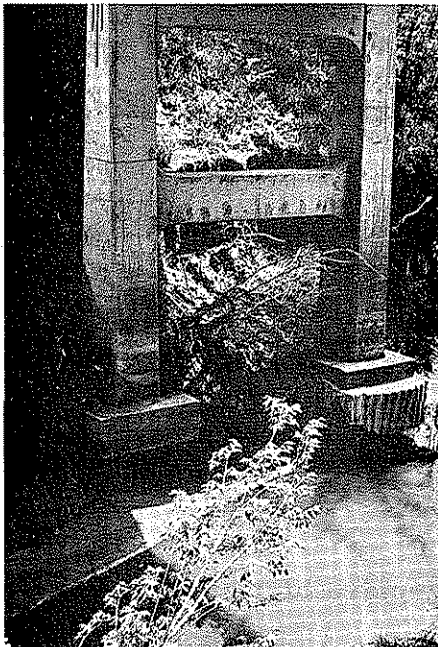
Plate 2. Degradation exposed pile cap of pier at left. Pier at right has had remedial work.

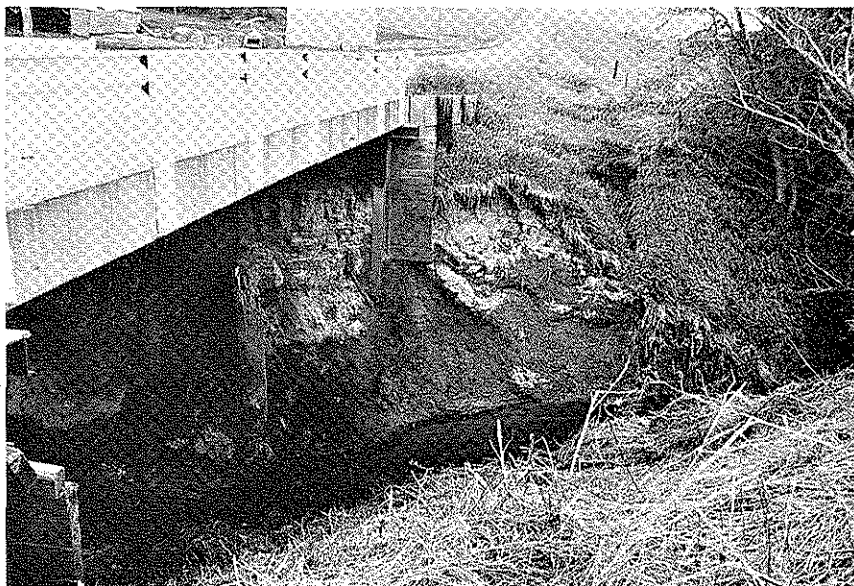
Plate 4. Degradation and the associated landslide has removed soil adjacent to the abutment on this Shelby County bridge.

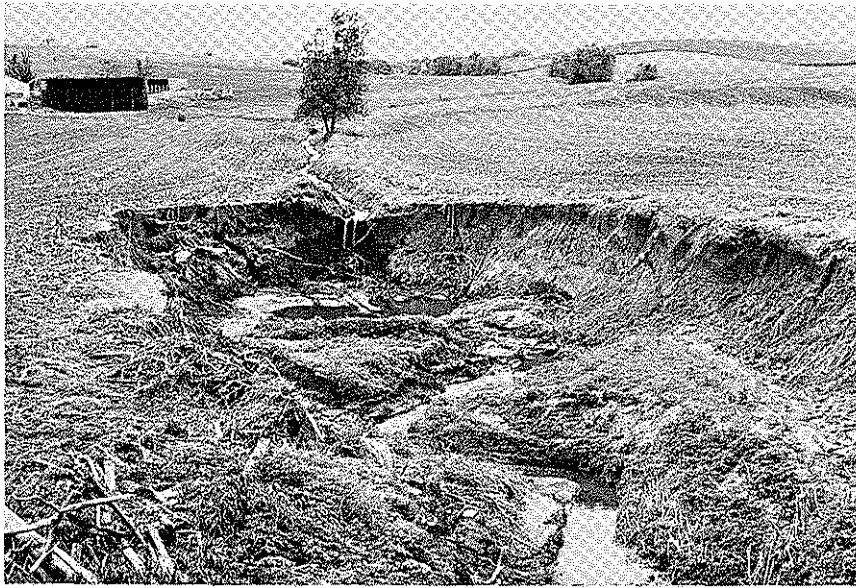
Plate 5. An example of a knickpoint eroding headward in a small tributary stream.

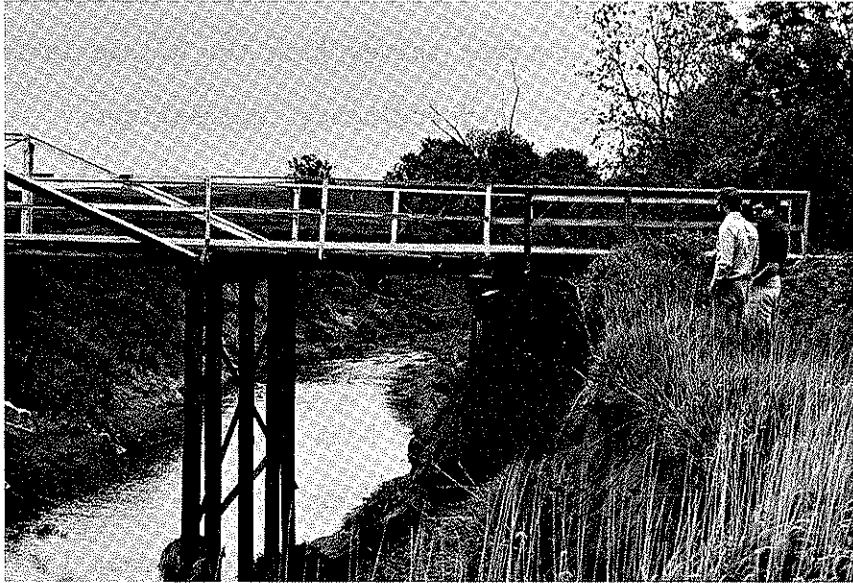
Plate 6. Stream degradation has exposed the bottom of the piles in this Crawford County bridge and caused a landslide which pulled soil from behind the abutment. Note that an approach span has been added to accommodate the increased valley width.

As pointed out earlier, channel degradation leads to landslides which cause an increase in channel width. An attempt was made to quantitatively define the problem by determining the number of bridges in the area with approach spans. In western Iowa, presence of approach spans usually indicates that spans have been added since construction (Plate 6). The Iowa DOT bridge inventory data on the number of bridges with approach spans are summarized in Table 6. These data indicate that problem structures are more abundant in counties with deep loess deposits. The bar graph in Fig. 17 shows (for the entire 13-county area) the distribution of the number of approach spans among the bridges having such spans. Although the majority of the bridges have fewer than 3 approach spans, there are 14 bridges with 8 or more approach spans. Of the 5,223 bridges in the 13-county area, nearly 18% have one or more approach spans.

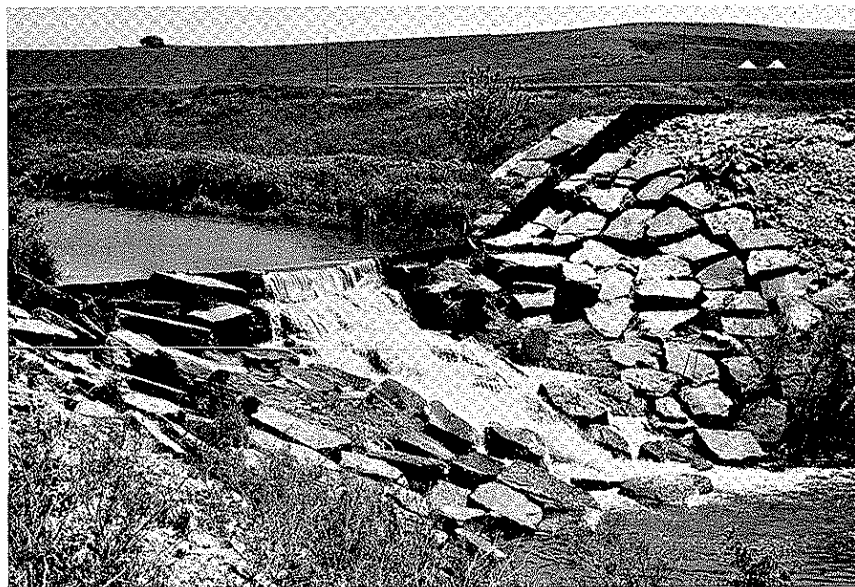
Plate 8. Grade stabilization structure consisting of a single row of sheetpile reinforced with derrick stone.

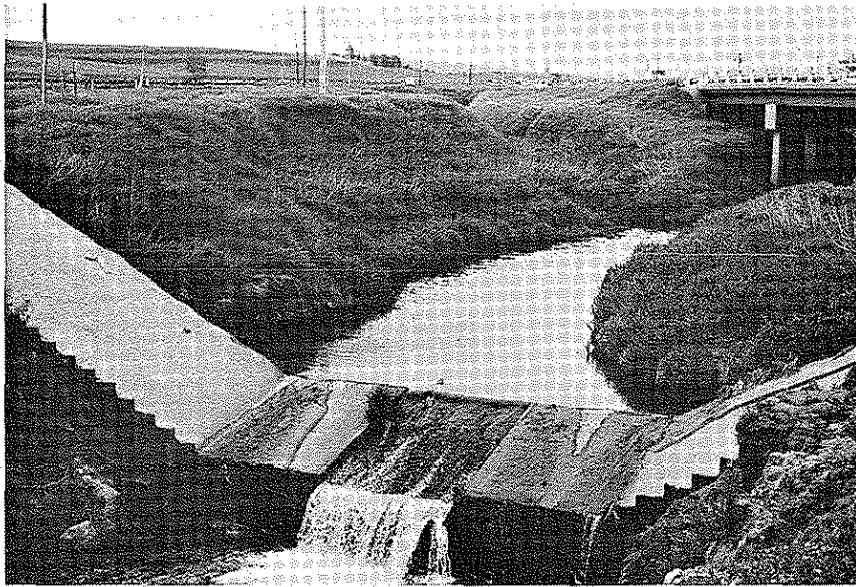
Plate 9. Grade stabilization structure consisting of double row of steel sheetpile with a concrete core and cap. Note large crack in right side resulting from adjacent landslide caused by downstream scour in plunge pool.

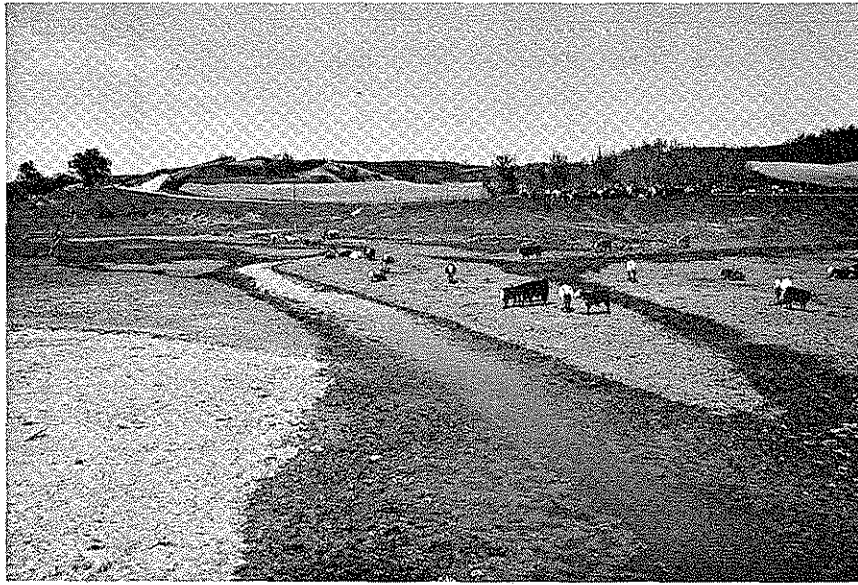
Plate 15a. The aggraded prism of sediment deposited upstream of a flume bridge in Monona County. Compare this photo with the downstream view in 15b.

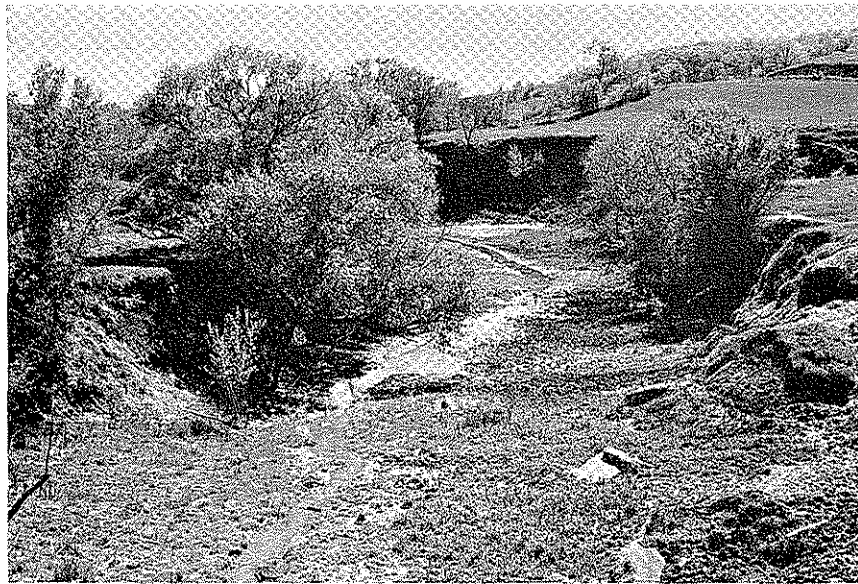
Plate 15b. A degraded channel downstream from a flume bridge. Compare this photo with the upstream view in 15a.

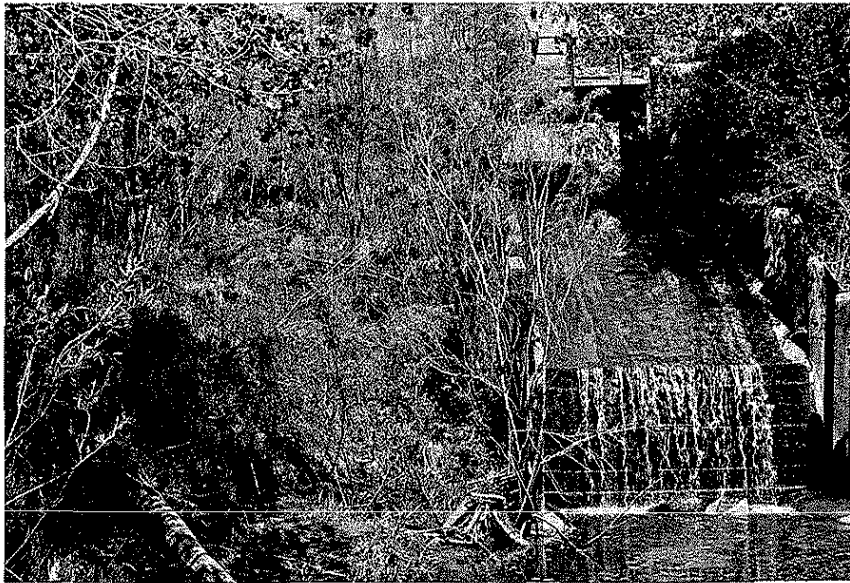
Plate 20. A foreshortened flume outlet; the irregular topography in the soil to the left of the flume is the result of landslides caused by seepage forces in the embankment.

Field observation of embankment instability induced by seepage through the embankment (Plate 20) suggests that some flume bridge embankments have been designed as highway embankments when in fact they should have been considered earth dams. It is also the opinion of many of the engineers in the area that failures in some cases have been caused by piping through the embankments or in other situations by uplift pressures and/or piping beneath the concrete. It is recognized that piping problems may result from poor construction rather than from poor design. The aforementioned application of plastic soil-cement may provide remedial measures when piping is observed but before a major
