## Dissimilar Metal Welds Between ASTM A709 Grade 50CR and Other Bridge Steels

**JASON T. PROVINES, P.E., Senior Research Scientist**  
Virginia Transportation Research Council

**Final Report VTRC 26-R45**

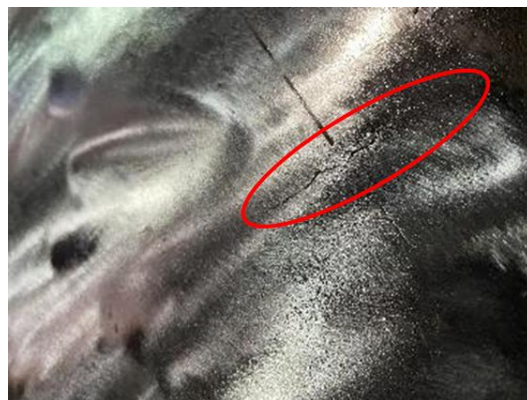
**Figure 2. Photograph of Crack in 50CR Steel Plate**

Furthermore, once the 50CR steel was delivered from the supplier, the fabricator discovered surface cracks in an entire heat of steel. The cracks were inspected with UT, and some were measured to be 1/2 inch deep. Figure 2 shows an example of one of these cracks. Because of the widespread nature of these cracks, the entire heat of steel had to be rejected and replaced. The replacement heat of steel also had a 7- to 8-month lead time, causing further delays to the project.

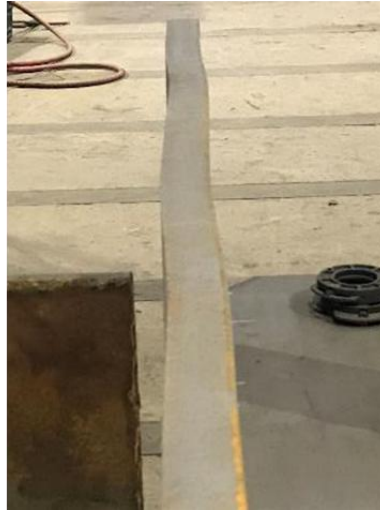
**Figure 3. Schematic and Photo of Waviness in 50CR Steel Plates**

VDOT also experienced challenges with lead times and quality on its fourth attempt at using 50CR steel on the Nottoway Spillway Bridge in 2023. Lead times on this project were 10 to 11 months and caused major delays. Some of the 50CR steel plates delivered also had significant waviness and were out of flatness tolerance prior to any welding. Figure 3 shows the severity of the waviness in the plates. The fabricator attempted to flatten the plate with heat straightening and hydraulic press fitting with tack welding, but both were unsuccessful. These quality issues with the 50CR steel caused further project delays.

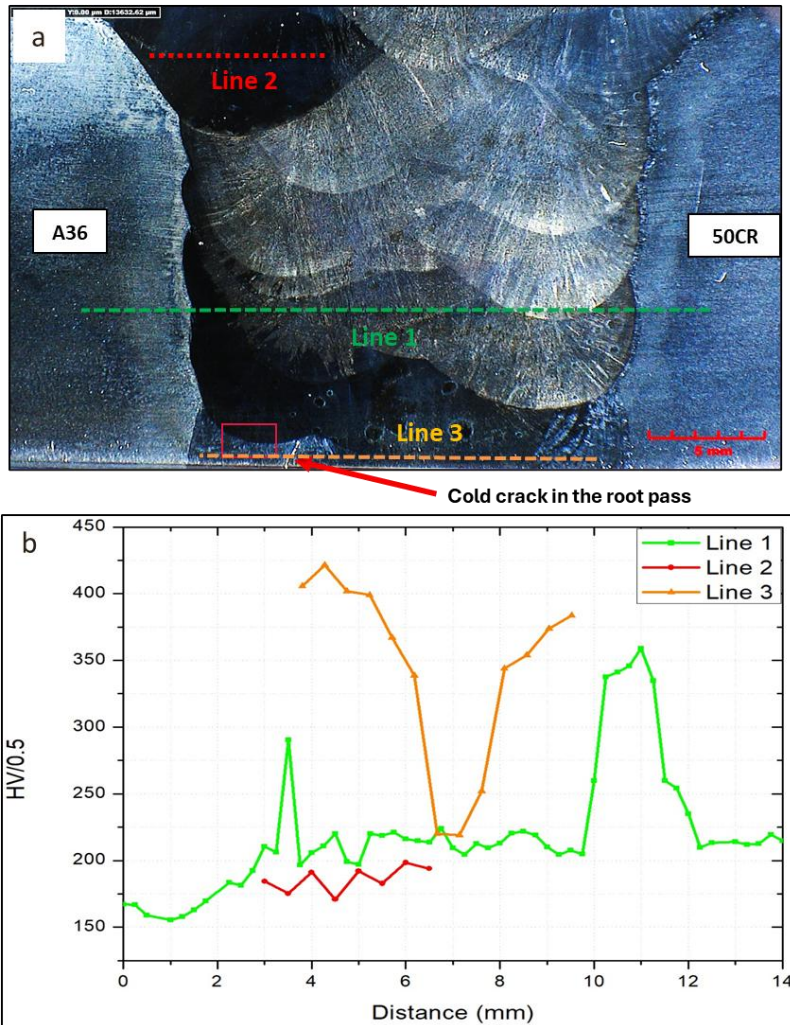
**Figure 19. Overview of Cold Cracking Analysis: (a) Macroscopic View of Specimen PQR-13 with Root Pass Crack; (b) Vickers Hardness Profile across Weld Regions with Hardness Lines Indicated in the Macrograph. A36 = A36 steel; 50CR = 50CR steel.**

The presence of residual welding stresses, combined with the formation of brittle martensite in the root pass, is believed to have caused the cold cracking. The cold cracking was resolved in the Group 2 and 3 welds by using the single-V with backgouge weld joint geometry. This joint type eliminated the need for carbon steel backing plates and mitigated the risk of dilution-induced cold cracking. No cold cracks were found in any of the Group 2 and 3 welds.

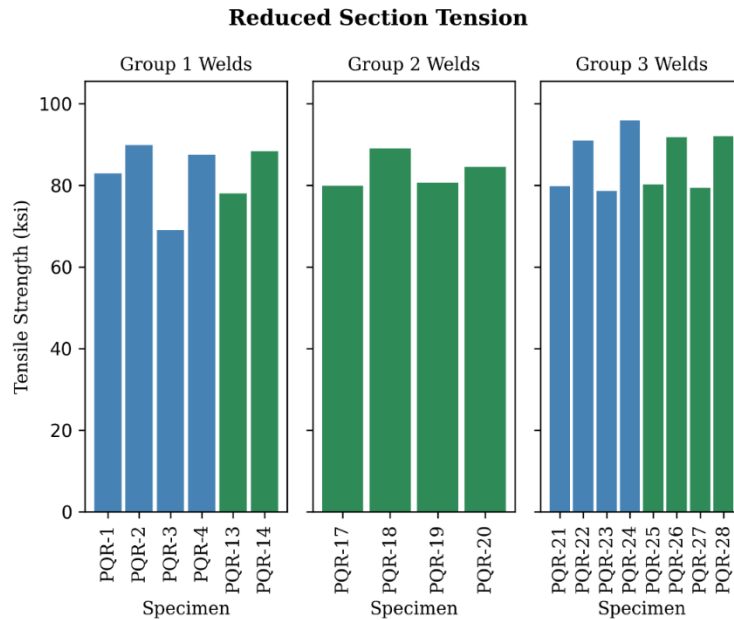
**Figure 21. Average Reduced Section Tension Testing Results. Blue bars represent shielded metal arc welding or flux cored arc welding, and green bars represent submerged arc welding.**

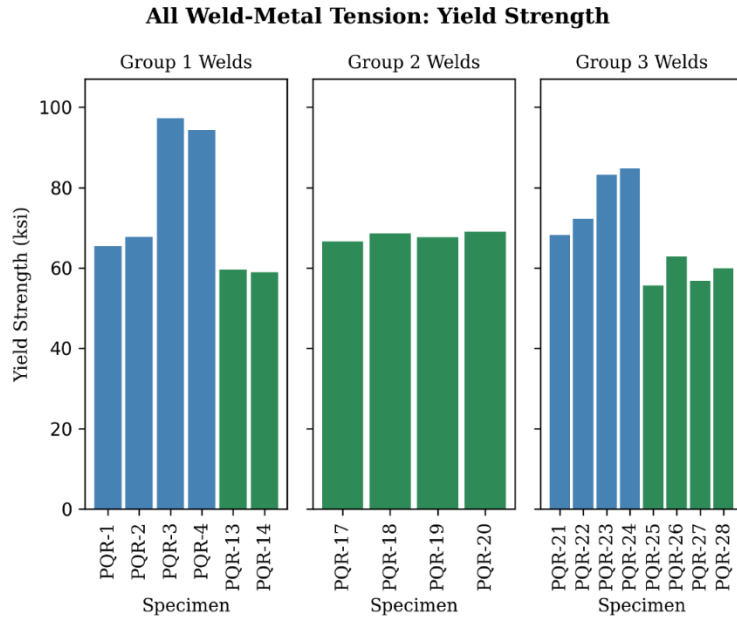
**Figure 22. Average Results for Yield Strength of All Weld-Metal Tension Testing. Blue bars represent shielded metal arc welding or flux cored arc welding, and green bars represent submerged arc welding.**

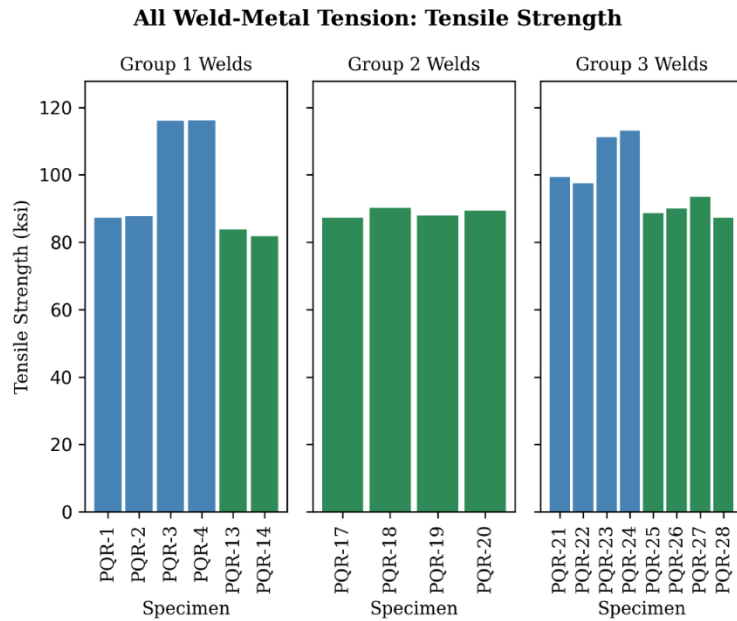
**Figure 23. Average Results for Tensile Strength of All Weld-Metal Tension Testing. Blue bars represent shielded metal arc welding or flux cored arc welding, and green bars represent submerged arc welding.**

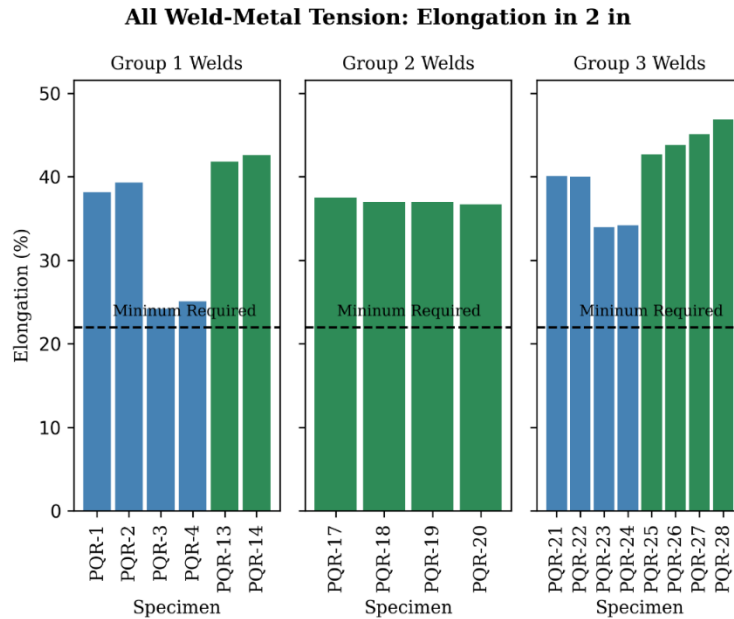
**Figure 24. Average Results for Elongation of All Weld-Metal Tension Testing. Blue bars represent shielded metal arc welding or flux cored arc welding, and green bars represent submerged arc welding.**

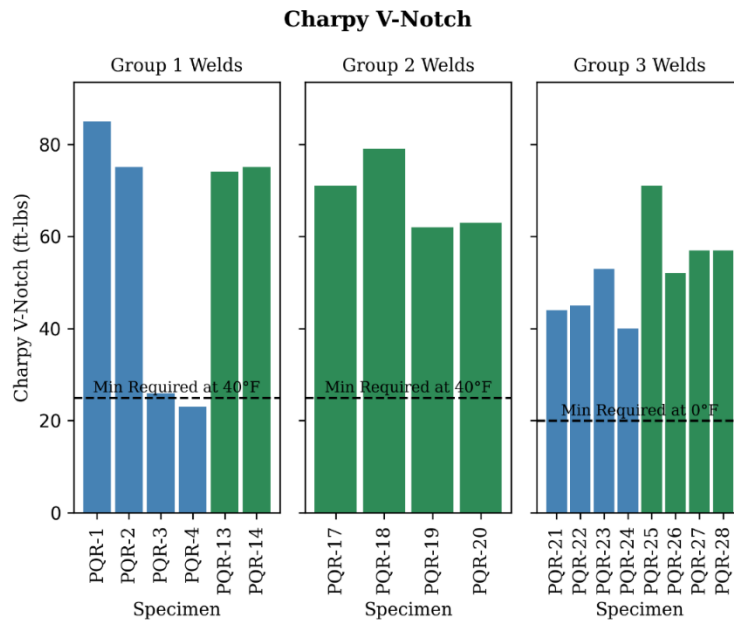
**Figure 25. Average Results for Charpy V-Notch Testing. Blue bars represent shielded metal arc welding or flux cored arc welding, and green bars represent submerged arc welding.**

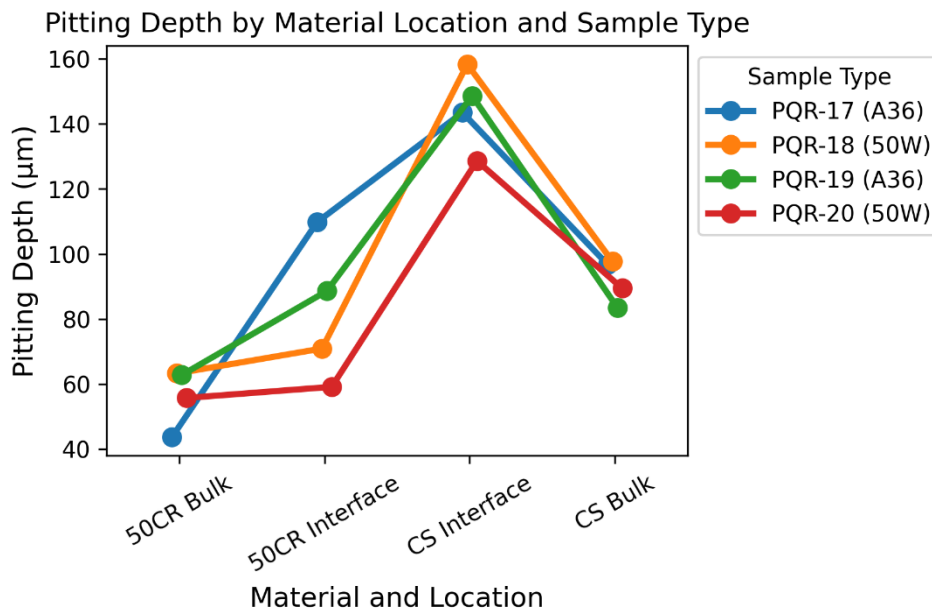
**Figure 26. Plot Showing Average Pitting Depth Measurements for Dissimilar Metal Weld Samples Exposed to Saltwater Droplet Testing. 50 CR = 50CR steel; 50W = 50W steel; A36 = A36 steel; CS = carbon steel.**

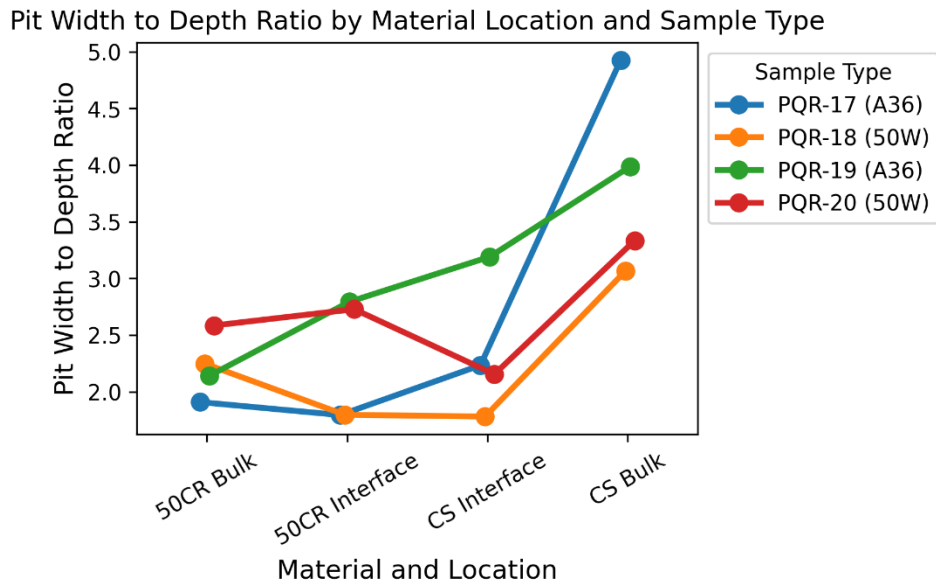
Figure 27. Plot Showing Average Pitting Width to Depth Ratio for Dissimilar Metal Weld Samples Exposed to Saltwater Droplet Testing. A36 = A36 steel; 50CR = 50CR steel; 50W = 50W steel; CS = carbon steel.

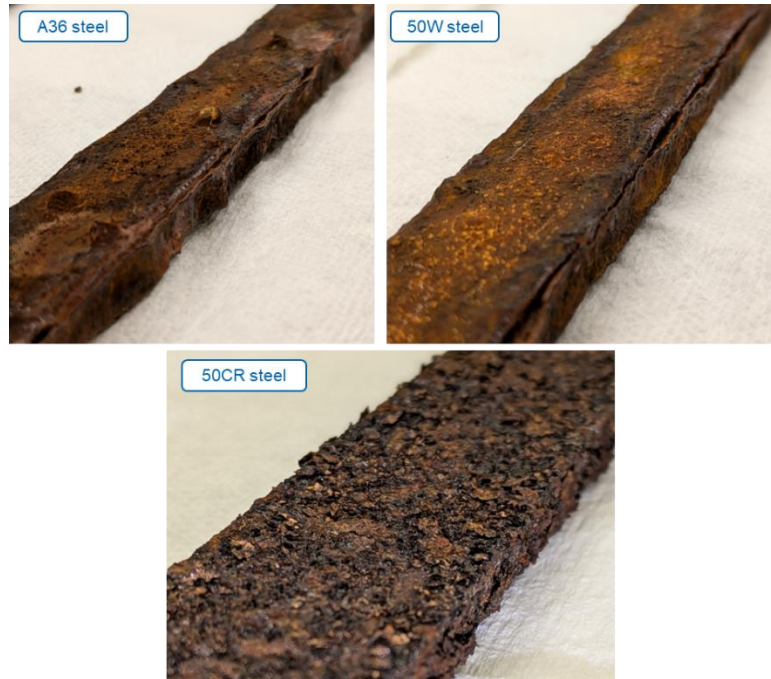
**Figure 28. Close-up Photos of Typical Base Metal Specimens before Blast Cleaning for Accelerated Corrosion Chamber Testing**

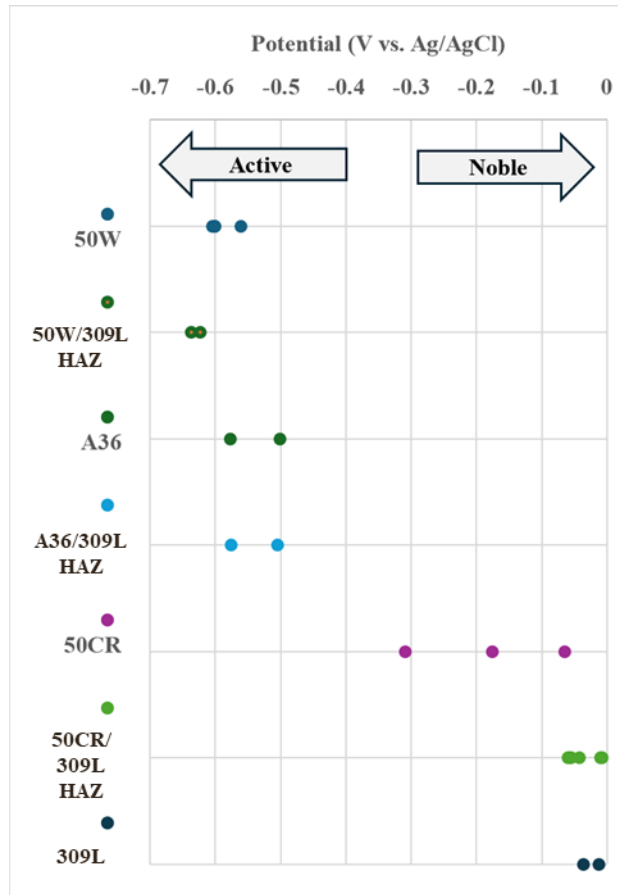
Figure 33. Open Circuit Potential Tests Run for 7,200 Seconds (2 hours) Showing the Relative Nobilities of Each of the Weld Metals Tested in 3.5 wt.% Sodium Chloride Solution. 50CR = 50CR steel; 50W = 50W steel; A36 = A36 steel; HAZ = heat-affected zone.

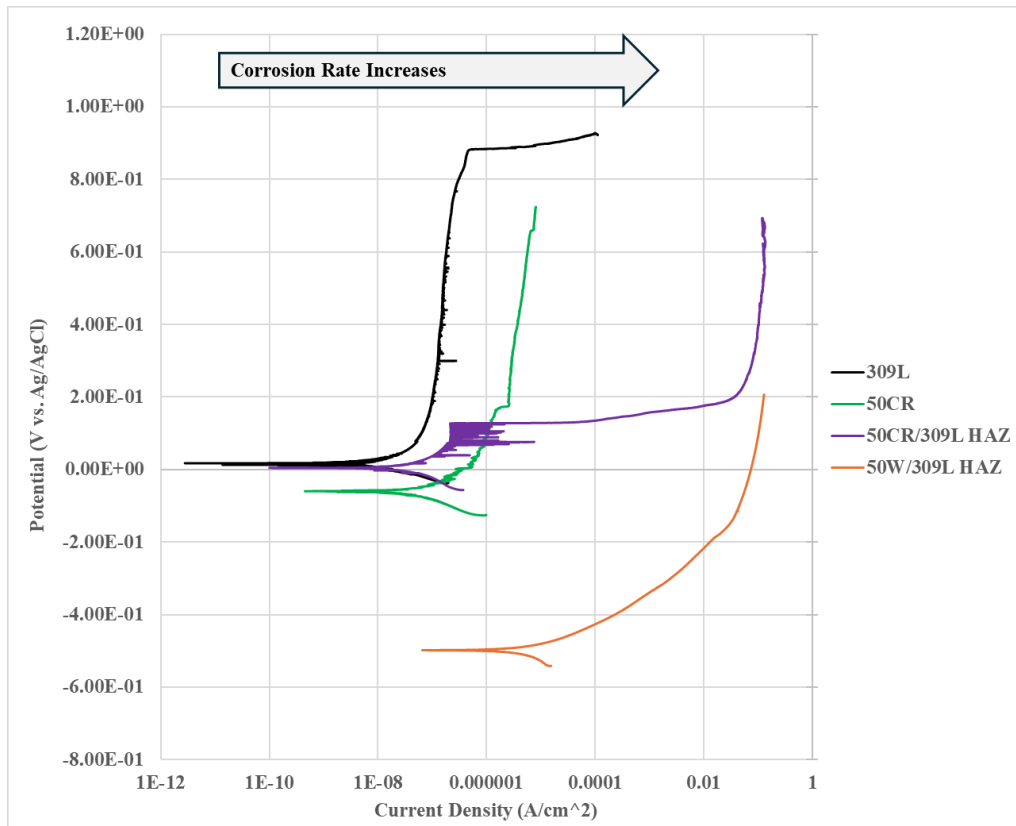
**Figure 34. Anodic Polarization Scan Results Show the Relative Activity between the More Active 50W Steel Compared with the 50CR Steel and the Most Noble 309L Weld Metal. Pitting potentials are clearly shown as rapid increases in current density once a threshold voltage is reached for the stainless steels. HAZ = heat-affected zone.**

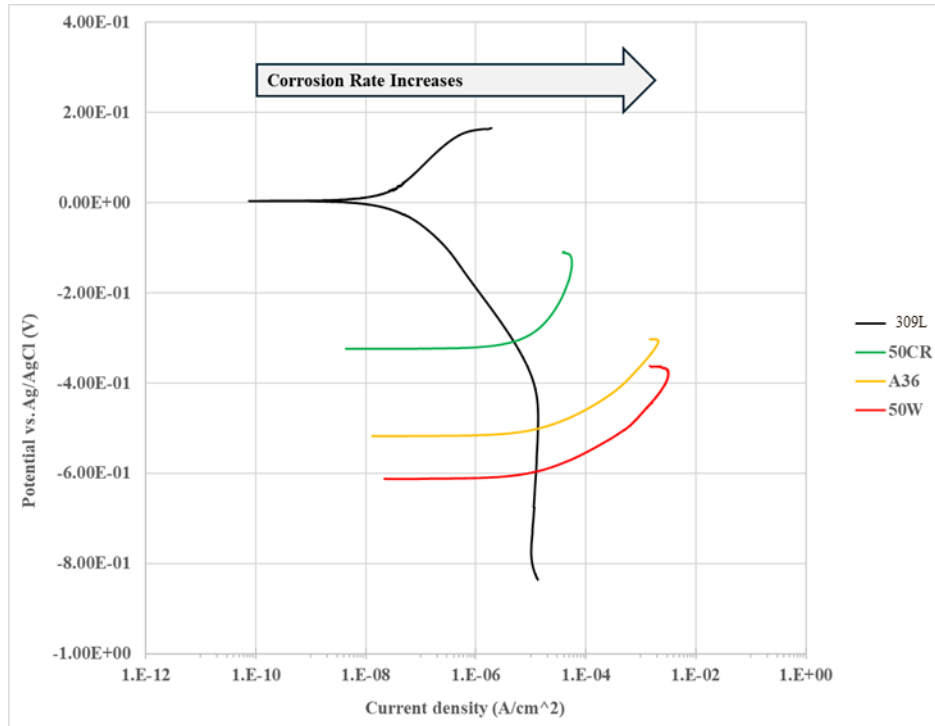
Figure 35. Potentiodynamic Scans for Each of the Base Metals. As seen in the comparison between each of the weld metals, the nobility of each of the metals decreases in the order of 309L weld metal > 50CR steel > A36 steel > 50W steel. The estimated current density for each of the couples, which is proportional to the corrosion rate, is lowest for 309L weld metal/50CR steel < 309L weld metal/50W steel < 309L weld metal/A36 steel.

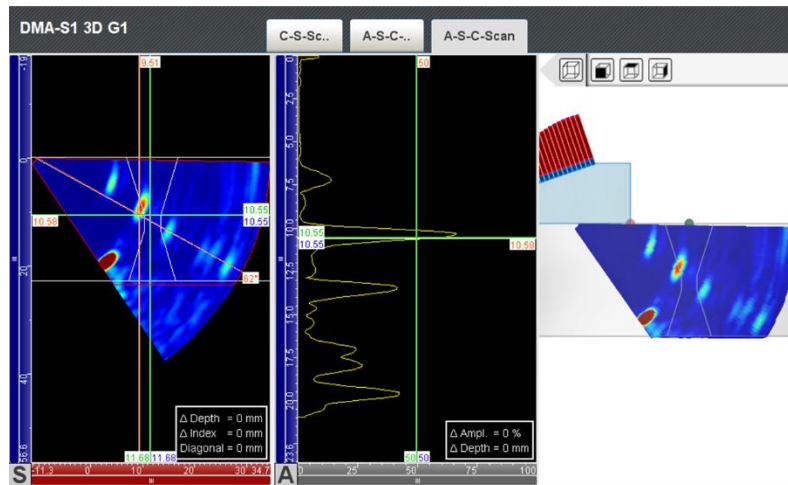
Figure 45. Improved Defect Detection Using Longitudinal Wave Probe
