Evaluation of Retroreflective Pavement Markers for Precision and Nonprecision Runways

Prepared By
FAA Technical Center
Atlantic City Airport, N.J. 08405

December 1982

Interim Report

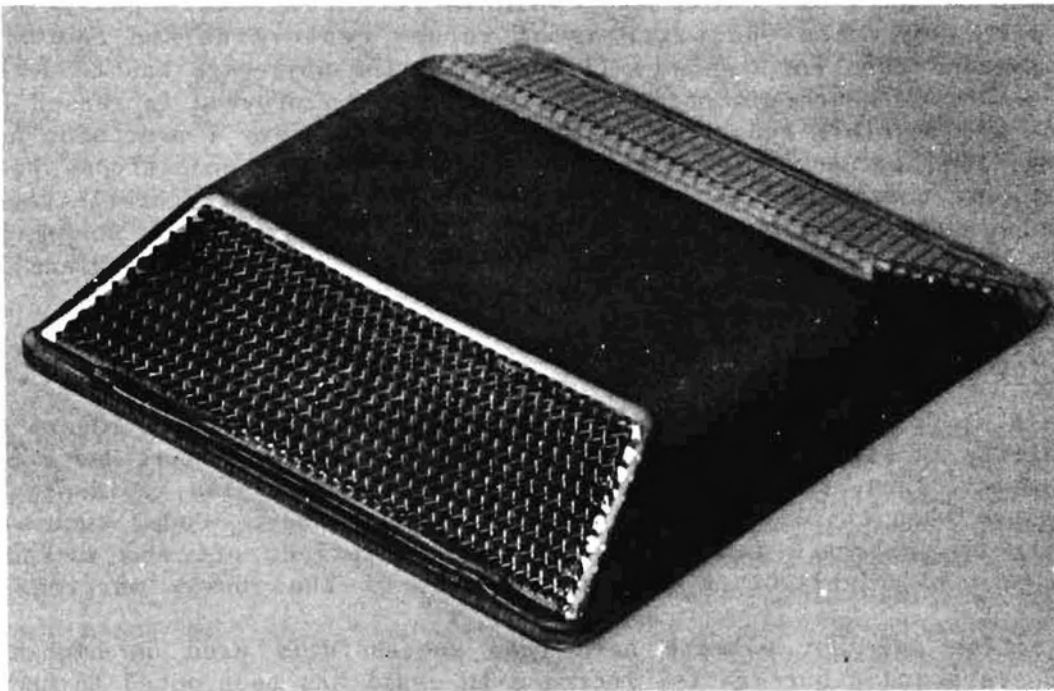
FIGURE 1. RETROREFLECTIVE PAVEMENT MARKER

Retroreflective pavement markers (figure 1) consist of an acrylic plastic shell fitted with a potting compound and having overall dimensions of 4 inches by 4 inches by 0.75 inch high. Two sides have sloping surfaces with one or two prismatic reflective faces, as required, to reflect incident light from single or dual directions. The area of each reflecting surface is 3.25 square inch. The unit used for this evaluation was the Stimsonite Model 911 marker which is their Model 88 modified by the company to provide an improved abrasion resistant surface. Surface modification is accomplished by adding a thin layer of untempered glass bonded to the prismatic reflective face. The Model 88 retroreflective marker is listed under Federal Aviation Administration (FAA) Approved Airport Lighting Equipment and Specification L-853 (references 3 and 4).

The retroreflective pavement markers, made of plastic, are 4 inches square by 0.75 inches high. Two sides have sloping surfaces with one or two prismatic reflective faces as required to reflect incident light from single or dual directions. The markers were installed on runway 4-22 at the Technical Center using an epoxy compound. The spacing and colors used were the same as those specified for Category II centerline and touchdown zone lighting systems.

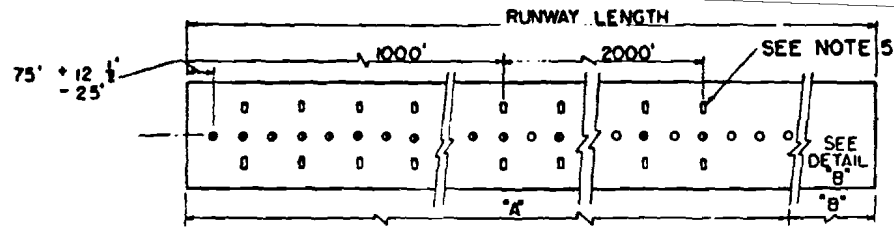
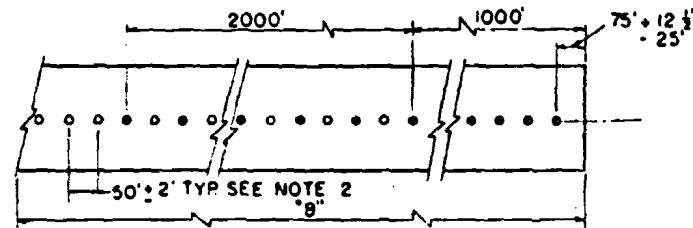
FIGURE A-1. RUNWAY CENTERLINE LIGHTING LAYOUT

- - Unidirectional touchdown zone light bar, 3 lights per bar
- - Bidirectional runway centerline light white both directions
- r o w - Centerline lights white (w) one direction and red (r) opposite direction.

DETAIL "B"

1. Centerline lights may be offset 2' to the right or left of the runway centerline to avoid the centerline paint markings.
2. The centerline lights may have a longitudinal tolerance of ± 2', a lateral tolerance of ± 1/4".
3. The last 3000 - foot to 1000 - foot section of the runway centerline displays an alternate red and white light signal.
4. The last 1000 - foot section of the runway centerline displays an all red signal.
5. The touchdown zone light bars are not required to be located at the same stations as the centerline lights. See figure 2 for configuration.

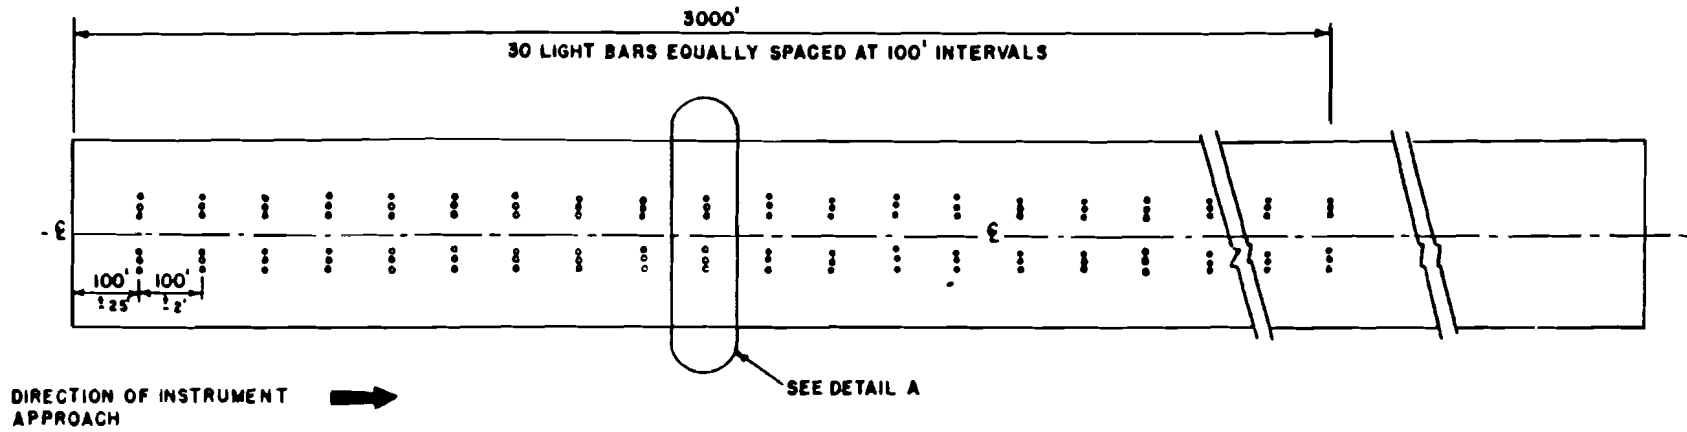
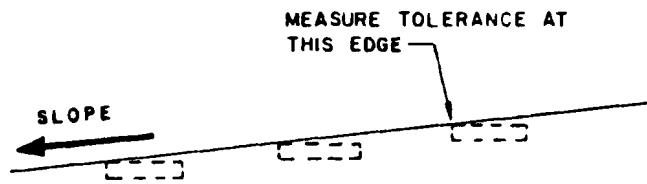
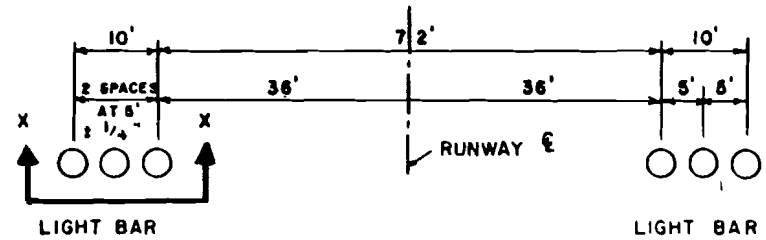
FIGURE A-2. TOUCHDOWN ZONE LIGHTING LAYOUT

DETAIL A

1. THE LONGITUDINAL INSTALLATION TOLERANCE IN LOCATING THE PAIRS OF TRANSVERSE LIGHT BARS SHOULD NOT EXCEED 2 FEET
LATERAL TOLERANCE OF LIGHTS IN A BAR IS $\pm 1/4"$
2. THE SPACING BETWEEN THE INNERMOST TOUCHDOWN ZONE LIGHT FIXTURES SHOULD BE UNIFORM THROUGHOUT THE LENGTH OF THE SYSTEM. THIS SPACING IS 72 FEET EXCEPT WHERE CONSTRUCTION PROBLEMS PREVENT THIS SEPARATION. IN THIS CASE, THE UNIFORM SPACING IS REDUCED TO NOT LESS THAN 65 FEET.

(1) Longitudinal Spacing. Provide the runway touchdown zone lighting system with rows of transverse light bars located symmetrically about the runway centerline. Each light bar consists of three unidirectional lights facing the threshold. Extend the system for a distance of 3,000 feet along the runway. Reduce this basic length to one-half the runway length for those runways less than 6,000 feet. Locate the first pair of light bars 100 feet from the landing threshold, followed by each succeeding pair at 100-foot intervals to the end of the system.

(2) Lateral Spacing. See Figure 2."
