Report No. UT-26.11

## **DURABILITY OF RAPID-SETTING CONCRETE REPAIRS ON PAVEMENT PANELS AND BRIDGE DECKS IN UTAH**

Utah Department of Transportation  
Research & Innovation Division

**Final Report  
February 2026**

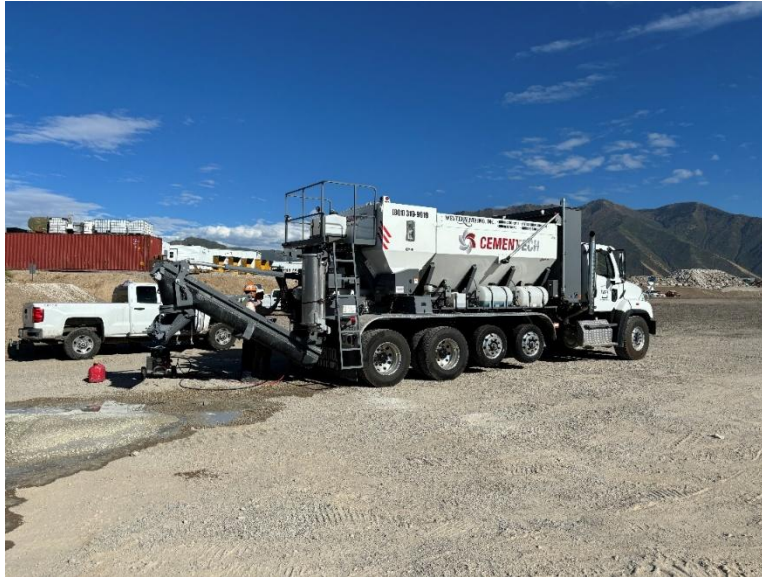
**Figure 2.2 Volumetric concrete mixer.**

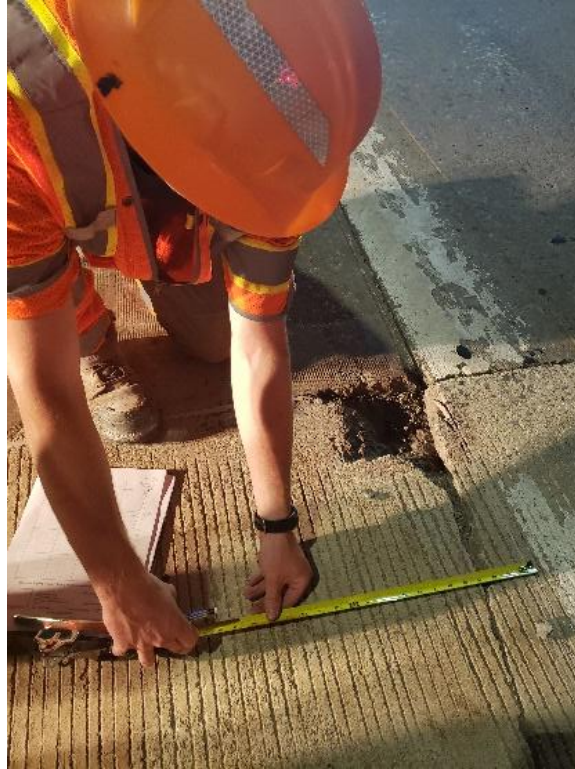
As illustrated in Figure 3.5, manual measurements of each observed distress were performed in general accordance with Federal Highway Administration guidelines (Miller and Bellinger, 2003) to prepare a distress map, or drawing, of each selected repair, including the locations and/or extent of cracks, scaling, and spalling. Crack widths were estimated using a

**Figure 3.5 Distress measurements.**

crack comparator card, with multiple measurements being recorded along cracks that clearly exhibited varying width. Chain dragging was performed to identify the occurrence of delamination, which was also mapped. Finally, distresses that were presumed to be the result of construction-related issues were noted. Photographs were taken to aid in data analysis, including, for example, quantifying the extent of scaling and estimating the locations of lane striping. As needed, work lights were used to illuminate the inspected repairs. Concrete surfaces appeared to be dry during visual inspection.

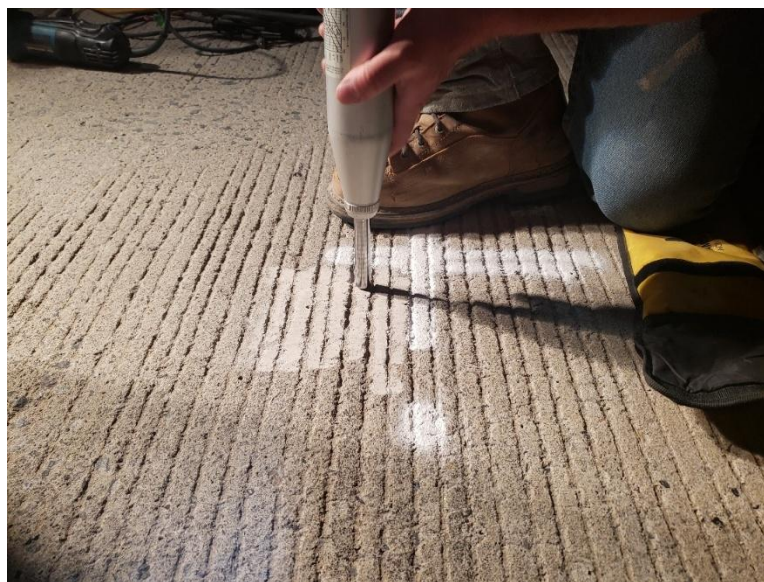
**Figure 3.6 Schmidt rebound hammer testing.**

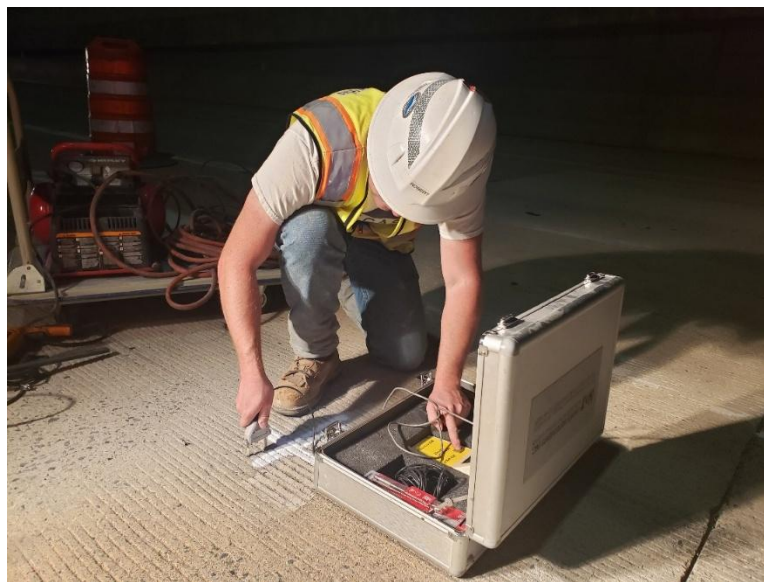
Resistivity testing was performed using a two-prong probe (Barrus, 2012). At each test location, two sets of holes were drilled approximately 1.5 in. apart, where a set included two 0.25-in.-diameter holes spaced 2.0 in. apart to match the prong positions. Each of the four holes

was drilled to a depth of approximately 0.5 in. After the holes were cleaned using compressed air, several drops of a conductive solution were added to each hole. The probe was then inserted into each set of holes as shown in Figure 3.7, and the resistivity was measured. The probe was then rotated end for end, and the resistivity was measured again. The surface temperature of the concrete at each test location was also measured using a spot radiometer.

**Figure 3.7 Resistivity testing.**

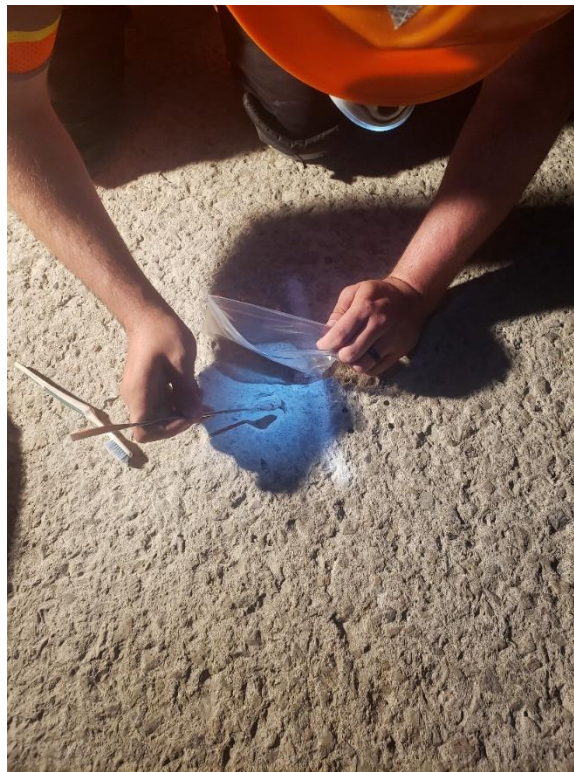
Concrete sampling included collection of concrete powder and concrete cores for laboratory testing. Concrete powder sampling was performed using carbide-tipped rotary hammer bits in four 1-inch-depth intervals at each test location. To minimize contamination of samples obtained from deeper intervals by inadvertent scraping of the inside of the hole nearer the surface, smaller bits were used with increasing depth, as shown in Table 3.3. After each depth interval was drilled, the resulting concrete powder was collected using a small scoop

**Figure 3.8 Concrete powder sampling.**

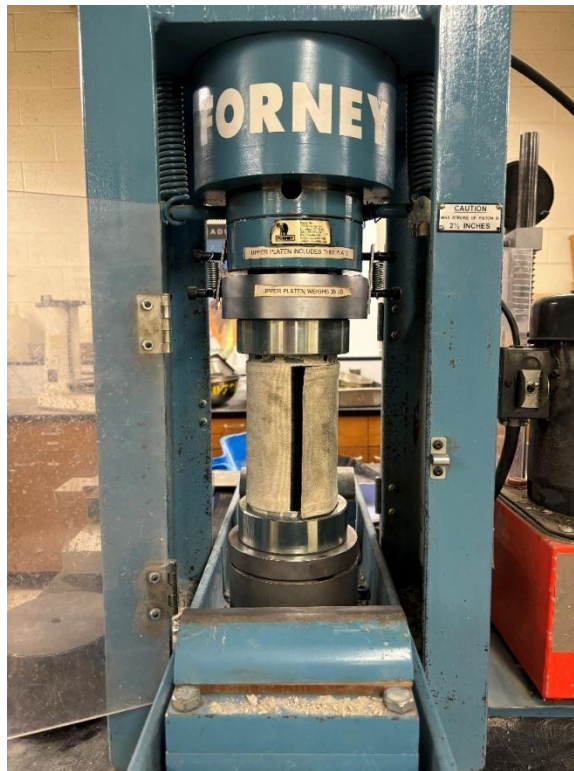
**Figure 3.12 Compressive strength testing.**

in./minute until failure. The compressive strength was determined by dividing the load at failure by the initial cross-sectional area of the core. Strength correction factors published in ASTM C42 (Standard Test Method for Obtaining and Testing Drilled Cores and Sawed Beams of Concrete) and duplicated in Table 3.4 were utilized when the ratio of the length to the diameter of a core was less than or equal to 1.75; as needed, linear interpolation was used to obtain values for specific ratios.

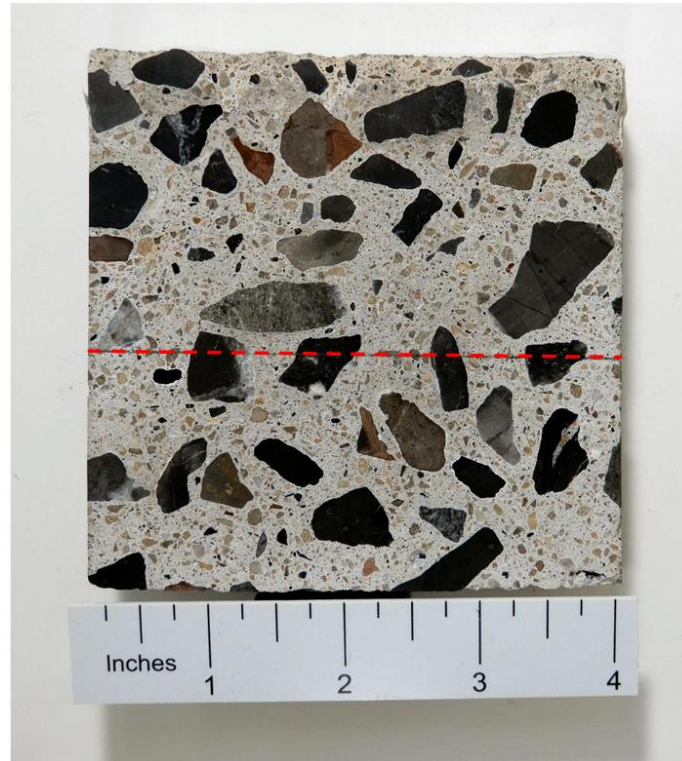
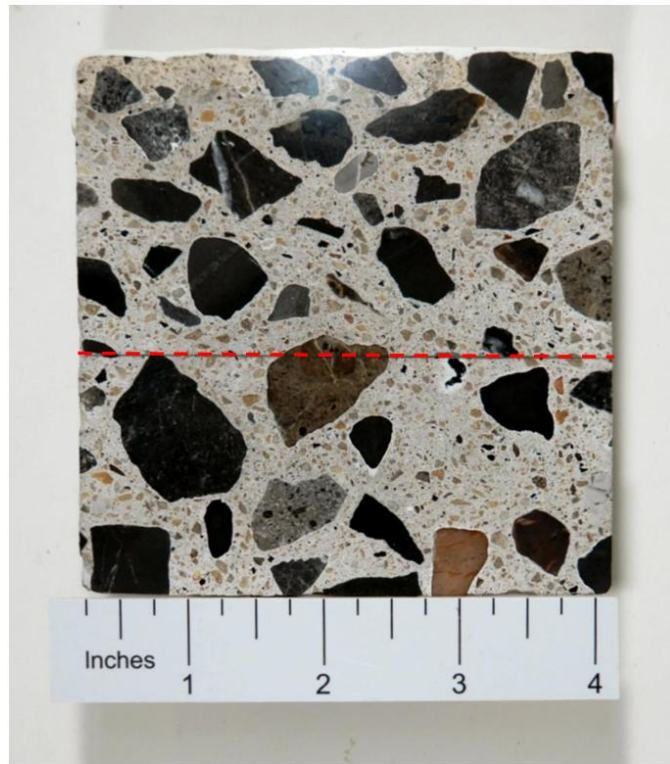
In Figures E.1 and E.2, the dashed red lines indicate the lower limit of the depth of analysis.

**Figure E.1 Section of core 1-10 (1).**

**Figure E.2 Section of core 1-10 (2).**
