**PLACEMENT OPTIONS FOR IN-STREET
PEDESTRIAN CROSSING SIGNS**

Final Report

SPR 870

Oregon Department of Transportation

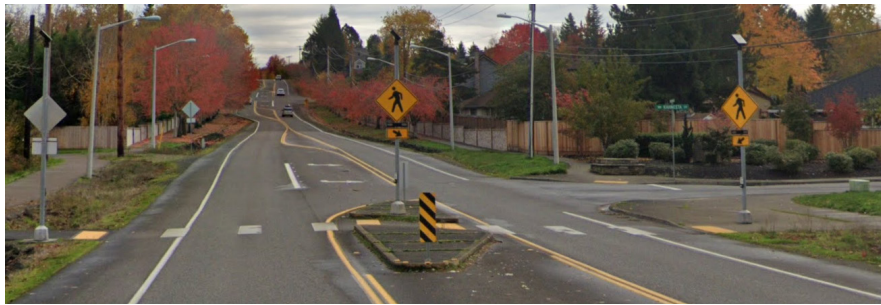
Figure 2.5: RRFB at Rock Creek Trail Crossing on NW West Union Rd.

RRFBs are used at uncontrolled locations to enhance pedestrian safety by incorporating a flash pattern to alert drivers to the presence of pedestrians. RRFBs were first granted interim approval by FHWA in 2008. These are typically activated by pedestrian pushbuttons. shows a RRFB situated at Rock Creek Trail Crossing on NW West Union Rd.

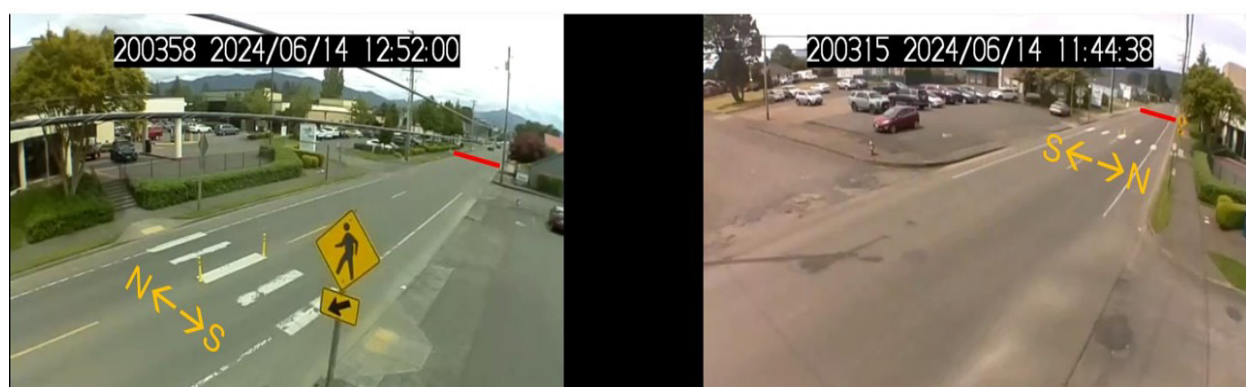
Figure 3.9: Reference Figure for Data Collection

A standardized data collection form was created in Excel to document the crossing events. For each location, the form included a unique figure featuring a screenshot annotated with pedestrian directional information and vehicle Stopping Sight Distance (SSD) to assist student coders during data collection.
