User-Centered Smart Traffic Sign Development Implementation Study

Department of Mechanical Engineering
University of Minnesota

Research Report
Final Report 2026-10

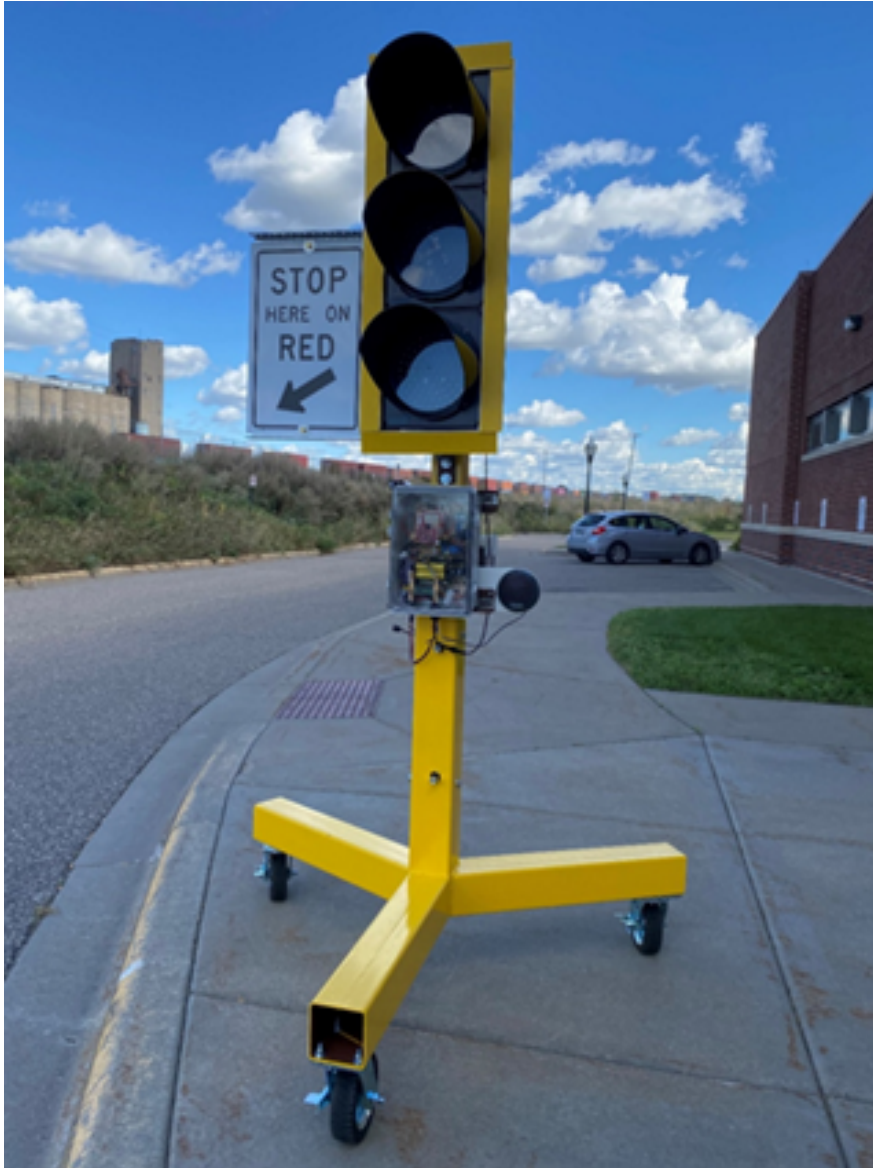
Figure 1.1: Photograph of the implemented smart work zone traffic signal from Phase 1.

Phase 1 of the study focused on the development of a user-centered smart traffic sign both in regard to testing the overall proposed sign design in a simulator from a driver behavior perspective and the sensing capabilities to detect and track oncoming traffic using low-cost sensors. Through this work a modified traffic signal was constructed capable of being operated via handheld remote. The modified traffic signal included a sensing system that would monitor vehicles that were either approaching the work zone at dangerous speeds or entering the work zone when the traffic signal was indicating for the driver to wait. Usability testing of the modified traffic signal in a driving simulation found lower expectancies and stopping rates of the traffic signal-based alarm system compared to a traditional flagger but did demonstrate evidence that drivers may be less likely to stop and remain stopped with the flagger STOP sign than the red ball indicator of the traffic signal. A follow up test found that the addition of the sensor audiovisual alarm system to a more traditional stop/slow flagger paddle saw improved performance. Based on these findings from phase 1 of the study, the proposed work to be accomplished within phase 2 is aimed toward field validation testing of the flagger style smart traffic signal prototype in regard to sensing capabilities, usability from the perspective of the workers, and resulting driver behavior.

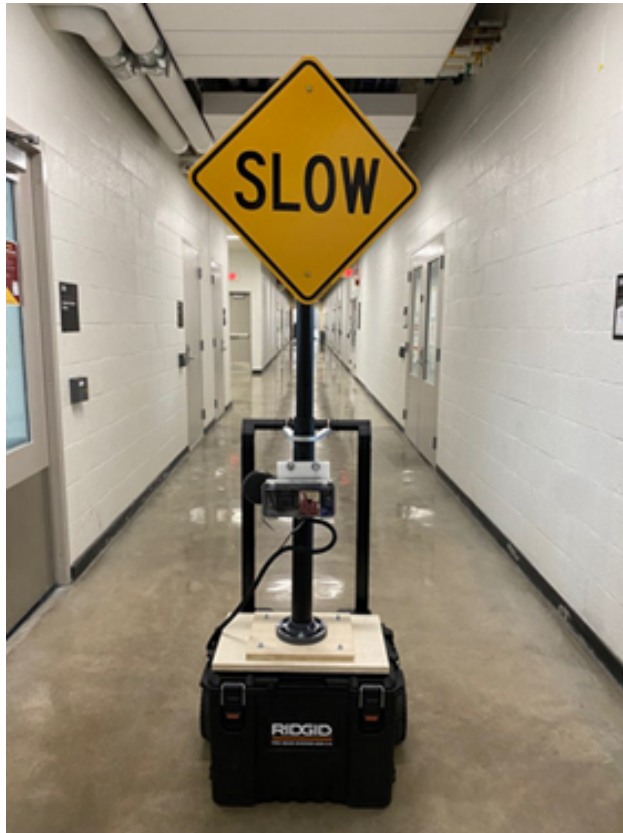
Figure 2.1 Photograph of instrumented sign for use by flag workers

A radar chip and antenna, a Raspberry Pi microprocessor, a loudspeaker and other accessory electronics are mounted on the lower pole. The lower pole does not rotate so that the radar on it is always facing in the same direction to monitor oncoming traffic.

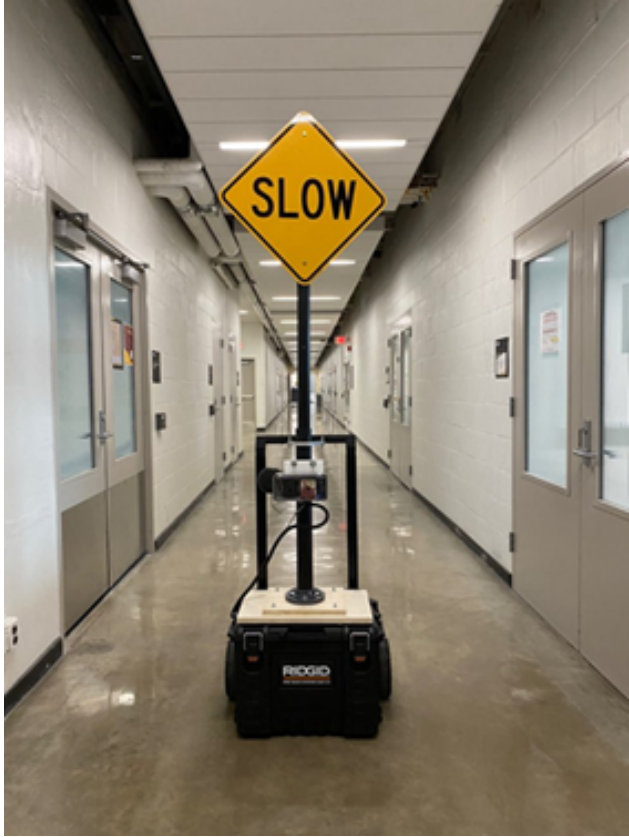
Figure 2.2 Photograph of instrumented sign being used with a taller height, showing adjustability of desired height

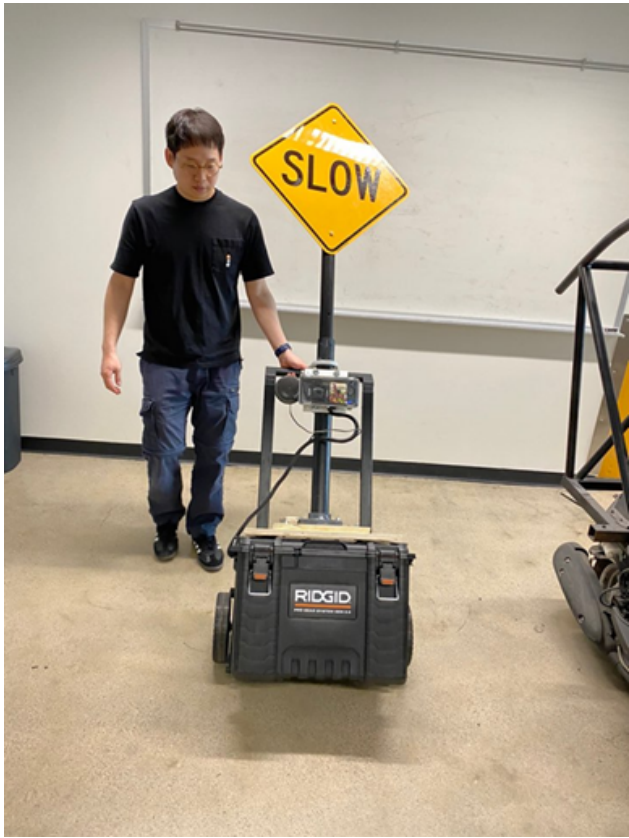
Figure 2.4 Photograph showing that the portable device can be easily wheeled over a concrete floor

The developed sign is portable and can be easily wheeled, as shown by one of the co-authors of this report in Fig.2.4.

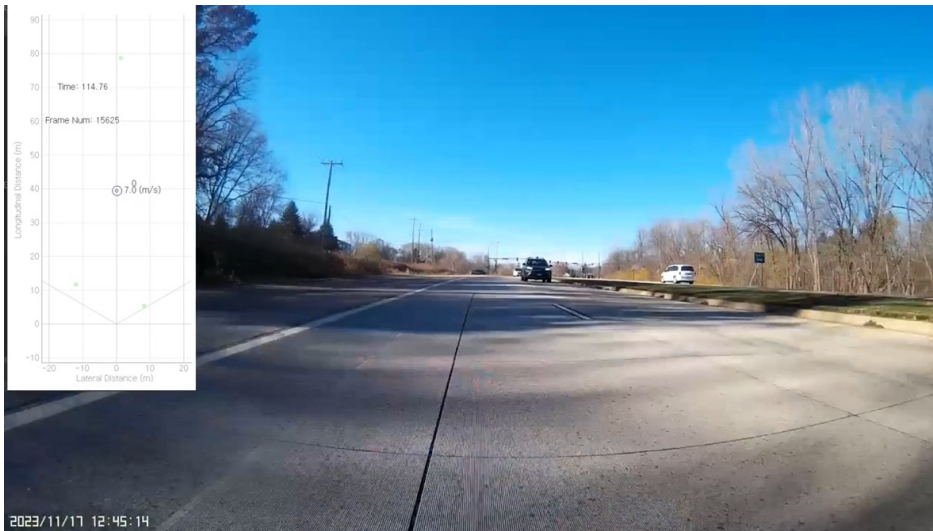
Figure 2.5 Complete electronics for a microprocessor-implemented distance tracking and audio-visual alert system

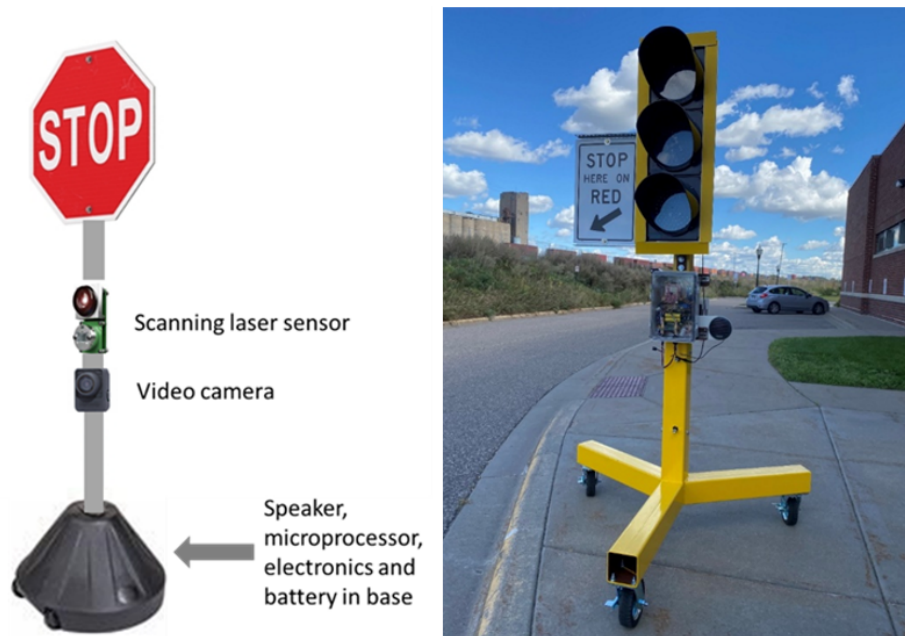
Figure 3.1 (left) Smart sign envisioned at proposal submission; (right) Phase 1 prototype developed from initial user inputs.

The two previous Phase 1 designs for the smart-sign device are shown in Fig. 3.1. (left) shows the concept envisioned at proposal time, a wheeled STOP/SLOW sign. Fig. 3.1. (right) shows the Phase 1 prototype: a remote-controlled traffic light operating in solid-red or flashing-yellow modes with embedded radar and trajectory-tracking software. User interviews suggested a remote light could let flag workers step out of the direct traffic line. However, the Phase 1 simulator study indicated a wheeled STOP/SLOW sign used by a flag worker was more effective at influencing driver behavior. Consequently, the Gen 2 prototype in Fig. 3.2 was developed in Task 2 of Phase 2.

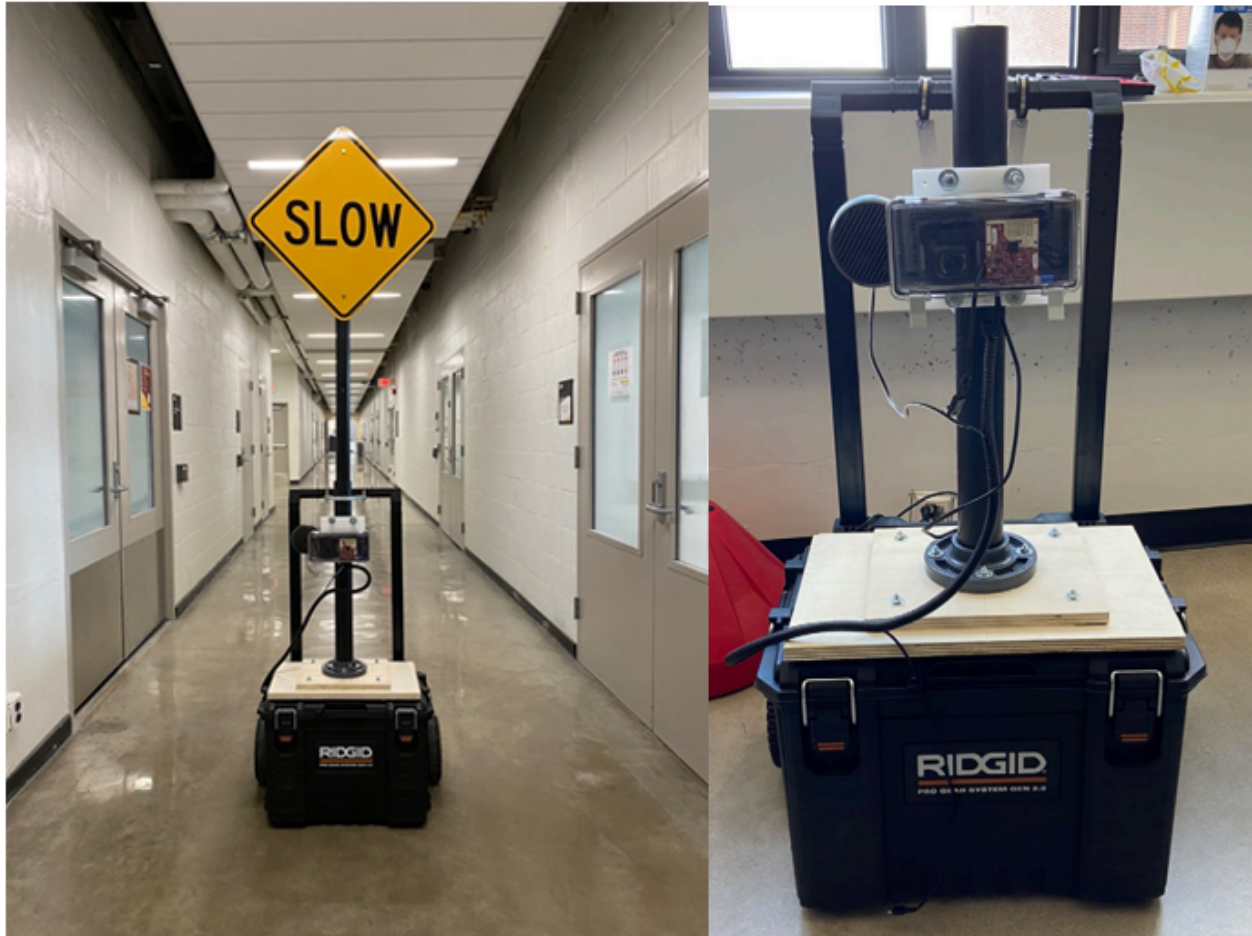
Figure 3.2 (a) Gen 2 prototype developed in Task 2; (b) radar and electronics decoupled from the STOP/SLOW sign.

The Gen 2 prototype consists of a STOP/SLOW sign on a wheeled box with rugged wheels (Fig. 3.2). Electronics and a heavy battery are housed inside the box; their weight helps prevent toppling in strong winds. A dual telescoping pole mounts to the box. The upper pole rotates to present STOP or SLOW and locks in place; it can be removed and stored separately for transport. A radar chip and antenna, Raspberry Pi, loud-speaker, and ancillary electronics are mounted on the lower (non-rotating) pole, keeping the radar oriented toward oncoming traffic.

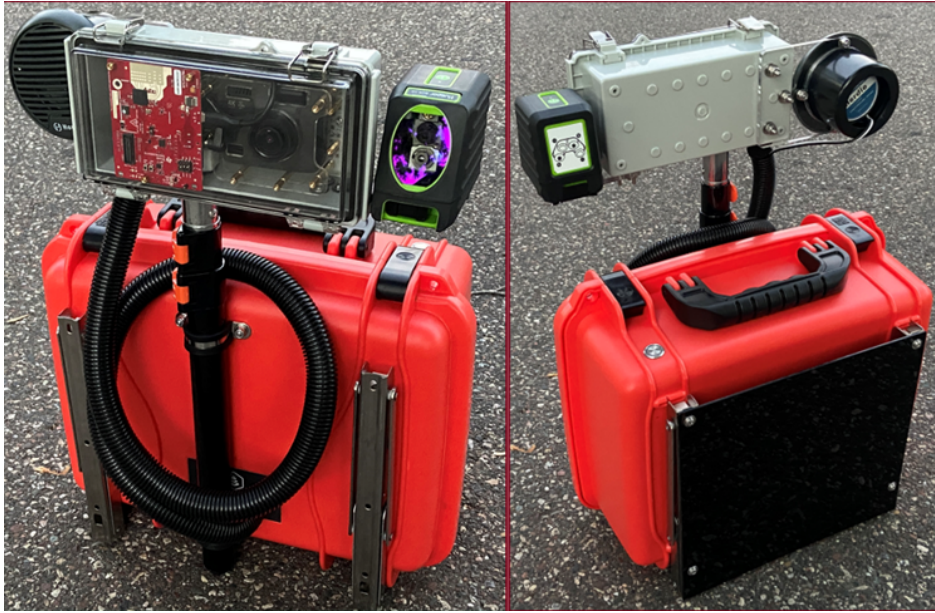
Figure 3.5 Front view of Gen 3 prototype (left) and rear view (right).

The Gen 3 prototype is a waterproof box containing the radar sensor and dash-cam. It collapses into a compact case for transport and expands for operation. A telescoping pole raises the radar to the needed height; folding shelf brackets stabilize the case against wind.

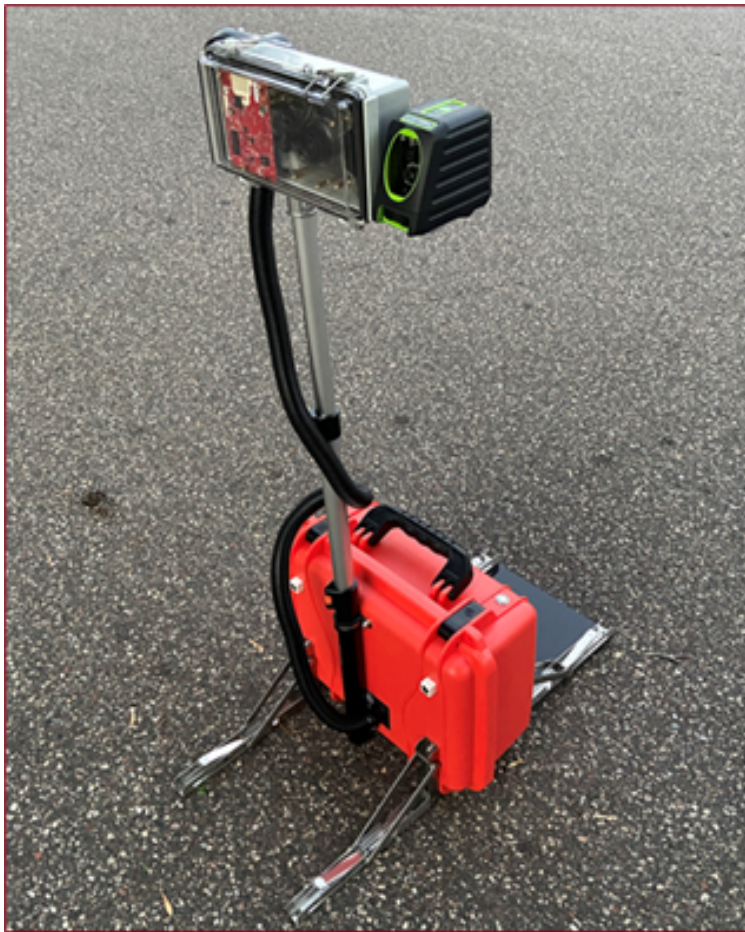
Figure 3.6 Expanded Gen 3 prototype ready for deployment.

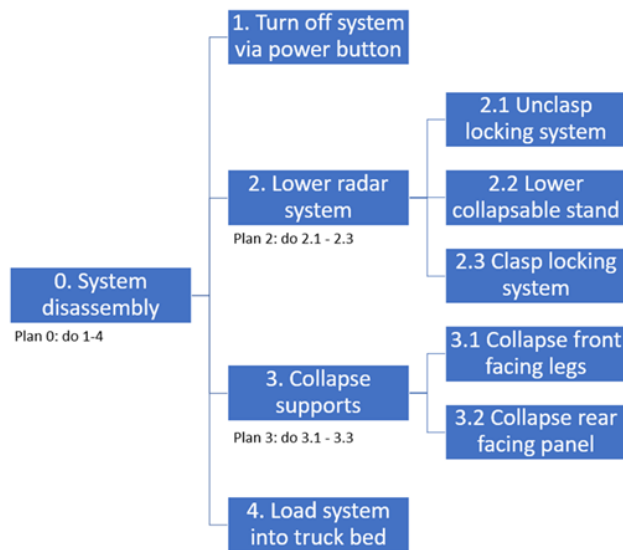
Figure 3.8 Hierarchical task analysis for disassembly of the Gen 3 prototype and loading into a truck.

The Gen 3 hierarchical task analysis identified 4 major tasks and 7 total steps (Fig. 3.8). Several tasks/steps were eliminated relative to Gen 2—for example, the shut-off procedure shrank from 3 tasks/7 steps (tasks 2–4 in Fig. 3.3) to a single step (task 1 in Fig. 3.8). Setup time decreased from 45 s to 15 s.

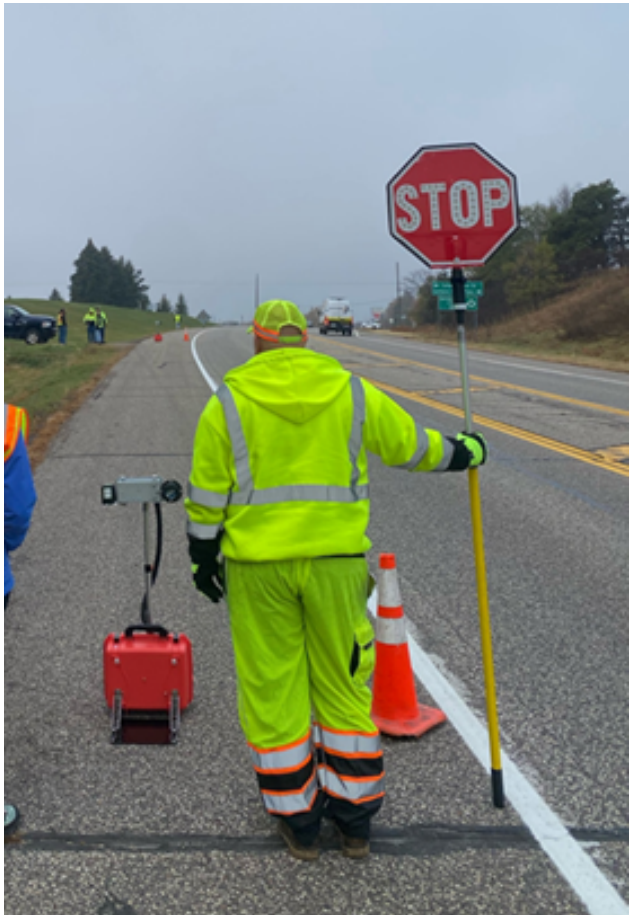
Figure 3.9 Pilot testing with the Washington County South Workshop in Woodbury.

The pilot configuration and location appear in Figs. 3.9 and 3.10. The alarm was disabled (enabled in code, speaker unplugged); the code logged events when the alarm would have triggered. Radar data are saved continuously and can be replayed for any trigger.

Data from Device 2 (Fig. 3.10) were used for analysis; its placement farther from the four-way stop let

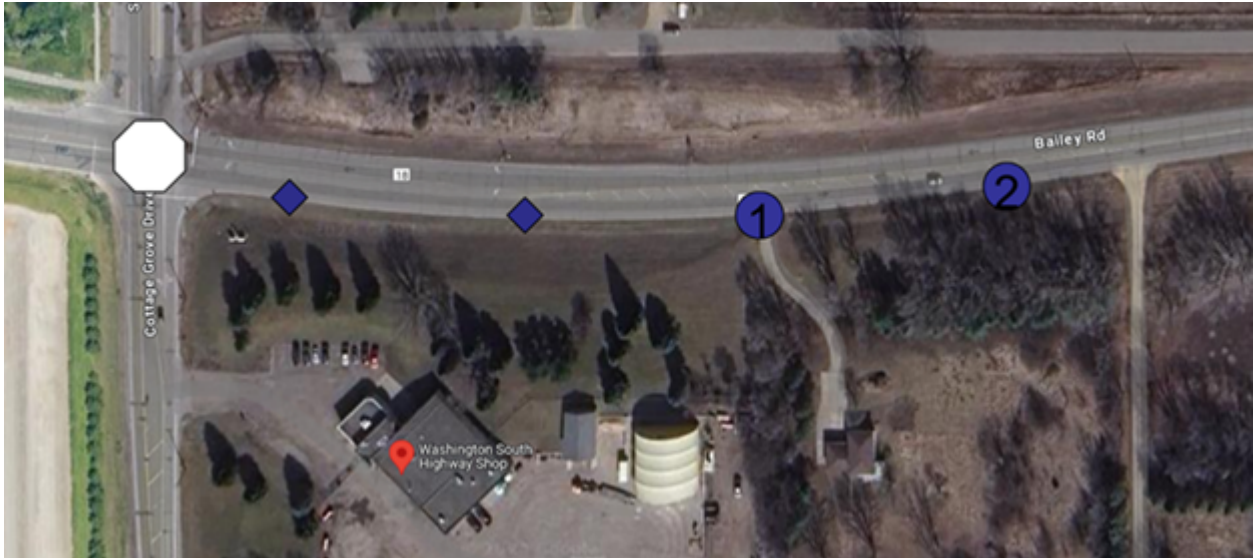
Figure 3.10 Locations of the pilot test.

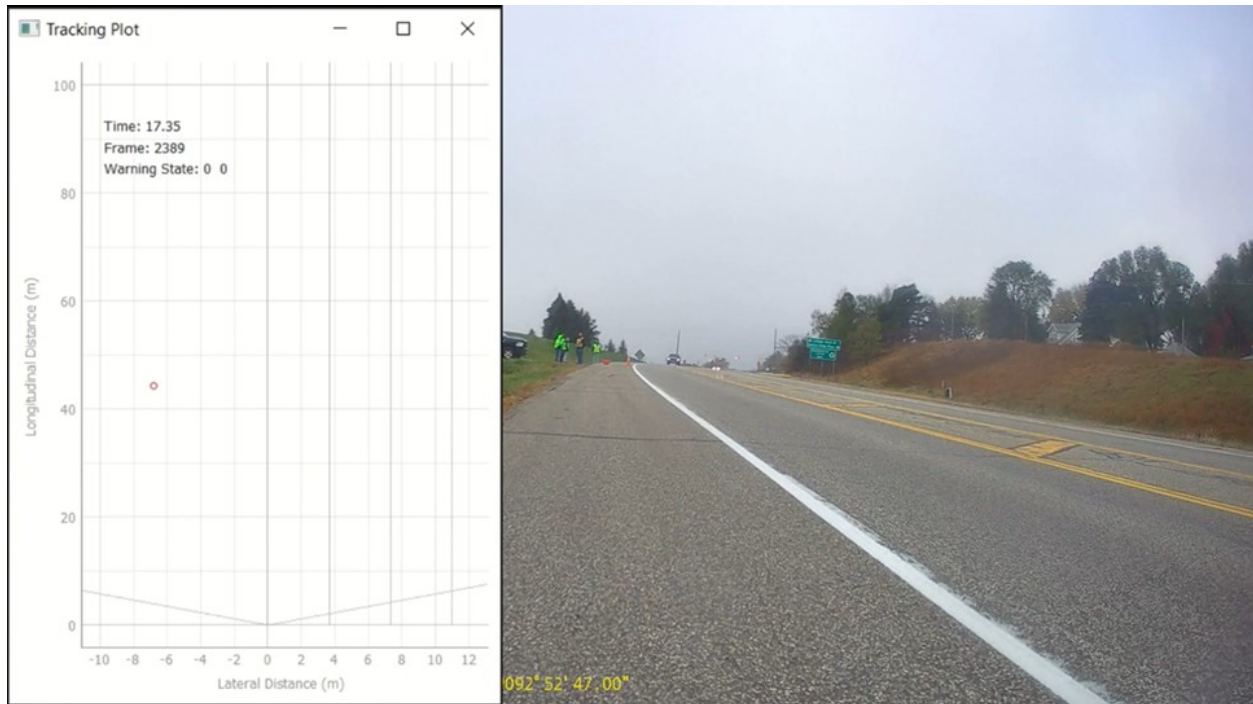
Figure 3.11 Screenshot of radar-tracking animations synchronized with video.

The system tracks vehicle trajectories well. Radar-predicted motion matched video observations. Synchronized camera/radar animations (see TAP slides) show four consecutive approaching vehicles (screenshot in Fig. 3.11), demonstrating consistent, reliable tracking.

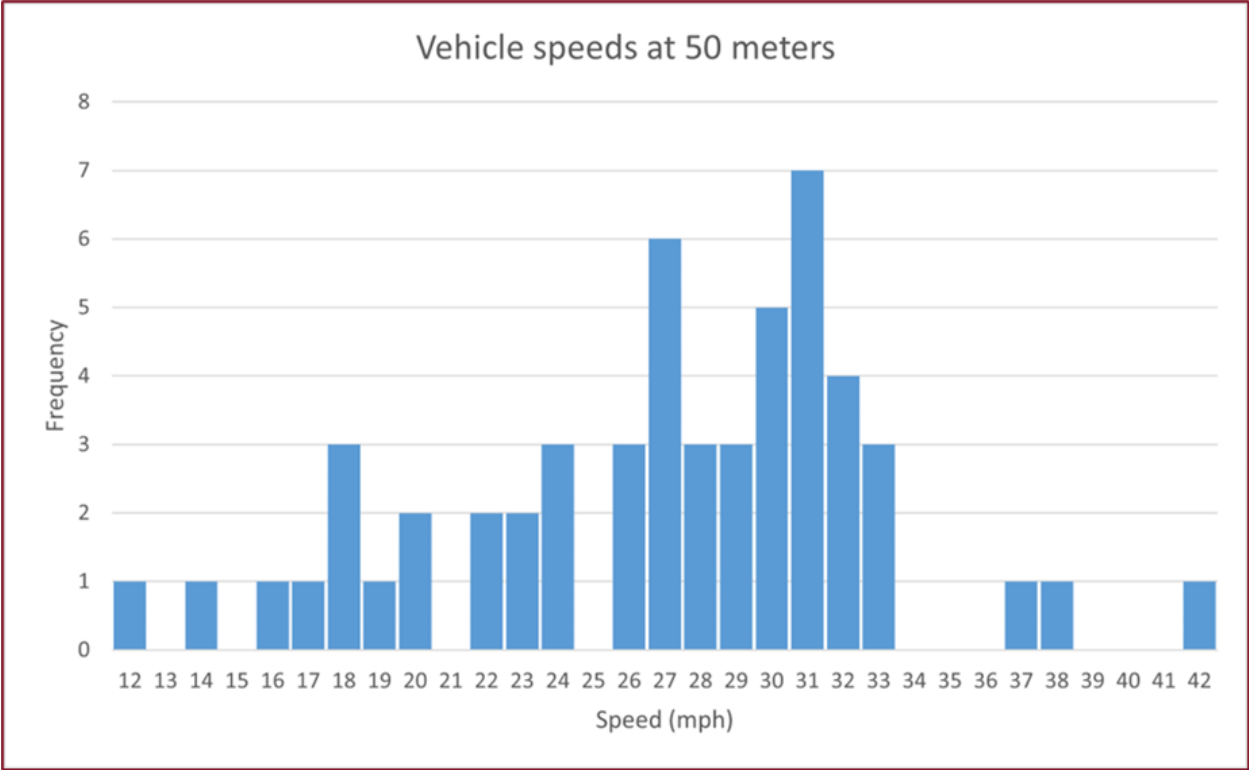
Figure 3.12 Distribution of speeds at 50 m by the radar system in Device 2 (Part 1 pilot).

Only one vehicle triggered the alarm during the 30-minute session. The warning curve was configured for a 35 mph limit at 0 m, allowing higher speeds farther out and lower speeds closer in. One fast vehicle accelerated through the zone and passed the flagger and Device 2 at 60 mph, clearly exceeding the limit; the alarm trigger was therefore correct. No false alarms occurred.

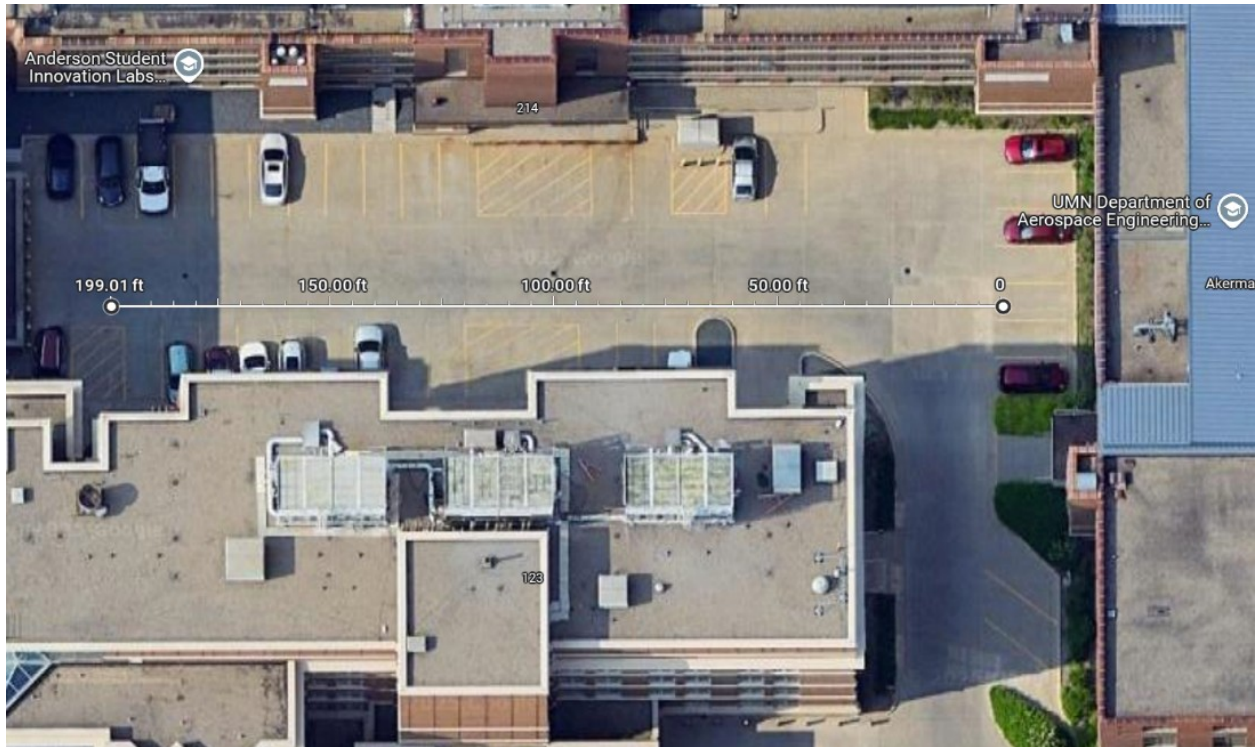
Figure 5.1 Aerial view (Google Maps) of sound testing site with distance overlay.

To ensure the alarm is audible inside vehicles, we informally tested candidate audio sources in the Mechanical Engineering parking lot (University of Minnesota): a car horn, a 70 W speaker, and a 120 W speaker, measured from 50 ft to 200 ft in 50 ft increments. The setup is shown in Fig. 5.1; results appear in Table 5.1. The car horn was consistently louder than either speaker at all distances; the two speakers were within ± 2 dB of each other. To ensure detectability at up to 80 m (262 ft), we selected the car horn for both prototypes. During field deployments, the *audio-visual alerts were issued by the downstream device*.

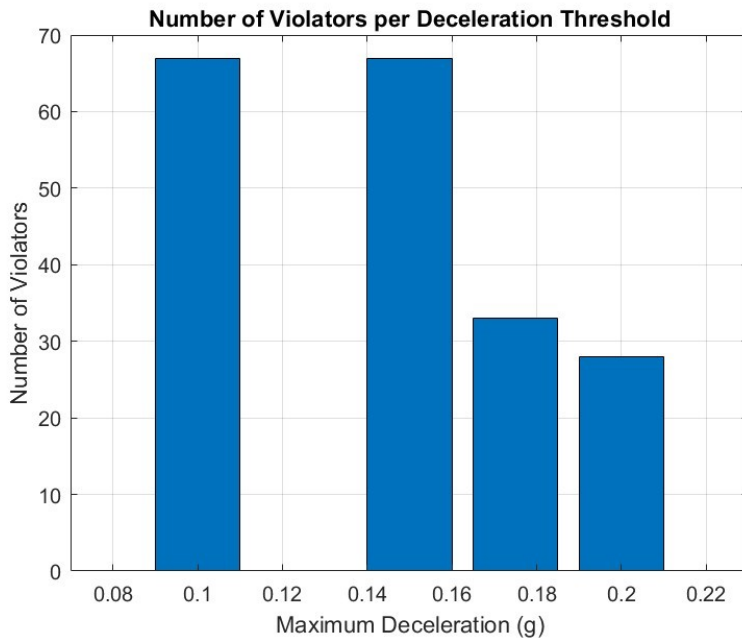
Figure 5.5 Violator count vs. different maximum deceleration thresholds.

using a maximum deceleration of 0.2 g to generate the warning curve. To further evaluate detection sensitivity, the analysis was repeated with different maximum deceleration thresholds. As shown in Fig. 5.5, the number of identified violators varies with the chosen deceleration limit. This parameter must be selected carefully so that it is neither overly lenient nor excessively strict, and its appropriate value is influenced by the roadway speed limit.

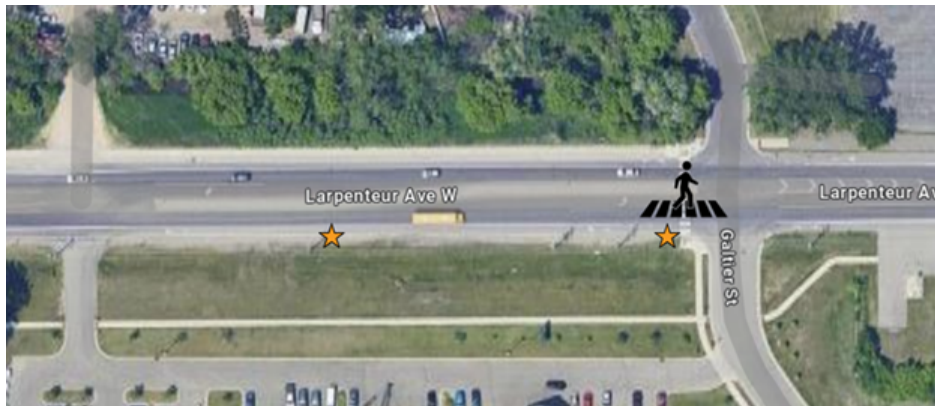
Figure 5.6 Aerial view (Google Maps) of Larpenteur Ave staged crossings with device locations (stars).

The third field implementation as part of the data collection took place at the intersection of Larpenteur Ave W and Galtier St in Saint Paul, MN. This deployment was conducted by the research team at a crosswalk and monitored vehicles traveling eastbound on Larpenteur approaching the crosswalk when a researcher was present acting as a pedestrian attempting to cross the crosswalk. These pedestrian crossings served as a surrogate for a flagger, in which the approaching vehicle is expected to come to a stop prior to the crosswalk, similar to coming to a stop before the flagger at a work zone. This surrogate form of data collection was selected as a potential method for collecting driving stopping behavior without the need to test at a work zone, providing more flexibility and opportunity to the research team. A diagram of this scenario is presented in Fig 5.6, which includes the locations of where the systems were deployed for data collection shown via orange stars.

In this testing, two devices were deployed 150 ft apart—one positioned directly at the crosswalk where the pedestrian was crossing and the other located 150 ft upstream. The upstream unit was used only for vehicle tracking and post-processing to verify the accuracy of the tracking algorithm, while the downstream unit was responsible for detecting potential violators. Across 52 pedestrian crossings, the first approaching vehicle yielded in 34 cases, the alarm was triggered in only one case, and the remaining 17 cases did not stop so the pedestrian could cross. For this evaluation, and consistent with findings from previous similar tests, a $0.2g$ warning curve (speed versus distance) was selected as the warning threshold for the downstream device. The violator was traveling at 19.43 m s^{-1} when 70 m away, which was beyond the warning curve and therefore triggered a warning. The audio alarm was not turned on, since this test was conducted solely by the research team without any transportation-agency staff present.

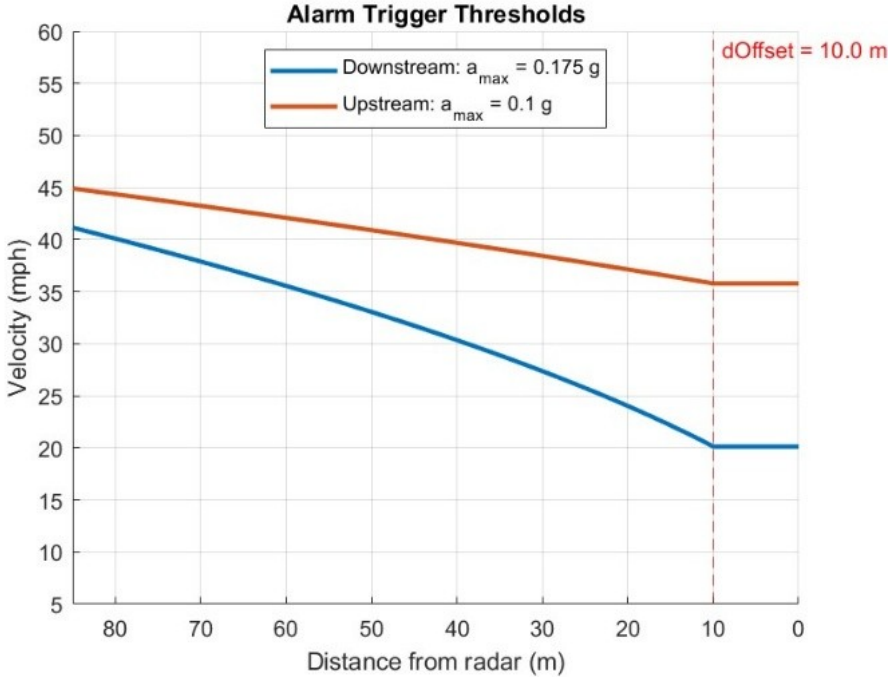
Figure 5.8 Downstream and upstream alarm thresholds.

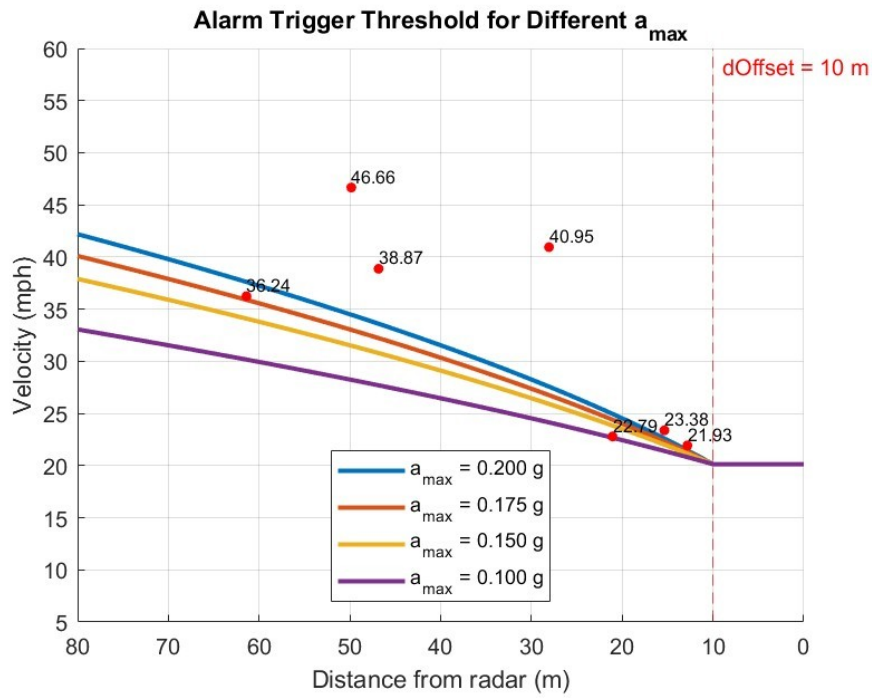
Figure 5.9 Violator speed vs. distance (downstream device).

In this test, a total of 481 vehicles were successfully tracked over approximately two hours. Of these, only 6 were identified as violators, representing 1.25% of the total. For this deployment, a maximum deceleration of 0.175 *g* was applied to define the warning curve on the downstream device, while a more lenient threshold of 0.1 *g* was used for the upstream device, as illustrated in Fig. 5.8. Fig. 5.9 shows the velocity–distance profiles of the 6 violators relative to the device under this threshold. Similar to previous tests, additional analyses were performed using different maximum deceleration values to assess how the choice of threshold influences violator detection. As observed in Fig. 5.10, the number of detected violators varies with this parameter, emphasizing the importance of selecting a value that is neither overly lenient nor excessively strict, and that aligns with the prevailing speed-limit conditions of the roadway.

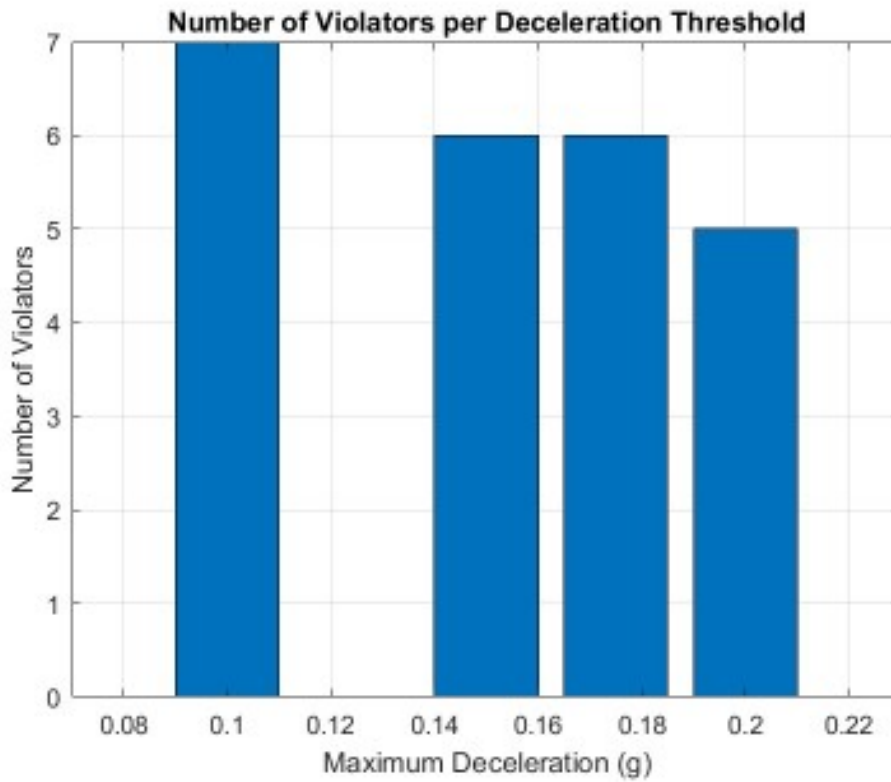
Figure 5.10 Violations vs. different maximum deceleration thresholds.

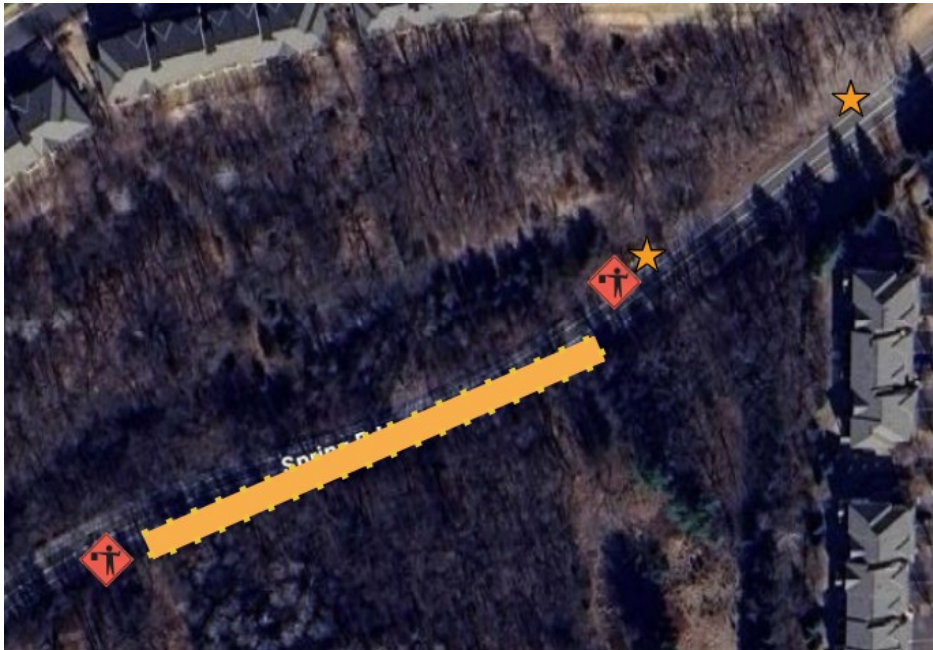
Figure 5.11 Aerial view (Google Maps) of Spring Rd (Eden Prairie) with layout and device locations (stars).

The next field implementation was carried out in Eden Prairie, MN, where the system was tested with dynamic STOP and SLOW modes for the first time, switching the mode in real time based on the flagger’s indications. The downstream device was positioned approximately 5 m ahead of the flagger, while the upstream device was installed about 55 m upstream. Both devices were equipped with audiovisual alarms to warn approaching drivers. On the downstream device, the alarm was activated only when the flagger signaled “STOP” and was deactivated when switching to “SLOW.” In contrast, the upstream device maintained the warning in both modes, ensuring continuous visibility to approaching traffic. The layout of this deployment is illustrated in Fig. 5.11, where the device positions are marked with orange stars.

For this deployment, a maximum deceleration of 0.2 g was applied to define the warning curve on the downstream device, while a more lenient threshold of 0.08 g was used for the upstream device, as illustrated in Fig. 5.12. Over a data collection period of approximately 1.5 hours, 37 vehicles were successfully tracked. Of these, 20 passed through in SLOW mode, where no warnings were required. The remaining 17 vehicles were tracked in STOP mode, with no violations observed. To further confirm this outcome, Figs. 5.13 and 5.14 illustrate that all radar points for both the downstream and upstream devices lie below their respective warning thresholds. While a small number of isolated points appear above the threshold, they do not correspond to the same vehicle across consecutive frames. Since a vehicle is classified as a violator only if it remains above the warning threshold for three consecutive radar frames (0.1 s total), no audio-visual warnings were issued during this test. As a positive outcome, no false alarms were triggered over the 1.5

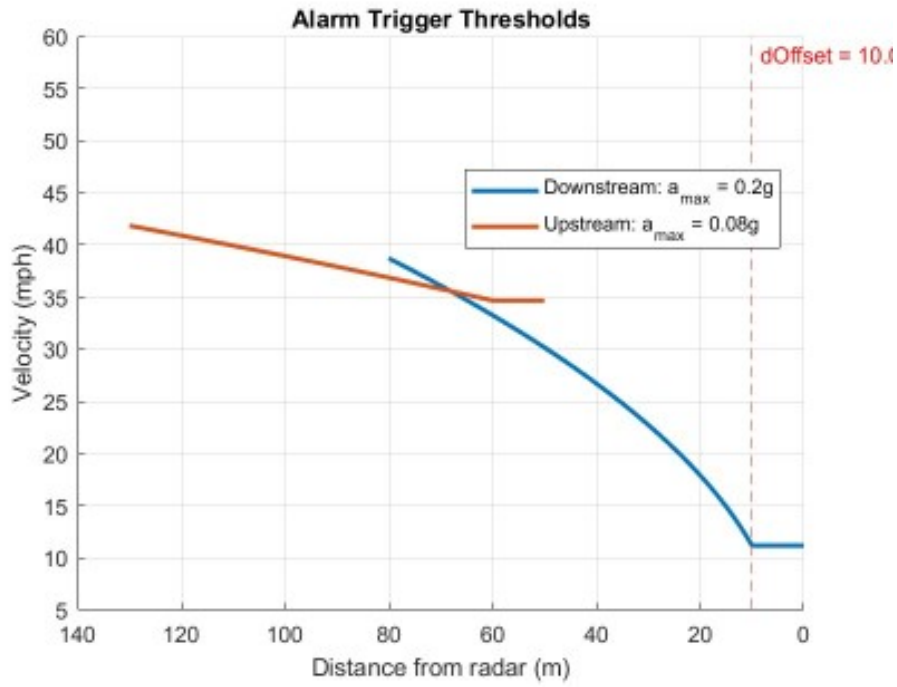
Figure 5.12 Downstream/upstream alarm thresholds.

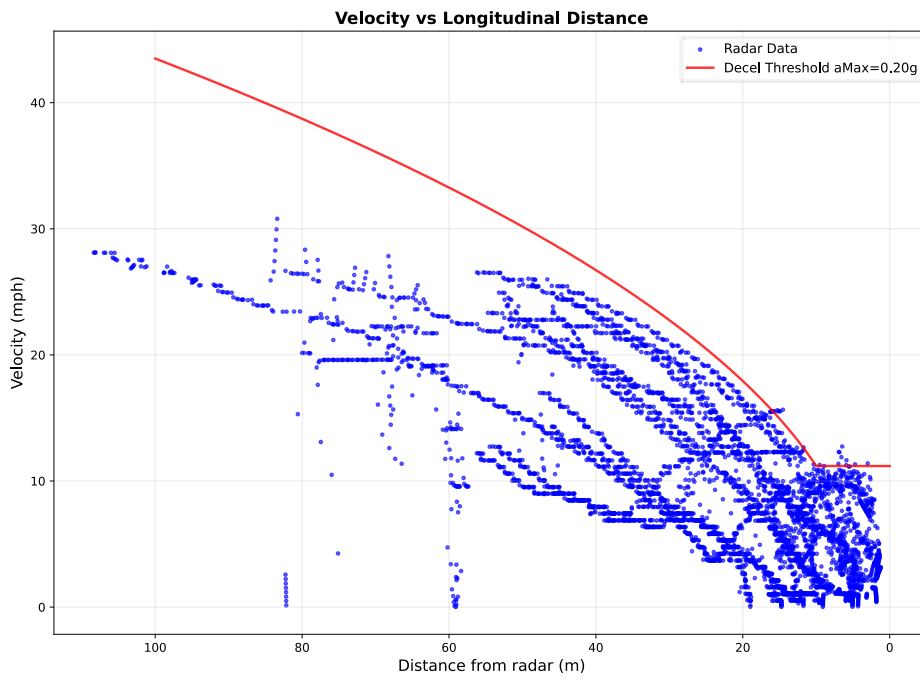
Figure 5.13 Downstream radar points vs. threshold.

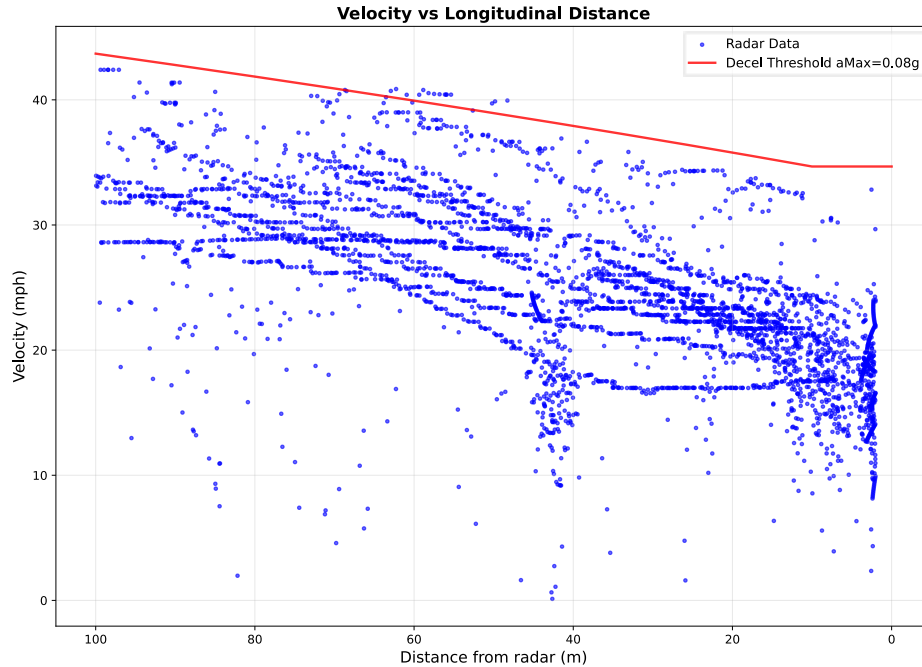
Figure 5.14 Upstream radar points vs. threshold.

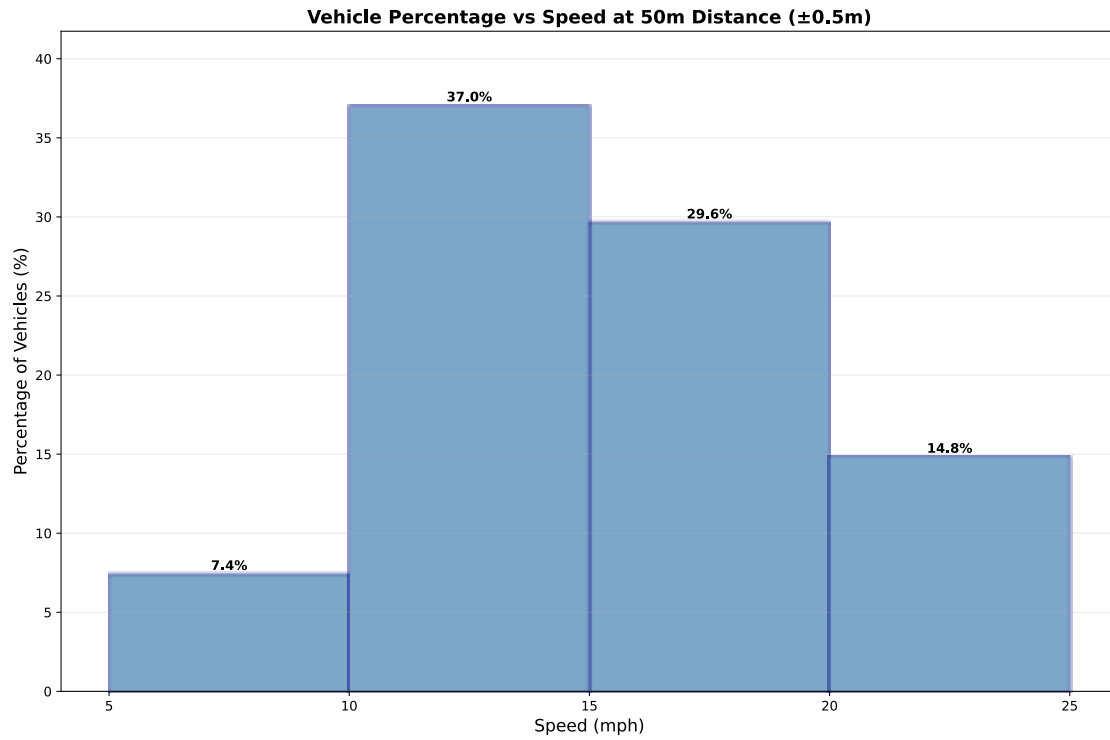
Figure 5.15 Vehicle speed distribution at 50 m (downstream device).

During the 1.5-hour data collection period, a total of 66 vehicles were tracked. Among them, 11 drivers received warnings from the upstream device which corresponds to a significantly higher percentage compared to previous testings. In this road the speed limit reduces from 35 mph to 30 mph right before the workzone, This might be a contributing factor to the substantial increase in number of violators. The 11 violators were subsequently tracked by the downstream device after receiving the initial upstream warning to assess their behavioral response. As shown in Fig. 5.18, vehicles were tracked by the upstream device until approximately 60 m upstream of the downstream unit, and thereafter by the downstream device as they passed. The results revealed that 6 vehicles reduced their speed following the upstream warning, while 5 drivers failed to respond adequately and received a second alert from the downstream device. Among these, 4 drivers decelerated after the second warning, and only one driver disregarded both warnings and

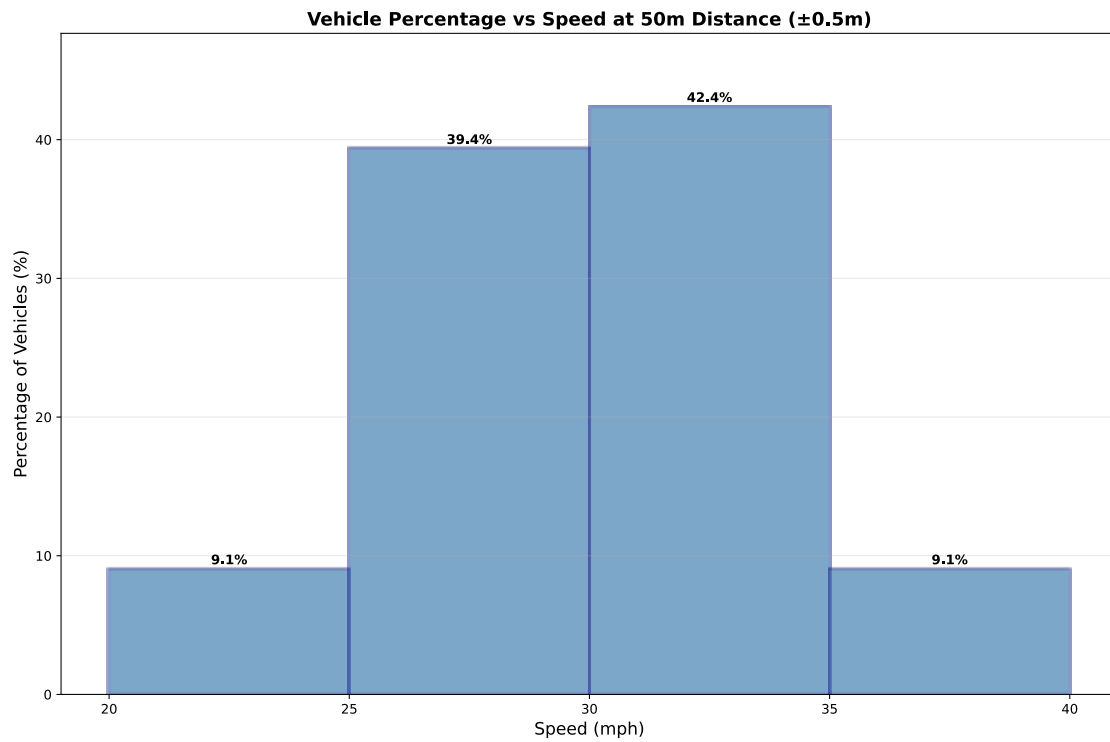
Figure 5.16 Vehicle speed distribution at 50 m (upstream device).
