User-Centered Smart Traffic Sign Development Implementation Study

Department of Mechanical Engineering
University of Minnesota

Research Report
Final Report 2026-10

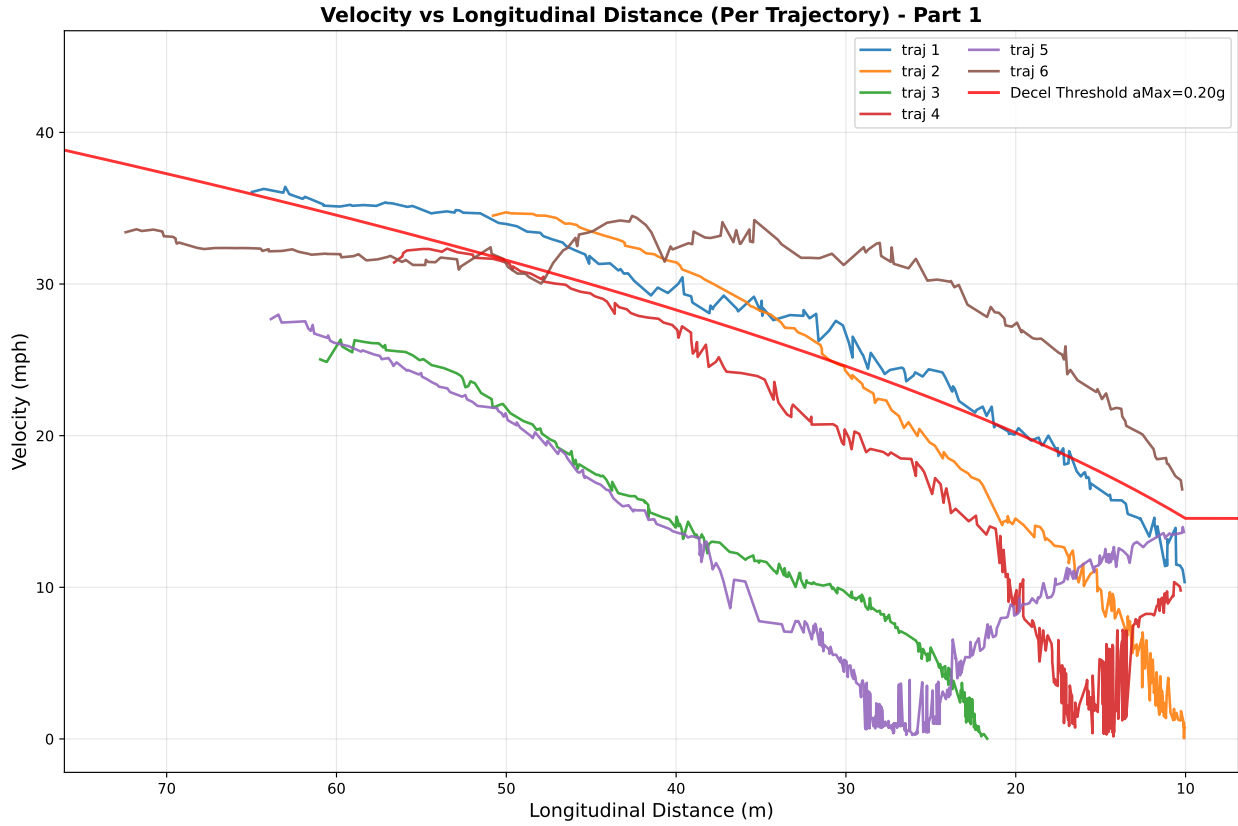
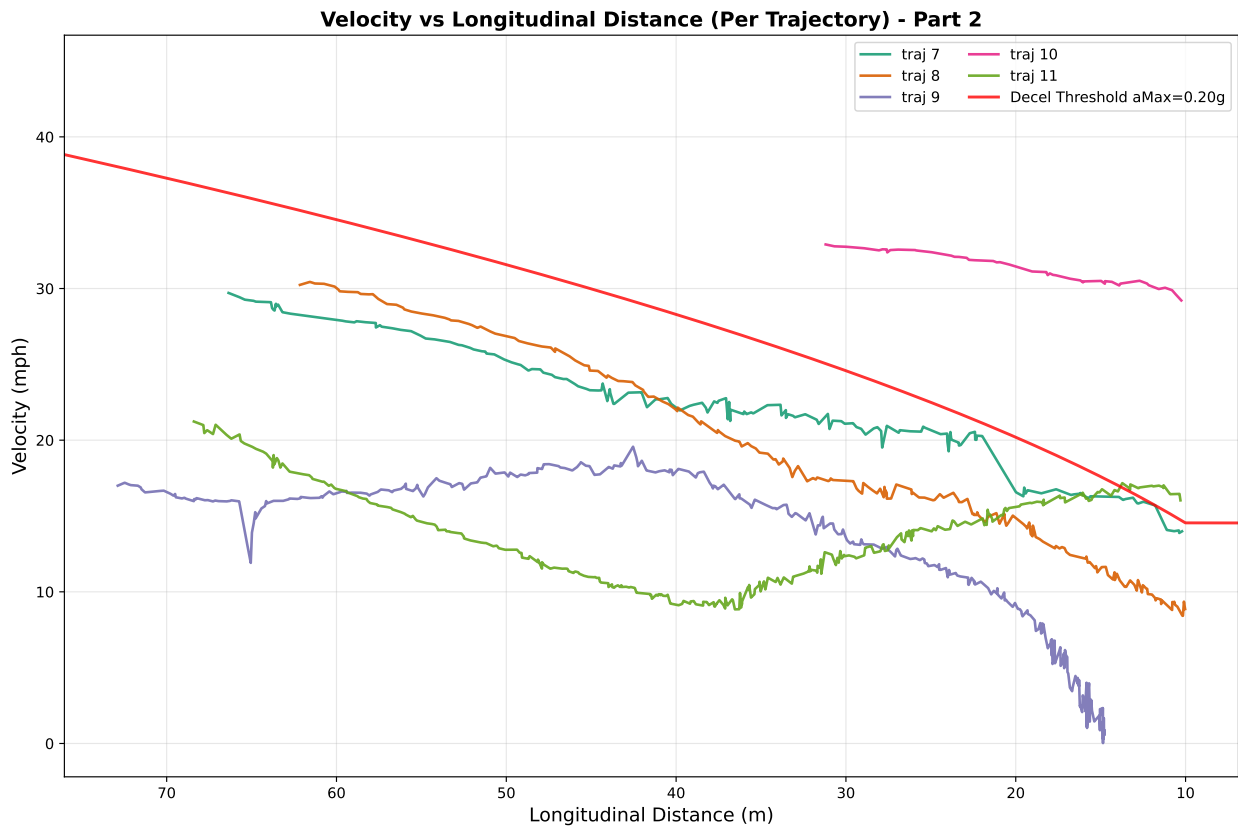
Figure 5.18 Joint vehicle trajectories recorded during the North Shore Drive field testing, showing velocity profiles with respect to longitudinal distance from the downstream radar point of view.

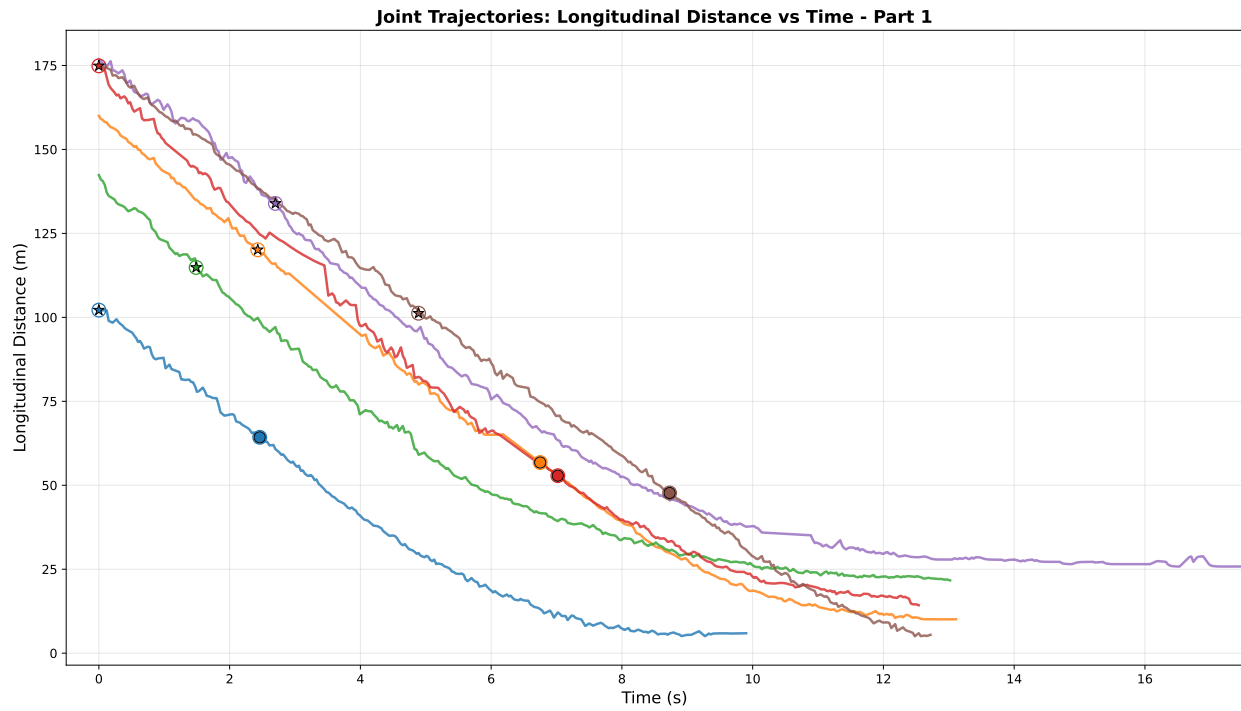
Figure 5.20 Joint Longitudinal distance profiles of the tracked vehicles during the North Shore Drive field testing. The top and bottom plots correspond to two subsets of the eleven trajectories that triggered warnings. Star markers denote the instants when upstream warnings were issued, while circular markers represent downstream warnings.

As illustrated in Fig. 5.19, most drivers began decelerating shortly after receiving the first warning, while some only responded after the second alert. A similar trend can be observed in Fig. 5.20, where the slopes of the longitudinal distance curves gradually flatten following the warnings, indicating smoother and progressive deceleration behavior as expected.

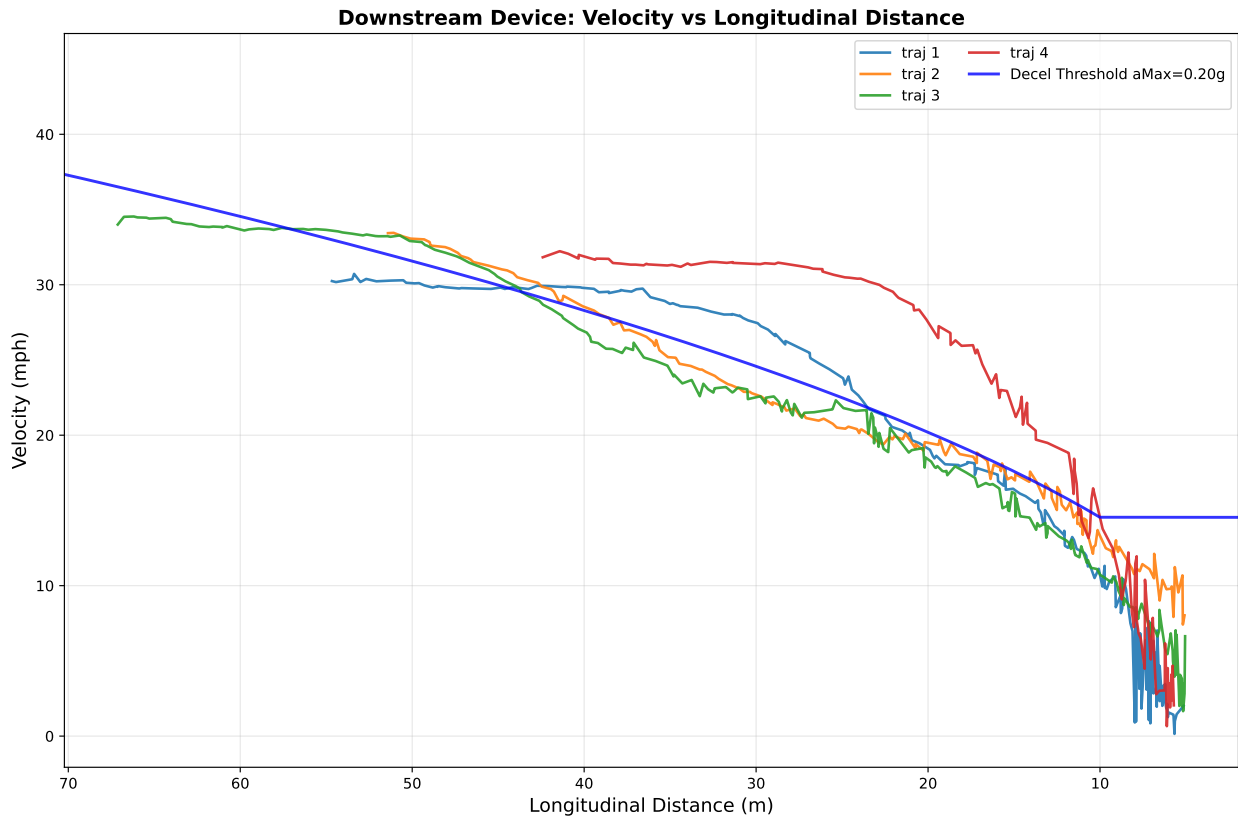
Figure 5.21 Velocity-distance profiles from the downstream device captured during the North Shore Drive field testing.

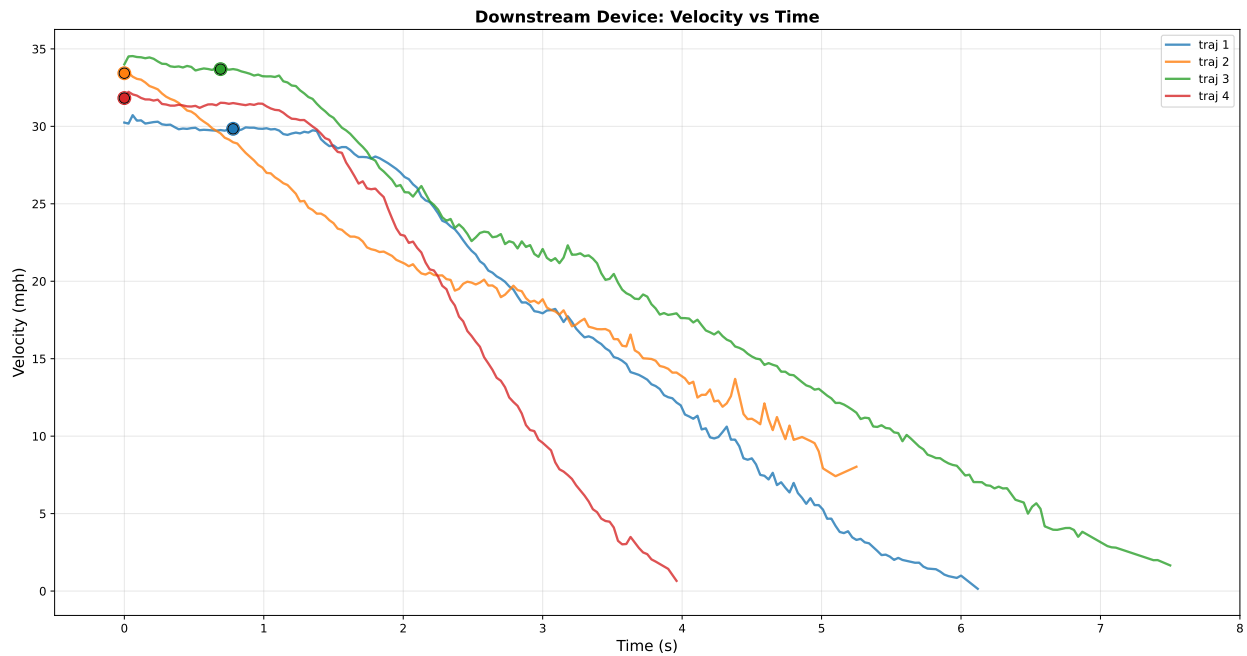
Figure 5.22 Velocity-time profiles from the downstream radar device during the North Shore Drive field testing. Each trajectory represents a vehicle that received a downstream warning, with circular markers indicating the moments when warnings were triggered.

As illustrated in Fig. 5.22 the velocity-time profiles show a noticeable drop in velocity shortly after the warning trigger points, indicating prompt deceleration behavior following the alerts. The varying steepness of the curves demonstrates differences in driver reaction times and braking aggressiveness. In Fig. 5.23 the profiles show a smooth decrease in distance, with the slope gradually flattening after the warnings, confirming that vehicles decelerated to a stop as they approached the flagger. These results validate that the warning system effectively influenced driver behavior, reducing vehicle speeds and improving safety in proximity to the work zone.

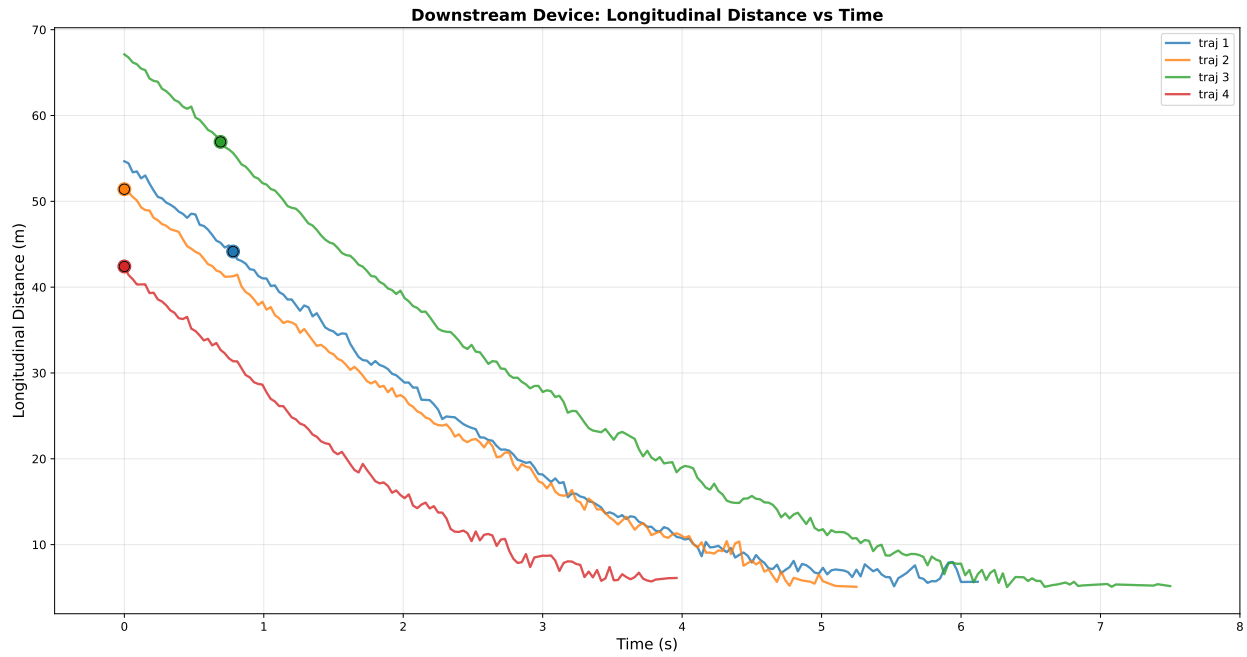
Figure 5.23 Longitudinal distance–time profiles recorded by the downstream device during the North Shore Drive field testing. Each curve corresponds to a vehicle trajectory, with circular markers indicating the moments when warnings were triggered.
