Performance of Jointless Bridges in Virginia

Final Report VTRC 26-R50

FINAL REPORT
PERFORMANCE OF JOINTLESS BRIDGES IN VIRGINIA

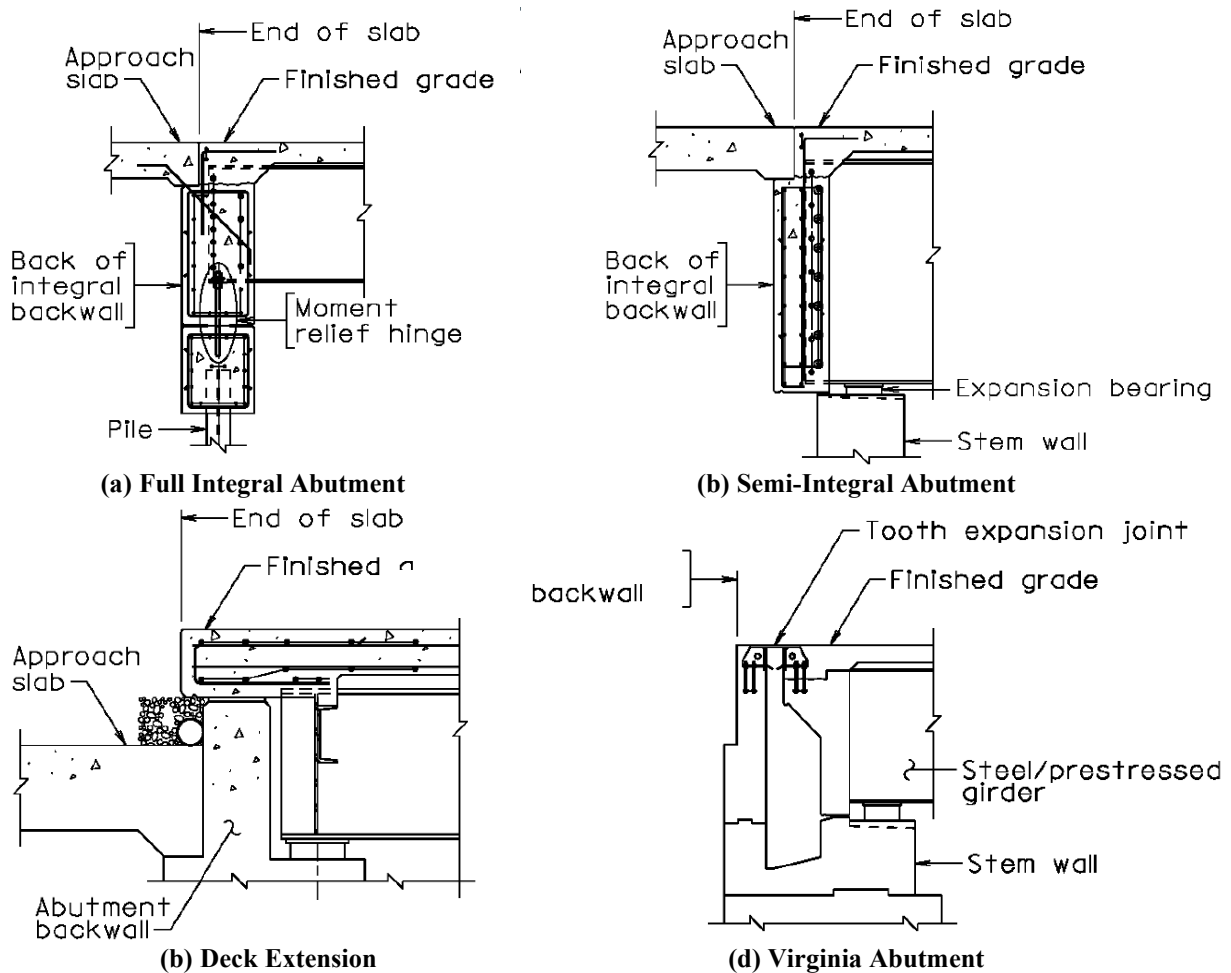
Figure 1. Jointless Abutment Types Used in Virginia (VDOT, 2024)

The full integral abutment type, also called "integral abutment" (Figure 1a), is characterized by bridge girders and deck cast monolithically with the integral backwall, which is cast on top of the footing. A moment relief hinge, consisting of a row of steel dowels connecting the footing and the backwall, is provided to reduce the bending moment in foundation piles.

Typically, a single row of steel H-piles is used, oriented along the weak axis bending and driven to a minimum of 25 feet to achieve pile tip fixity. However, prestressed concrete piles are also allowed.

The next design alternative involves a conventional cantilever abutment combined with a deck slab extension over the top of the abutment backwall (Figure 1c). Structurally, this alternative is not an integral design because the beams are not embedded in the backwall, but the design effectively provides a jointless bridge deck. With proper subsurface drainage details, water is directed away from the joint area behind the backwall. This type of design lends itself to retrofitting existing conventional bridges when deck replacement is needed.

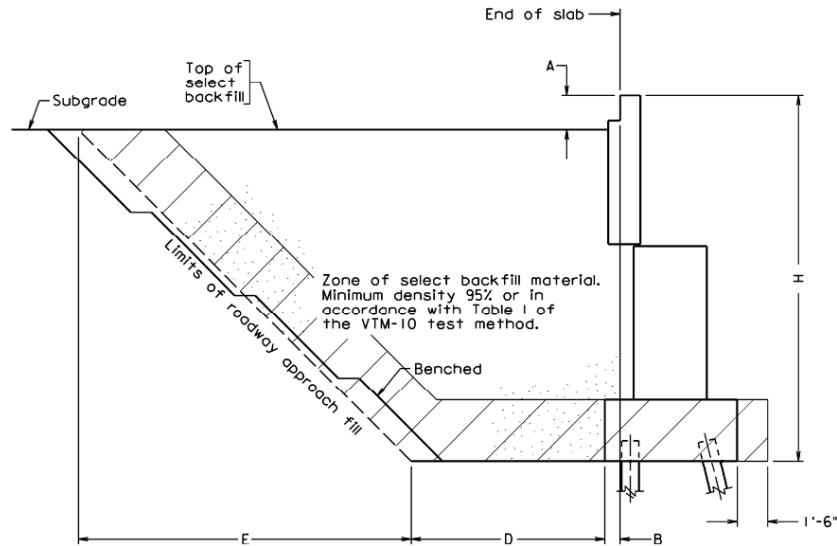
Figure 3. Select Backfill Material Behind Abutment (VDOT, 2024). VTM = Virginia Test Method.

Prior to 2006, VDOT practice called for a loosely compacted, "porous backfill" behind the abutment. The intent of specifying loose placement was to avoid exerting excessive lateral loads on the backwall. This practice was revised in 2006 by mandating compacted granular fill with a California Bearing Ratio value of 30. The objective was to reduce the approach settlement.

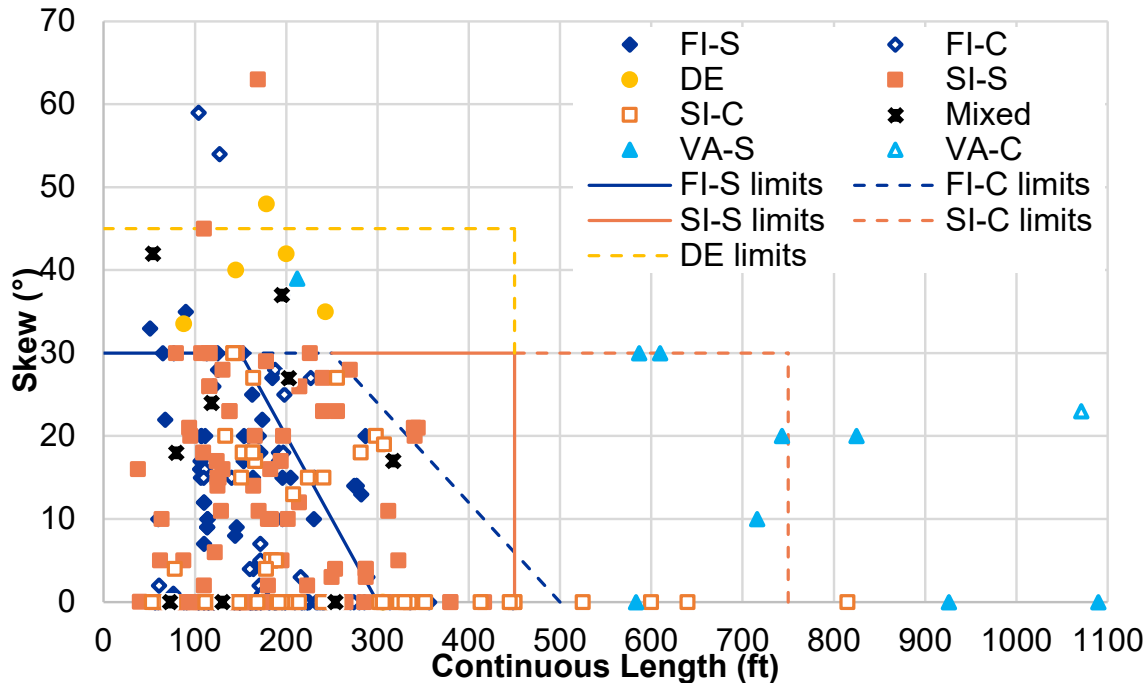
Figure 9. Entire Inventory of VDOT’s Jointless Abutments. C = concrete superstructure; DE = deck extension; FI = full integral; S = steel superstructure; SI = semi-integral; VA = Virginia.

Figure 9 shows the entire inventory of VDOT’s jointless bridges, represented in terms of continuous span length and superstructure skew angle relative to the current design limits for various abutment types. A few structures (13 steel full integral, one steel semi-integral, one concrete semi-integral, one deck extension type of abutment) exceeded the specified span, skew limit, or both. The inventory also included four abutment types that exceeded the technical guidance limits, in which “mixed” represents any set of abutments in a bridge where the design types of the two abutments are different, jointless, or are otherwise. All the “mixed” cases involve steel superstructures. Two were supported by a combination of one full integral and one conventional abutment, with a large skew (42°), and the other with a combination of a moderate

skew and span length that placed the structure outside the limits for steel full integral-type bridges. The other two cases involved both full integral and semi-integral abutments, one with a high skew (37°) and the other with a skew-span length combination that exceeded the limits for the steel full integral-type of abutment.

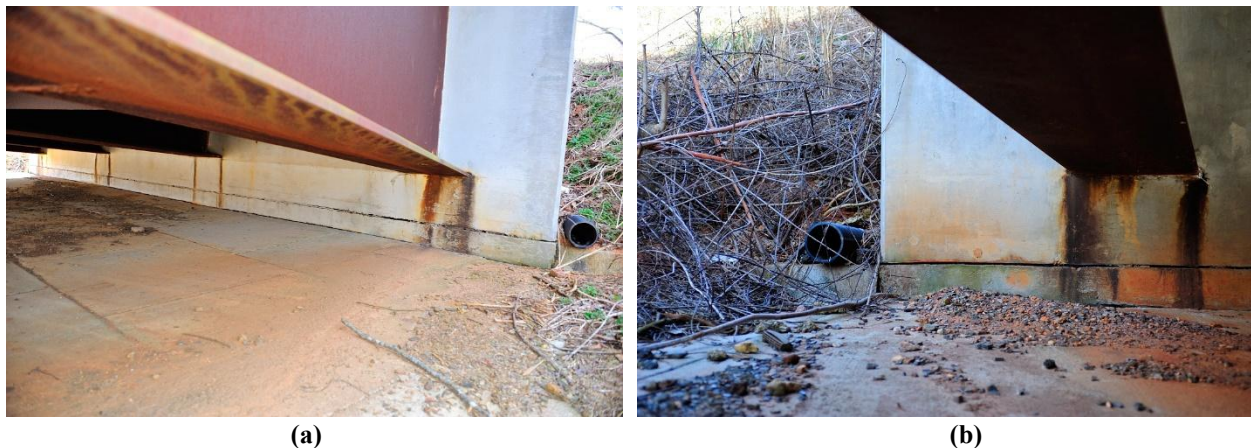
Figure 13. Photographs of Rust Staining at Full Integral Abutments: (a) Bridge 25957; (b) Bridge 25959

The only visually noticeable feature detected at many full integral bridges with uncoated weathering steel superstructure was the rust staining of concrete at the locations of contact (Figure 13). Some of the observed concrete staining was extensive.

It should be noted that the rust staining of concrete was observed not only at full integral bridges but also on other jointless bridge types. Moreover, it was frequently observed not only at the exterior beams, which are typically exposed to rainfall, but also near the interior beams.

The problem of unsightly rust staining on concrete calls for verifying current detailing practices. Guidelines for the recommended use of weathering steel are compiled by the National Steel Bridge Alliance (2022). To limit staining, the National Steel Bridge Alliance recommends using temporary protection in the form of plastic sheeting over the substructure concrete during the first few months the weathering steel is in service. Also, when the beam ends are cast integral with the abutment backwall, the National Steel Bridge Alliance recommends coating the encased portion of the beam with a protective primer. The primer or primed and painted coating must project past the backwall-beam interface for a sufficient distance to protect against the moisture buildup caused by the temperature differential between the backwall and the beam exposed to the atmosphere. Additional guidance on the proper use of unpainted weathering steel is provided in the Federal Highway Administration (FHWA) Technical Advisory 5140.22 and in the FHWA-HRT-23-116 report (FHWA, 1989, 2024). The UK detailing practice calls for suitable sealant along all interfaces between weathering steel and concrete to prevent excessive corrosion

(Highways England, 2019). It is not evident if the rust stains observed at interior beams originated during construction, before the deck was cast, or if they subsequently developed on a bridge in service.

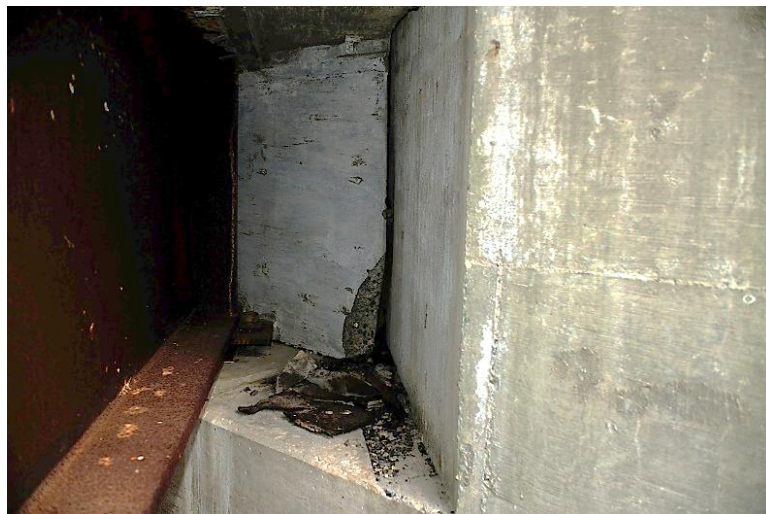
Figure 15. Photograph of Backfill Spill at Semi-Integral Abutment (Bridge 28475)

At the acute end of the integral backwall, the rotation can cause widening of the gap at the vertical interface with the adjoining wingwall, resulting in the spill of crushed stone backfill material (Figure 15).

Figure 31 shows the proposed revision of the sealing detail at the vertical gap between the backwall and adjoining wingwall, developed in Staunton District. The intent is to prevent unbound backfill material from spilling through the gap. A geotextile fabric combined with a polyvinyl chloride pipe provides an effective seal at the interface. Internal end plugs are installed in the pipe to ensure full interface contact along the entire gap length.

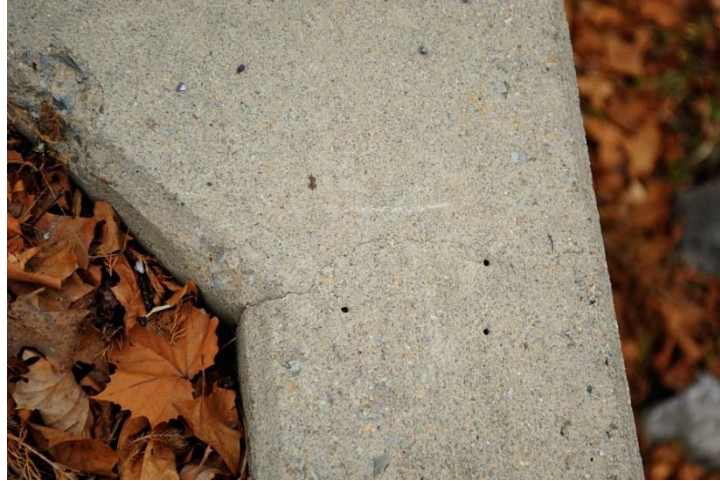
Figure 16. Photograph of Wingwall Crack at Semi-Integral Abutment with 45-Degree Skew (Bridge 28475)

Horizontal rotation of the superstructure and the resulting lateral interaction with the abutment can also lead to concrete cracking at the wingwall interface due to an increase in earth pressure (Figure 16).

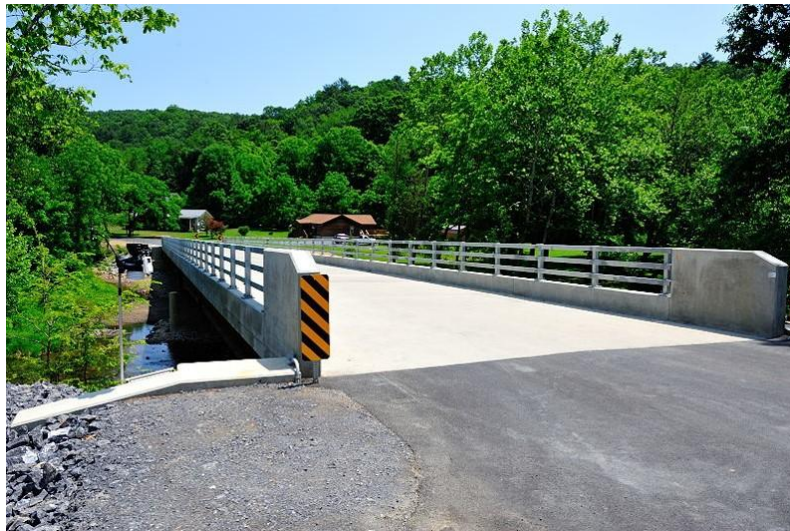
Figure 17. Photograph of Structure No. 29342—Route 638 over Jackson River in Alleghany County

One of the bridges, Structure No. 29342 in Staunton District, is an example of a jointless bridge constructed with one full integral and one semi-integral abutment (Figure 17). This design choice was imposed by limited right-of-way at the site.

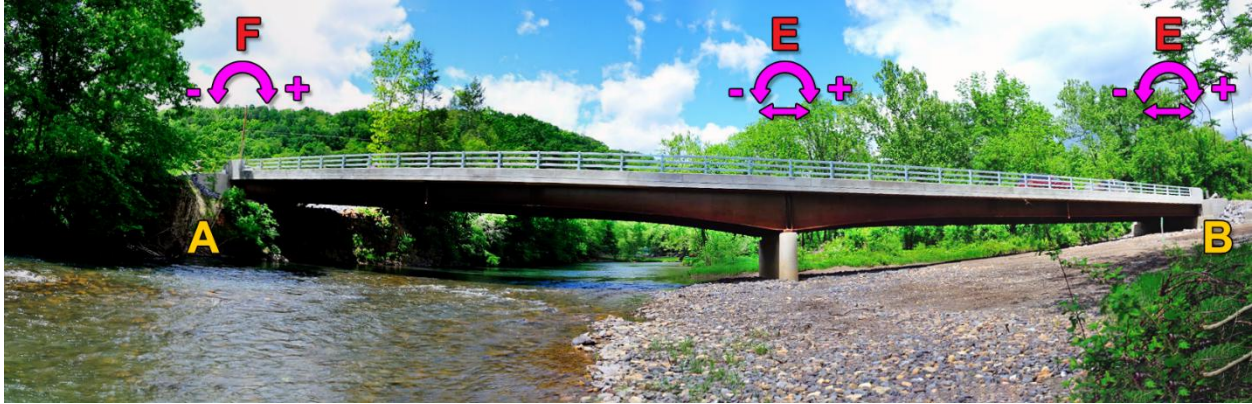
The initial design of Bridge 29342 included a pile-supported full integral abutment. A design change was made during construction, resulting in the abutment footing being cast directly on the bedrock stratum. With the expansion bearings installed over the pier, the bridge is effectively fixed longitudinally at the full integral abutment (A) and thermally expanding along its entire span length toward the semi-integral abutment (B), as Figure 18 shows.

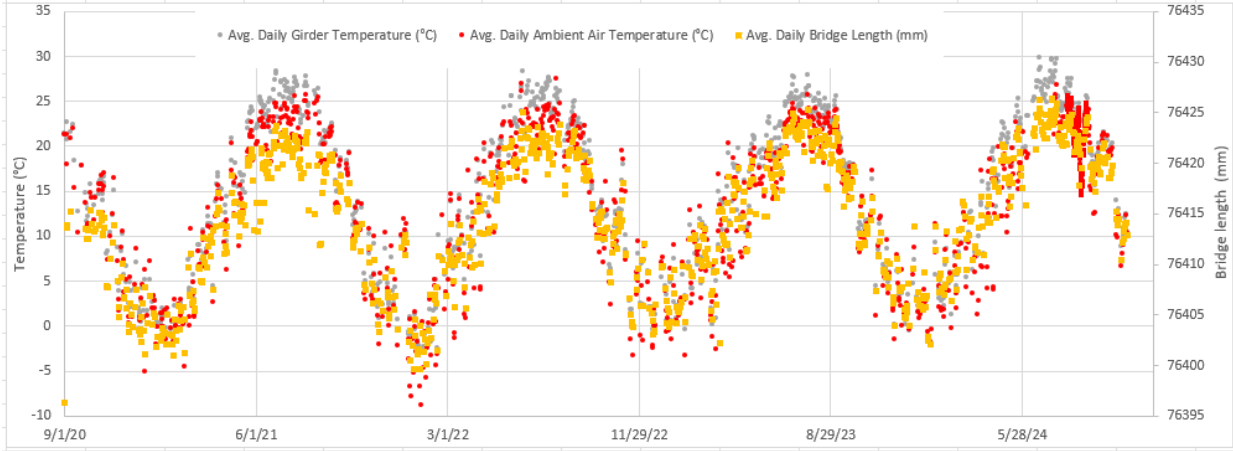
Figure 19. Backwall-to-Backwall Distance and Temperature at Structure No. 29342

Because of its unique design, VTRC personnel have been monitoring this bridge using onsite instrumentation at the request of the Staunton District Bridge Office. Field data collected during a 4-year monitoring period (since construction) do not indicate structural distress manifested by excessive stress, lateral displacement, rotation, or concrete cracking and spalling. As a part of that data collection, the distance between backwalls was measured using two laser sensors. Figure 19 shows the plot of overall backwall-to-backwall distance measurements, together with the corresponding temperatures, monitored during the 4-year period.

As expected, the seasonal pattern of displacements is sinusoidal. A similar, diurnal pattern of thermally induced bridge displacements was also observed. The lateral displacement range is approximately 25 mm (1 inch), with a corresponding ambient air temperature range of 35°C (approximately 63°F) during the 4-year monitoring period. The entire range of movement was observed at Abutment B, whereas Abutment A remained stationary. Additional displacement sensors installed at the bearing locations over the pier and at the semi-integral abutment confirmed this magnitude of lateral movement over time.

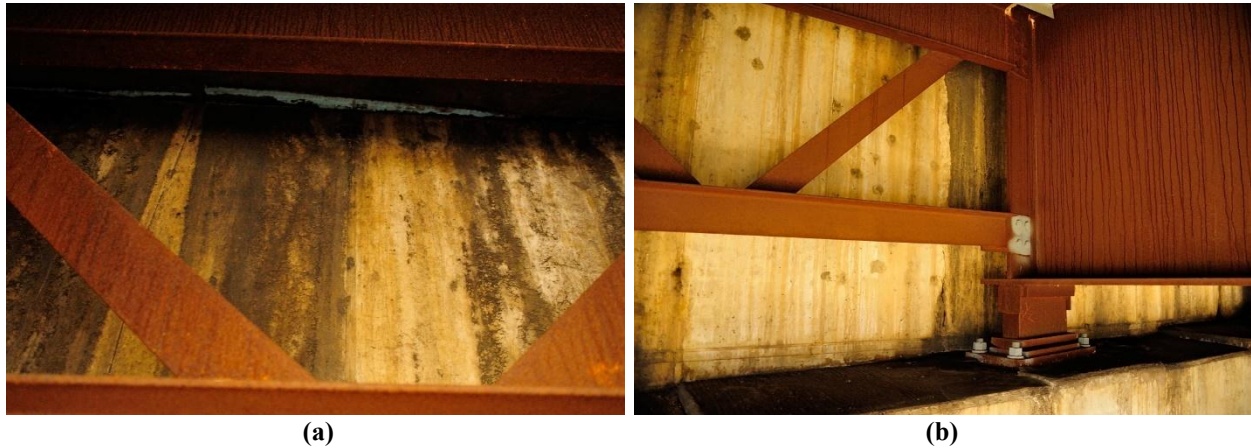
Figure 20. Photographs of Leaking Joint at Deck Extension Down the Backwalls for Bridge 27733: (a) Abutment A; (b) Abutment B

Site visits indicate that bridges with deck extensions are generally performing well. No signs of structural distress were observed. The only noticeable maintenance issue evident on some deck extensions is the leakage between the underside of the slab and the top of the abutment backwall, resulting in the drainage runoff spilling on the beam seats and bearings (Figure 20). All four deck extension bridges in this sample set had steel superstructures and were constructed between 2003 and 2008. None of these structures had the most recent VDOT drainage details.

The water leakage problem at the deck slab extension has been largely addressed by revising drainage and drip bead details at the slab edge underside (

Figure 32). This current detail for deck extensions is based on the modified Virginia Department of Highways standard for steel beam bridges, originally developed in 1951 (Park Thompson, personal communication). The original standard was improved by lengthening the deck extension beyond the backwall and adding drainage detail.

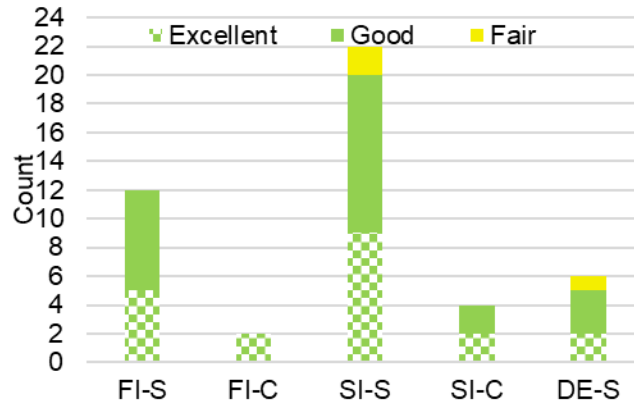
Figure 21. Count of Backwalls Observed with a Given General Condition, for a Given Abutment-Superstructure Type. C = concrete superstructure; DE = deck extension; FI = full integral; S = steel superstructure; SI = semi-integral.

Overall, integral backwalls in the jointless bridges surveyed in this study performed well, with 93% of them classified as either excellent or good condition (Figure 21). All the full integral and semi-integral backwalls supporting concrete superstructures were found in excellent condition, whereas approximately one-half of the full integral and semi-integral types supporting steel superstructures had that same rating. Of the three abutment types supporting steel beams, deck extension had the lowest performance, with only 25% in excellent visual condition, and another 63% in good condition. Generally, the best performing backwalls tended to be those at bridges with either small skews or with short span lengths (Figure 22).

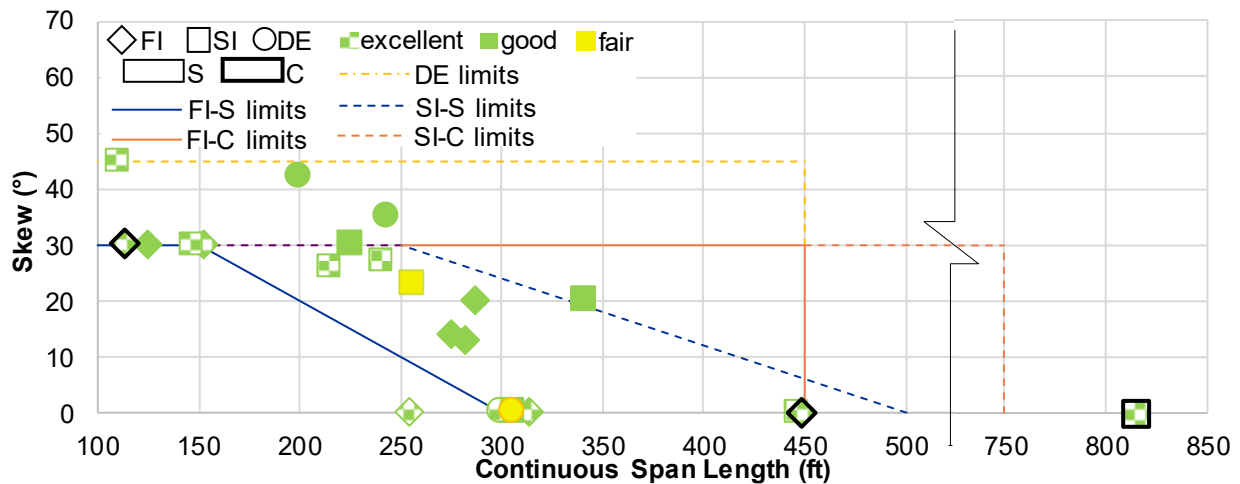
Figure 22. Visual Condition of Surveyed Abutment Backwalls for Given Continuous Span Length and Skew. C = concrete superstructure; DE = deck extension; FI = full integral; S = steel superstructure; SI = semi-integral.

The two bridges with “fair” backwalls, 26452 and 27733, were constructed in 2001 and 2003, respectively. The results in Figure 22 may not reflect the more recent construction, because these two bridges were built during a time when a contractor was permitted to use high early-strength concrete with up to 800 lb/yd³ of cementitious material. VDOT no longer allows that option for two reasons: the high cementitious content leads to substantial moisture-related shrinkage and larger temperature differentials inside the structure. Both of these effects can cause cracking that extends below the concrete surface. Also, in 2015, VDOT implemented the comprehensive use of a newly developed low-shrinkage A4 modified concrete mix to limit cracking in bridge decks, which has been reported to perform satisfactorily (Park Thompson, personal communication).

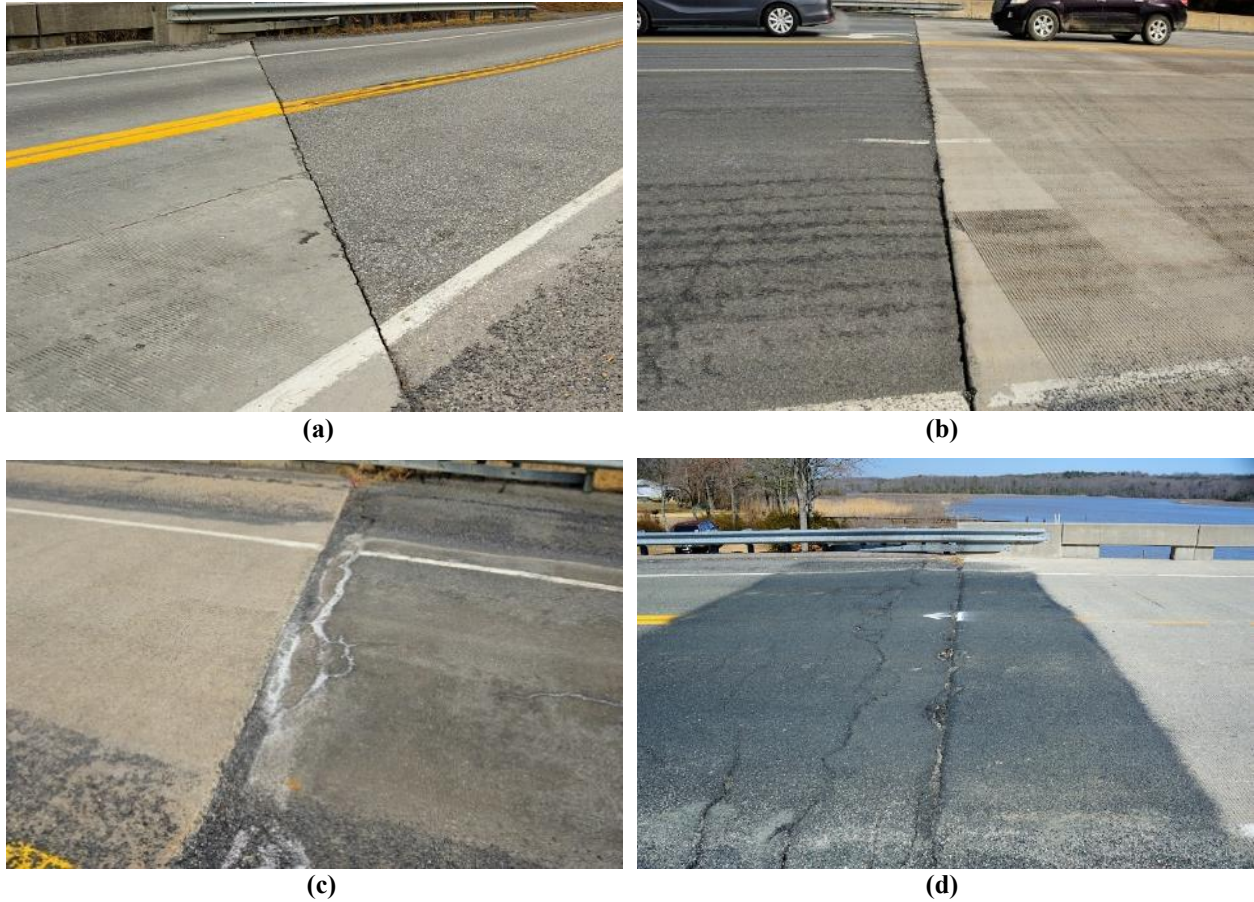
Figure 23. Photographs of Visual Reference for Qualitative Approach Condition Assessment: (a) Excellent; (b) Good; (c) Fair; (d) Poor

Numerous signs of approach-pavement distress are present at many of Virginia’s jointless bridges. Pavement distress is a common problem related to soil-structure interaction associated with the thermally induced lateral expansion and contraction of the bridge superstructure, which interacts with the adjoining roadway approach embankment. Figure 23 shows examples of qualitative ratings. Note that the relatively long continuous span length of 815 feet, lack of concrete approach slabs (included in the original design but not constructed), and soft subsurface soils exacerbated the “poor” condition of pavement approach of the example (Bridge 27344).

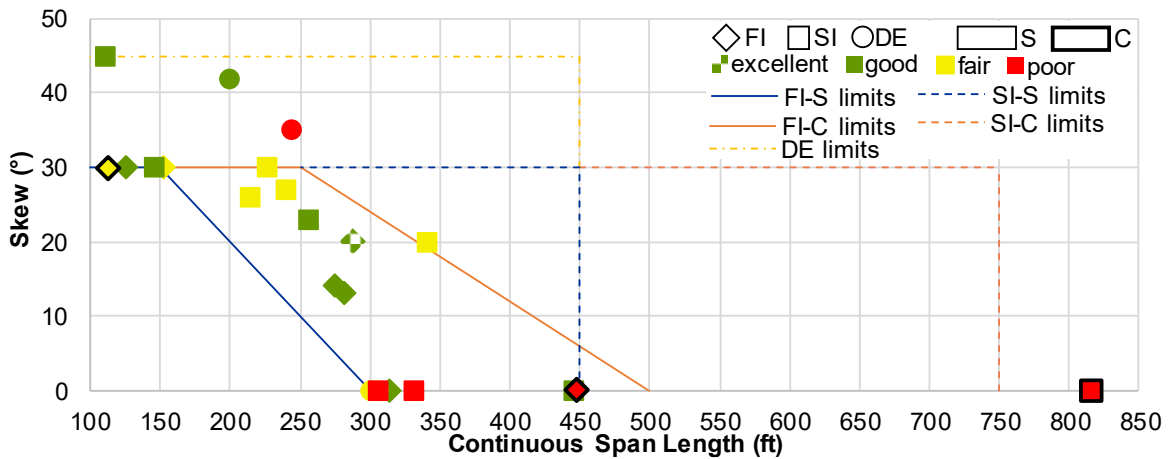
Figure 24. Visual Condition of Surveyed Pavement Approaches at Jointless Bridges. C = concrete superstructure; DE = deck extension; FI = full integral; S = steel superstructure; SI = semi-integral.

Figure 24 provides a summary of visual observations related to the pavement approach surface condition observed during field inspections. Although the continuous span length and skew angle appear to be significant variables, other factors clearly influence the overall performance of bridge roadway approaches.

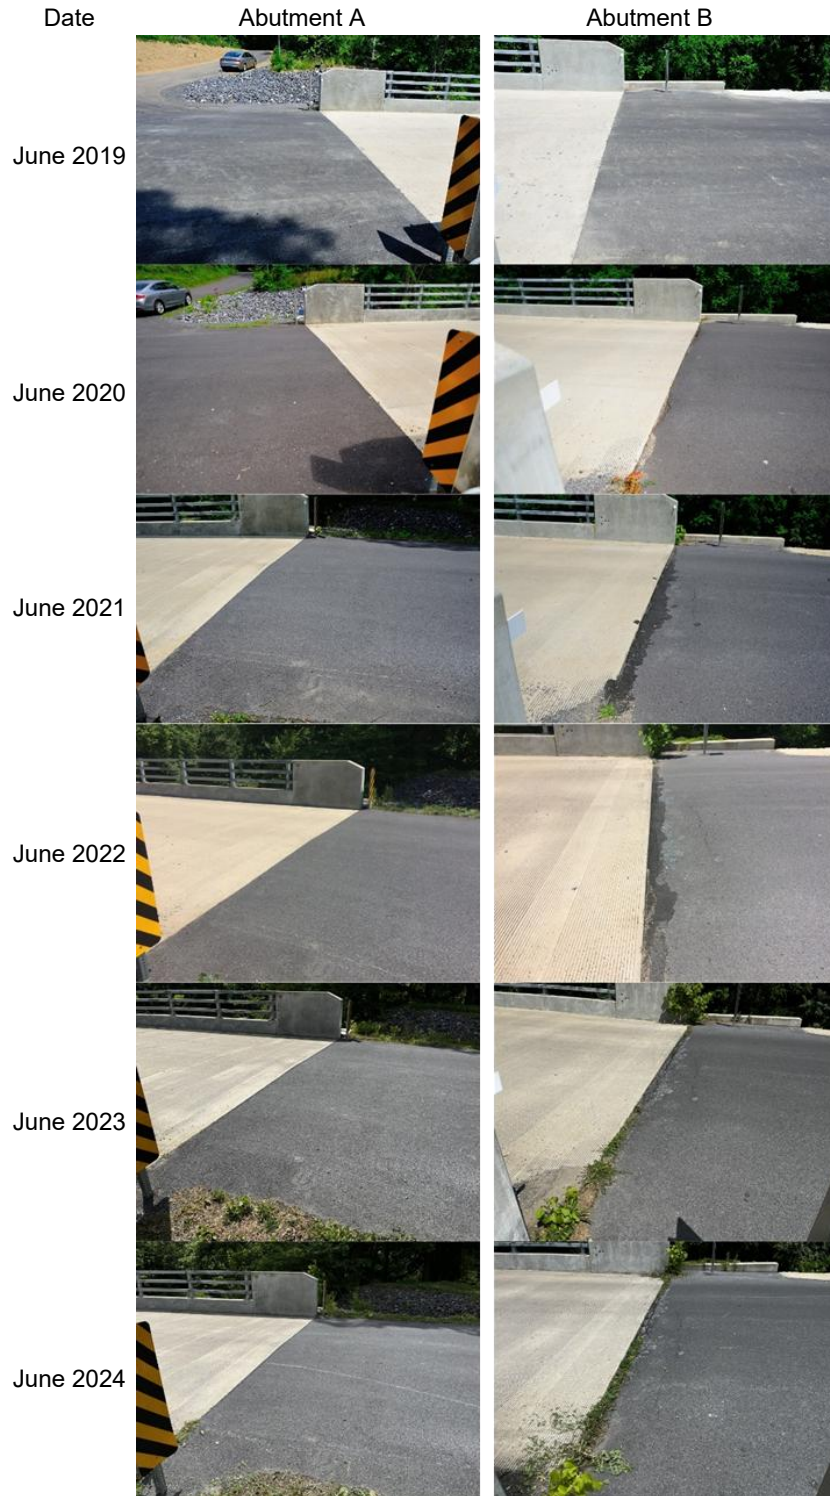
Base material underlying asphalt pavement typically consists of unbound crushed stone. The pavement section is designed for appropriate traffic loading but not for longitudinal loading. Figure 25 shows the long-term visual comparison of pavement approach conditions at Structure

Figure 25. Photographs Comparing the Approach Condition at Abutment A (Full Integral) versus Abutment B (Semi-Integral) for Bridge 29342
 No. 29342. The same roadway pavement section performed well at the stationary Abutment A while experiencing localized distress at Abutment B undergoing lateral cyclic movement in Figure 19.

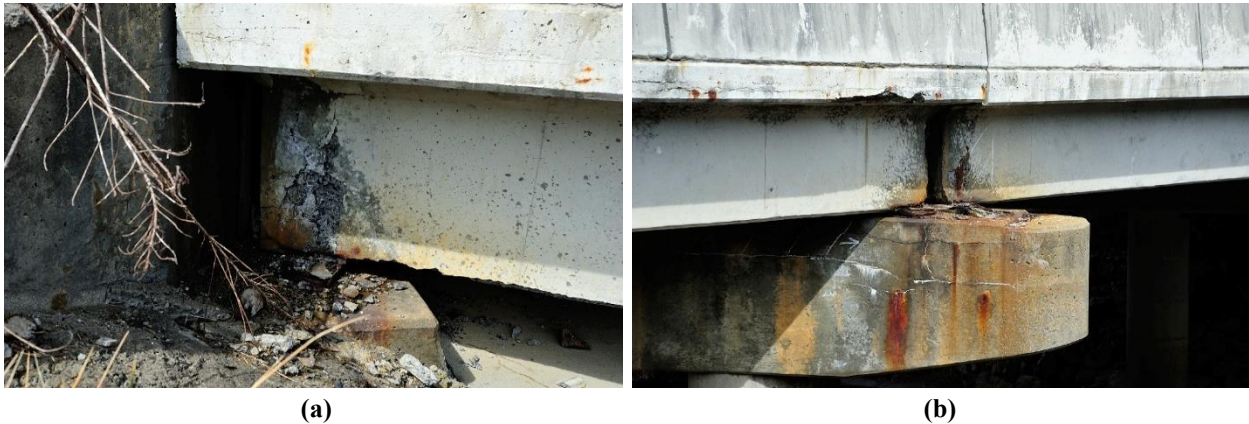
Figure 26. Photographs Showing Deteriorated Beam Ends in Bridge 4554, a Structure with Joints at Abutments and Piers: (a) Abutment A; (b) Pier 1

The need to construct resilient bridges that require less extensive maintenance during their service life motivates a trend toward jointless bridge design. Figure 26 shows an example of a conventional bridge encountered during the study. This bridge with joints exemplifies the commonly occurring maintenance problem of leaking deck expansion joints and the resulting damage to beam ends and substructure elements.

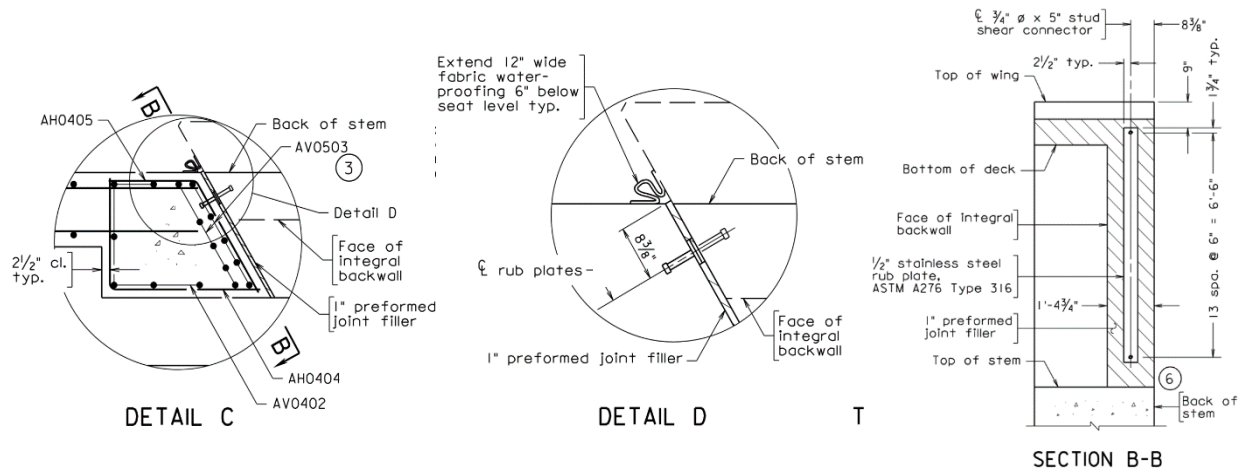
Figure 28. Various Views of VDOT's Current Load Buttress Detail (VDOT, 2024)

generation of noncollinear reaction forces (Figure 29). Figure 29 indicates that a tangential force component is needed to balance the rotation. Theoretically, friction generated at the interface between the backwall and the adjoining backfill material provides this force. In practice, however, this frictional resistance cannot be relied on under all service conditions. As the bridge contracts, water runoff and deicing chlorides can enter and lubricate the interface gap before the bridge starts expanding. During the subsequent expansion, no effective frictional resistance can be mobilized. The resulting movement of the skewed superstructure is particularly apparent on single-span semi-integral bridges with no rotational restraint provided by the pier bearings.

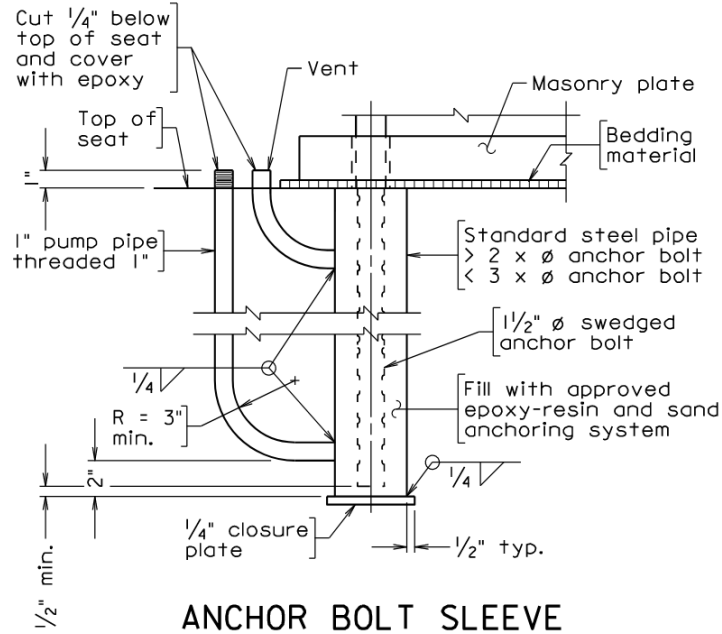
ANCHOR BOLT SLEEVE

In addition to the load buttress, constructing U-back wingwalls on skewed bridges provides significantly increased lateral resistance to superstructure rotation. Also, wider slots in the sole plates have been allowed to provide additional clearance for anchor bolts. To ensure proper centering of the anchor bolt within the wide slot, steel sleeves are embedded in the abutment seat (Figure 30).

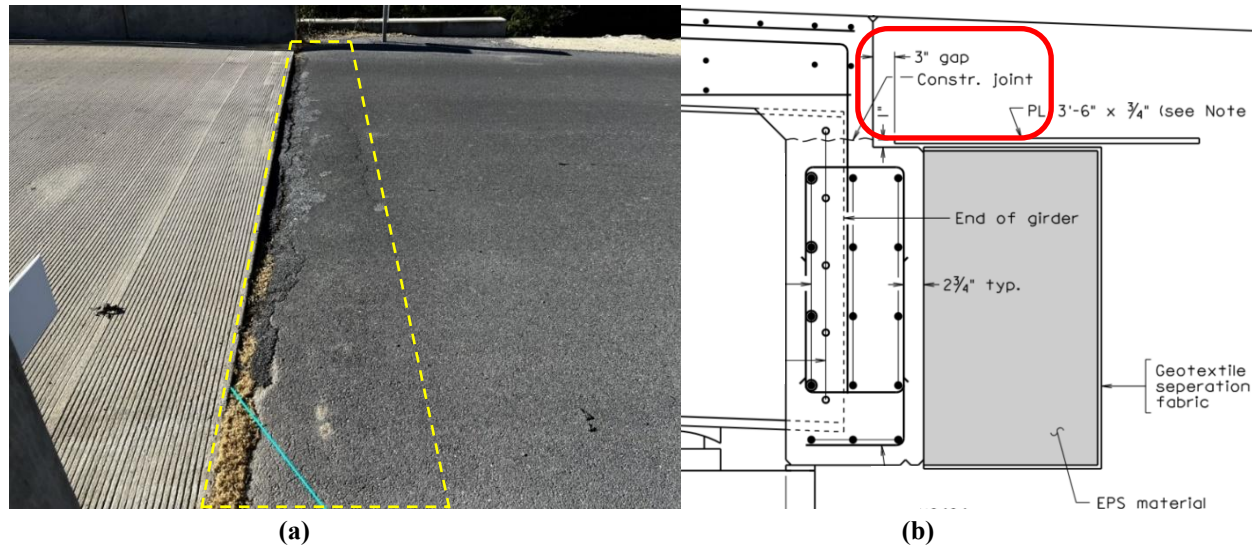
The elasticized EPS layer reduces the lateral pressure acting on the abutment and accommodates thermally induced lateral displacements. Its design thickness is based on the estimated range of abutment thermal movement, subject to a minimum specified thickness of 10 inches. EPS typically terminates at the approach slab seat elevation. On a bridge without concrete approach slabs, the integral abutment cyclic movement results in a localized pavement distress in the immediate vicinity of the bridge deck, as the red outline directly above the 24-inch-thick EPS layer shows in Figure 33a. This region is a relatively shallow zone of direct vertical contact (approximately 20 inches deep) between the bridge and the pavement section. In contrast, the approach embankment zone below the pavement section interacts with the bridge abutment through the 24-inch elasticized EPS layer, which absorbs lateral deformations.
