Mitigation of Tenting of Transverse Cracks and Joints in Asphalt Pavement

Department of Civil and Environmental Engineering
University of Minnesota Duluth

April 2026

Research Report
Final Report 2026-16

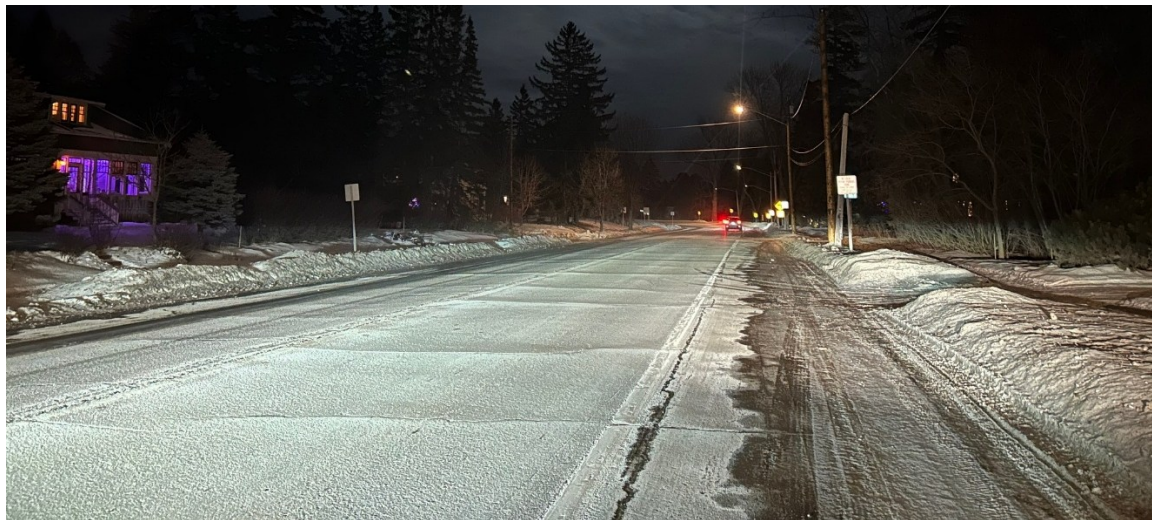
Figure 1.1 (a) The anatomy of the tenting, (b) a photograph of tenting showing the slope of the pavement at either side of the cracks, and (c) distorted pavement profile because of tenting.

In climates similar to Minnesota's, transverse cracks frequently develop a secondary winter distress known as tenting or heaving. Tenting refers to the upward movement of asphalt along the edges of the crack due to ice formation beneath the pavement surface. This upward movement increases pavement roughness and decreases ride quality. Figure 1.1 illustrates the anatomy of tenting and shows two photographs of tented transverse cracks. The first photograph demonstrates the significant slope of the pavement in the immediate vicinity of a tented crack. The second photograph, taken at night, highlights the distorted profile of a pavement section heavily impacted by multiple tented cracks. Tented cracks with peak heights exceeding 2.5 mm can affect ride quality (Johnson & Olson, 2008) and pose safety concerns for motorists, especially under low-visibility winter conditions. Additionally, tented cracks deteriorate more rapidly than non-tented cracks and often evolve into potholes before the pavement reaches its intended service life.

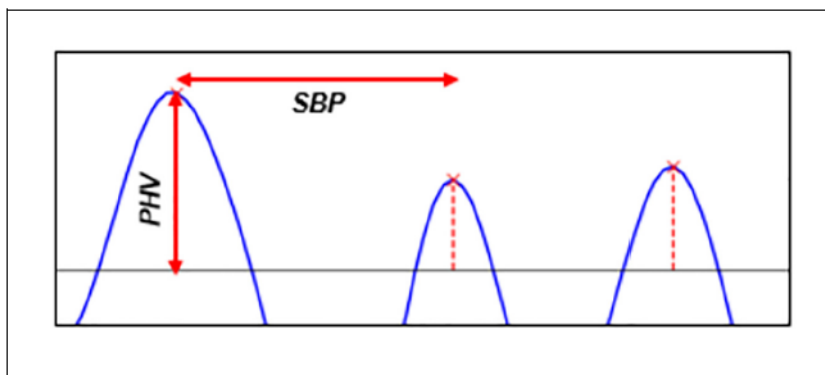
Figure 2.4: PHV and SBP, tenting parameters developed in Zegeye-Teshale et al. (2021) study.

The assessment of tenting is crucial for understanding its impact on pavement roughness and ride quality, as well as for studying the effectiveness of various mitigation strategies. The severity of tenting is defined by the peak height of the heaved crack. The research conducted by Teshale et al. (2021) made significant developments in this area by developing a non-destructive testing methodology for the tenting measurement. This research introduced two specific parameters, which are the peak height value (PHV) of the heaved crack and spacing between peaks (SBP) of the consecutive tented cracks, as shown in Figure 2.4.

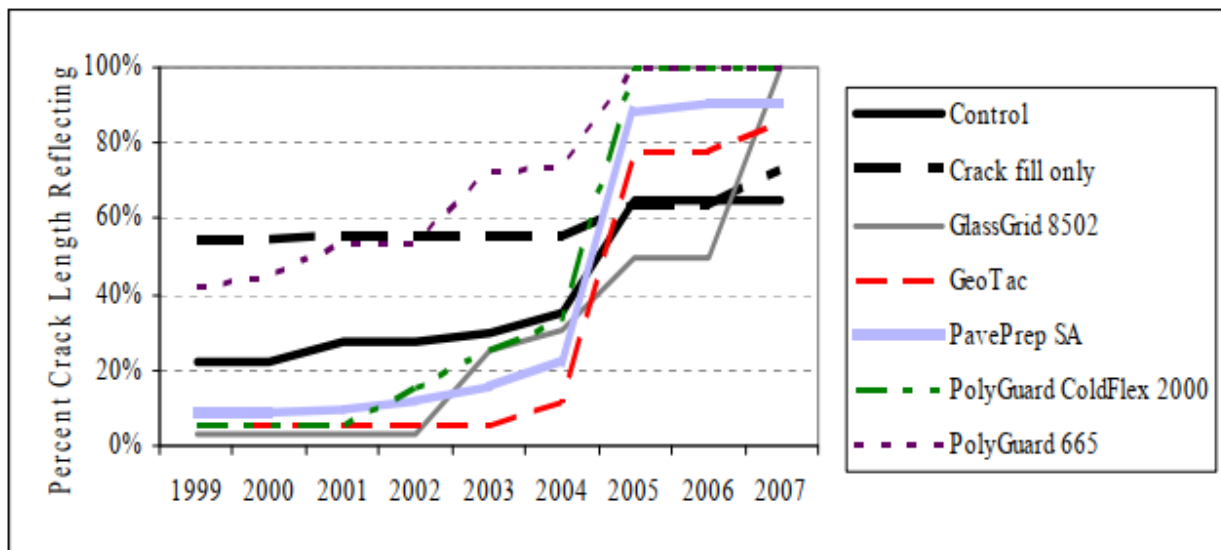
Figure 2.8: Percentage of crack length reflected from the original HMA layer to the overlay (Bush and Brookes, 2007)

It was found that the geosynthetic material helped decrease the percentage of cracking. In their study, the percentage of reflective cracking was studied as a function of different categories of geosynthetic material and crack-fill-only options. Figure 2.8 shows the comparison of the percentage of reflective crack length from the year 1999 to 2007. It was found that the GlasGrid 8502 geosynthetic material performed the best in reducing reflective cracking. Since the geosynthetic material can reduce tension transfer to the overlay, the possibility of reflective cracking is minimized.

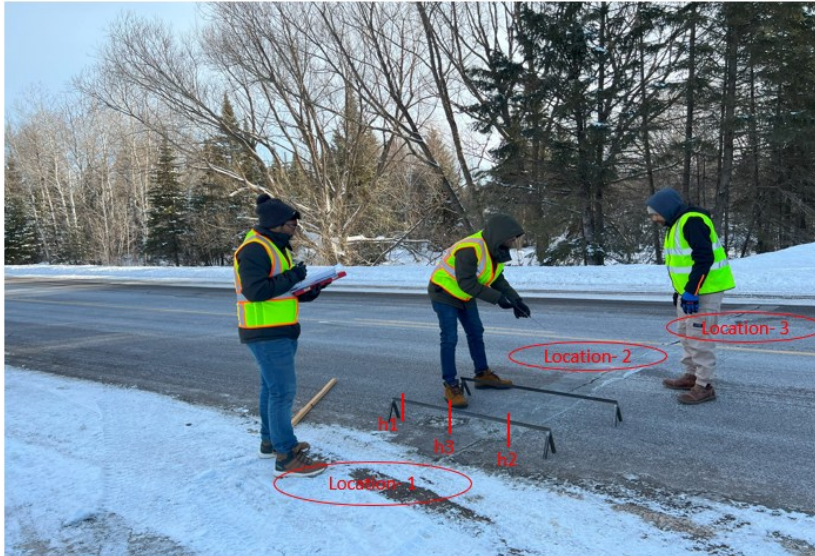
Figure 3.3 Tenting measuring device and the location of the measurements in a transverse crack

Figure 3.4 shows the tenting peak height calculation procedure. For each tenting measurement, at first, the measuring device was placed on the road centering crack as shown in Figure 3.3. Three elevation readings, h_1 , h_2 , and h_3 were taken. The peak height was calculated using Equation 1.

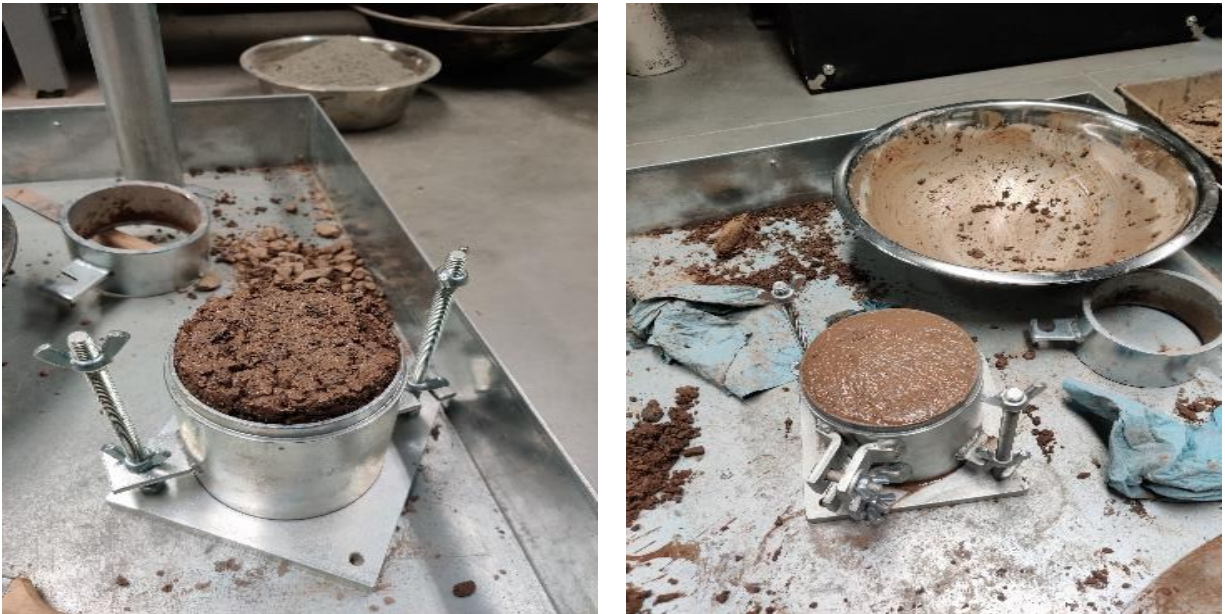
Figure 3.7 Photographs showing Proctor test of the base material

pulverized and mixed with the required amount of water and aggregate. A subsequent mix was prepared with a 2% increase in moisture content, and the compaction procedure was repeated. This cycle continued in 2% increments until the compacted sample weight began to decrease, indicating the optimum moisture content had been exceeded. Figure 3.7 shows pictures of the proctor test of the aggregate base material.

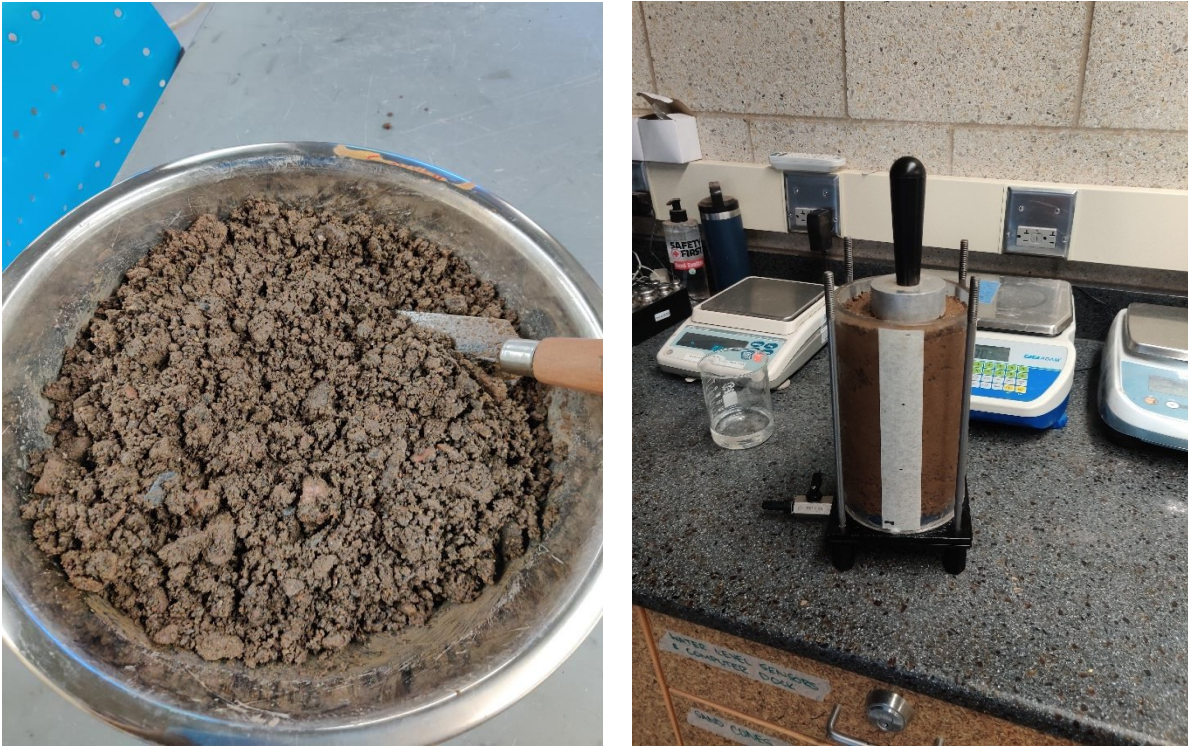
Figure 3.10 Aggregate mixed with water at OMC and Compacted sample in the permeability test mold.

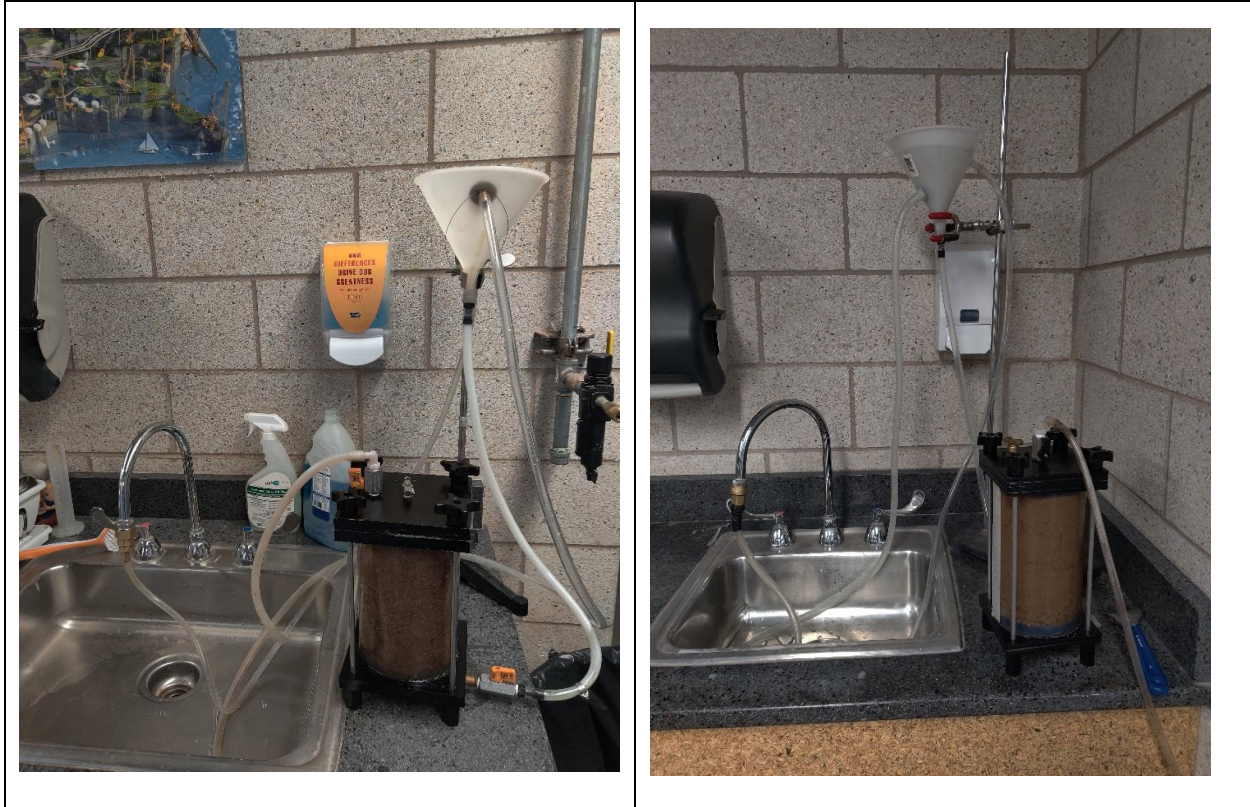
Figure 3.11 Permeability test setup images

After compaction, another porous stone and filter paper were placed on top of the sample. Then, the top lid was placed on top of the mold. Vacuum grease was applied to the sides of the mold before closing the lid to ensure an airtight seal. The specimen was attached to the inlet water pipe to allow water to run through the sample. The flow of water was adjusted slowly until a constant water head level was achieved. The specimens were kept under this water flow until they were completely saturated. Water was collected in a graduated cylinder from the outflow tube, and the collection time was recorded. This process was repeated multiple times until readings were consistent, indicating steady flow. The closest three readings were used to compute the coefficient of permeability. Water temperature was also recorded to determine the viscosity correction factor. The head difference in the water level, or the height difference between the inflow and outflow, was also recorded. Figure 3.11 shows two images of the constant head test setup.

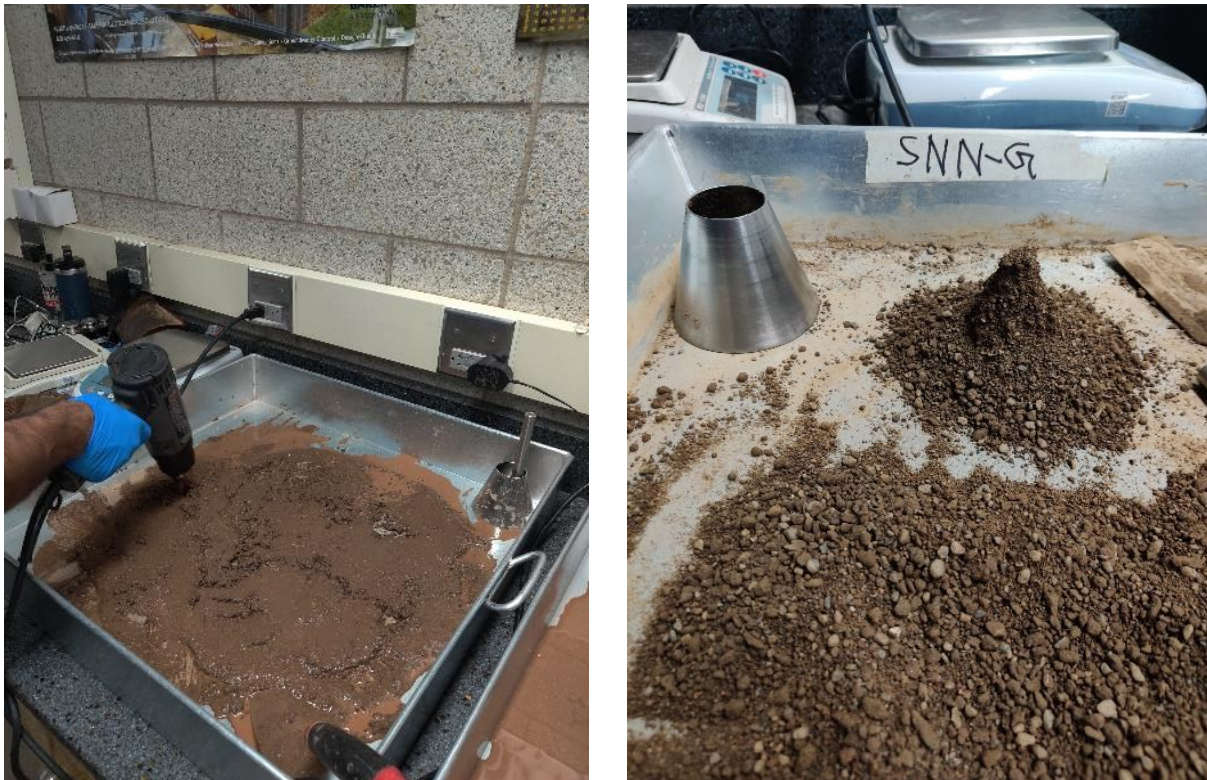
Figure 3.13 Fine aggregate drying using heat gun (left) and checking for SSD condition (right)

The testing procedure for fine aggregate parallels that of coarse aggregate and was conducted in accordance with ASTM C128. First, the aggregates were dried in the oven. Then, the aggregates were placed in a bowl and submerged in water for 24 hours. The excess water was then drained very slowly from the bowl to ensure no fines were lost. The wet aggregate was spread on a non-absorbent surface (steel tray) and dried using a heat gun and the drying process continued until achieving saturated surface dry (SSD) particles as per ASTM C128 (Figure 3.13). During the drying process, the aggregates were mixed frequently to ensure homogeneous drying.

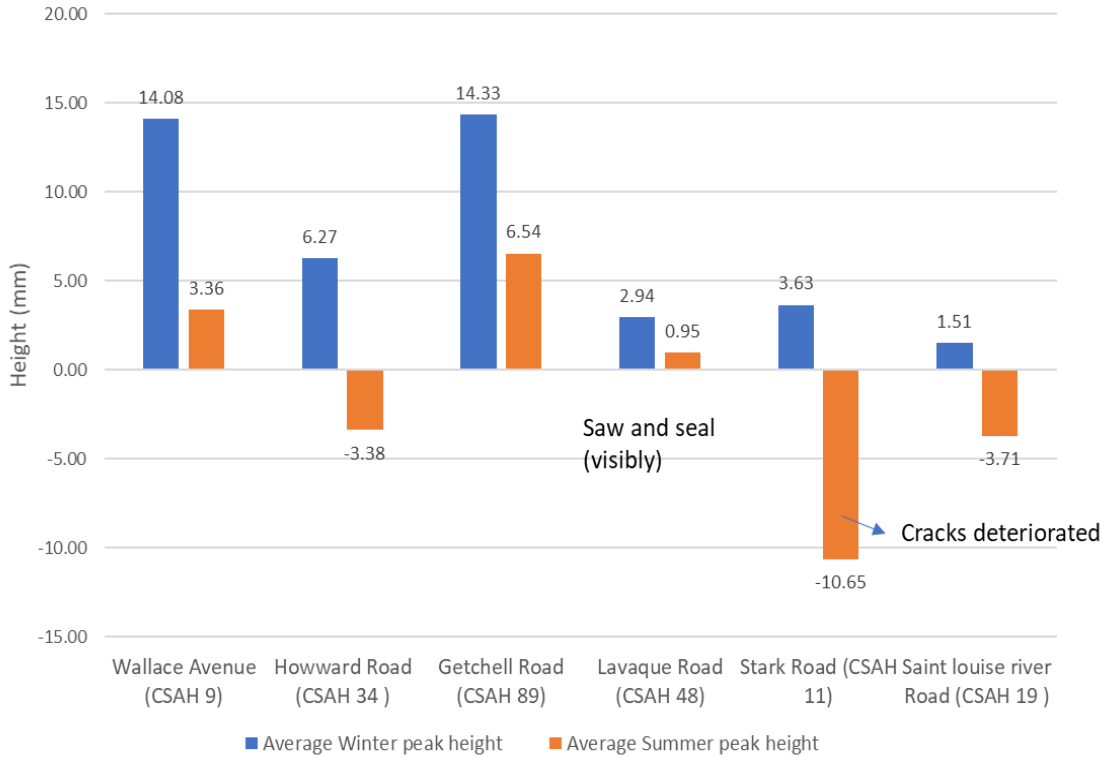
Figure 4.1: Average winter and summer tenting peak height of different roads.

The winter tenting results, presented in Figure 4.7, Figure 4.8, and Figure 4.9 showed that tenting peak height was as much as 7 mm, 9 mm and 8 mm at some locations in the MN-37D, US169D, and US-169I, respectively. These ranges of tenting were also observed in the two of the six roads measured in the present study (Figure 4.1).

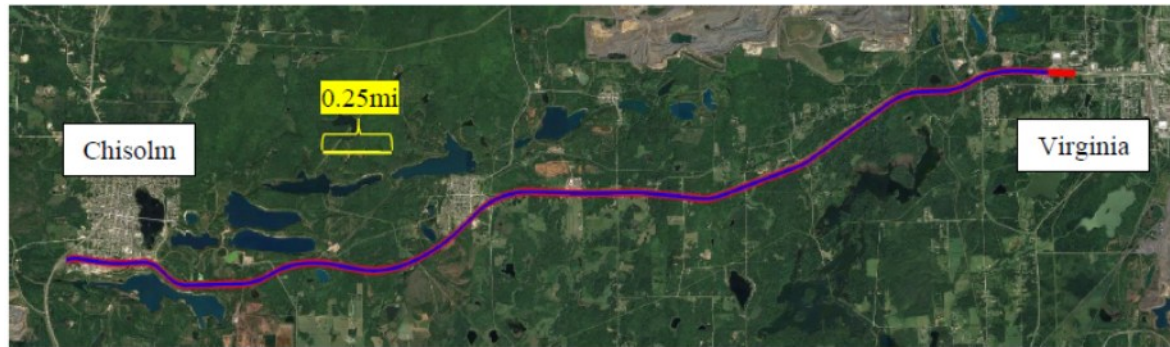
Figure 4.6: US-169I Test Section (red line - 2021, and magenta line -2020).

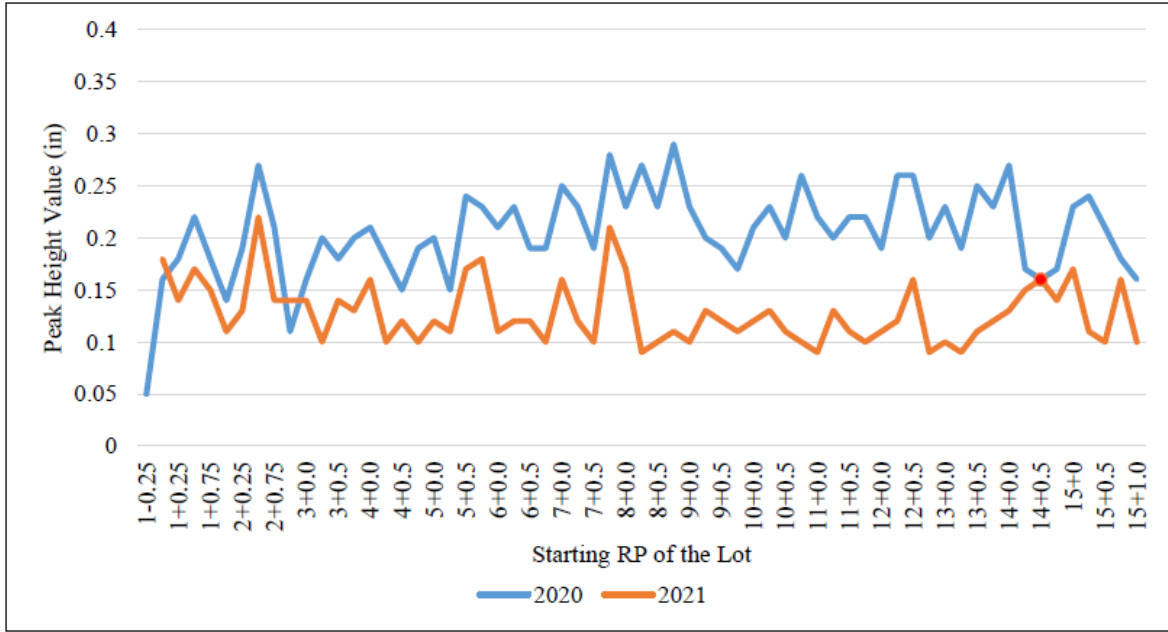
Figure 4.7: Tenting Results for MN-37D.

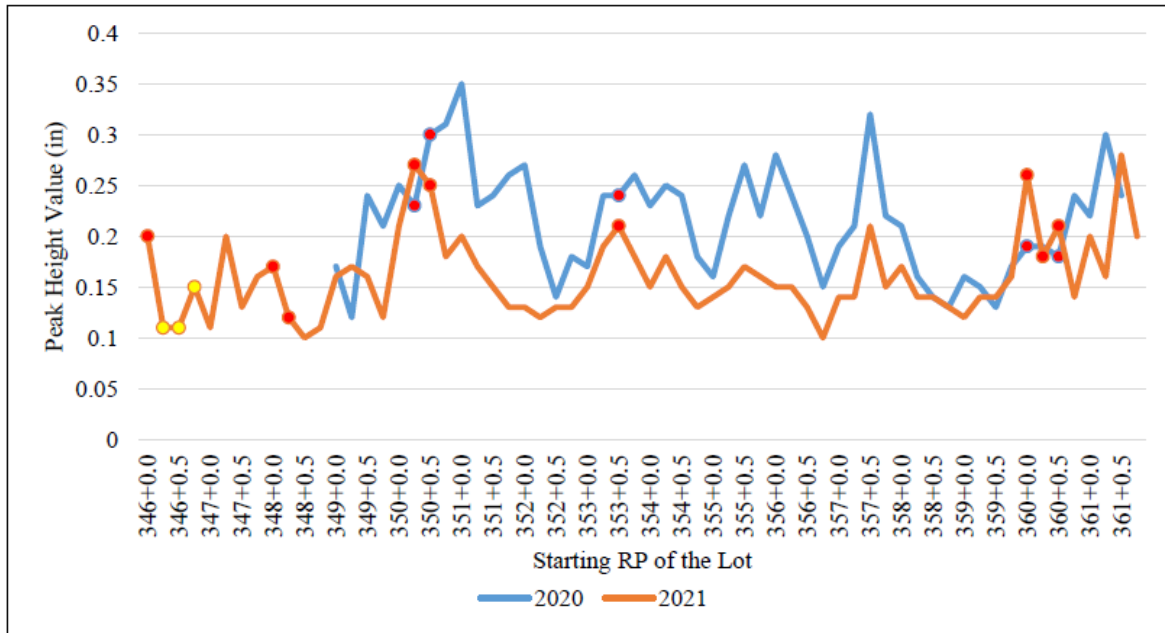
Figure 4.8: Tenting Results for US-169.

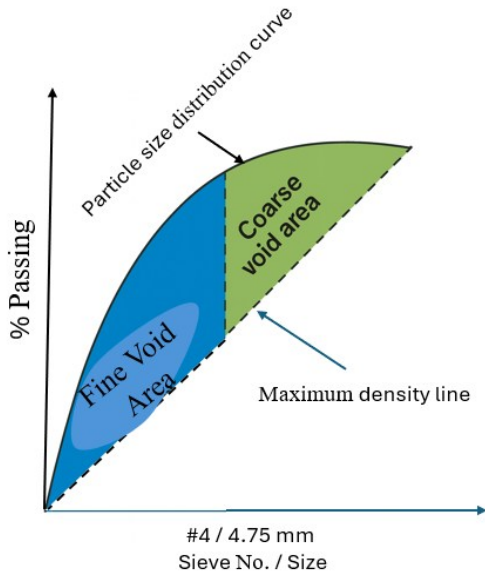
Figure 4.15: Fine void area and coarse void area.

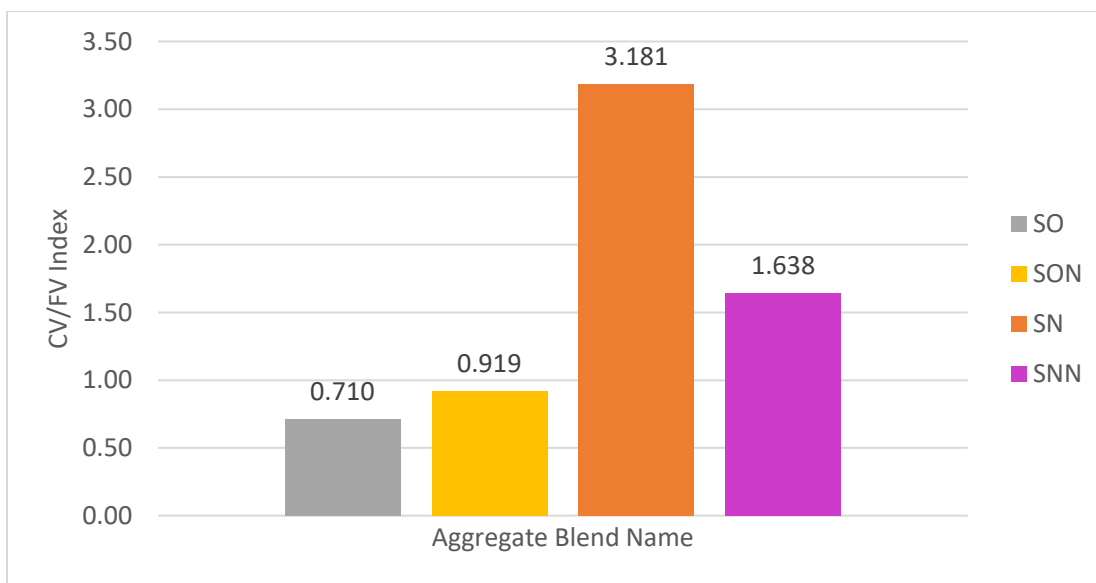
Figure 4.16: Comparison of the CV/FV value of the four different blend

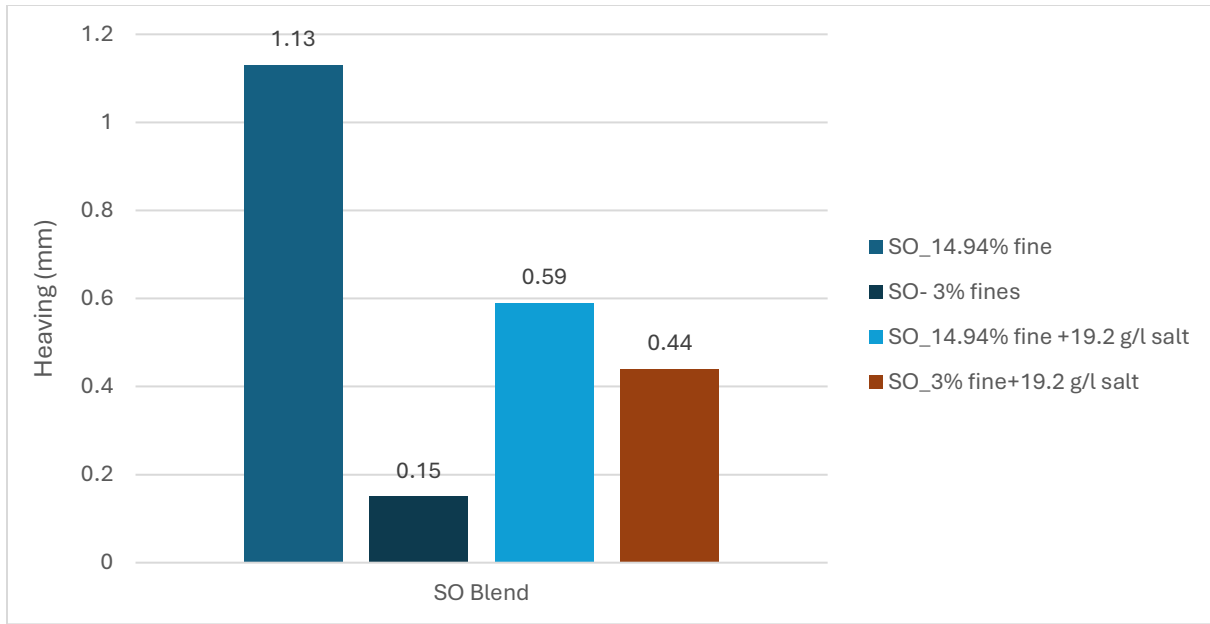
Figure 4.20: Frost heave test results of samples prepared from SO blend

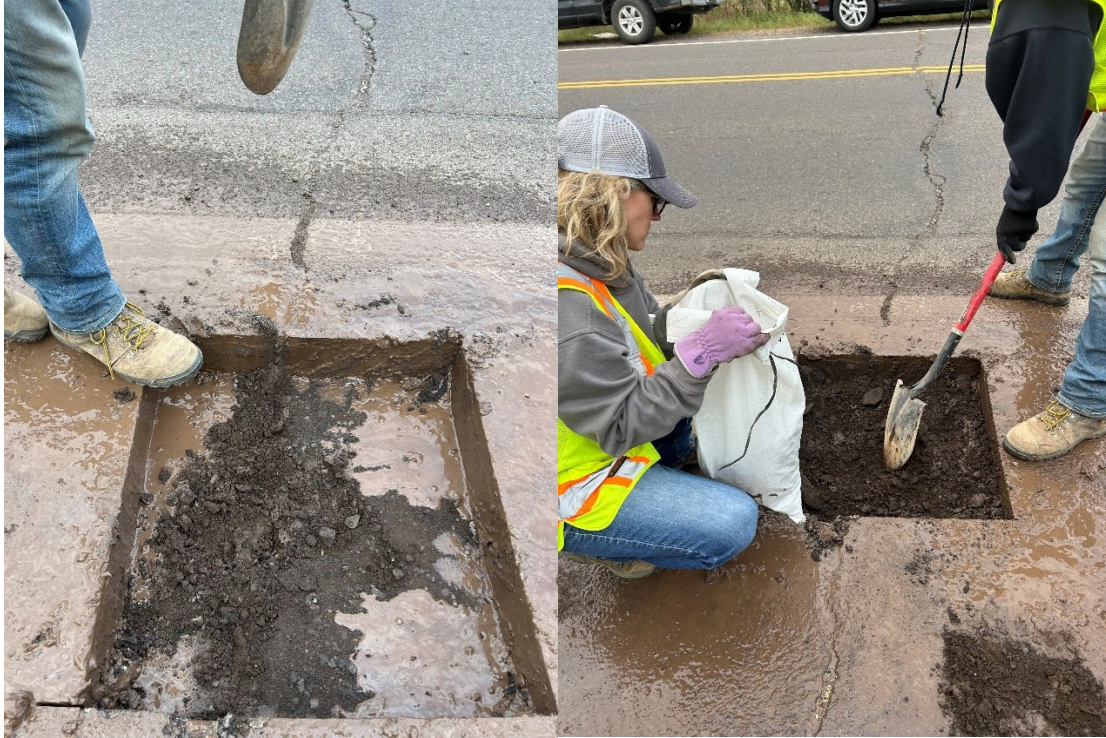
Figure 4.30: Base materials collection from the project site

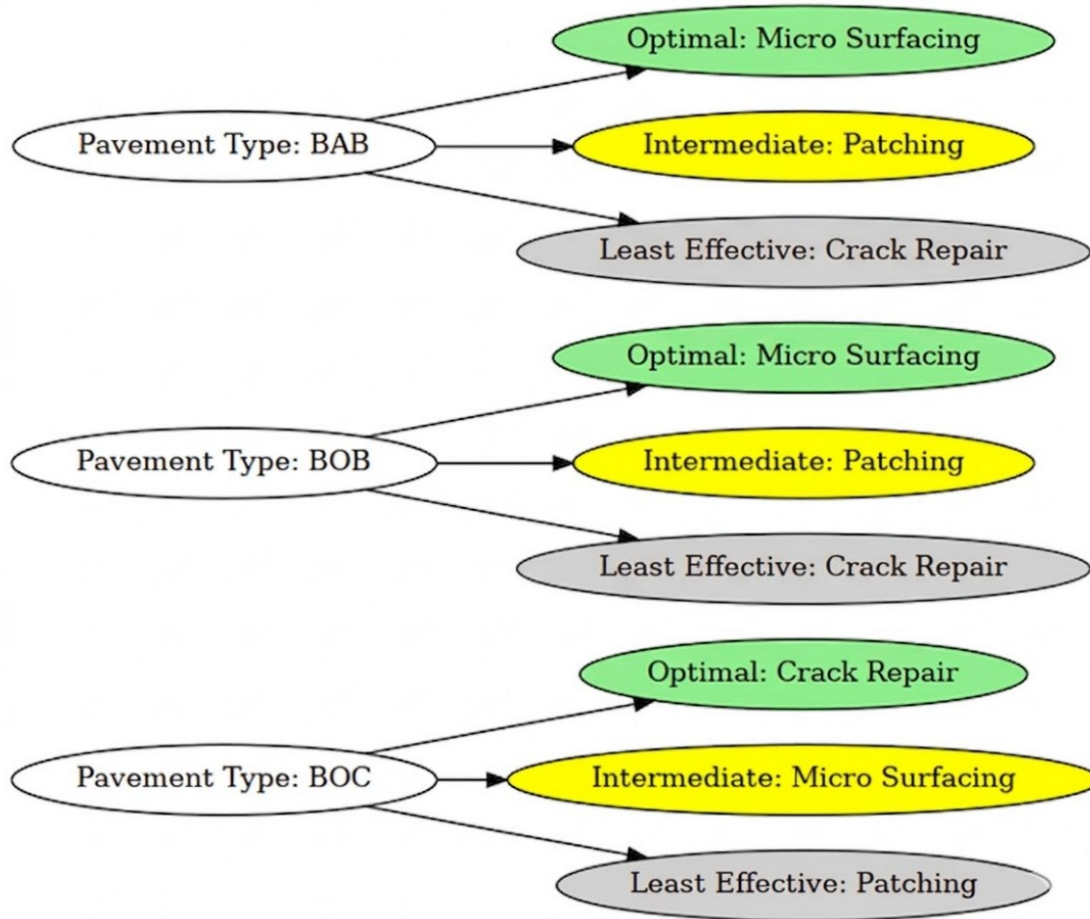
Figure 5.1: Decision tree for selecting pavement treatment to decrease tenting on the existing pavement.
