DOT/FAA/CT-82/153  
DOT/FAA/RD-82/85

# Evaluation of Precision Approach Path Indicator (PAPI)

FAA Technical Center  
Atlantic City Airport, N.J. 08405

April 1983

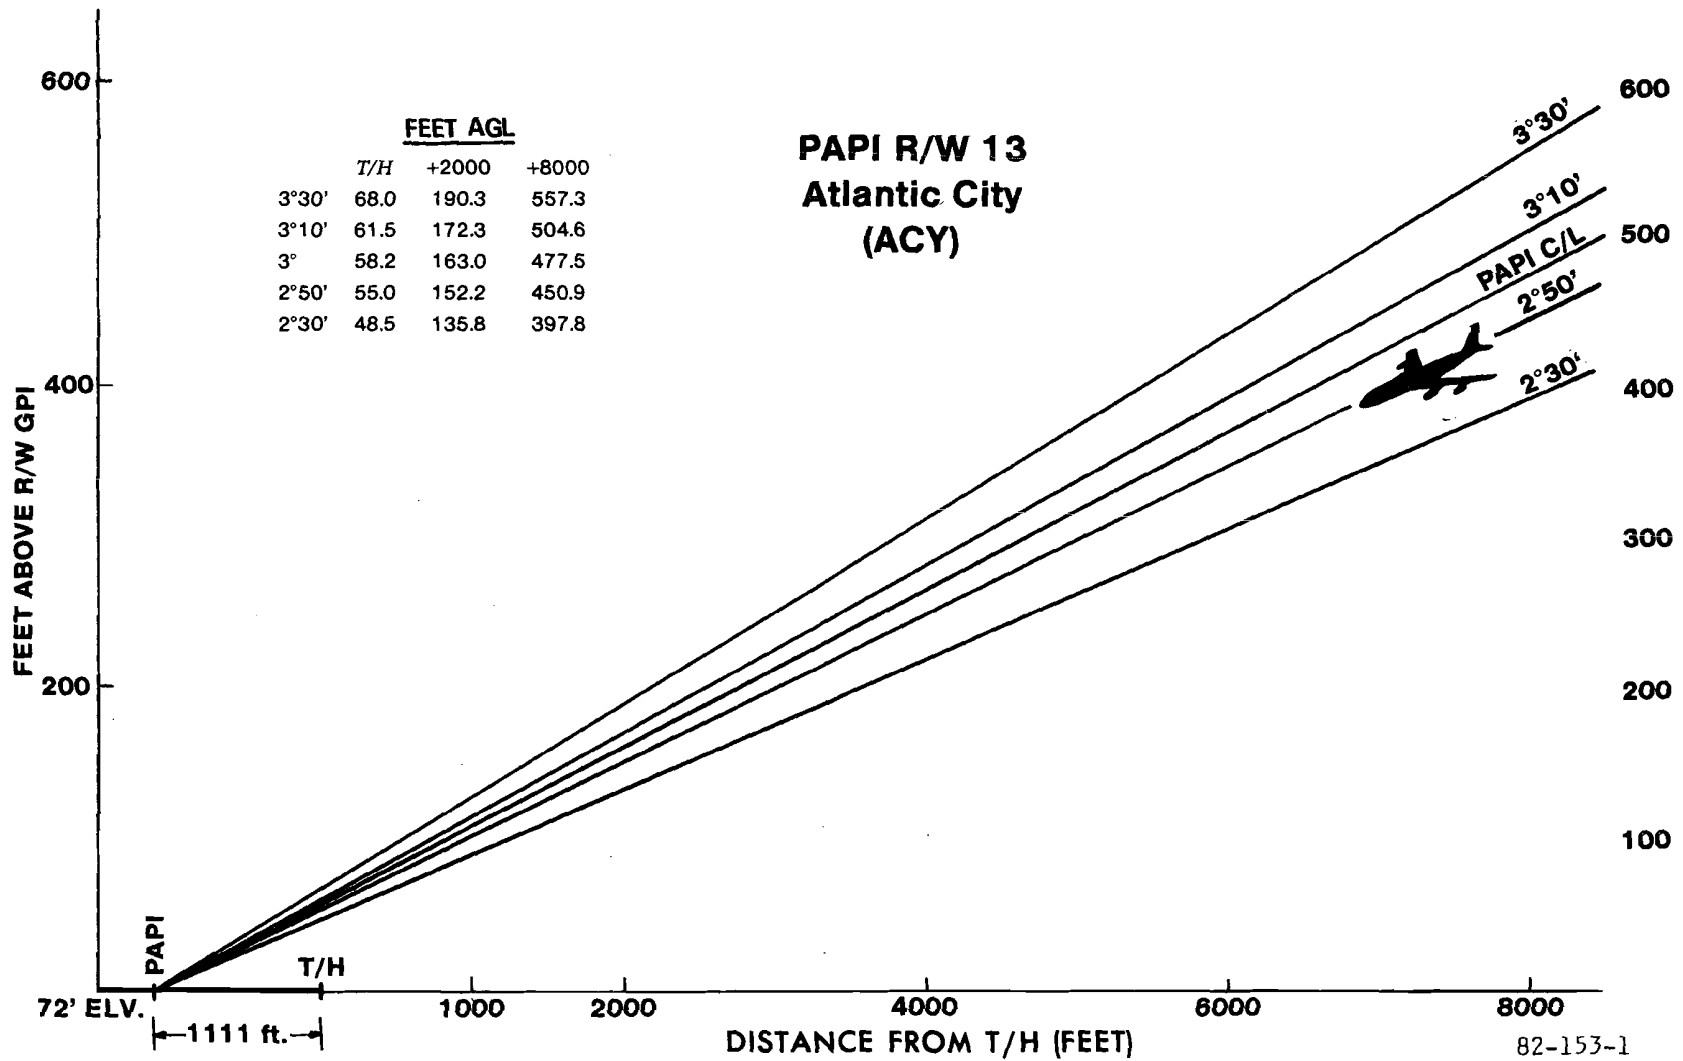
FIGURE 1. PAPI APPROACH PATH (SIDE VIEW)

The PAPI system consists of a bar of four light units (three lamps per unit) facing the approach end of the runway. Each unit is set at a slightly different angle (20 minutes apart) and emits a beam of high intensity light, the upper half showing white and the lower half showing red. Figure 1 depicts a side view of the signal sectors in the approach zone. As seen by the approaching pilot, it consists of a bar of four quick transition red/white light units whose on-glidepath signal (usually 3°) is two red and two white lights (figure 2). When the aircraft is slightly below glidepath (between 2° 50 minutes and 2° 30 minutes), the signal changes to three red and one white light. When the aircraft is further below glidepath (below 2° 30 minutes), a fly-up signal of four red lights is seen. Conversely, deviations above the glidepath will cause the red light units to turn successively white. In this configuration, the lights can be seen at about 5 miles from the threshold of the runway (in unlimited visibility) and the on-glidepath signal depth gradually reduces to approximately 6 feet at the threshold.

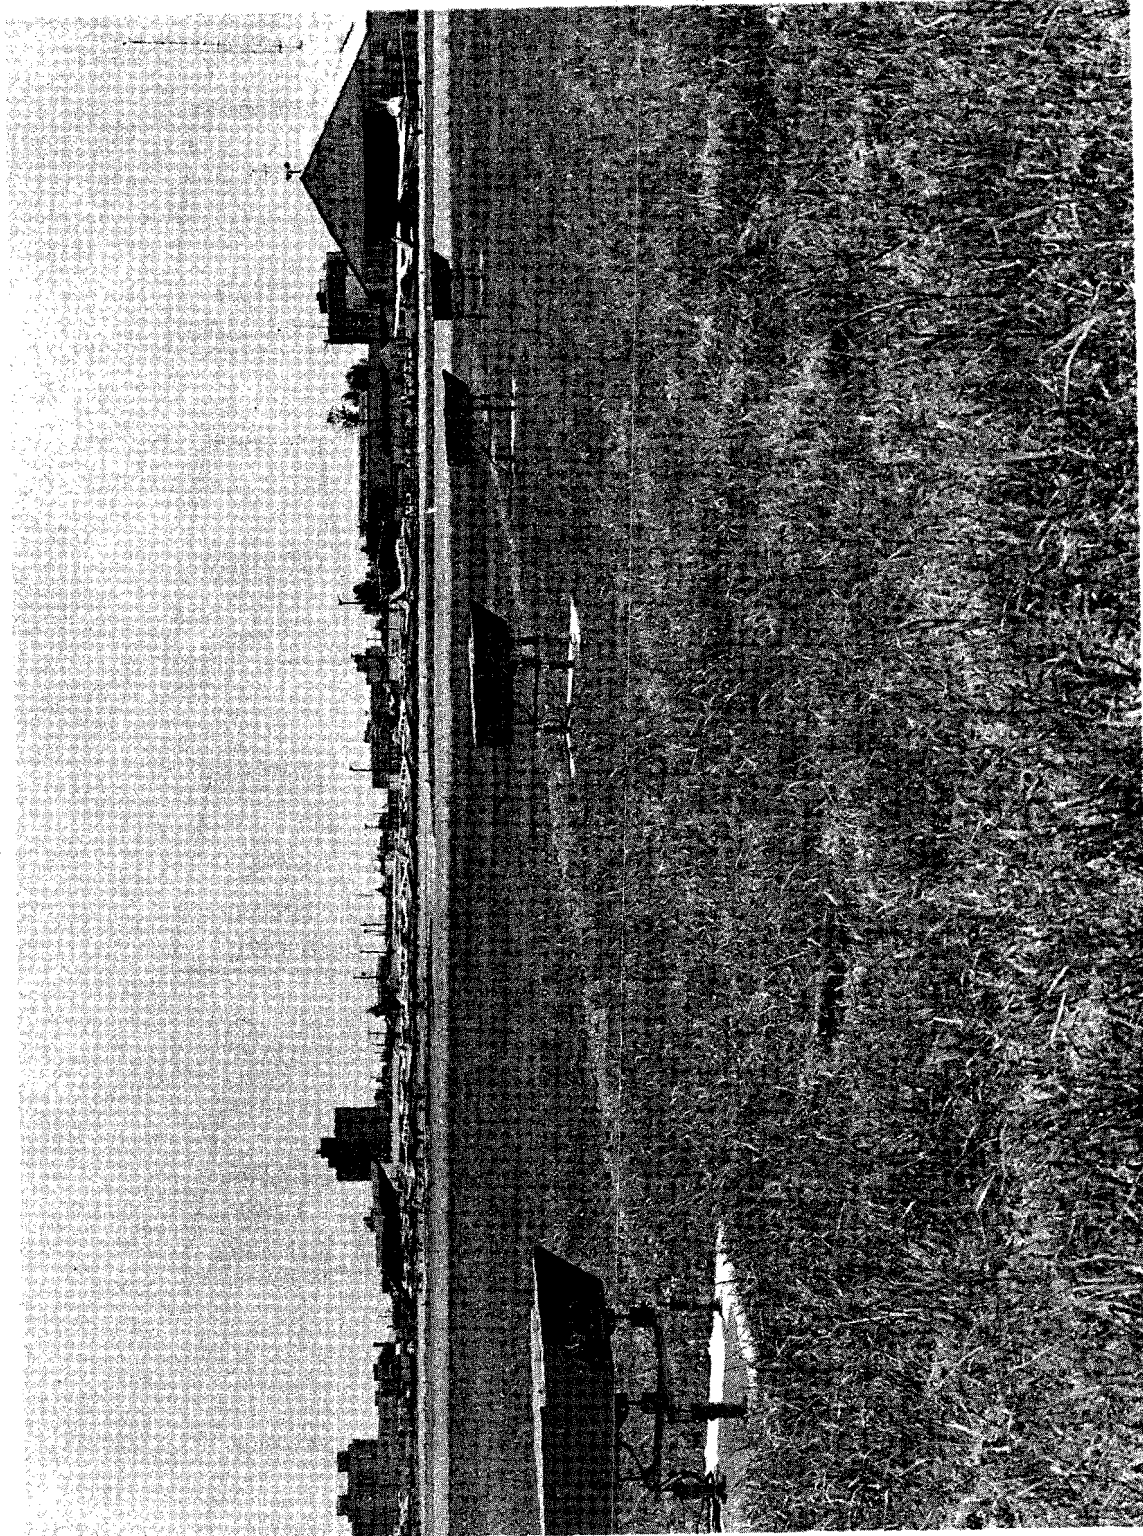
FIGURE 3. BARREL PAPI SYSTEM AT BADER FIELD

The physical configuration of the PAPI system (4 boxes) is shown in figure 3, each box being similar in appearance to the standard red/white VASI box. They require the same type and amount of power as required for a four-box VASI system and, therefore, there is no change in the power requirements if a PAPI system is to be substituted for a four-box VASI system. Most of the flight testing was accomplished on a model BLC MK 6 PAPI system (figure 4) manufactured by the Barrel Lighting Company, Limited of England. Some testing, however, was performed on early

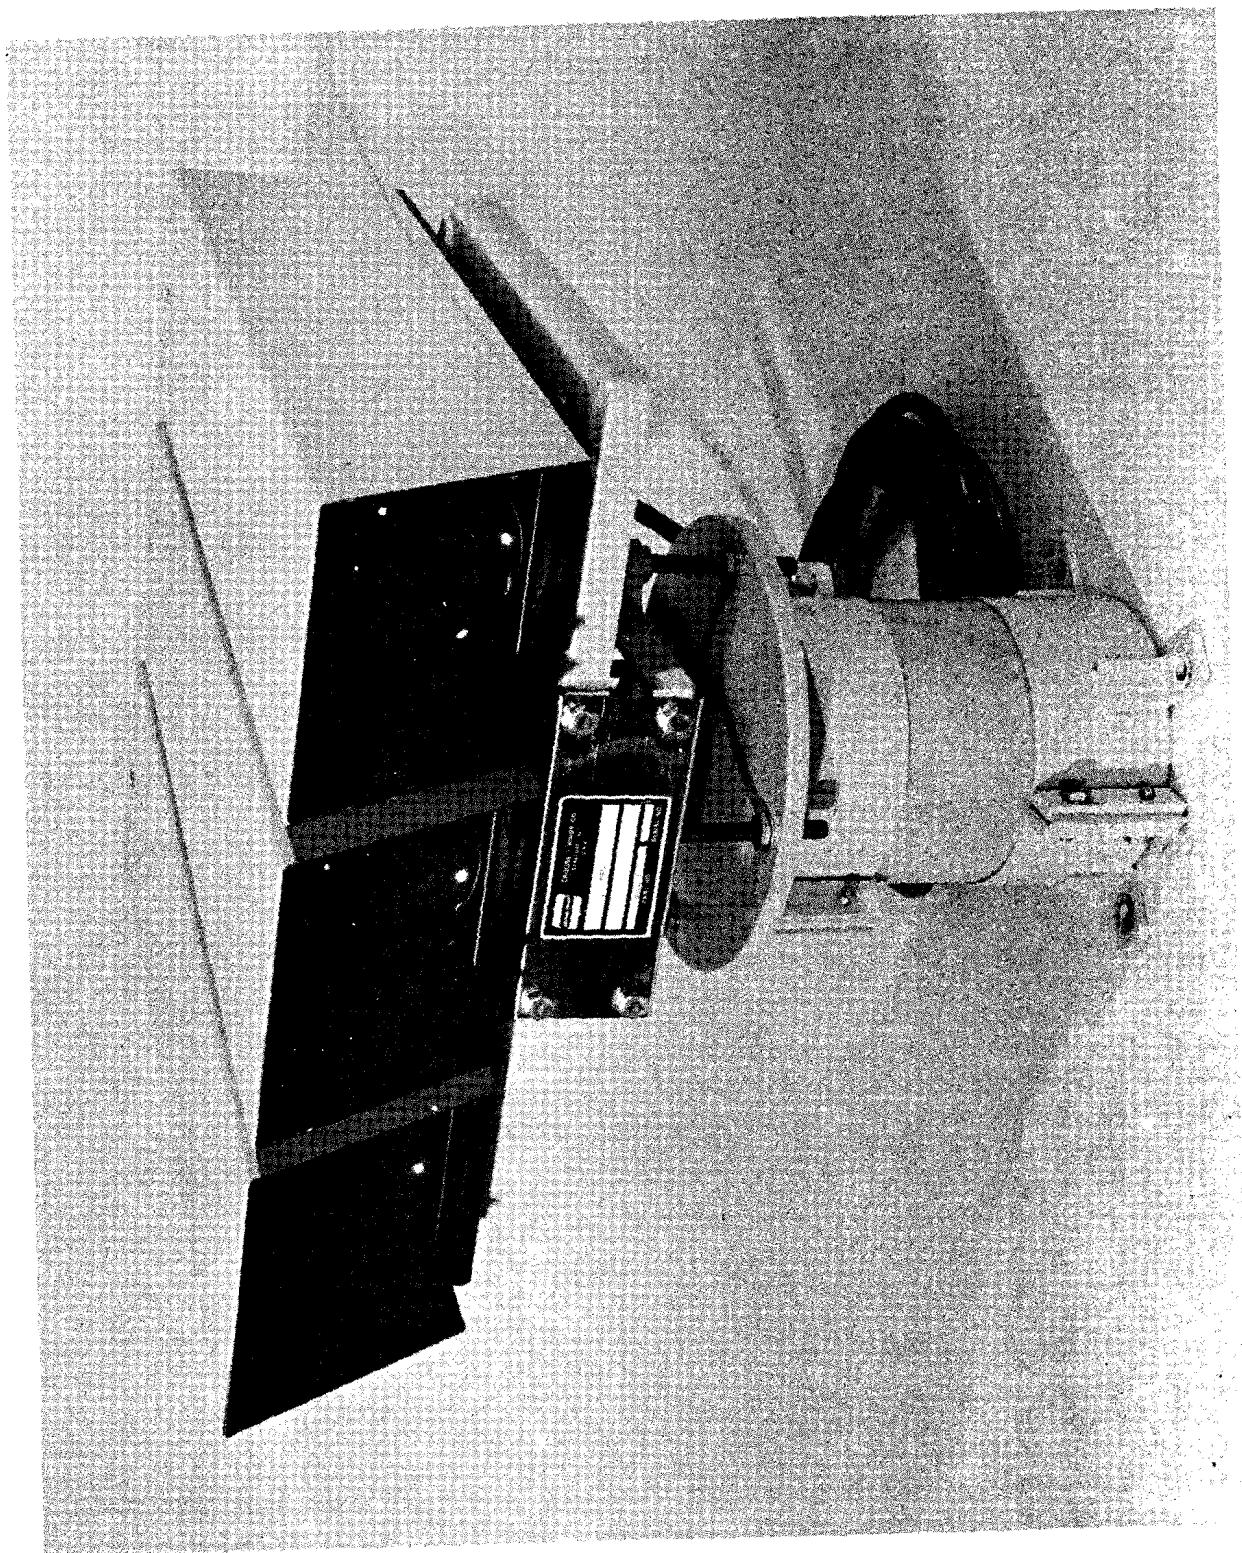
FIGURE 5. CROUSE-HINDS PAPI UNIT

versions of PAPI units built by ADB of Belgium and by Crouse-Hinds, Syracuse, New York (figure 5).

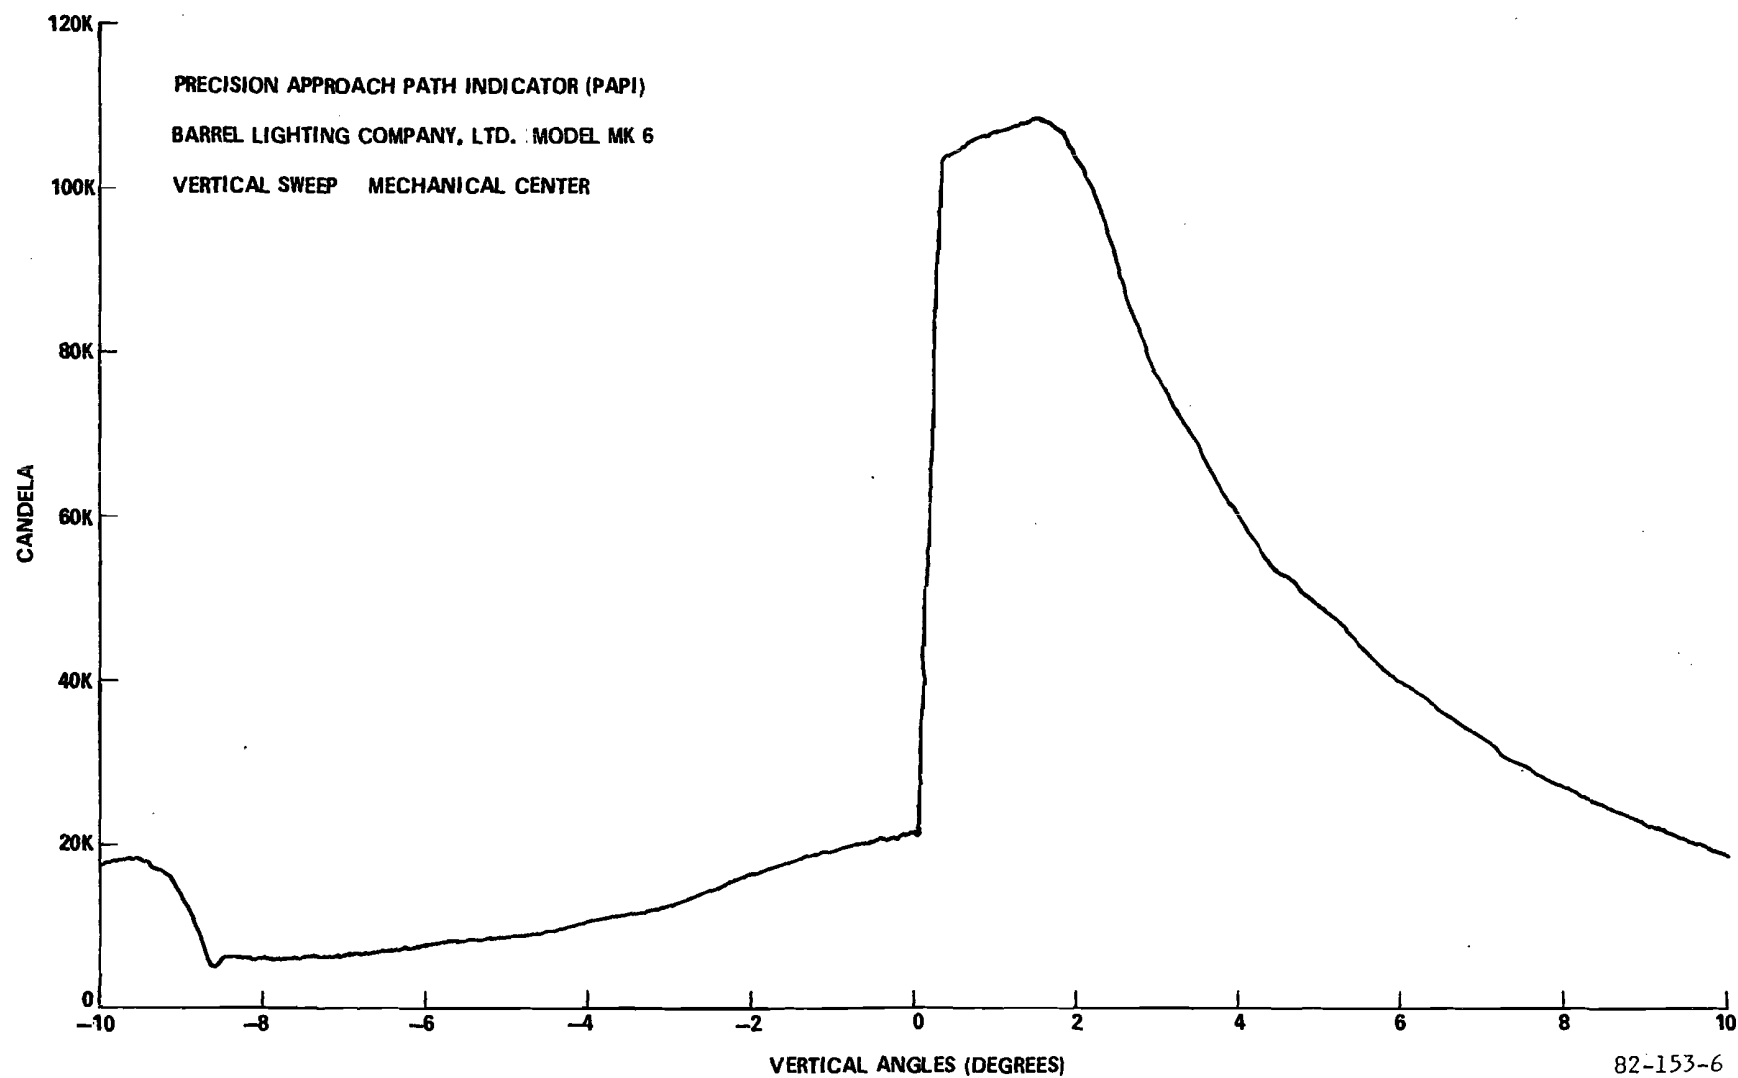
FIGURE 6. VERTICAL INTENSITY DISTRIBUTION CURVE

Photometric measurements were made on the Barrel Lighting Co. PAPI fixture. The lamps are standard 30 volt, 200 watt, 200PAR locomotive lamps. Horizontal and vertical intensity distribution measurements were obtained for the units. Figure 6 shows the vertical beam distribution of both the red and the white signals of one PAPI unit when measured from minus 10 degrees to a plus 10-degree elevation. It also displays the quick transition (approximately 3 minutes of arc) from one color to the other. Figures 7 and 8 show the horizontal intensity distribution of the white and red signals, respectively, taken at peak beam intensity. The peak intensity of the white signal, occurring at 1.5° elevation, was 112,000 candelas and the peak intensity of the red signal, occurring at 0° elevation, was 22,000 candelas. Transmittance tests were made on the red filters of the Barrel unit, and

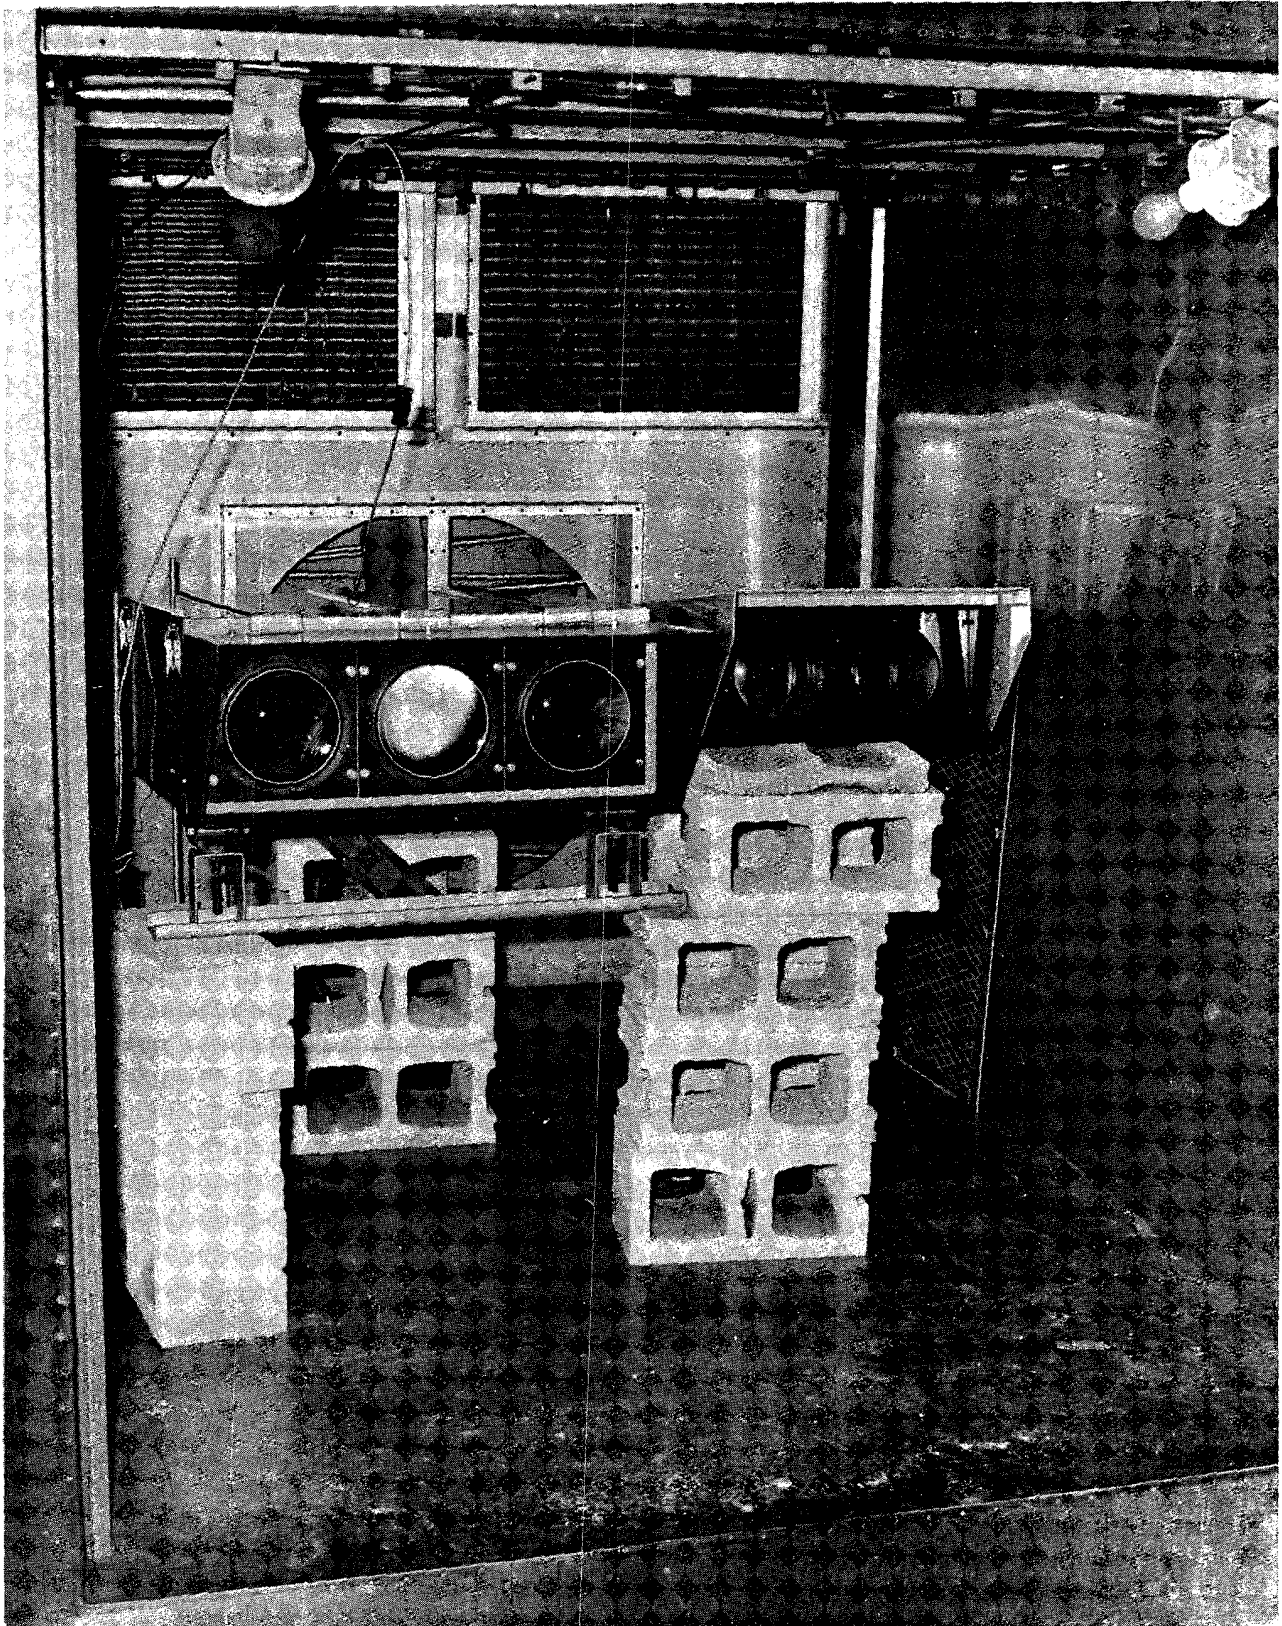
FIGURE 9. ENVIRONMENTAL TESTING OF PAPI UNITS

In order to test this atmospheric moisture condition on the PAPI units, man-made fog or condensation was created by soaking the units in a temperature chamber at low temperatures (30° F) and then immediately subjecting them to normal room temperatures that were at least 30° F higher and more humid. This created condensation on the units, similar to that observed when a bathroom mirror fogs up after a shower. The following four condensation tests were performed to determine the operational conditions under which condensation, with resultant signal deterioration, would or would not occur.

For the initial test, both the British Barrel Lighting Company Limited MK 6 and the Belgian ADB units were installed in the walk-in temperature/humidity chamber (figure 9) in such a manner that their signals could be seen through the glass viewing port. After the units were cold soaked at 30° F for 2 hours with the lamps deenergized, the chamber door was opened and warm humid air was allowed to enter the chamber. The exterior lens surfaces of both PAPI units were almost immediately covered with condensation, resulting in a uniform distortion of the projected signal that was perceived as a pink overall signal. The units were energized at 6.6 amperes intensity at this time. The ADB unit displayed a deeper pink hue since its red filters are normally a deeper red hue than those of the Barrel unit. The interiors of the boxes were then checked and virtually no internal condensation was found. Within 1/2 hour, the lenses of both units were clear of any condensation and normal signal presentations were evident.

One of each of the Barrel and the ADB PAPI units were placed in the temperature/humidity chamber (figure 9) in such a manner that their light signals were projected through the viewing port with the red/white transition zone clearly

displayed 24 feet from the units. Lines were marked on a wall at the precise location of the transition zone for each unit. Both units, with lamps deenergized, were then heat soaked for 24 hours at 131° F and 95 percent humidity. After the soaking, the units were energized and the position of the transition zone noted. The ADB unit transition zone had not shifted at all, although the zone was slightly less well defined. The Barrel unit transition zone had shifted upward 3/16 of an inch with the zone just as distinct as before the soaking. The lamps were left ON for 1/2 hour and then turned OFF for 1/2 hour. They were then turned back ON and it was found that the transition zones had not shifted. The units were then deenergized and left OFF for 24 hours at a normal room temperature and humidity. After this 24-hour period, the light transition zones were again checked and it was found that the Barrel unit transition zone had returned to its original position. The ADB unit transition zone displayed no evident shifting during the entire test procedure.

From the above test, it can be seen that the Barrel system, under high temperature and humidity conditions, may exhibit a transition zone shift of approximately 2 1/4 minutes of arc upward. This is equivalent to 7.81 inches upward at a distance of 1000 feet from the unit, or 6.51 feet upward at a range of 2 miles. This transition zone shifting, even with such extreme temperature and humidity changes, is not of sufficient magnitude to be considered an operational problem.

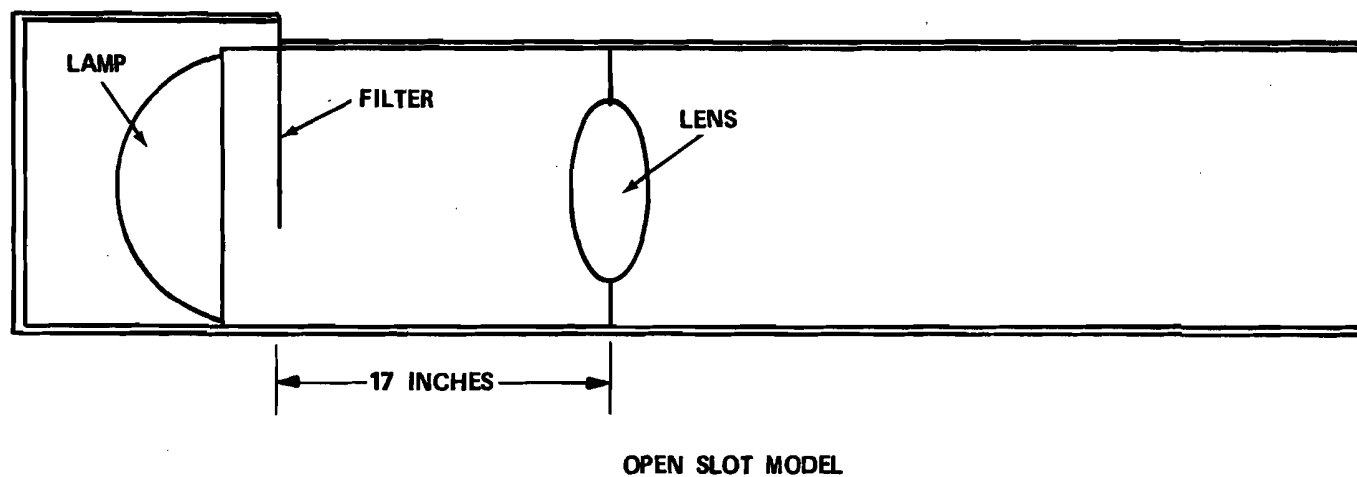
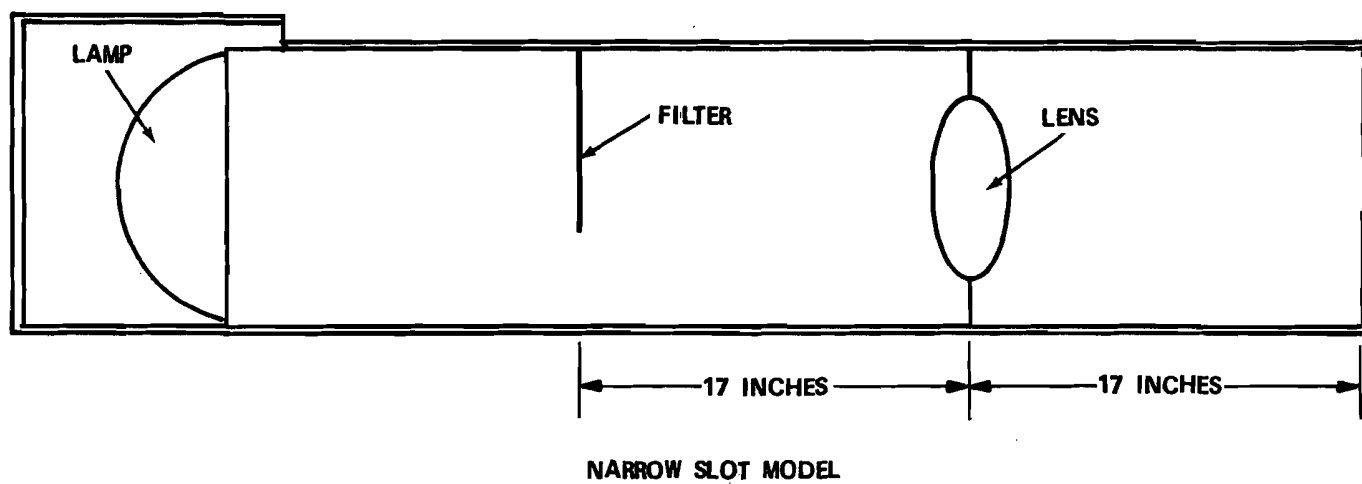
FIGURE 10. VASI/PAPI MODIFICATIONS

The "open slot" model mounting arrangement of the optical components included unfluted red filters in their normal mounting positions, with the 6-inch lenses mounted at the focal length, 17 inches forward of the red filters. The normal 2-inch slotted front face of the VASI box was completely removed, leaving the front of the box open.

The "narrow slot" model design required that the 6-inch lenses be moved forward so that the focal length plane was coincident with the normal 2-inch slot on the front of the box to insure maximum signal emission through the 2-inch slot. The lens,

4. It was found that Sylvania and General Electric VASI boxes can be modified to project the sharp transition PAPI signal through retrofitting of projector lenses in the units. Modification of the VASI box transition bar dimension alone does not provide the required sharp transition signal.

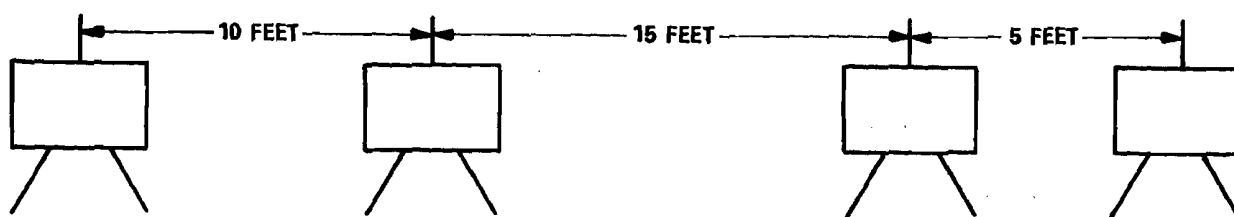
Additional flight testing was conducted to determine whether PAPI signals could be readily seen and resolved with individual PAPI units installed closer together than specified by the British (minimum spacing of 33 feet). Four Barrel PAPI units were installed at the Technical Center in the configuration shown below.

The spacing of the experimental arrangement was so constituted that individual pairs of units could be energized, in turn, to provide lateral spacings of 5, 10, 15, 20, 25, and 30 feet as desired. Approaches were flown, from extreme range, with an Aero Commander 680 aircraft, a Bell 206L helicopter, and a Sikorski S-76 helicopter to determine the maximum distances (range) at which signals from two PAPI light units could be resolved and identified as two distinct light sources. Known landmarks on the ground and distance measurement equipment (DME) in the aircraft were used to observe and record maximum resolution ranges for pairs of PAPI units with lateral spacings as indicated above. A conservative approach was taken in this test and resolution ranges were not established until the lights were judged to be sufficiently distinct so as to insure that an unfamiliar pilot could clearly determine that individual lights from the PAPI system could be seen separately. The flight tests were conducted in VFR weather conditions, in daylight and at night, with at least 4 1/2 nautical miles of visibility.

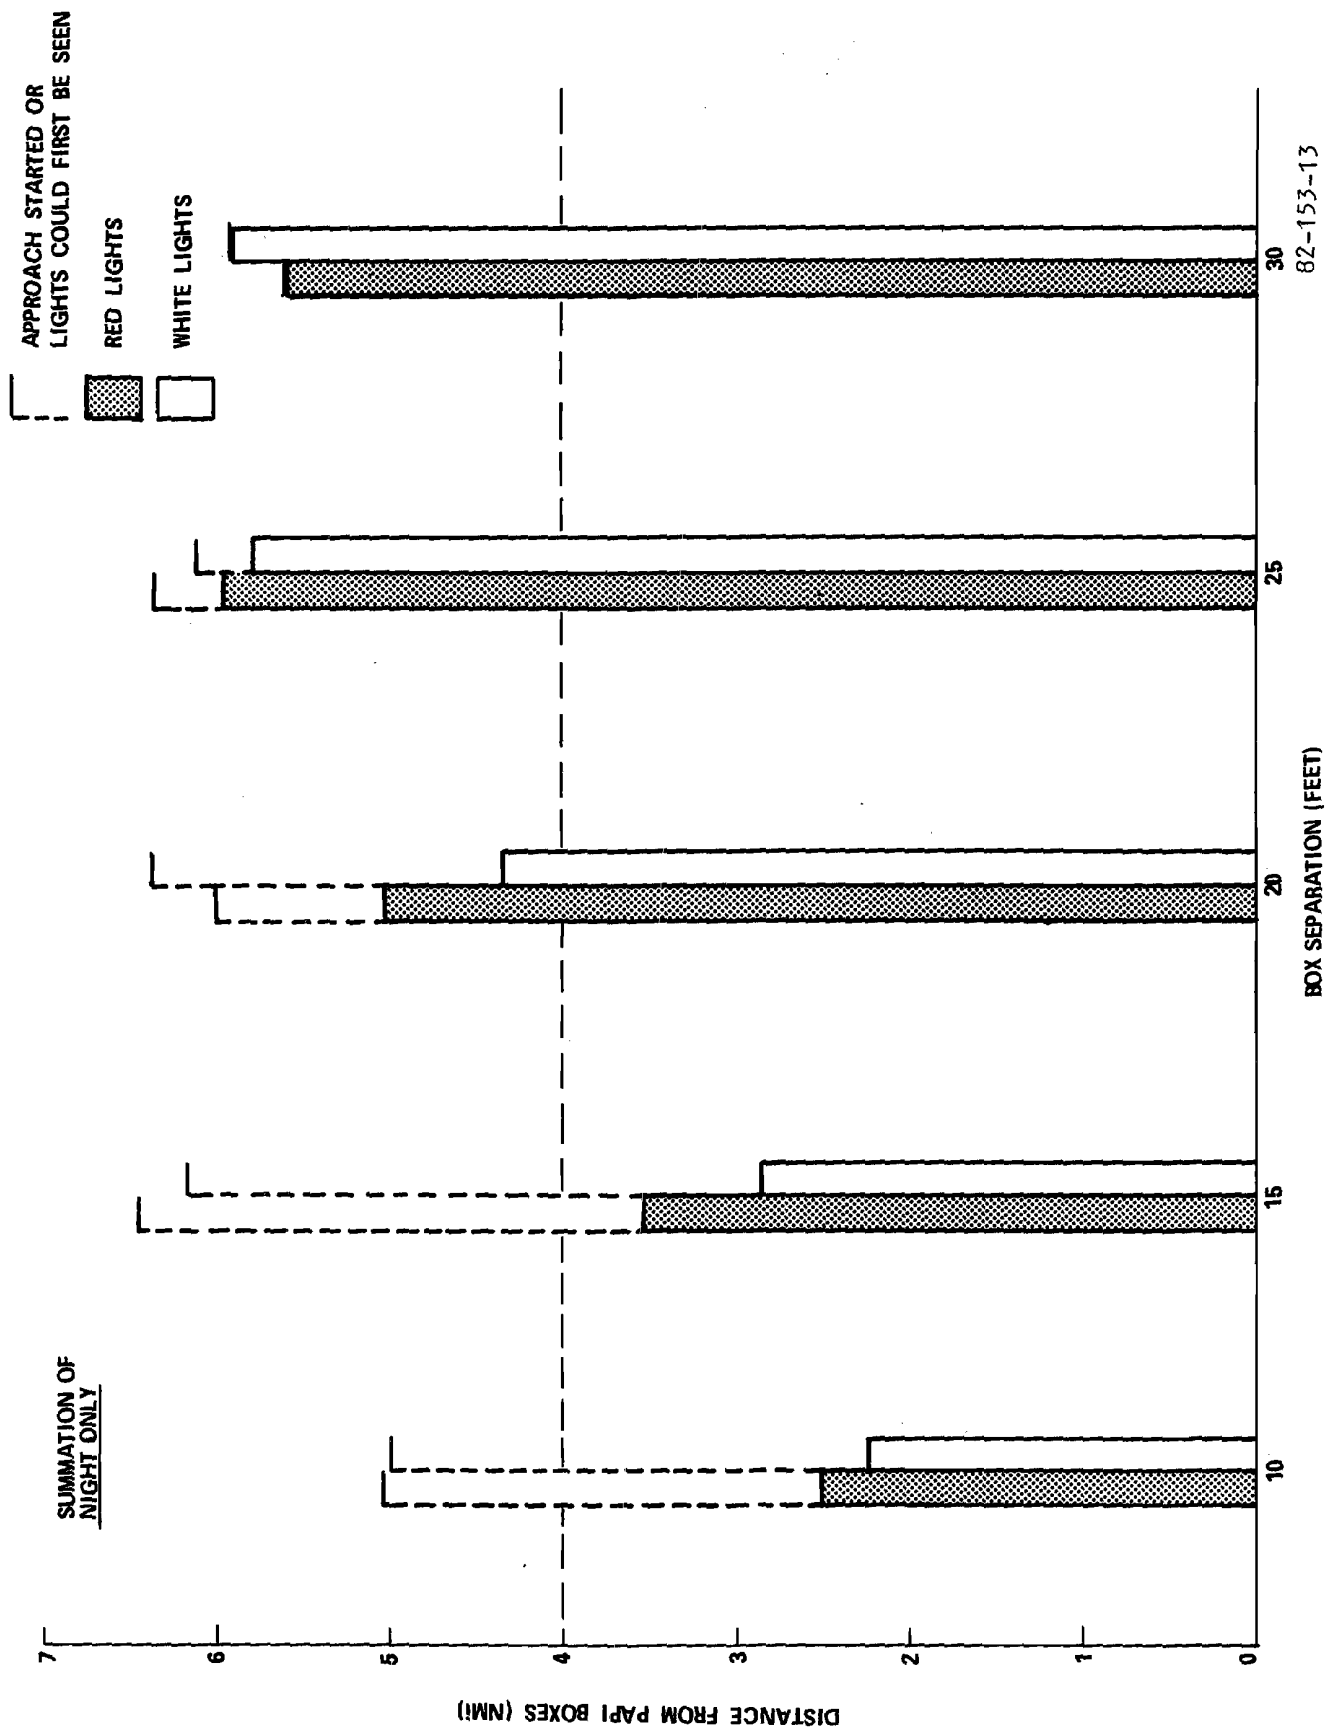
FIGURE 13. GRAPH OF NIGHTTIME RESOLUTION TESTS

NIGHTTIME TEST RESULTS. (Figure 13). Power supply current, at night, was set at 3.8 amperes, midway between the current values for intensity steps 2 and 3 on the standard five-step regulator. It had been determined, during the previous night flight testing of the PAPI system, that this intensity was preferred by the majority of pilots who flew the PAPI at the Technical Center. In each test session, it was determined that the pilots, at night, were able to resolve individual PAPI red and white light signals with spacing as close as 20 feet at ranges of 4 nautical miles. FAA Advisory Circular AC 150/5340-25, "Visual Approach Slope Indicator (VASI) Systems," specifies 4 nautical miles as the minimum useable range for a standard four-box VASI. Lateral spacing of less than 20 feet resulted in determined resolution ranges of less than the required 4 nautical miles and were judged to be inadequate.

It follows from the above determinations, with regard to both night and day conditions, that lateral spacing of PAPI units installed at smaller General Aviation airports could be reduced to as little as 10 feet and still provide adequate guidance within ranges of 2 to 3 miles from the runway threshold.

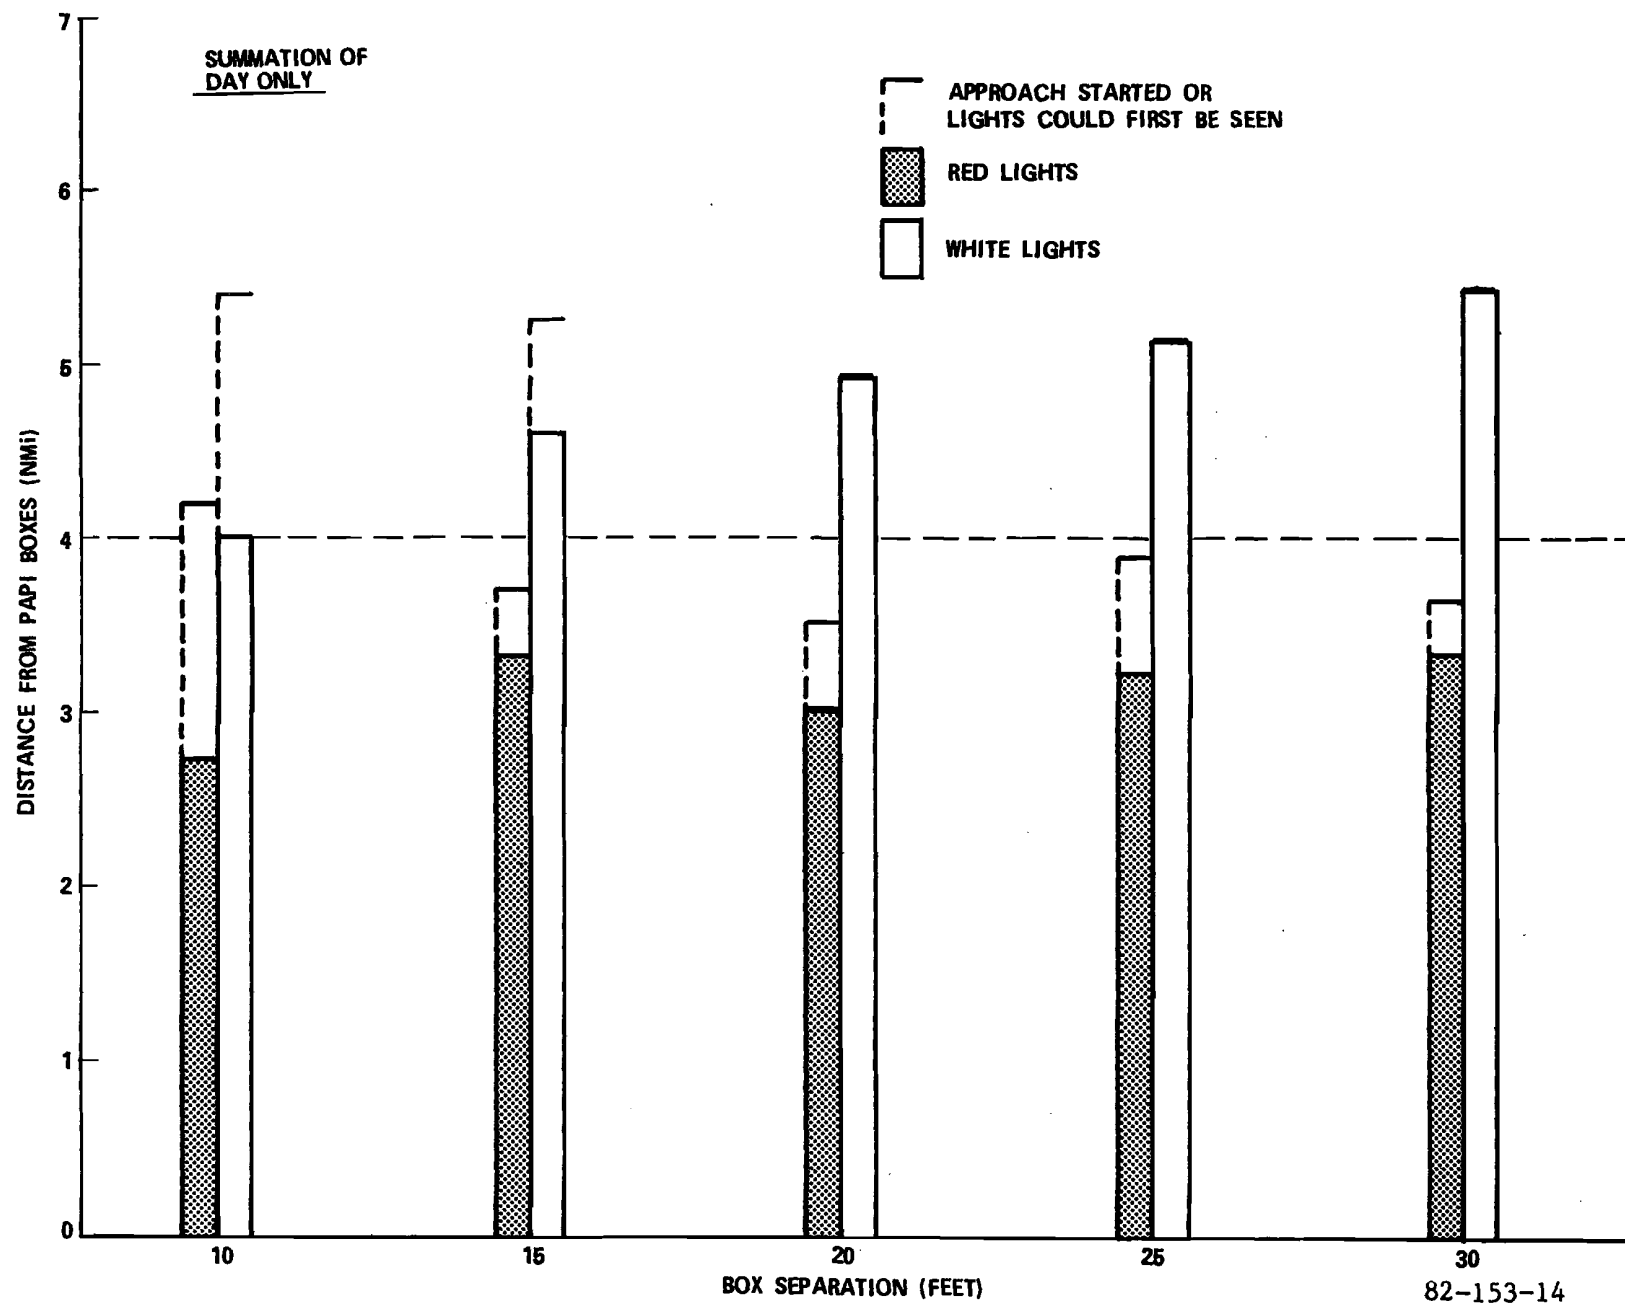
FIGURE 14. GRAPH OF DAYTIME RESOLUTION TESTS

DAYTIME TEST RESULTS. (Figure 14). Power supply current, during daytime, was set at 6.6 amperes which is the current value for intensity step 5 on the standard five-step regulator. Pilots were barely able to resolve the PAPI red light signal at 4-nautical mile range with the greatest lateral spacing of 30 feet. In fact, resolution ranges for the red signals were relatively constant at slightly greater than 3 nautical miles, regardless of lateral spacings less than 30 feet. This should not be construed to mean that a full four-box PAPI system could not be used at a 4-nautical mile range, in daylight, since a pilot familiar with the system could easily determine his long range relationship to glide path by counting the discernible white lights of the system.

The average resolution range of the PAPI white lights, during daytime, exceeded 4 nautical miles even when the lateral spacing of PAPI units was as close as 10 feet.

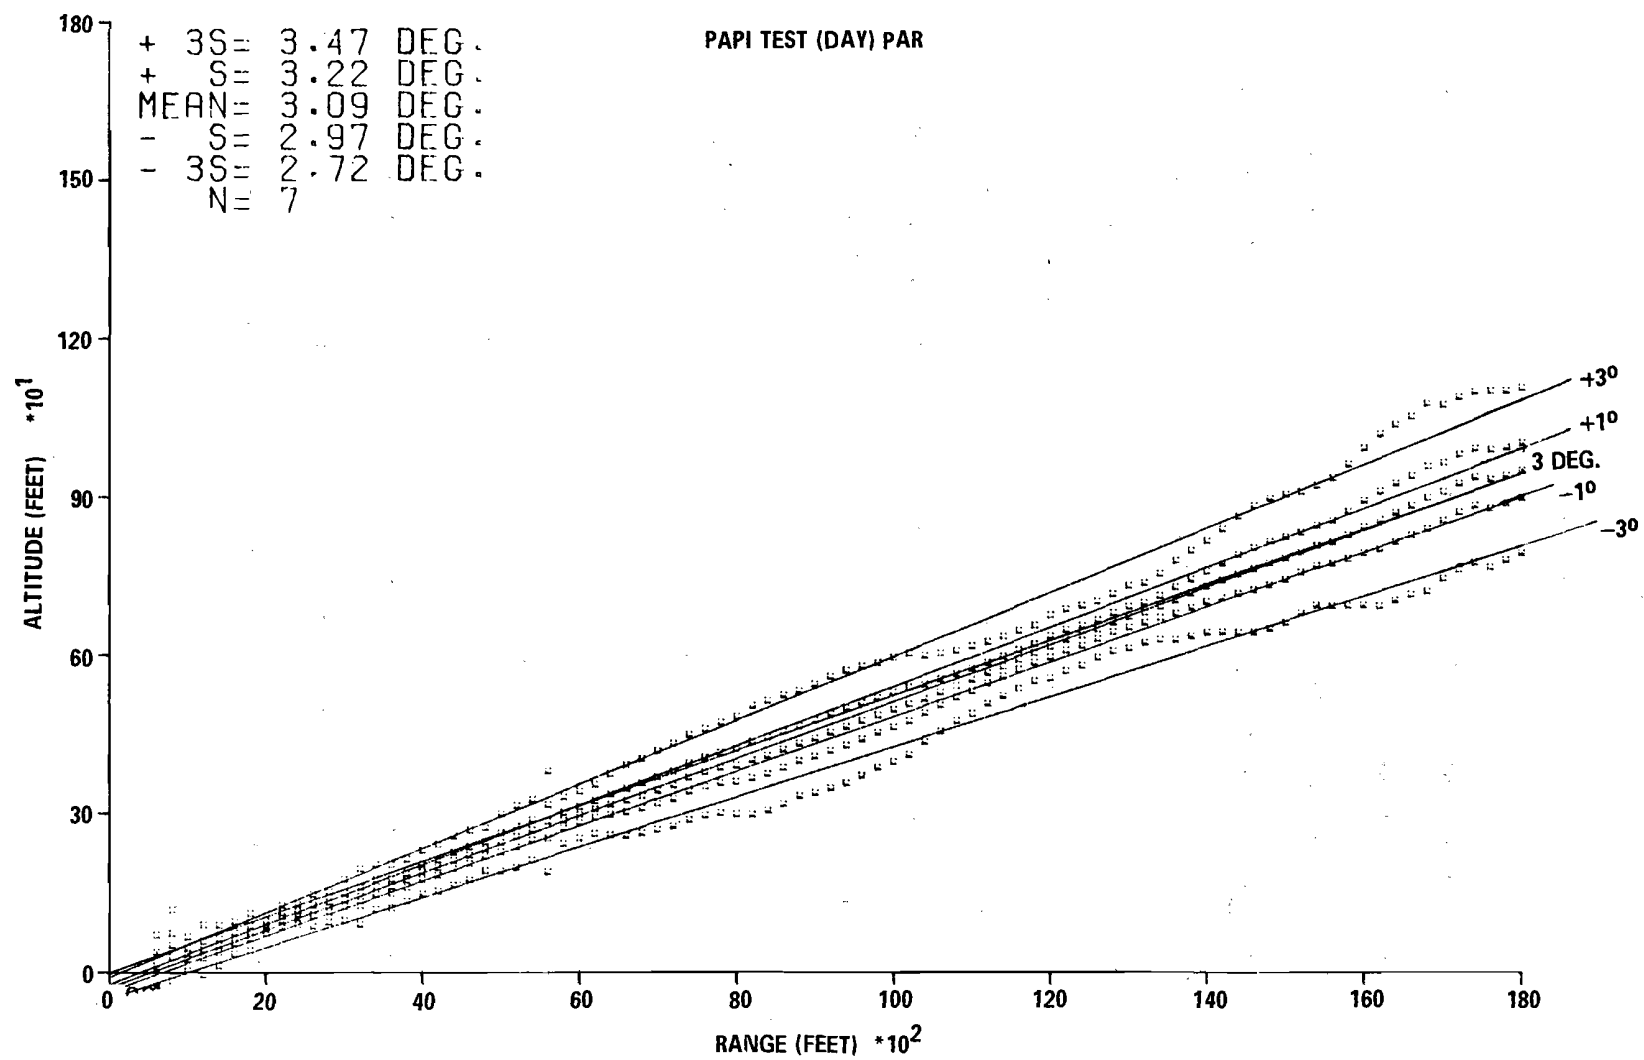
FIGURE D-5. PAPI STATISTICAL DAY PLOT

Attached as Appendix I is a compilation and summary of the data results of the questionnaires obtained from the test pilots during these tests. Also included are composite graphs, separated into daytime runs (figure 3) and nighttime runs (figure 4), showing the accuracy of the system as obtained by Radar tracking and reduced by our computer system. A statistical plot in figure 5

provides a graph that is broken down into 200 foot segments of range. Each range segment, when drawn together, provides a linear regression line. Lines representing the  $\pm 3 \sigma$  deviation indicate that 99.74 percent of all aircraft flying the PAPI would remain within this corridor. The data obtained is offered without comment for this data report. Further testing of this type is planned and will be included in the final report of PAPI.

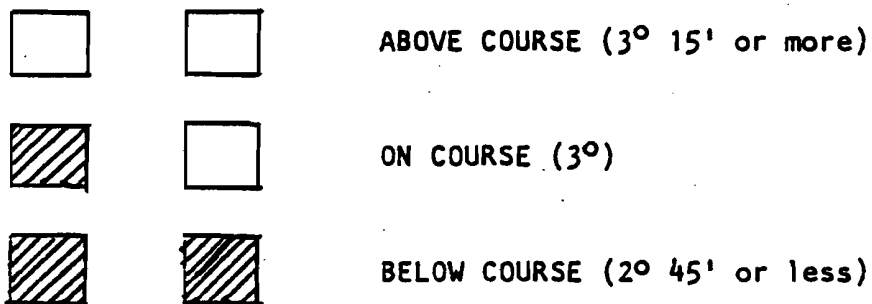
The tests now being conducted will provide data to determine whether a "Two Box" PAPI system can be successfully used on small airports with runways of 5,000 feet or less. The intended purpose of the "Two Box" PAPI is for use where it may not be necessary to have the five incremental paths provided by the full blown PAPI system. The arrangement of the units is similar to the full blown PAPI system except that only two boxes are used. The  $3^{\circ}$  glide-slope is midway between the angular setting of the pair of light units. The on-course signal is one red and one white light, the above course (greater than  $3^{\circ} 15'$ ) is two white lights, and the below course (less than  $2^{\circ} 45'$ ) is two red lights. These are depicted in the diagram below.

For this test, the units are located 1,000 feet down runway 4 on the right-hand side. Once you have accomplished a sufficient number of approaches to this system, please fill out the postflight questionnaire provided.
