DOT/FAA/CT-83/5  
DOT/FAA/RD-82/91

# **Identification of Exit Taxiways (Retroreflective Markers Only)**

Larry W. Hackler

Final Report

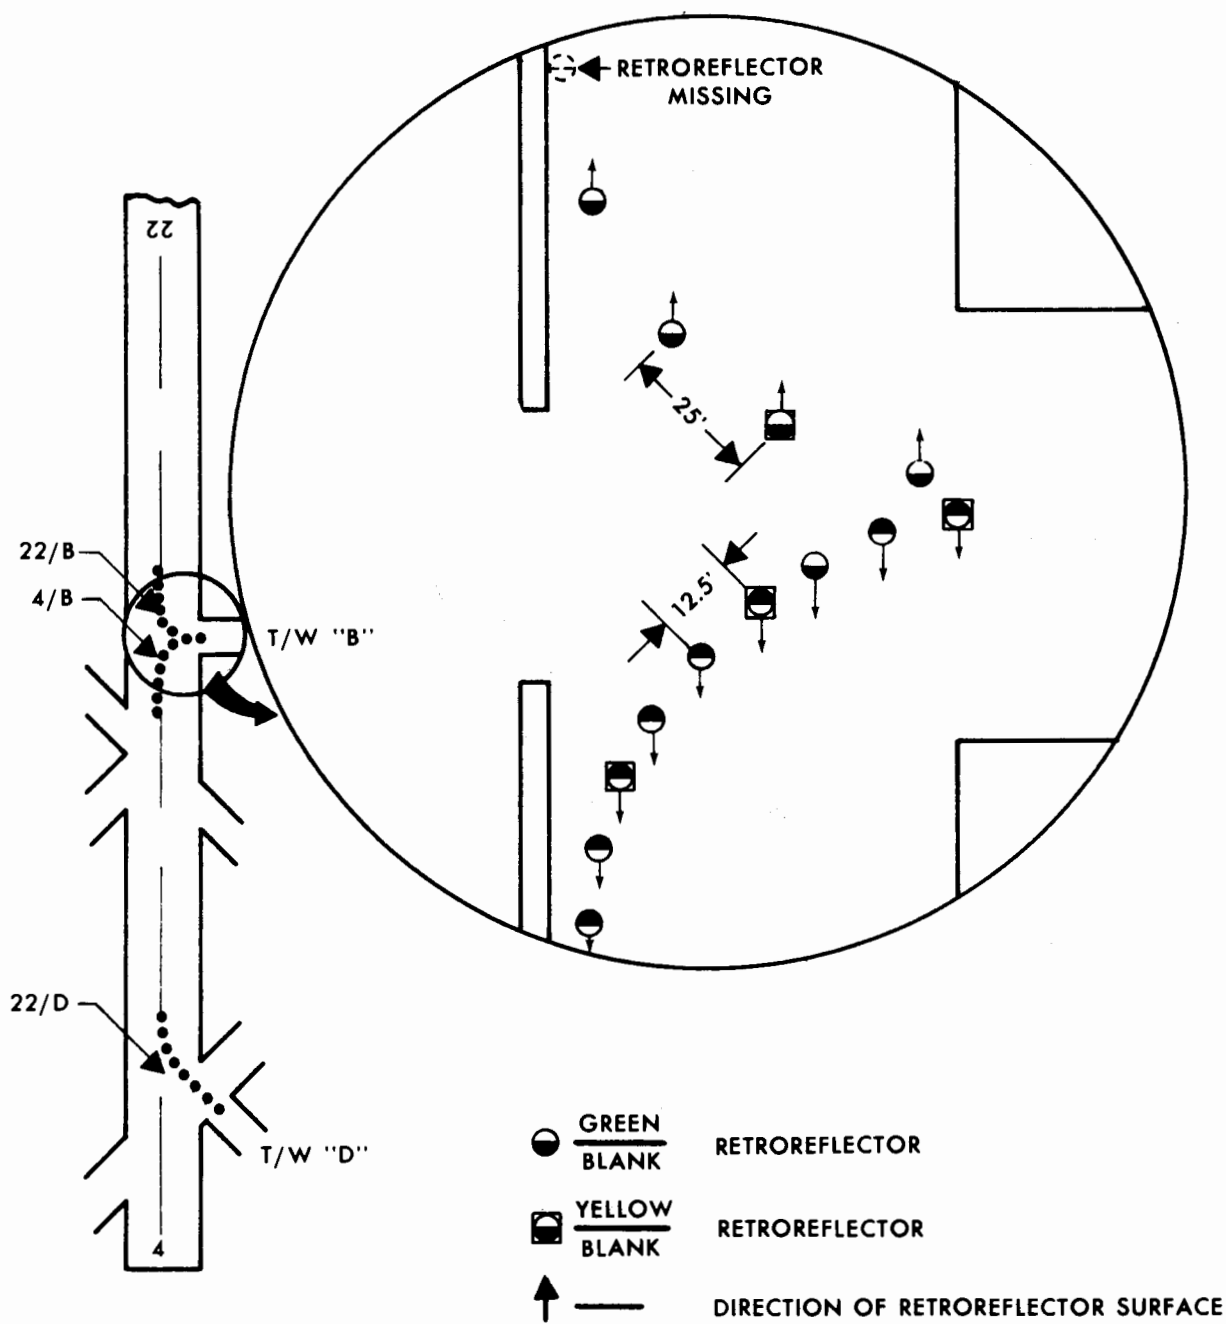
FIGURE 1. RETROREFLECTOR CONFIGURATION AT ATLANTIC CITY AIRPORT  
(ACY) ATLANTIC CITY, NEW JERSEY

Retroreflective markers were installed on runway 4/22 at the FAA Technical Center's Atlantic City Airport (ACY). Runway 22 exits identified were Delta and Bravo (22/D and 22/B). Runway 4 had only Bravo exit identified (4/B). For taxiway 4/B 12.5 foot (4 meter) spacing of the retroreflectors was applied along the arc while 25 foot (8 meter) spacing was used for the other exits (figure 1).

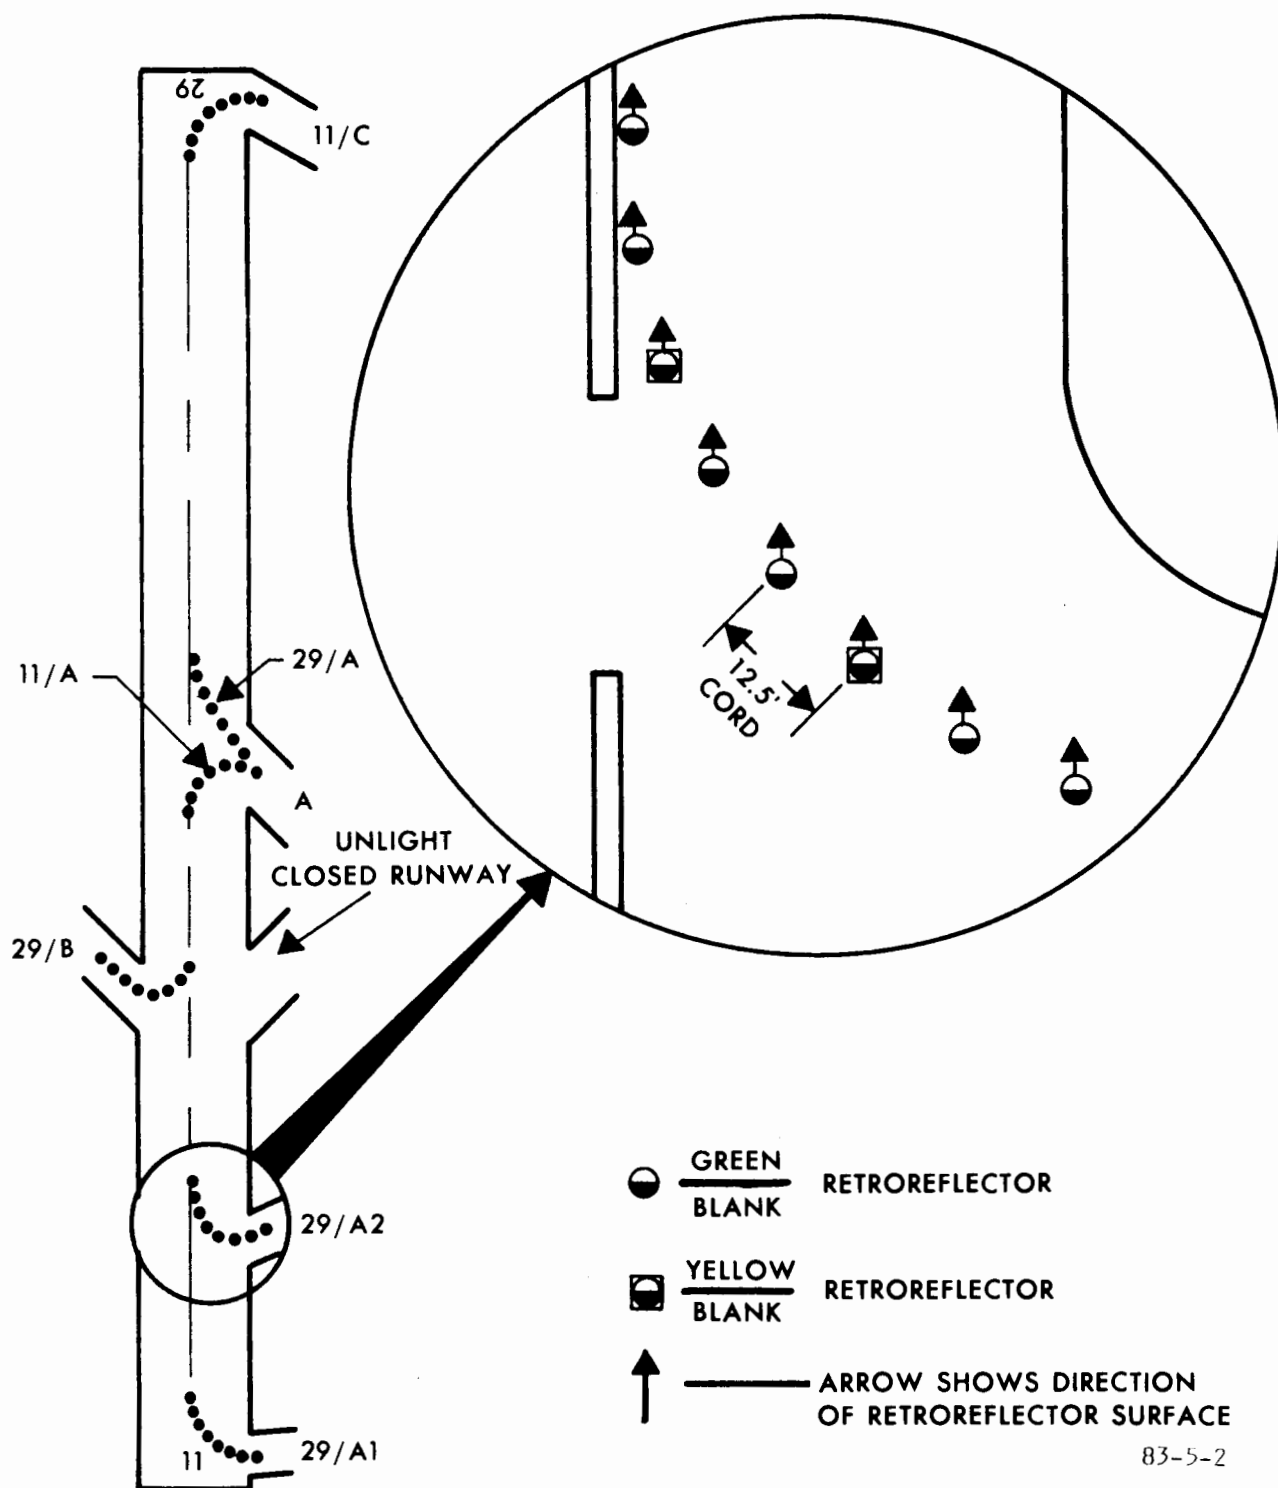
FIGURE 2. RETROREFLECTOR CONFIGURATION AT ATLANTIC CITY/MUNICIPAL/  
BADER FIELD (AIY), ATLANTIC CITY, NEW JERSEY

The retroreflective markers were installed with 12.5 foot (4 meter) spacing on runway 11/29 at Bader Field in Atlantic City, N.J. Six exit taxiways were marked with the retroreflectors. Two were marked on runway 11 (11/A and 11/C) and four were marked on runway 29 (29/A, 29/B, 29/A2, and 29/A1) (figure 2). Interviews and questionnaires were used to collect data from the Bader Field test.

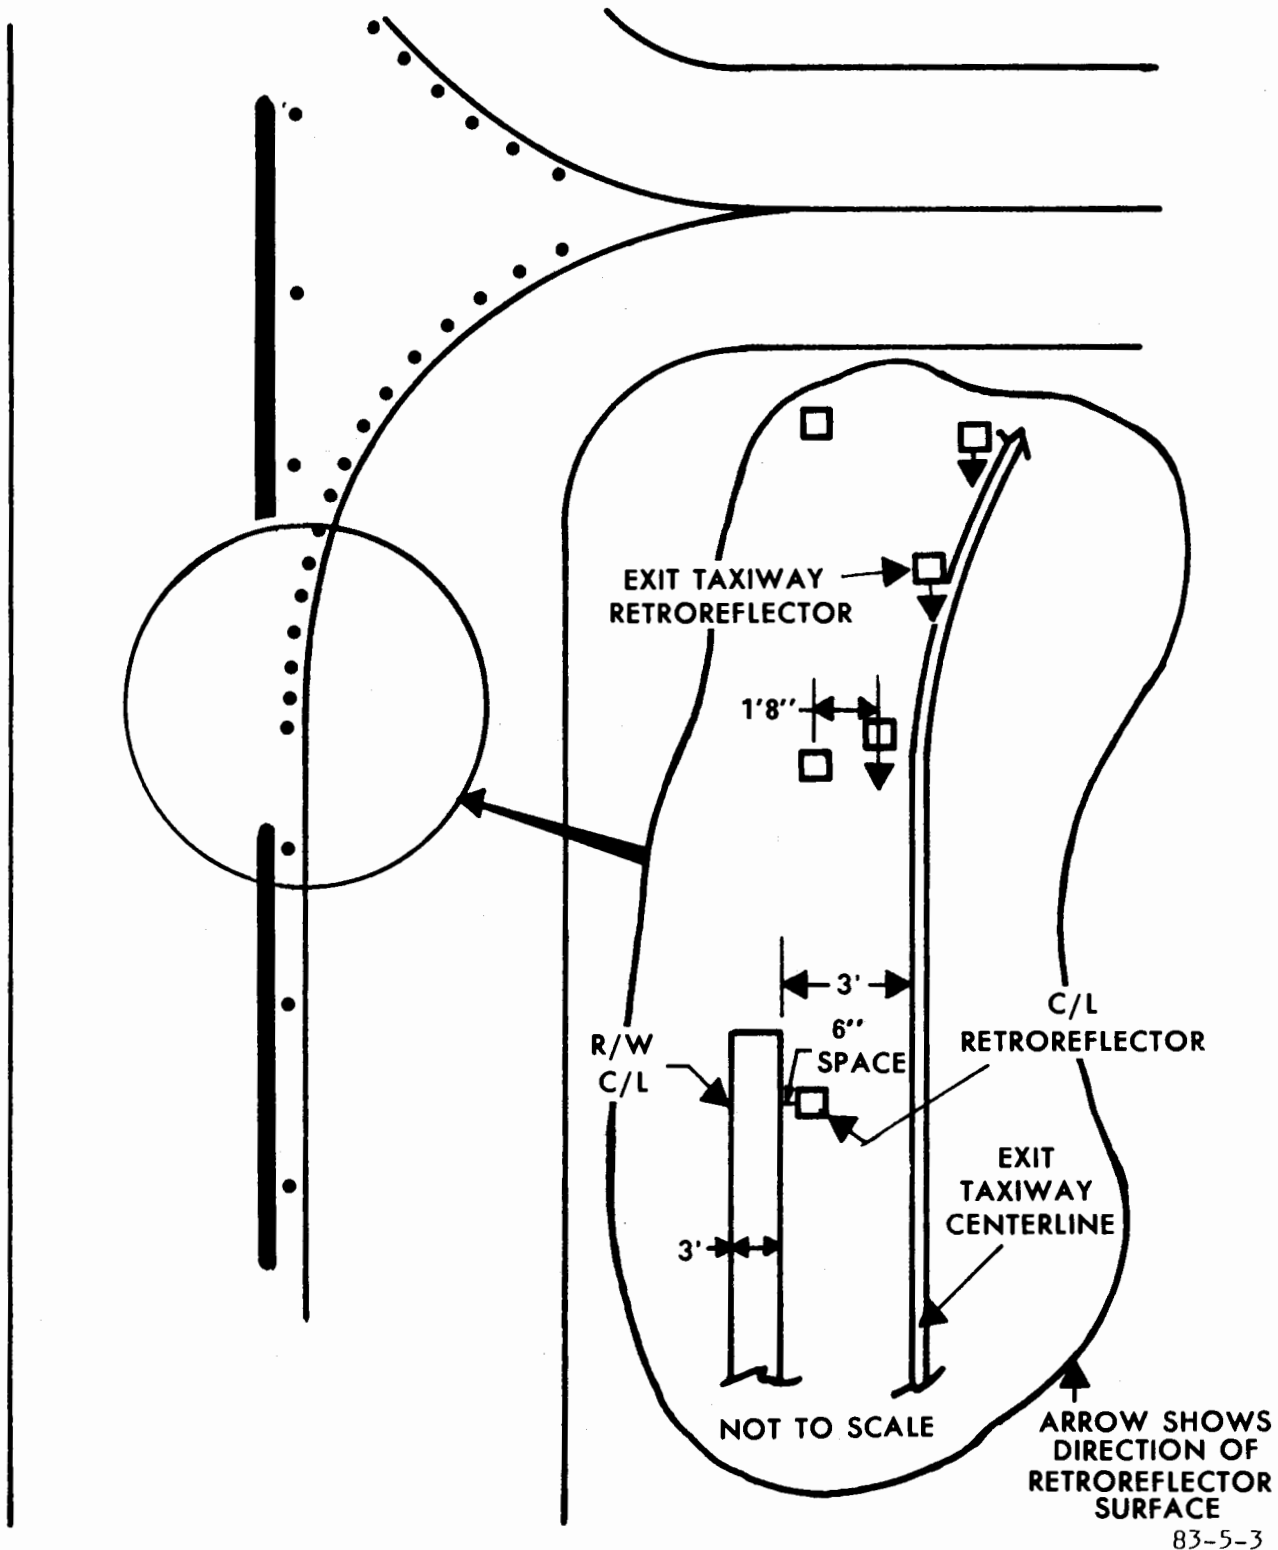
FIGURE 3. LAYOUT OF EXIT TAXIWAY RETROREFLECTORS WITH CENTERLINE RETROREFLECTORS ON SAME SIDE AS EXIT TAXIWAY

The unidirectional retroreflectors should be placed so that they have a cord of 12.5 feet (4 meters) (table 1). The first retroreflector should be located on the arc where it is tangent to the runway centerline. The first exit taxiway retroreflector should be located as close as possible to the centerline of the runway. If runway centerline retroreflectors are used, then the runway centerline retroreflectors should be placed on the side having the most frequently used exits. See figures 3 and 4.

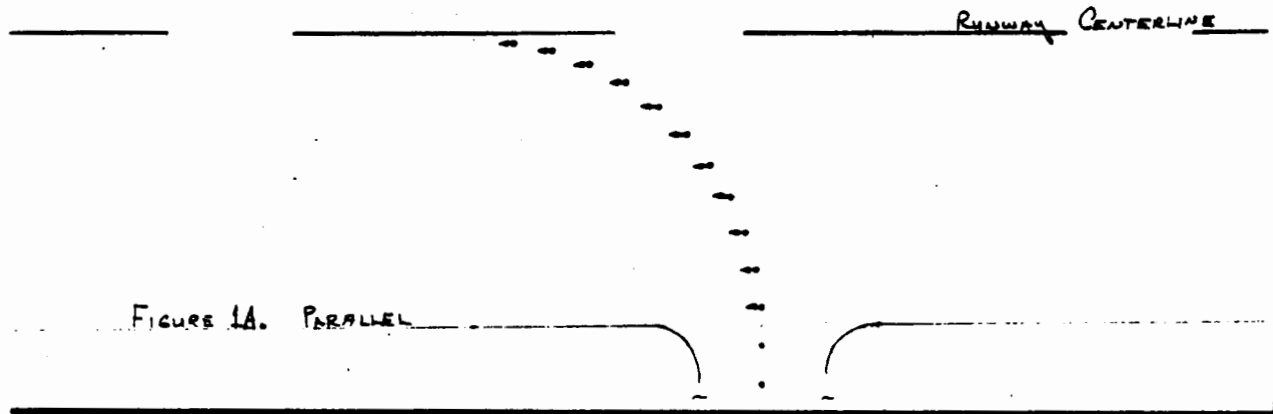
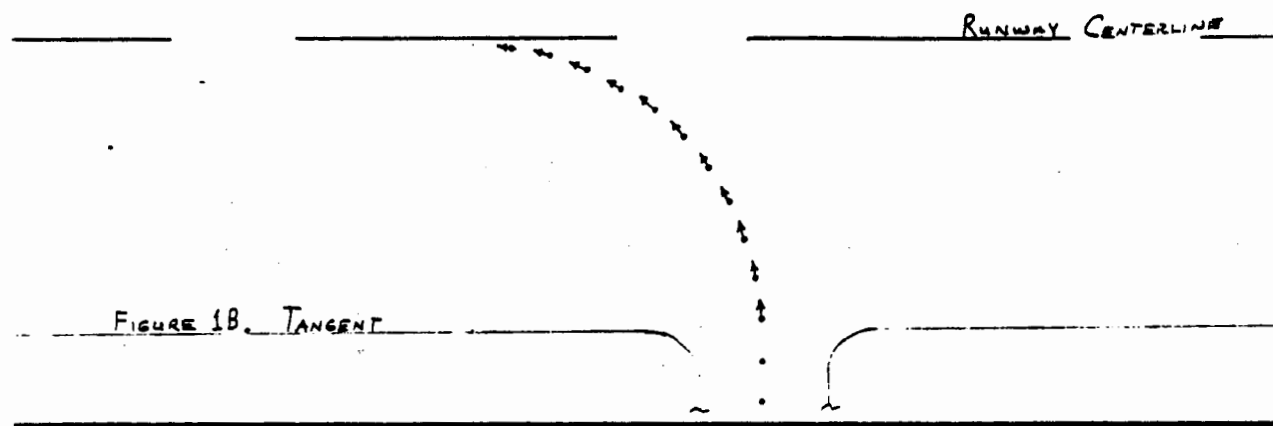
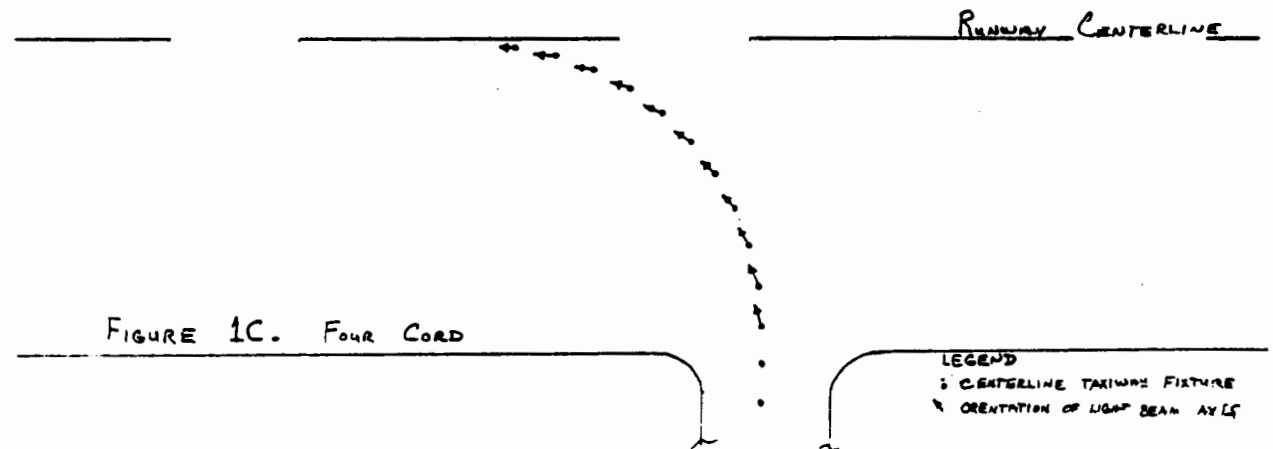
FIGURE 1. EXIT TAXIWAY LIGHT AIMING

1. Parallel to the runway centerline (Figure 1A).
2. Tangent to the exit taxiway centerline curve (Figure 1B).
3. Toed-in to intersect the exit taxiway centerline at a point equal to four times the spacing of the lights (cord) (Figure 1C).
4. Miscellaneous aimings determined by trial and error.

All aiming methods proved to have objectionable characteristics when used with the L-852N fixtures. The tangent and toed-in aiming methods were found to be acceptable when used with the L-852W fixture.

5. The aiming of the L-852W lights four cord ahead for unidirectional lights and tangent to the exit taxiway centerline for bidirectional lights was acceptable.
