# **Evaluation of Steel Bridge Girders Damaged by Over-height Vehicle Strikes Using Terrestrial Laser Scanning and Machine Learning**

**ICT Project R27-225**

**July 2026**

ICT Series Report No. 26-011

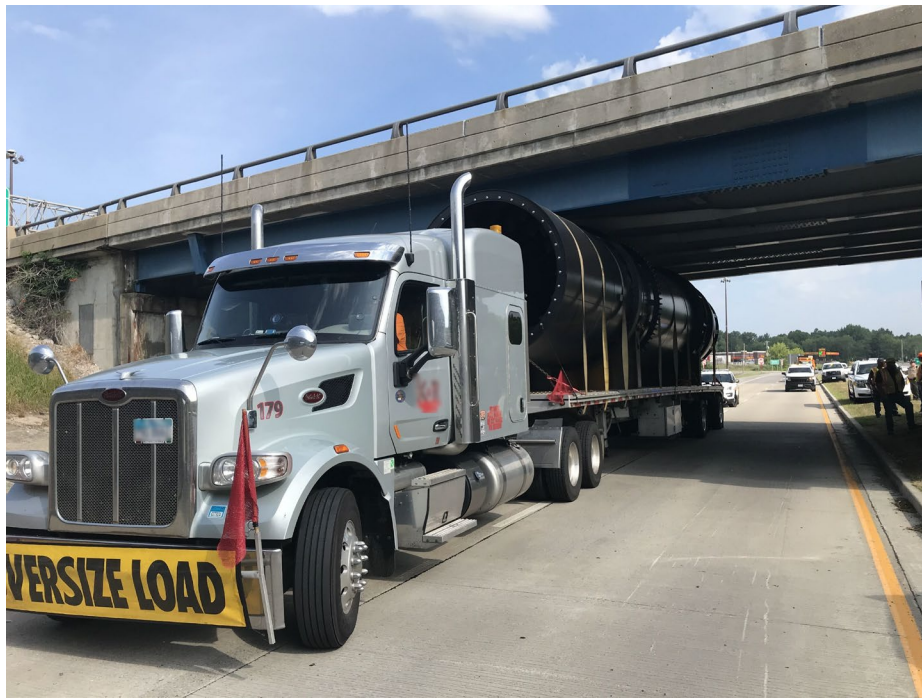
**Figure 1. Photo. Over-height vehicle lodged beneath a bridge following an impact incident.**

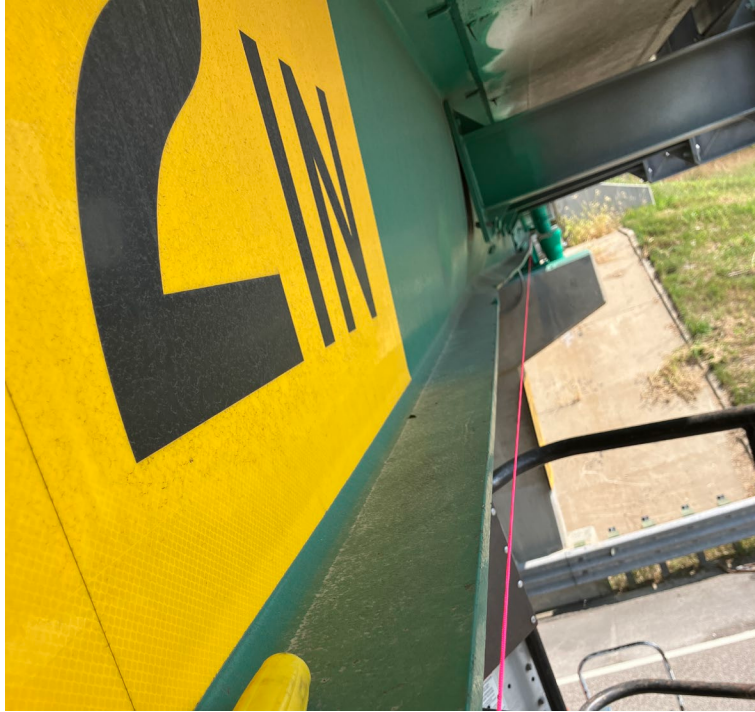
**Figure 4. Photo. Stringline placement for hand measurements of flange deflections on IDOT bridge SN 084-0077 Girder 19. (The stringline is colored pink.)**

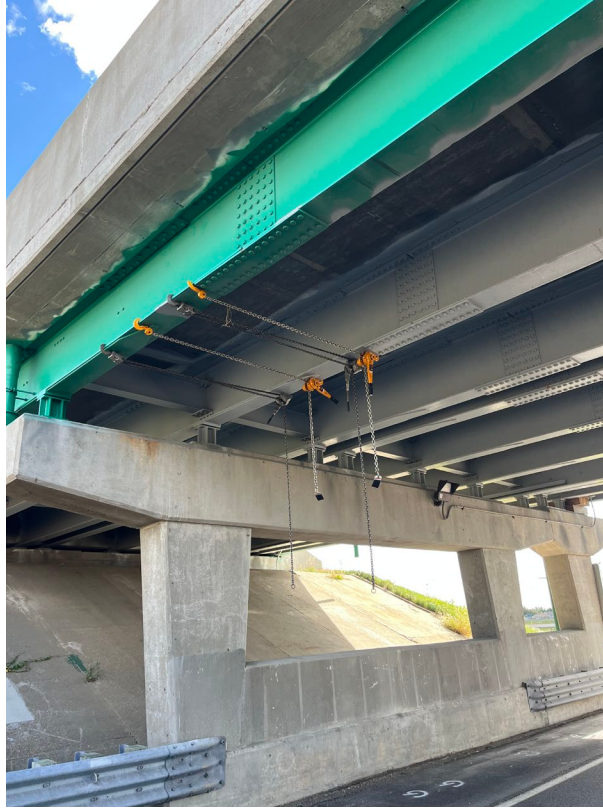
**Figure 6. Photo. Straightening IDOT bridge SN 084-0077 Girder 10 (fascia girder) using chains attached to Girder 11 (first interior girder).**

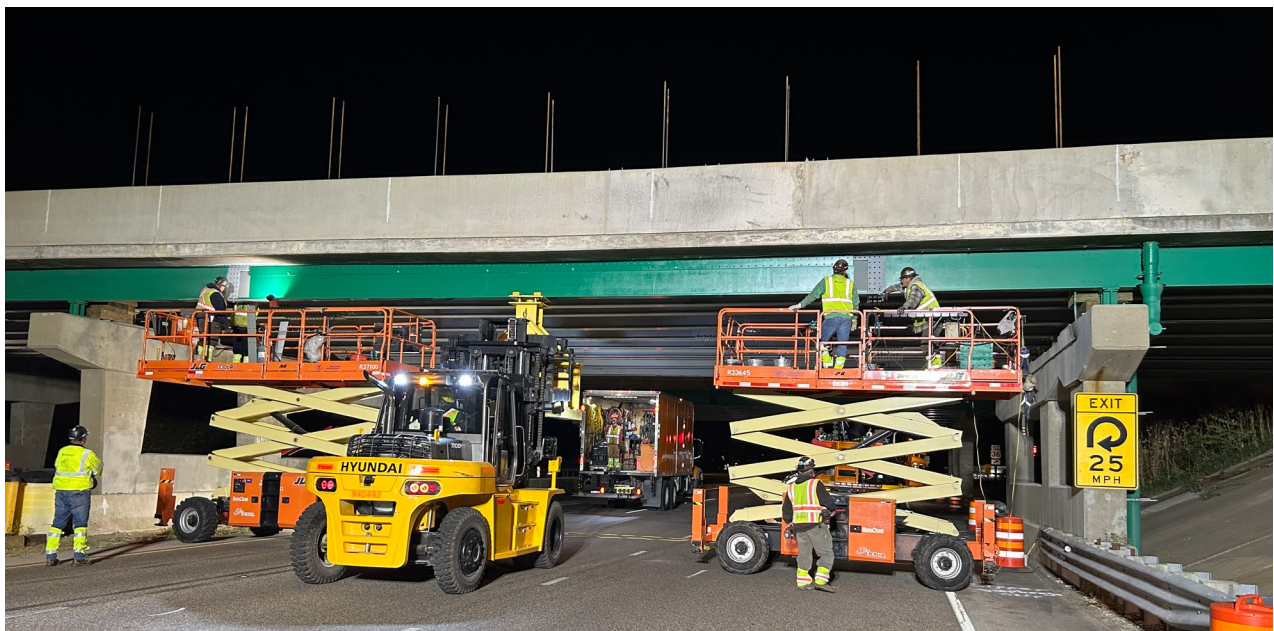
**Figure 7. Photo. Installation of a “zipper detail” repair for IDOT bridge SN 084-0077 Girder 19 (fascia girder). The replacement section has been lifted into place, but bolts have not yet been installed.**

The full section of a non-composite girder can be replaced without removing the existing concrete deck, whereas a full-section composite girder replacement requires also replacing a portion of the deck over the girder (and possibly the concrete parapet, if repairing a fascia girder). To facilitate repair installation for composite I-girders, IDOT commonly uses a “zipper detail” method in which only the bottom flange and lower portion of the web are replaced in the damaged area. The new portion of the girder is attached via bolted connections. Typical details and additional considerations are discussed in the *Structural Services Manual*. A photograph of an in-progress “zipper detail” repair is included in Figure 7.

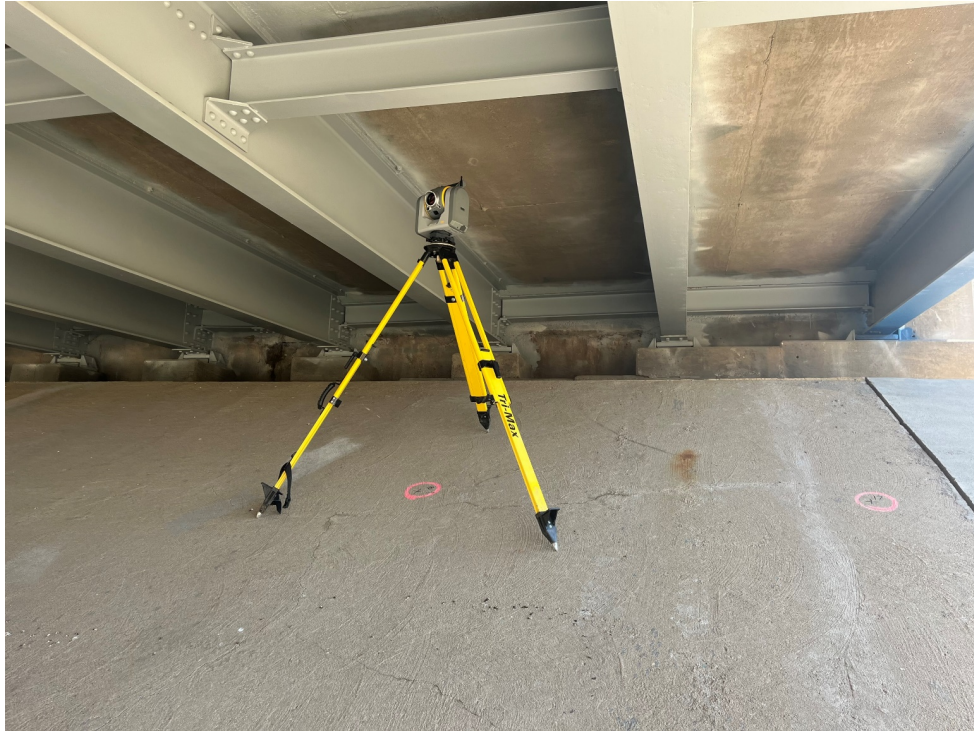
A. Scanner positioned on the slope wall. Control points are marked with pink paint.

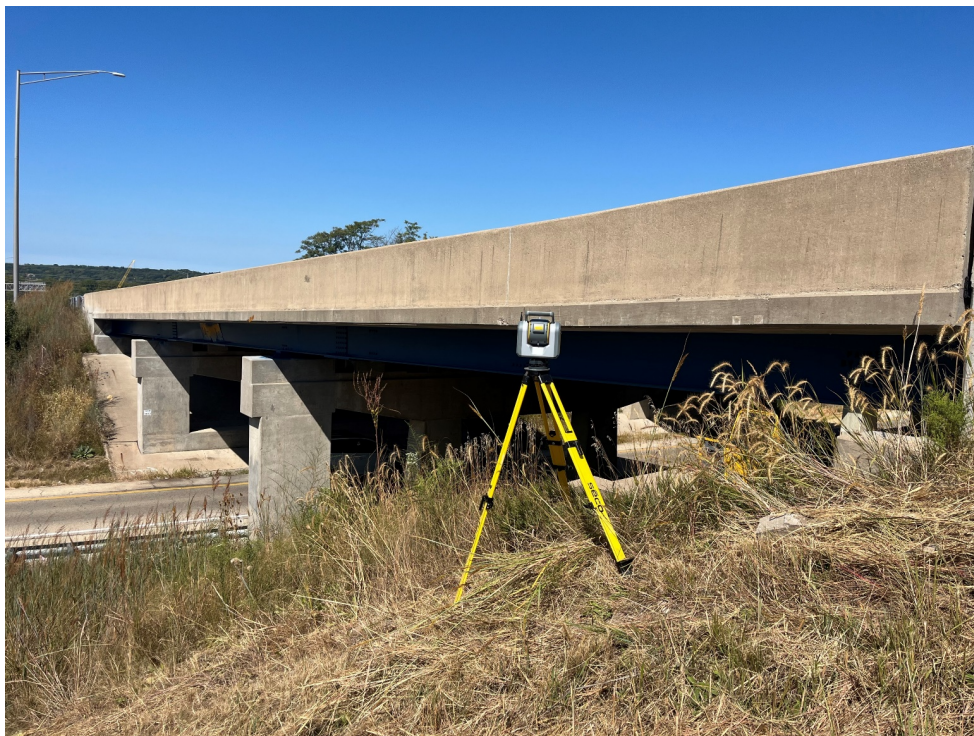
B. Scanner positioned on the approach embankment next to a bridge.

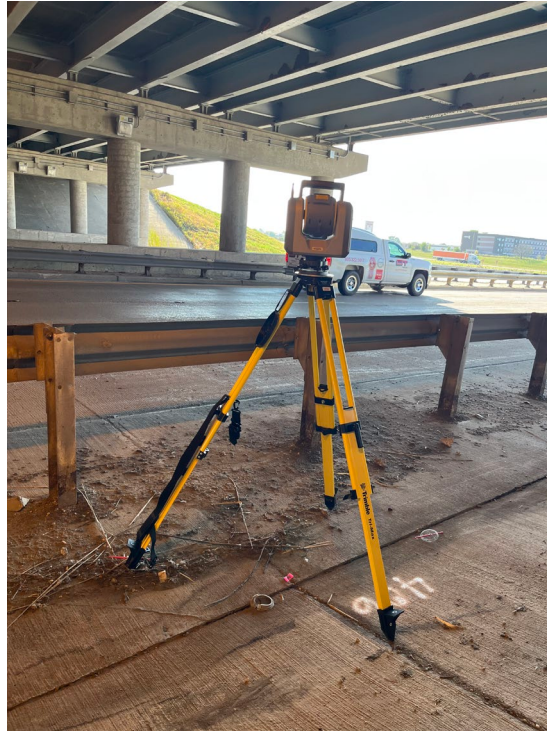
C. Scanner positioned on the shoulder underneath a bridge.

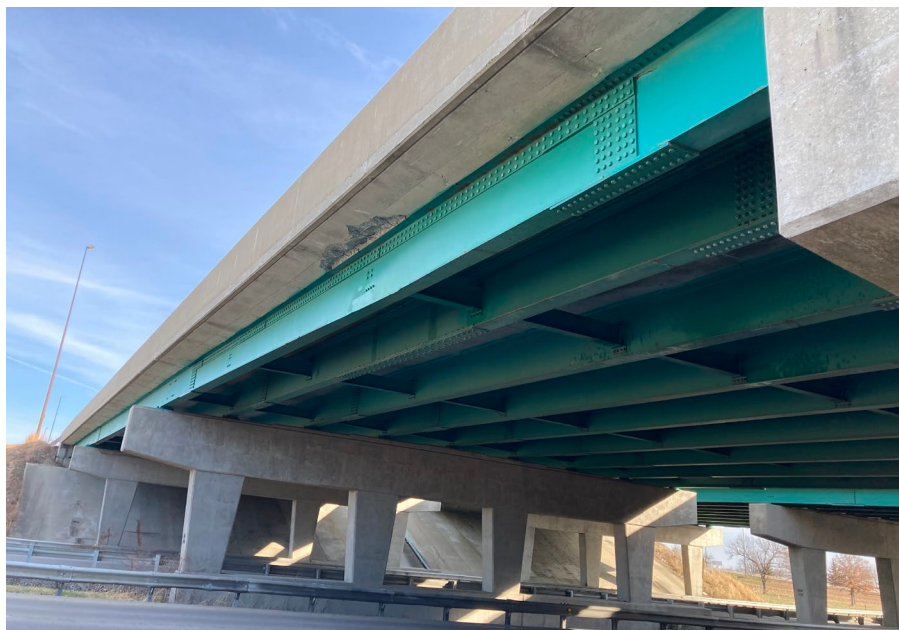
Figure 61. Photo. Overall view of damage to IDOT Bridge SN 084-0014. Girder 18, the front fascia girder, was damaged in the strike (the impact occurred from left to right).

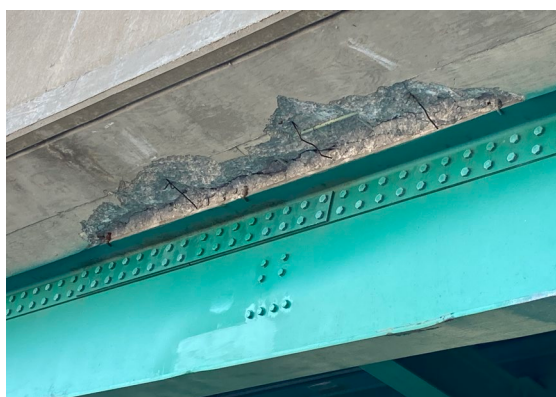
Figure 62. Photo. Close-up view of damage to the concrete deck above the impact point on the fascia girder of IDOT Bridge SN 084-0014 Girder 18.

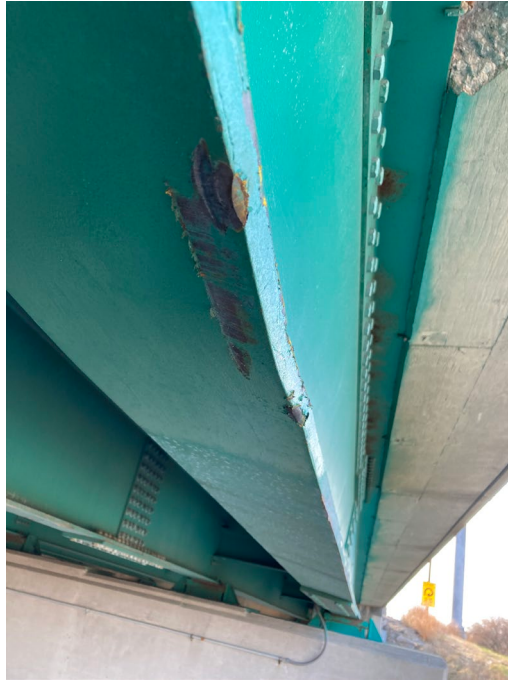
**Figure 63. Photo. Close-up view of the impact point on IDOT Bridge SN 084-0014 Girder 18. Small nicks and scratches are visible.**

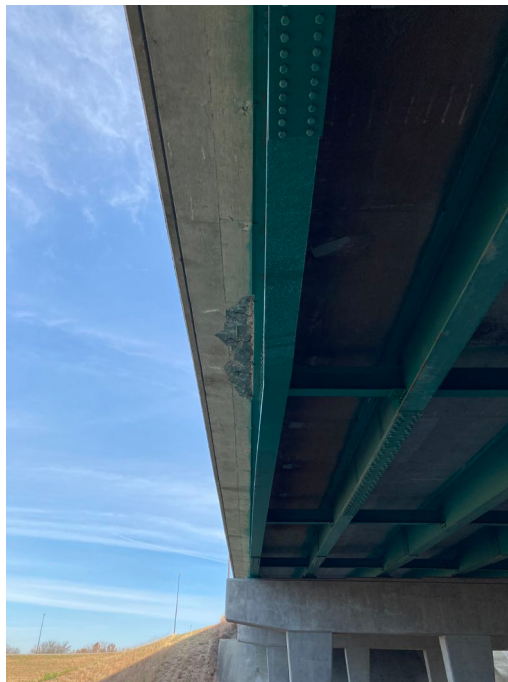
**Figure 64. Photo. Bottom view of damage to IDOT Bridge SN 084-0014 Girder 18, looking toward the center pier. The girder is displaced toward the right.**

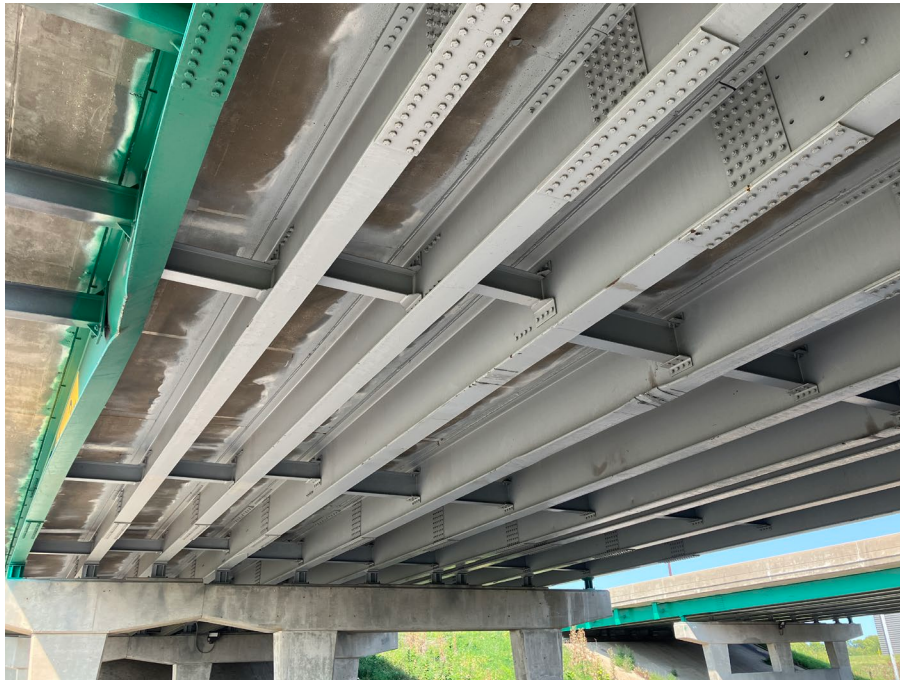
Figure 65. Photo. Overall bottom view of damage to IDOT Bridge SN 084-0077; Girder 19 is the left fascia girder (the impact occurred from left to right).

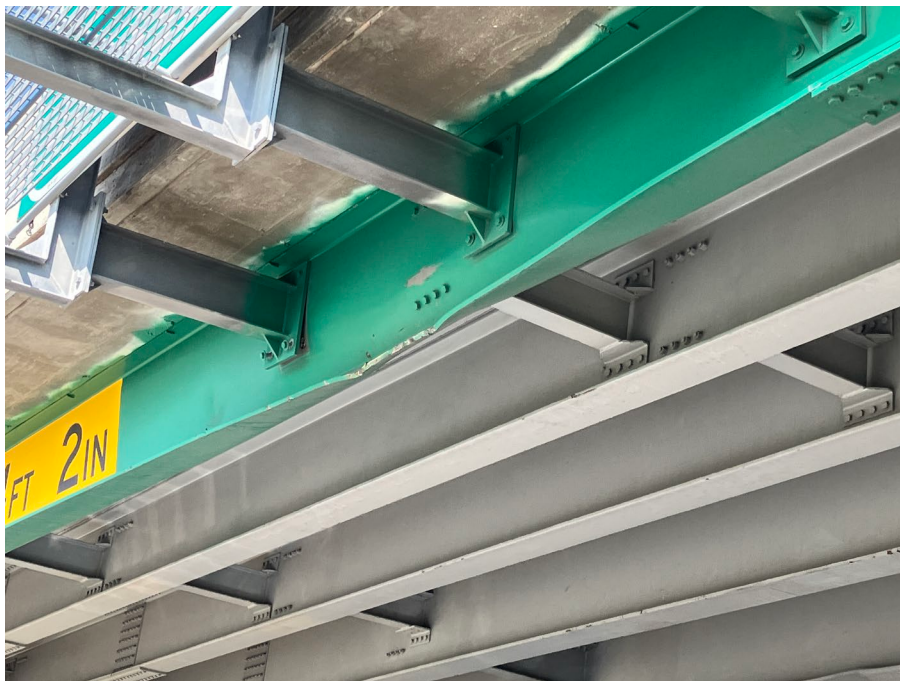
Figure 66. Photo. Front view of damage to IDOT Bridge SN 084-0077 Girder 19.

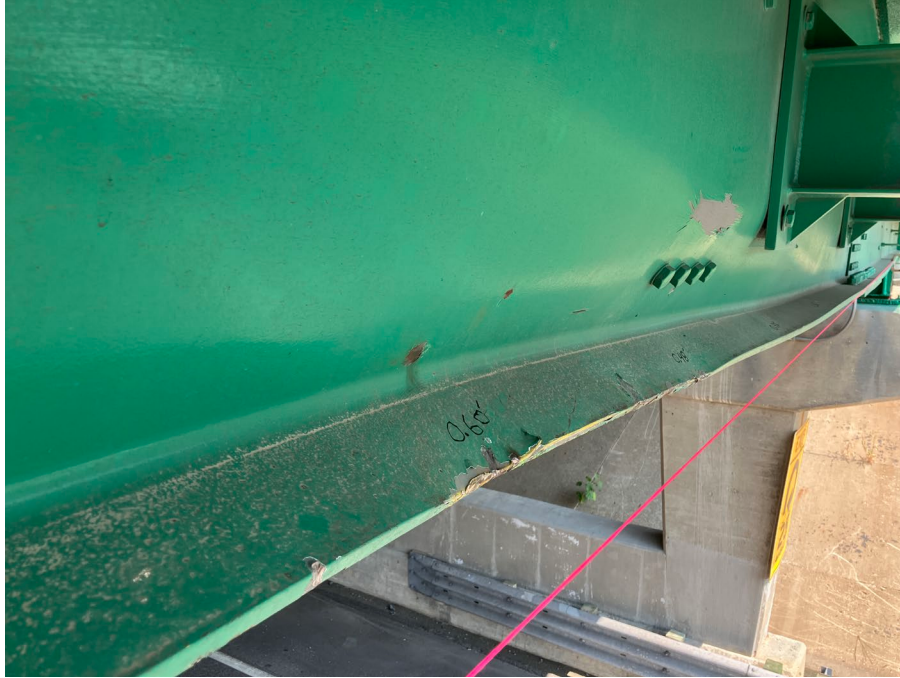
**Figure 67. Photo. Close-up view near the impact point on IDOT Bridge SN 084-0077 Girder 19. Small nicks and scratches are visible. (The stringline reference is pink.)**

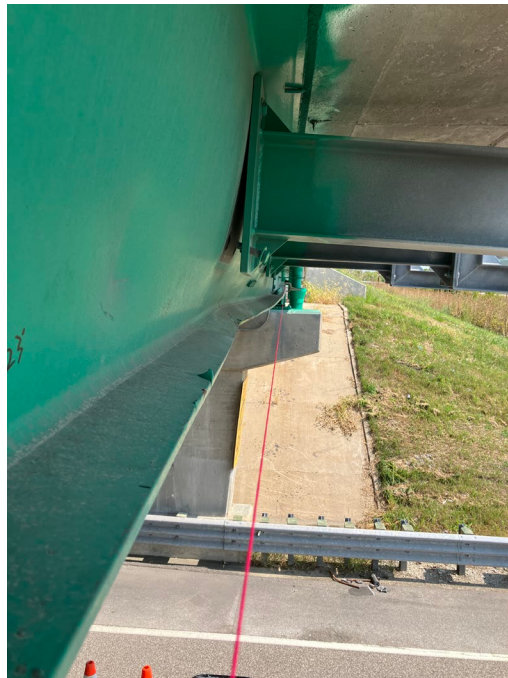
**Figure 68. Photo. Longitudinal view of damage to IDOT Bridge SN 084-0077, looking away from the center pier. (The stringline reference is pink.)**

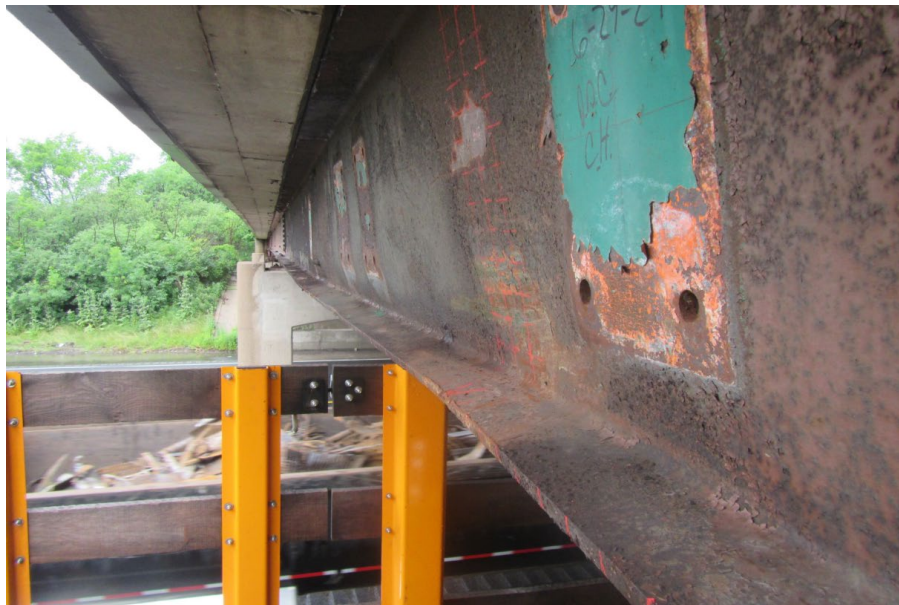
**Figure 69. Photo. Damage to IDOT Bridge SN 016-0918 Girder 1, looking toward the center of the span. Red marks drawn on the web indicate the longitudinal location of impact, while bolt holes and green paint indicate directional sign attachment points.**

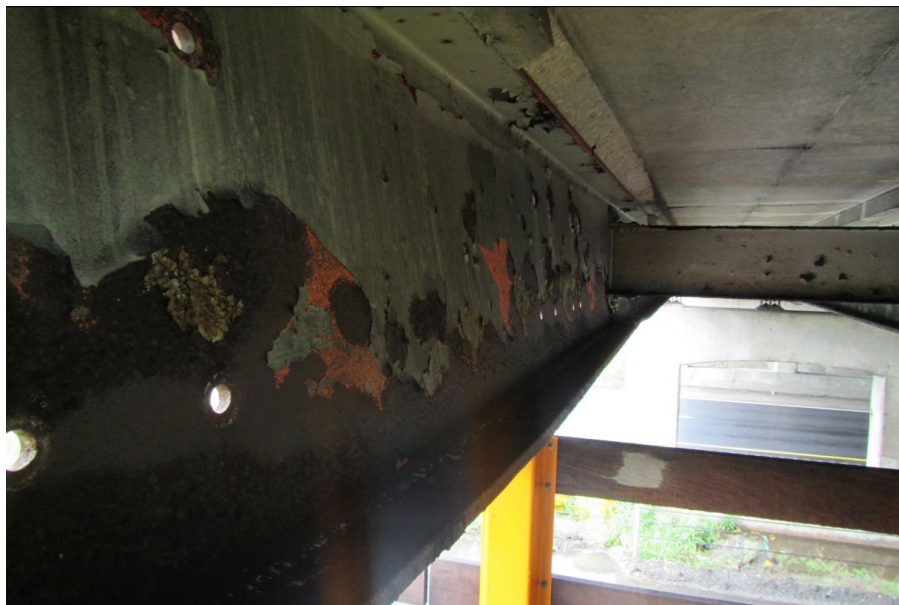
**Figure 70. Photo. Back view of damage to IDOT Bridge SN 016-0918 Girder 1, looking toward the center of the span. Paint on the back of the girder is peeling.**

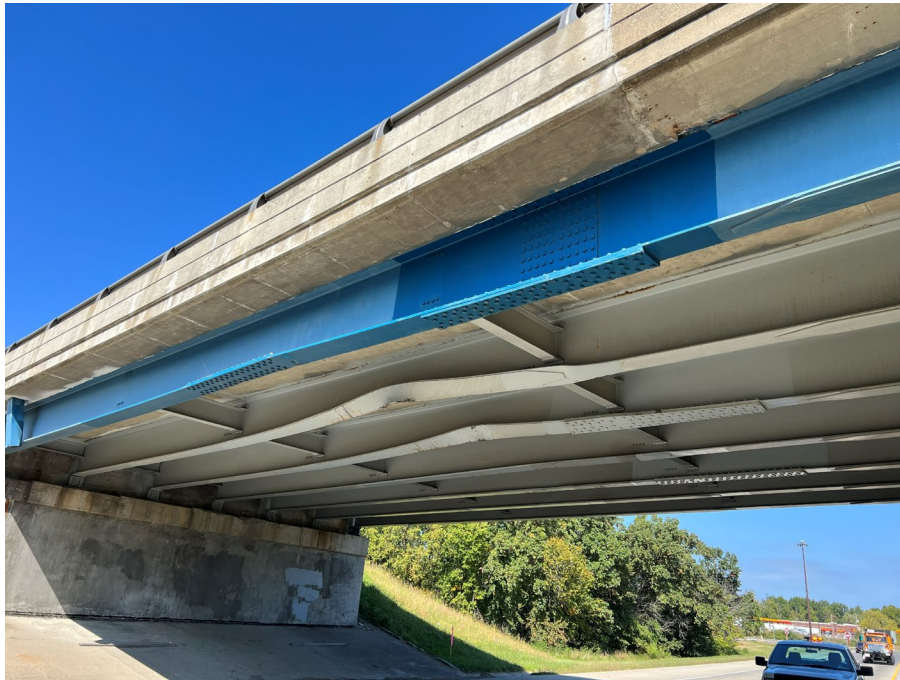
**Figure 71. Photo. Overall view of damage to IDOT Bridge SN 041-0067. Girder 6 is the first interior girder from front. (Several girders were damaged by the oversized load shown in Figure 1.)**

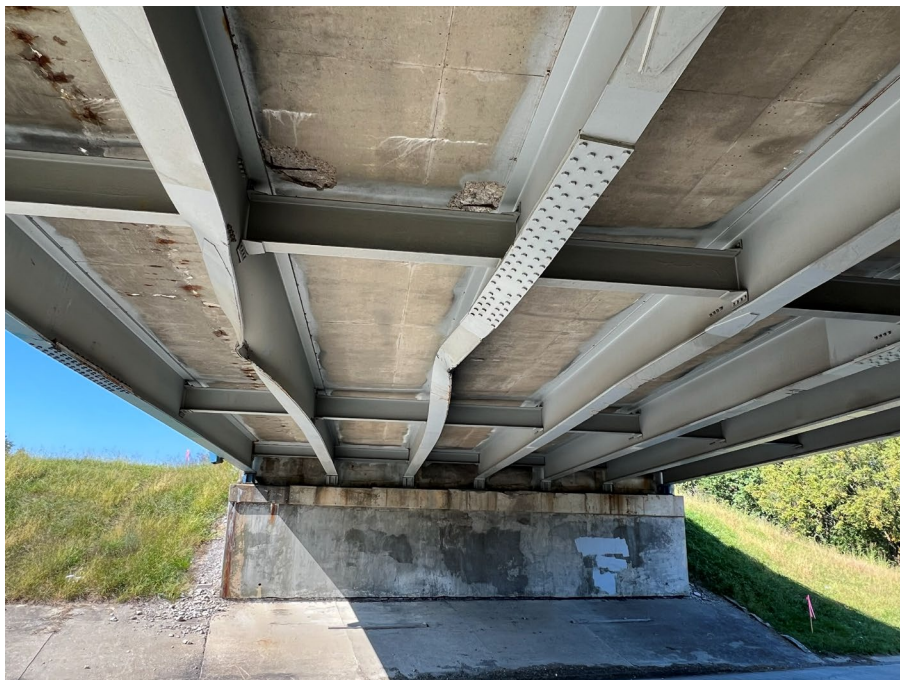
**Figure 72. Photo. Overall bottom view of damage to IDOT Bridge SN 041-0067. Girder 6 is the first interior girder from left and was damaged most severely.**

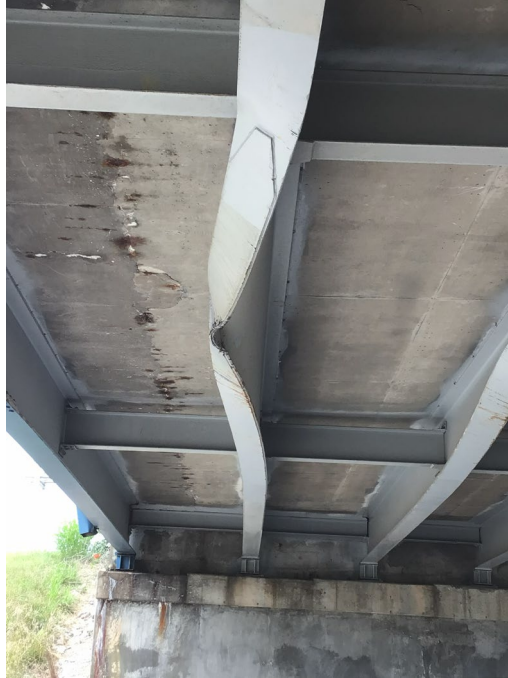
**Figure 73. Photo. Bottom view of damage to IDOT Bridge SN 041-0067 Girder 6, showing excessive displacement.**
