DOT HS 813 817

August 2026

# **Comparative Analysis of Impedance and Gas Sensor Diagnostics for LFP/Graphite Cell Failures**

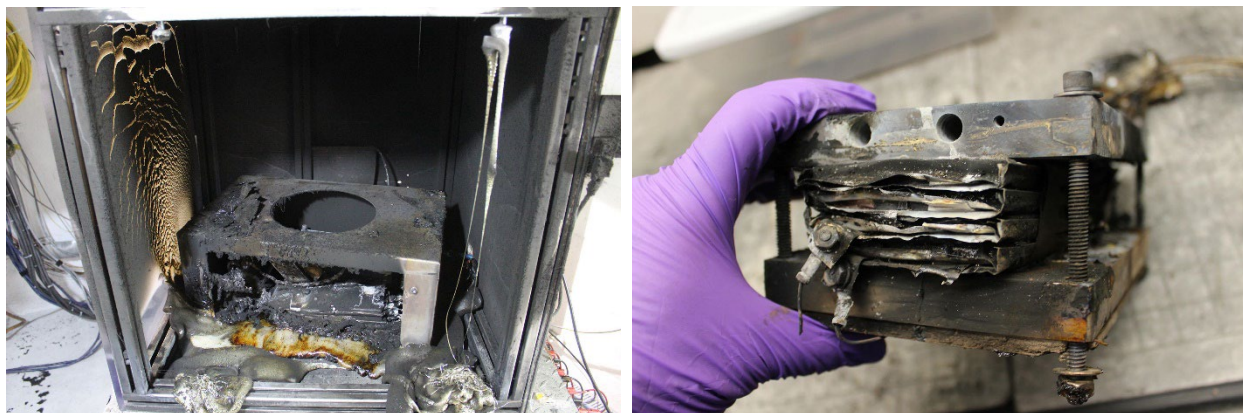
Figure 12. Post-overtemperature images of the 4p2s LFP/graphite battery pack

Video footage of the test shows initial swelling of the failed cell, followed by light smoke emission from a minor vent in the pouch casing. After several minutes, the cell vented at a higher gas release rate, quickly filling the test enclosure with dense smoke. Ignition of the gases occurred shortly afterward, producing a flame jet directed toward the polycarbonate viewing panel, which subsequently melted. Although polycarbonate is often cited as having a melting point of 230° C, it is an amorphous polymer and does not really have a sharp melting point like crystalline materials. Instead, it has a glass transition temperature near 147° C and softens progressively when exposed to elevated temperatures. The intensity and duration of the hot gases and flames were sufficient to deform and melt the panel, as well as damage other components inside the test enclosure. Figure 12 shows posttest images highlighting the melted polycarbonate cover and damaged aluminum parts, providing visual confirmation of the extreme thermal conditions sustained during the event.

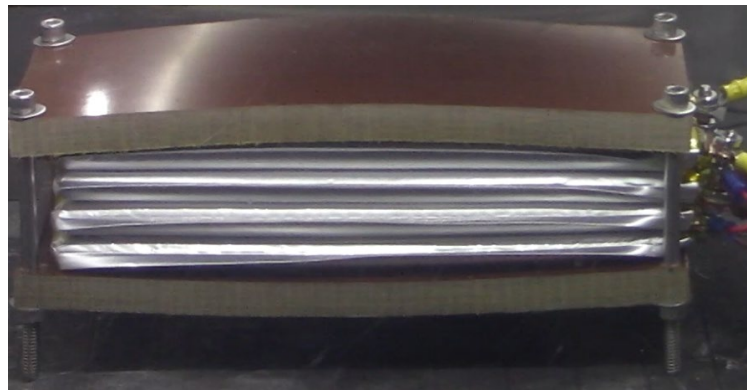
Figure 20. Still frame captured from the video of the 1s4p OC test

Video footage showed continuous cell swelling during the first 10 minutes, corresponding to SOC levels up to 116 percent. The swelling was substantial enough to visibly deform the phenolic blocks, as seen in Figure 20. This deformation may have restricted internal pressure relief, potentially intensifying localized heating and accelerating the onset of failure. Venting, electrolyte leakage, and light smoke followed shortly afterward, with rapid gas generation and dense smoke accumulation observed between 120 percent and 125 percent SOC (12 to 25 minutes into the test). Despite the significant gas release, there was no evidence of thermal runaway or flame ignition. Post-test inspection, shown in Figure 19(d), revealed dried electrolyte residue, minor burn marks, and casing breach, but no major structural damage.
