## Application of MAPOD to Handheld Ultrasonic Rail Flaw Inspection

| REPORT DOCUMENTATION PAGE | | | | | Form Approved<br>OMB No. 0704-0188 | |
|---|---|---|---|---|---|--|
| 4. TITLE AND SUBTITLE<br><br>Application of MAPOD to Handheld Ultrasonic Rail Flaw Inspection | | | | 5a. CONTRACT NUMBER<br>693JJ6-18-D-000005 | | |

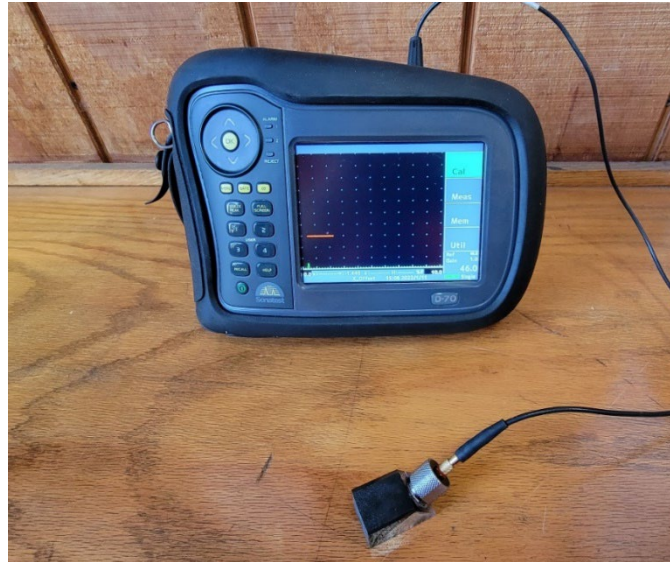
**Figure 5. Typical ultrasonic wedge, transducer, cable, and detector**

The team used an ultrasonic transducer fitted to a plastic wedge and connected by a cable to an ultrasonic flaw detector. The transducer and wedge together are referred to as the probe. [Figure 5](#) shows the typical equipment setup.

An operator uses the equipment by sliding the probe along the top of the rail while looking for peaks on the detector's display. Peaks that do not correspond to reflections from the rail's exterior surfaces can indicate the presence of internal flaws. Once a flaw has been found it can be sized by sliding the probe backward and forward, and from side to side, repeatedly on the top of the rail. This is typically performed by finding the scan positions that result in half the maximum signal response. In these positions, half the ultrasonic beam is reflected from the flaw and the other half continues into the rail. This method is suitable for flaws larger than the area covered by the ultrasonic beam, but adjustments are necessary for smaller flaws.

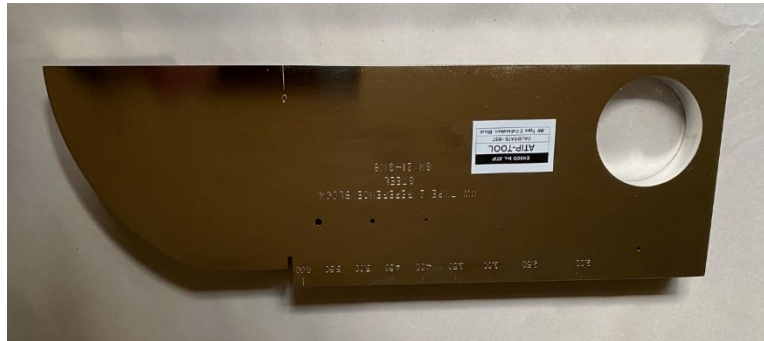
**Figure 6. IIW Type 2 calibration block**

calibrate the angle. The 1/16-inch diameter hole on the bottom right of the block is typically used to calibrate the gain.
