# **Field Evaluation of High-Performance Cold Mix (HPCM) Products**

Materials Division  
and  
Planning & Research Division

Arkansas Department of Transportation

## **Final Report**

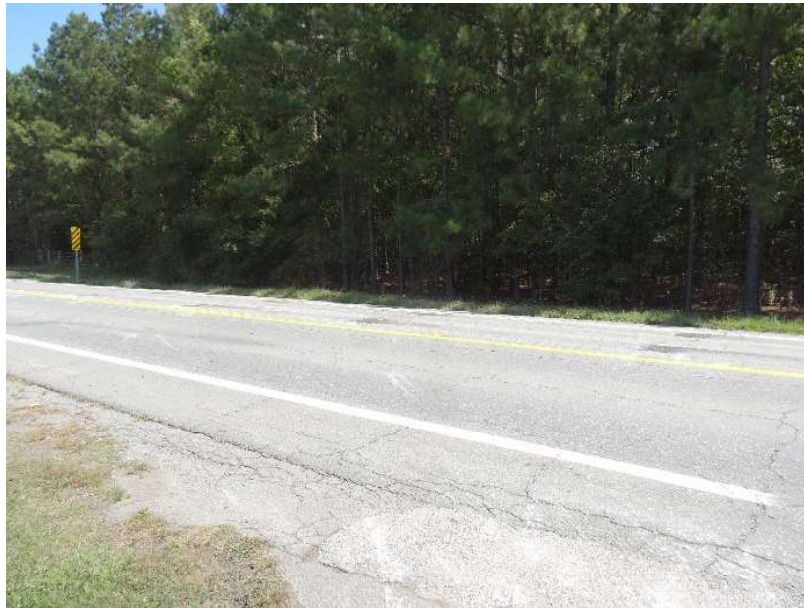
**Figure 1. Highway 338, Dixon Road, Little Rock, Arkansas**

**Figure 1** shows the test site on Highway 338, also known as Sweet Home Cutoff/Dixon Road in Little Rock, Arkansas, which reflects the traffic and road conditions that ARDOT maintenance staff frequently see during routine pothole repair operations; it was chosen as the test location for this evaluation. The roadway is a good place to assess the field performance of HPCM materials under practical service conditions, as it experiences frequent daily traffic, including medium to heavy-duty trucks and passenger cars. Pothole development is usually linked to surface aging, cracking, and localized deterioration, all of which were evident in the pavement portion chosen for the study. These current pavement conditions offered a useful setting for evaluating the long-term performance and durability of the repair materials under real-world traffic and environmental exposure.

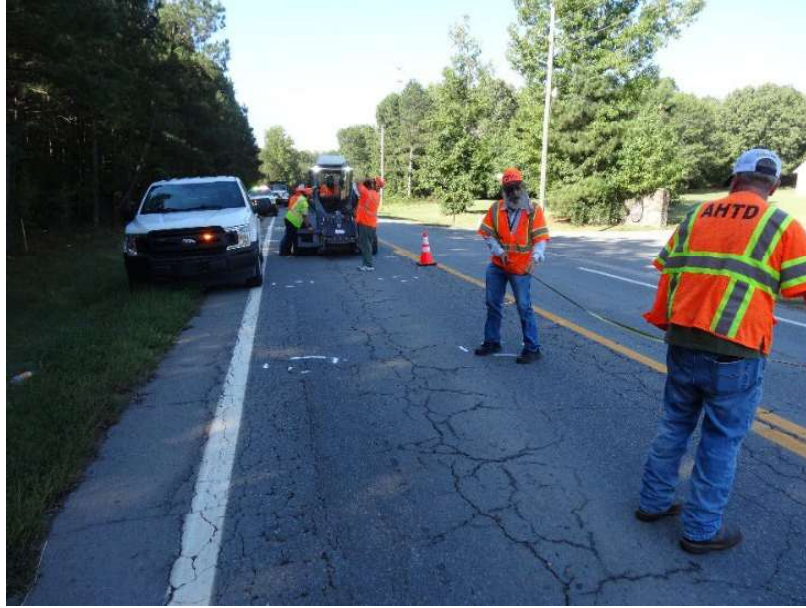
**Figure 2: Test Site Layout**

The westbound lane was chosen for the investigation because it provided sufficient space to construct multiple test sections while maintaining similar pavement and road conditions across all repair materials. Proper traffic control measures, including cones, traffic lights, and signs, were implemented during fieldwork. The sites for the HPCM placements were marked with measuring tape and paint, as illustrated in **Figure 2**.

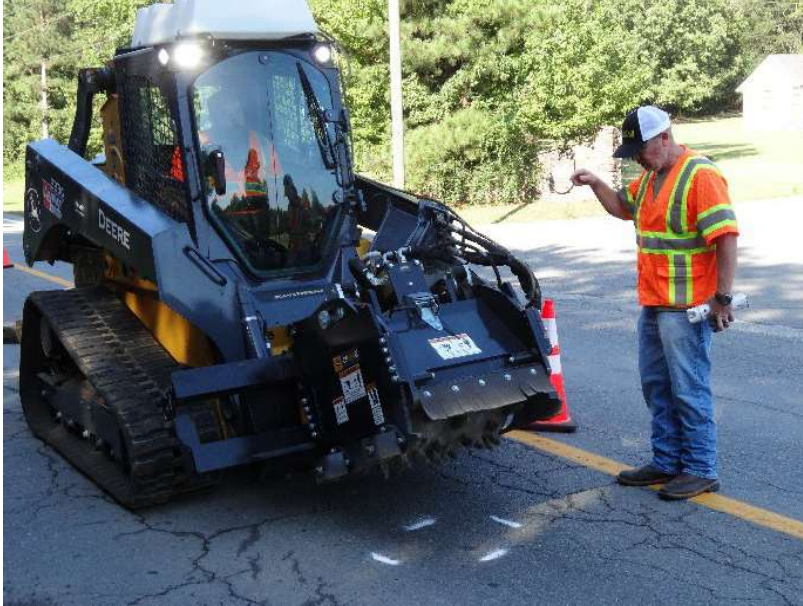
**Figure 3. Pothole Creation by Milling**

To assess the field performance of HPCM materials under controlled conditions, artificial potholes were created on the existing pavement surface. To ensure that variations in performance primarily indicate the properties of the HPCM materials rather than differences in repair dimensions, the potholes were created with consistent depth and geometry. The correct spacing between potholes was maintained at approximately 15 feet between each different HPCM set in the direction of traffic to avoid overlapping stress zones and allowing for independent monitoring of each repair section. To ensure consistent testing conditions, 16-inch by 16-inch potholes were created in the two-wheel paths of the roadway. Initially, the designated spots were milled using a skid steer with single-drum mill fitted with cutting teeth, as illustrated in **Figure 3**, to form rectangular grooves. These grooves were then cleaned using pneumatic tools and manual methods. **Figure 4** displays the final cleaned groove after milling.

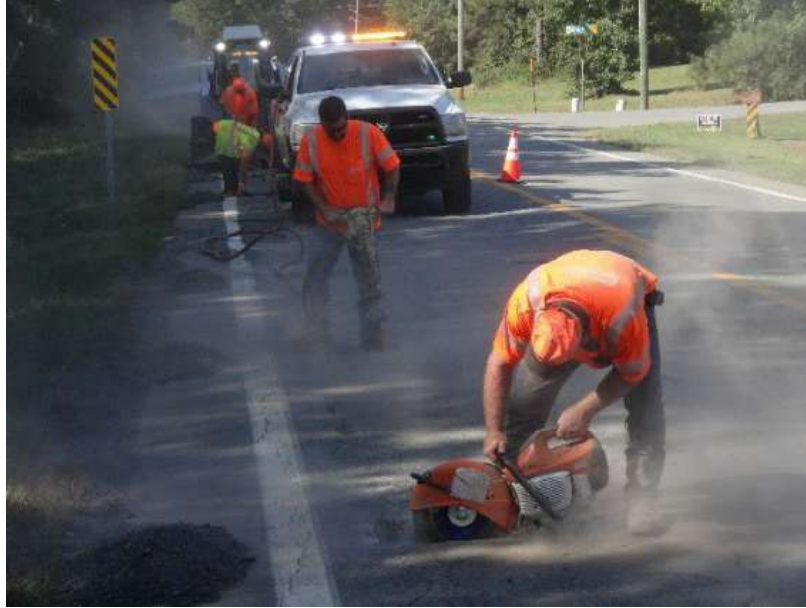
**Figure 5: Cutting Edges with a Saw and Breaking with a Jackhammer**

This study involved creating two types of potholes to assess HPCM's performance under various conditions. One type was formed by simply milling and cleaning the grooves, as shown in **Figure 4**. The other was made by milling then cutting the edges with a chop saw and breaking them with a jackhammer to form a proper rectangular shape with a relatively uniform bottom, as shown in **Figures 5 and 6**. The grooved patterns are positioned along the center line on the left wheel path, while the rectangular saw-cut pattern runs along the right edge of the road on the right wheel path. The simple milling pattern takes less time to prepare than the rectangular saw-cut pattern, allowing for quicker traffic opening. Both patterns were subsequently tested for performance.

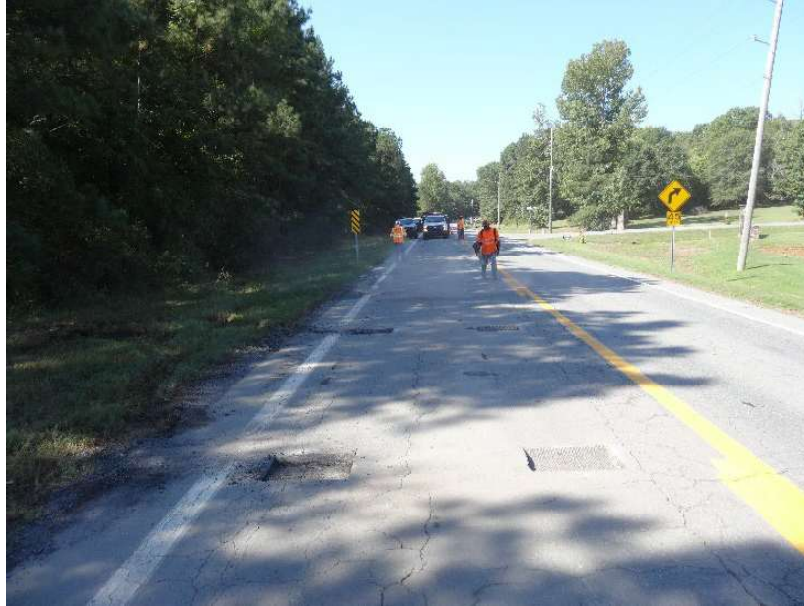
**Figure 7. Prepared Site with Potholes**

**Figure 7** displays the final prepared site after creating the necessary potholes and cleaning.

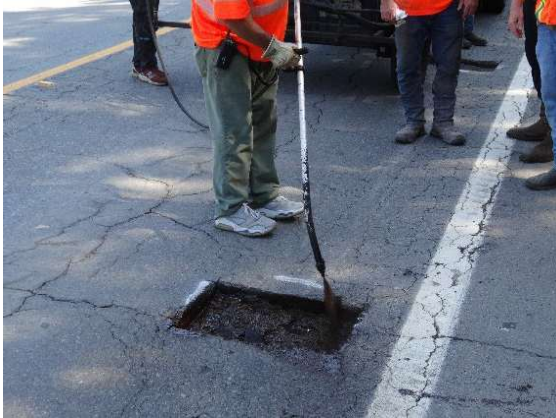
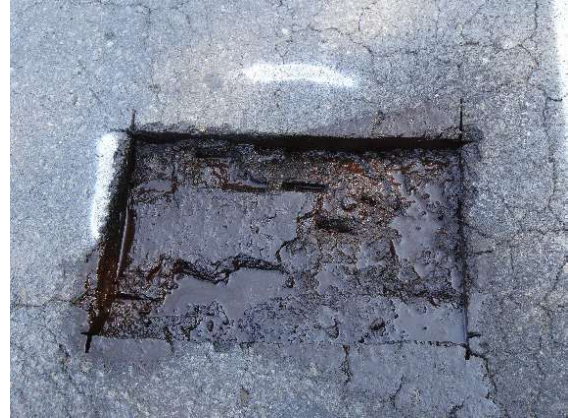
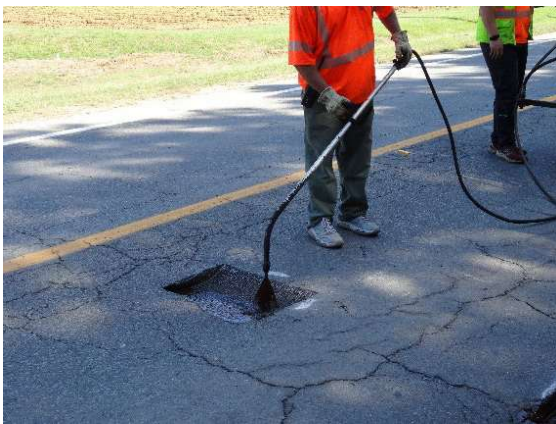
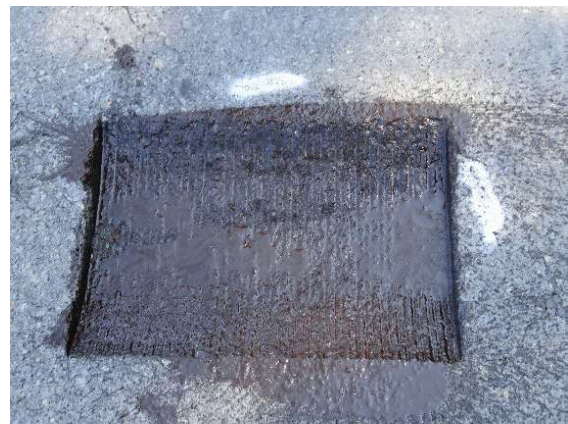
**Figure 8. Applying a Uniform Tack Coat Layer to all the Surfaces of the Prepared Pothole**

After excavating the potholes, a standard asphalt tack coat (CSS-1 at 100 degrees F) was applied to the interior surfaces of the prepared grooves and sawed holes - making sure to tack the sides of the holes. This step helps ensure a strong adhesive bond with the existing pavement, preparing the patches for the new cold-mix asphalt. The tack coat was evenly sprayed over the rough, fractured aggregate floor and along the vertical saw-cut perimeter walls, as shown in **Figure 8**. Extra effort was made to coat the irregular depressions left by the jackhammer to prevent water infiltration. The same technique was used on the grooved surface. A field operator used a pressurized wand sprayer attached to an asphalt emulsion tank to apply the liquid tack coat evenly. This application fully covered two types of excavated test patches. The vertical edges and corners received complete coverage to reduce the risk of joint separation or raveling.

(a) Spraying Tack Coat on a Rectangular Cut

(b) Tack Coat Applied on a Rectangular Pothole Surface

(c) Spraying Tack Coat on a Grooved Milled Patch

(d) Tack Coat Applied on a Grooved Pothole Surface

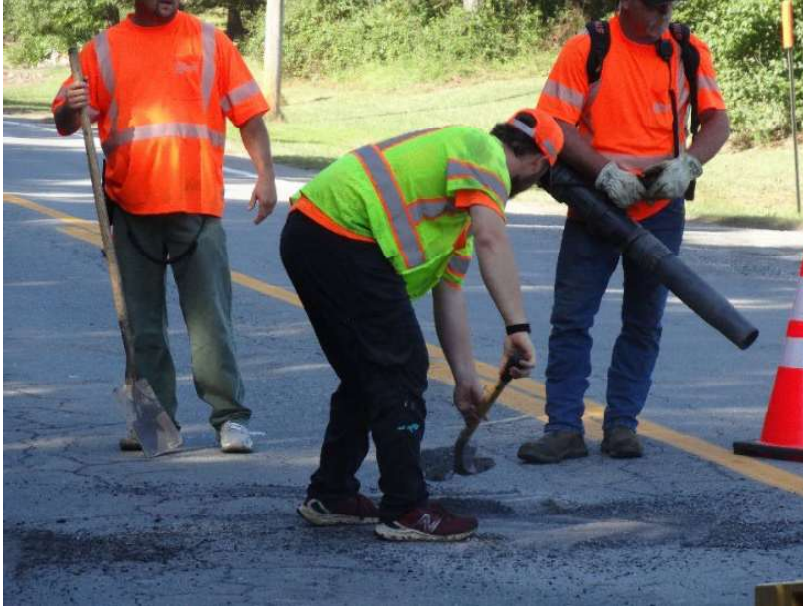
**Figure 9. Placing HPCM Material in Potholes**

The HPCM materials were applied in the repair zones following each manufacturer's or supplier's instructions, after the potholes were prepped and cleaned. These materials were carefully handled and transported to maintain their consistency and workability. Plant-produced materials were delivered in 5-gallon buckets and installed using standard maintenance procedures, while bagged items were opened and directly placed into the potholes. To ensure even distribution throughout each repair area, the potholes were gradually filled and bonded with the existing pavement making sure to completely fill the corners and edges as shown in **Figure 9**. The repair materials were placed and slightly overfilled above the pavement surface to allow for proper densification during rolling and traffic loads as depicted in **Figure 10**.

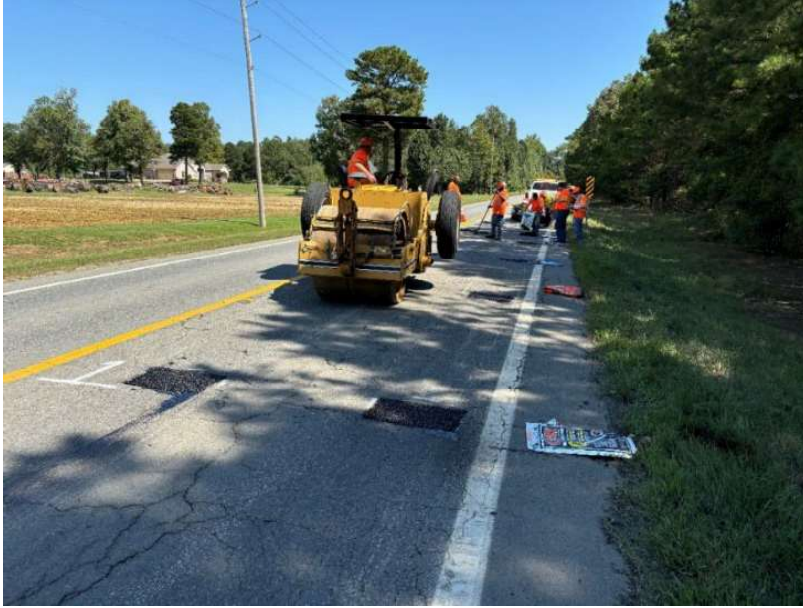
**Figure 11. Compacting Placed HPCM Material**

Subsequently, compaction was performed in accordance with field maintenance protocols and manufacturer instructions, using suitable tools and techniques. Each hole was hand tamped and rolled with a roller to densify the material, creating a stable, dense patch, as shown in **Figure 11**. Achieving proper compaction was essential to improve patch stability and increase resistance to moisture penetration and traffic wear.

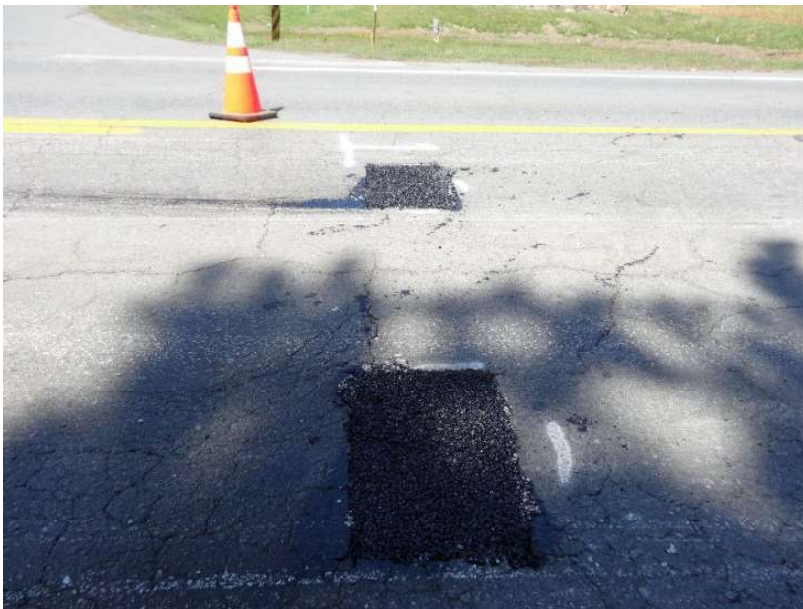
**Figure 12. HPCM Material After Placement and Compaction**

Material handling, workability, stickiness, ease of compaction, and overall constructability were observed during placement. Some materials required more effort to assemble, while others were easier to spread and compress. After compaction, the repaired areas were inspected to ensure the patches were well seated and roughly level with the surrounding pavement. The route was reopened to traffic once placement and compaction were complete. **Figure 12** shows the test section after placement and curing.

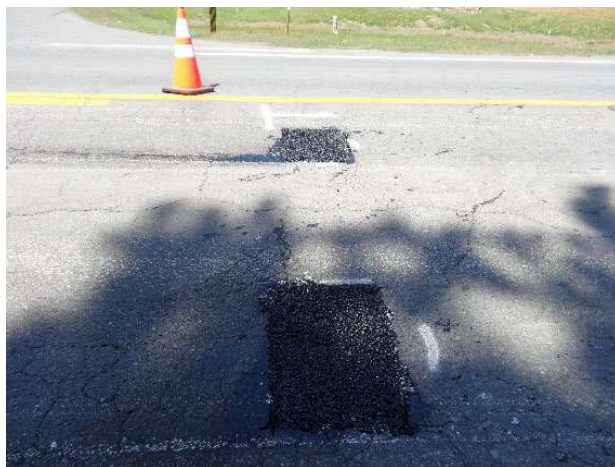
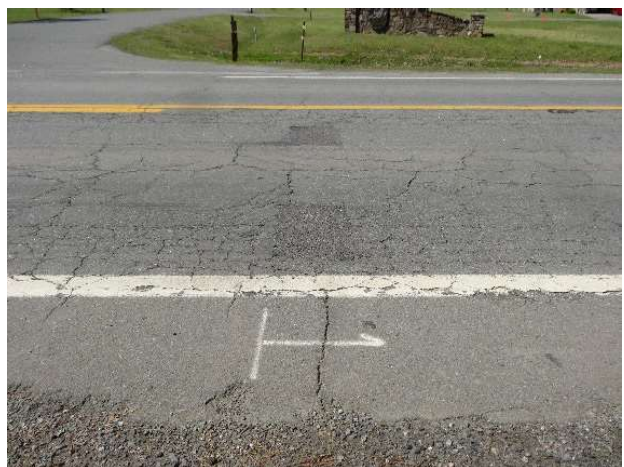
**Figure 13. Product 1: Newly Laid and After 12 Months**

Product 1 demonstrates good overall field performance throughout the evaluation period. The patches remained largely stable with only minor settlement observed in later inspections. Small pop-outs of existing pavement developed on the test strip during the monitoring period, indicating localized material loss of the existing pavement at the patch edge. No rutting, shoving, raveling, cracking, or bleeding was observed. Overall, Product 1 exhibited moderate resistance to traffic loading and maintained satisfactory patch integrity.

**Figure 13** shows the patches after installation and after 12 months at the time of the final inspection.

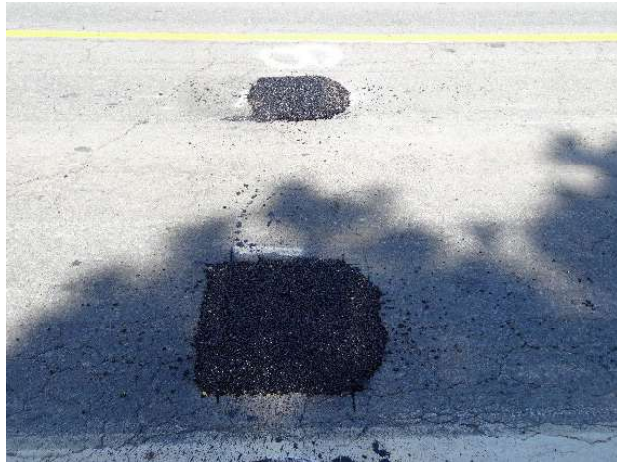
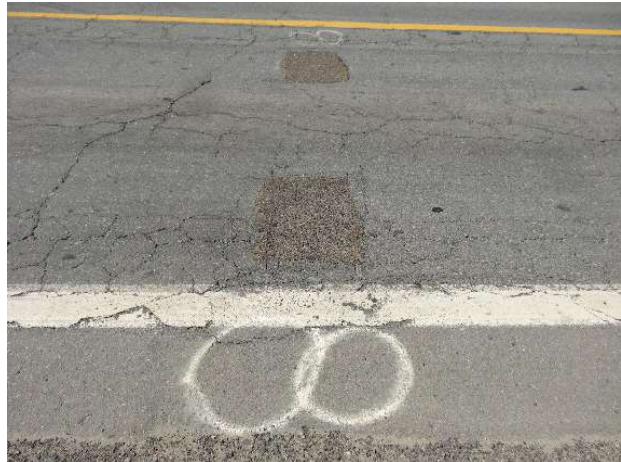
**Figure 20. Product 8: Newly Laid and After 12 Months**

Product 8 demonstrated the best overall field performance among all evaluated materials. Both patches remained in good condition throughout the monitoring period and stayed nearly flush with the surrounding pavement surface. No significant settlement, pop-outs, rutting, shoving, raveling, cracking, or bleeding were observed. The material maintained excellent patch integrity and exhibited superior resistance to traffic-related distress in the surrounding pavement. **Figure 20** displays the patches after installation and after 12 months, as seen during the final inspection.

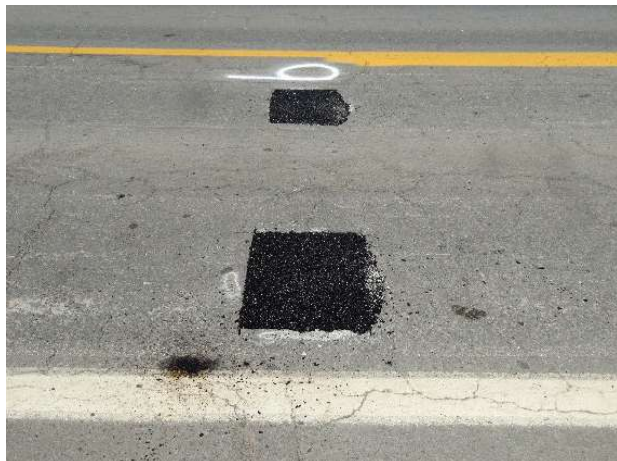
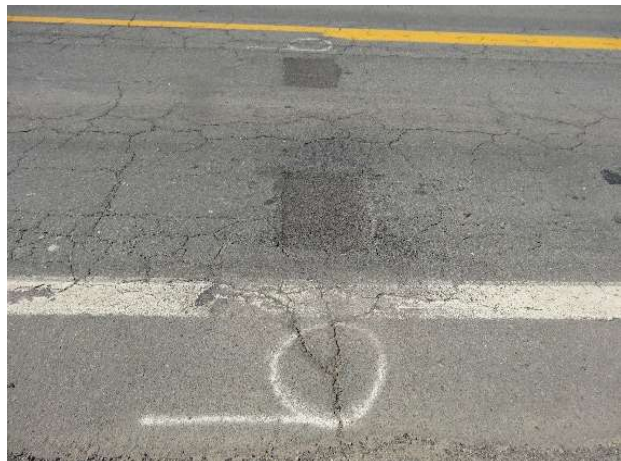
**Figure 21. Product 9: Newly Laid and After 12 Months**

It should be noted that Product 9 material had not been received from the manufacturer at the time the test strip was installed. Temporary material was used for the first six days. Upon receipt, the temporary material was removed, and the specified Product 9 material was installed in its designated location. Although the patches remained intact, the observed deformation indicated reduced resistance to traffic loading. No rutting, shoving, pop-outs, raveling, cracking, or bleeding were observed. Overall, Product 9 performed like all other products, except product 8.
