DOT/FAA/CT-88/27

# **Electro-Impulse De-Icing Research**

## **(Fatigue and Electromagnetic Interference Tests)**

Final Report

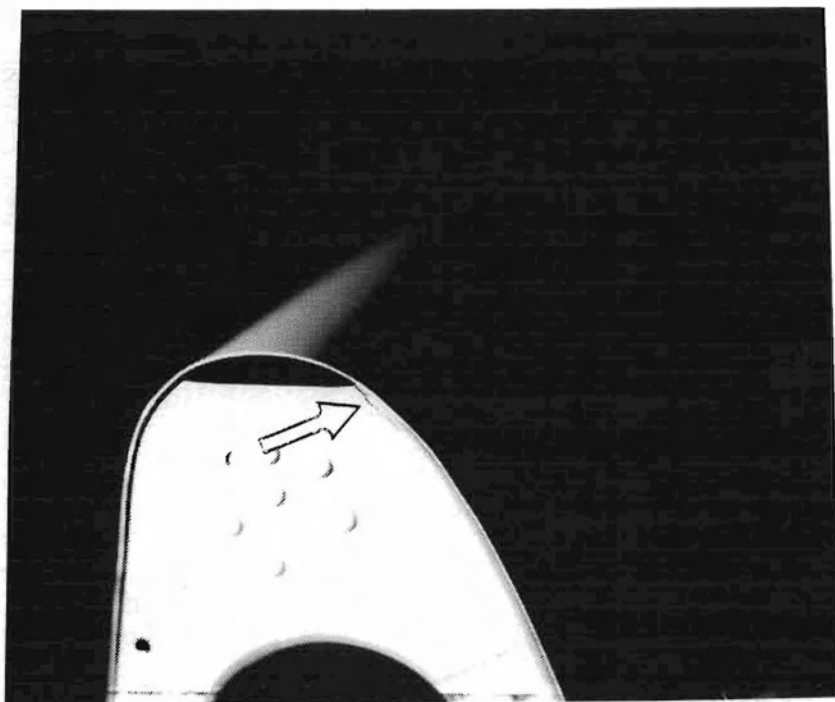
Figure 2-5  
Hairline Crack on End Rib (Crack is at Upper  
Right Corner of Rib) (0.025-Inch Skin)

After 15,000 impulses, disassembly and inspection showed a hairline crack in the outboard end closure ribs, shown in Figure 2-5. No other damage could be detected. The stability of the electrical parameters can be seen in the data of Table 1, and in the current trace in Figures 2-6 and 2-7.

Similarly, the end closure rib which was rather casually inserted, showed the danger of ignoring fatigue considerations. The rivet holes misalignment and failure to bond the rib led to hairline cracking. The main conclusion is that fatigue is a solvable problem, but the EIDI system can cause fatigue breakage when stress concentration points are permitted in the design.

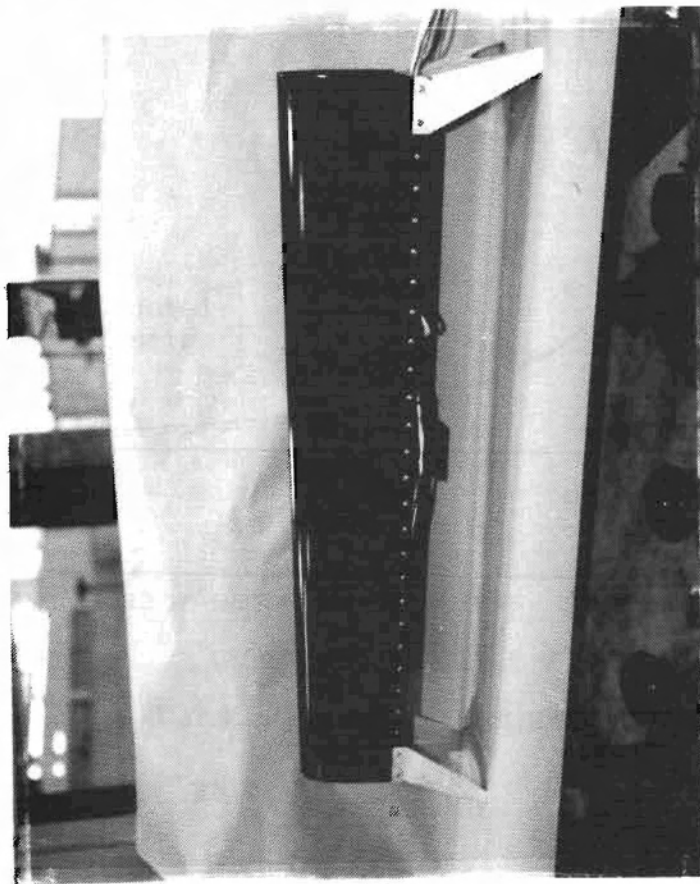
Figure 2-14  
Composite Leading Edge Model

The leading edge was supported by its spar, as shown in Figure 2-14. Figure 2-15 shows the coils mounted on the spar and Figure 2-16 shows the leading edge with doublers bonded in place. The closure ribs were screwed to the model at each end as seen in Figure 2-16.

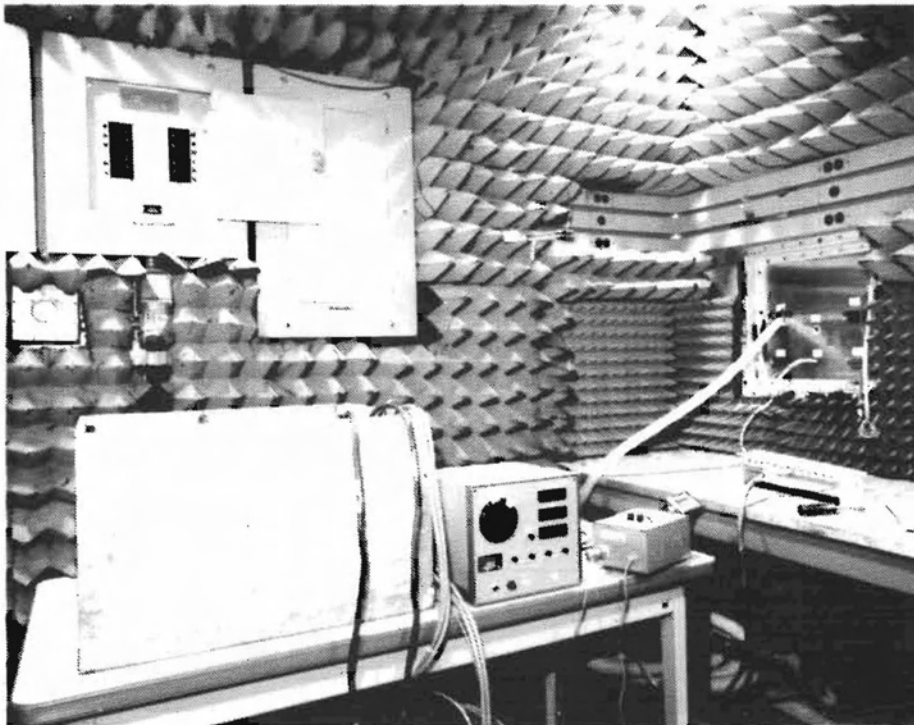
Figure 3-2  
Small Shield Room. From Left to Right are Power Supply  
(in large wooden box), Control Unit, Timer and Power Wires  
Leading into Main Shield Room.

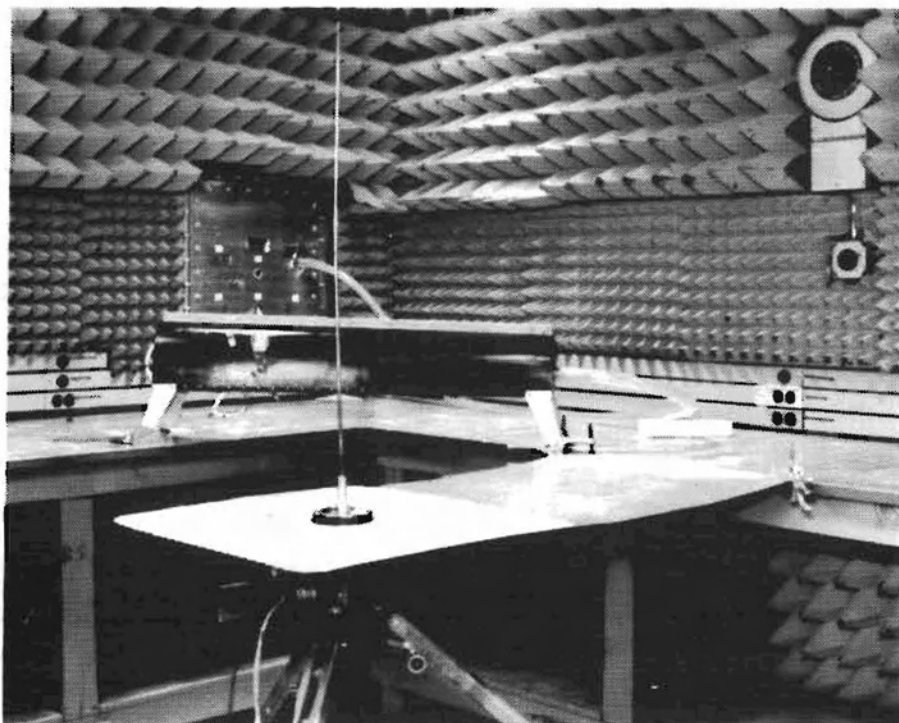
Figure 3-9  
First Test Setup for Composite Wing

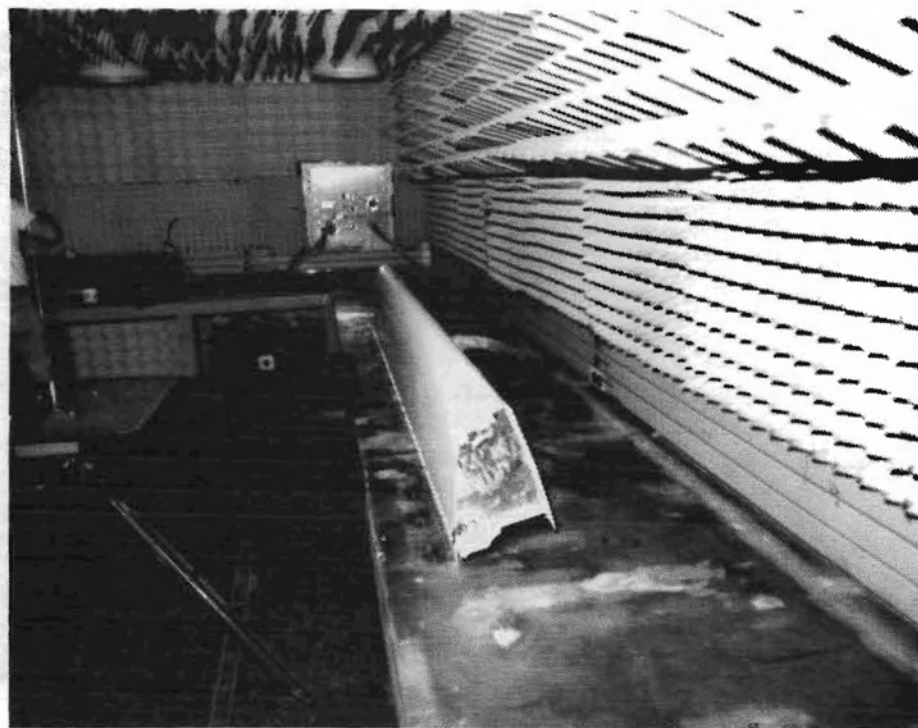
Figure 3-12  
Setup for Second Test Set
