**Report No. CDOT-2007-2**  
**Final Report**

# **SERVICE LIFE AND COST COMPARISONS FOR FOUR TYPES OF CDOT BRIDGE DECKS**

**George Hearn**  
**Yunping Xi**

**September 2007**

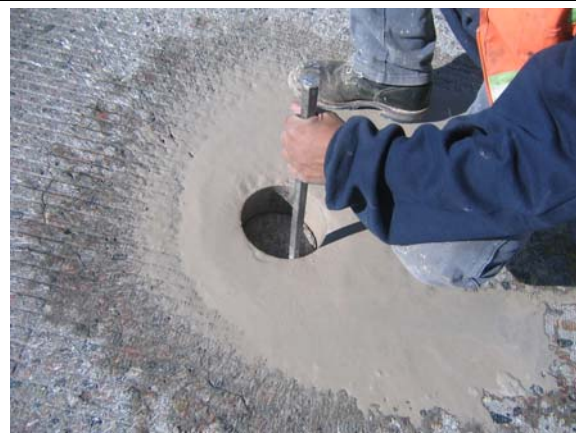
Figure 13 - Coring Concrete Samples on Bridge G-22-BJ. The Core Was Broken in the Traffic Lane
