**Report No. CDOT-DTD-R-2006-9  
Final Report**

# **IMPLEMENTATION OF PROVEN PCCP PRACTICES IN COLORADO**

**COLORADO DEPARTMENT OF TRANSPORTATION  
RESEARCH BRANCH**

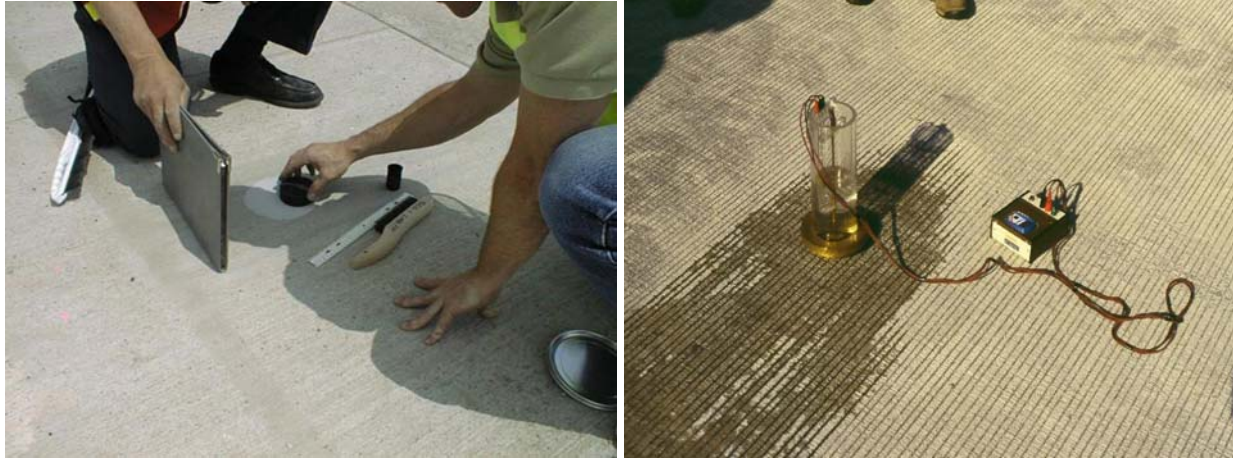
Figures 5 and 6: Sand Patch and Outflow Meter Testing

This is an indirect measure of texture as shown below. A cylinder with rubber seals on its lower end is placed on the surface and loaded by weights to assure good contact. An electric timer is connected to probes inside the cylinder. The cylinder is filled with water. To start the test, the plunger sealing of the outlet is lifted and the water escapes between the rubber seals and the pavement surface. The time for the water to escape is a measure of texture. Deep textured surfaces will allow fast escape of water; i.e., the outflow time for deep textured surfaces is shorter than the outflow time for shallow textured surfaces.

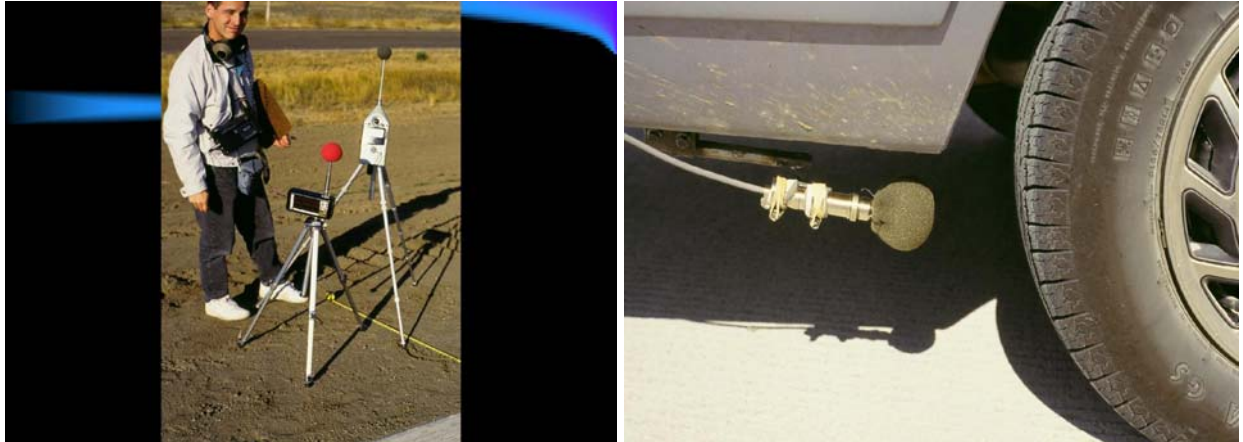
Figure 9: SPL Measurements at Roadside and Behind the Rear Tire

The data extracted from the recordings were A-weighted sound levels, as well as 1/3-octave SPL with frequencies between 100 and 5000 Hz.

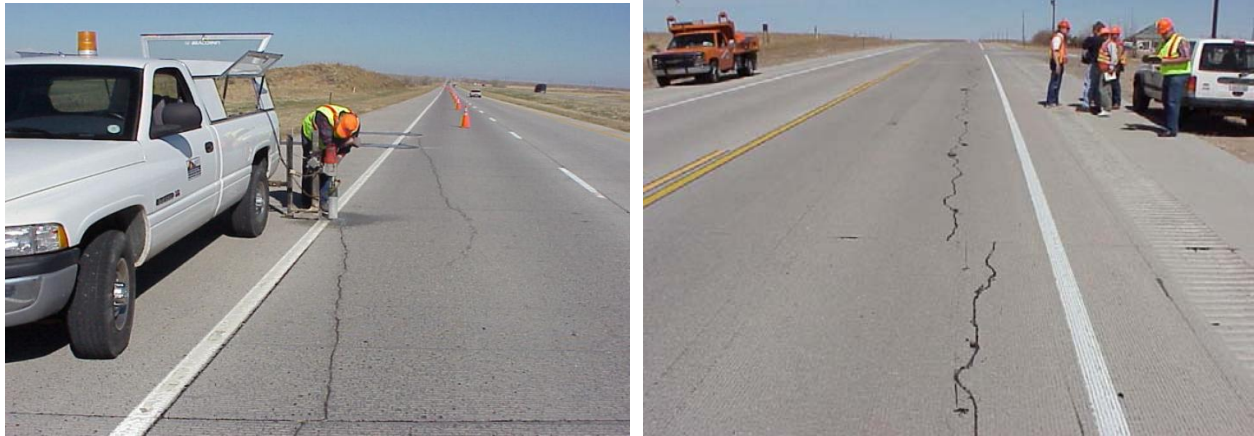
Figures 22 and 23: Longitudinal Cracks Due to Improper Depth of Saw Cut

Examination of cores from several locations on US-287 and I-70 revealed longitudinal joints with sawcut depth that were less than 1/3 of the thickness of the pavement, i.e., not deep enough to instigate the weakened plane cracking. As a result, longitudinal cracks developed to relieve the internal stresses in the concrete. This discovery eliminated the 14-foot-wide slabs as a possible cause of these longitudinal cracks.

- Premature longitudinal cracking due to improper depth of the longitudinal saw-cut can be prevented by adhering to CDOT's present specification, which requires saw-cut depth of  $D/3$  for 12-foot slabs and  $0.4D$  for 14-foot slabs. It is recommended that project engineers in the field measure saw-cut depth at intervals of 1 per 1/10 of a mile (528 feet). This specification has already been incorporated into CDOT's Field Materials Manual.

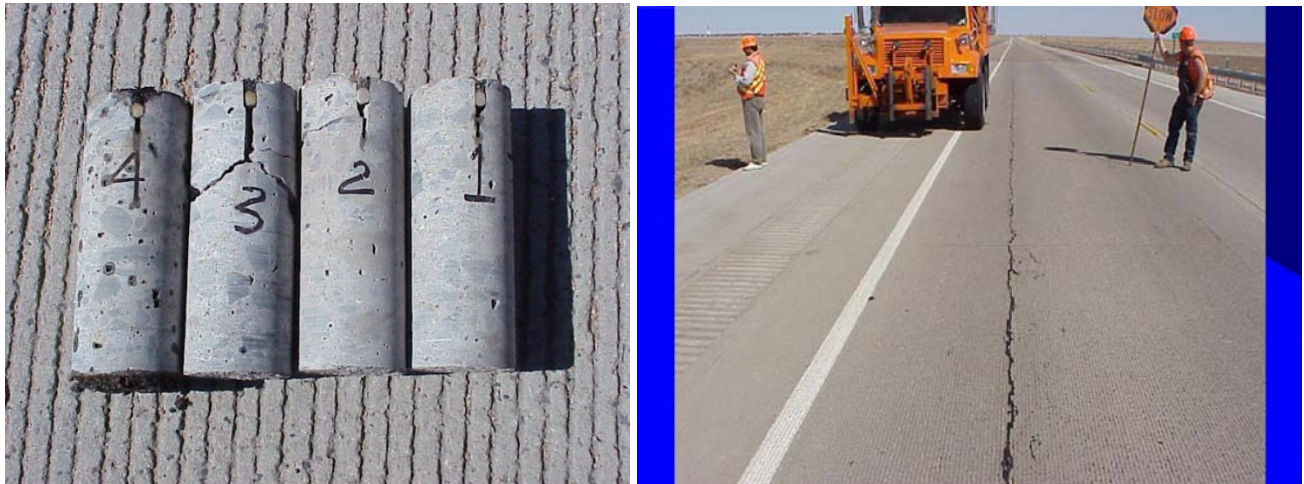
Figure 24: Cores Showing Non-Working Joints

Figure 25: Vibrator Trails

Some of the longitudinal cracks on US-287 were assumed to be due to vibrator trails created by malfunctioning of paver vibrators. Laboratory testing revealed a definite relationship between

improper vibration practices and longitudinal cracking in the path of the vibrators. Cores taken from three different locations on and next to the vibrator trails were sent to Construction Technology Laboratories (CTL) for petrographic analysis. Air-void system analysis was performed in accordance with the modified point-count method of ASTM C 457-98, “Standard Test Method for Microscopical Determination of Parameters of the Air-Void System in Hardened Concrete.” The cores were cut longitudinally and one of the resulting surfaces was finely lapped (polished) and analyzed using a computerized apparatus.

The results showed the air content of the cores taken on the vibrator trails to be consistently lower (30-60 percent lower) than the air content of the cores taken next to the vibrator trails. Visual examination of the cores taken on the vibrator trails revealed non-uniform dispersion of the aggregate, indicating segregation of the mix caused by malfunctioning of the vibrators. High vibrator frequencies and/or prolonged vibrations at lower paver speed were determined to be the main factors that caused segregation and eventually longitudinal cracking along the vibrator trails.

- It is strongly recommended that the paving contractors equip their paving machines with frequency monitoring devices for the vibrators. These monitoring devices provide the transportation agencies and the paving contractor a necessary tool to help achieve a quality concrete pavement that is long-lasting. CDOT has already adopted and fine tuned the Iowa DOT's specification for monitoring the frequencies of the vibrators. This specification was fully implemented at the completion of this study. To view this specification visit CDOT's website.

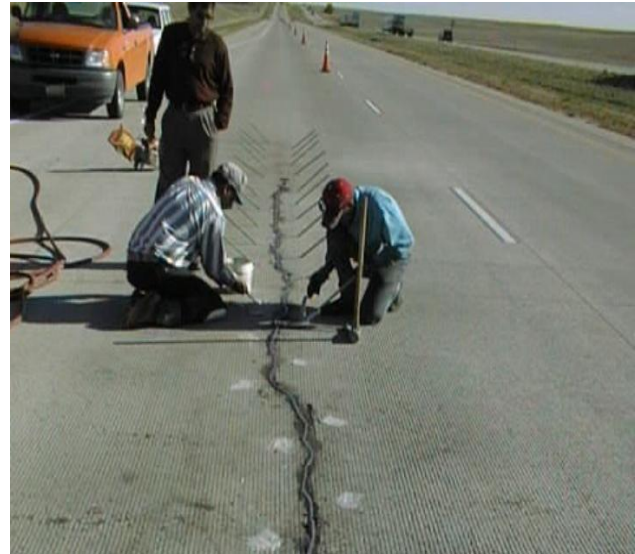
Figure 27: Cross Stitching

To alleviate the problem, slurry injection in conjunction with cross stitching was used to temporally seize the swelling. To properly address the problem of swelling soil, Region 1 is planning on removing the existing subsurface materials and replacing them with choice materials.
