**Report No. CDOT-DTD-R-2005-20**  
**Final Report**

# **PERFORMANCE OF COLORADO'S FIRST RUBBLIZATION PROJECT ON I 76 NEAR STERLING**

**Robert LaForce, P.E.**  
**Yeh and Associates**

**January 2006**

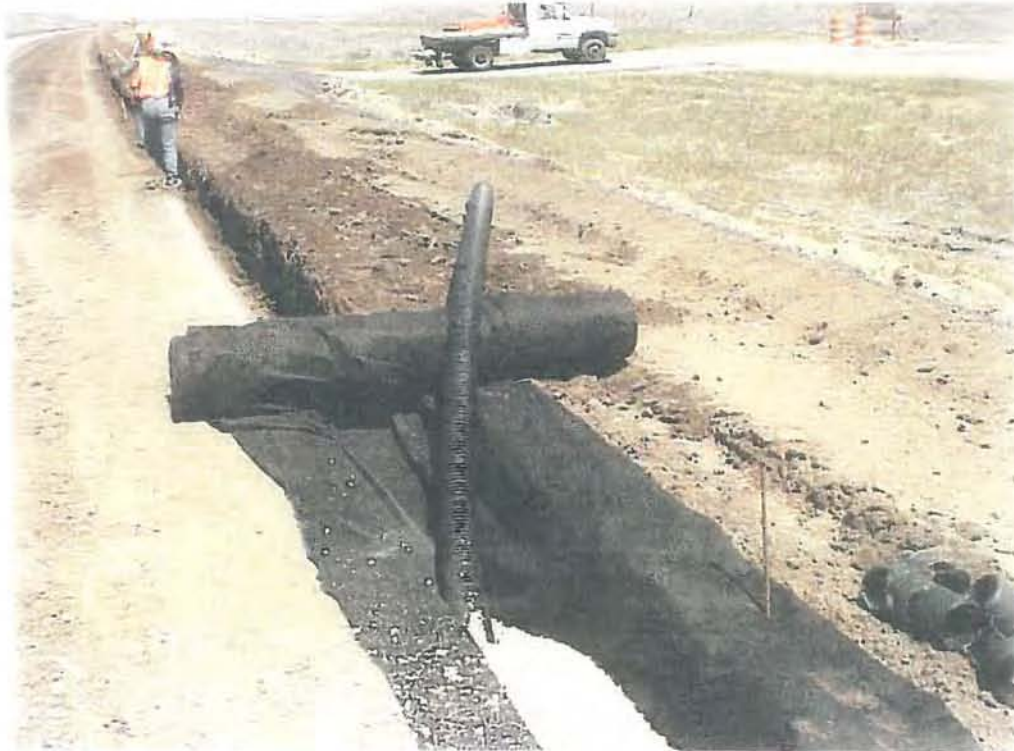
**Figure 3. Typical Edge Drain Construction**

Edge drains used in conjunction with the rubblization are a recommended feature to control subgrade moisture. Preventing moisture buildup in the subgrade is important for the long-term performance of the pavement as well as during the construction phase. Although this section of highway was built on a permeable sandy subgrade, edge drains were installed as part of the roadway design in the event that there was any subgrade moisture. The edge drains were specified and installed according to CDOT M-Standard M 605-1. Figure 3 shows typical edge drain installation.

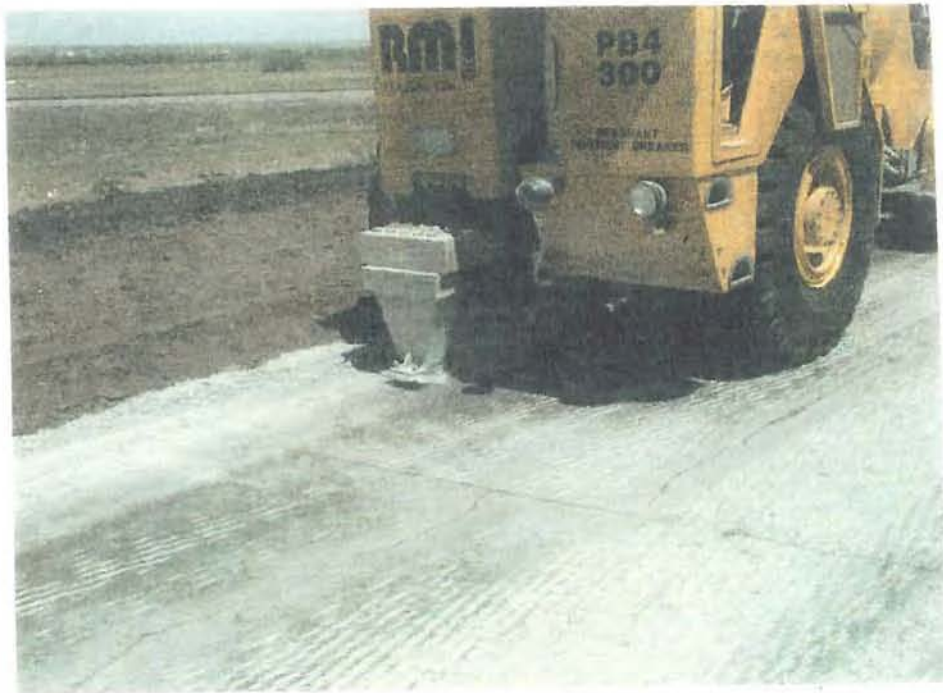
**Figure 5. Resonant Breaker**

The specifications for this type of process required that the concrete pavement be broken up with a self-contained, self-propelled, resonant frequency pavement-breaking unit capable of producing low-amplitude 2,000-pound force blows at a rate not less than 44 cycles per second. The majority of rubblized concrete pieces should be 1 to 3 inches nominal size. (Specification in Appendix A of the Construction Report)

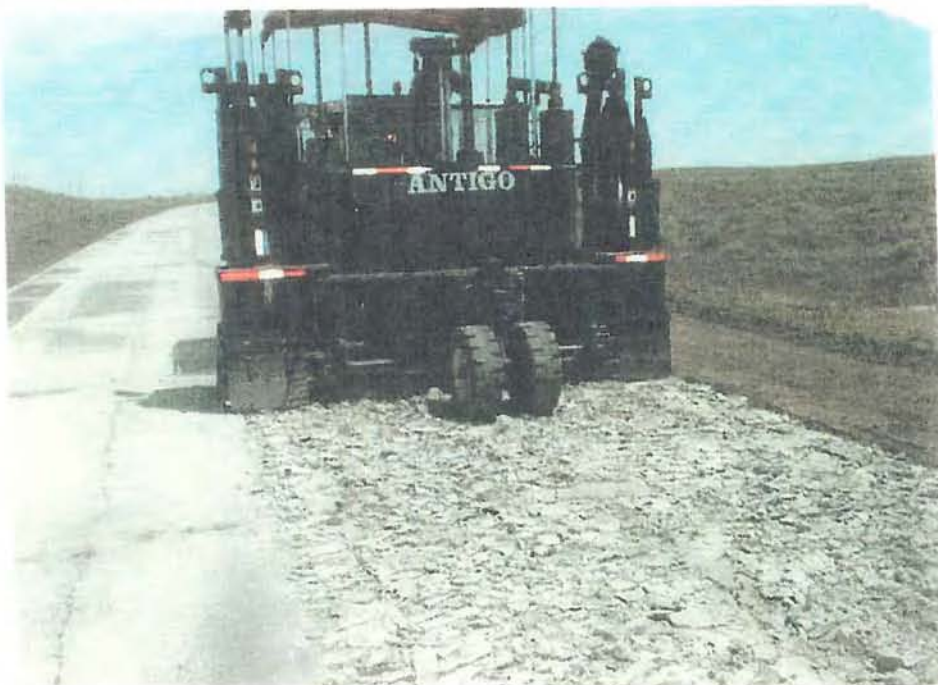
**Figure 6. Multi-head Hammer**

With this process, the concrete pavement is broken up with a self-contained, self-propelled unit with hammers mounted laterally in pairs with half of the hammers in a forward row and the remainder diagonally offset in a rear row, so there is continuous breakage from side to side. The equipment was capable of rubblizing a 13-foot lane in a single pass. The existing concrete was broken into pieces ranging from sand size to pieces generally 3 inches or less in size in the top half of the concrete pavement, and 9 inches or less in the bottom half of the concrete pavement. (The specification is Appendix B of the Construction Report)

As with the resonant breaker sections, a 4-foot by 4-foot test section was excavated to visually inspect and verify that the multi-head hammer was producing the specified sizes. A steel vibratory roller fitted with “Z” pattern grid on the drum face operating in the vibratory mode was used to seat the rubblized pavement. Figure 6 and 7 shows the multi-head hammer and the Z-pattern roller. This equipment was provided by Antigo Construction Company of Antigo, Wisconsin.

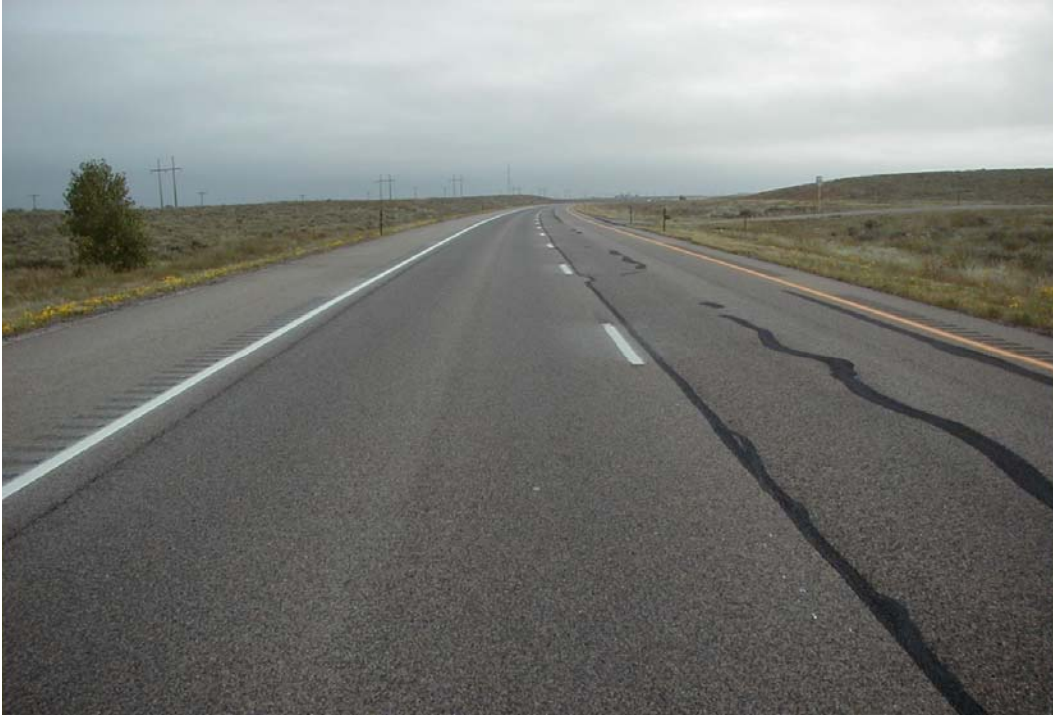
**Figure 11. Typical WB Condition (9/24/05)**

As a final note on cracking, the project was visited in September 2005. Figures 10 and 11 document the condition of the rubblization test sections. The top-down cracking has progressed in both directions with the eastbound lanes having more severe deterioration than the westbound lanes.

CDOT Maintenance forces have sealed most of the longitudinal cracking and the centerline of paving joint in both directions. The longitudinal joint between the shoulder and driving lane is now opened throughout the project length and will be sealed in the future.
