# **EVALUATING A TWO-STAGE ROADSIDE DITCH DESIGN TO IMPROVE ENVIRONMENTAL PERFORMANCE**

**Final Report  
June 2026**

Submitted to:  
Iowa Department of Transportation  
Project No. 20-SPR1-002

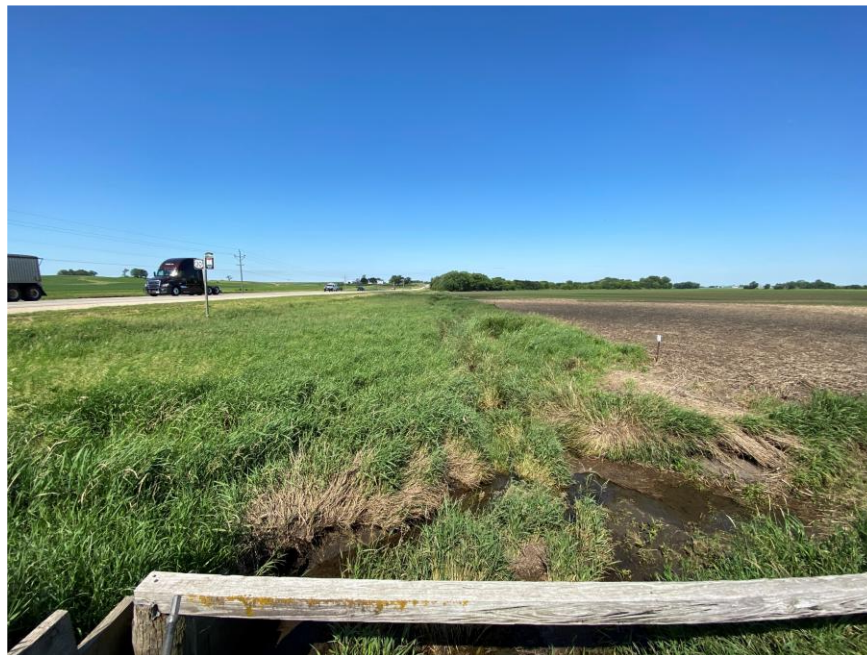
**Figure 2-2.** The roadside ditch prior to two-stage construction.

The natural ditch prior to the two-stage intervention was approximately 1-1.5 m wide and 1 m deep, and it meandered slightly within its confines. The slope of the ditch on the floodplain of Prairie Creek was 0.06%. The pre-construction ditch was visibly incised, displaying a migratory nick-point in the central area of the test channel. The upper part of the incised ditch was abundantly covered by mature, uniformly distributed grass density. Vegetation was dominated by smooth brome (*Bromus inermis*), bare ground/thatch, reed canary grass (*Phalaris arundinacea*), and stinging nettle (*Urtica dioica*) (Figure 2-2). This type of vegetation community is very common in disturbed roadside ditches throughout Iowa.

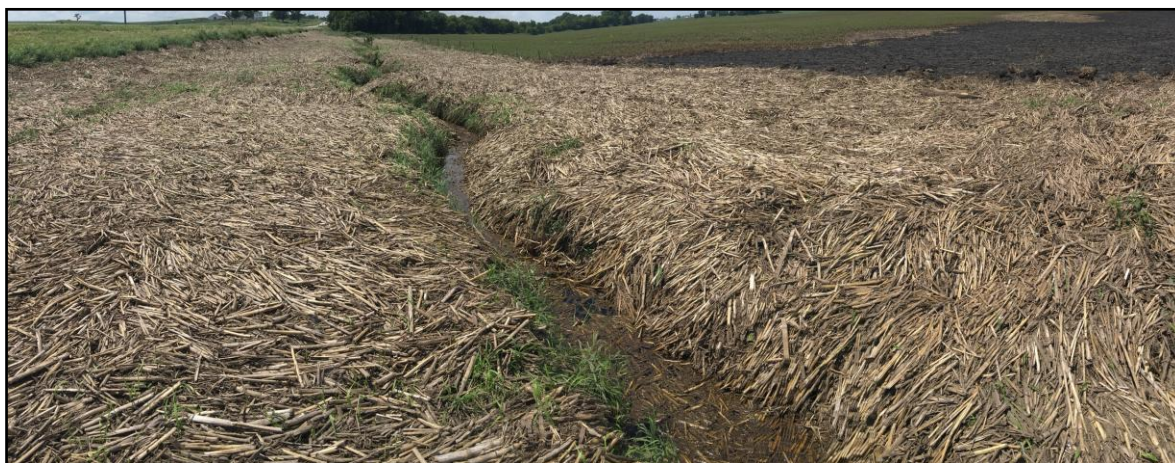
**Figure 2-5** (top) Stream stage in the ditch in 2020. Note the small initial peak on June 18 followed by a much larger event on June 25. (bottom) Photograph taken on July 2 at the ditch following the June 25 event and the large amount of corn residue observed at the site.

On June 15, 2020, a pressure transducer was installed in the ditch at the approximate longitudinal midpoint to collect stage readings every 15 minutes (aka “stage sensor”). An initial small flow event (1-year return flow) was captured on June 18, 2020, but on June 25, 2020, the area experienced significant rainfall and a large flood event was observed (Figure 7). The ditch area was completely inundated and the surface flows brought in a massive amount of corn residue (Figure 2-5).

Based on the ditch stream stage observed on June 18 and using the nearby information from the Prairie Creek Tributary, ditch flow for the 1-year event was estimated to be 25 cubic feet per second (cfs).

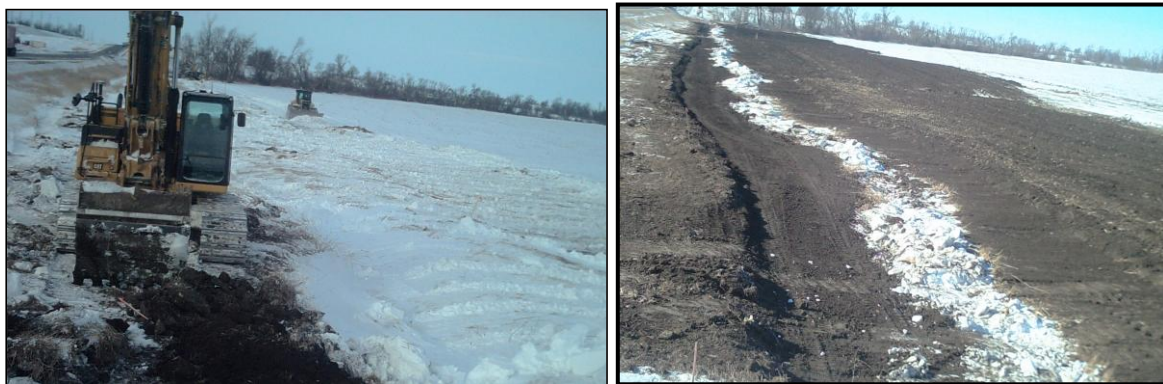
**Figure 2-9.** (Left) Excavation work initiated on January 17 and (Right) work finalized on January 21, 2022.

On January 17, 2022, 2-stage ditch construction was initiated at the site and the grading work was finalized on January 21, 2022 (Figure 2-9). On April 18, 2022, the two-stage ditch was seeded and finalized (Figure 2-10).

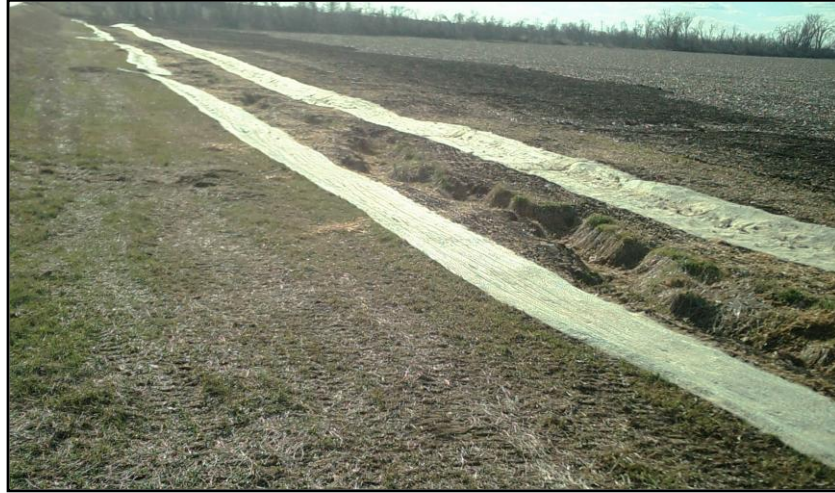
**Figure 2-10.** Seeding finalized at two-stage ditch site.

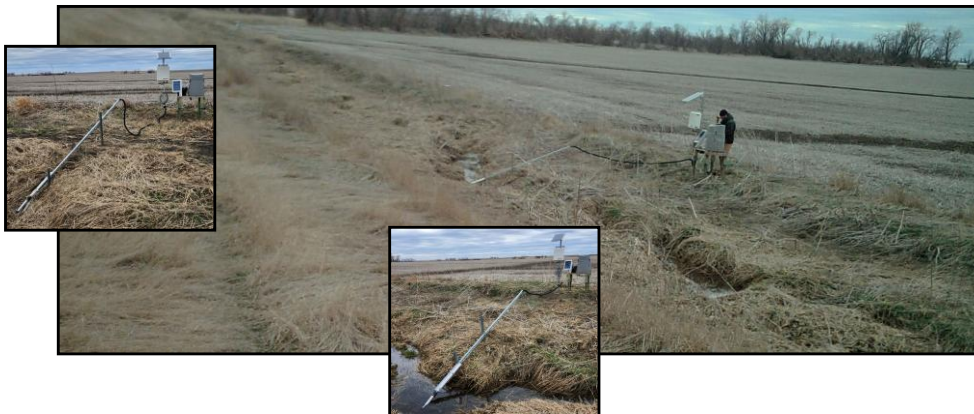
**Figure 2-11.** Instrumentation deployed on April 3-4, 2023.

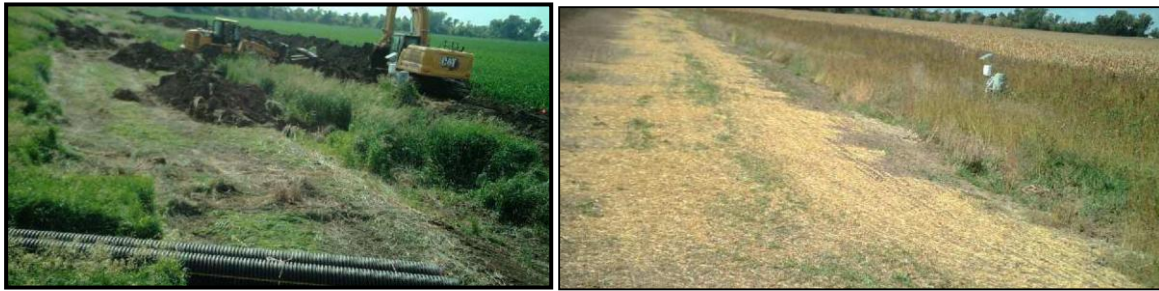
**Figure 2-12.** (left) Excavation of a portion of the ditch on June 13, 2023; (right) finished road grading and shoulder repair in close proximity of the ditch as seen on October 20, 2023.

June 12-15, 2023, a portion of the ditch near the repaired tile line was excavated. This was unplanned and unexpected and the excavation disrupted the vegetation growth and monitoring of

the ditch site (Figure 2-12). In addition, for periods between July 10 and October 20, 2023, the webcam captured several periods of unplanned excavation and road grading in close proximity to the ditch (Figure 2-12). Shoulder expansion of Highway 30 encroached on the ditch and sediment runoff into the ditch was observed.

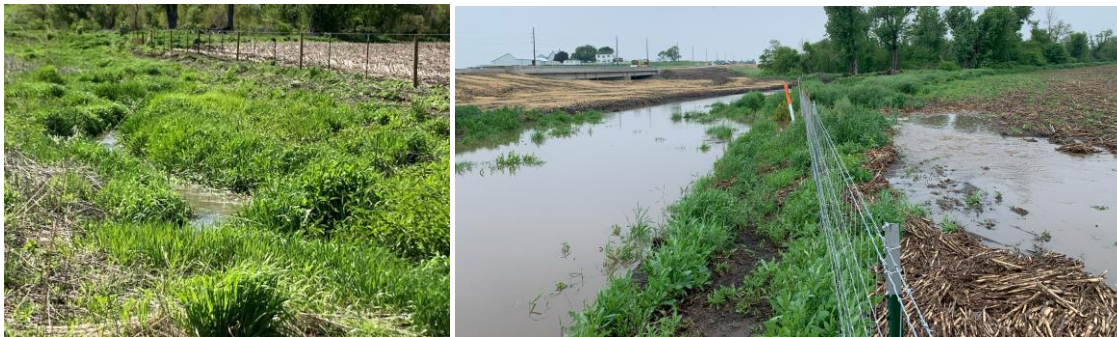
**Figure 2-13.** (left) Baseflow in the two-stage ditch on May 7, 2024. (right) Stormflow captured in the ditch on May 21, 2024.

On March 1, 2024, instrumentation was deployed at the ditch, including upstream and downstream turbidity sensors. From April to mid-June, 2024, the two-stage ditch operated as planned. On site visits confirmed that the ditch was retaining sediment (phosphorus) with the widened channel by the floodplain vegetation, baseflow was observed for the entire length of the ditch and there were no backwater anomalies in flow along the length. The two-stage ditch captured several events in the spring of 2024 and appeared to work as planned (Figure 2-13).

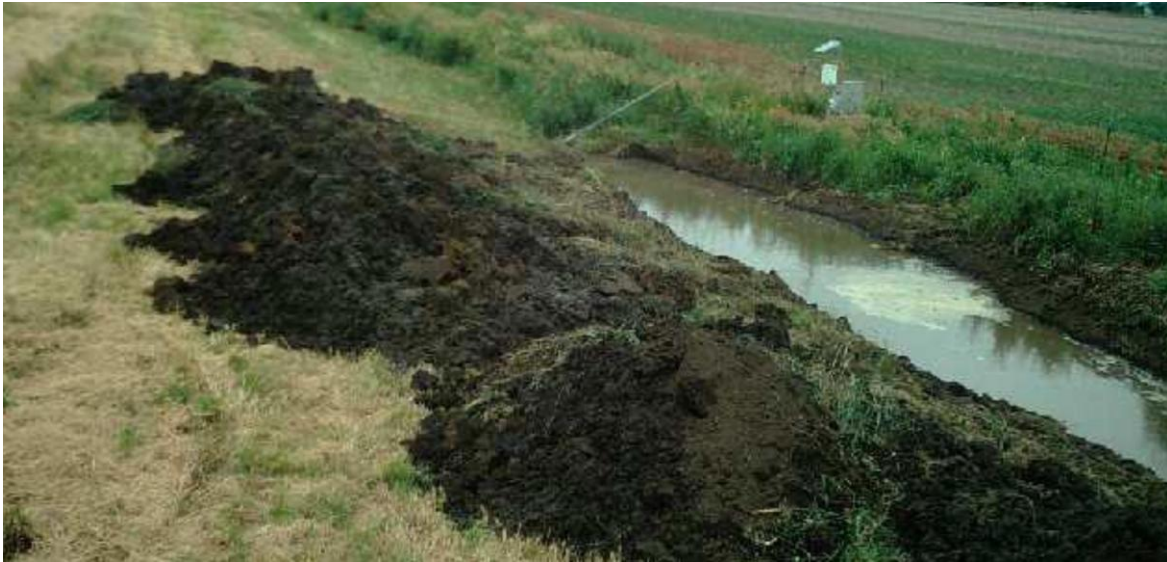
**Figure 2-14.** Excavation of the two-stage channel on June 19-22, 2024, that ended the monitoring project.

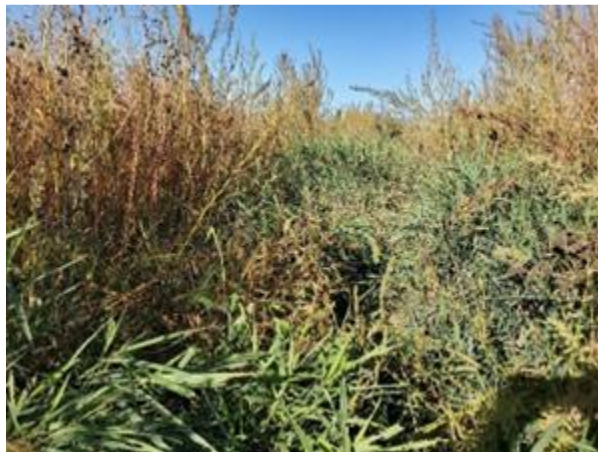
**Figure 4-1.** View of typical main channel vegetation post-construction (September 2022).

The two-stage ditch prototype represented a large ecological improvement from the previous conventional ditch (Figure 4-1). Where the conventional ditch was dominated by a handful of invasive species, implementing a two-stage ditch with native vegetation increased species richness nearly sixfold. Further study is needed to understand if these gains in biodiversity are typical or lasting. Since invasive species were still common in the overall right of way, it is unclear whether plant species richness will be maintained over long timeframes. Follow up vegetation surveys should occur on new two stage ditches, especially when vegetation is mature. Surveys conducted five or more years post-construction will provide better evidence about the longer-term nature of two-stage ditch vegetation.
