**Report No. CDOT-DTD-R-2005-22**  
**Final Report**

## **PCCP TEXTURING METHODS**

**January 2005**

**COLORADO DEPARTMENT OF TRANSPORTATION**  
**RESEARCH BRANCH**

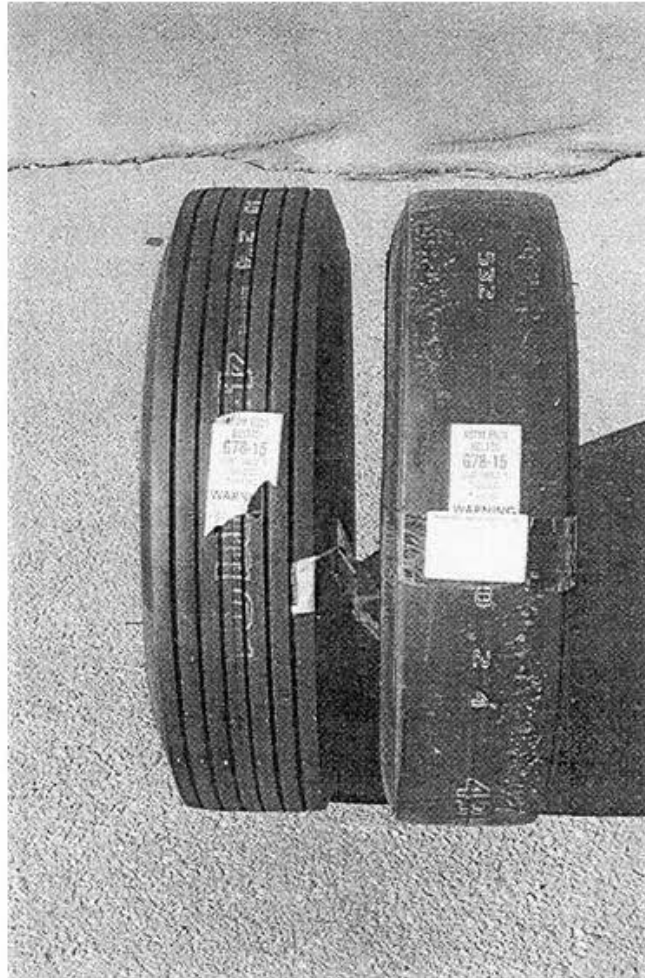
Photo 1: View of the ribbed tire (ASTM E 501 and  
The smooth tire (ASTM E524)

The primary reason for the ribbed tire's insensitivity to macrotexture is its deep grooves, which provide drainage for water regardless of pavement macrotexture. On the other hand, tests with the smooth-tire (ASTM E 524) have produced skid-resistance data which are sensitive to both macrotexture and microtexture (5). Another advantage of using a smooth tire is that the influence of tire wear on the friction data is eliminated (6). Photograph 1 compares the ribbed and the smooth tires.

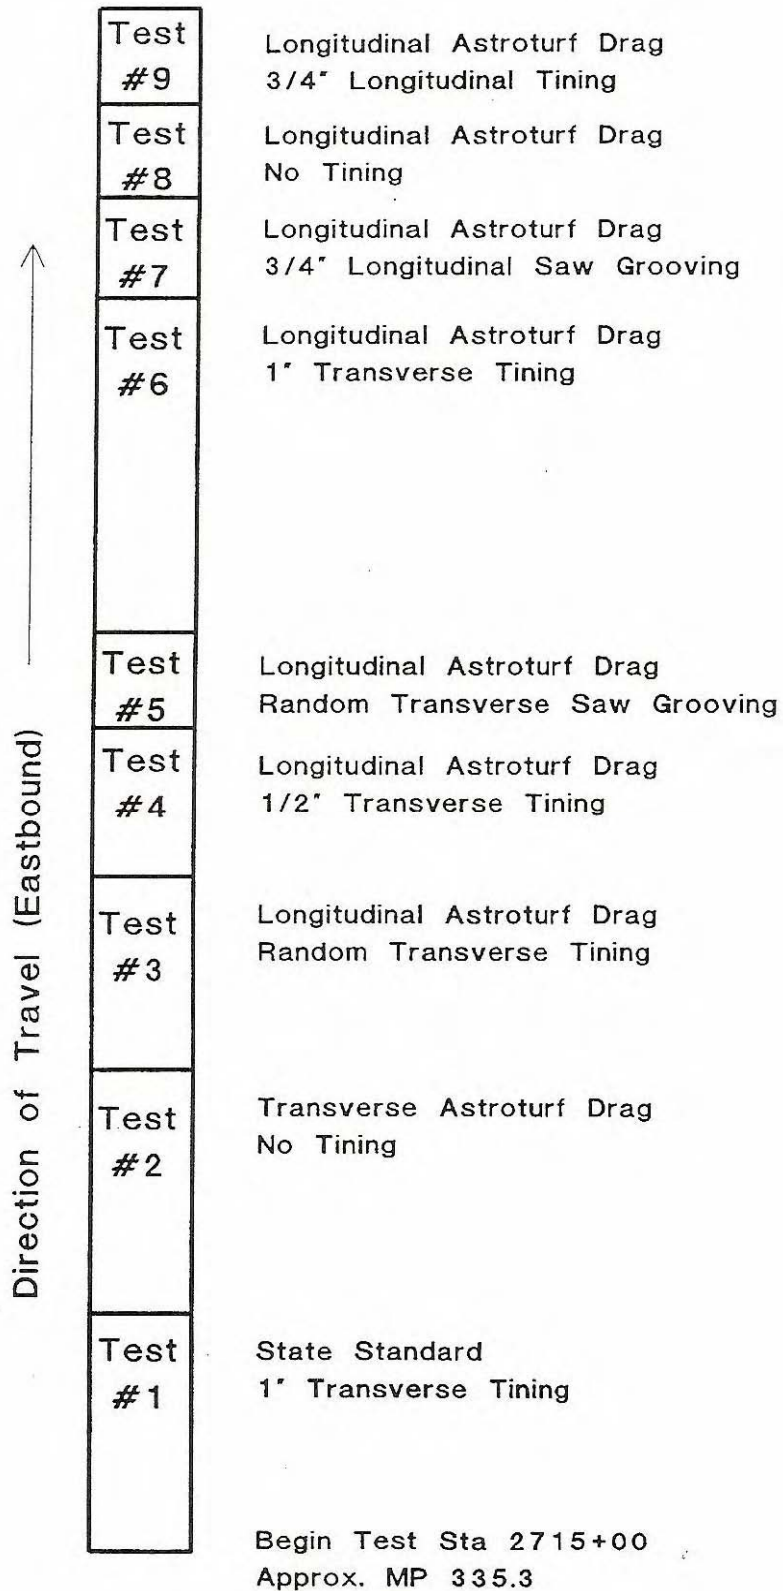
Figure 2  
 CONCRETE TEXTURING STUDY on I 70 at DEER TRAIL  
 TEST SECTION LAYOUT  
 (Length is to scale)

Note: Burlap drag was applied to all test sections immediately behind the paver as shown in Photograph 2. The depth and the width of all the tining and sawing were specified at  $1/8" \pm 1/16"$ .

Figure 2 shows the sequence of the test sections as constructed.

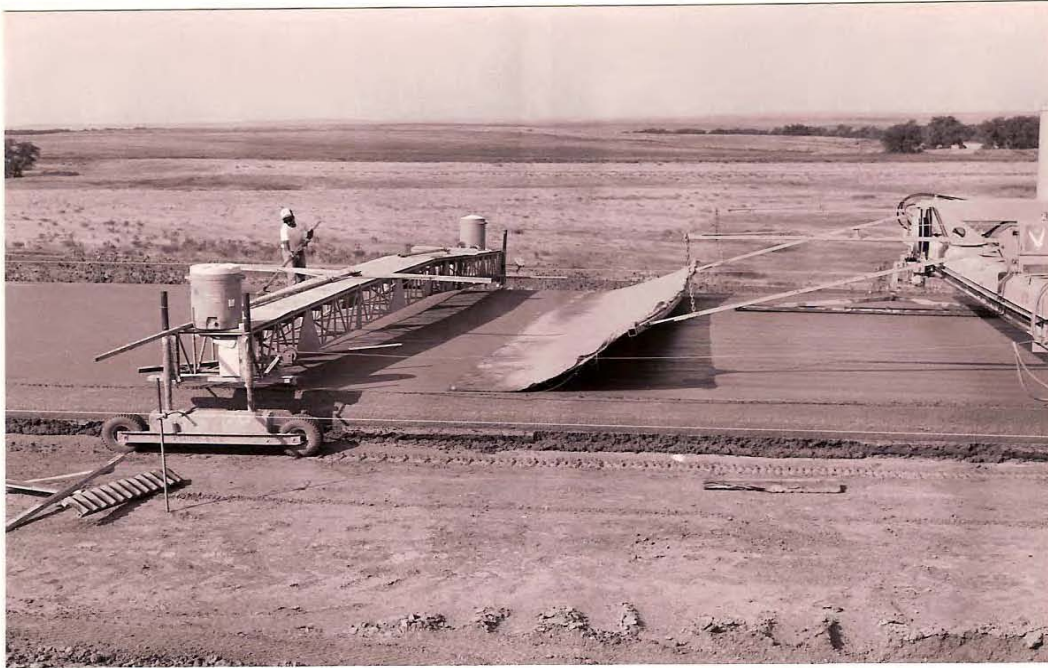
Photo 2: Burlap drag was applied to all test sections

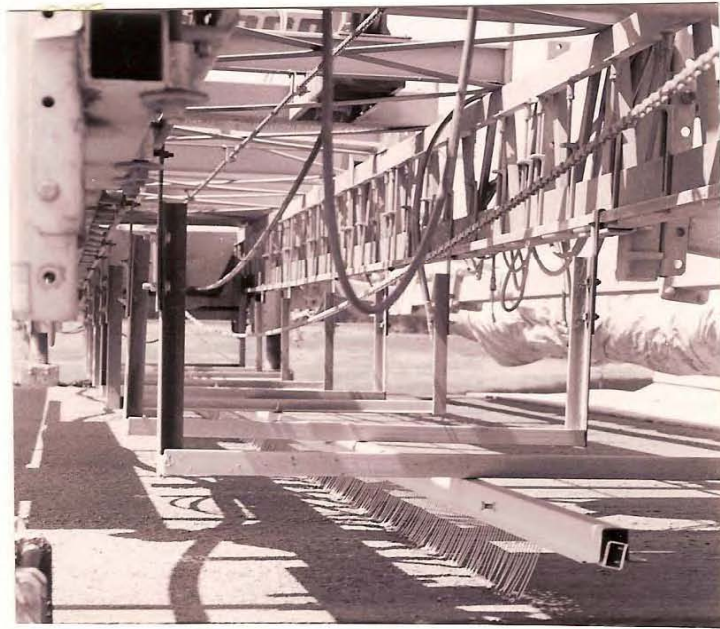
Photo 3: View of the longitudinal tining assembly

The tining-bridge was also used to drag astro-turf in the front and to apply curing compound from the back. During the installation of the longitudinal tining, the tines rolled the concrete paste (mortar) into popcorn-like balls all over the surface of the pavement (Photograph 4). However, once the concrete cured, these mortar balls were crushed by the traffic at the construction site and then easily removed by brooming.

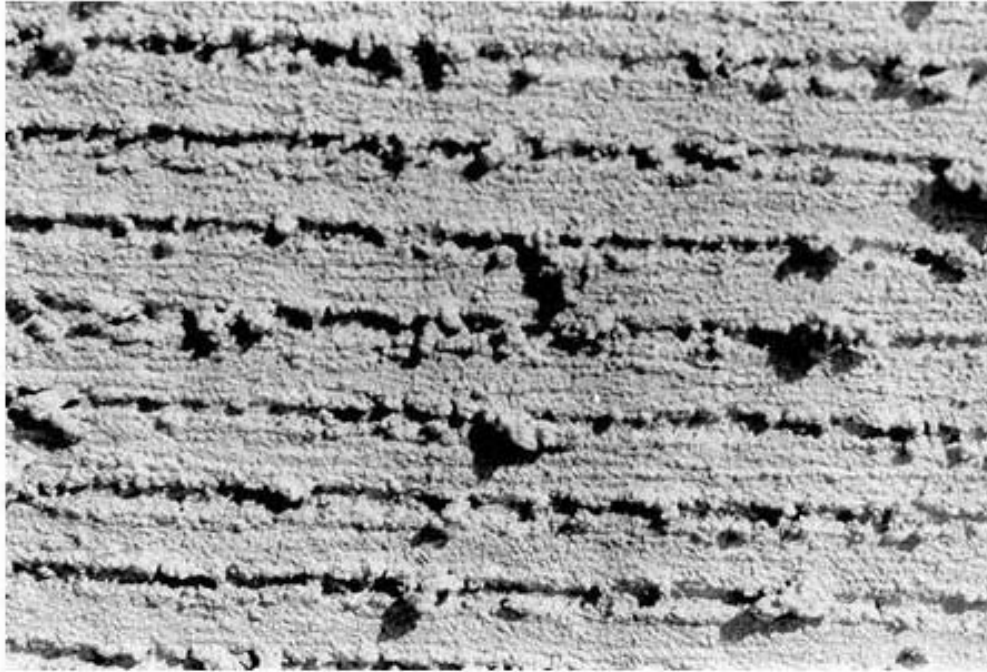
Photo 4: Popcorn-like mortar balls (longitudinal tining)

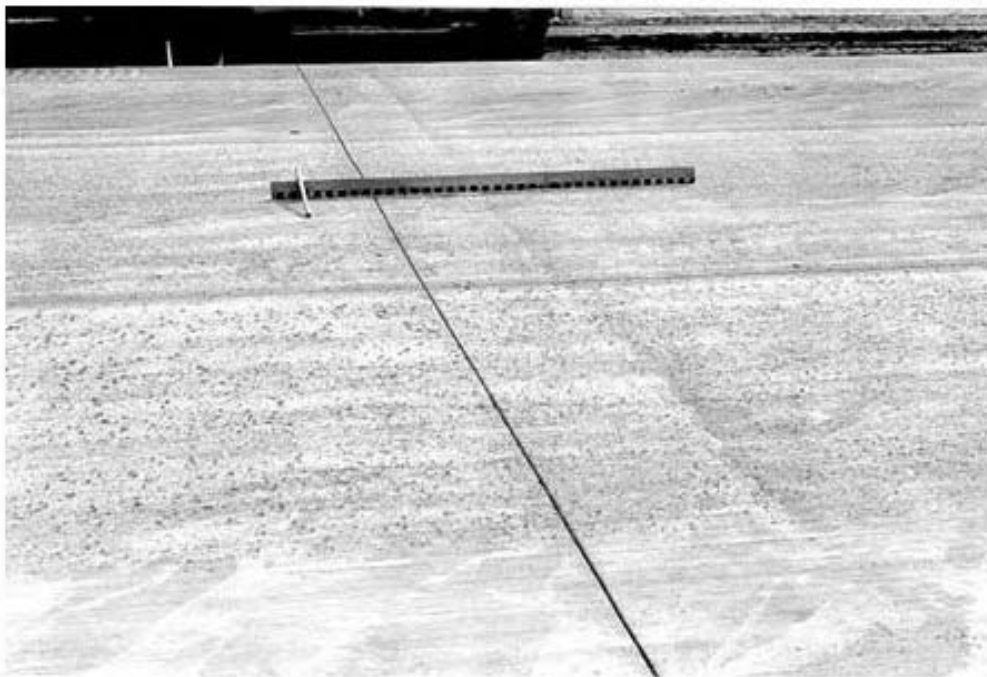
Photo 5: Transverse indentation of plastic concrete

Every time the tining operation was stopped, the tines formed a transverse indentation across the pavement surface as shown in Photograph 5. For future longitudinal tining, the contractor should be required to make provisions for raising the tines when the tining operation is stopped. This should prevent indentation of the plastic concrete surface.

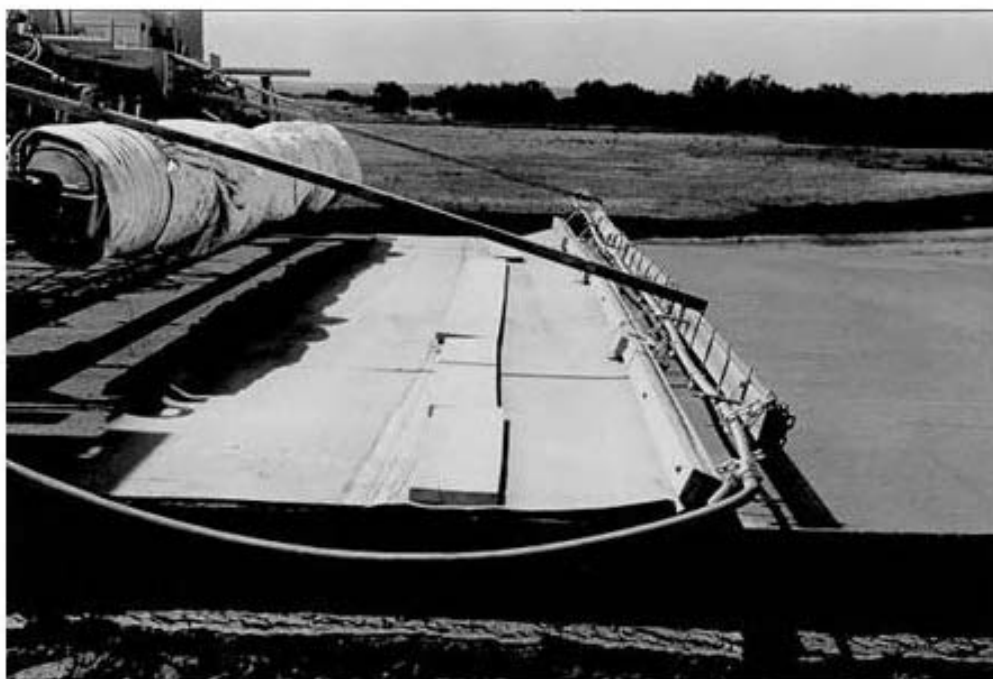
Photo 6: View of the astro-turf drag with planks for added weight

The longitudinal astro-turf drag was applied from the front of the bridge simultaneously with longitudinal tining. The astro-turf used was 38 feet wide, covering the entire width of the pavement surface and 5.8 feet long, of which 4.8 feet contacted the surface. Due to a very stiff mix (slump of less than 1") the astro-turf was not capable of forming deep enough texture. To make the texturing more pronounced, several boards were placed on the astro-turf as shown in Photograph 6. Occasionally, the surface of the contact area became plugged with mortar (Photograph 7) and the tining operator had to raise the astro-turf and shake out the excess grout.

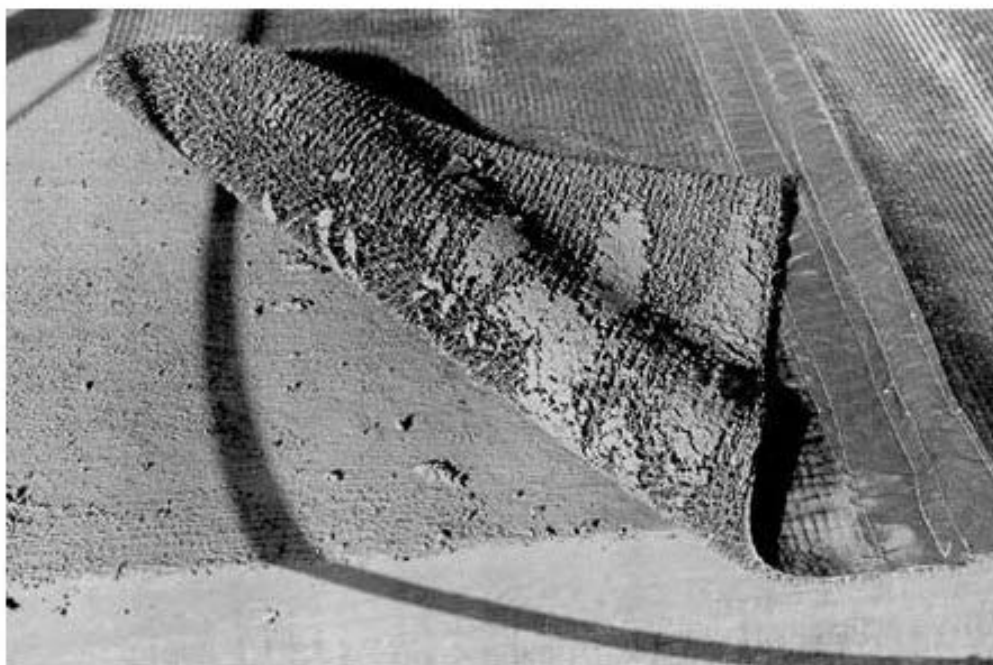
Photo 7: Astro-turf plugged up with grout

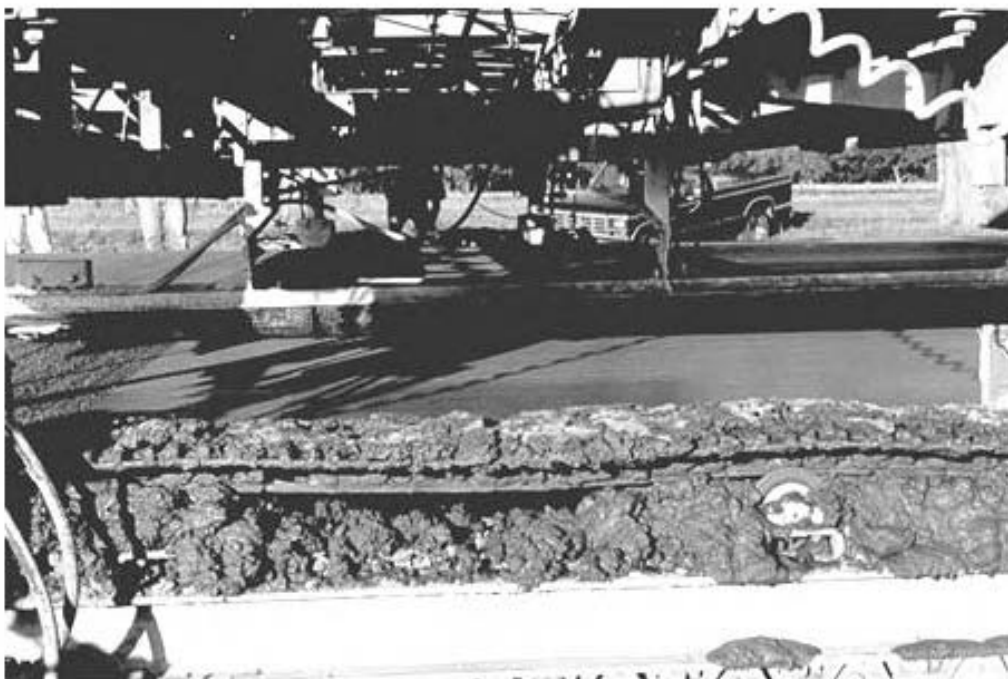
Photo 8: Installation of transverse astro-turf texture

Prior to installing transverse astro-turf test section the Principal Investigator (P.I), the Region I Materials Engineer, and the contractor met to discuss the possibility of encountering problems with the transverse texturing operation. It was decided to texture only the first 100 feet of the day's paving with this method to determine its feasibility and its possible continuation for the entire day's paving. If it was determined that transverse astro-turf was not adequately texturing the pavement surface, the contractor could then be directed to convert from transverse astro-turf texturing to longitudinal astro-turf texturing. However, as it can be seen in Photograph 9, the astro-turf adequately textured the pavement surface and as a result, transverse astro-turf texturing was continued for the entire day.

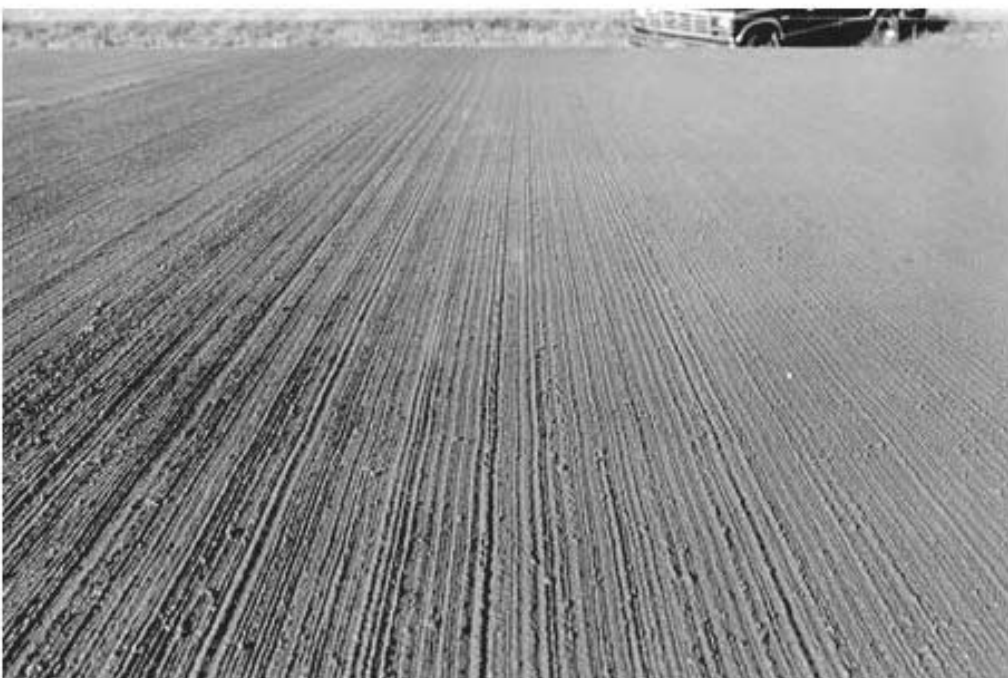
Photo 9: Close-up of transverse astro-turf texture

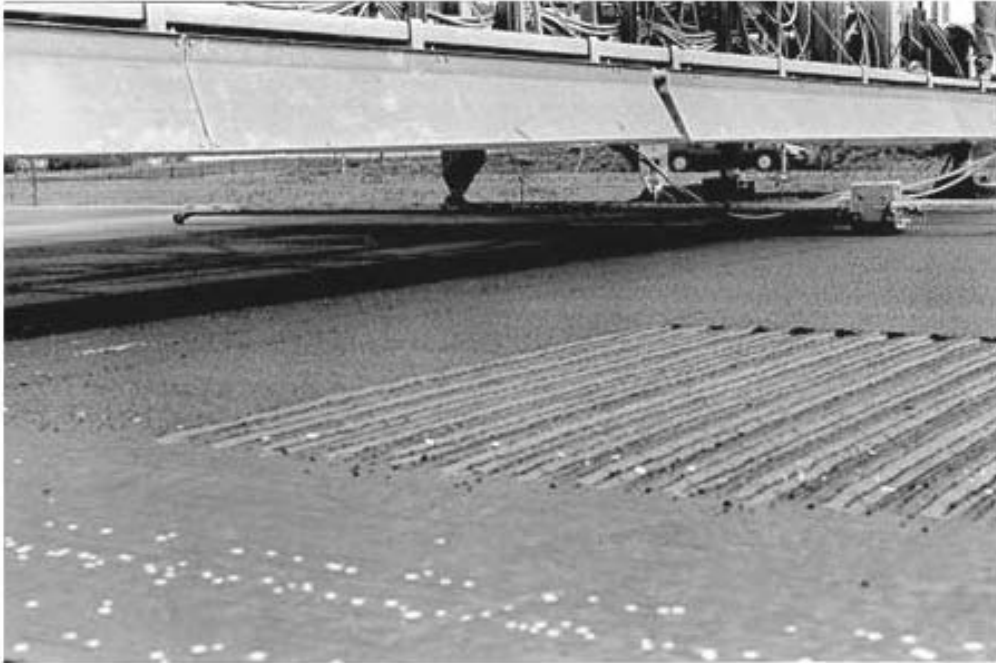
Photo 10: Typical transverse tining operation

Photograph 10 shows a typical transverse tining operation. The state standard test section (control) which uses combination of burlap drag and 1" uniform transverse tining is shown in Photograph 11. Photograph 12 shows the combination of astro-turf drag with transverse tining of 1/2" uniform spacing. Transverse tining with random spacing of 5/8", 7/8" and 3/4" is shown in Photograph 13.

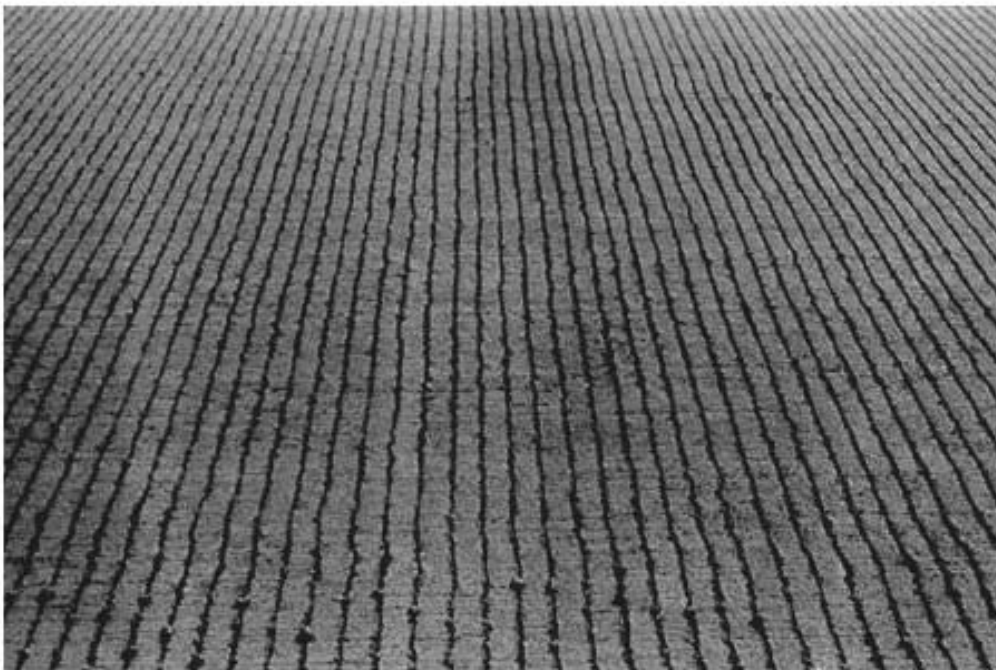
Photo 11: 1-inch uniform spaced transverse tining (state standard)

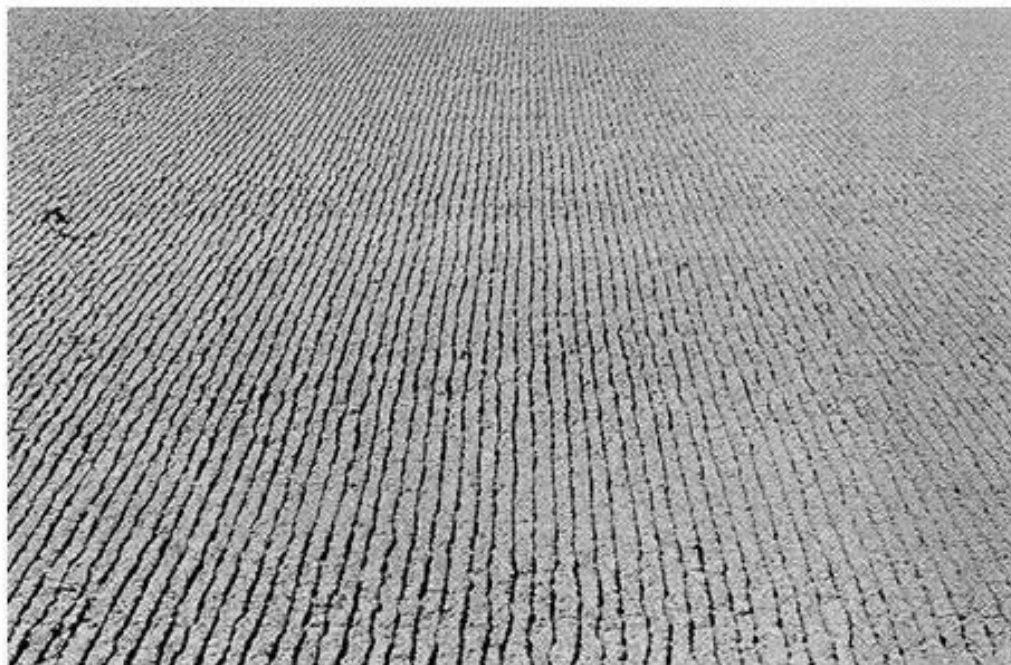
Photo 12: 1/2-inch uniform spaced transverse tining

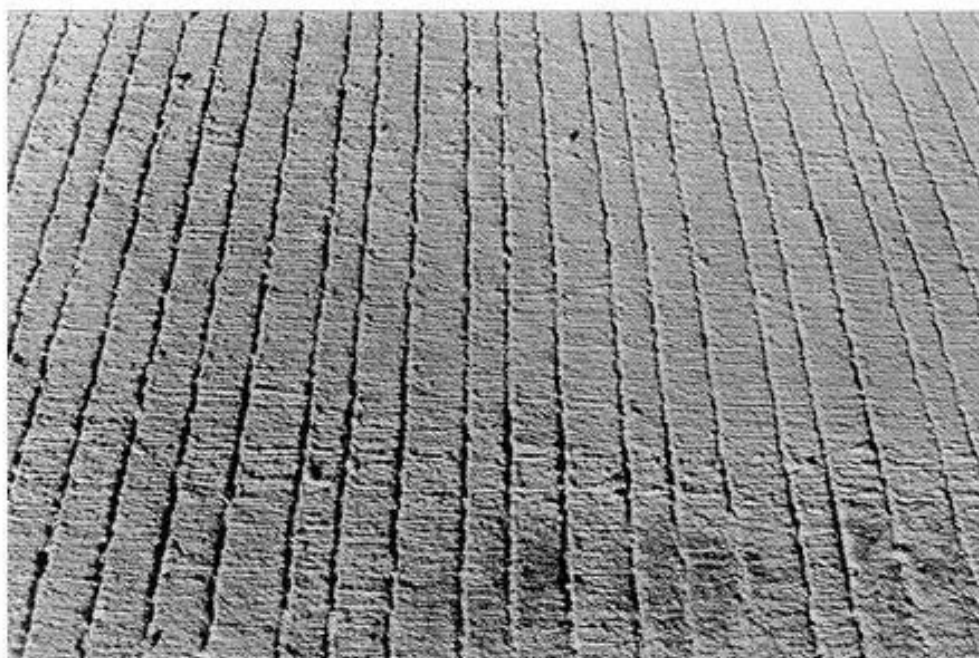
Photo 13: Random transverse tining with 5/8", 7/8", and 3/4" spacing

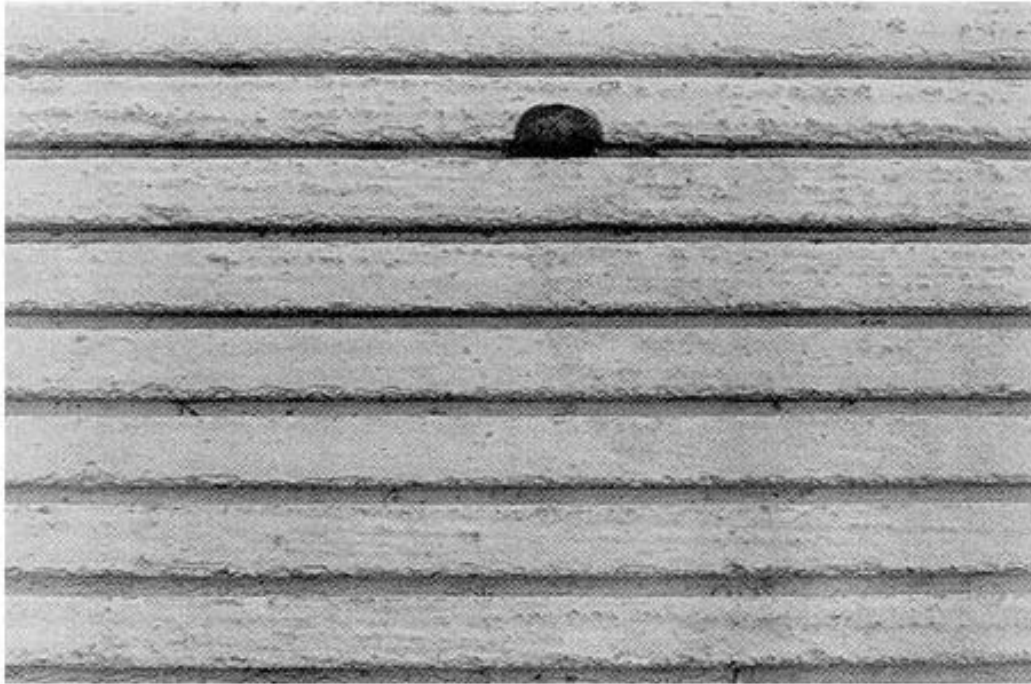
Photo 15: Close up view of longitudinal grooves

A self-propelled sawing machine (CUSHIN CUT, HG-130) was used to install the longitudinal grooves with uniform spacing of  $\frac{3}{4}$  of an inch (Photograph 14). The grooving machine was equipped with 46 blades, 14 inches in diameter each, and had a total effective cutting width of 34-1/2 inches. The machine, which had an approximate cutting rate of 1000 linear feet per hour, required 12 passes to groove the entire test section. Photograph 15 shows a close-up view of the longitudinal grooving. The rumble-strips on both the left and the right shoulders were also grooved. Photograph 16 shows a grooved rumble strip on the right shoulder.

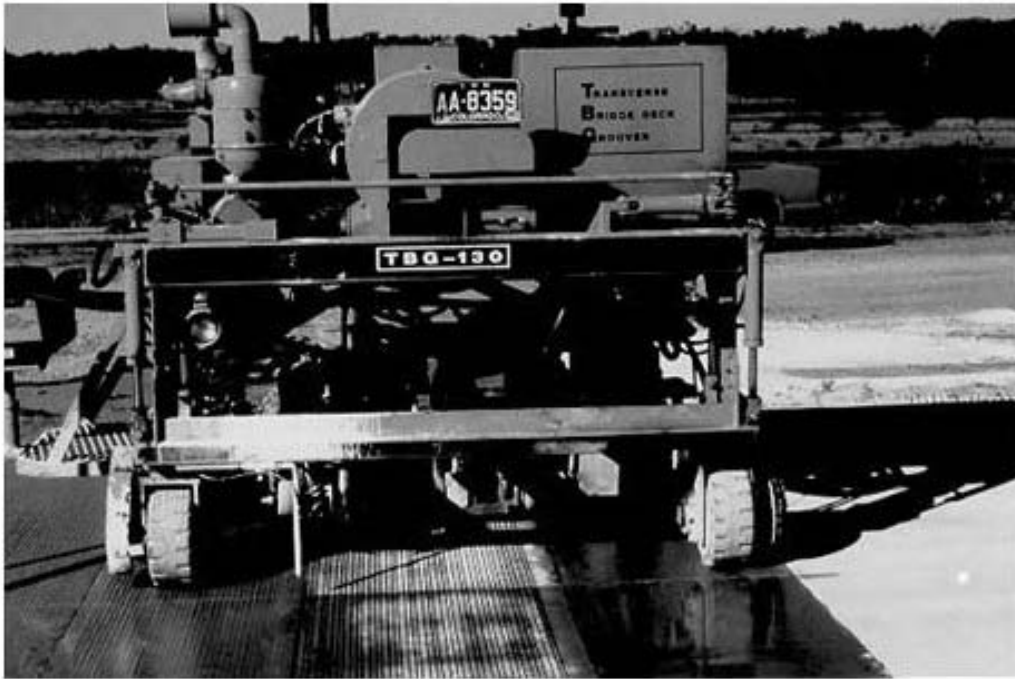
Photo 17: Installation of transverse grooves

A self-propelled Transverse Bridge Deck Groover (TBDG) was used to install the transverse grooves with random spacing of  $\frac{5}{8}$ ,  $\frac{7}{8}$ , and  $\frac{3}{4}$  of an inch, as shown in Photograph 17. The transverse grooving machine was equipped with a moving head, with 38 blades, 14 inches in diameter each, and with a total effective cutting width of 29 inches. A close-up view of the transverse grooving is shown in Photograph 18.

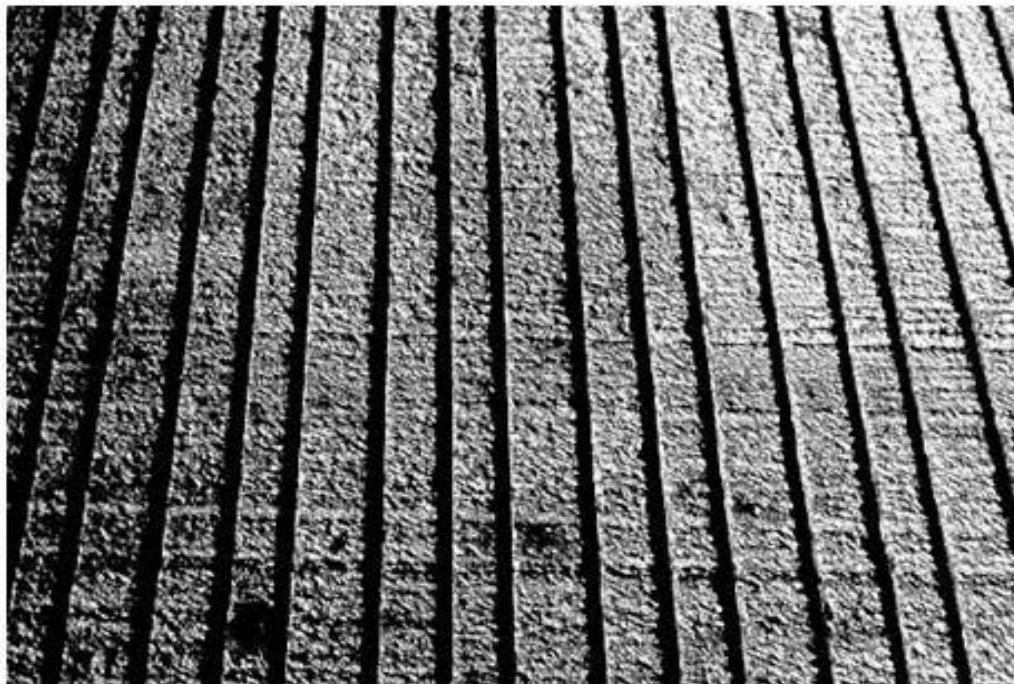
Photo 18: Close-up view of random transverse grooves with  $5/8$ ",  $7/8$ ", and  $3/4$ " spacing

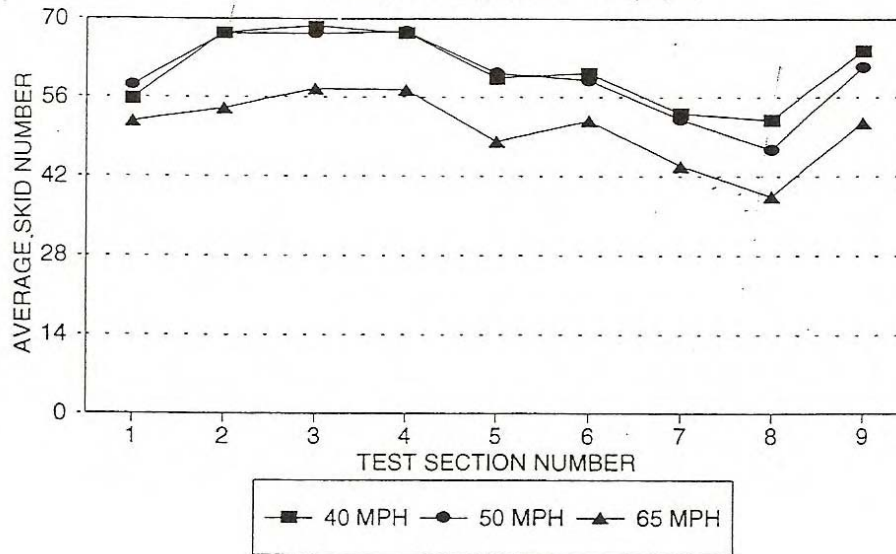
Figure 3

## RIBBED-TIRE SKID NUMBERS OCTOBER 1994

The difference in skid numbers for microtexture and macrotexture were not as evident or consistent using the ribbed tire. This phenomenon confirms the findings of many research papers, revealing the insensitivity of the ribbed-tire towards macrotexture. The primary reason for the

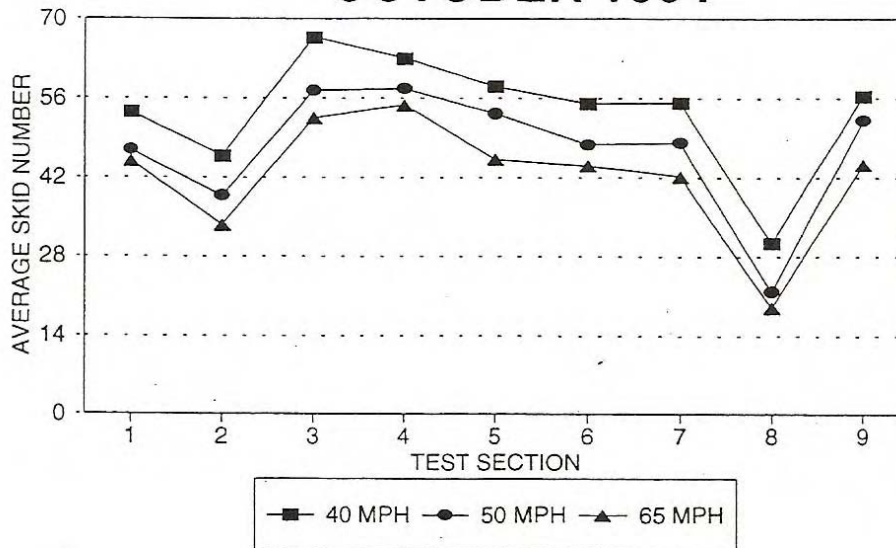
Figure 4

## SMOOTH-TIRE SKID NUMBERS OCTOBER 1994

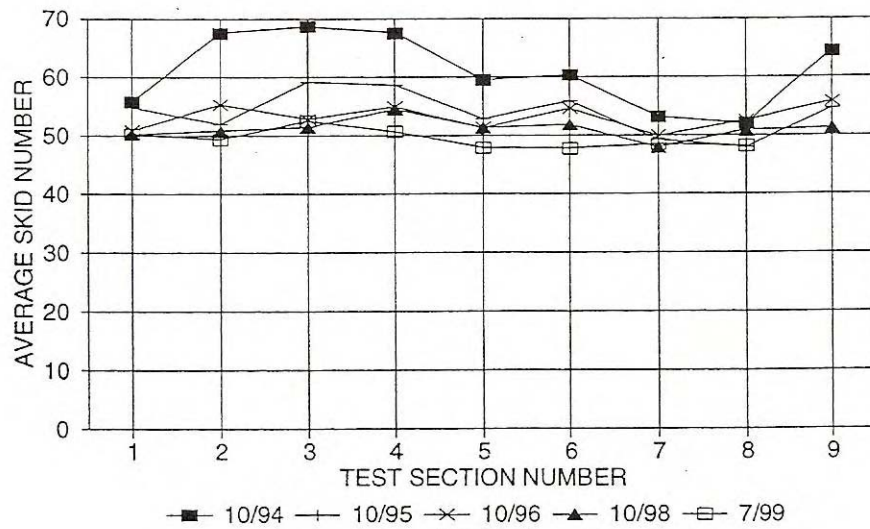
Figure 5

## RIBBED-TIRE SKID NUMBERS 40 MPH

It should be noted however, that even though the 1995 SN40R were much lower than the 1994 SN40R, they were still much higher than the skid number of 35, which is being used by many states as their minimum acceptable limit. The drop in the magnitude of 1995 skid numbers taken with smooth-tire at 40 mph (SN40S) was even more pronounced. The 1995 SN40S were an average of 11 points lower than their corresponding 1994 SN40S. As before, test section 2 showed the highest drop, approximately 24 points.

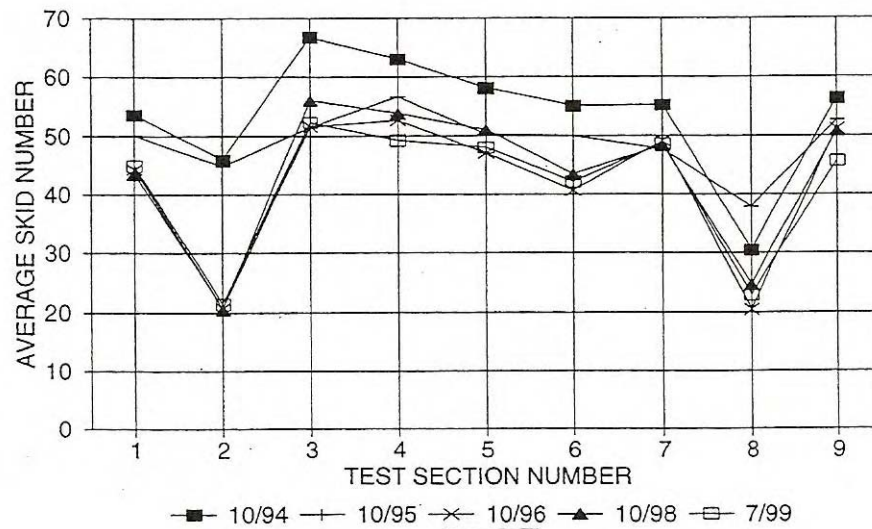
Figure 6

## SMOOTH-TIRE SKID NUMBERS 40 MPH

The rate of reduction in skid numbers for the smooth-tire were also minimal. The drop in the skid numbers magnitude from 1995 to 1996 averaged less than 1 point (.80 to be exact), while the rate of drop from 1994 to 1995 averaged 11 points. As before, the two microtexture test sections (test sections 2 and 8) showed very low skid numbers, SN40S = 20.6 and SN40S = 20.4

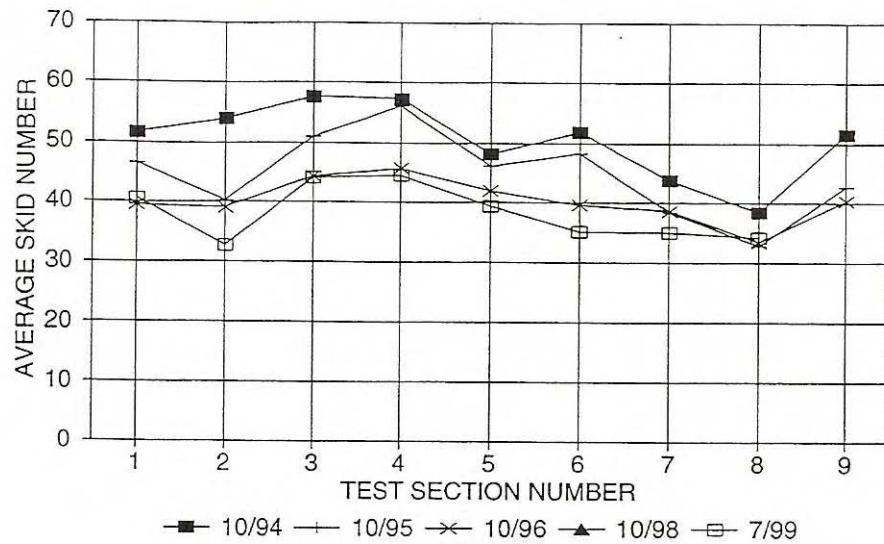
Figure 7

## RIBBED-TIRE SKID NUMBERS 65 MPH

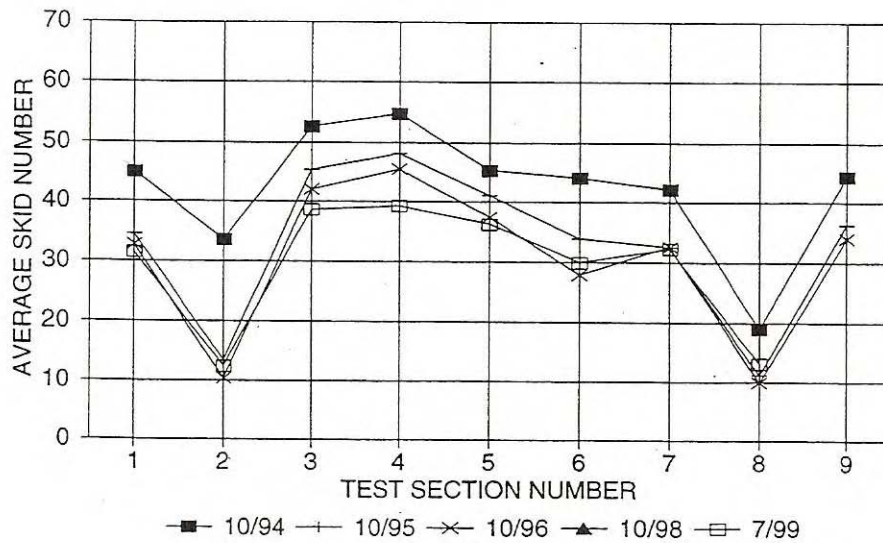
Figure 8

## SMOOTH-TIRE SKID NUMBERS 65 MPH

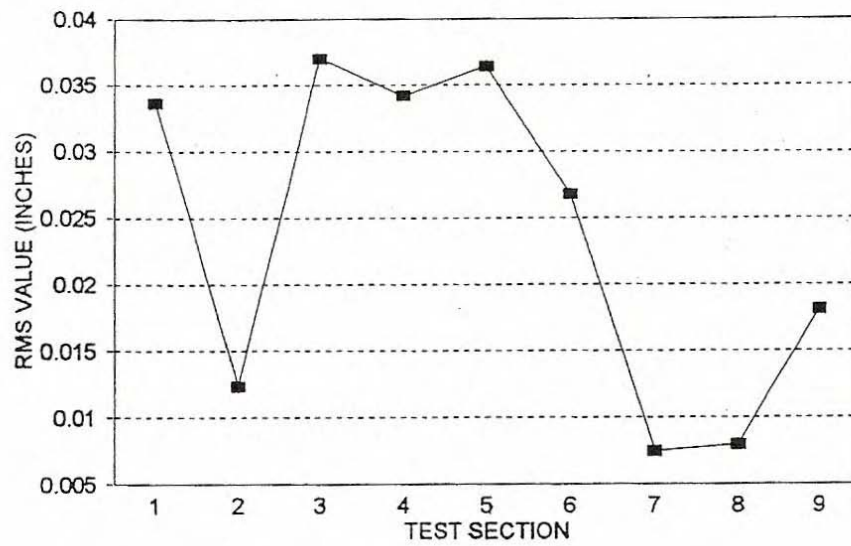
## TEXTURE MEASUREMENT LASER VAN

An rms (root mean square) value is computed for each of the two profiles. The final output is an average rms value for the test section. Figure 10 compares the average rms values for the

individual test sections. As expected, the texture van showed lower values for sections 2 and 8 with microtexture; however, it also showed low values for longitudinal sawing (test section 7) and for longitudinal tining (test section 9). This may indicate that the laser van is more sensitive to the transverse texture than to the longitudinal texture. It should also be noted that, of the two microtexture (section 2 and 8), section 2 with the transverse orientation showed higher rms values.

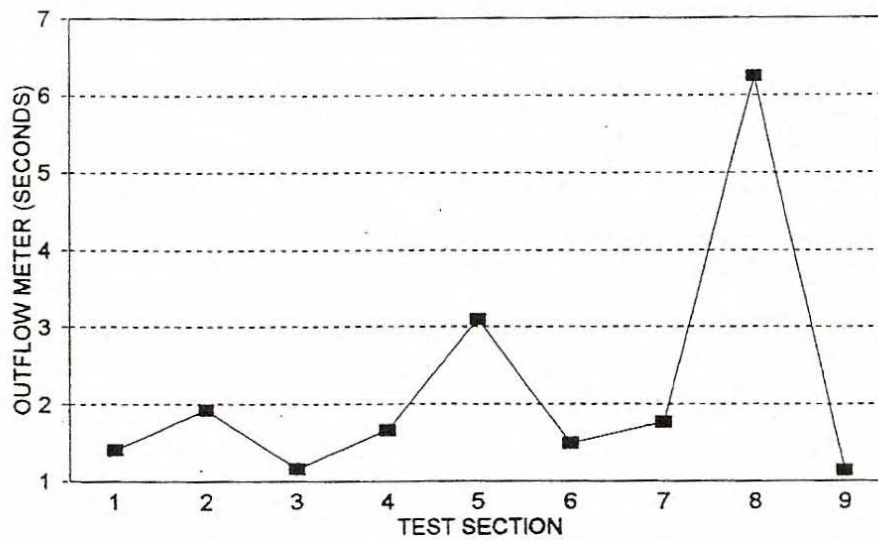
Figure 11

## INDIRECT TEXTURE MEASUREMENT WATER FLOW METER

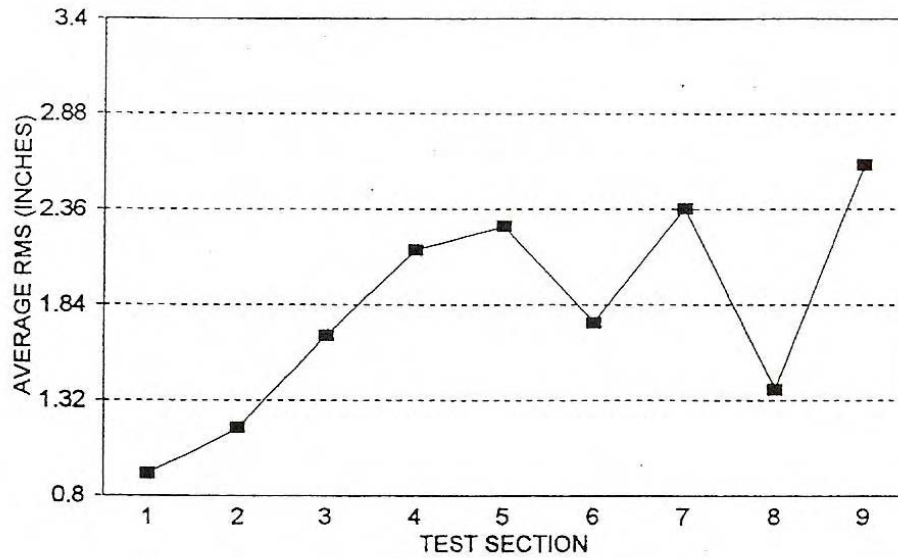
Figure 12

## TEXTURE MEASUREMENT

LVDT BEAM

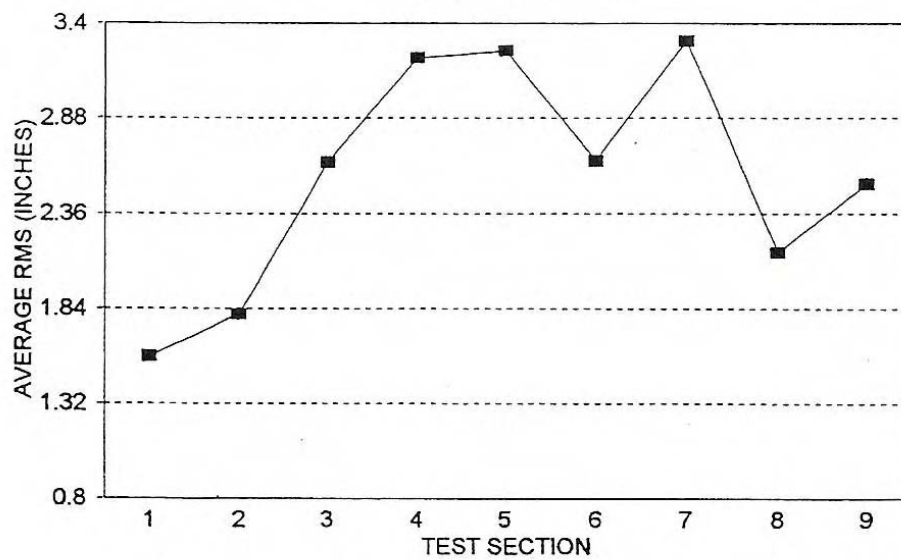
Figure 13

## TEXTURE MEASUREMENT

LASER BEAM

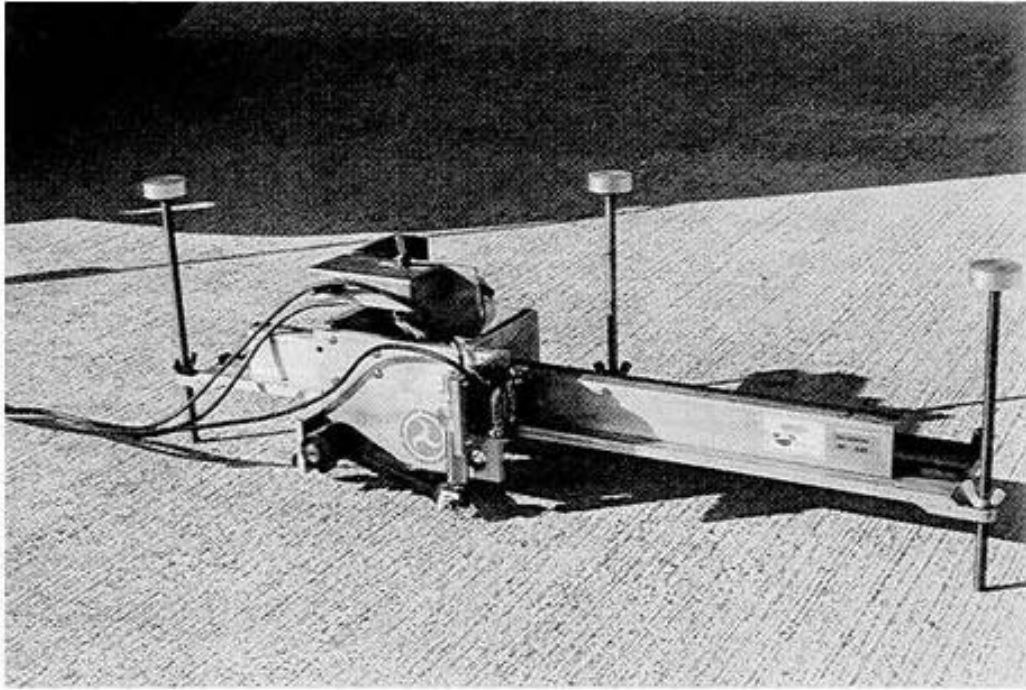
Photo 21: Texture beam, equipped with an LVDT and a laser stylus

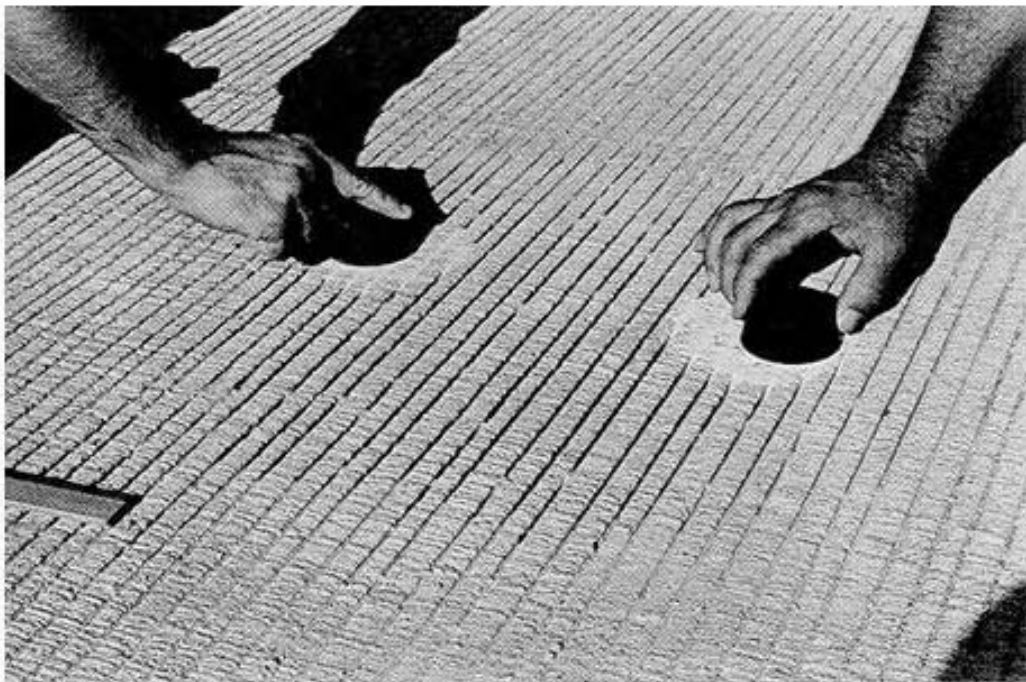
Photo 22: Sand patch test for measuring texture depth

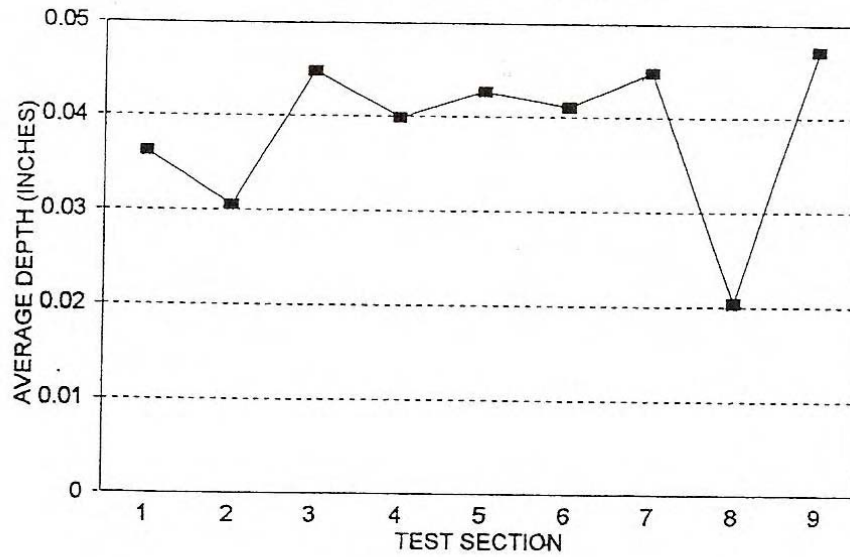
Figure 14

## TEXTURE MEASUREMENT SAND PATCH METHOD

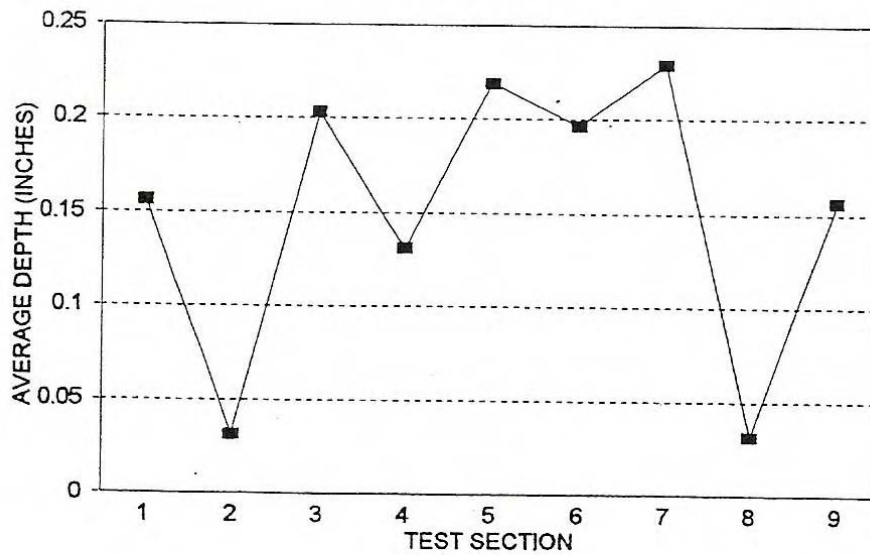
Figure 15

## TEXTURE MEASUREMENT TIRE GAUGE

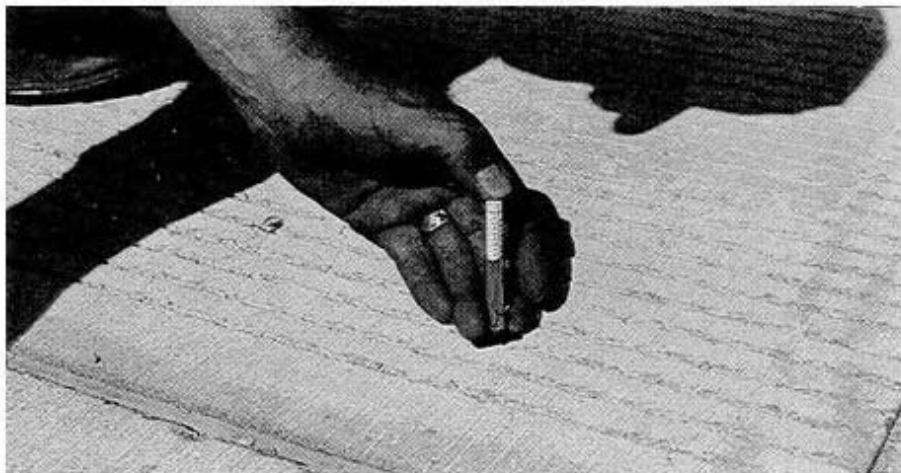
Photo 23: Texture depth measurement using a tire tread depth gauge

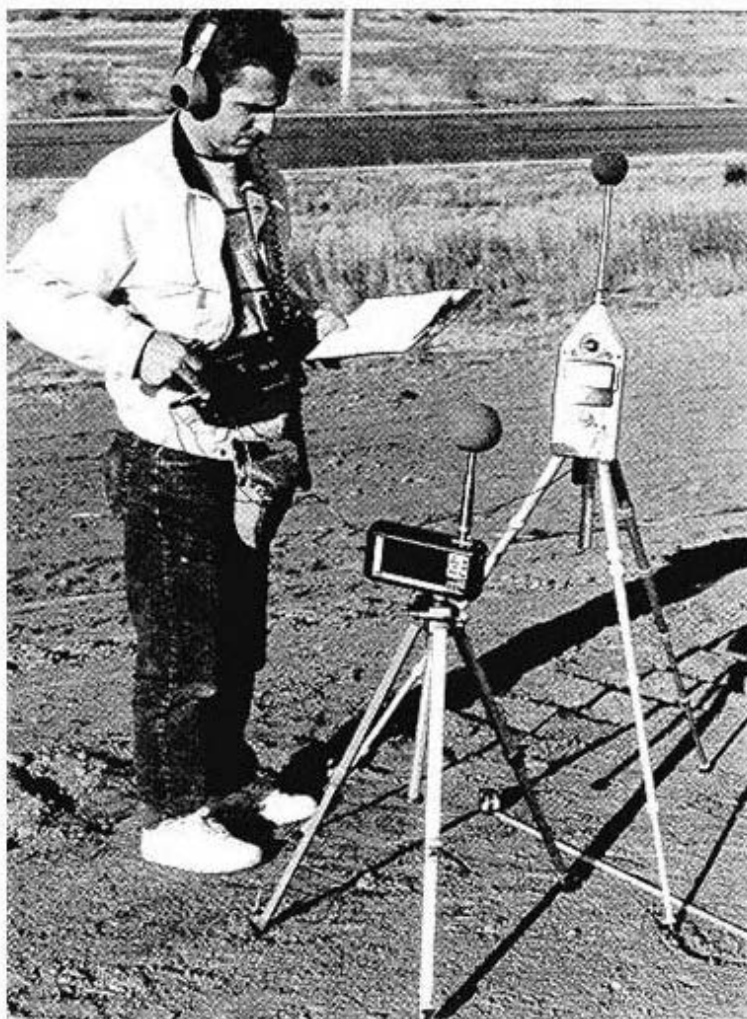
Photo 24: SPL measurement at the roadside

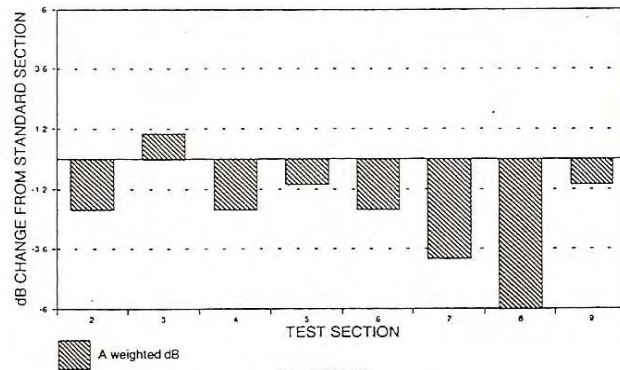
### SPL AT THE SHOULDER COMPARED TO STATE STANDARD SECTION

However, it should be noted that measurements taken with the engine on and with the engine off produced the same SPL, indicating that the tire noise was predominately louder than the engine noise. Figure 16 compares the change in SPL measurements of all the test sections relative to control section (state standard) at the shoulder. The sound generated at the control section was normalized to represent a datum (zero sound level pressure). Except for test section 3 (random transverse tining), all the other test sections showed lower decibels (dB) than the control section. Section 8 showed the lowest sound level pressure (6 dB lower than control).

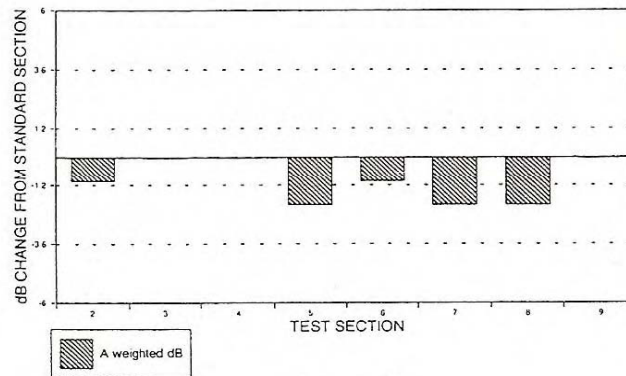
Figure 17

### SPL INSIDE TEST VEHICLE COMPARED TO STATE STANDARD SECTION
