**Report No. CDOT-DTD-R-2005-22**  
**Final Report**

## **PCCP TEXTURING METHODS**

**January 2005**

**COLORADO DEPARTMENT OF TRANSPORTATION**  
**RESEARCH BRANCH**

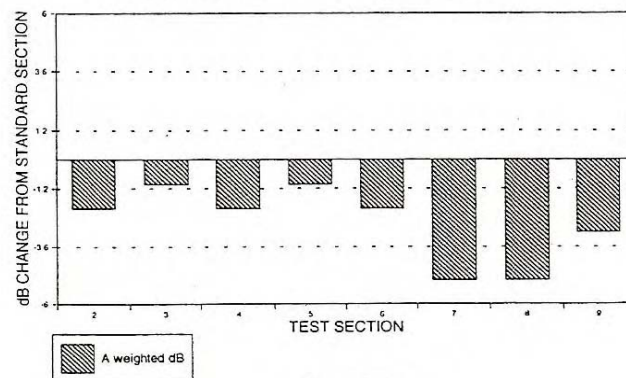
Figure 18

### SPL AT REAR TIRE COMPARED TO STATE STANDARD SECTION

All the test sections showed lower sound levels than the control section as shown in Figure 18. Section 7 and 8 showed the lowest dB, 5 1/2 dB lower than the control section. It should be noted that for all the conditions mentioned above, 3 sets of data were acquired and then averaged. Figure 19 compares the A-weighted SPL measurements of all the three conditions. As expected, the SPL measurements taken near the rear tire and inside the test vehicle showed the highest and lowest dB respectively.

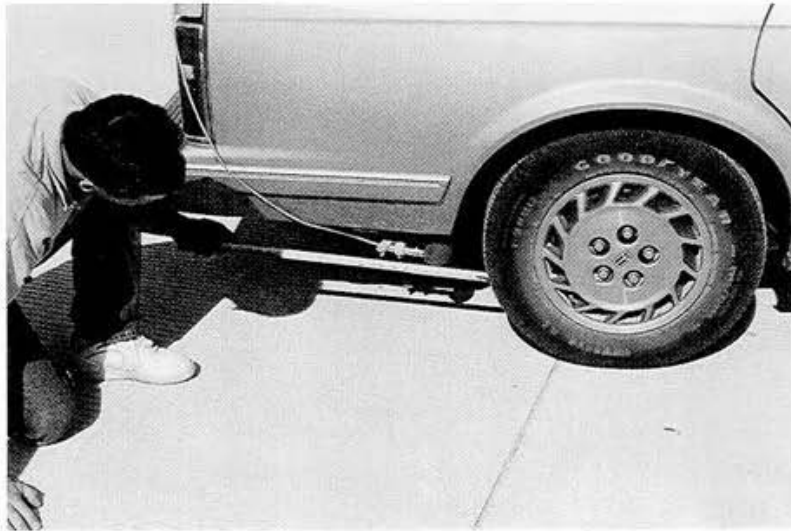
Photo 25: View of the microphone behind the rear tire

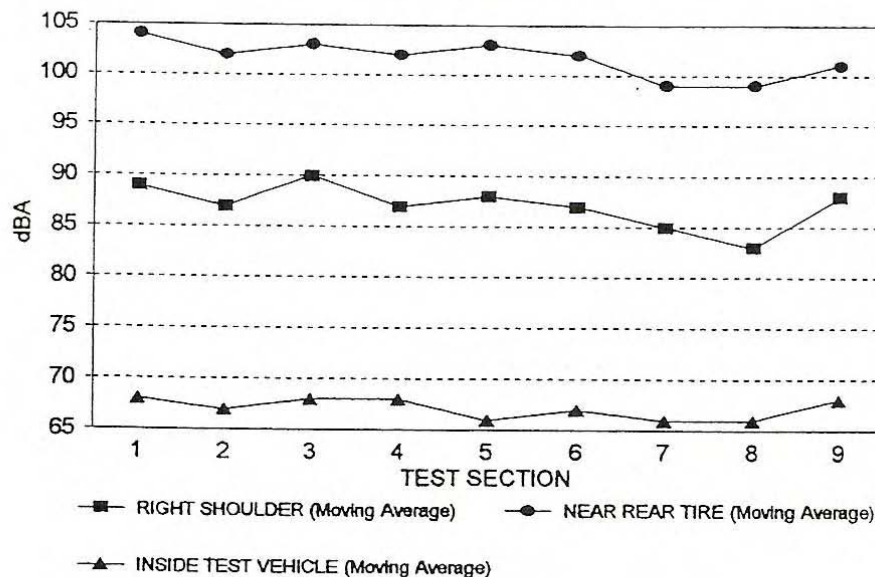
Figure 19

## A-WEIGHTED SOUND LEVELS

OCTOBER 1994

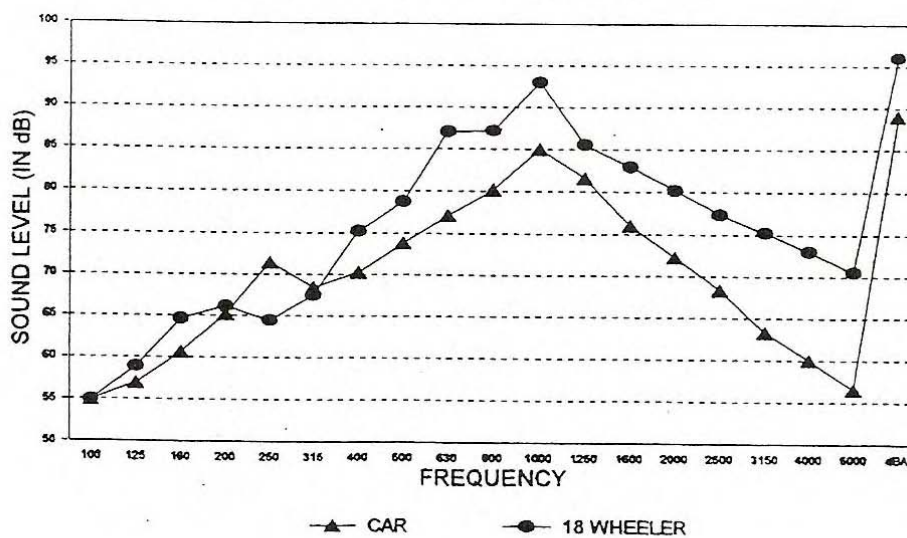
## SPL COMPARISONS

CAR vs. TRUCK (SHOULDER SECT 1)

Figure 20 compares SPL Frequency distribution of a semi-truck with the test vehicle in a 1/3-octave band format (100 – 5000 Hz), as well as A-weighted SPL at the roadside. As it can be

seen in this figure, the SPL for both the truck and the test vehicle peaked at 1000 Hz. However, the figure shows the noise from the truck (Photograph 26) to be at the higher annoyance range (by about 8 dB) than the noise from the test vehicle. The A-weighted dB for the truck was also 7 dB higher than the A- weighted dB of the test vehicle.

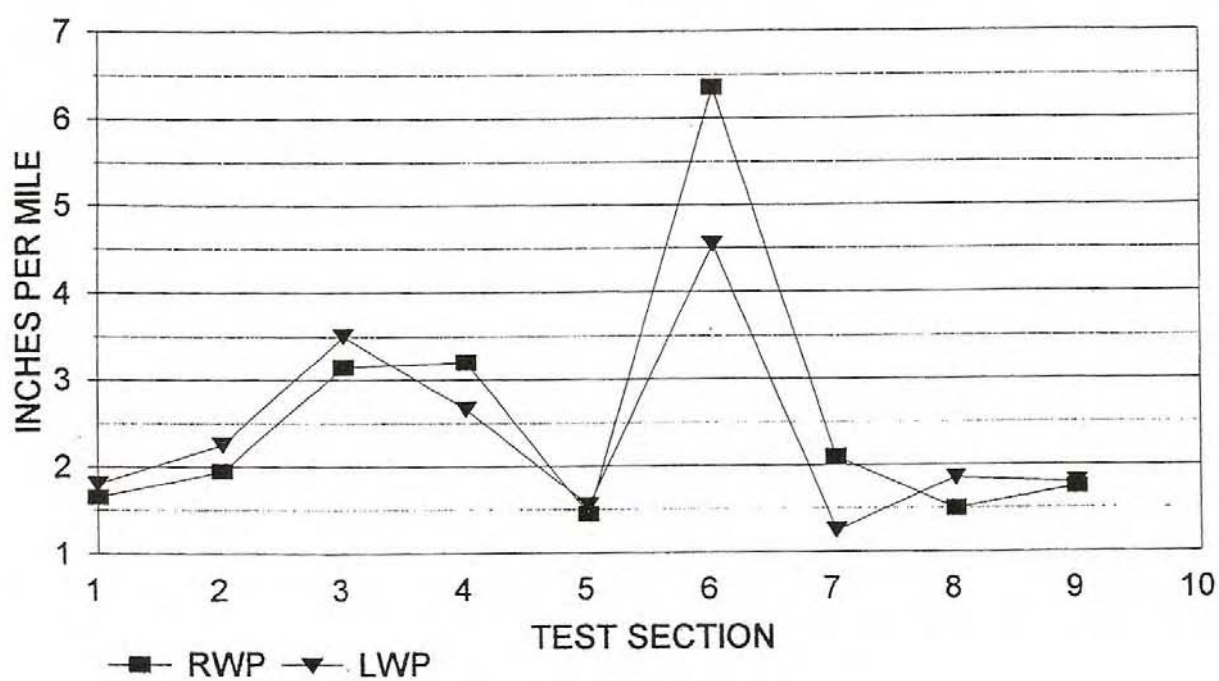
Figure 21

# PROFILOGRAPH

OCTOBER 1994

Test section 6, which was textured using a combination of longitudinal astro-turf and 1-inch uniform tining, exhibited the highest roughness. It should be noted that dynamic effects that act on suspension systems and generate vibrations inside vehicles are primarily due to megatexture or small-scale roughness (explained below). The influence of surface texture on ride quality, with the exception of noise level, is minimal.
